# Jemena Electricity Networks (Vic) Ltd

## Replace Zone Substation Heidelberg (HB) Transformers

2019 and 2020 Business Case

BAA-RSA-800109

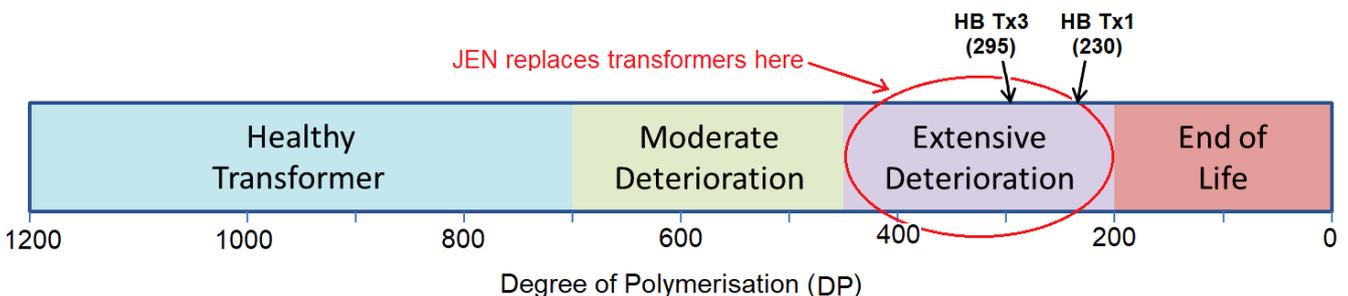
**Figure OV-2: Degree of Polymerisation Index**

The DP values of 230 and 295 from the two transformers at HB confirm the mechanical strength of the cellulose has deteriorated and is placing the transformers at an increased risk of failure. A close-in feeder fault will impose mechanical stress on the winding and may tear the paper and reduce the electrical insulation, resulting in a catastrophic transformer failure. This is a critical issue.

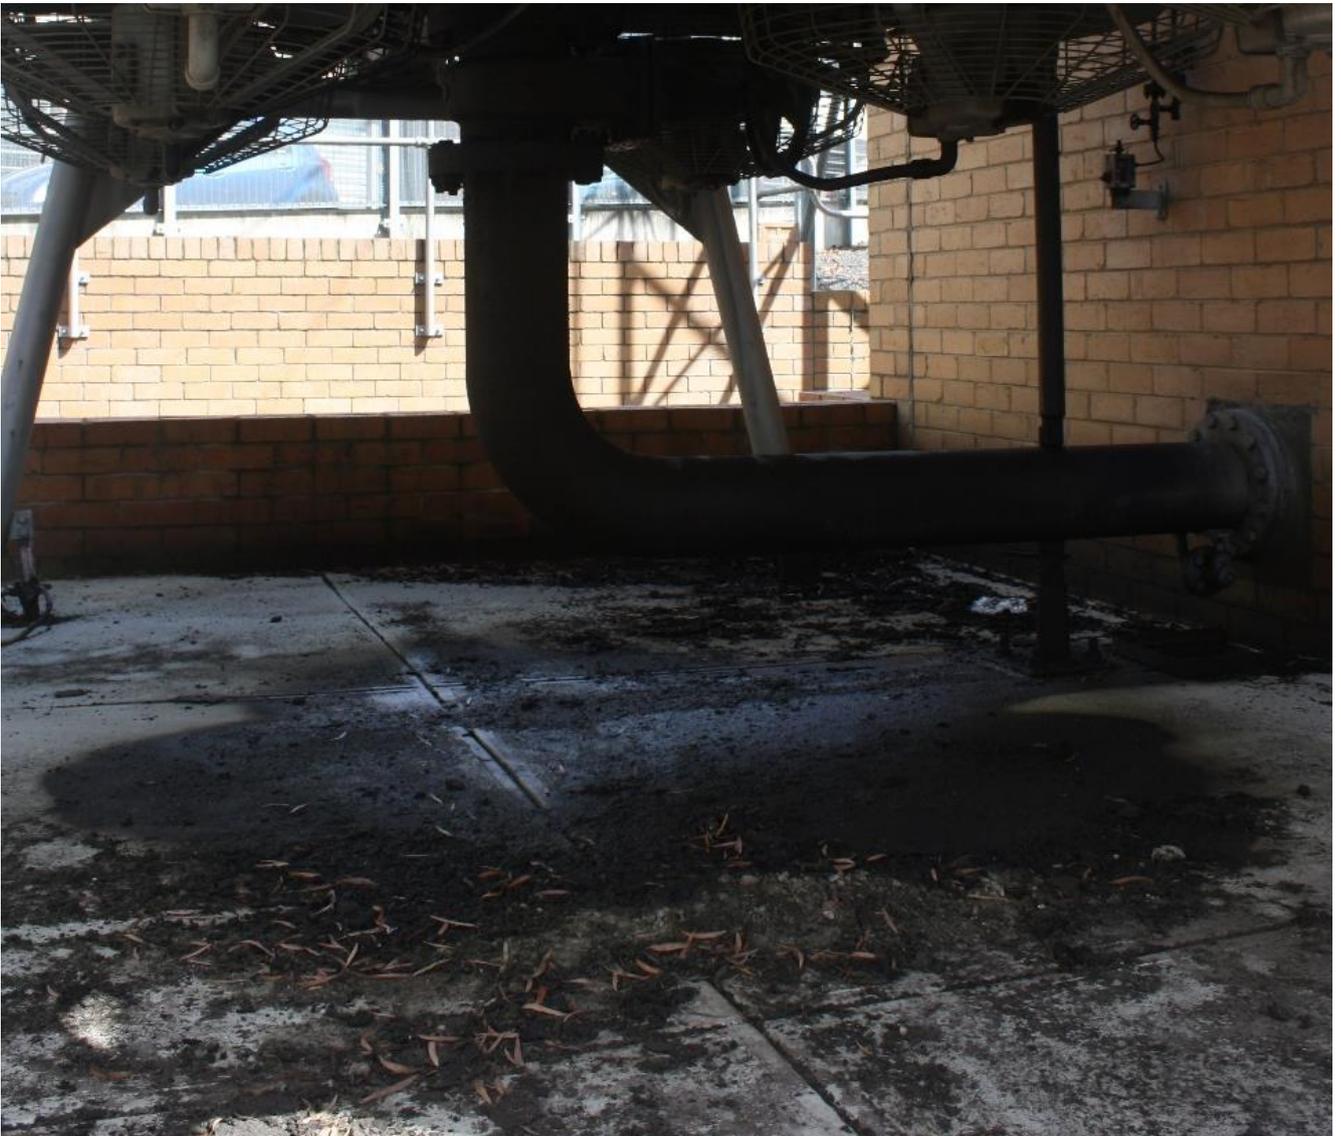
Figure 2–4: HB No.1 Power Transformer Radiator Oil Leaks

#### **5. The transformers have a history of oil leaks on the main tank and radiators.**

This is not an issue that is driving the replacement of the transformers; however, it does require elevated levels of operating expenditure to manage. The oil leaks make the transformer's maintenance intensive. These issues are not driving the replacement of the transformers however they require elevated levels of maintenance to manage. By replacing the No.2 transformer and making the No.1 transformer a hot standby, the maintenance costs could be minimised and used to offset the cost to replace the transformers.

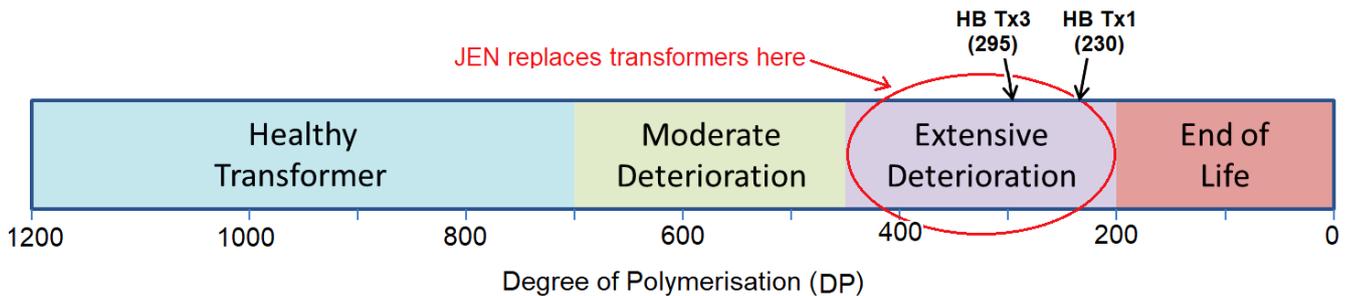
**Figure 2–5: Degree of Polymerisation Index**

The PDC/RVM test results indicate that the paper strength of the No.1 and 3 transformers at HB is extensively deteriorated, as shown in Figure 2–5 below.

The DP values of 230 and 295 derived from the PDC/RVM testing of the two transformers at HB confirm the mechanical strength of the insulation has deteriorated and is placing the transformers at an increased risk of failure. A close-in feeder fault will impose mechanical stress on the winding and may tear the paper and reduce the electrical insulation, resulting in a catastrophic transformer failure. This is the critical issue.
