Alice Springs corroded poles replacement (NMP22)

Regulatory Business Case (RBC) 2024-29

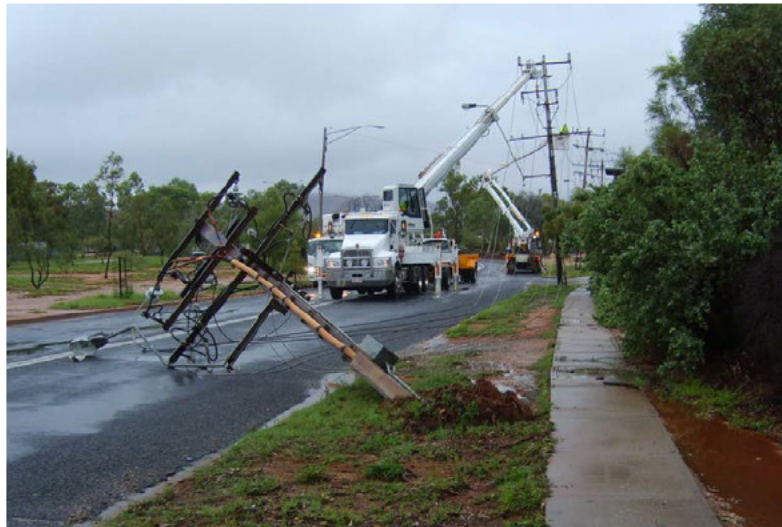
The unassisted² failure of a steel power pole due to corrosion of the pole footing in Alice Springs in January 2015 caused concern regarding the condition of pole assets in the Alice Springs area. The pole had been in service for approximately 40 years before it failed, which is considerably less than the expected service life for steel poles of 60 years and the average life in the NEM of 53 years.

Figure 1 Undoolya Rd Pole Failure 10/01/2015 Due to Footing Corrosion

The combination of the high soil salinity soil and the direct exposure of the unprotected steel (not fully encased or water blocked concrete) was deemed to have accelerated the corrosion and to have led to the pole failure.

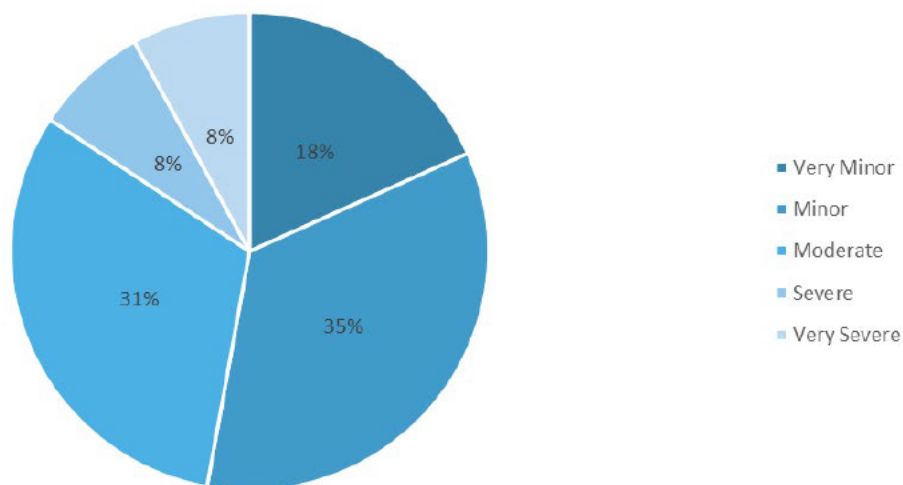
Figure 6 shows a summary of the inspections results from July 21 through to Feb 22. It demonstrates that 47% of poles were sufficiently deteriorated to require action to be taken. This was comprised of 16% of poles which were severely or very severely deteriorated and required remediation within 6 months and an additional 31% were moderately deteriorated and required remediation within a year. Minor and very minor categories do not require any action.

Figure 6 Summary of inspection results
