Cable tunnel refurbishment program (PRJ006)

Regulatory Business Case (RBC) 2024-29

Appendix B. Detailed survey of cable tunnel condition

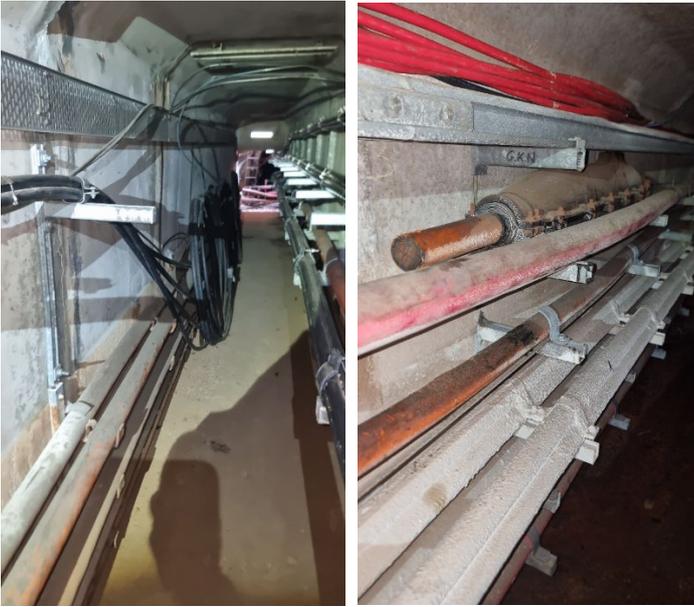
Figure 3 Mitchell Street

| Cable tunnel location | Condition report | Photos taken |
|---|--|---|
| Mitchell St | <p>Mitchell St has two decommissioned LV cables, one XLPE and one PILC cable that could be removed, roughly 50 to 100m long each. The general state of Mitchell St is okay but could do with a clean up at all pit entry sites.</p> <p>Minor crack repairs required.</p> <p>There is rusted unistrut from MSS to Daly street down Mitchell St.</p> <p>This sump pump appears to be operating fine.</p> | Yes |

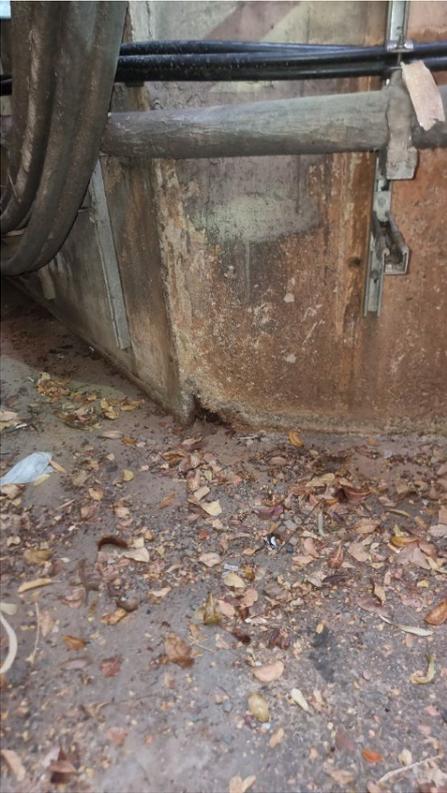
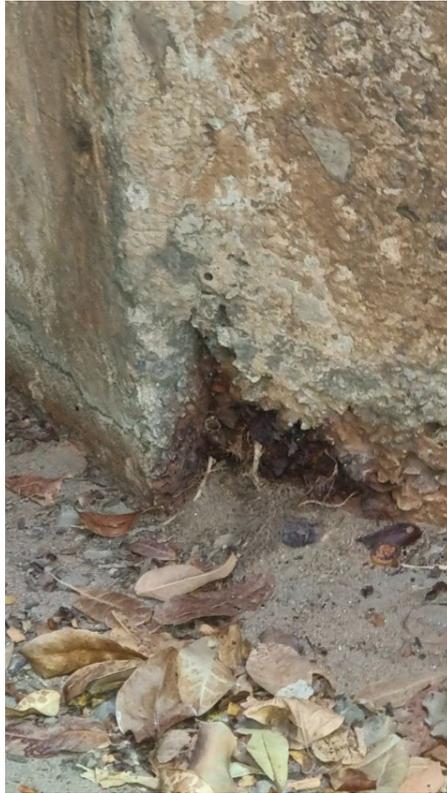
Figure 5 Briggs Street

| Cable tunnel location | Condition report | Photos taken |
|---|--|---|
| Briggs St | <p>Briggs St is also in relatively good condition. However there's a few conduit penetrations that require sealing around. There is significant silt build up around half way down this tunnel section.</p> <p>Sealing is required along the floor in sections.</p> | Yes |

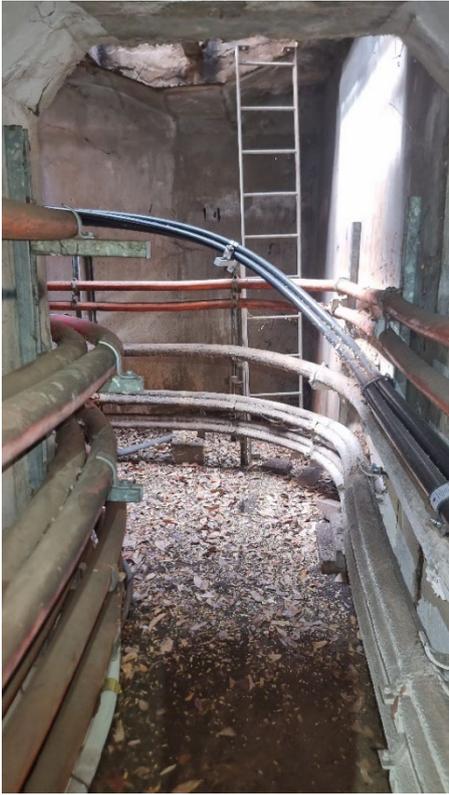
Figure 7 Smith Street

| Cable tunnel location | Condition report | Photos taken |
|---|--|---|
| Smith St | <p>Smith St is only a small section of tunnel and is in okay condition.</p> | Yes |

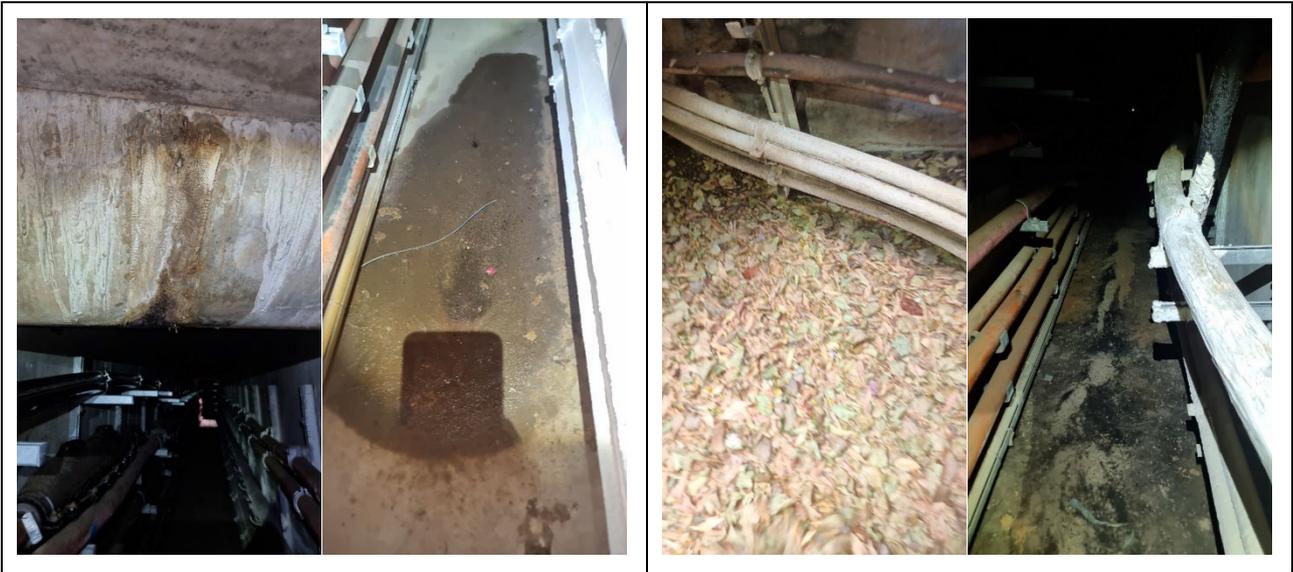
Figure 8 Lindsay Street

| Cable tunnel location | Condition report | Photos taken |
|---|--|---|
| Lindsay St | <p>I have found a leaking pipe that requires repairs. Significant root damage, and cracking to tunnel walls causing silt build up.</p> | Yes |

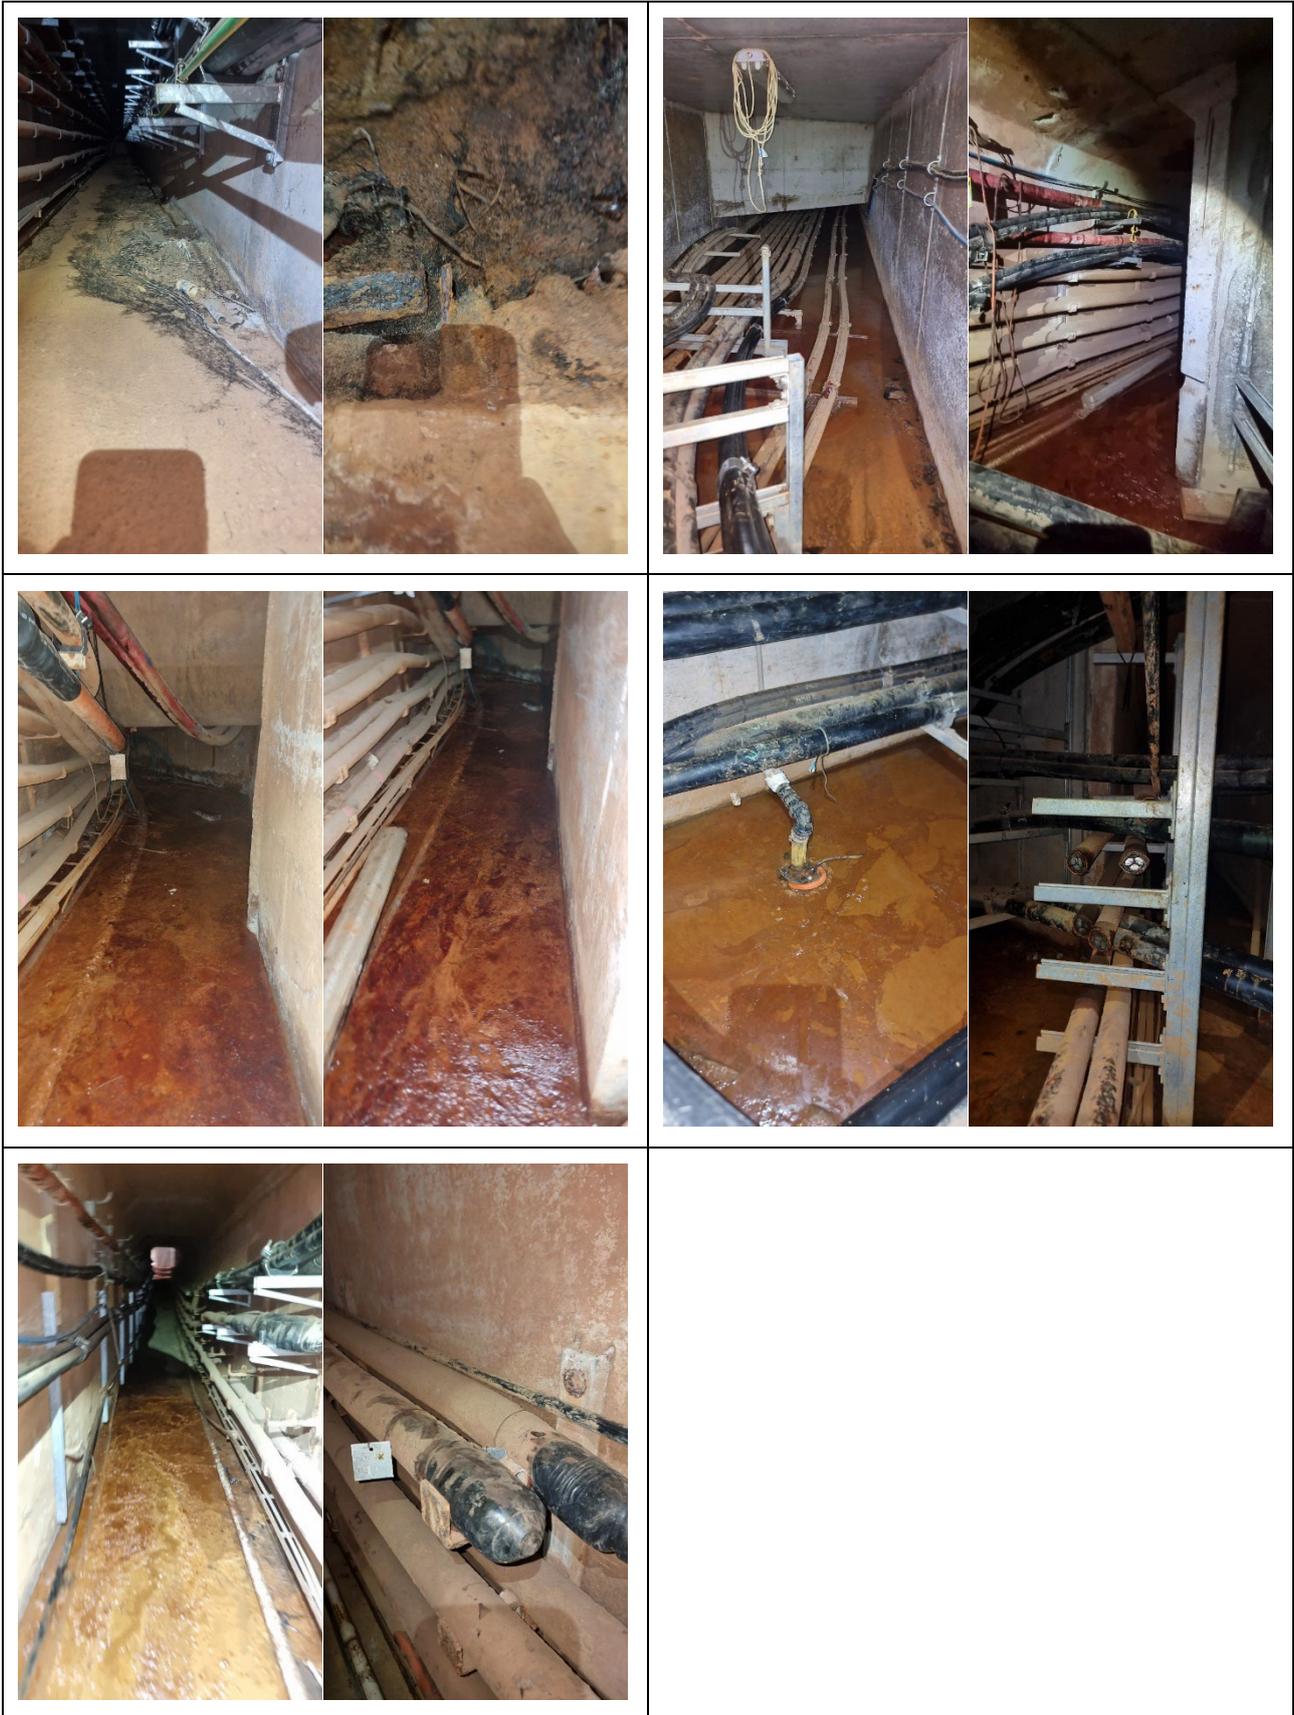
Figure 10 Lindsay Street / DZSS

| Cable tunnel location | Condition report | Photos taken |
|---|--|---|
| Lindsay St/ DZSS | <p>This section of tunnel is the worst, mainly due to it being the lowest point. More cracks/ root ingress. Significant silt build up. Sump pumps do work but are continuously blocked. This section requires thorough cleaning and absolutely stinks. I dread working in the part of the tunnels. Climbing through the low section is very unpleasant. Please note there is another large pump here but I couldn't get to it without filling up my gum boots. There's also a few decommissioned cables that require removing.</p> | Yes |

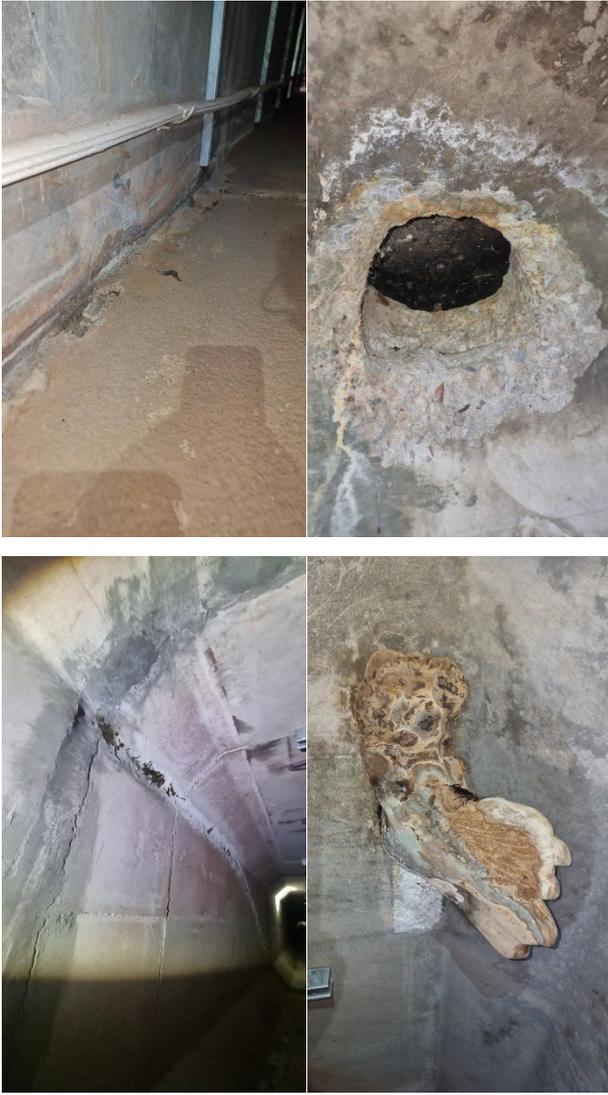
Figure 11 McMinns St

| Cable tunnel location | Condition report | Photos taken |
|---|--|---|
| McMinns St | <p>Cracks, roots and silt build up. Unsealed penetrations.</p> | Yes |

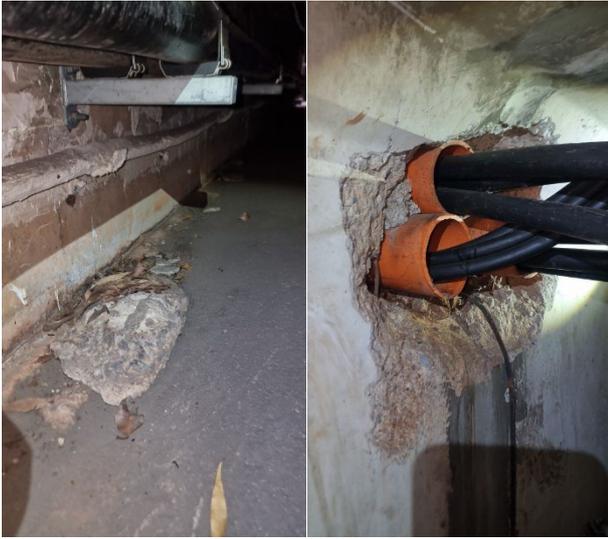
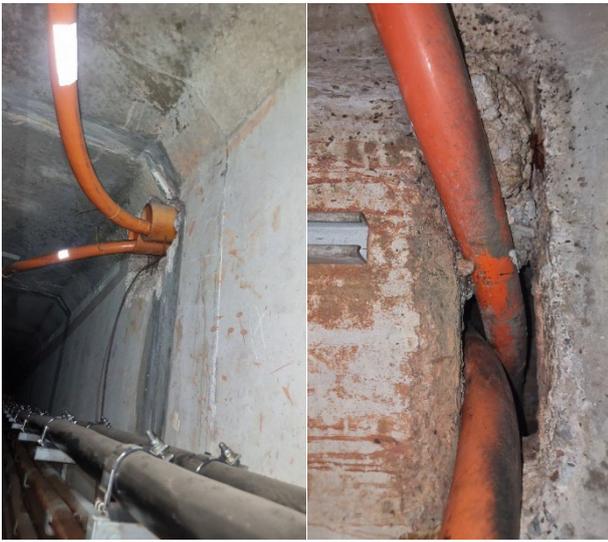
Figure 12 Knuckey St

| Cable tunnel location | Condition report | Photos taken |
|---|--|---|
| Knuckey St | <p>Not too bad. Very congested is sections. Penetrations require sealing.</p> | Yes |

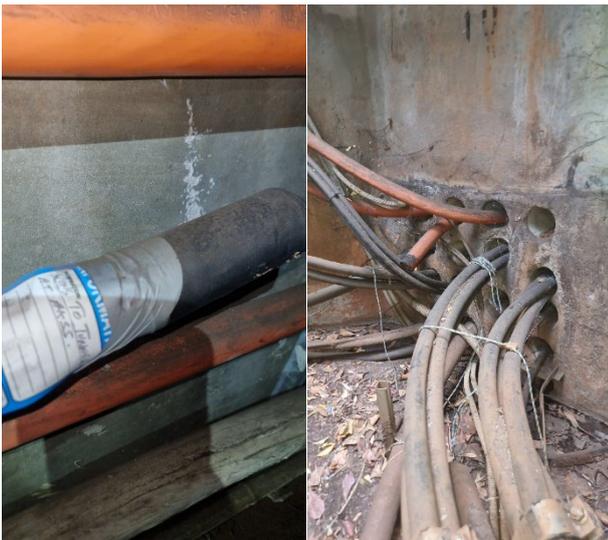
Figure 13 Bennet St

| Cable tunnel location | Condition report | Photos taken |
|---|--|---|
| Bennett St | <p>Spare decommissioned HV cable. Tunnel in okay condition.</p> | Yes |

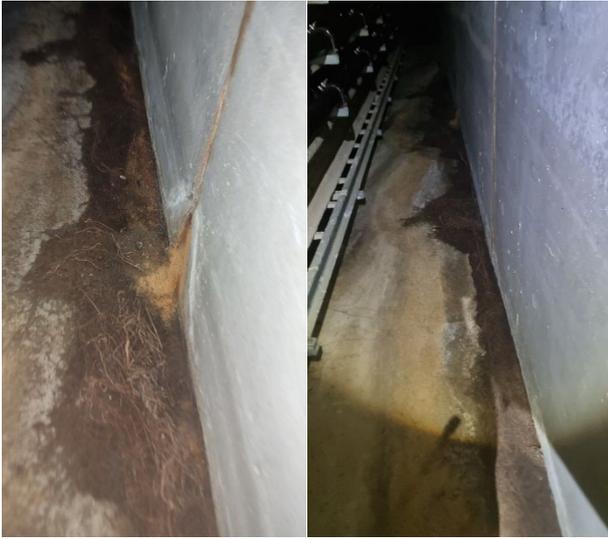
Figure 14 Woods St / FBSS

| Cable tunnel location | Condition report | Photos taken |
|---|--|---|
| Woods st/ FBSS | <p>In okay condition. A few cracks here and there. Mild silt build up. Minor root damage.</p> | Yes |
