POWERLINK QUEENSLAND REVENUE PROPOSAL

CP.02516 Garbutt Transformer Replacement

Transformer T1 & T2 Condition Assessment T046 Garbutt Substation

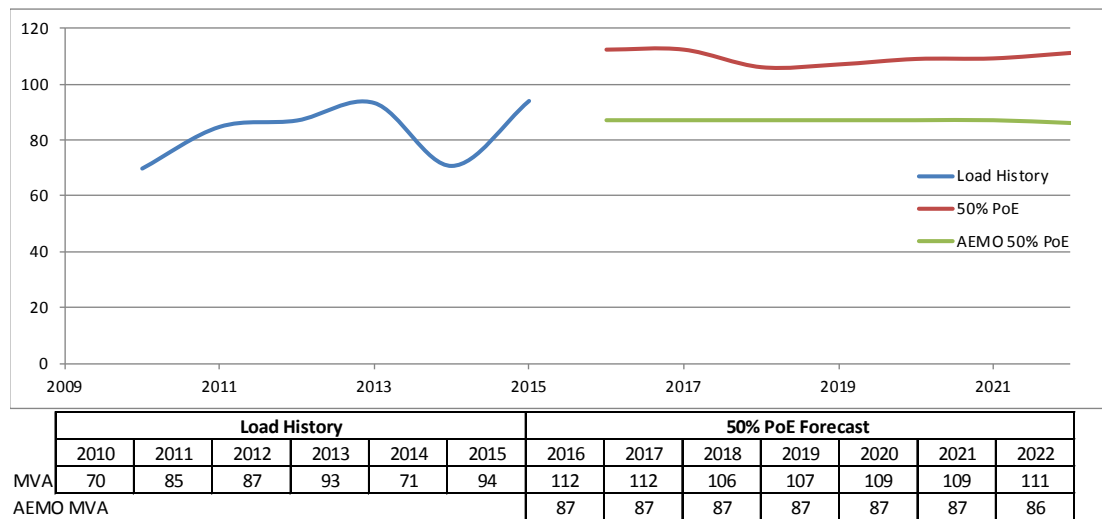
Figure 1: Historic and Forecast loads for T046 Garbutt

The historic and forecast loadings for T046 Garbutt (66kV) are shown in Figure 1. Note that as Garbutt is an injection point into a meshed 66kV network, the load under contingency is supported by the surrounding substations at Dan Gleeson, Townsville South and Townsville East.
