Supporting
document 5.22.2

Angle Park North Photographs

2020-25 Revised
Regulatory Proposal
10 December 2019

Angle Park Asset Condition Photographs

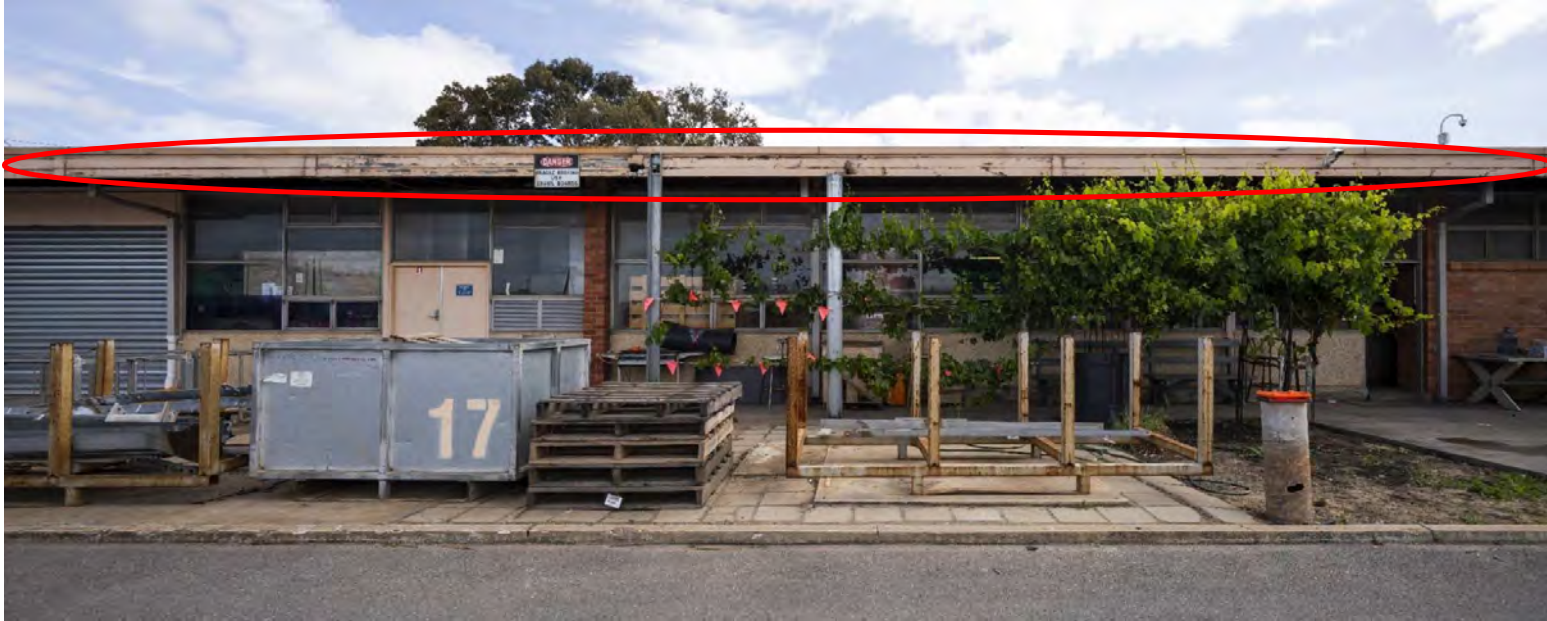
Southern side of the old Admin building – timber fascia rot and degradation

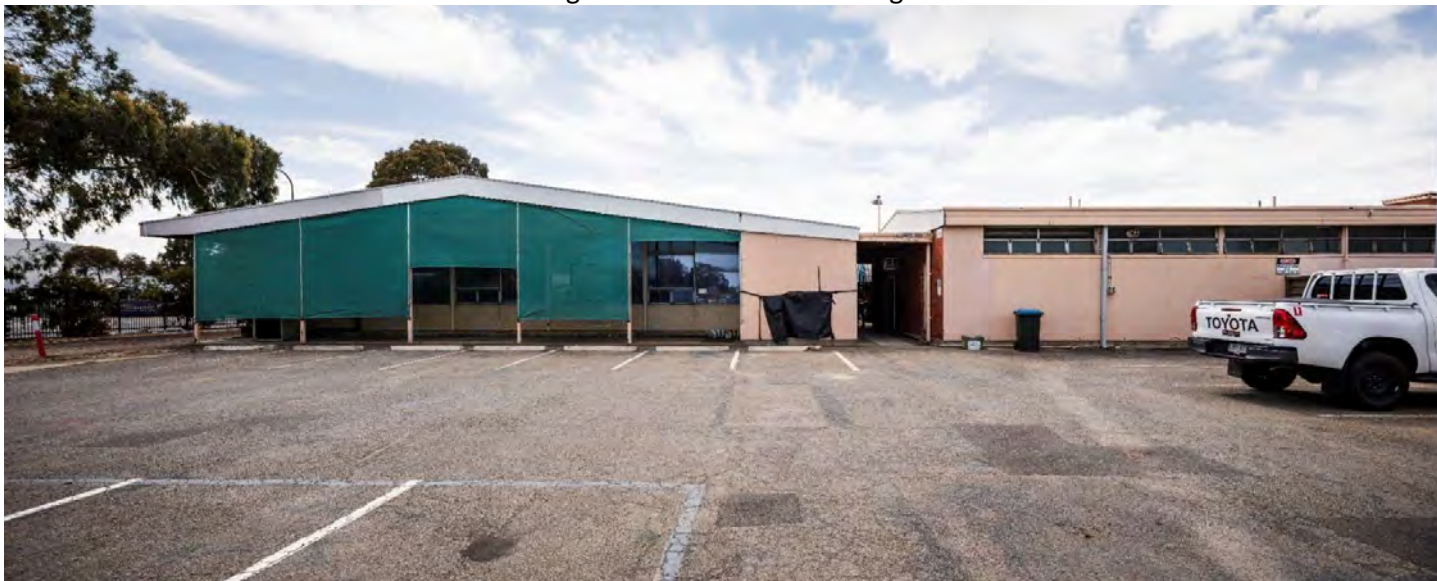
Western façade of Old Admin building and toilet block, Pavement degradation and cracking to light vehicle car park

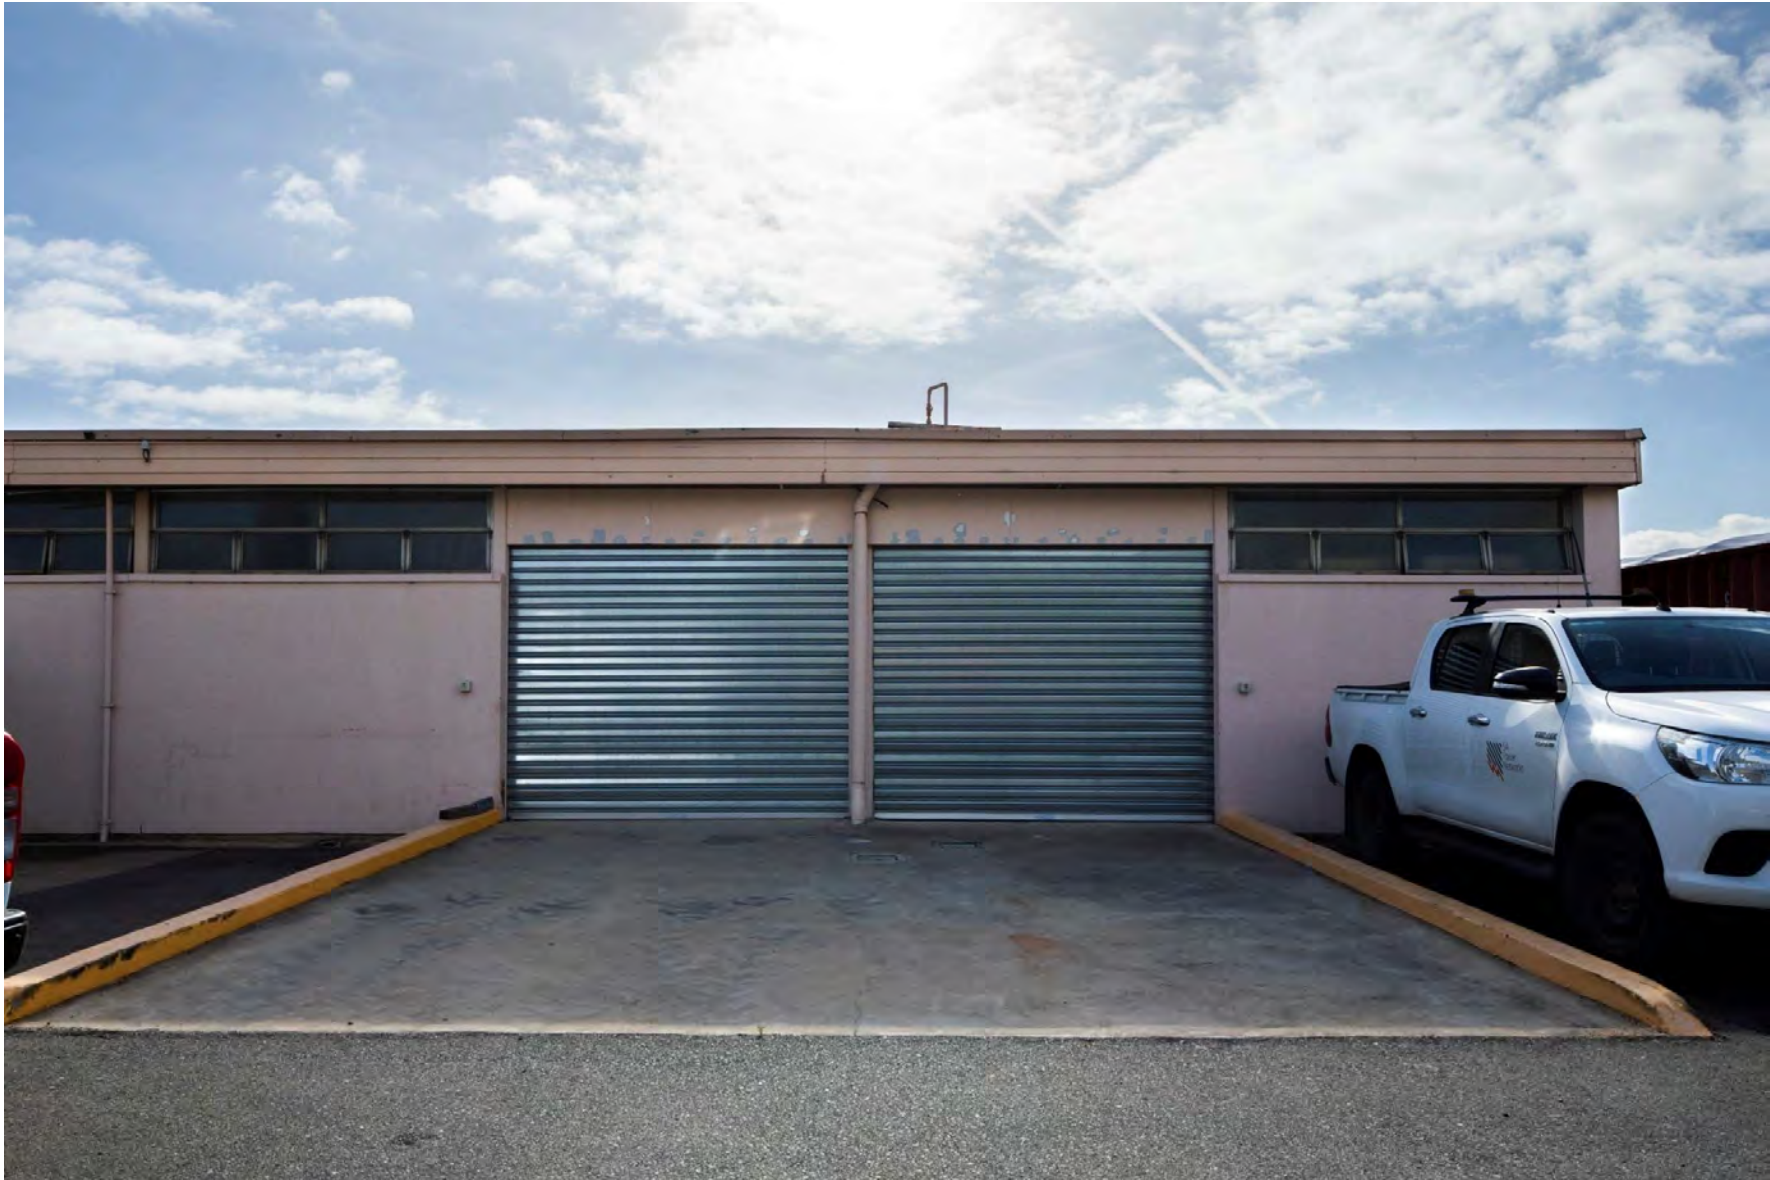
- Original Fibre Cement cladding and fascia to the Amenities block with previous repair sections, refurbished roller doors.

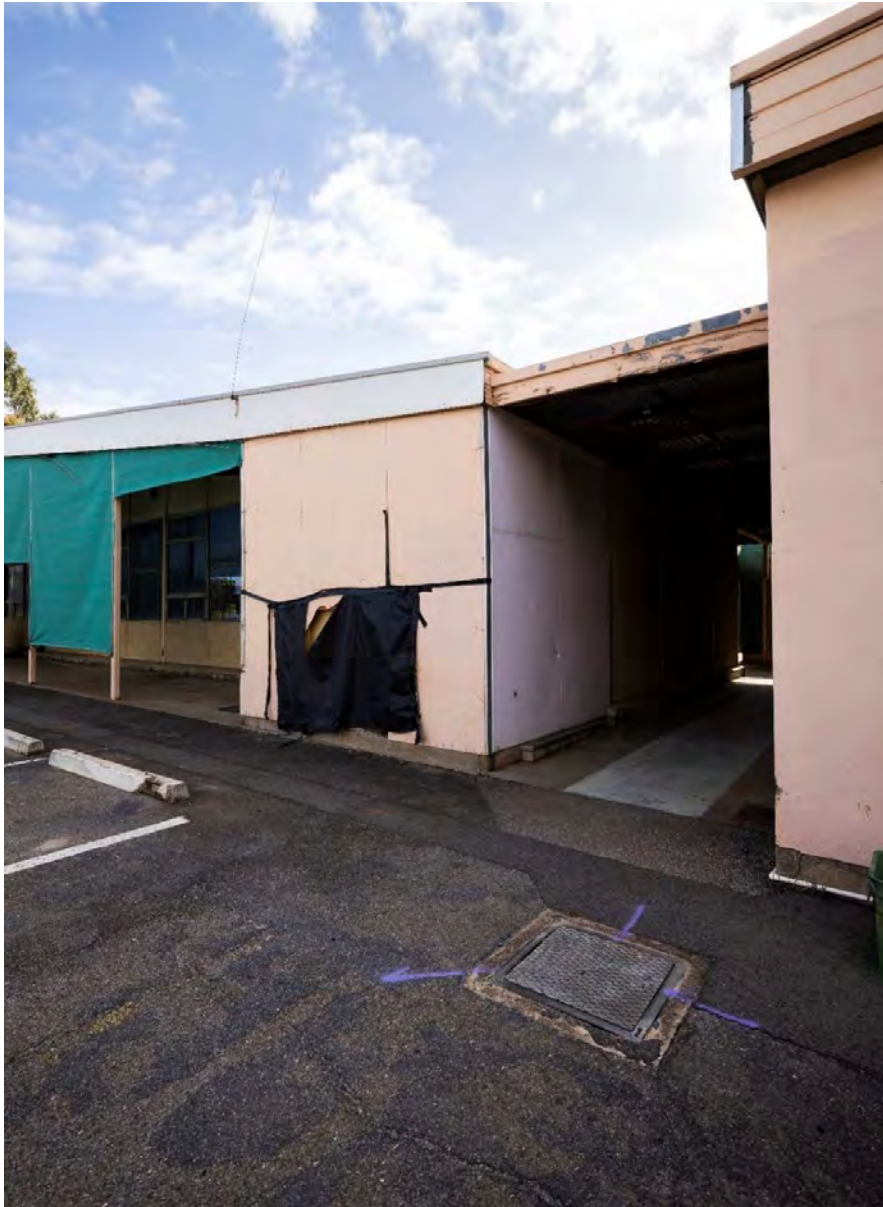
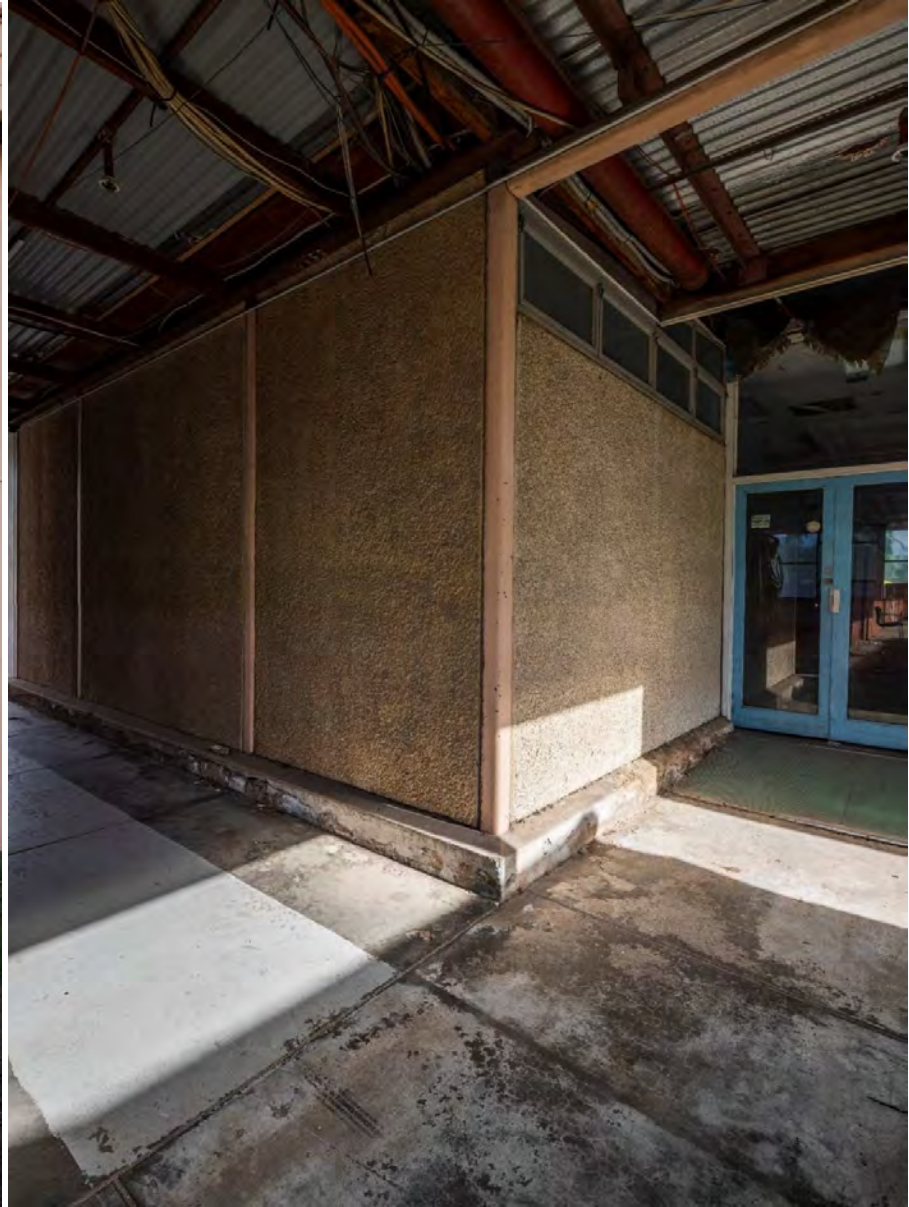
- Cement fibre cladding in various states of rot and disrepair and damage. Concrete cancer and rising damp damage.

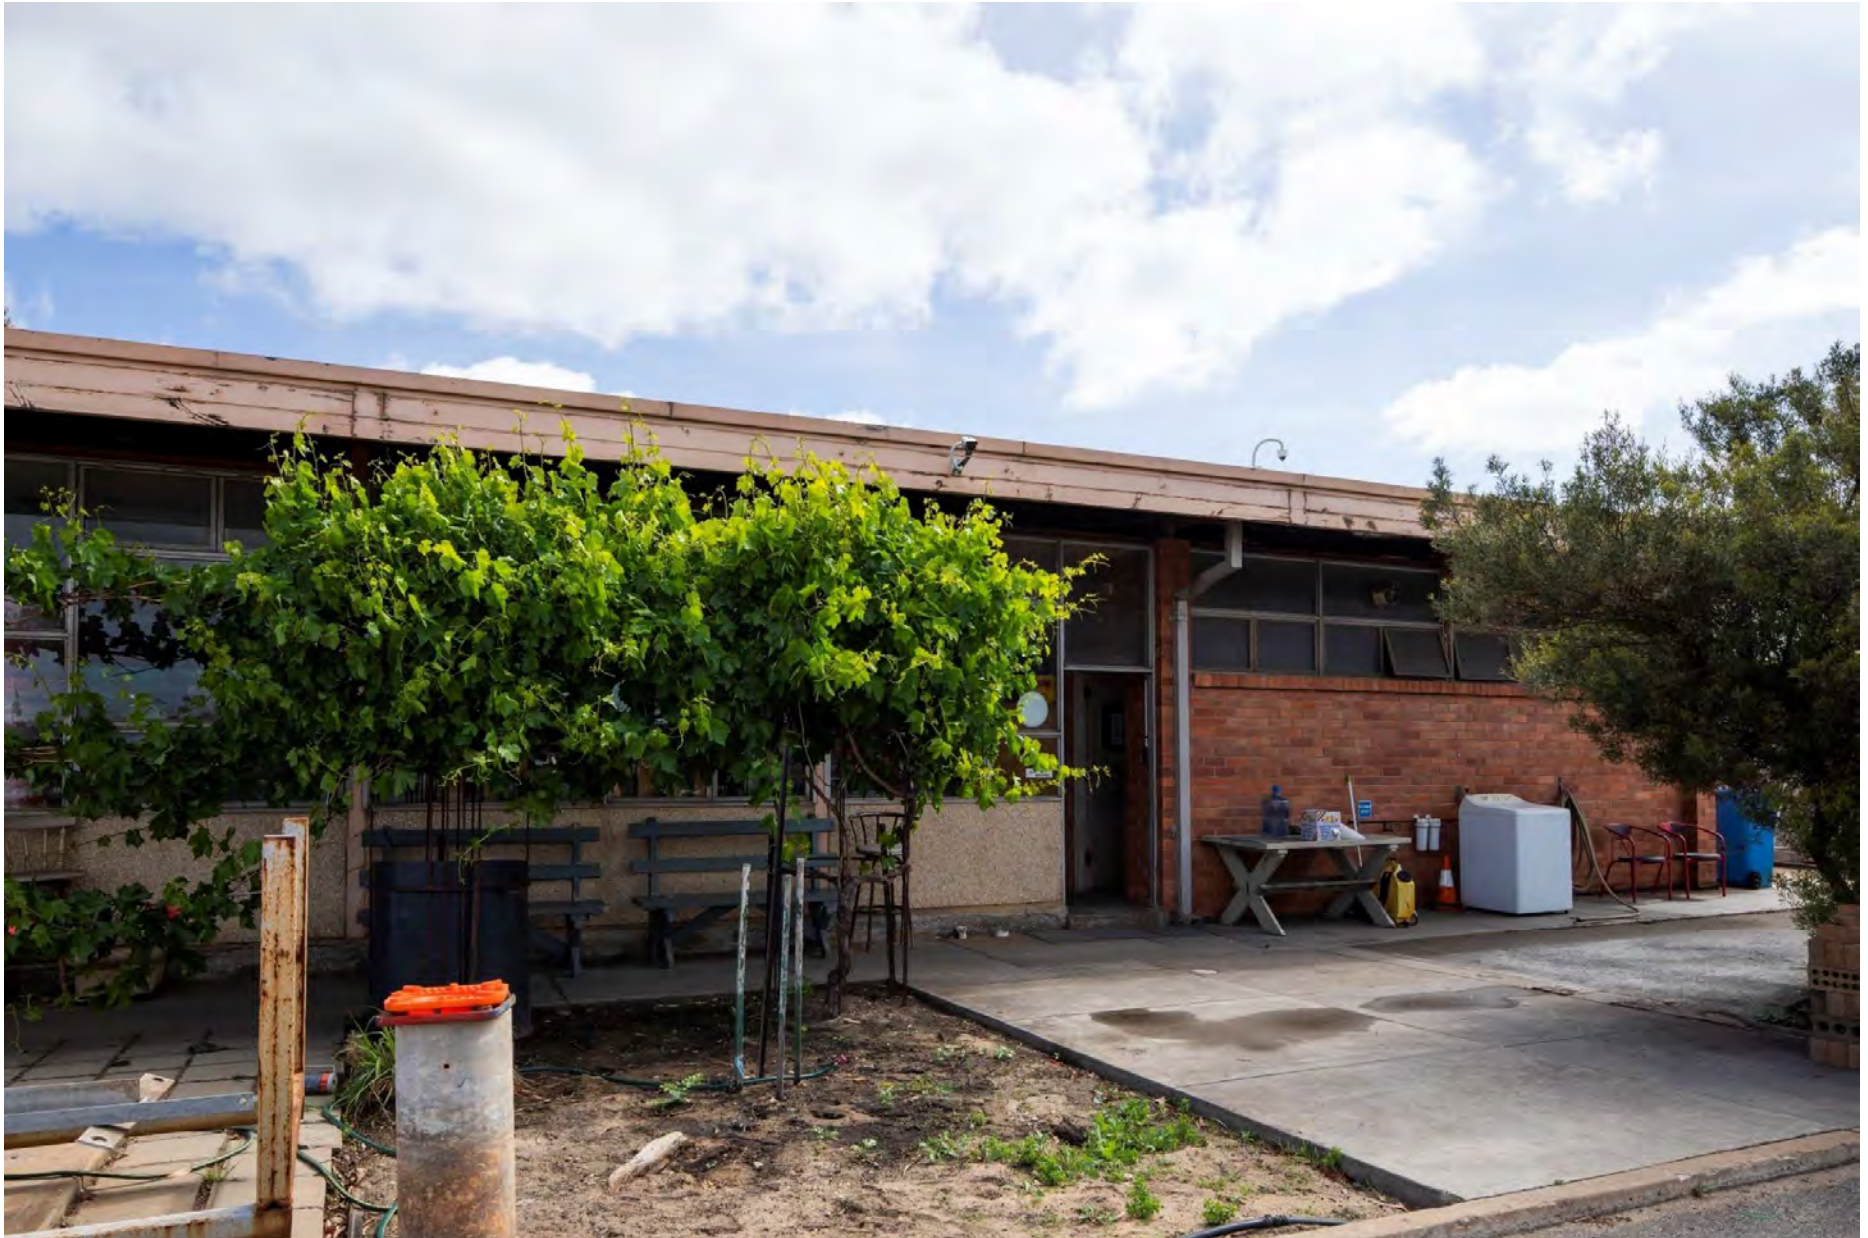
- Transmission area in the rear of the old admin guttering and timbers in very poor condition.

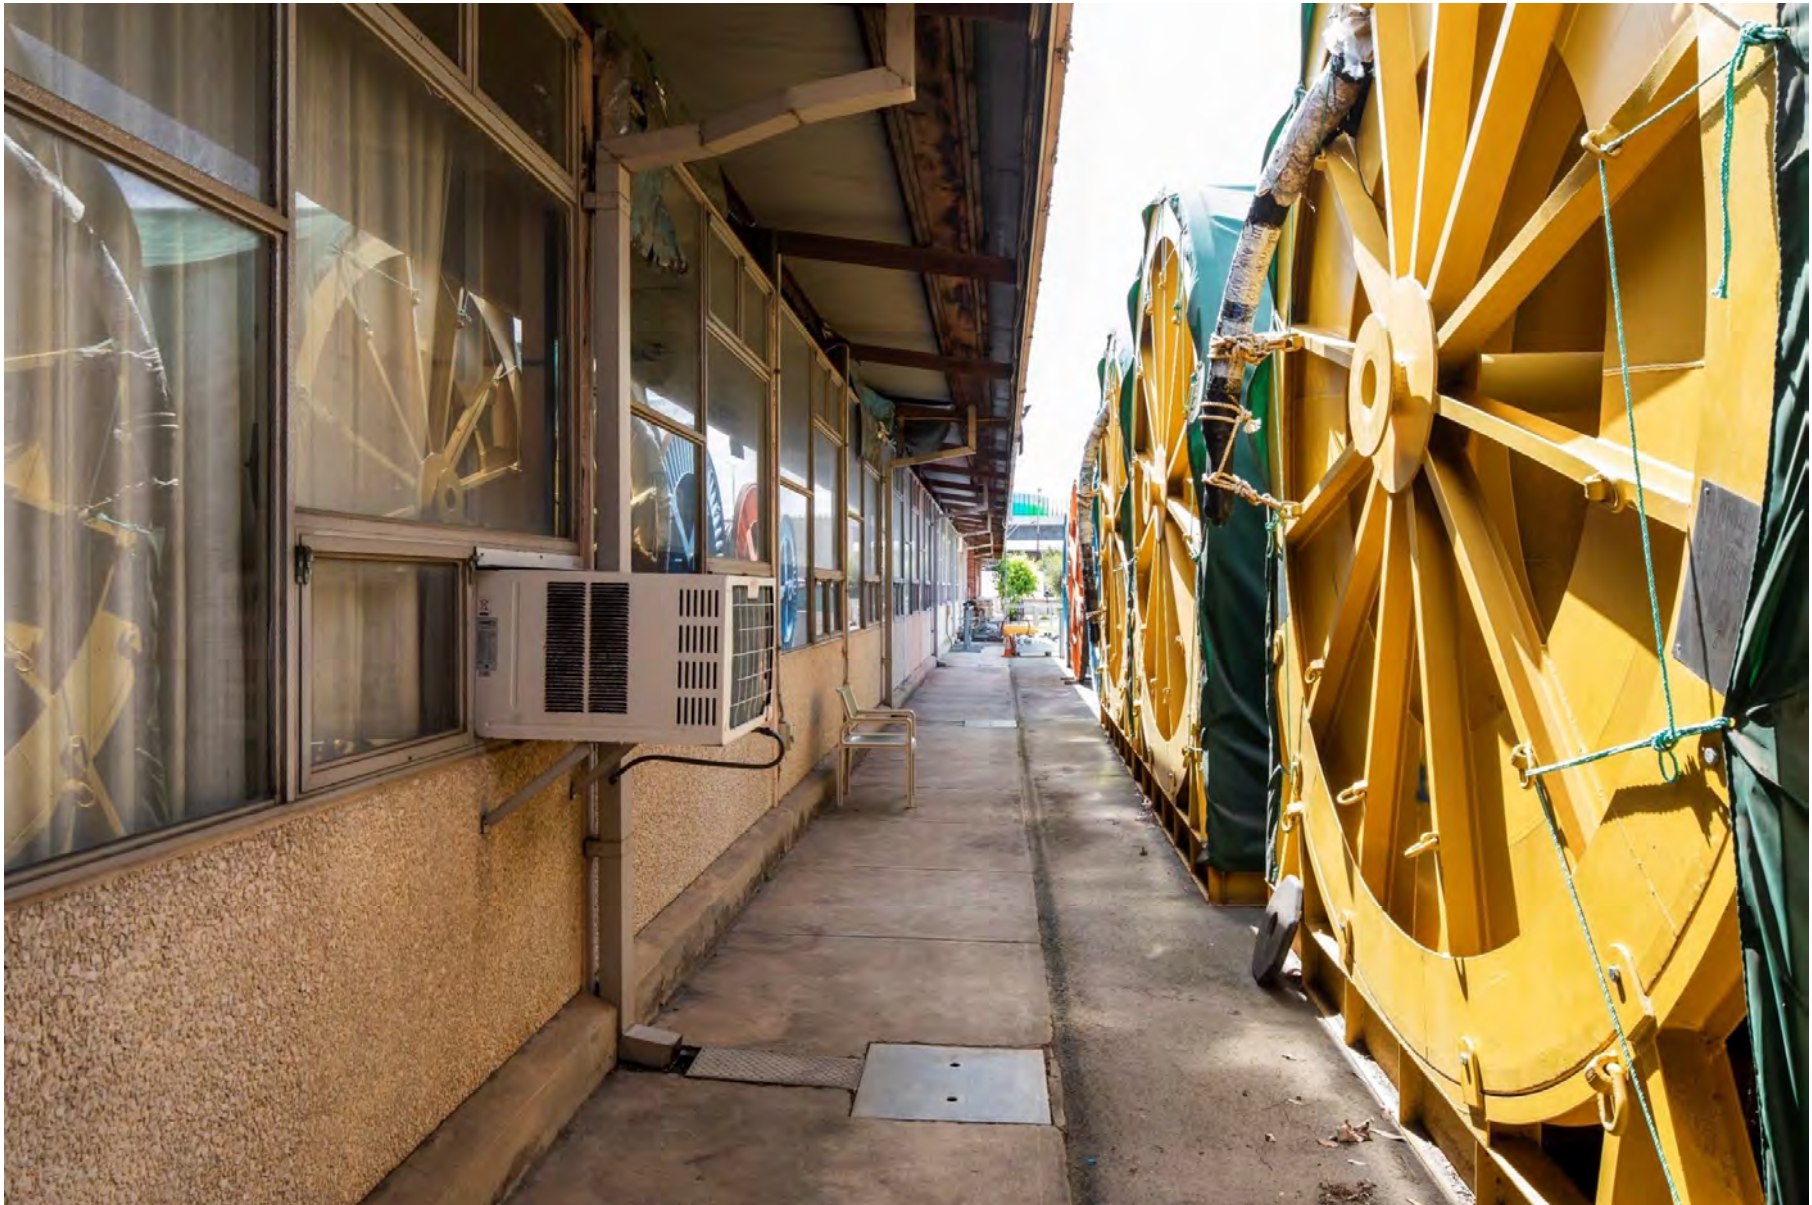
- Gutters and down-pipes in very poor condition, rising damp and concrete cancer to floor and wall foundations, timber rot to roofing beams.

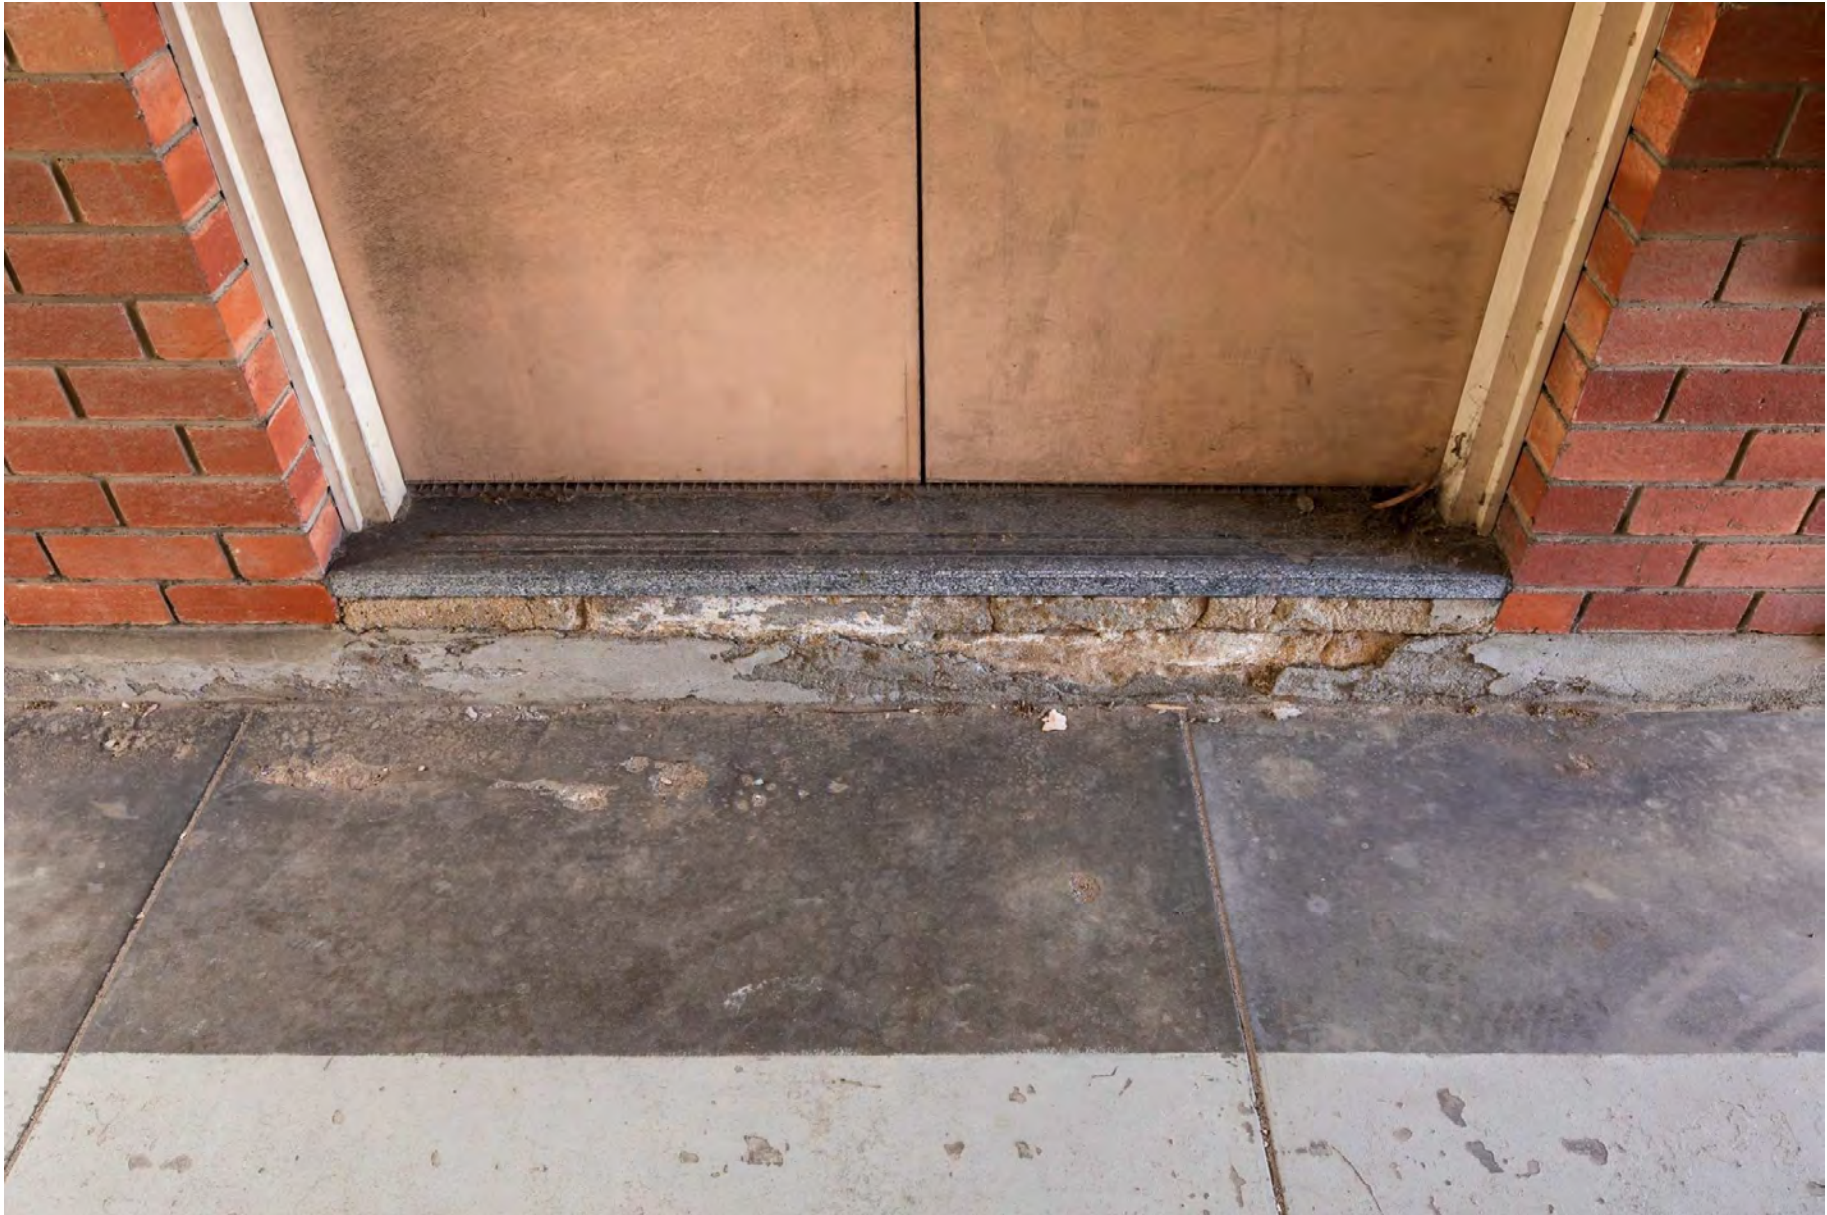
- Rising Damp and Concrete cancer to original admin building foundations.

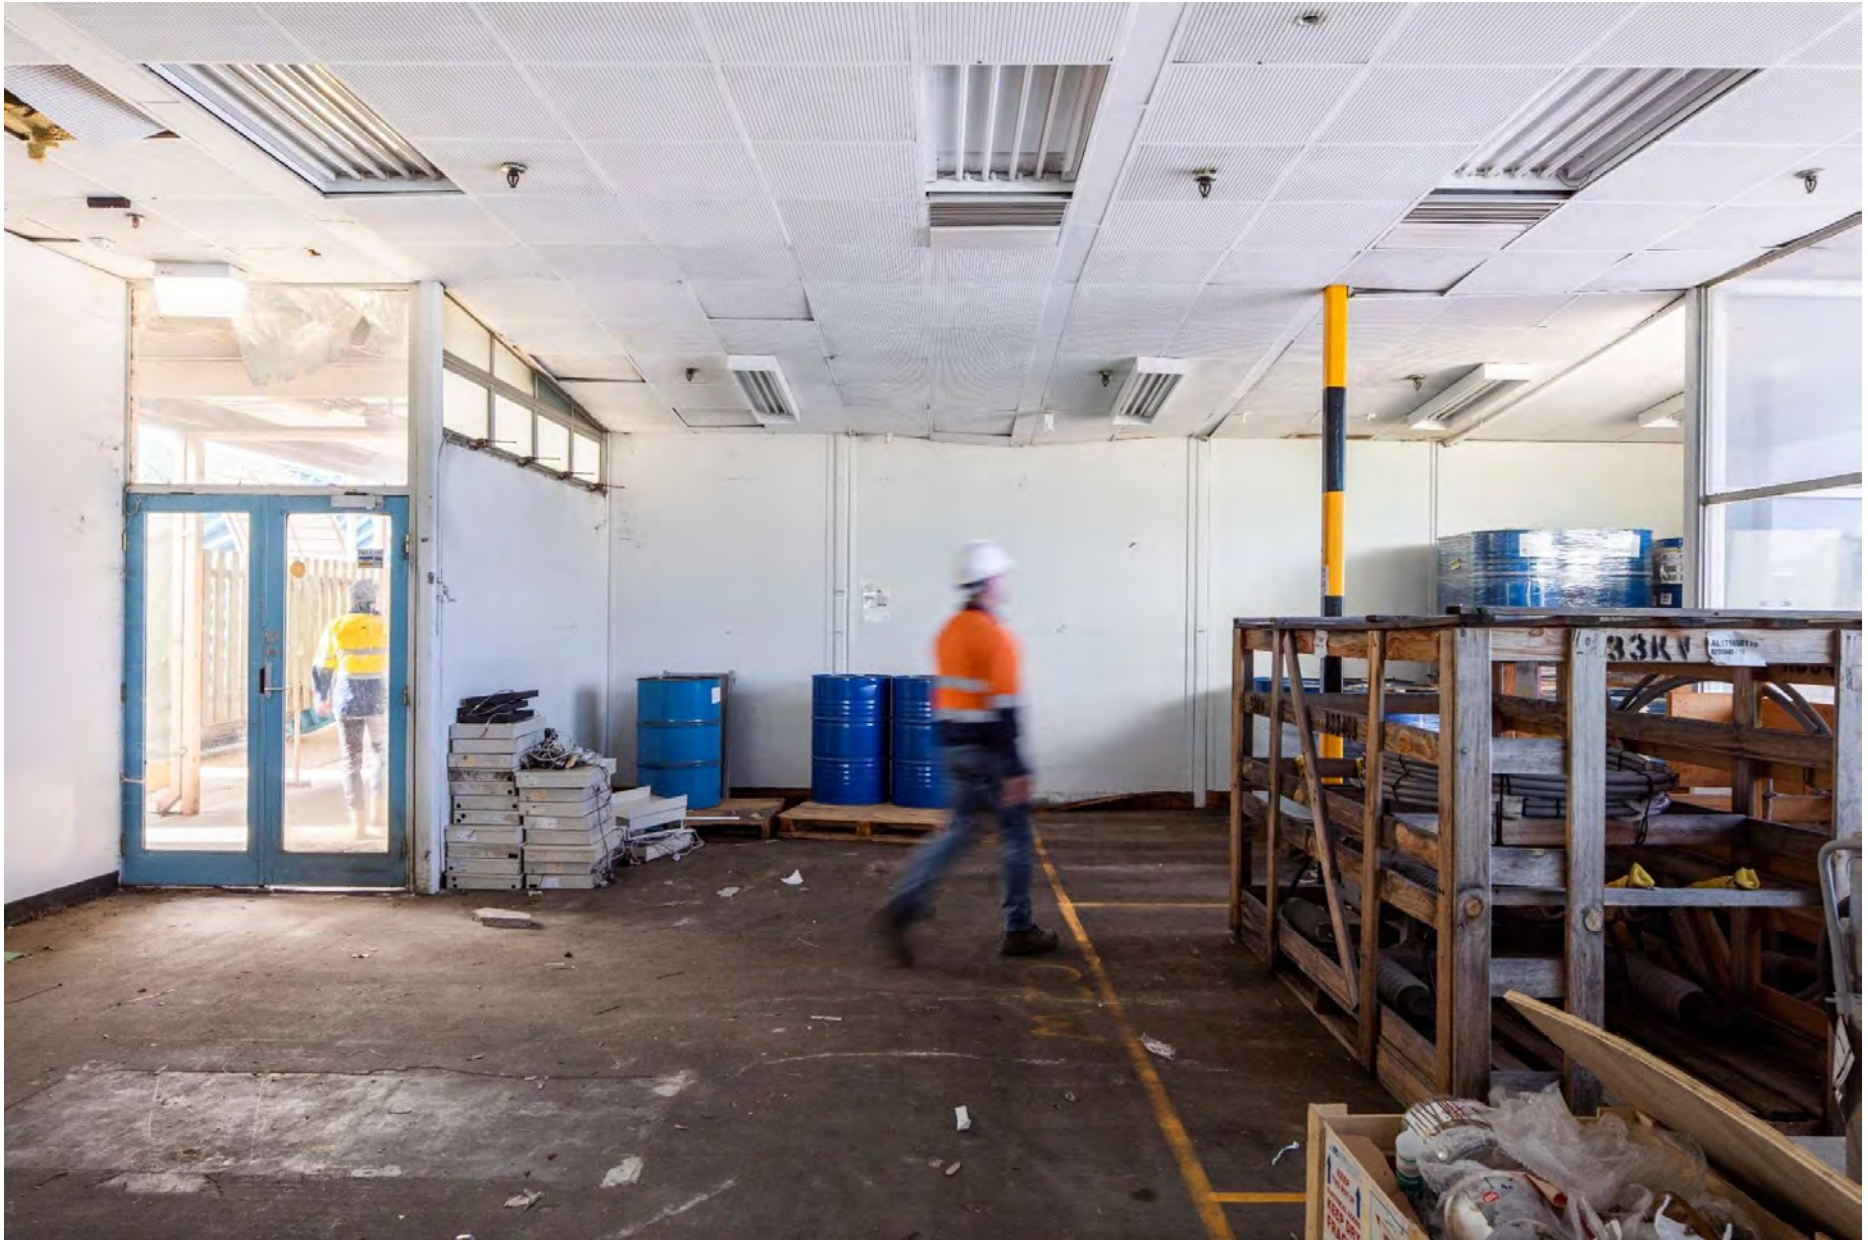
- Collapsed ceiling sections, wall damage and floor condition inside old admin building.

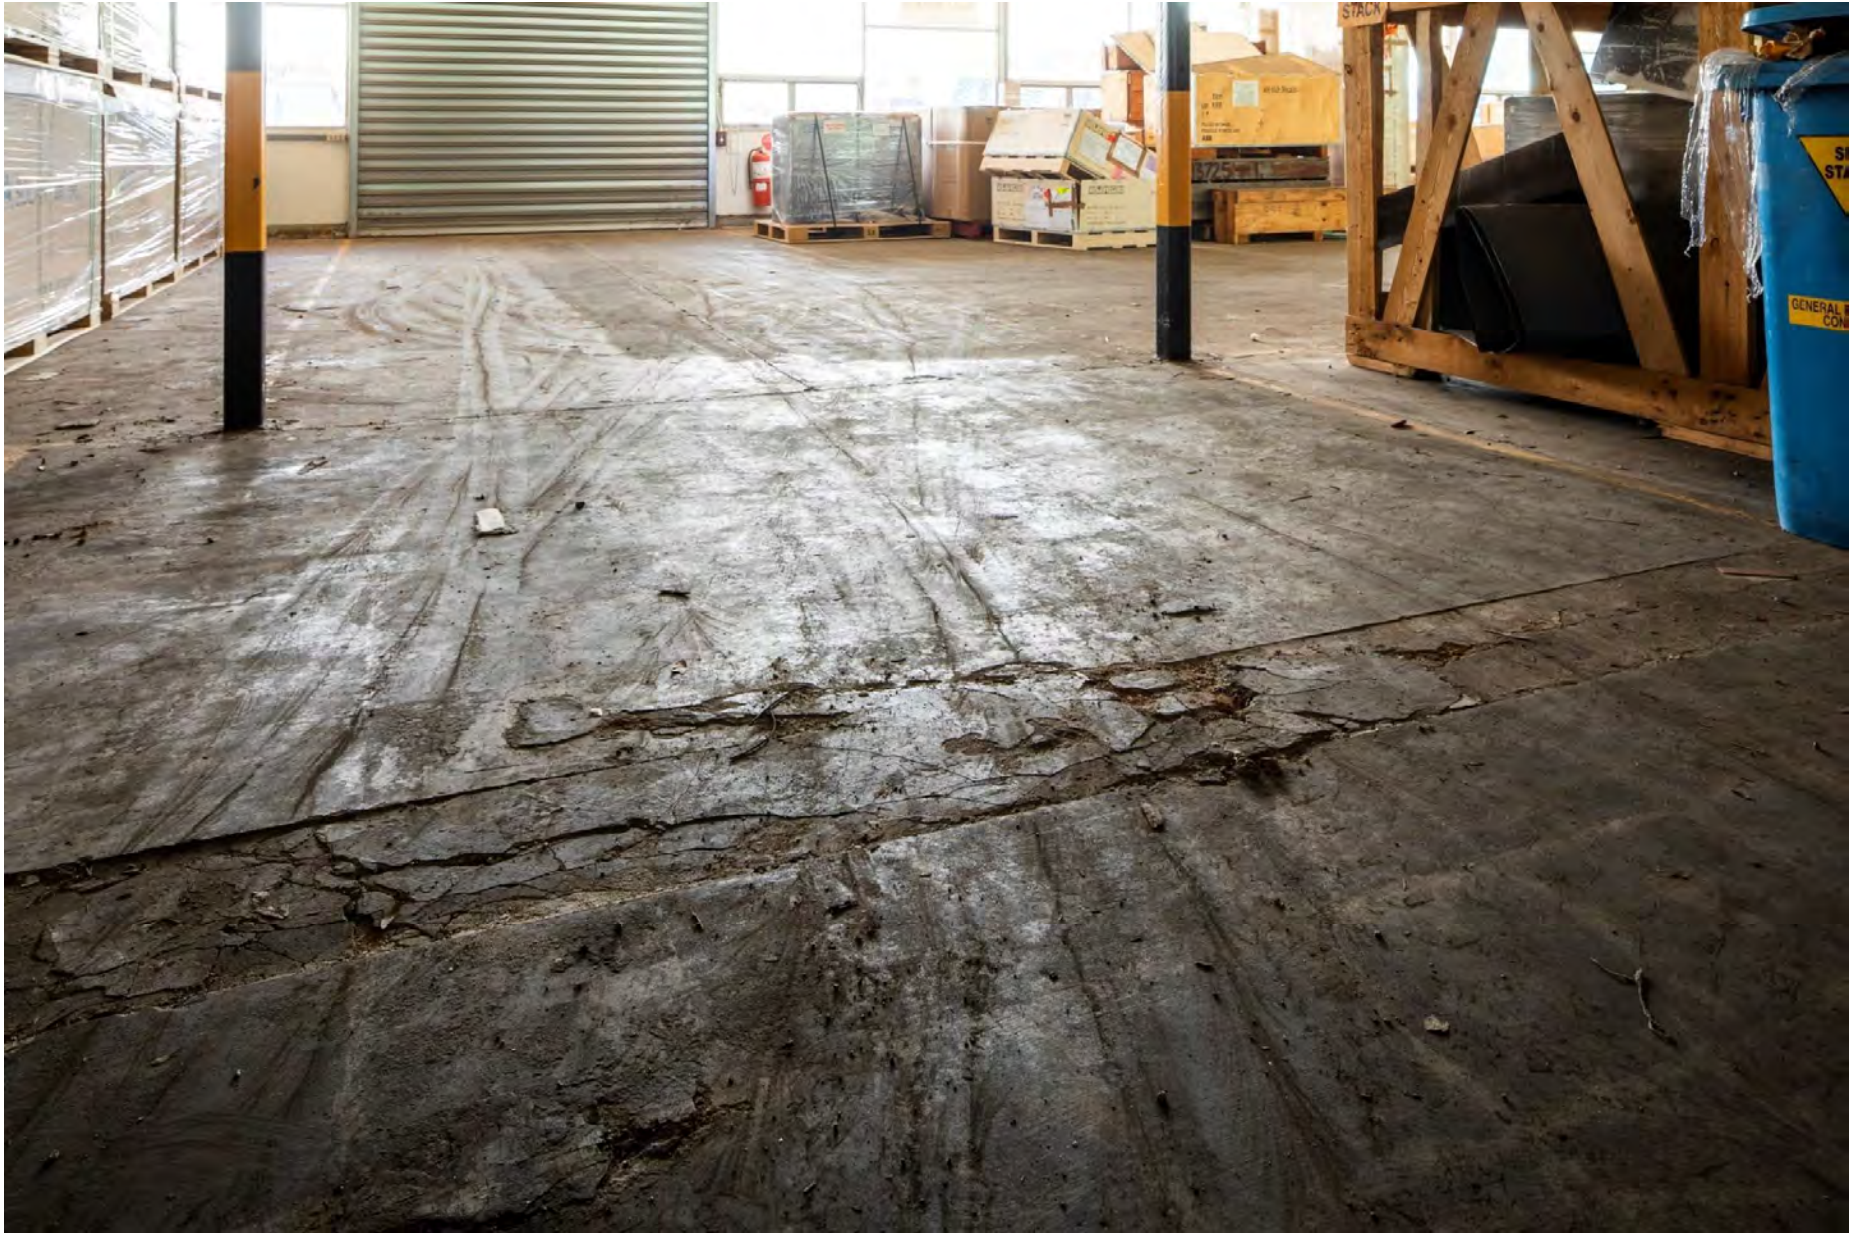
- Extensive floor cracking, rising damp and concrete cancer throughout interior of the old admin building.

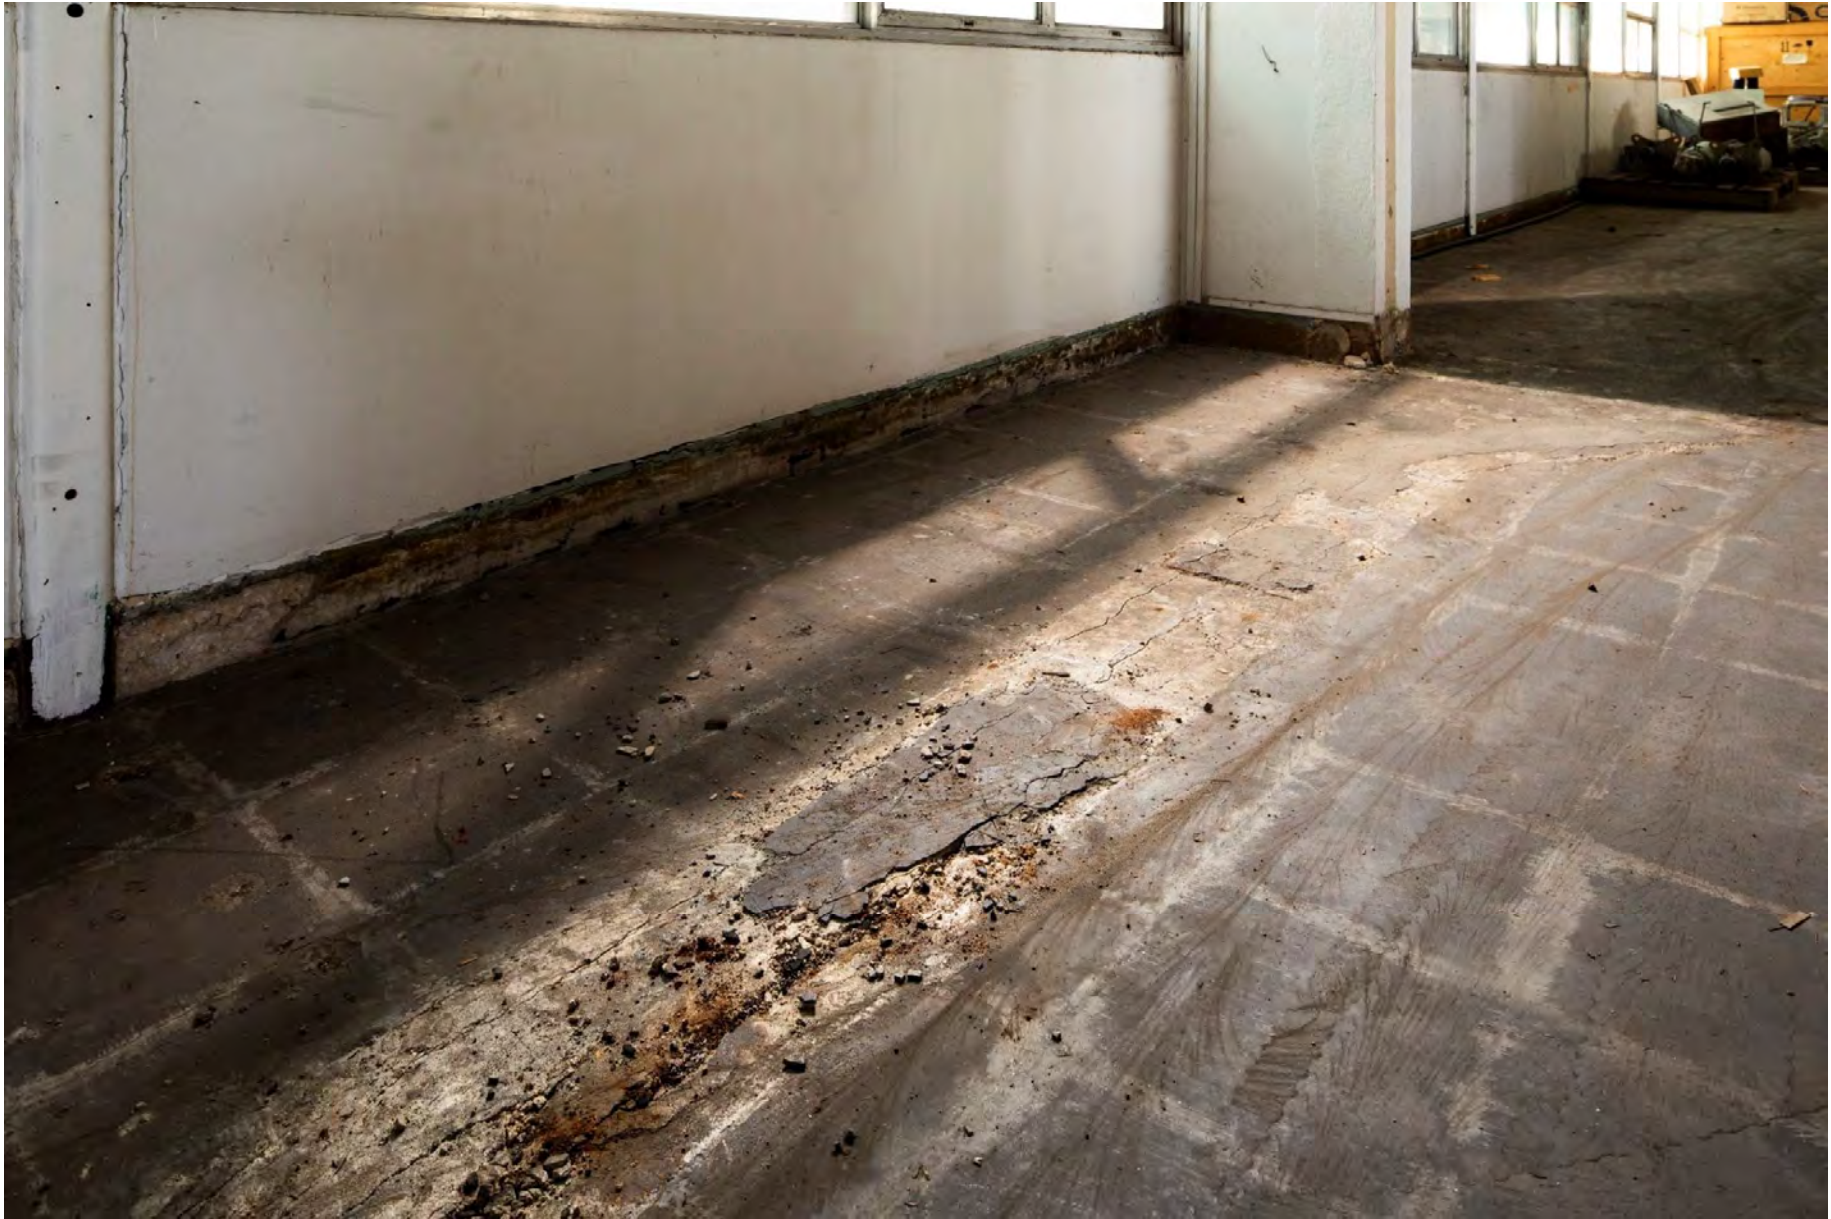
- Extensive floor cracking, rising damp and concrete cancer throughout interior of the old admin building.

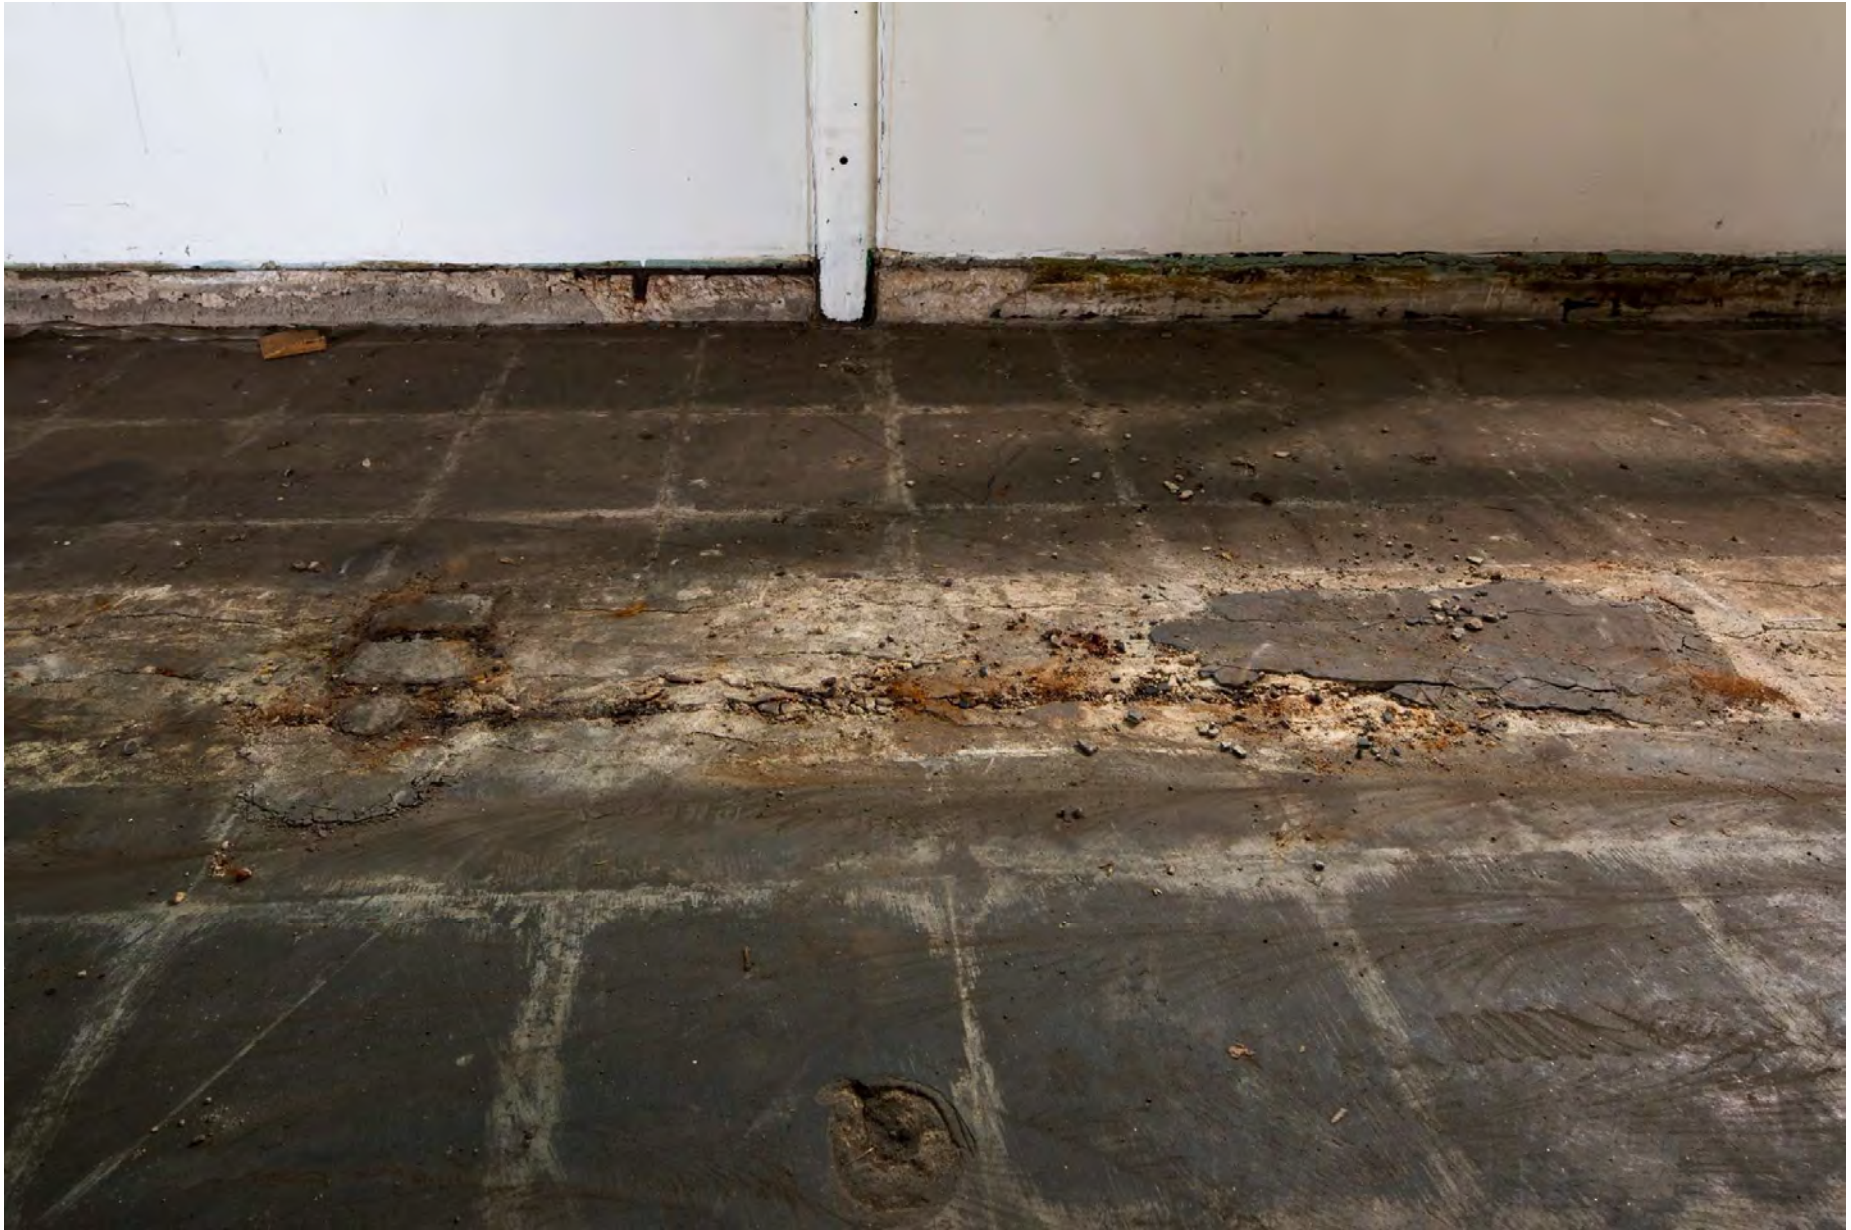
- Extensive floor cracking, rising damp and concrete cancer throughout interior of the old admin building.
