Supporting
document 5.22.2

Angle Park North Photographs

2020-25 Revised
Regulatory Proposal
10 December 2019

Angle Park Asset Condition Photographs

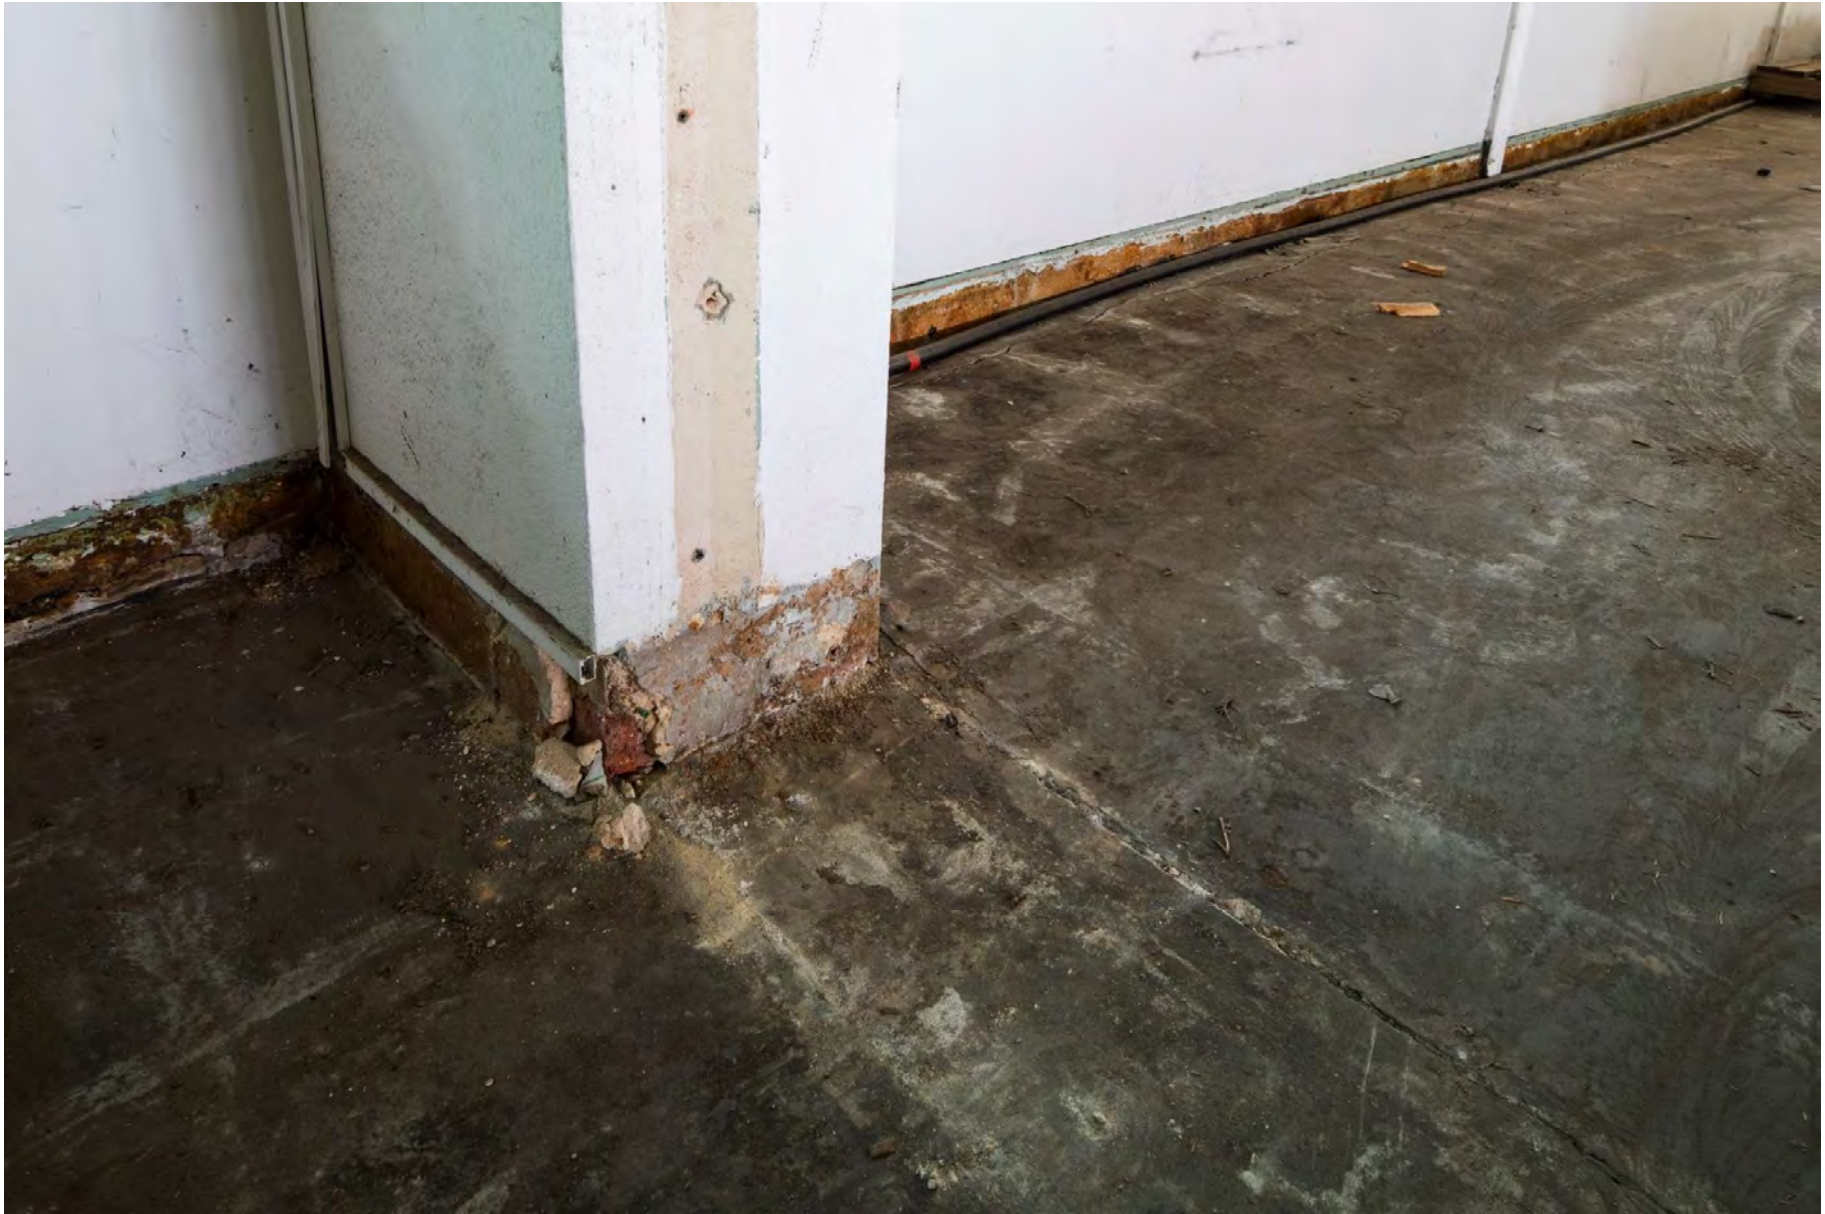
- Extensive floor cracking, rising damp and concrete cancer throughout interior of the old admin building.

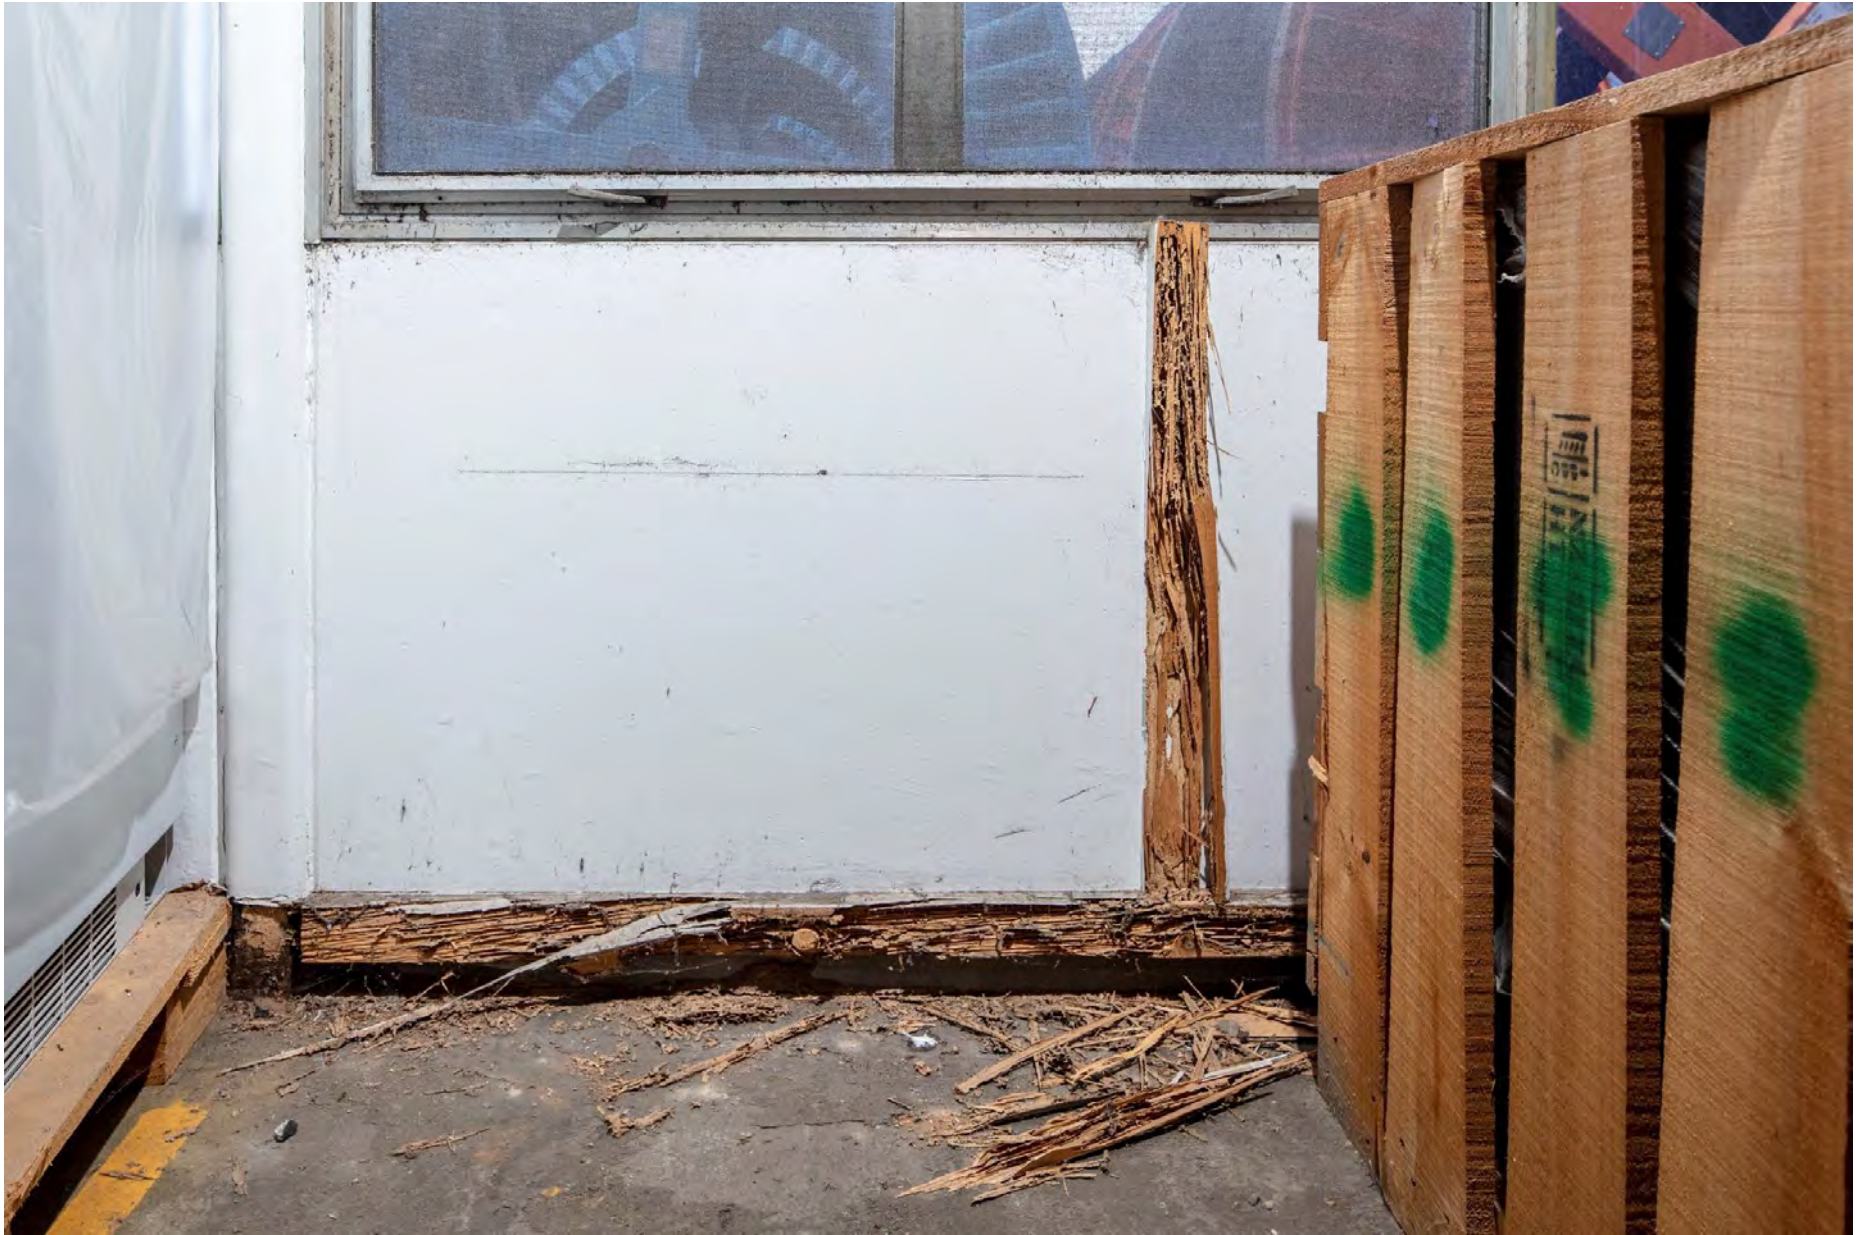
- Significant termite damage to internal timberwork in old admin building.

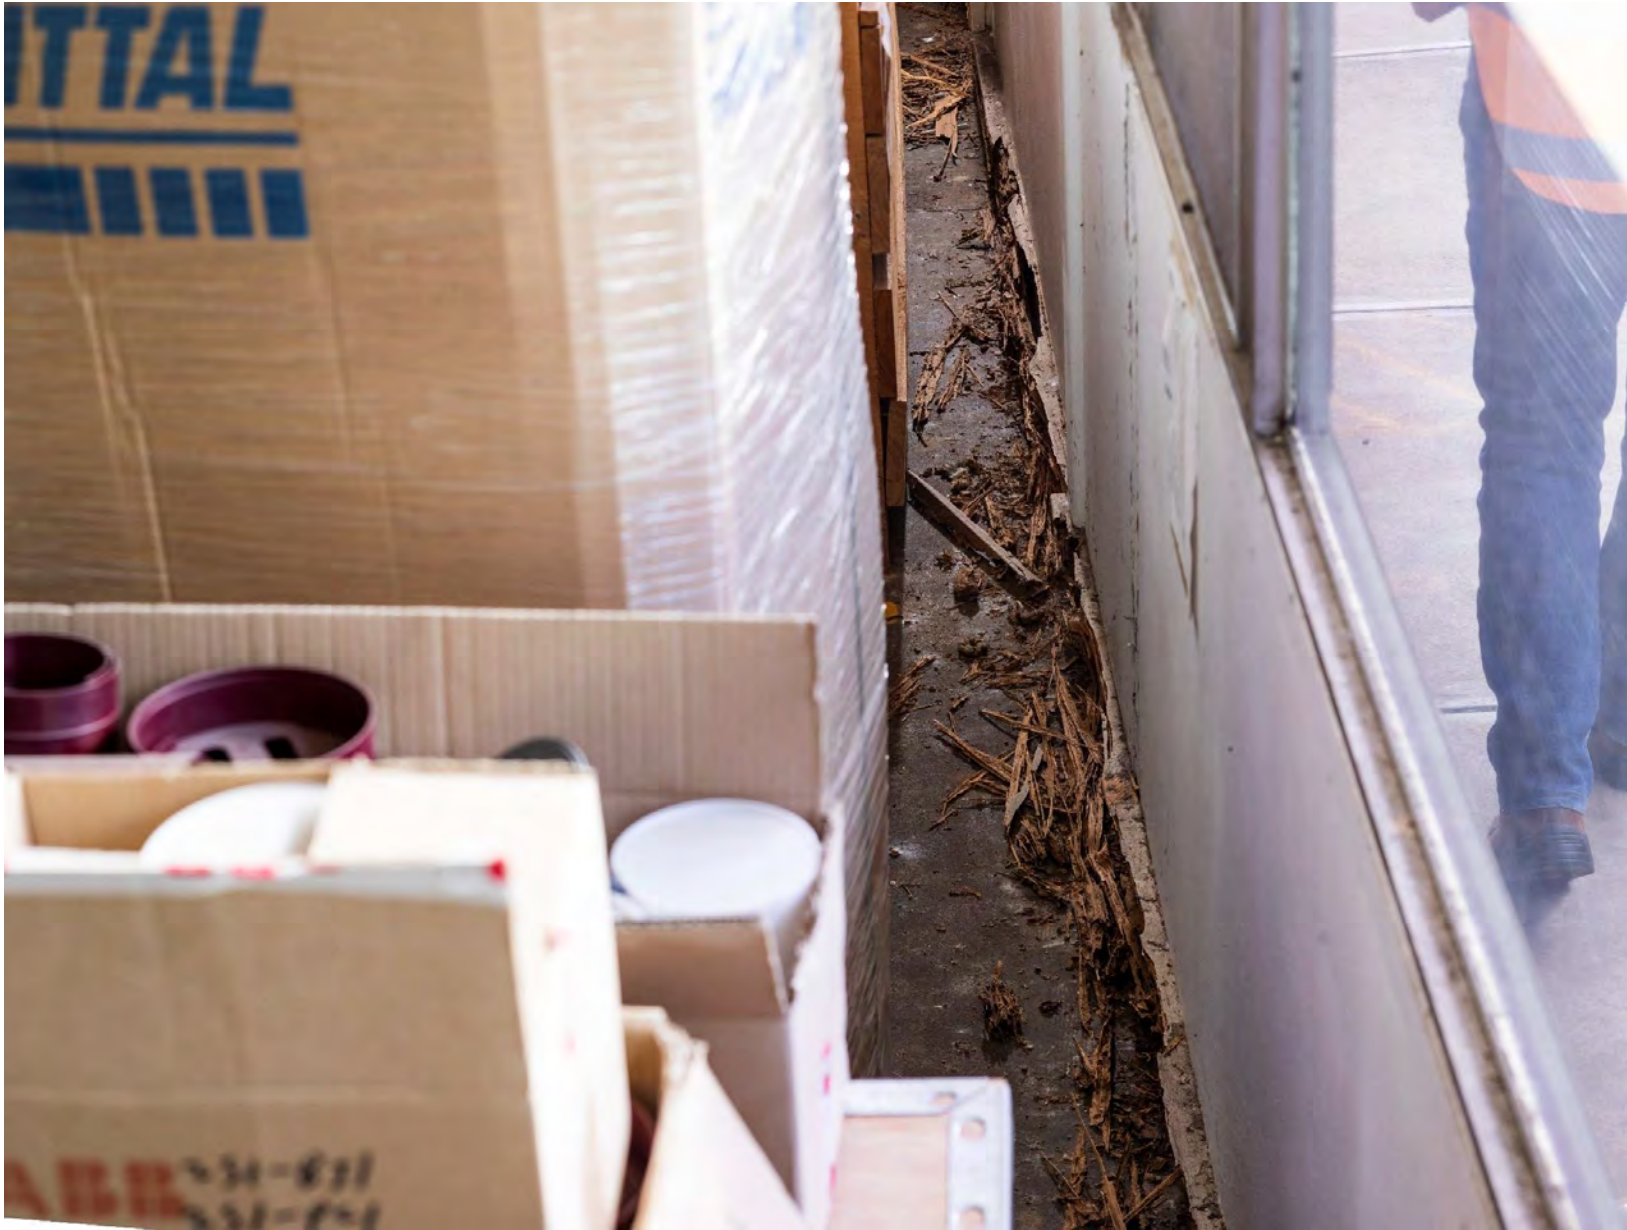
- Significant termite damage to internal timberwork in old admin building.

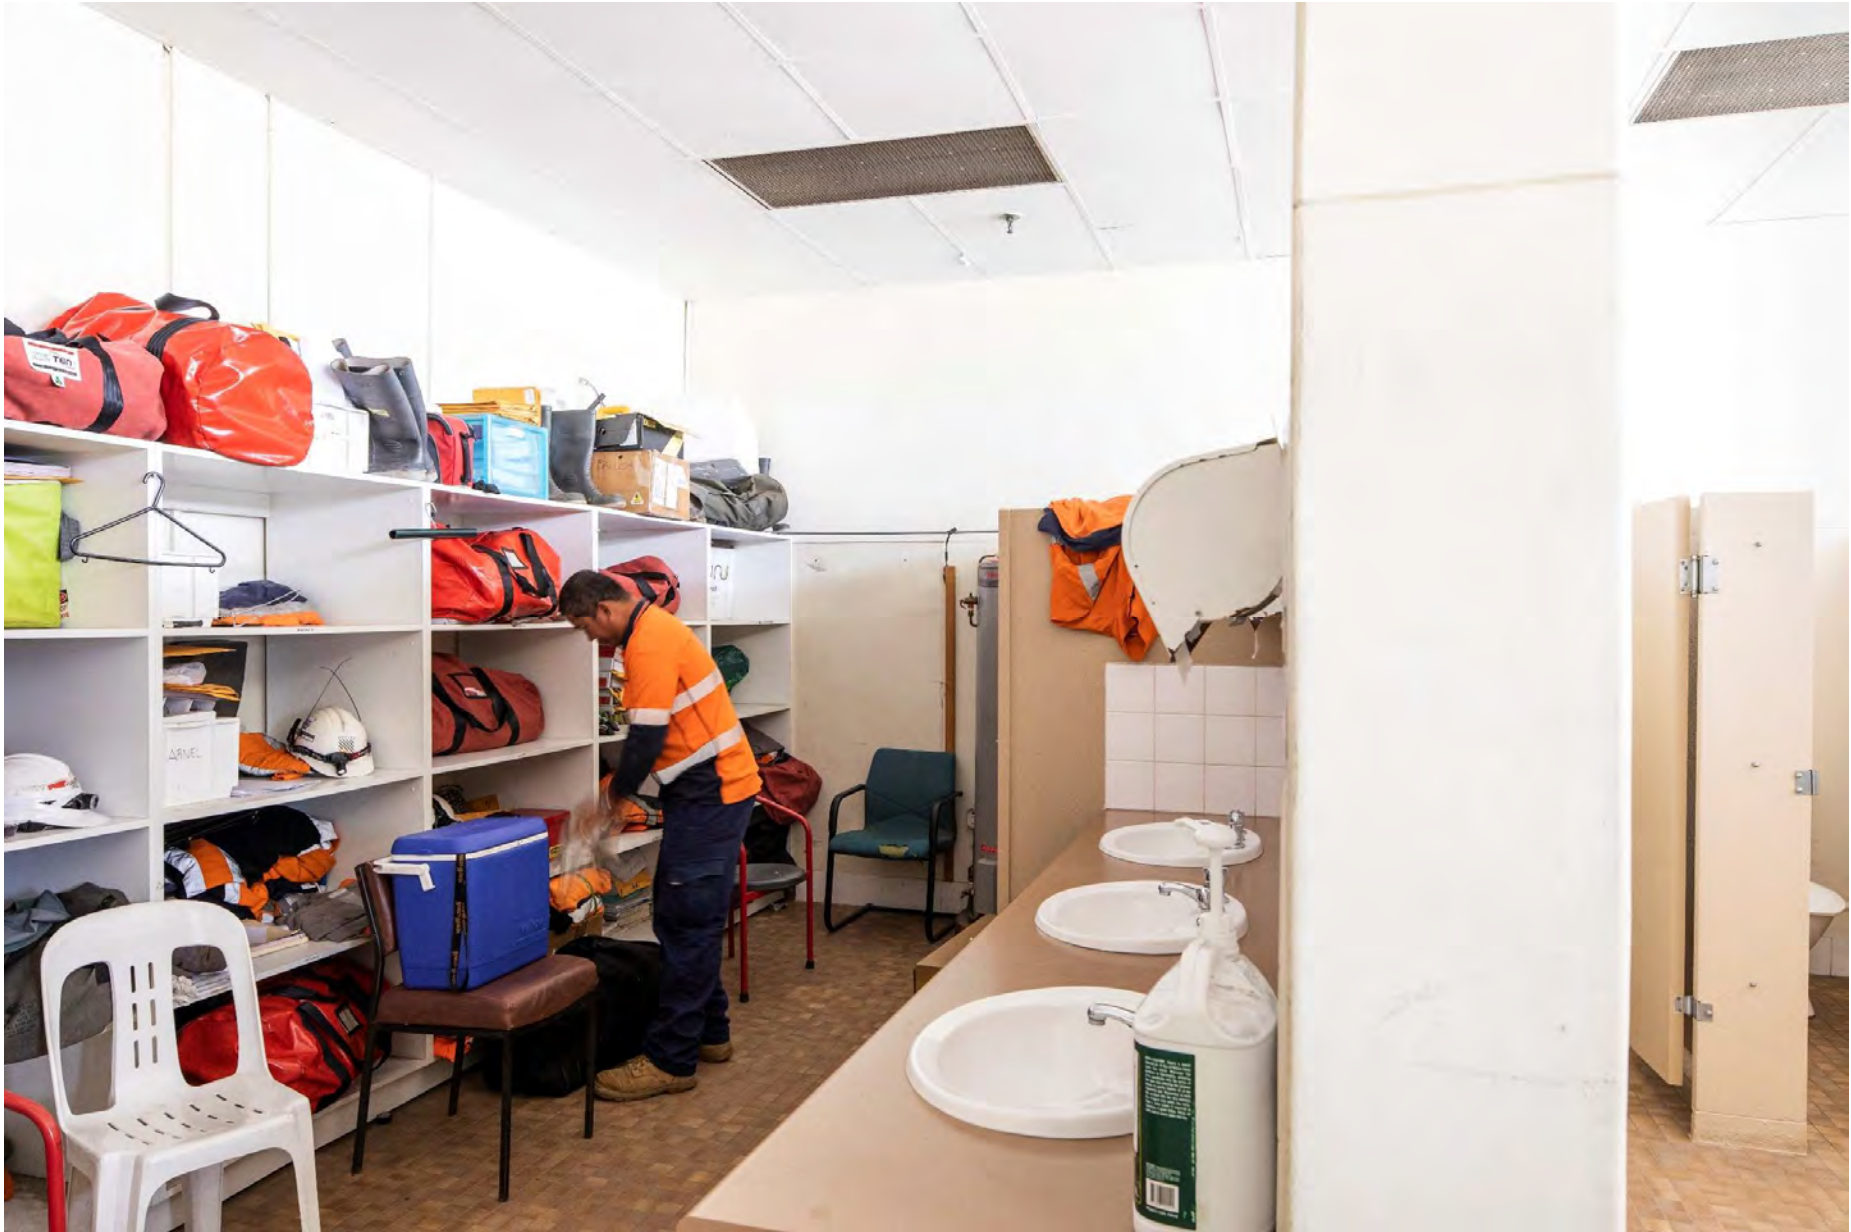
- Transmission breakout area, bag storage and toilets all in the same area with no dedicated female facilities. All in poor condition.

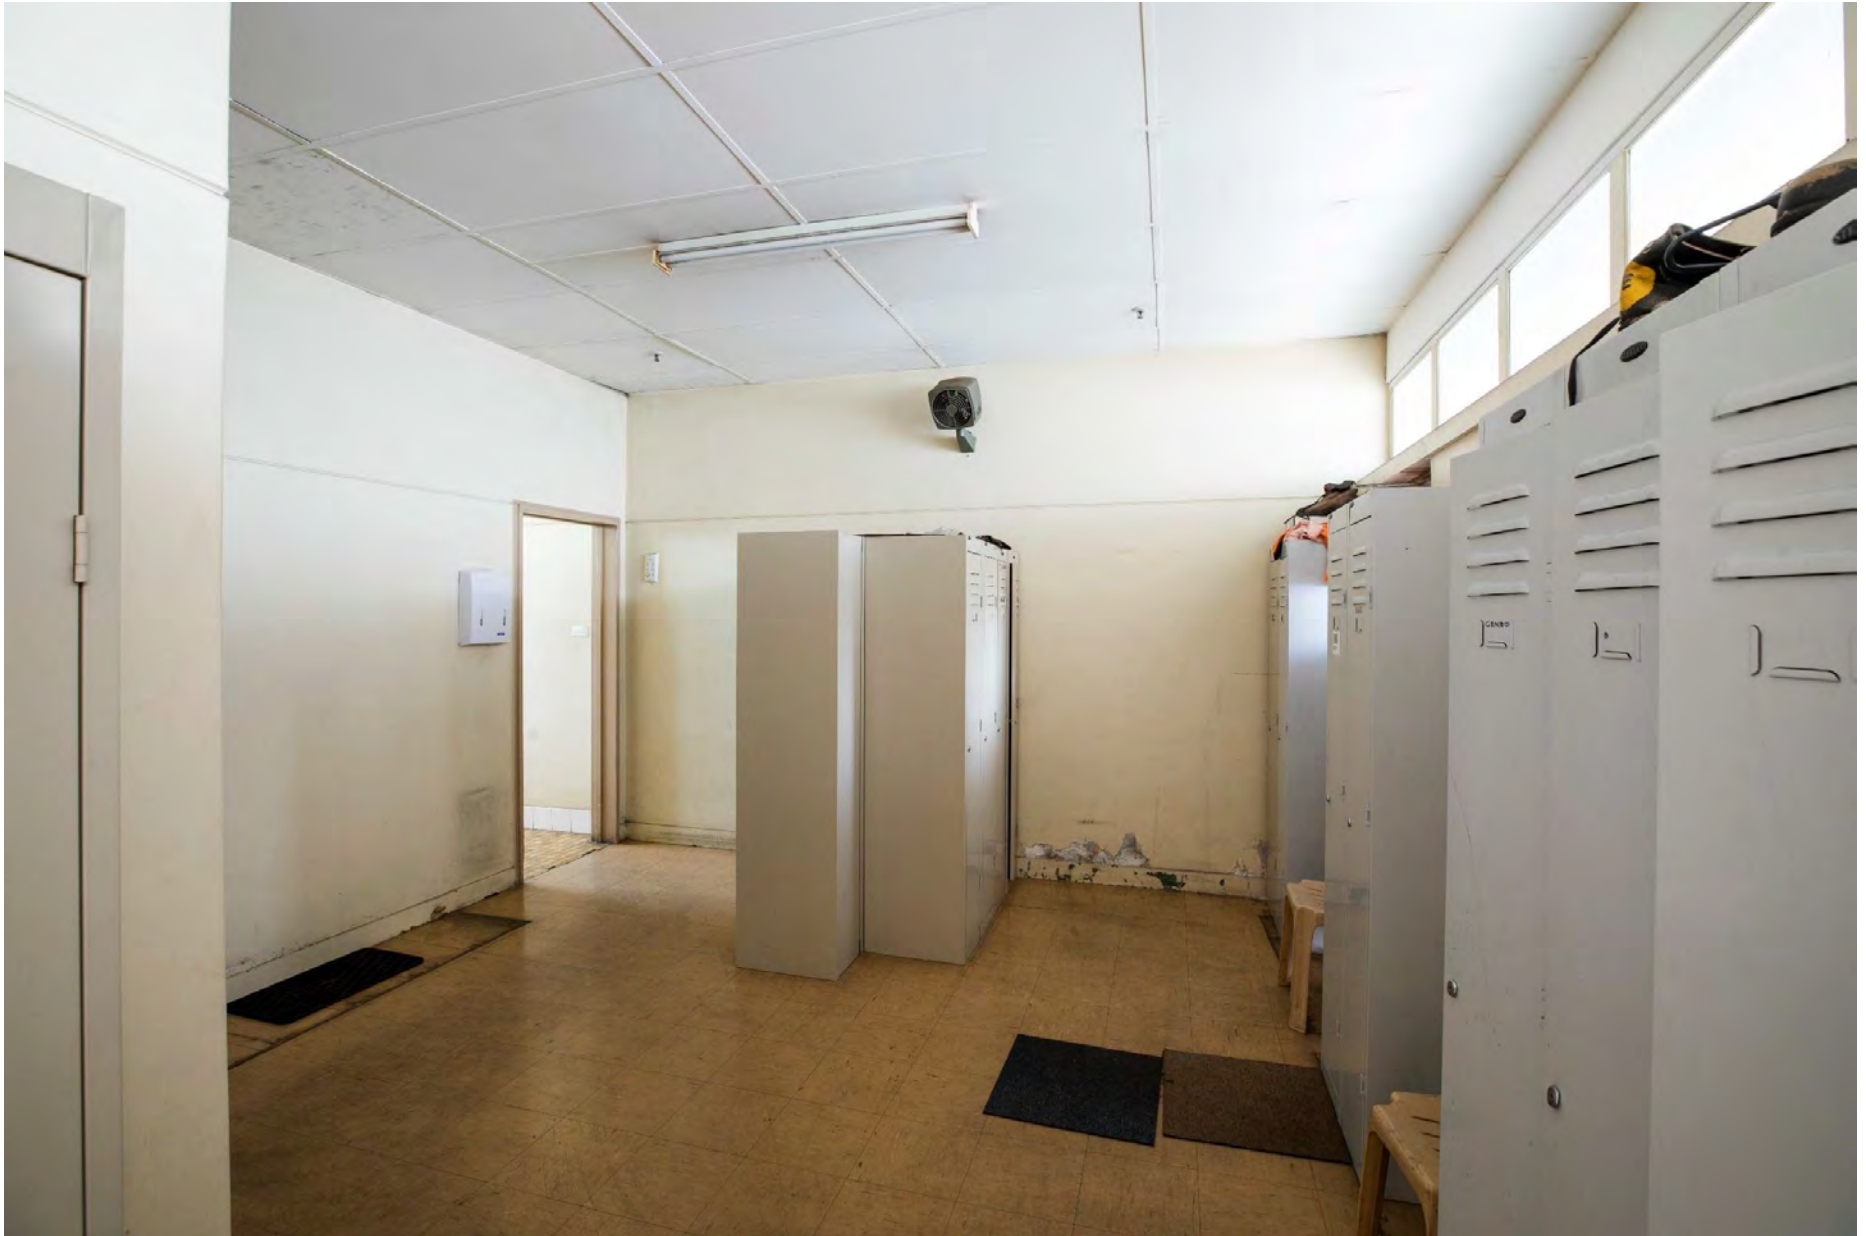
- Locker rooms in poor condition

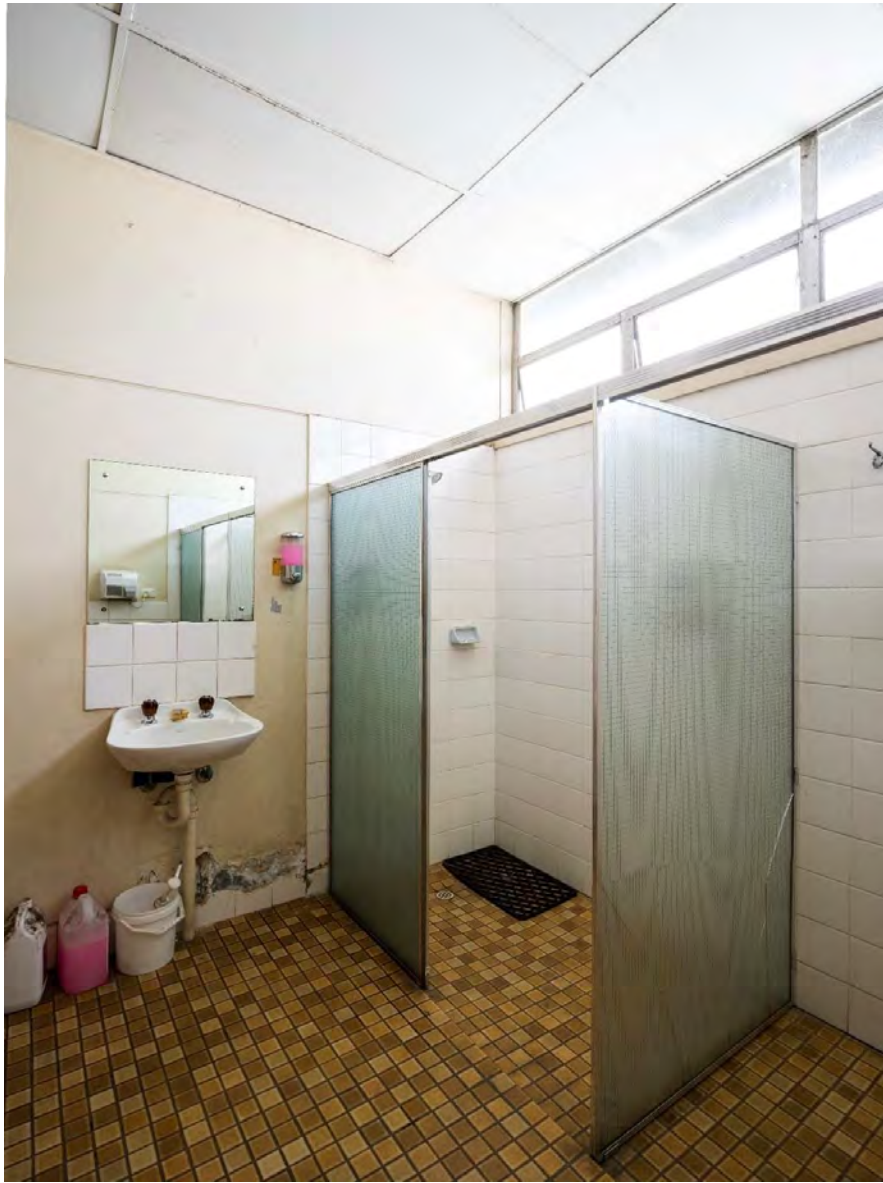
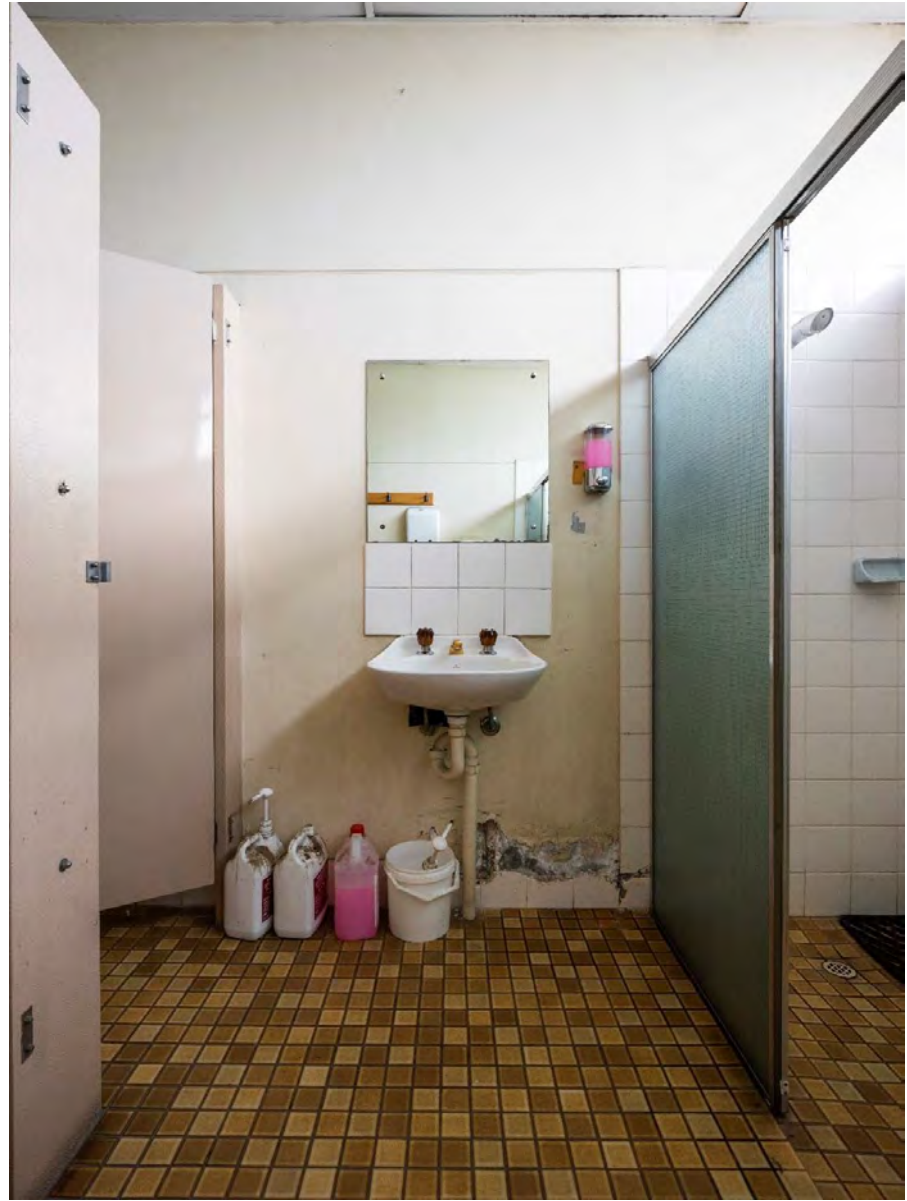
- Toilet and shower cubicles all original 1950's fit-out in very poor condition.

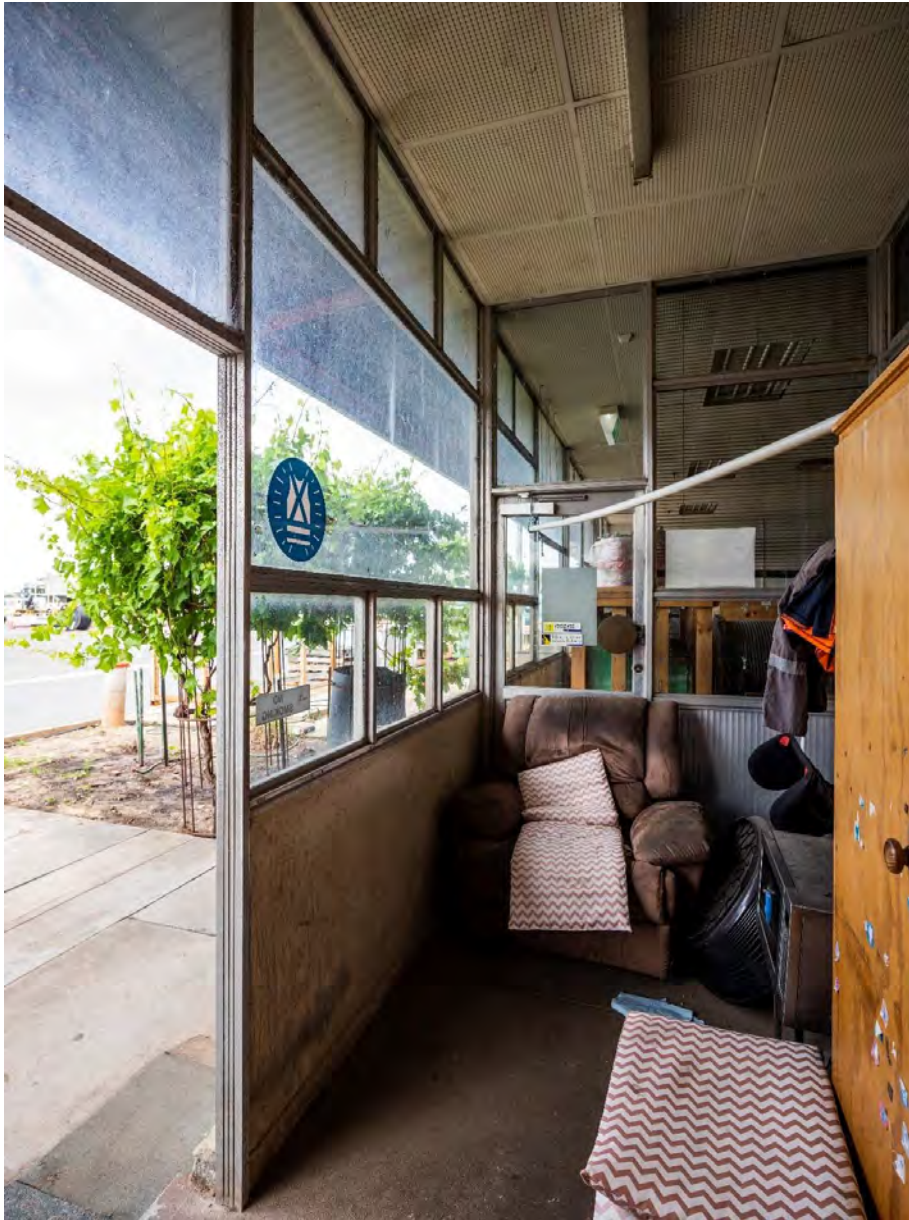
- Small Break out area with Microwave in very poor condition

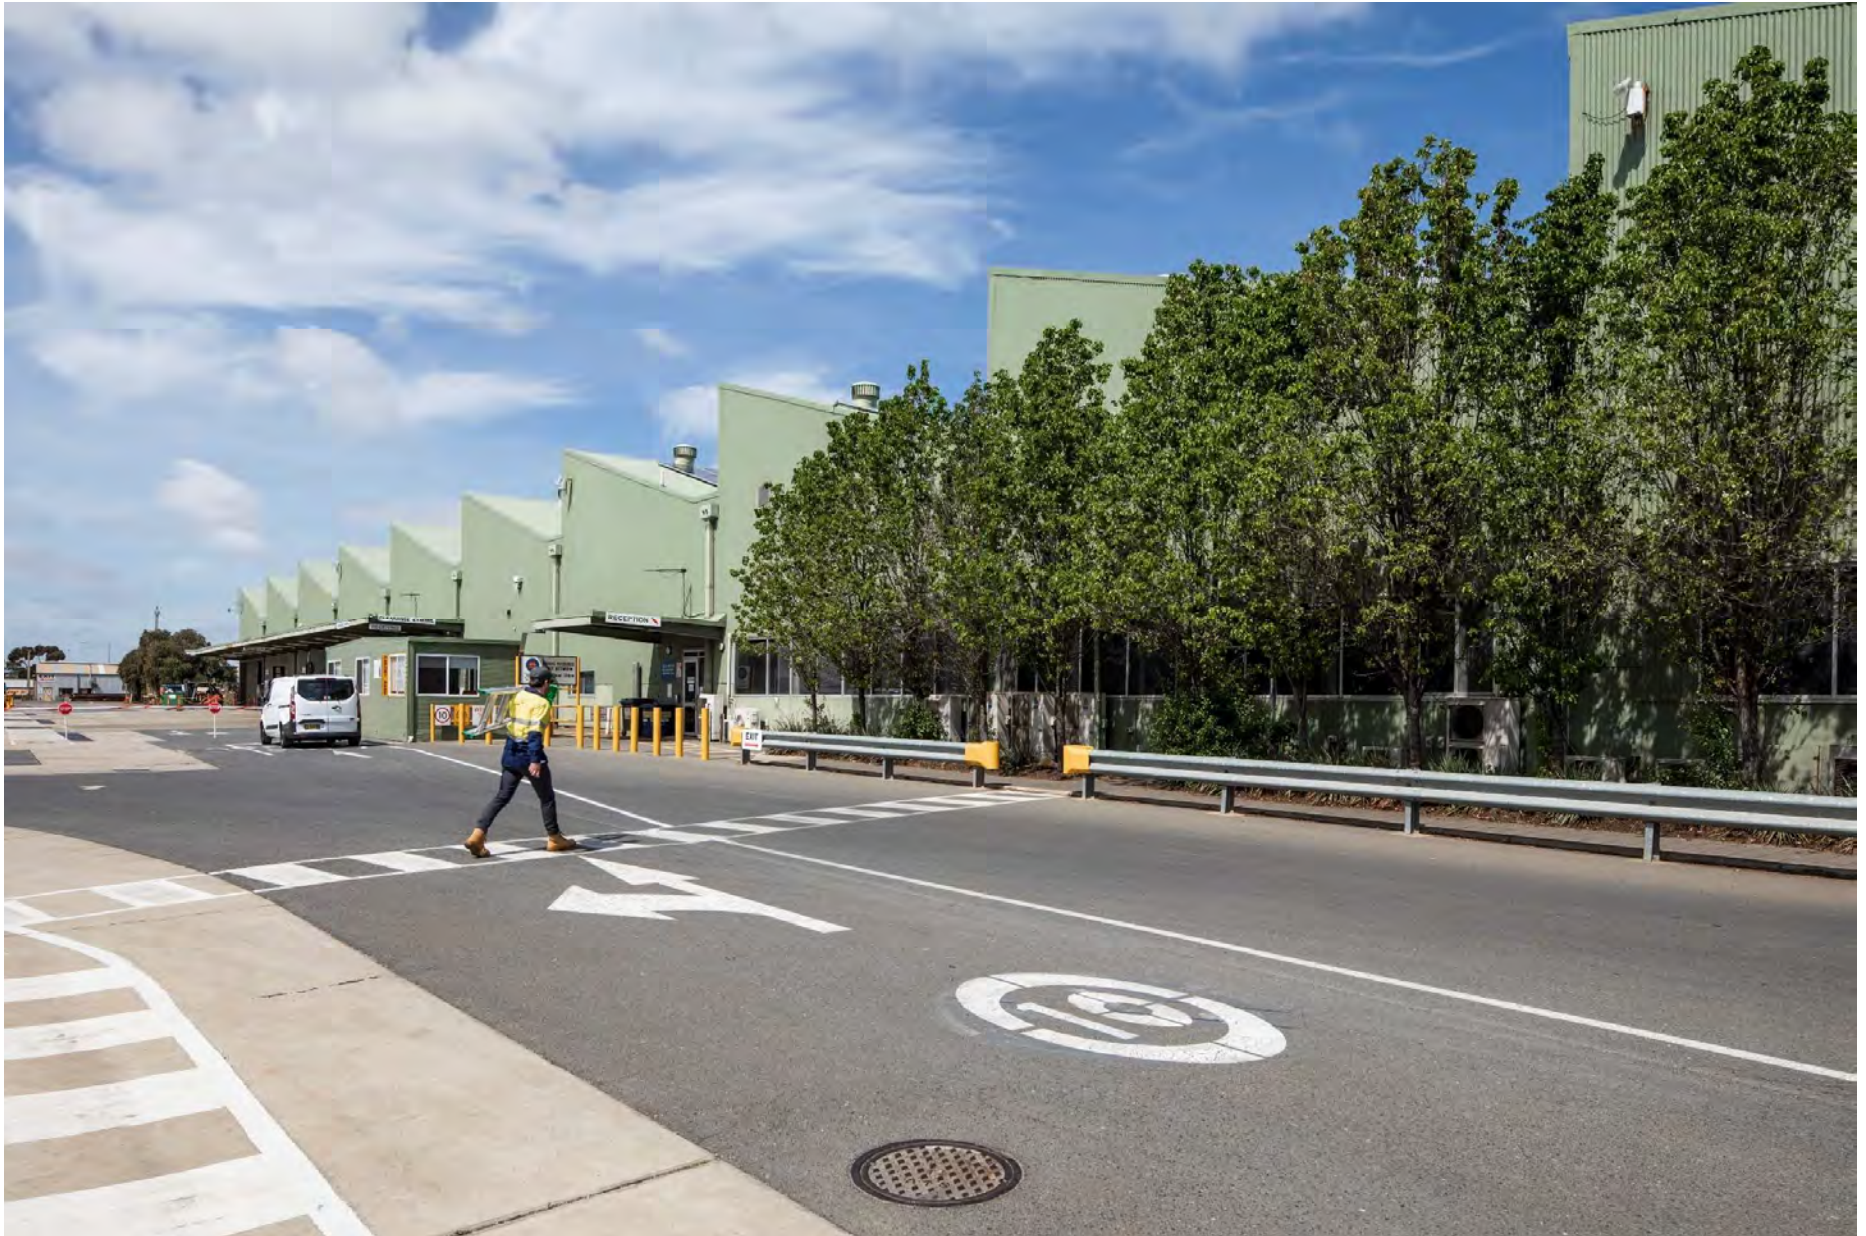
- Pedestrian Walkway between Transmission Area and Logistics Admin building. Crosses main driveway for two-way Heavy Vehicle Flow.

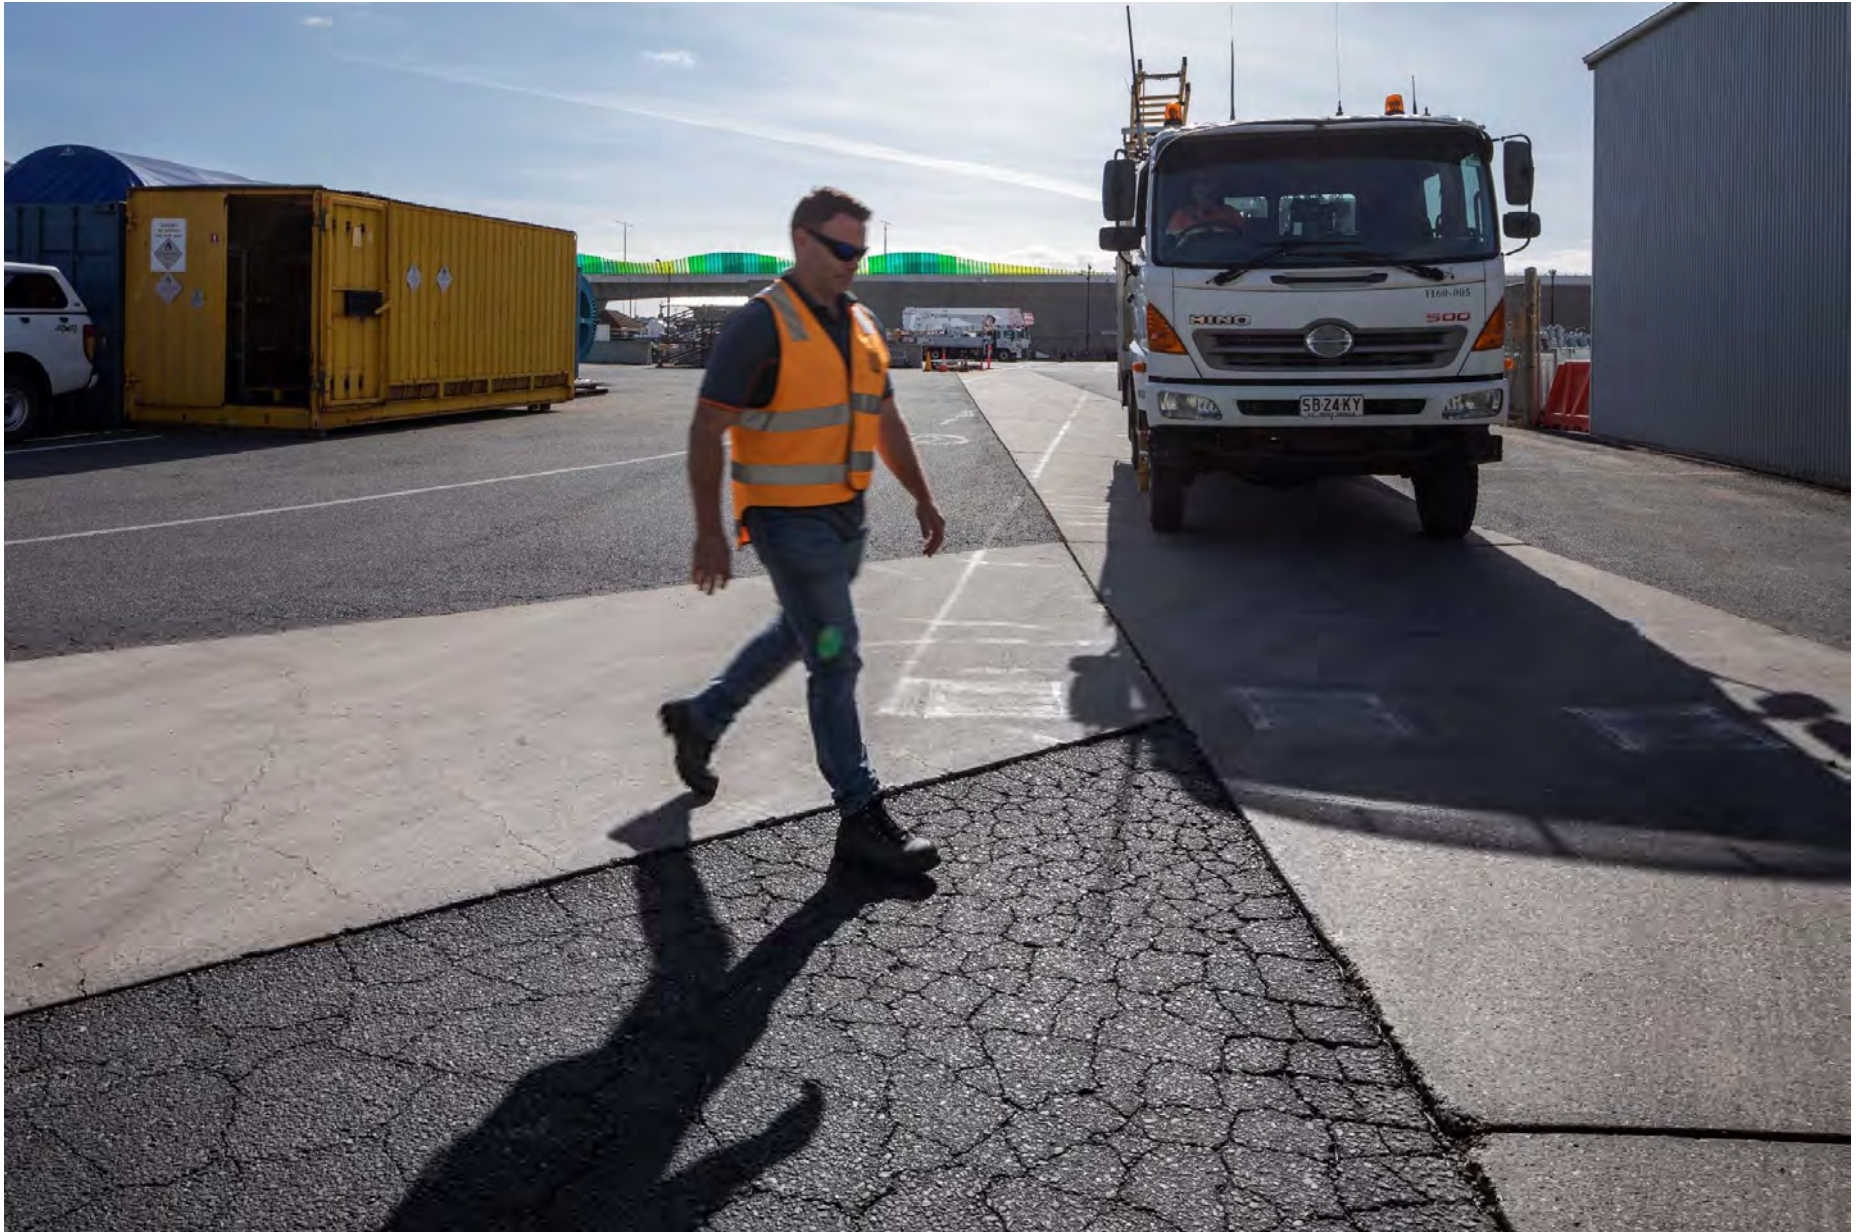
- Cracking and damage to pedestrian walkways, thoroughfares and concrete drainage areas.

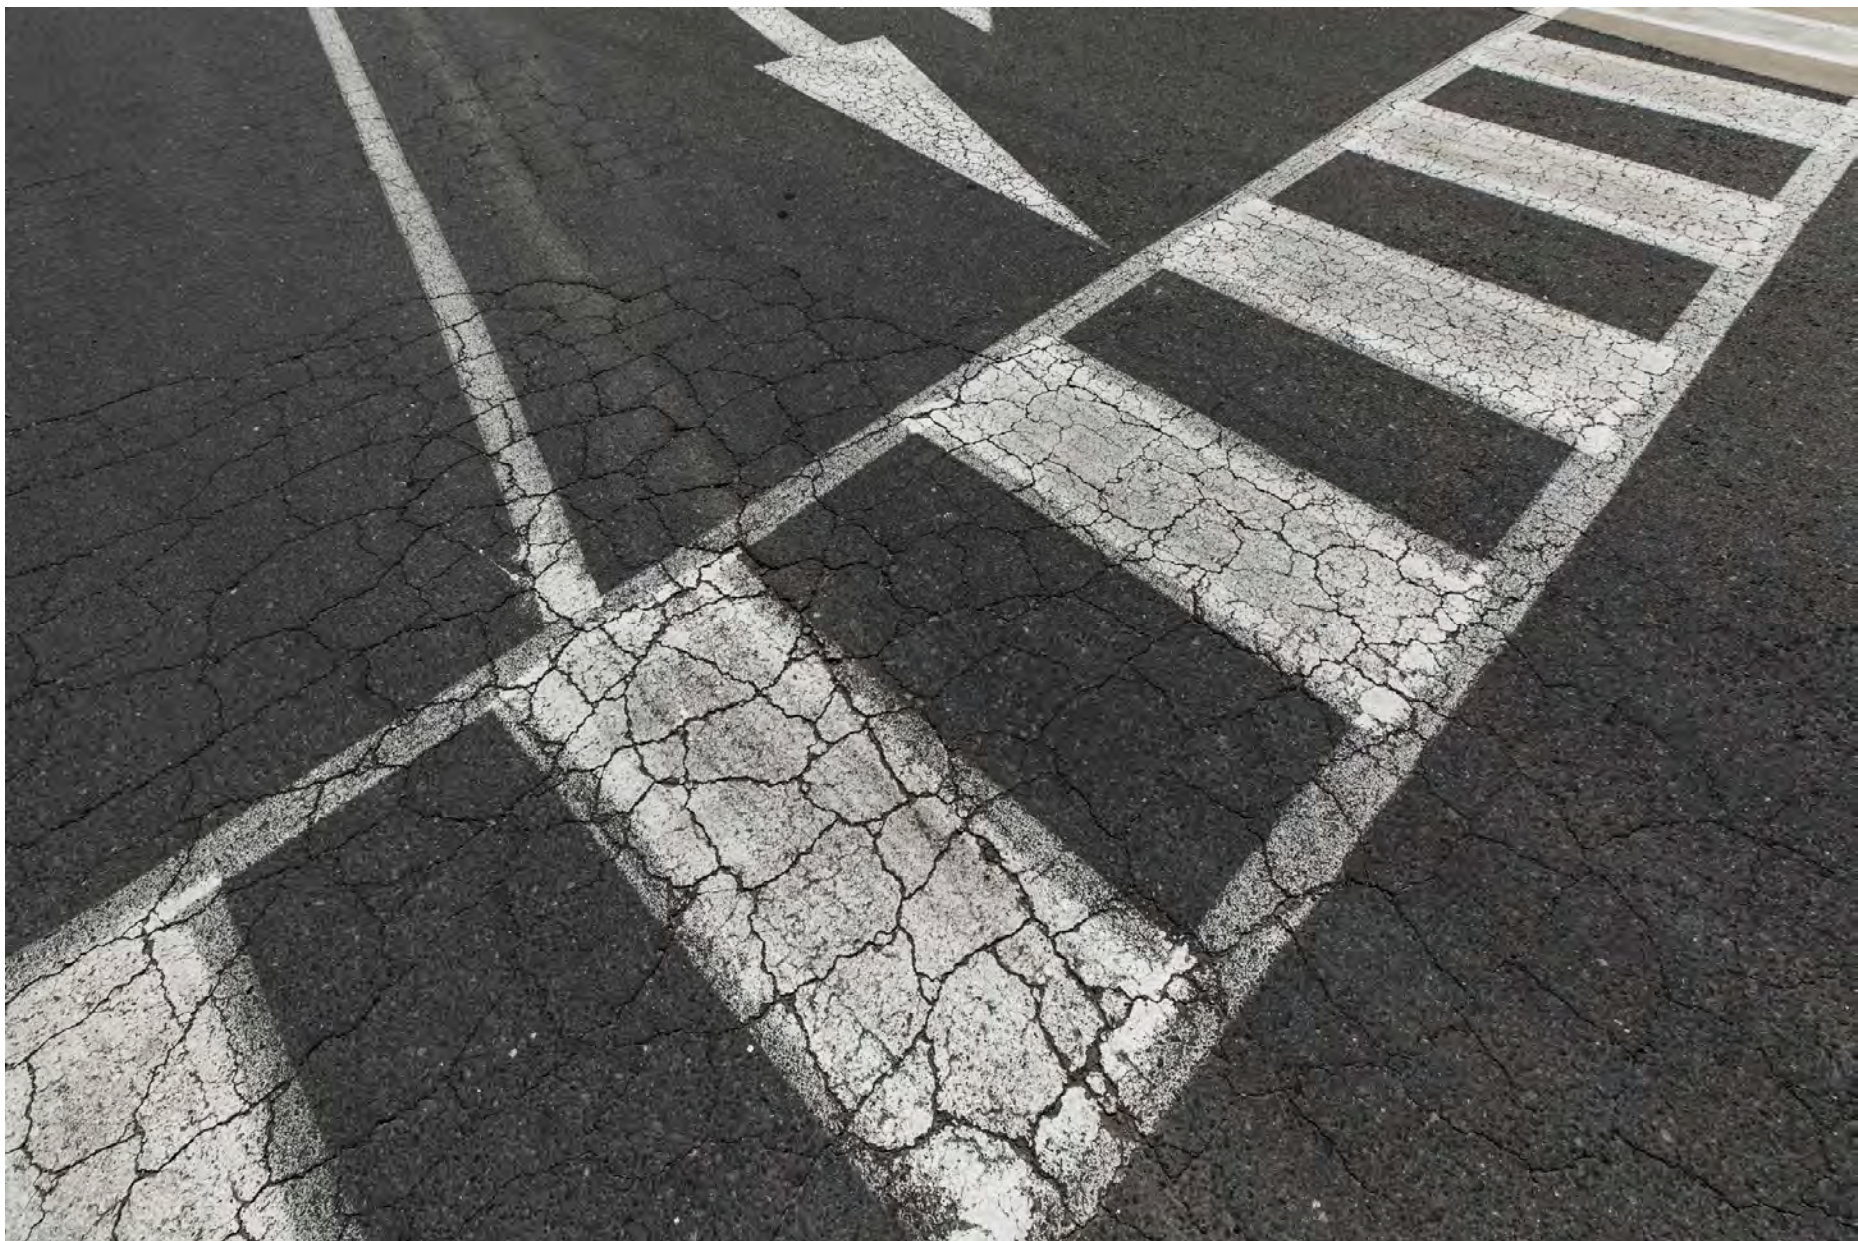
- Cracking and damage to pedestrian walkways.
