Supporting
document 5.22.2

Angle Park North Photographs

2020-25 Revised
Regulatory Proposal
10 December 2019

Angle Park Asset Condition Photographs

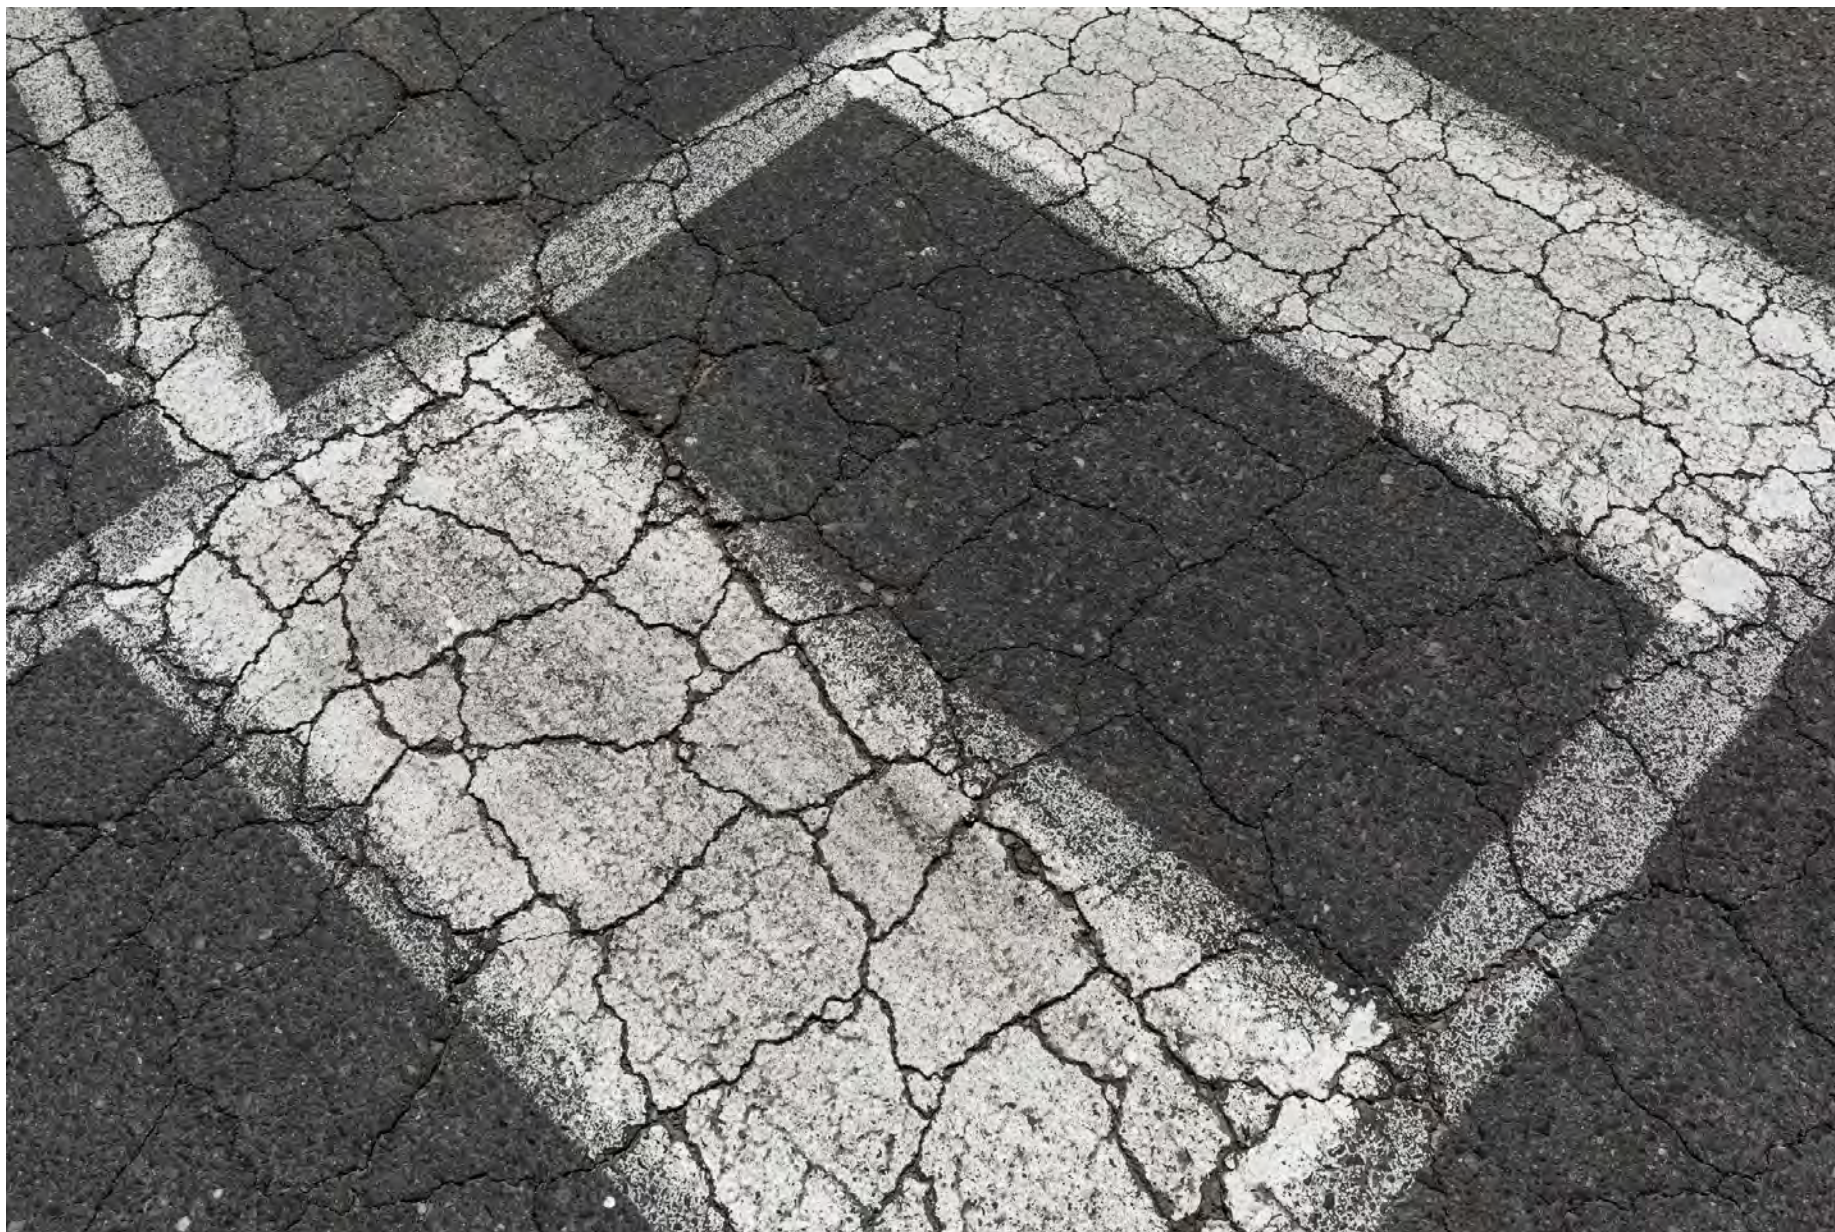
- Cracking and damage to pedestrian walkways

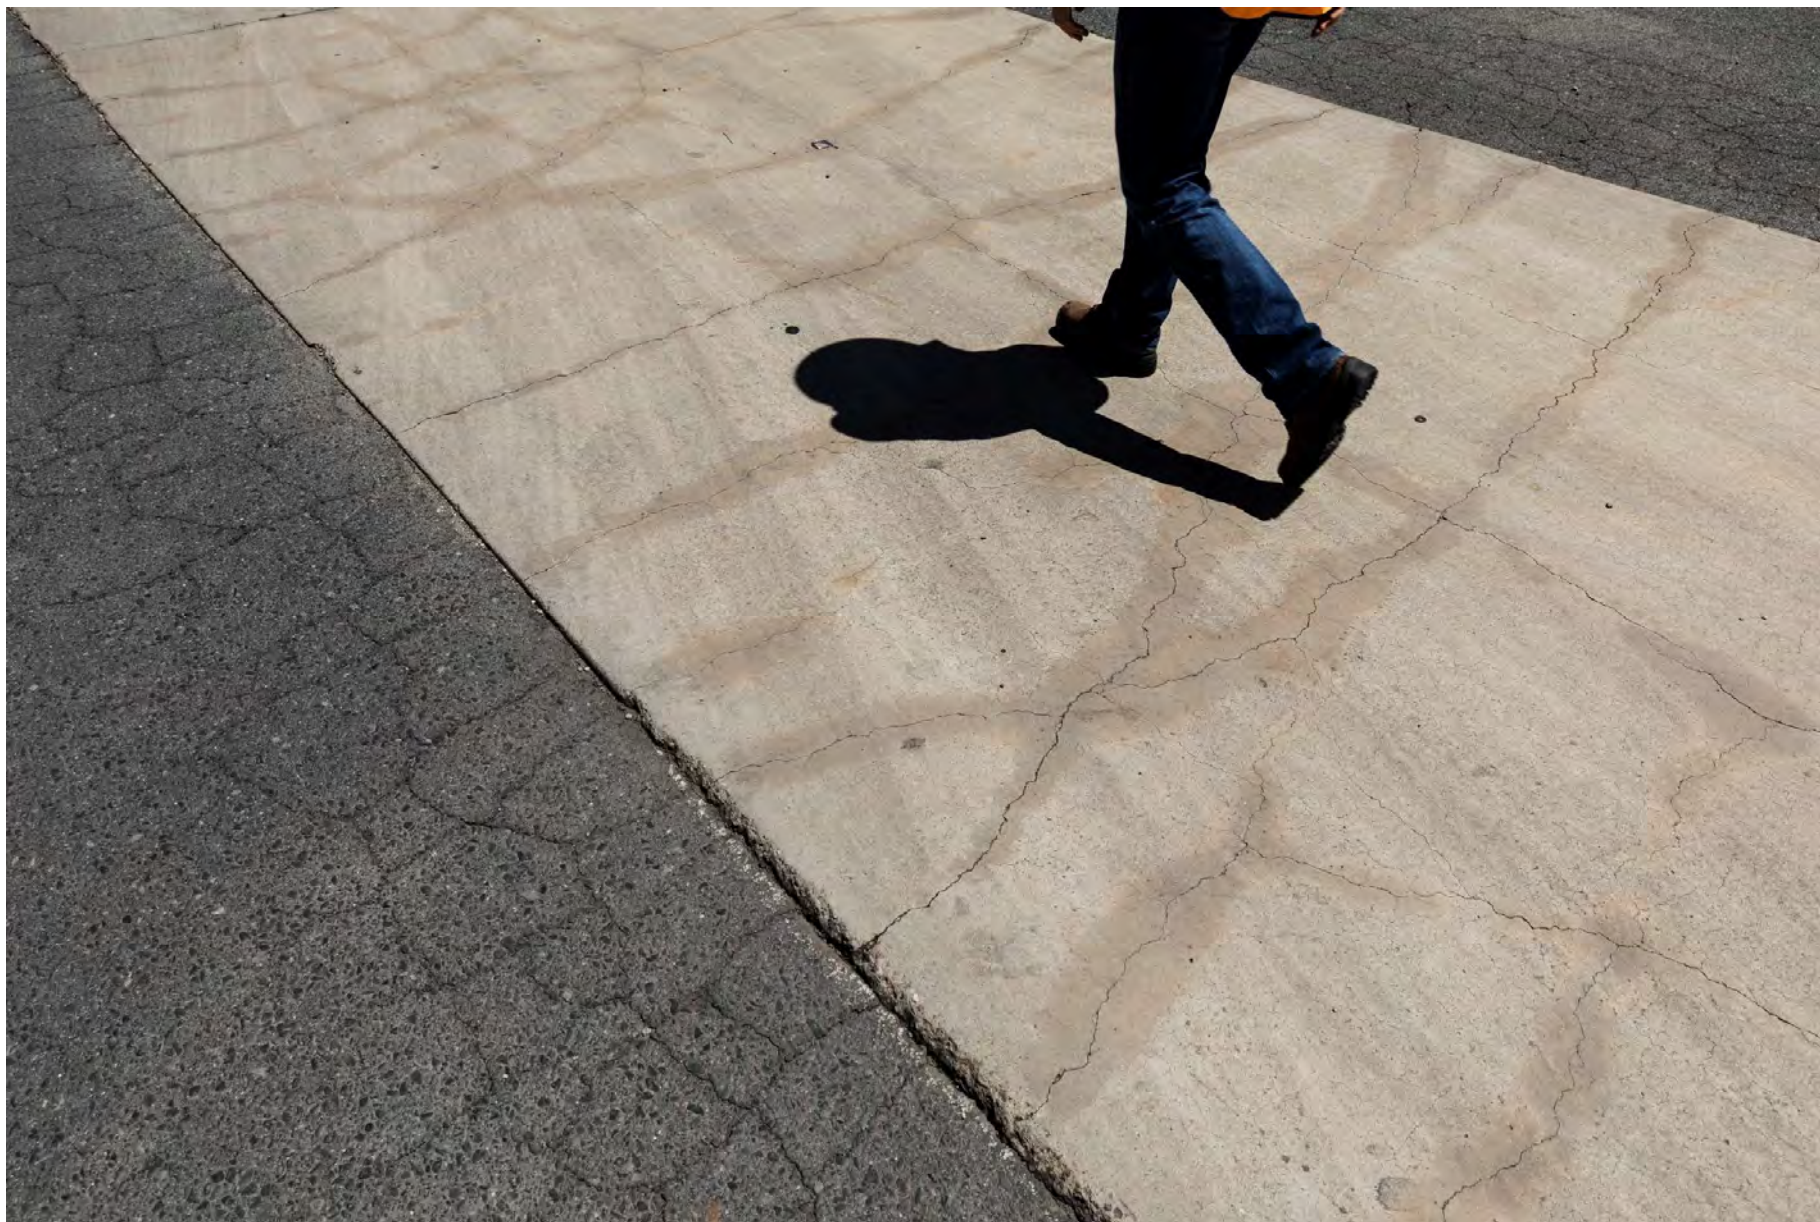
- Cracking and damage to pedestrian walkways, thoroughfares and concrete drainage areas. Also showing previous glue repair failures.

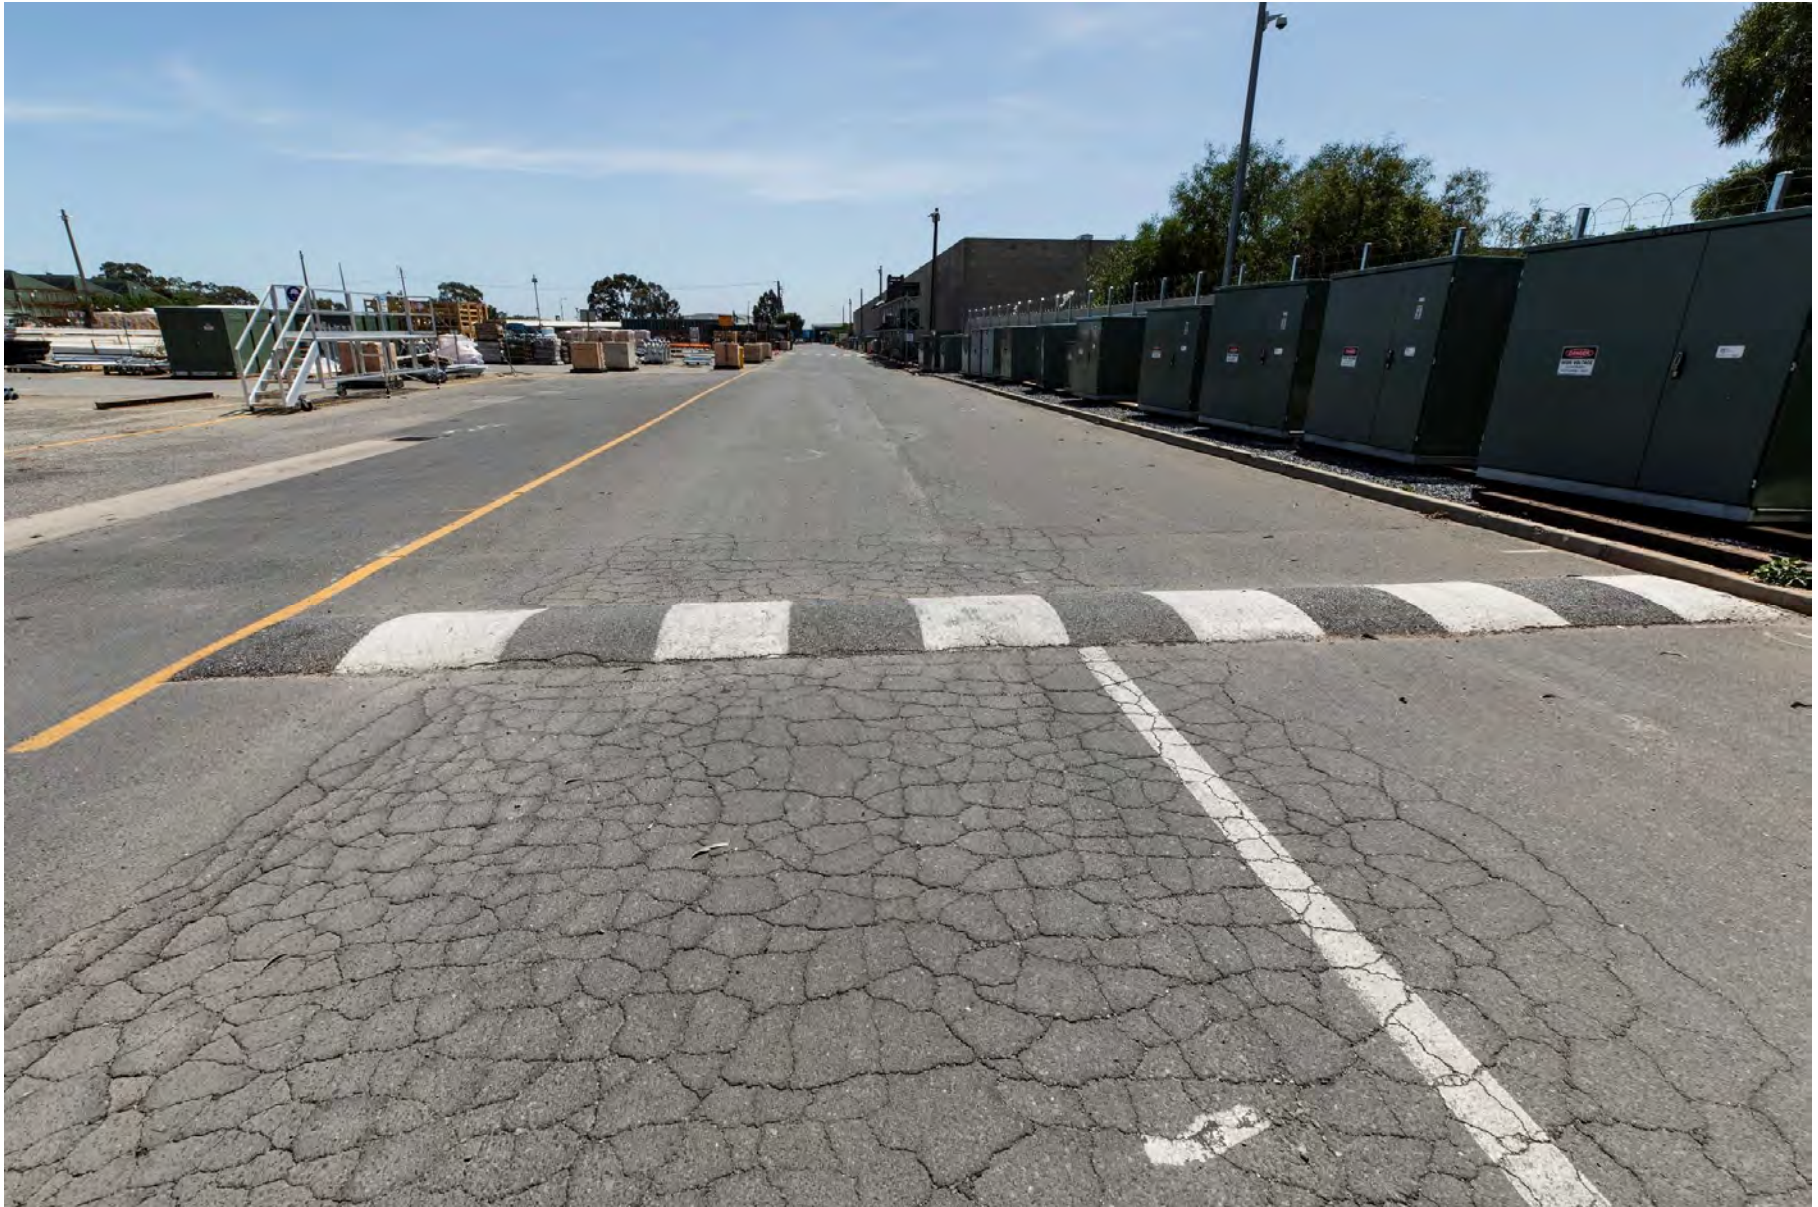
- Significant bitumen damage to semi-trailer route and turning circles and Transmission Heavy Vehicle Parking and Storage areas

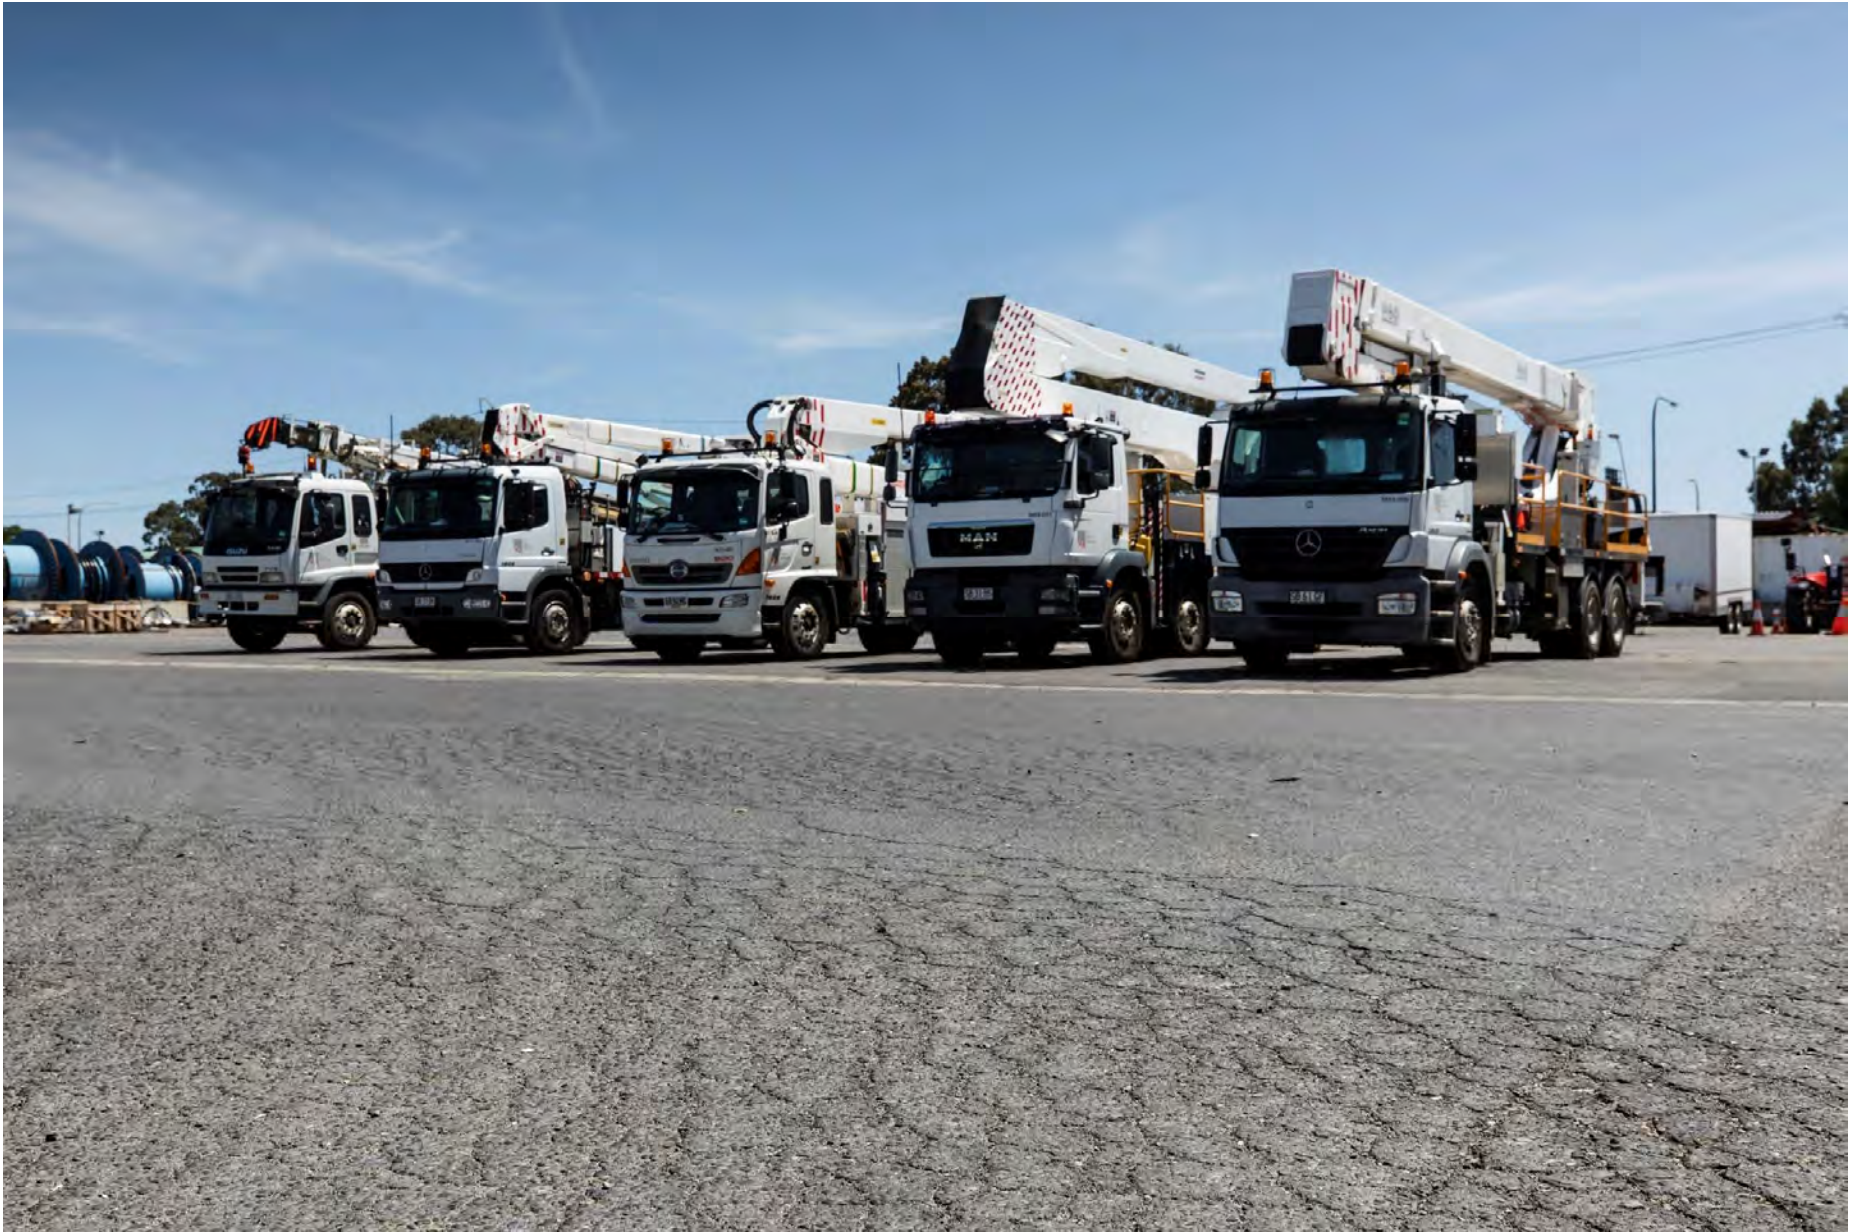
- Significant bitumen damage to semi-trailer route and turning circles and Transmission Heavy Vehicle Parking and Storage areas

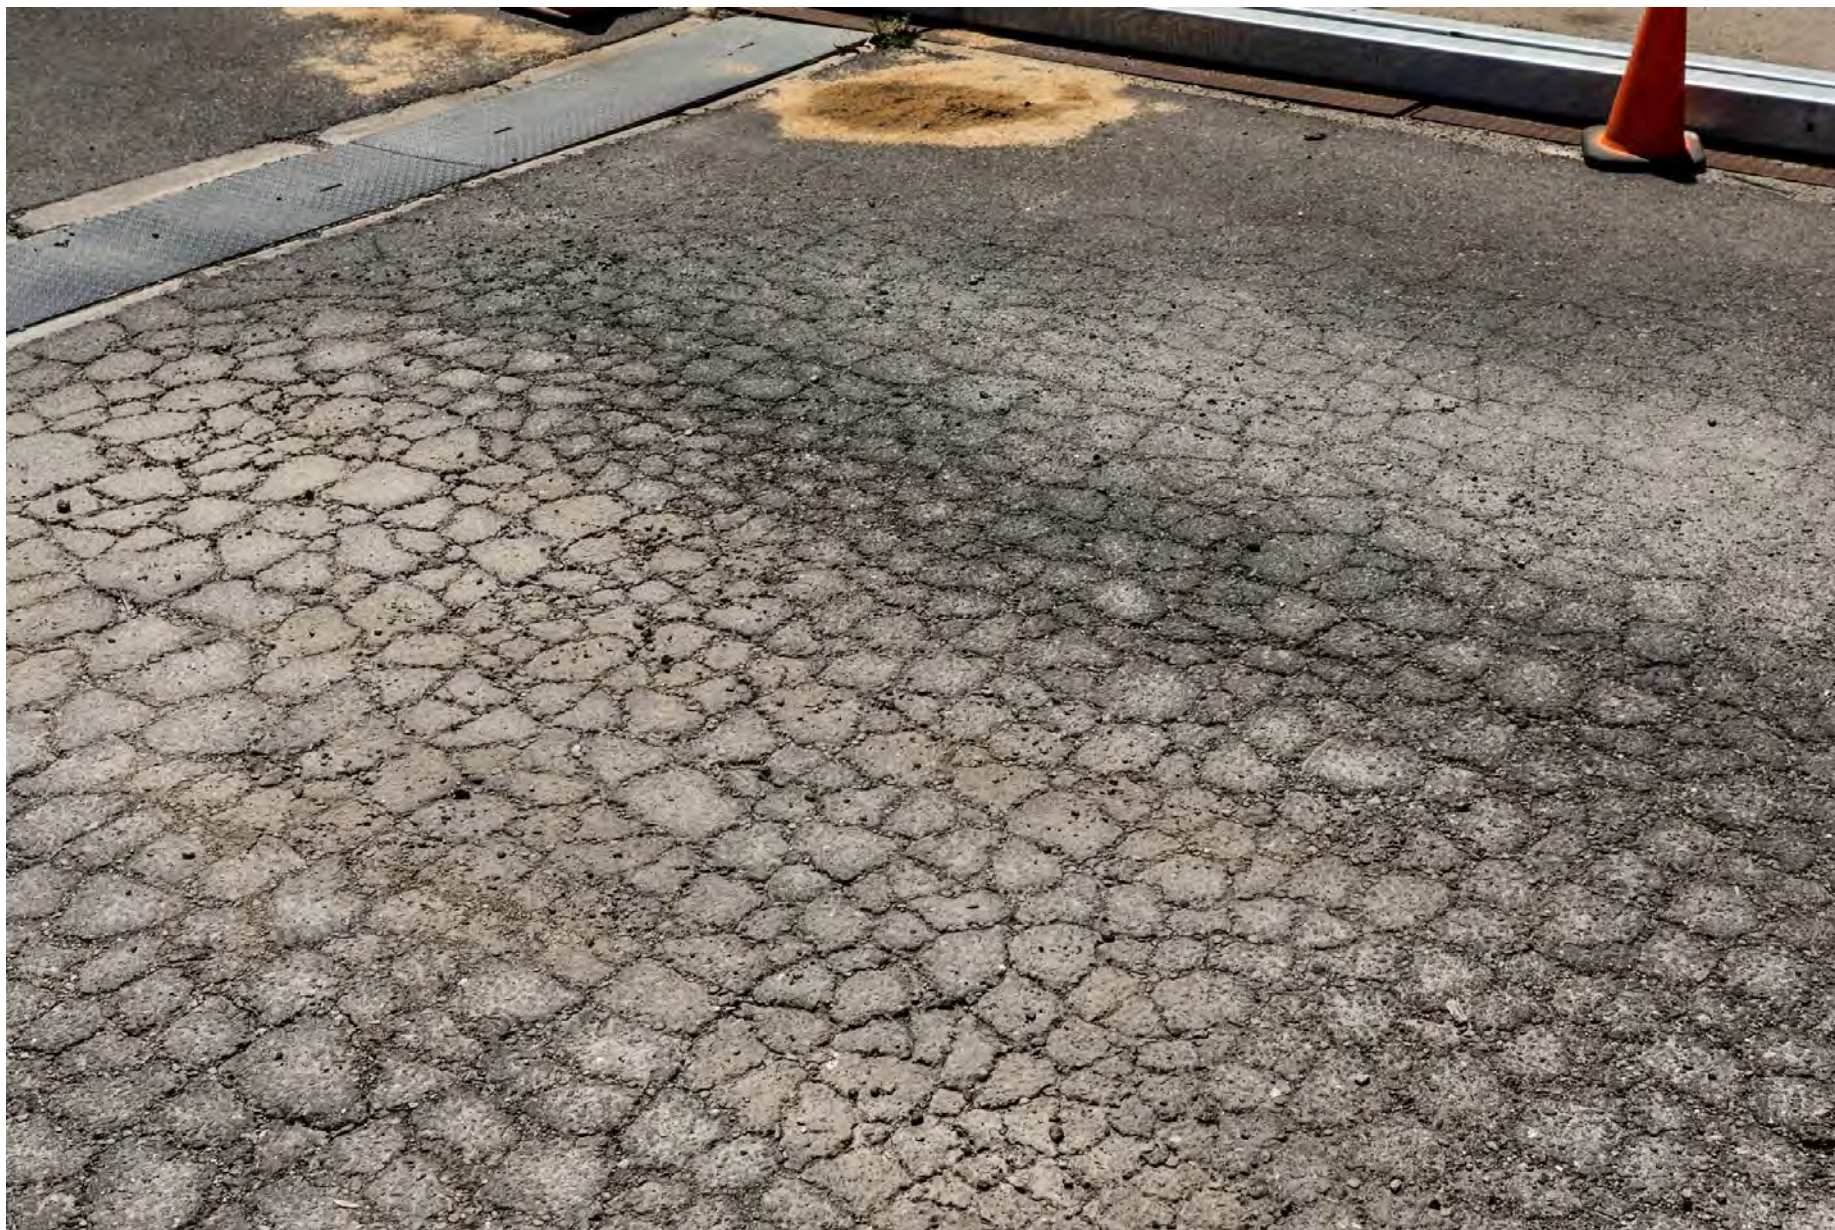
- Significant bitumen damage to semi-trailer route and turning circles and Transmission Heavy Vehicle Parking and Storage areas

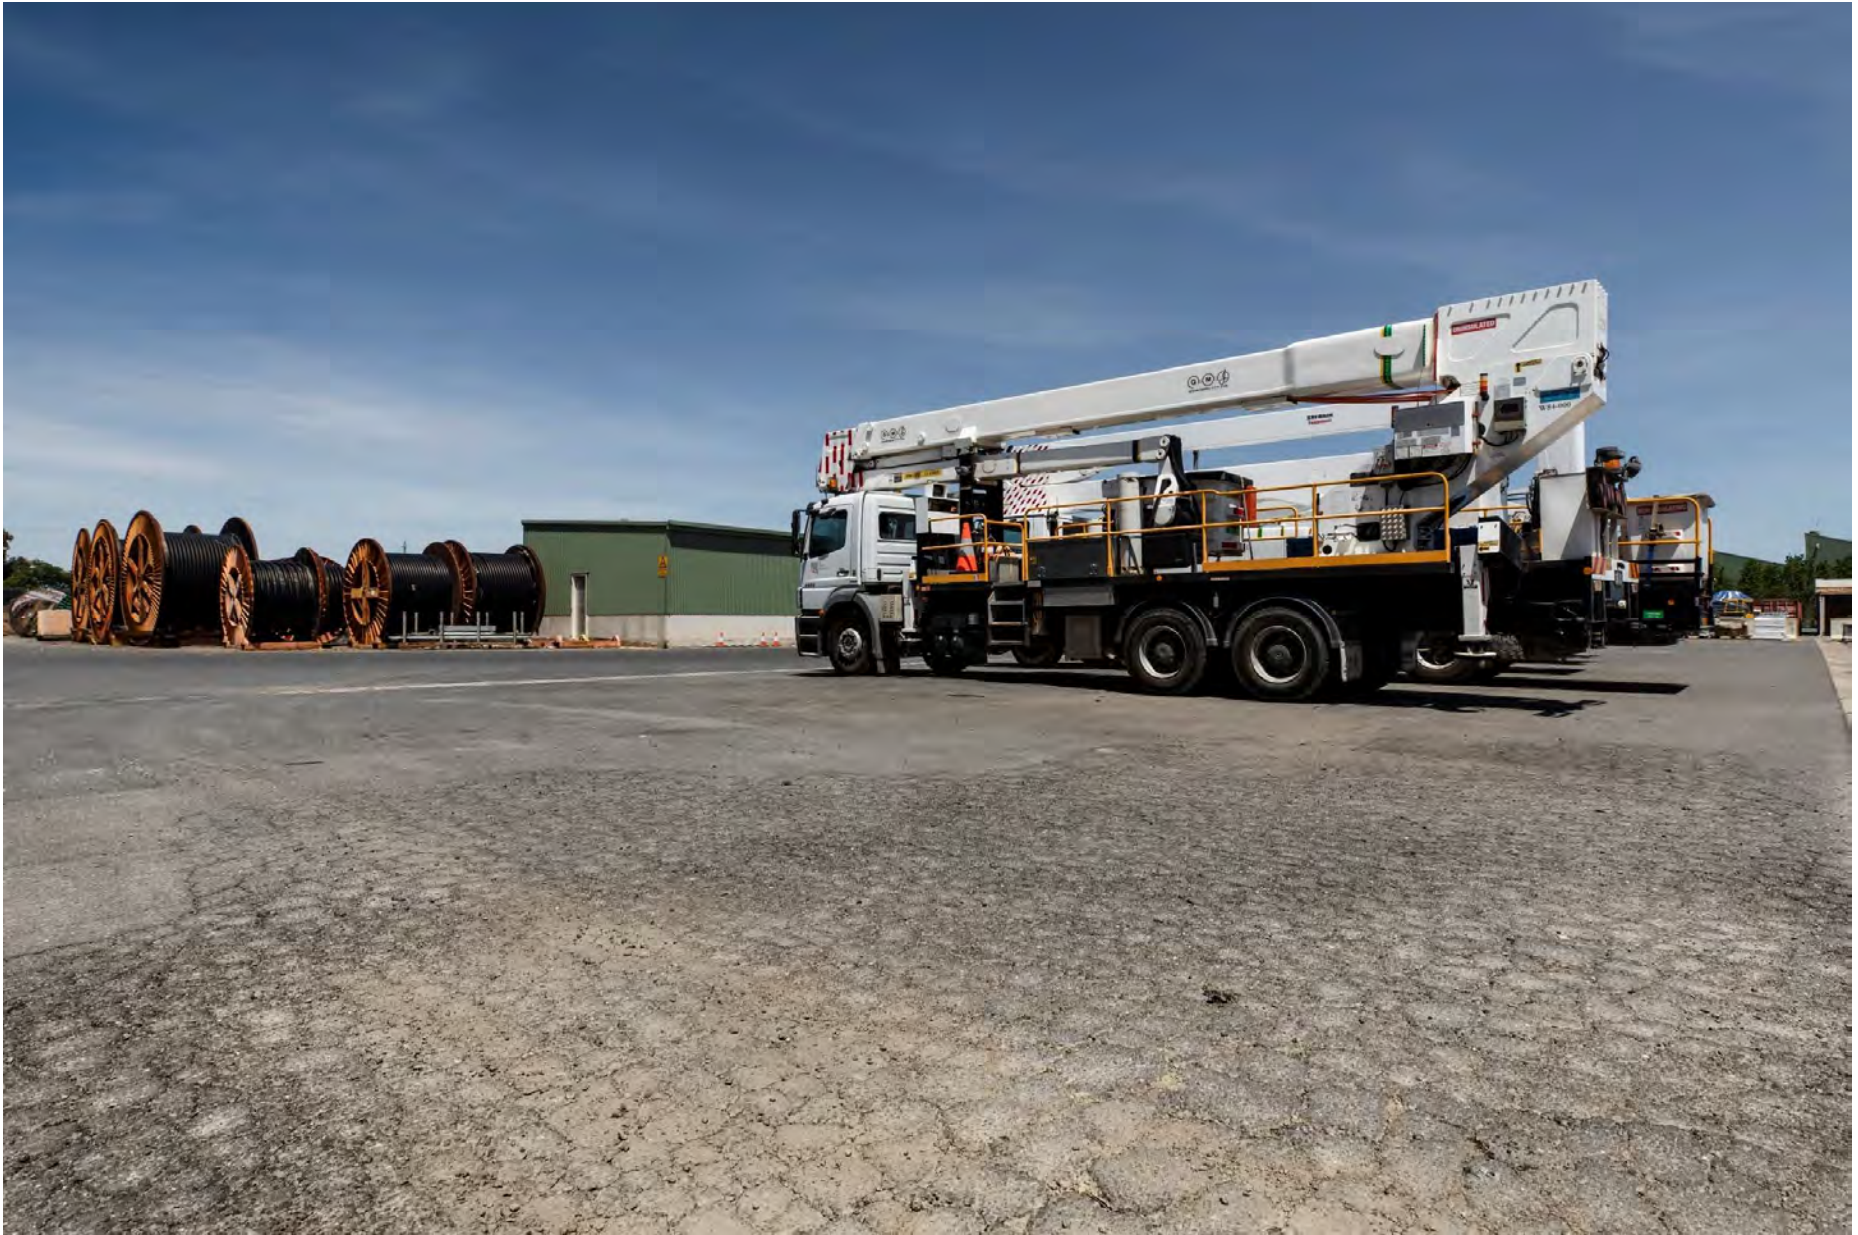
- Significant bitumen damage to semi-trailer route and turning circles and Transmission Heavy Vehicle Parking and Storage areas

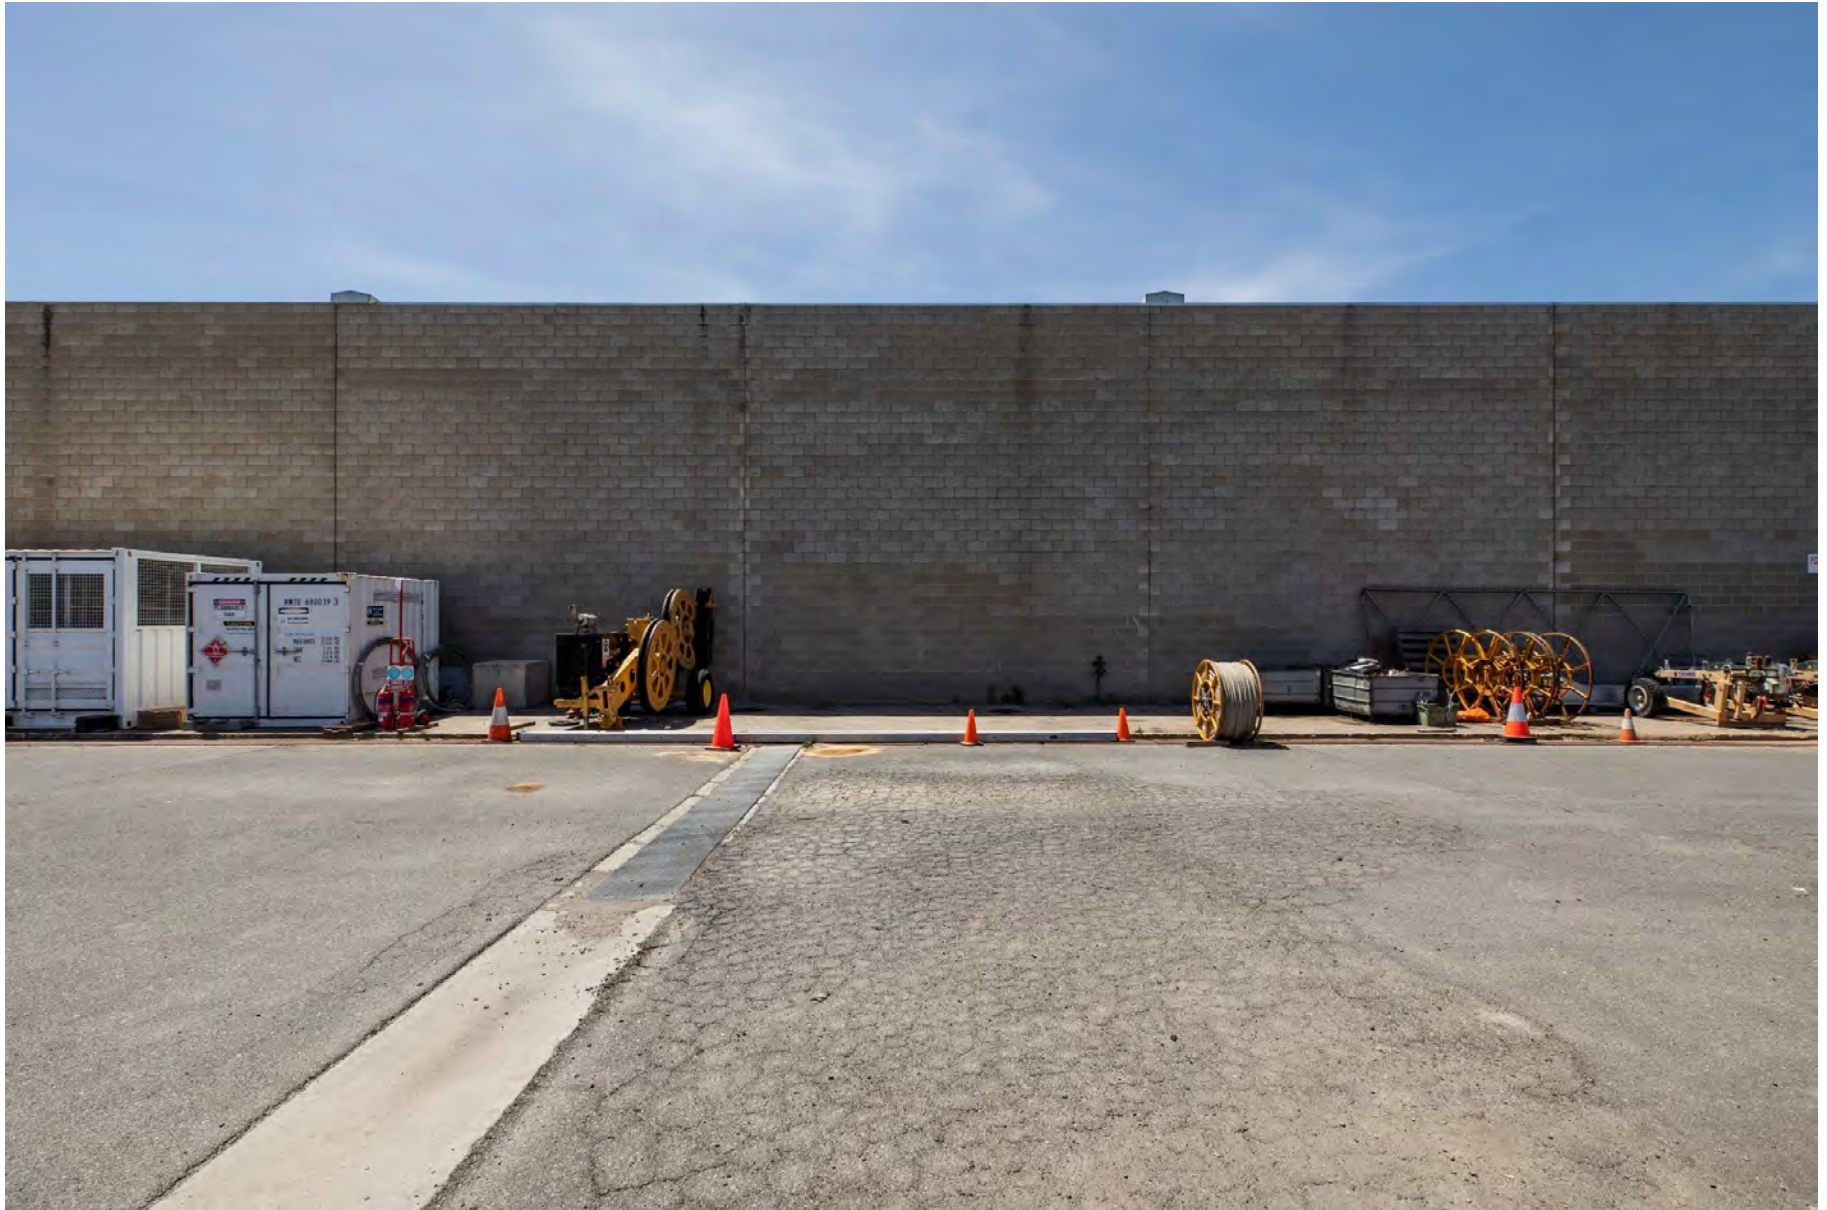
- Significant bitumen damage to semi-trailer route and turning circles and Transmission Heavy Vehicle Parking and Storage areas

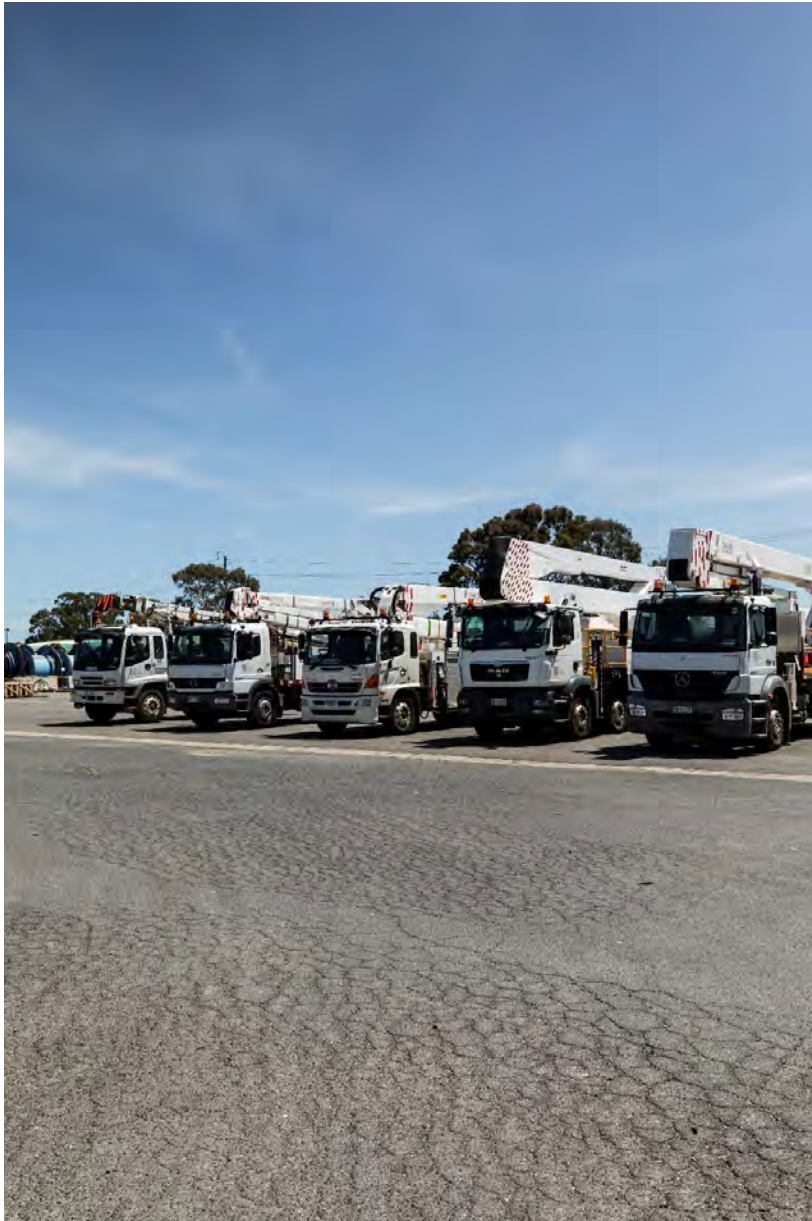
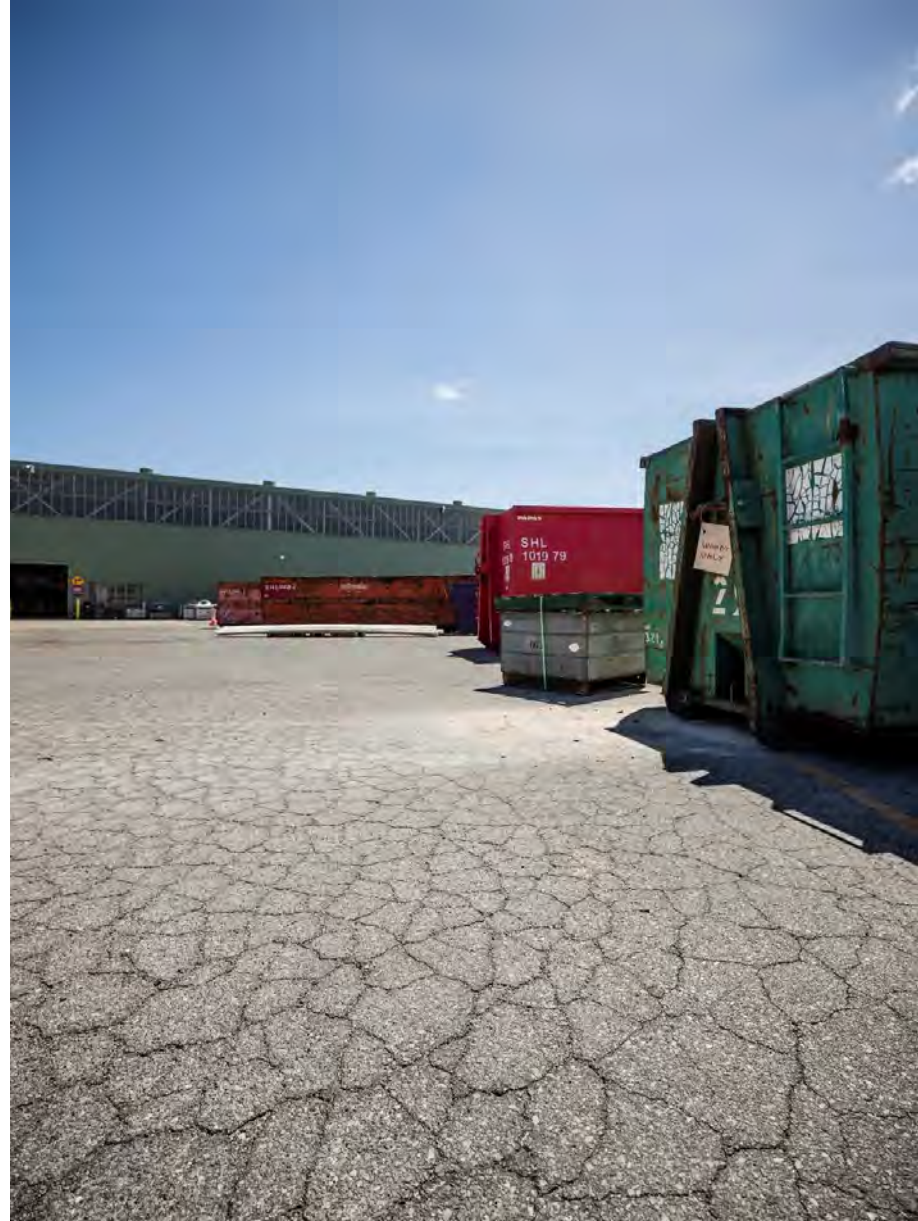
- Further cracking and potholing and subsidence of sub-grade to logistics salvage area.

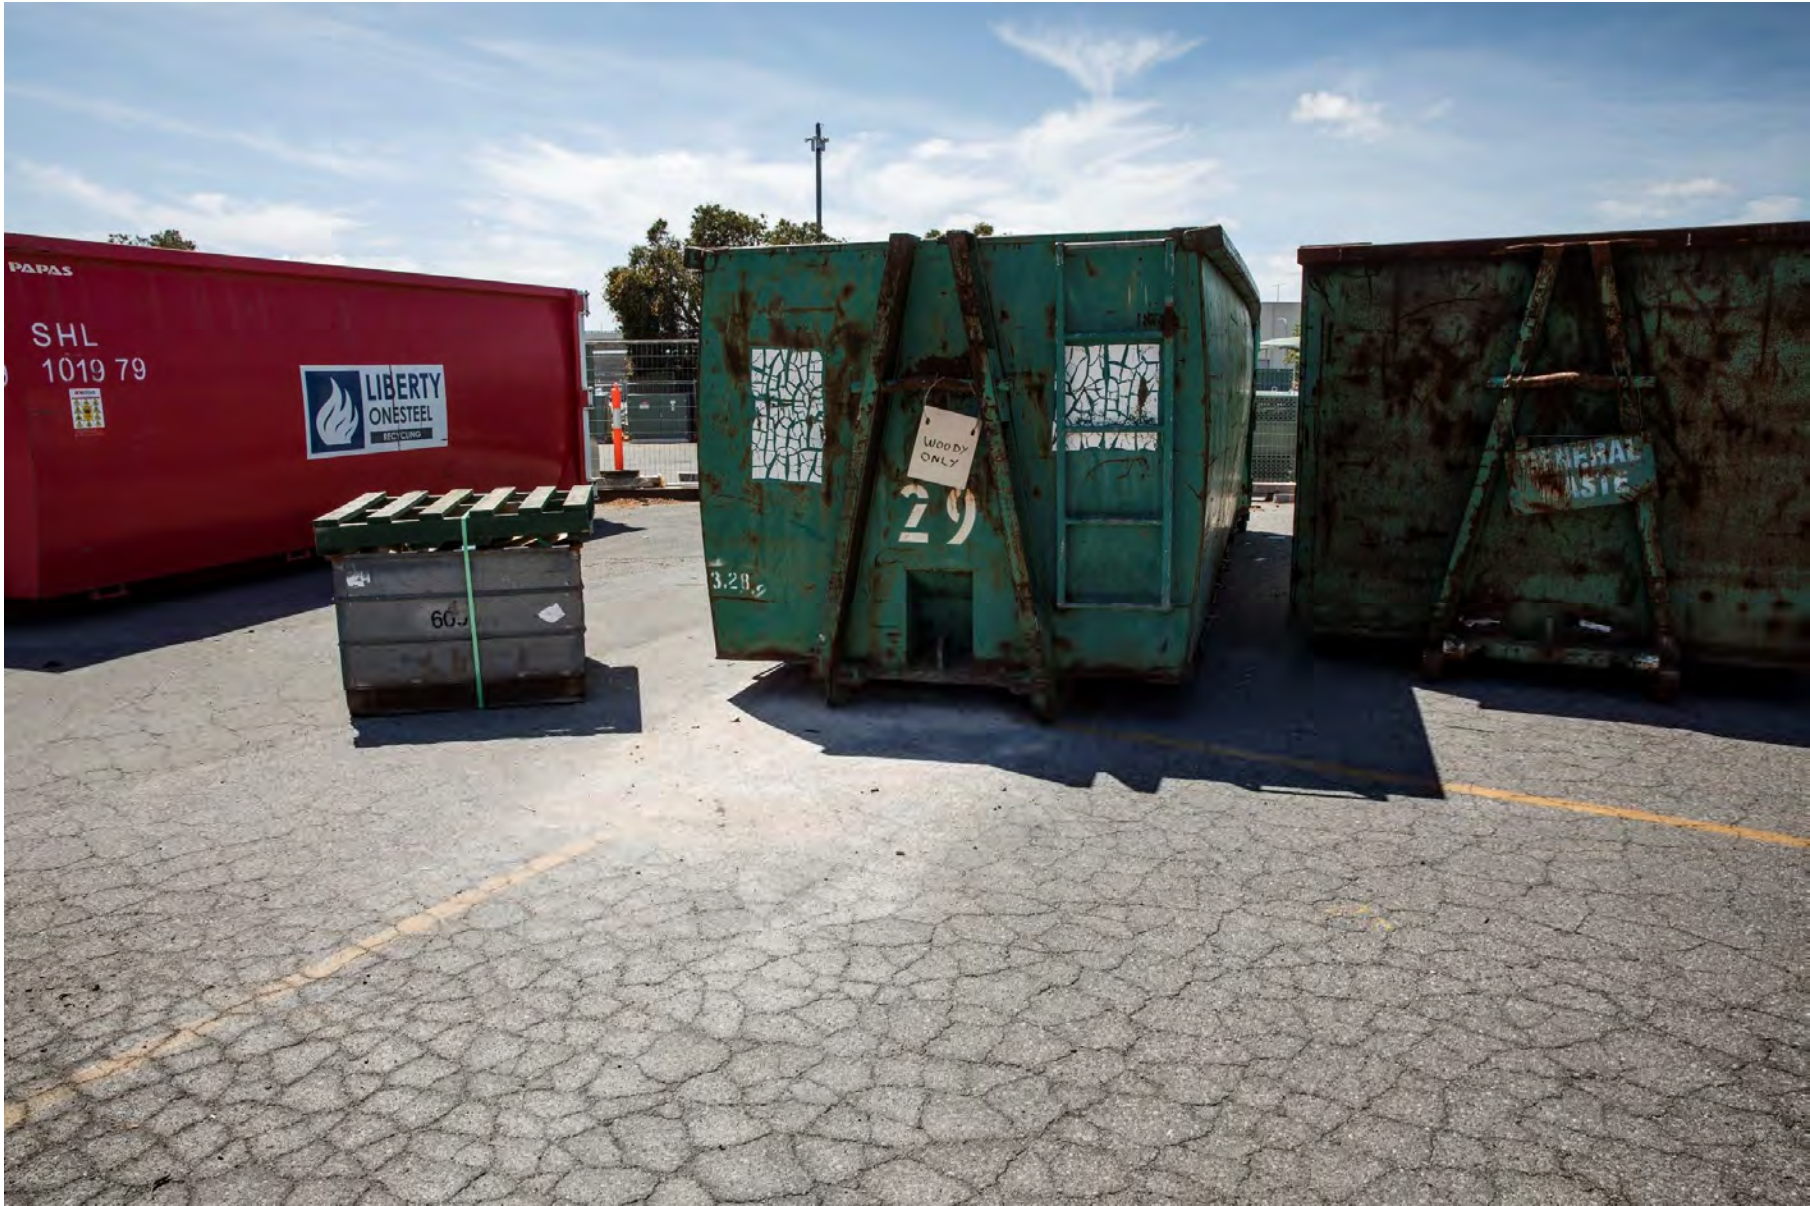
- Extensive full-thickness bitumen cracking to salvage bin storage, loading and unloading areas (9m storage bins can be over 3 tonne in weight).

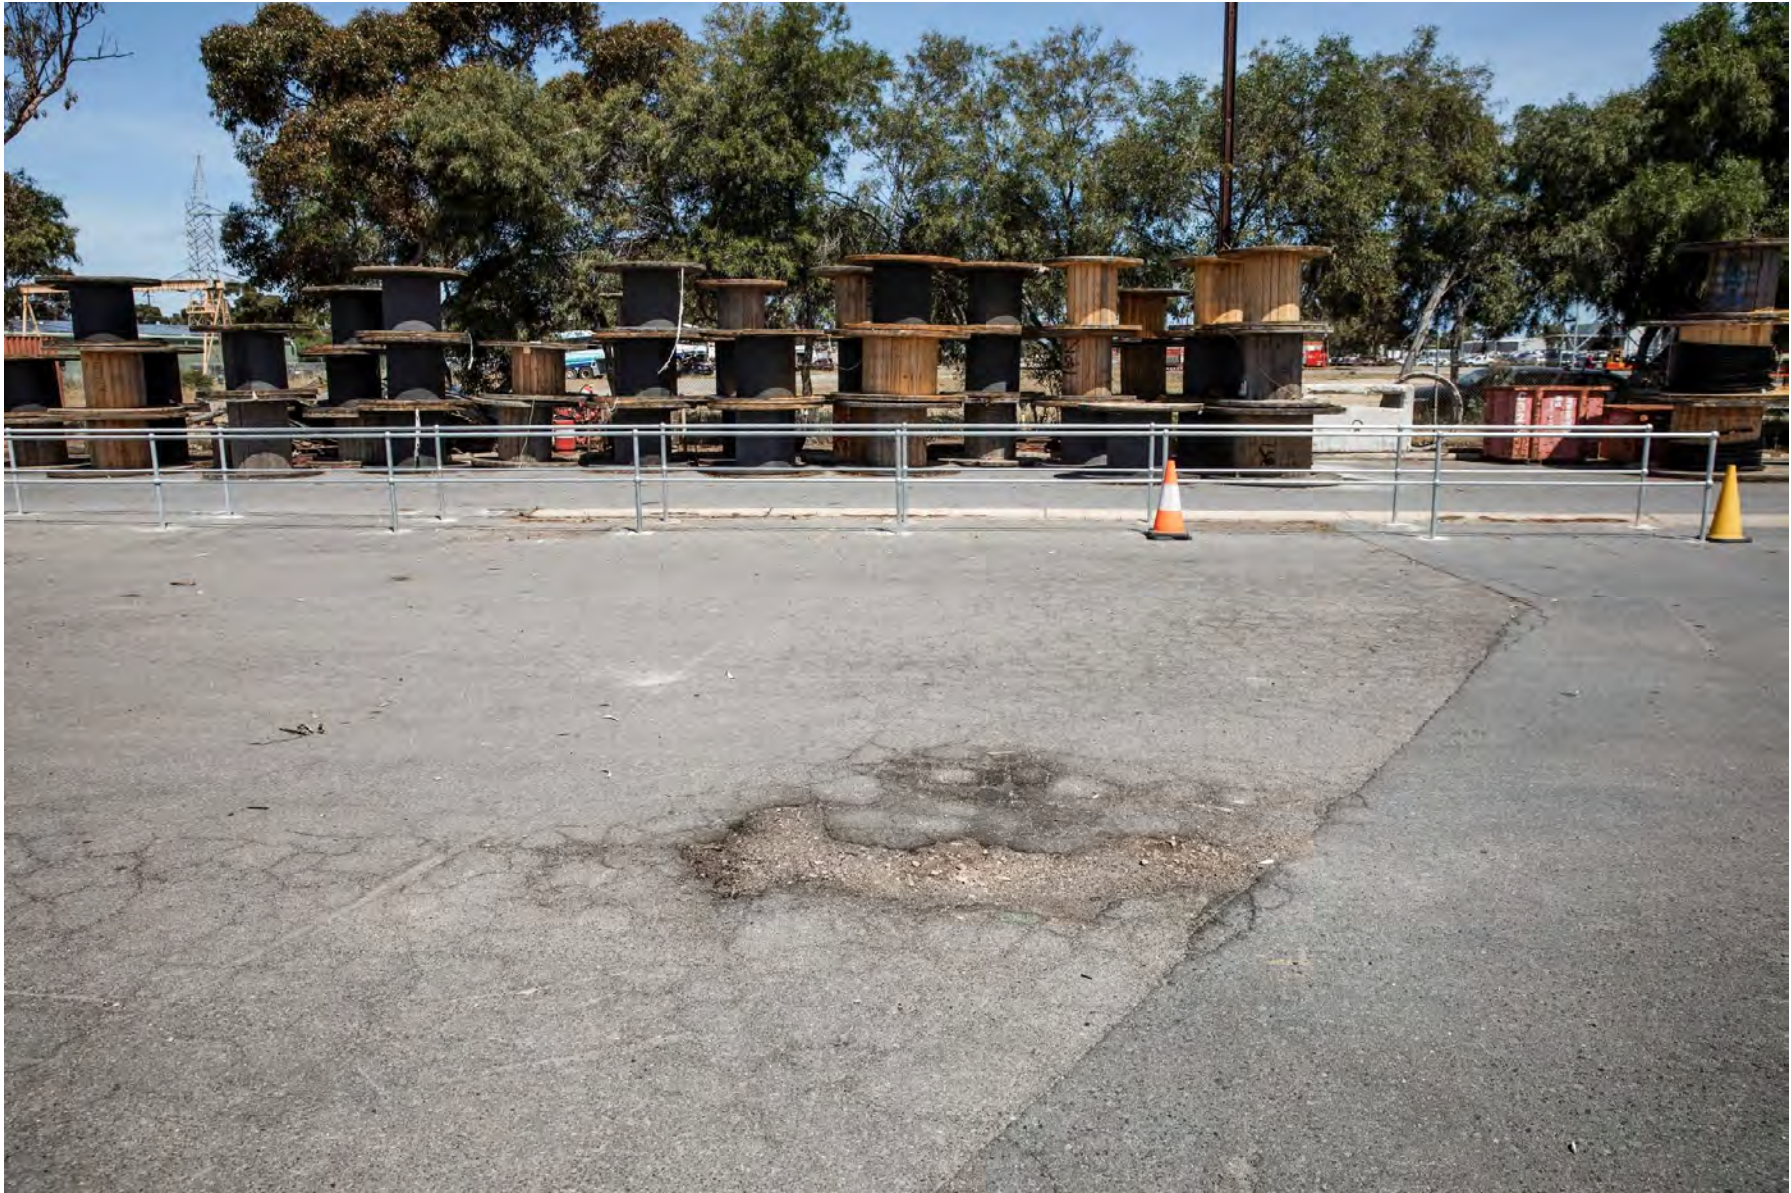
- Further cracking and potholing and subsidence of sub-grade to logistics salvage area.
