Supporting
document 5.22.2

Angle Park North Photographs

2020-25 Revised
Regulatory Proposal
10 December 2019

Angle Park Asset Condition Photographs

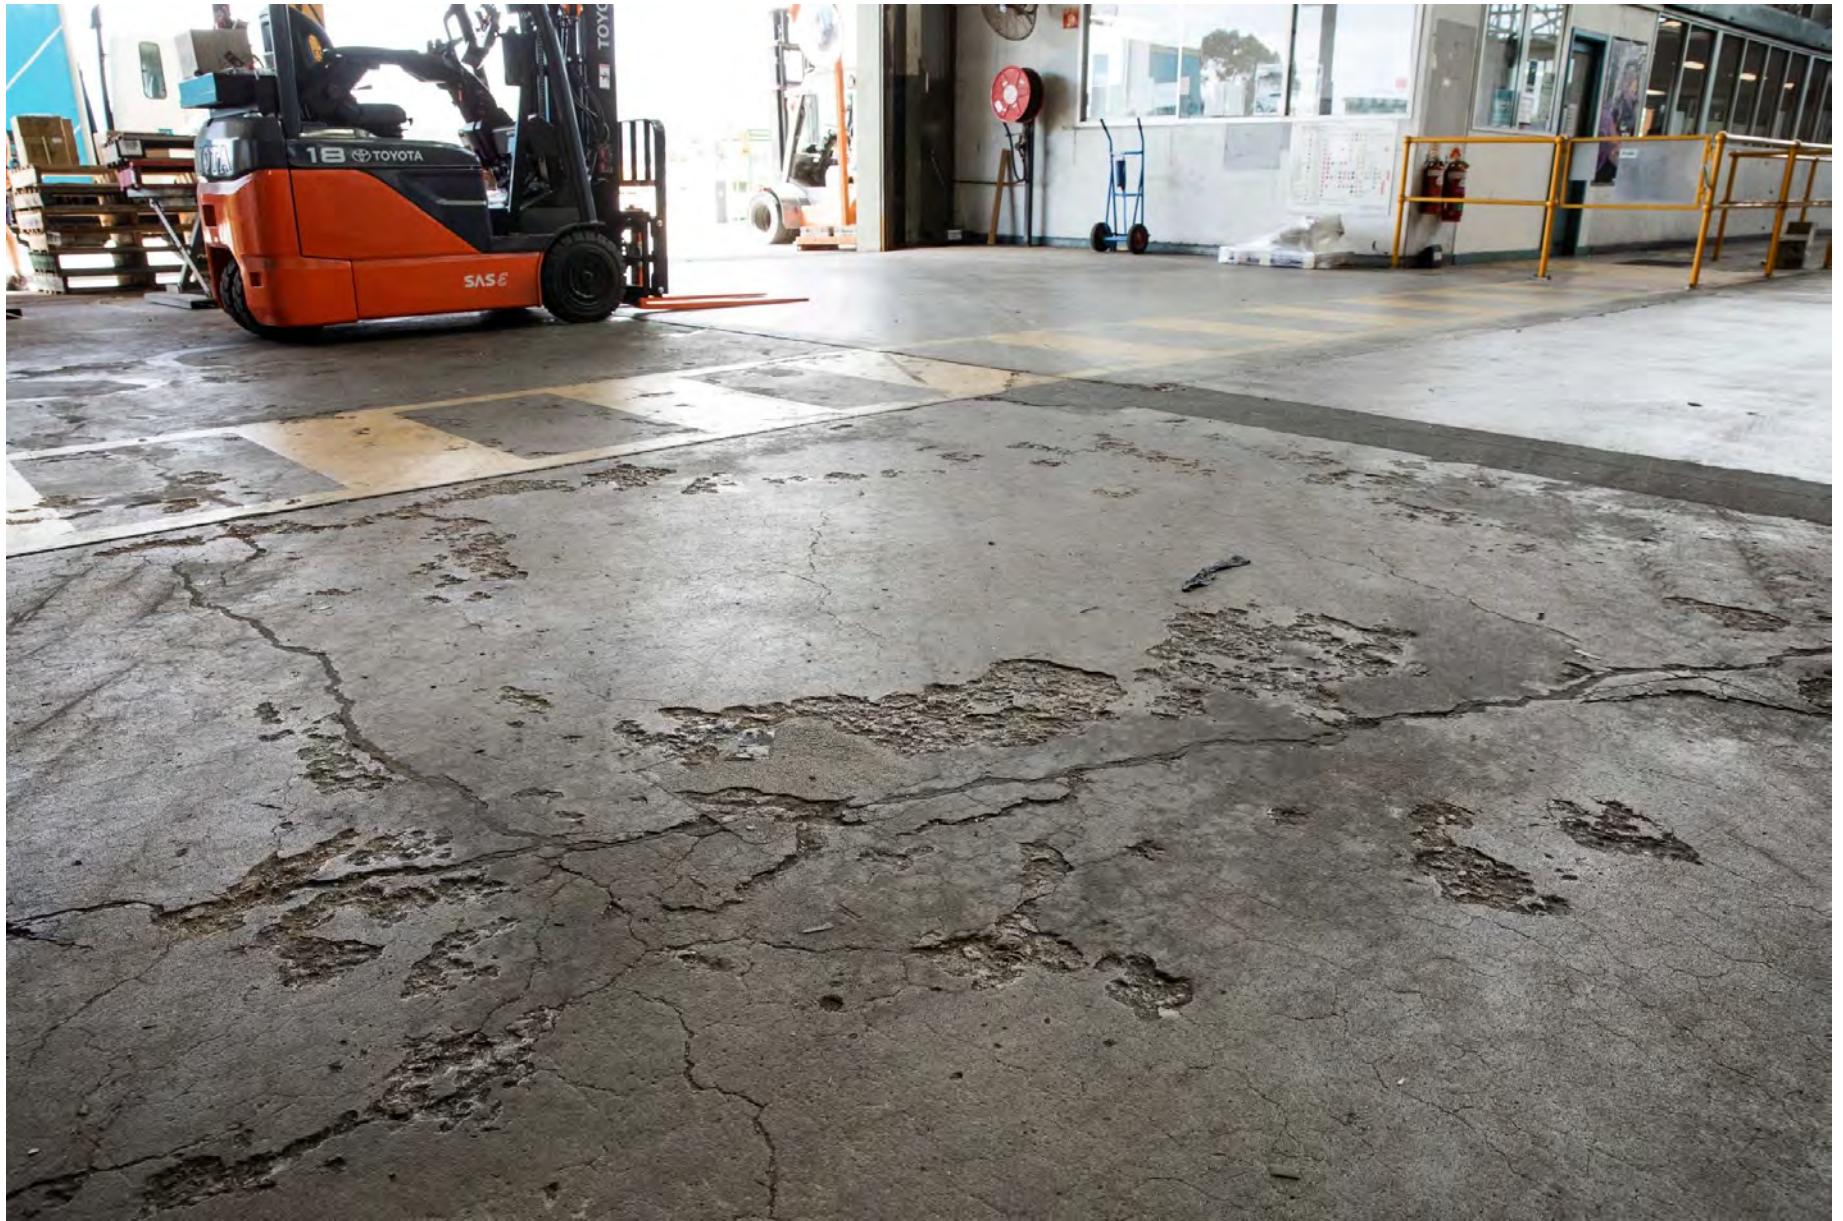
- Concrete Cracking and de-lamination to large areas of the logistics warehouse floor.

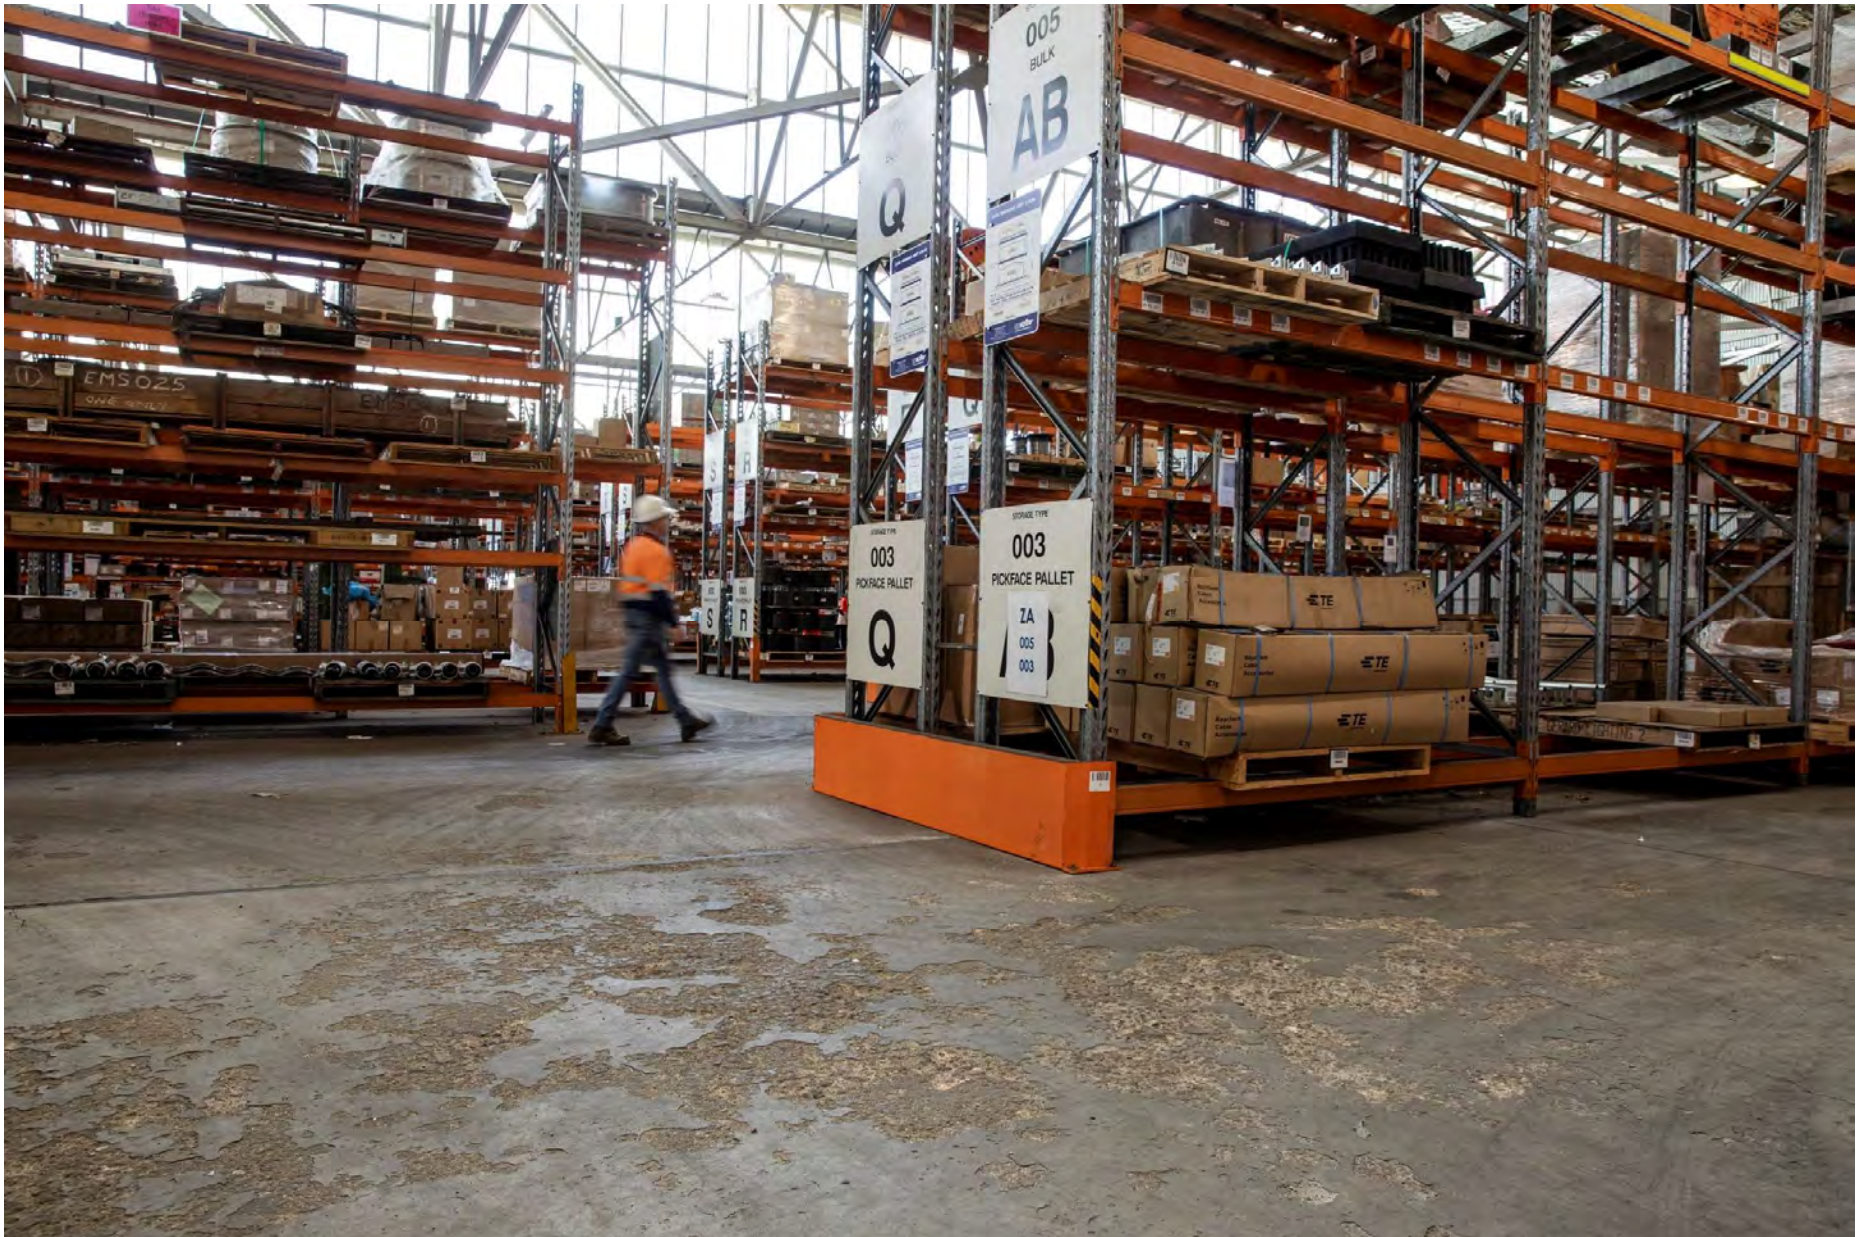
- Concrete Cracking and de-lamination to large areas of the logistics warehouse floor.

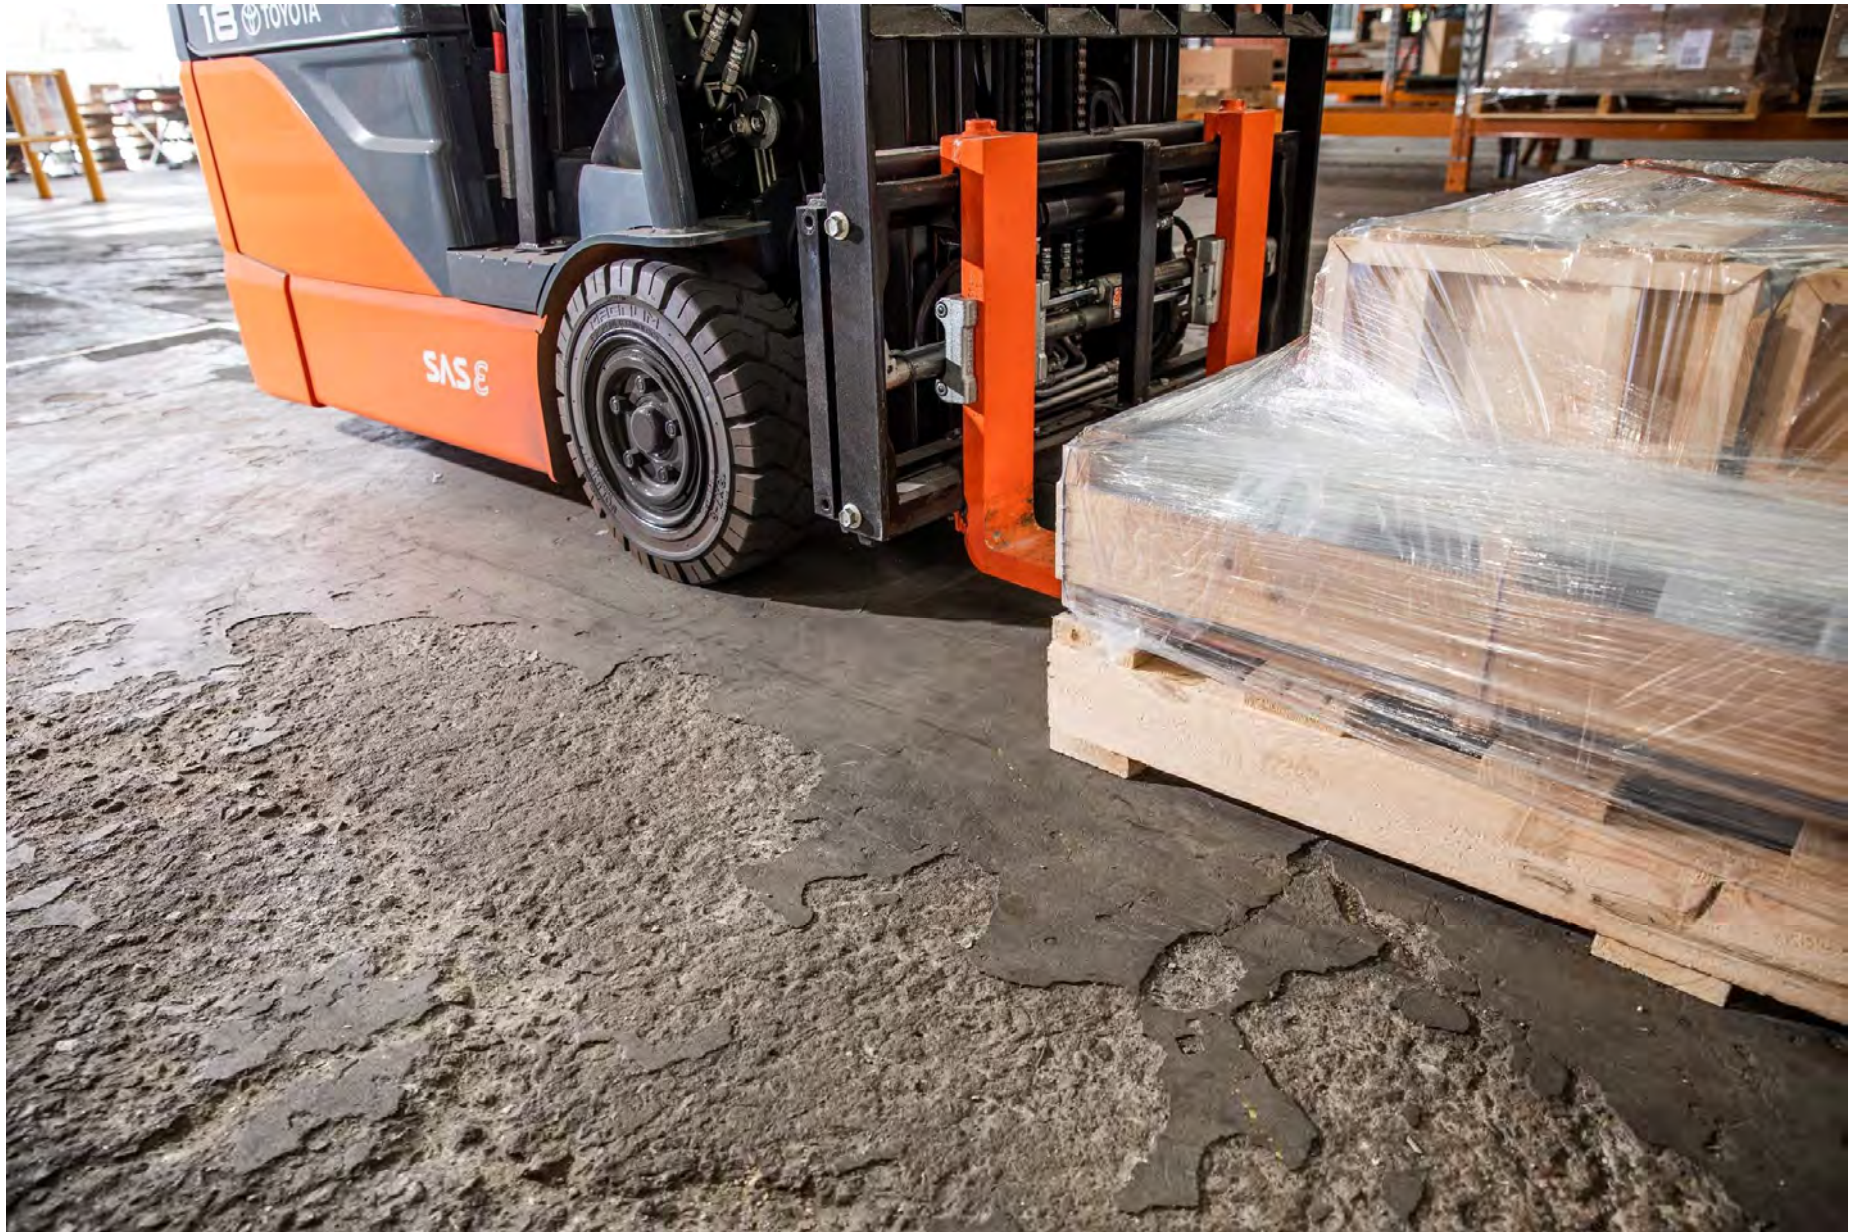
- Detailed views of cracking and de-lamination

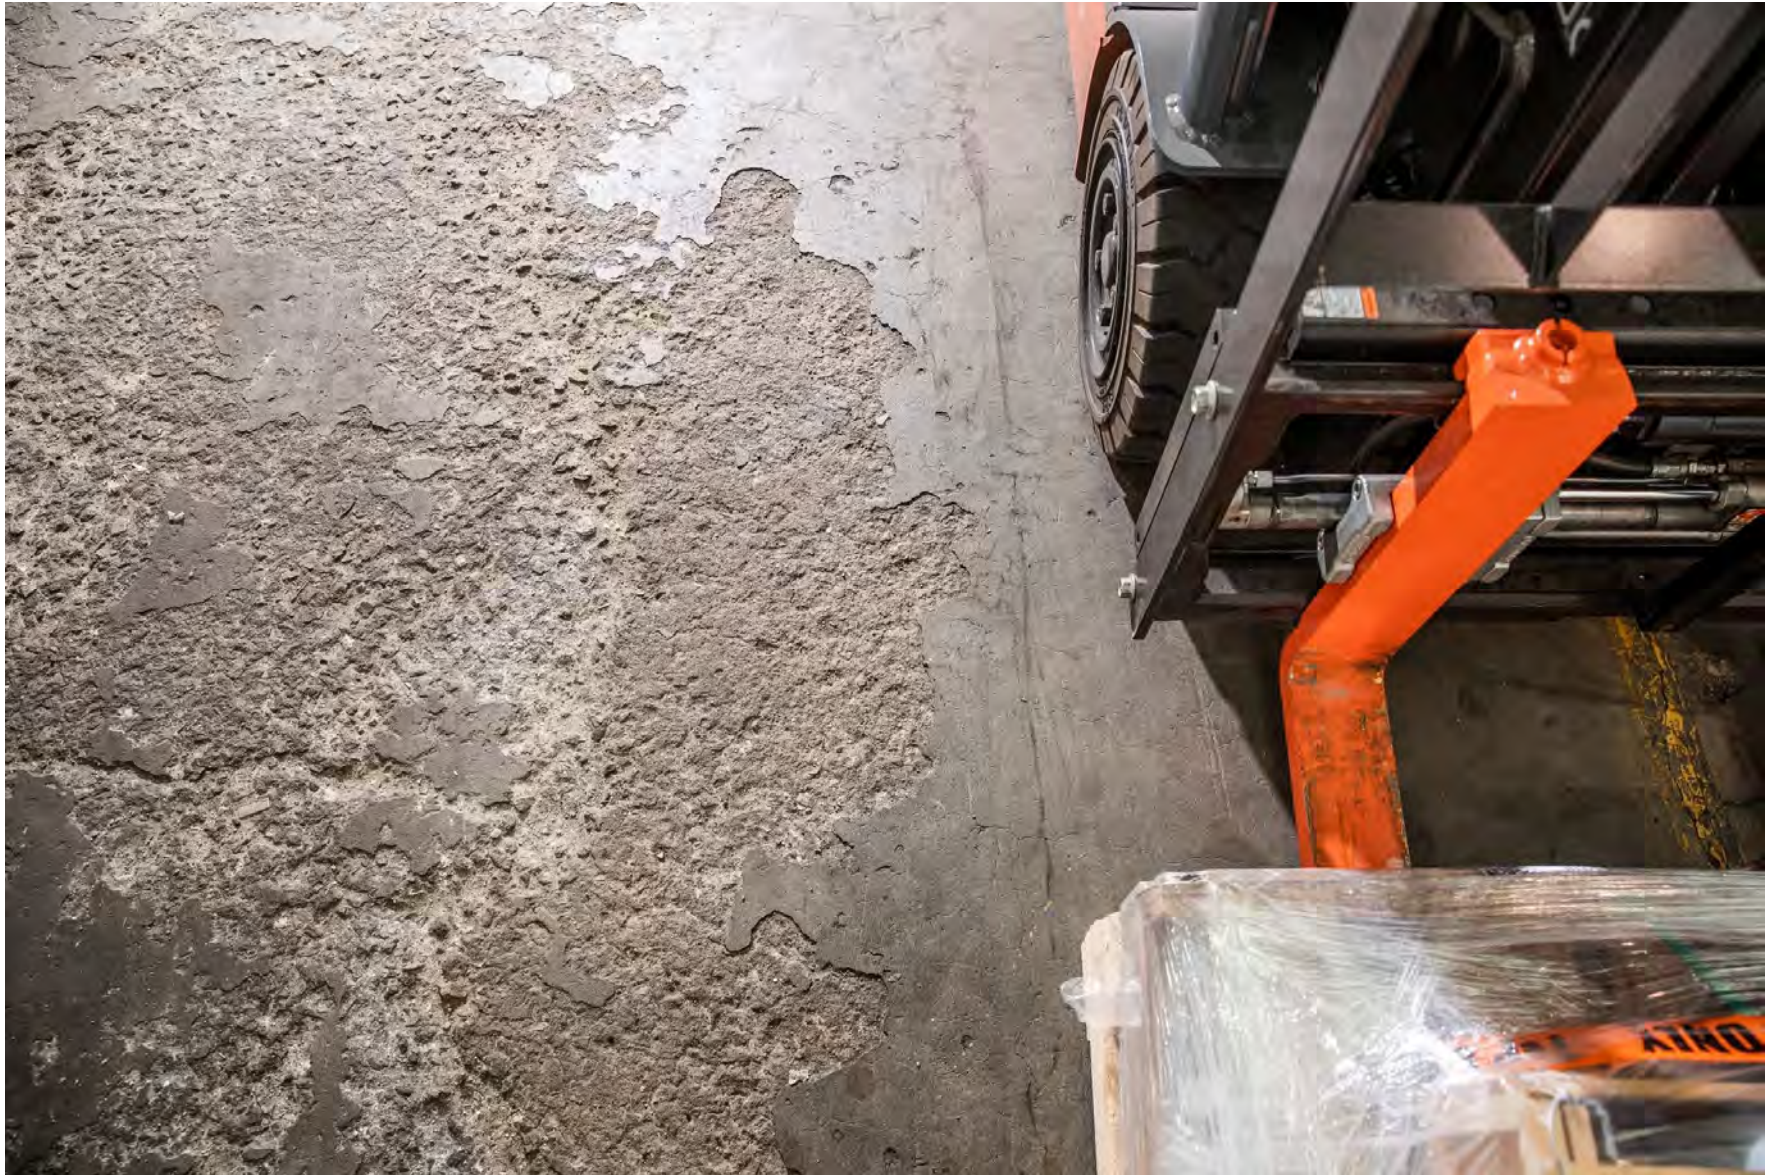
- Detailed views of cracking and de-lamination

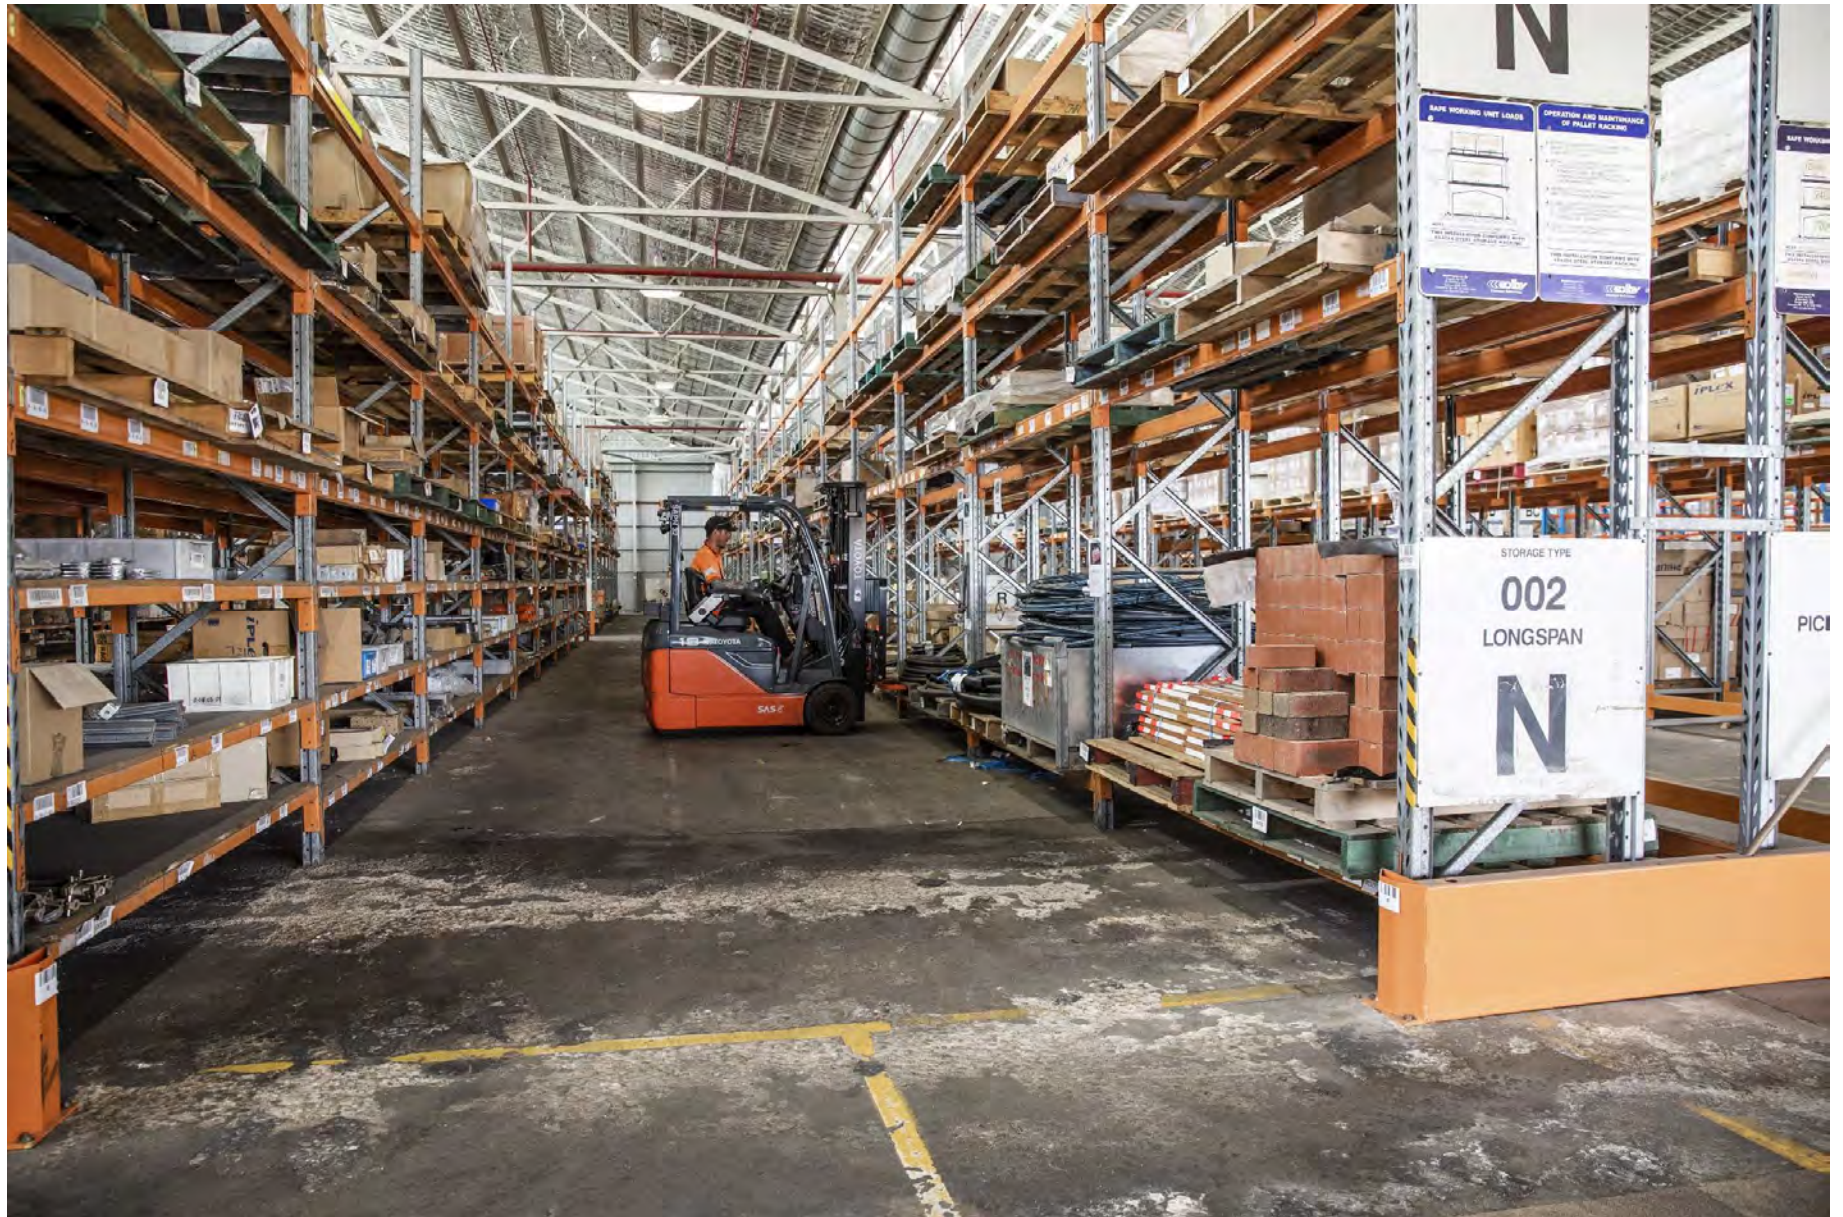
- Concrete Cracking and de-lamination to large areas of the logistics warehouse floor.

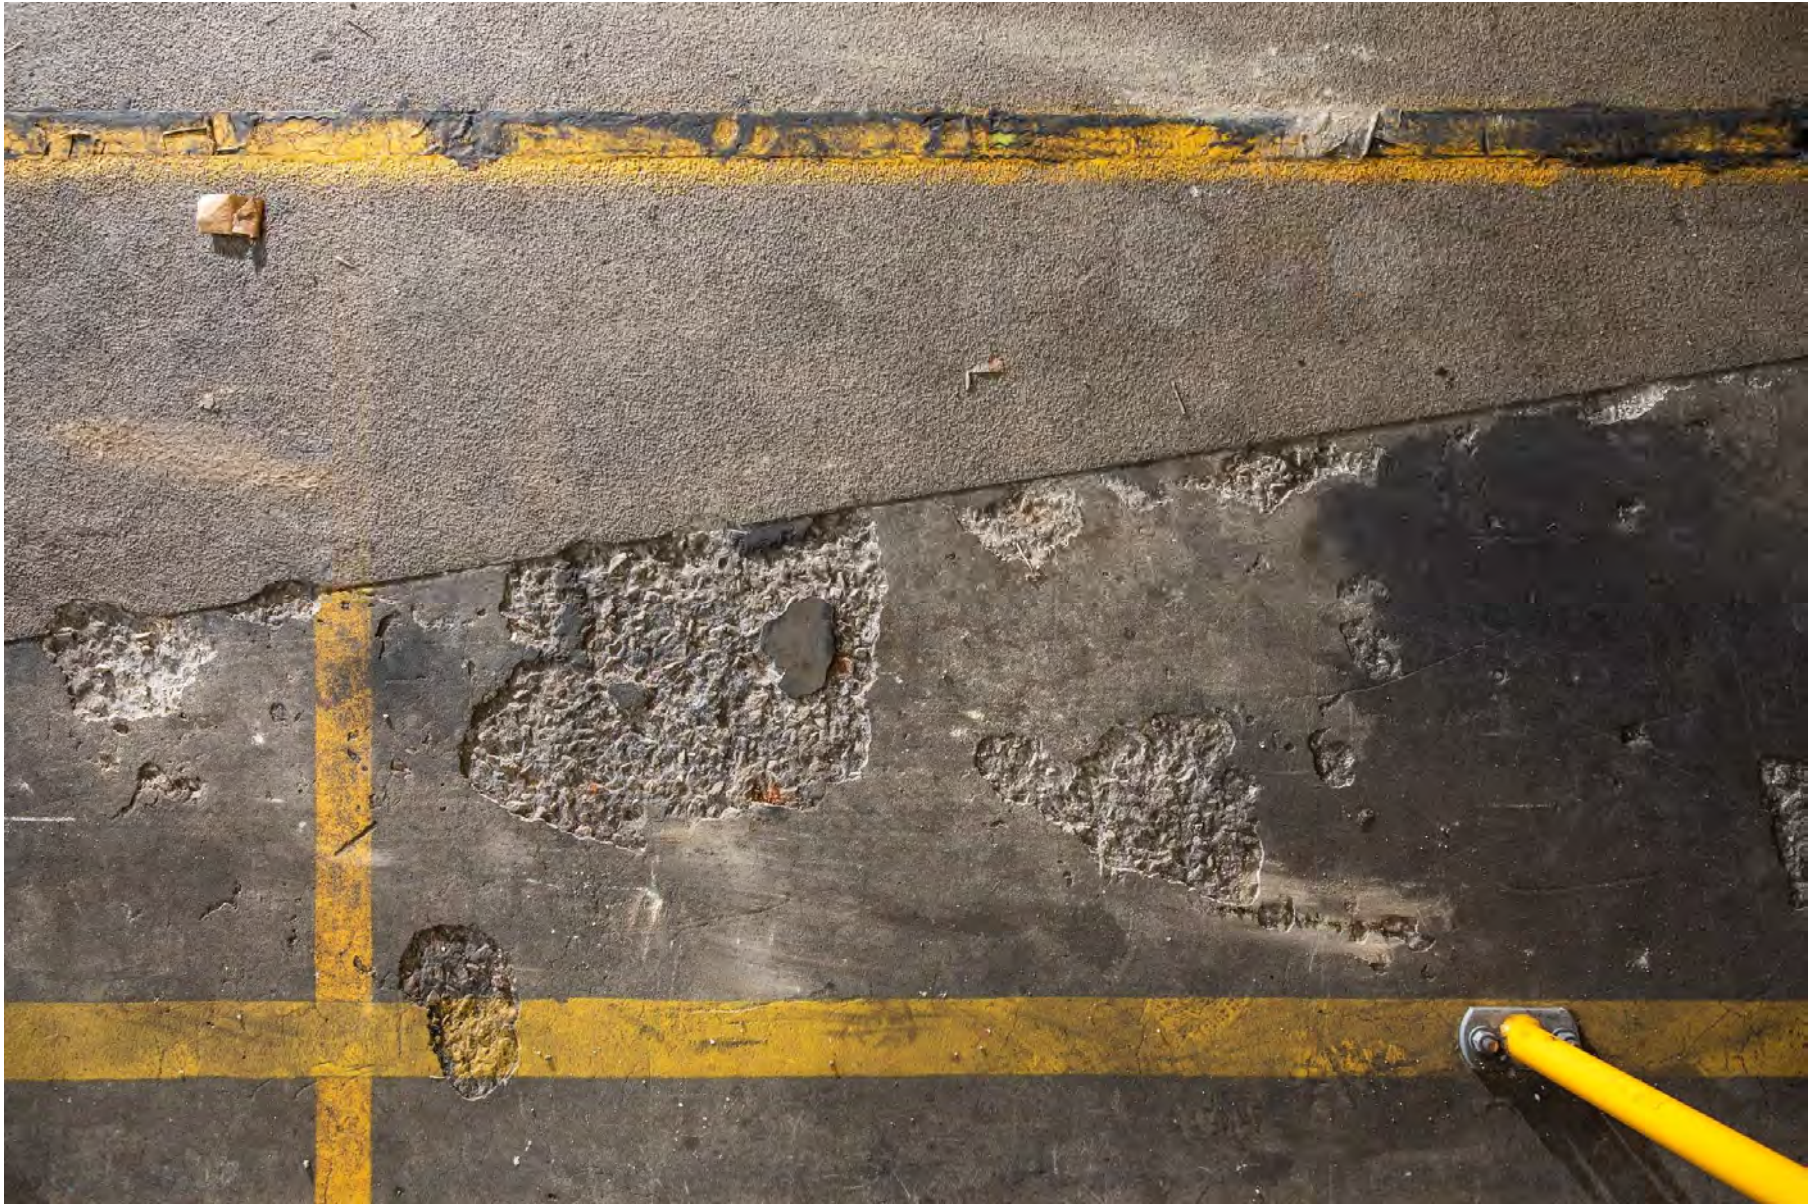
- Previous repairs with levelling compounds and epoxy/composite coverings

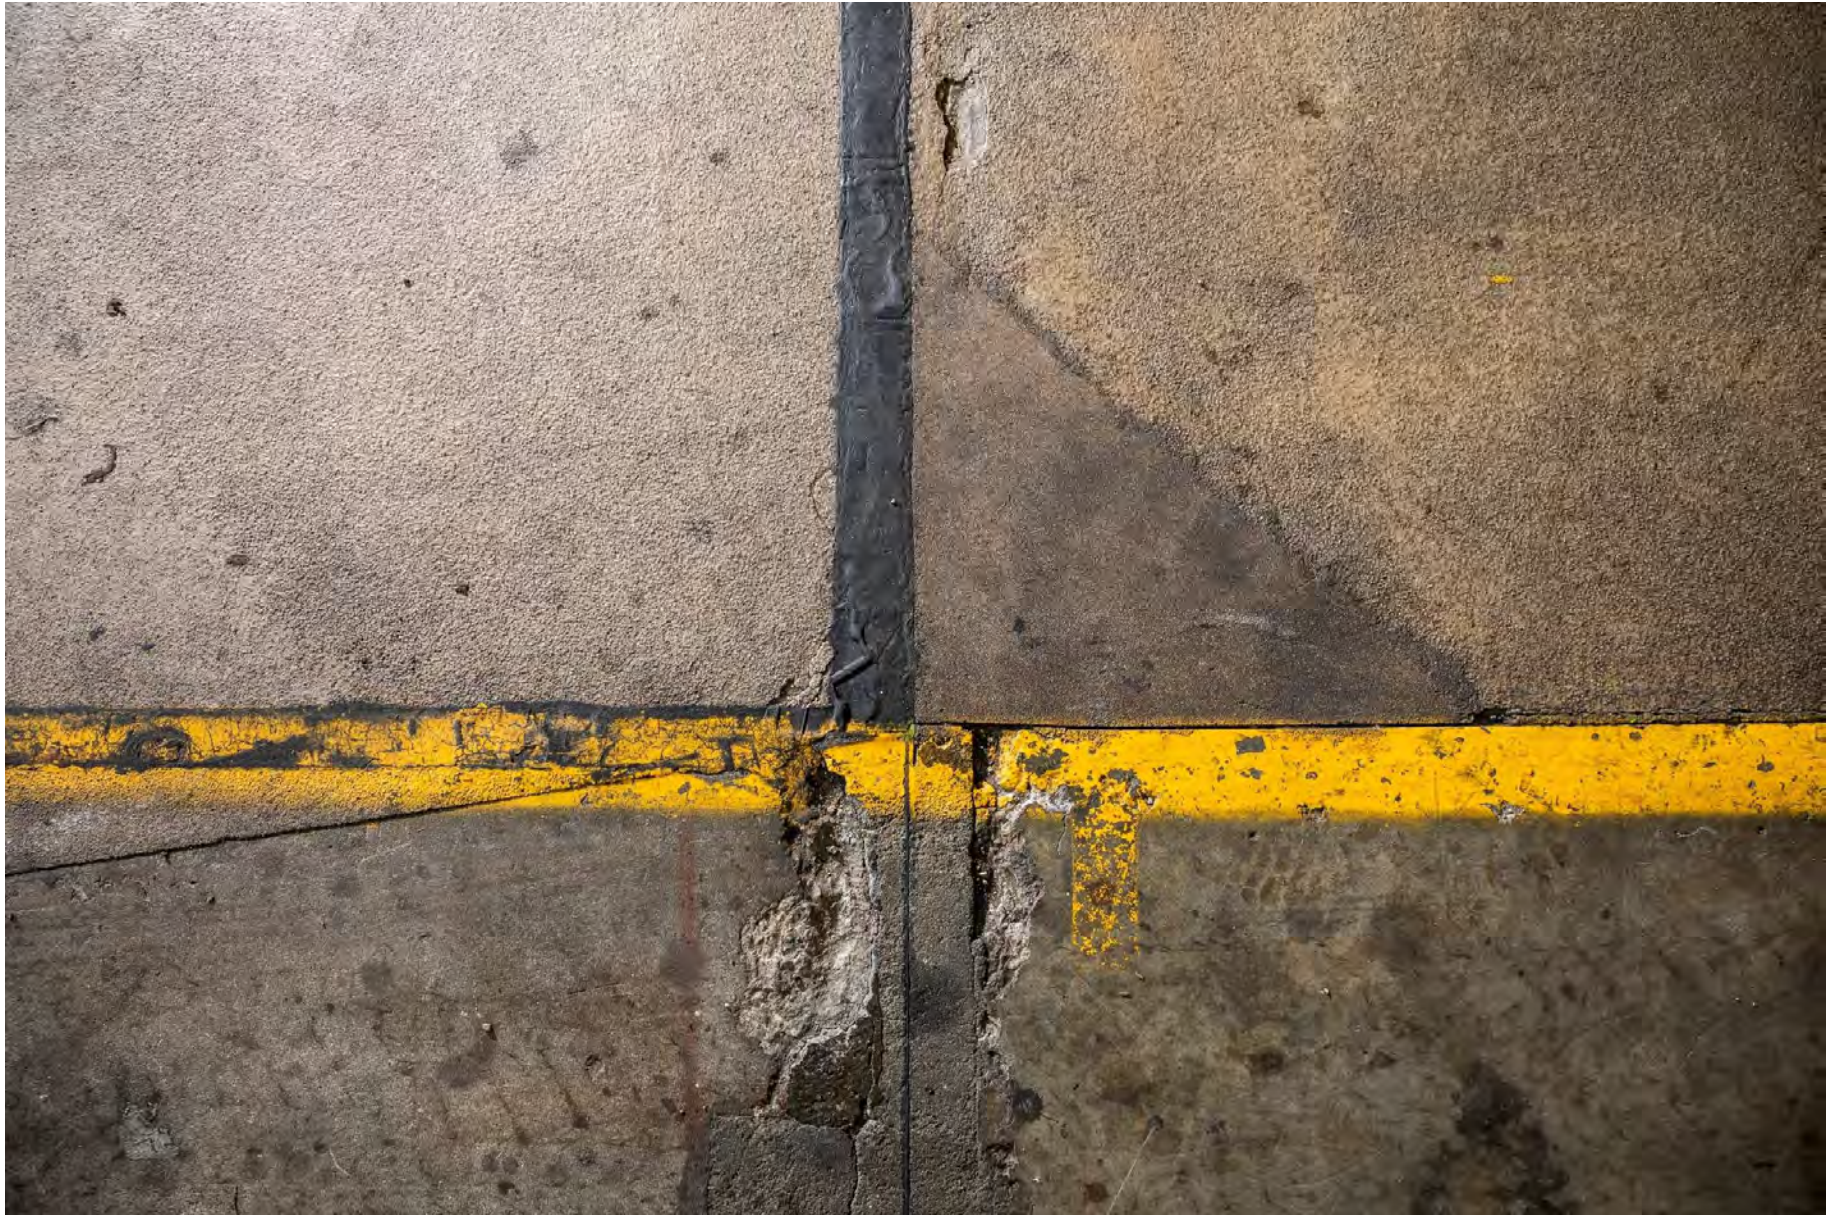
- Previous repairs with levelling compounds and epoxy/composite coverings

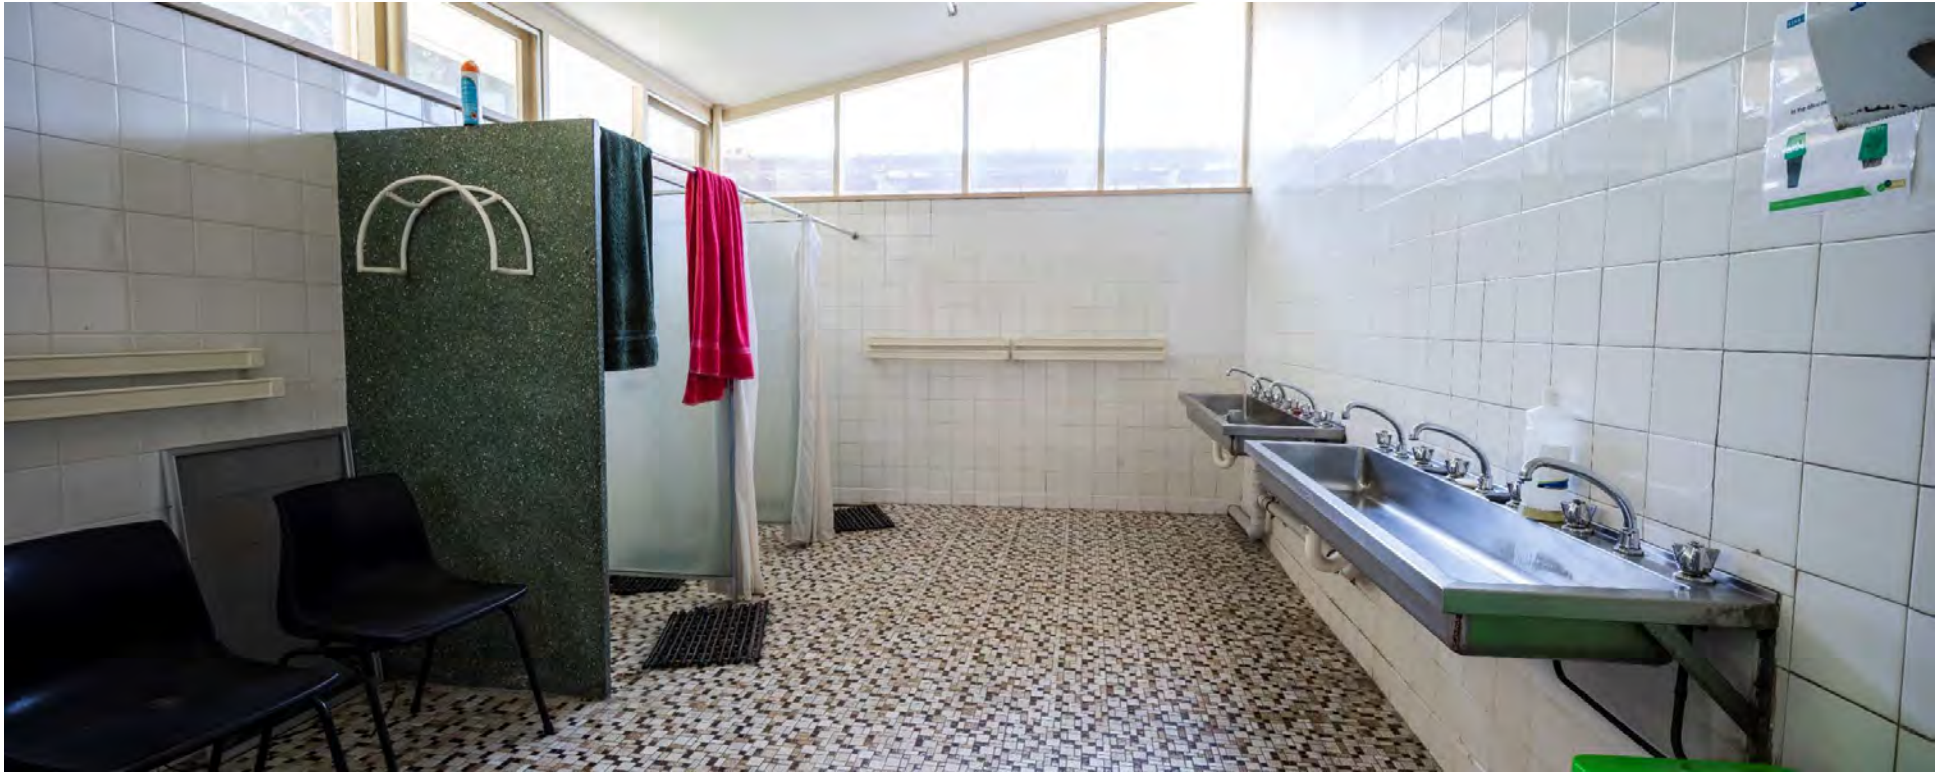
- Pole construction showers all in very poor condition and original fit-out

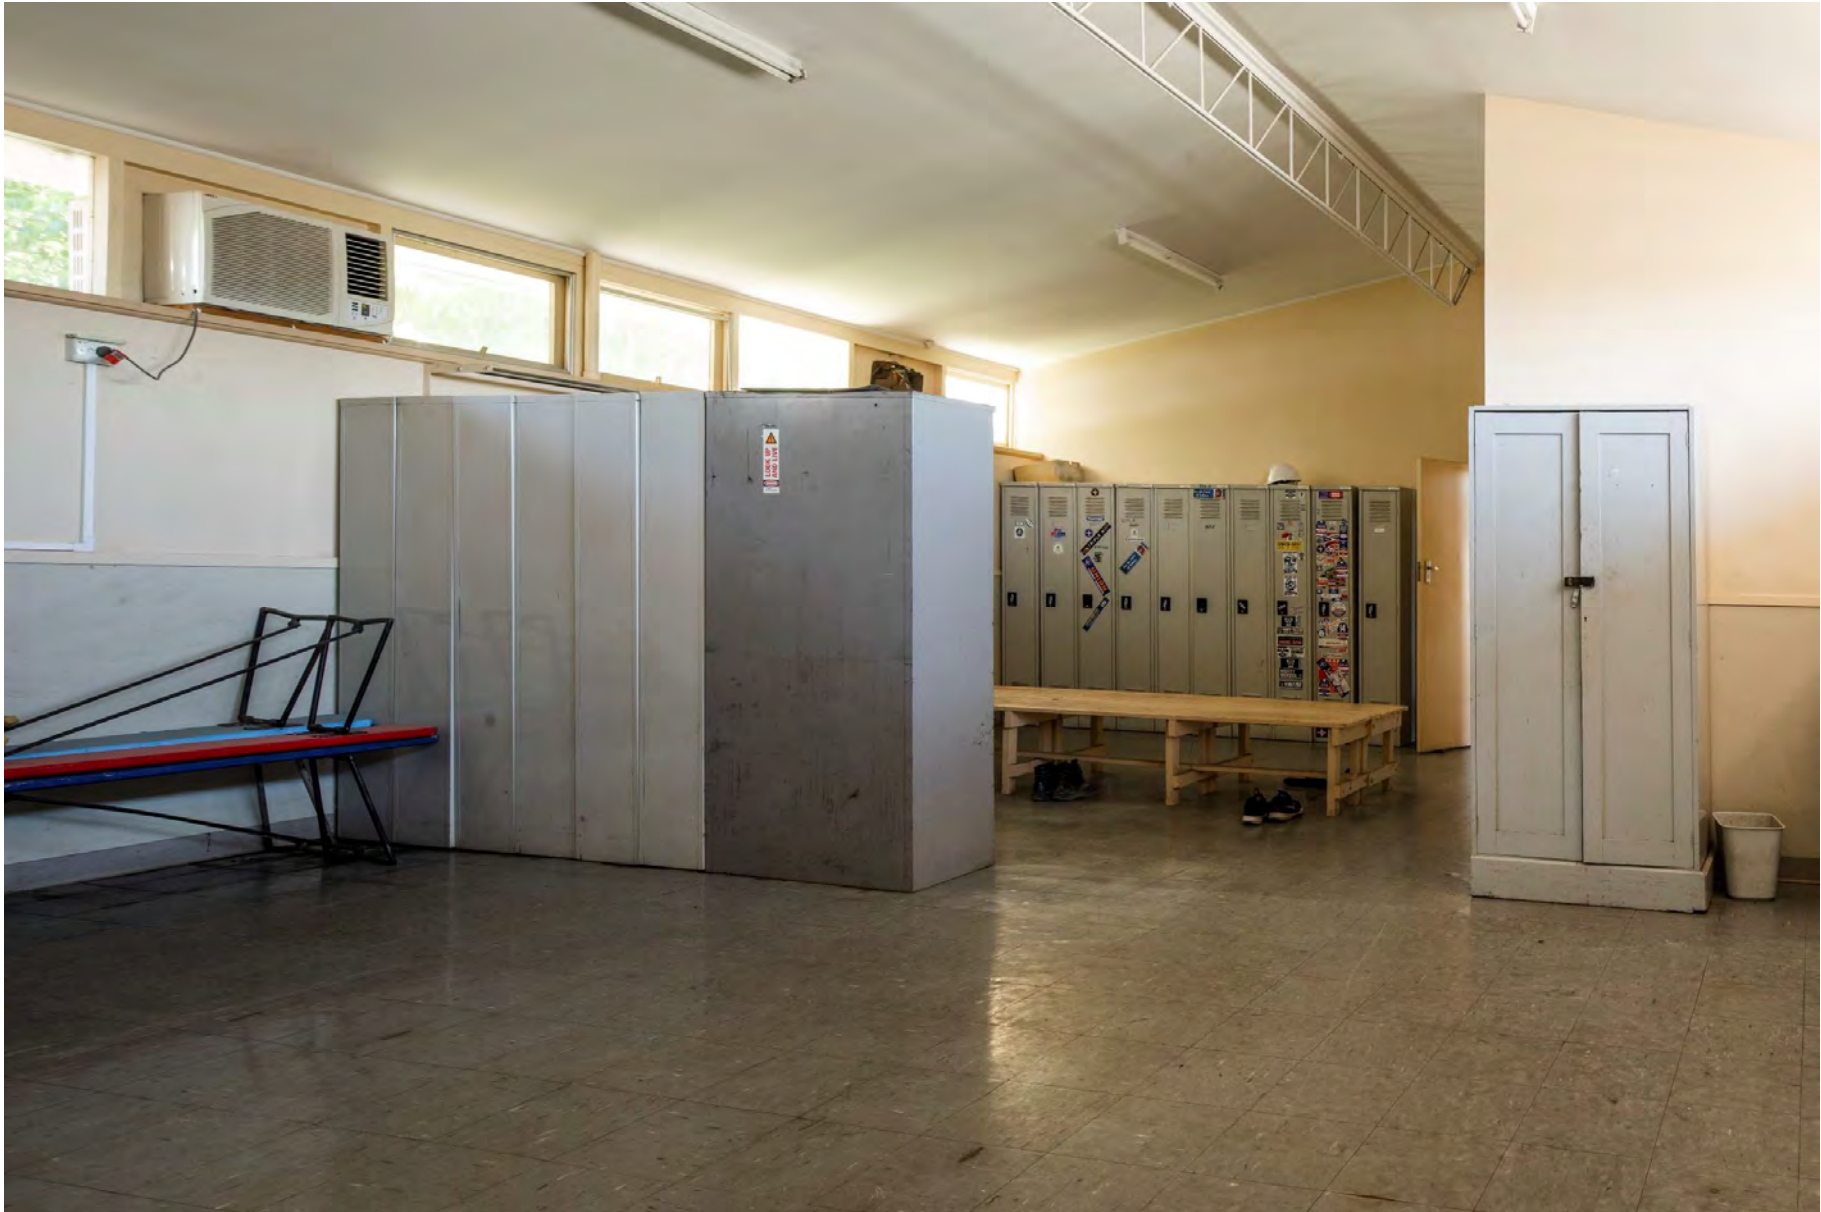
- Pole Construction Locker Room – Original 1950's fit-out

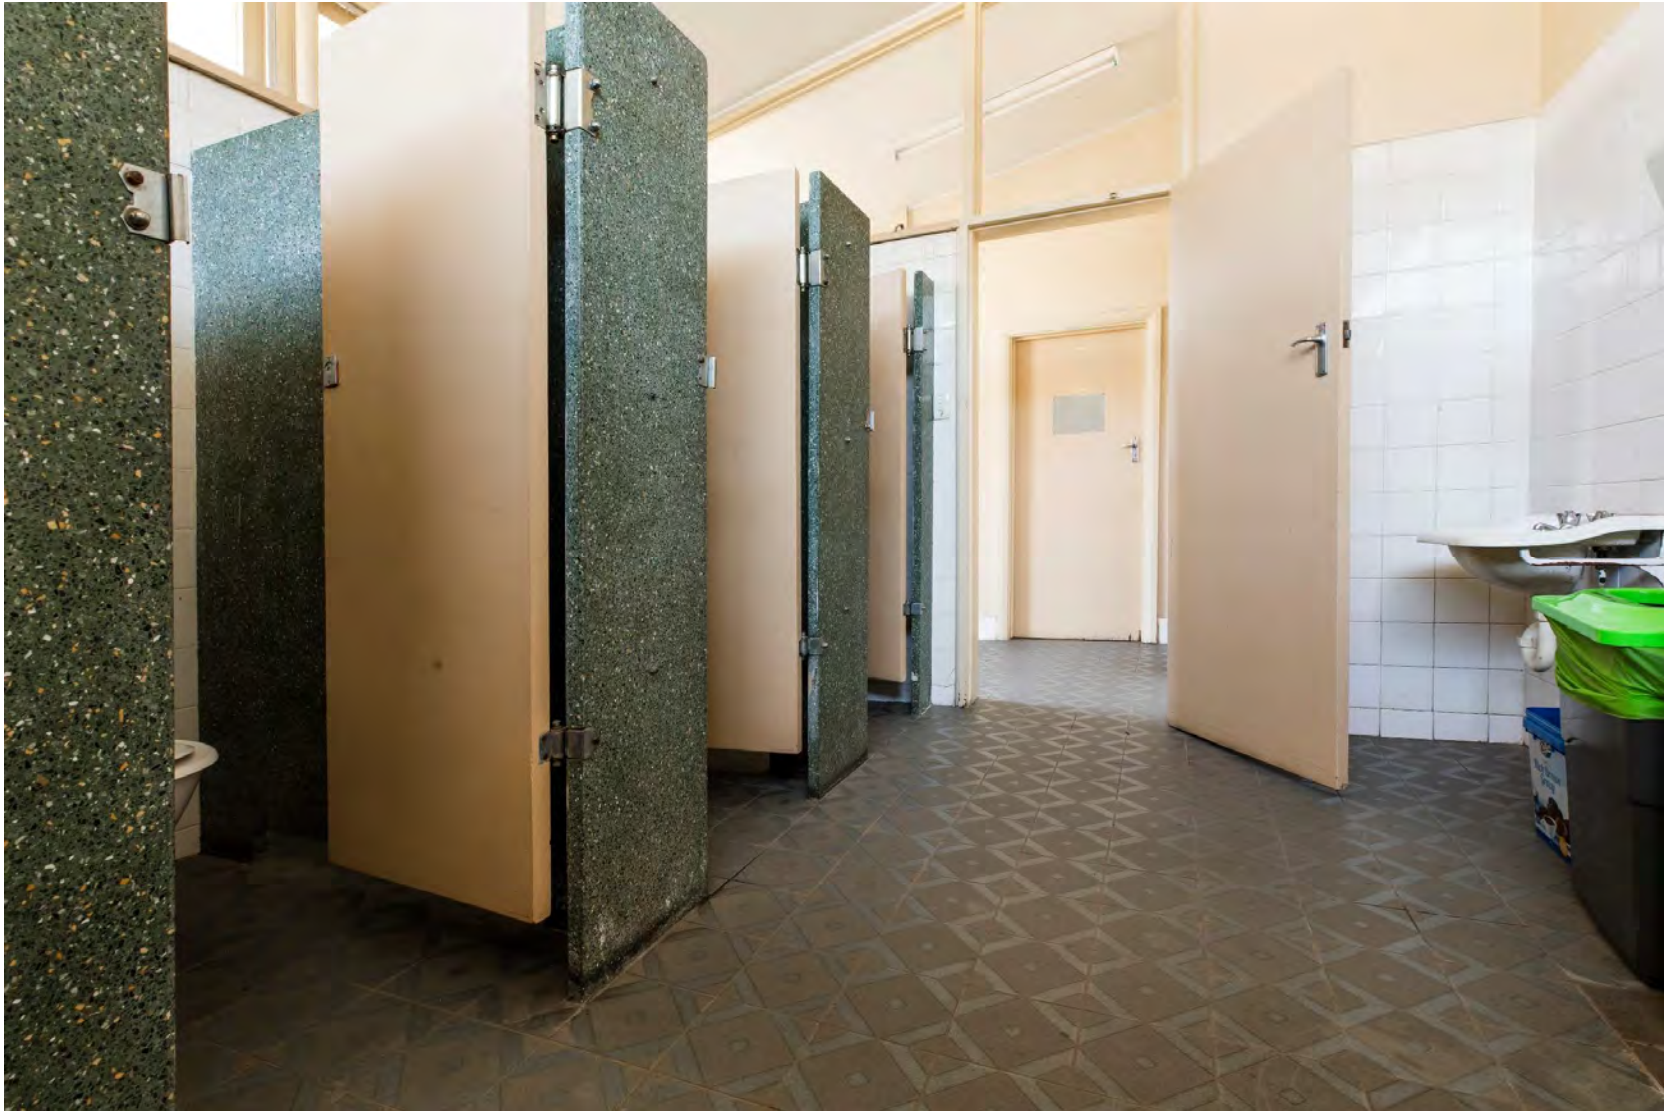
- Pole construction toilets all in very poor condition and original fit-out
