Supporting
document 5.22.2

Angle Park North Photographs

2020-25 Revised
Regulatory Proposal
10 December 2019

Angle Park Asset Condition Photographs

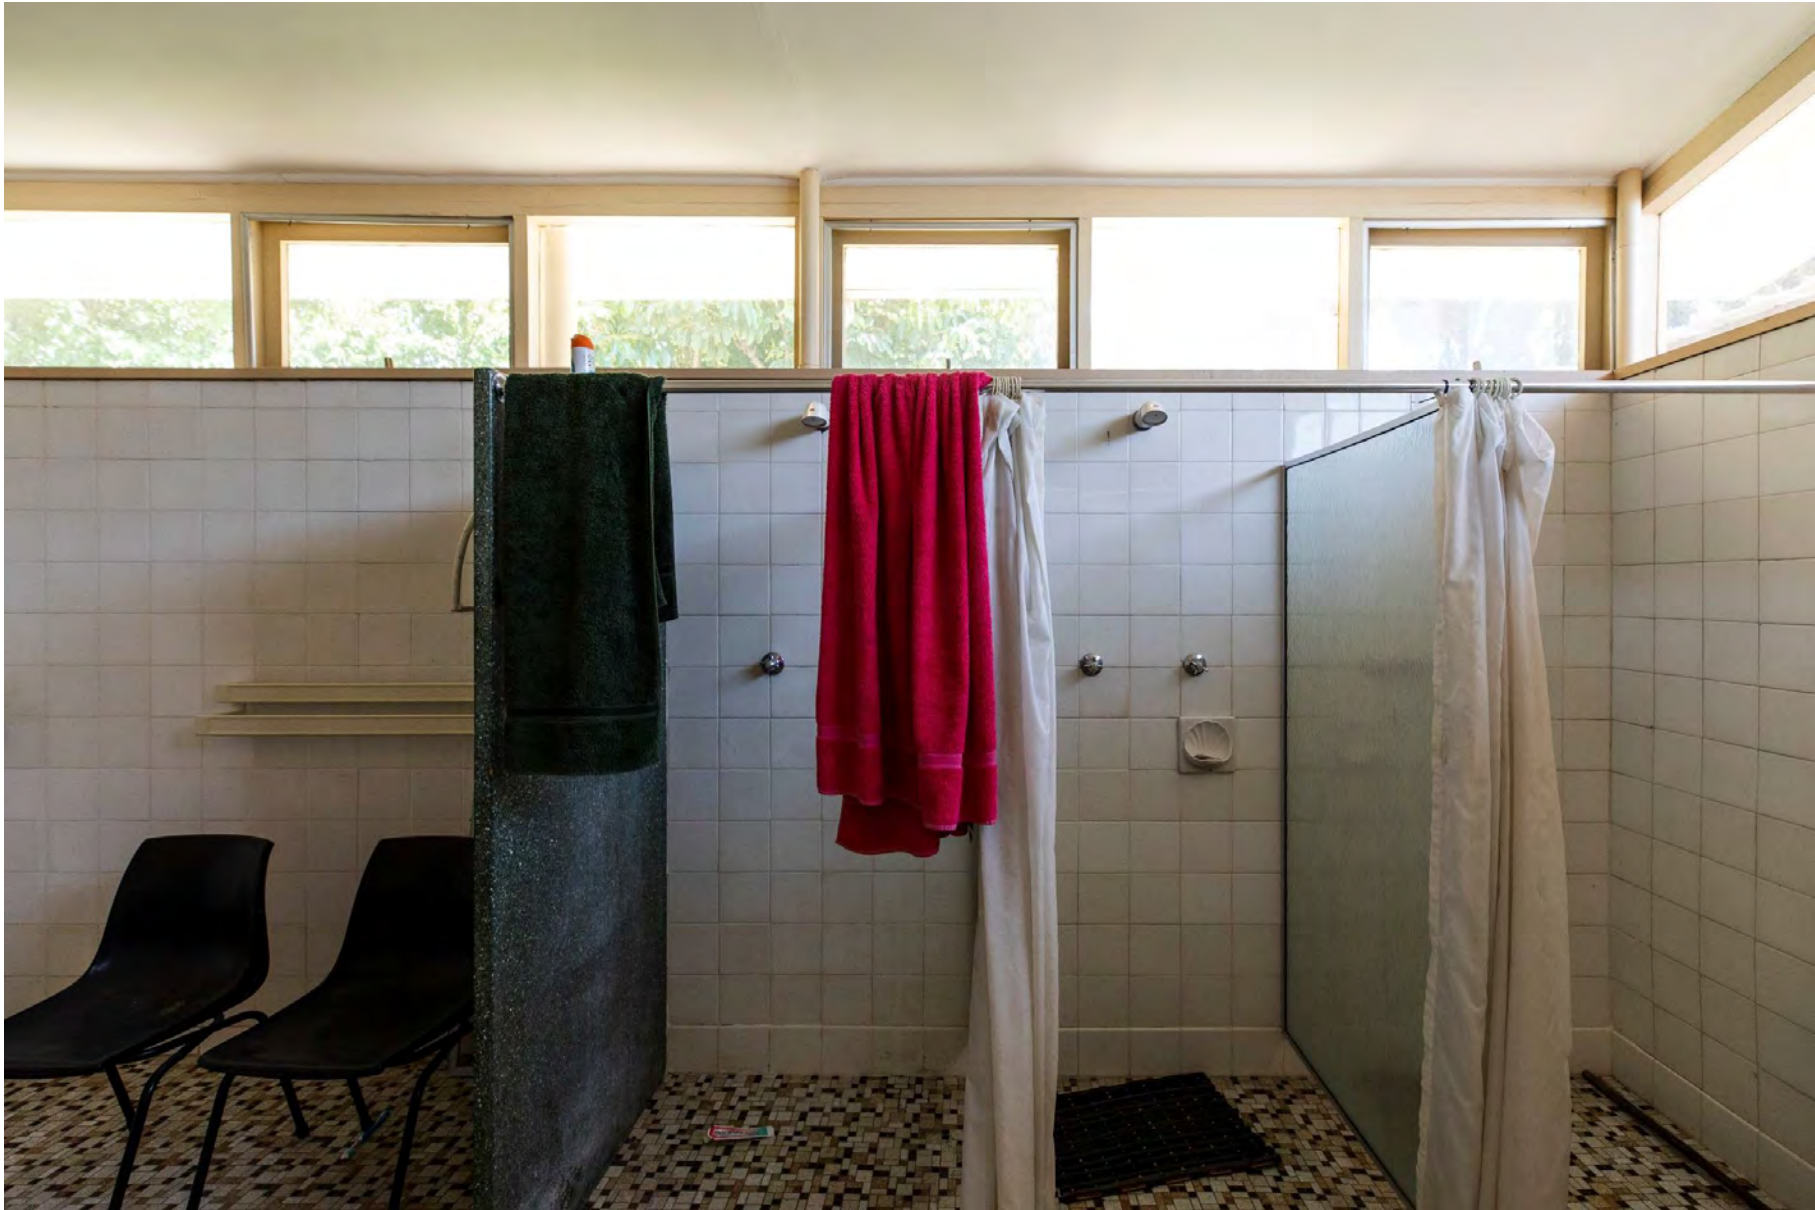
- Pole construction showers all in very poor condition and original fit-out

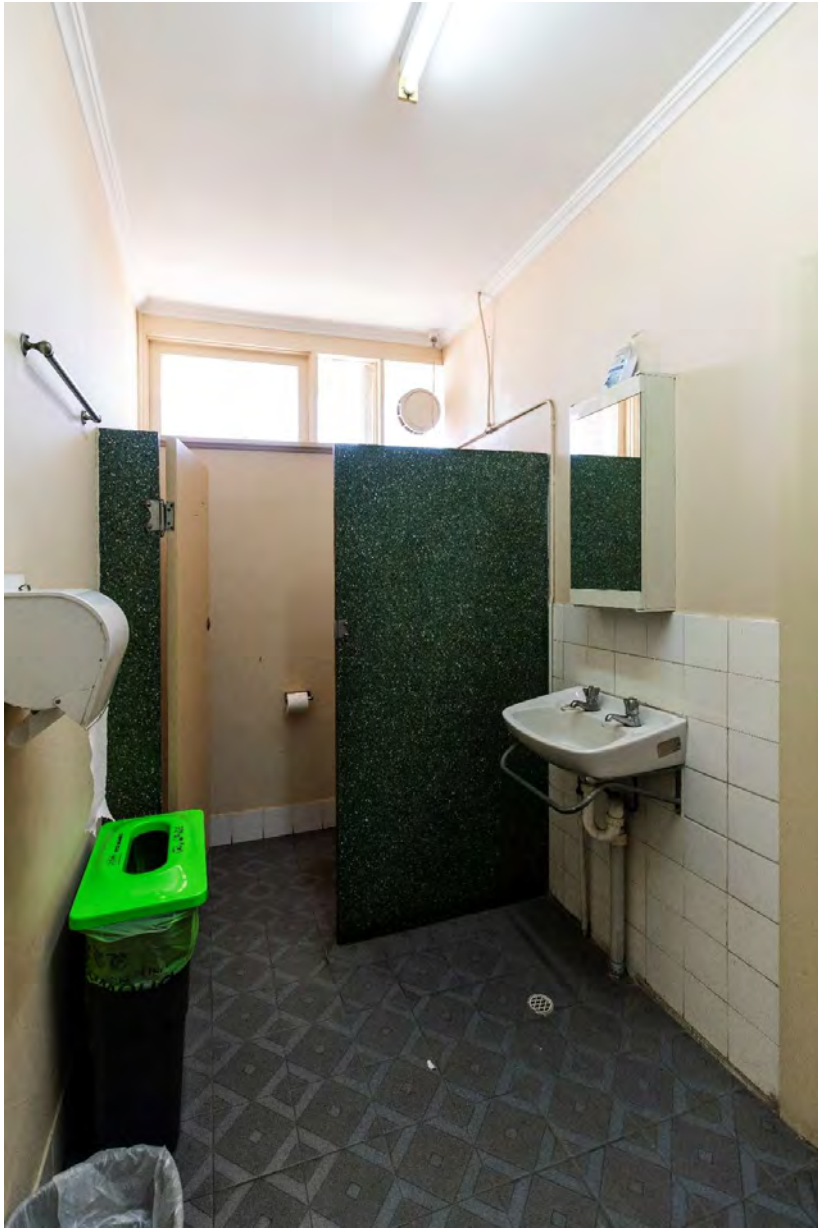
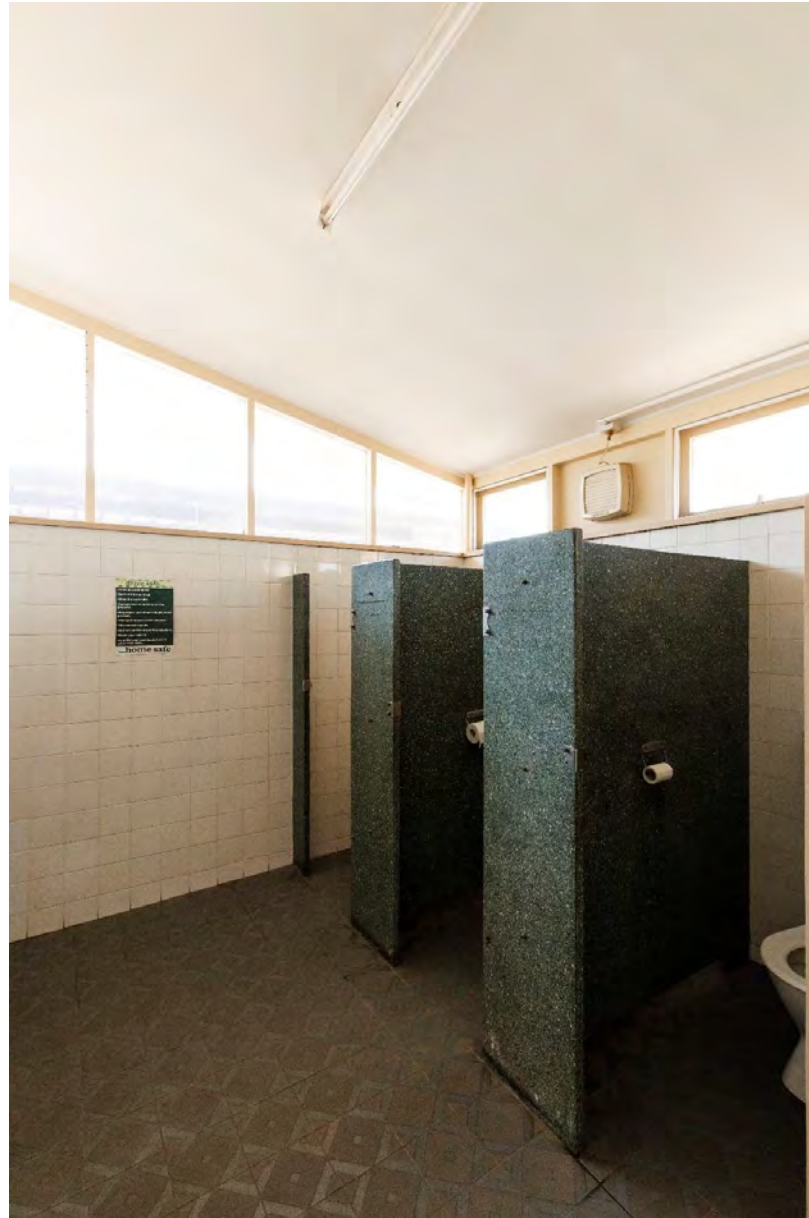
Pole Construction Ladies Toilet – No Female Shower

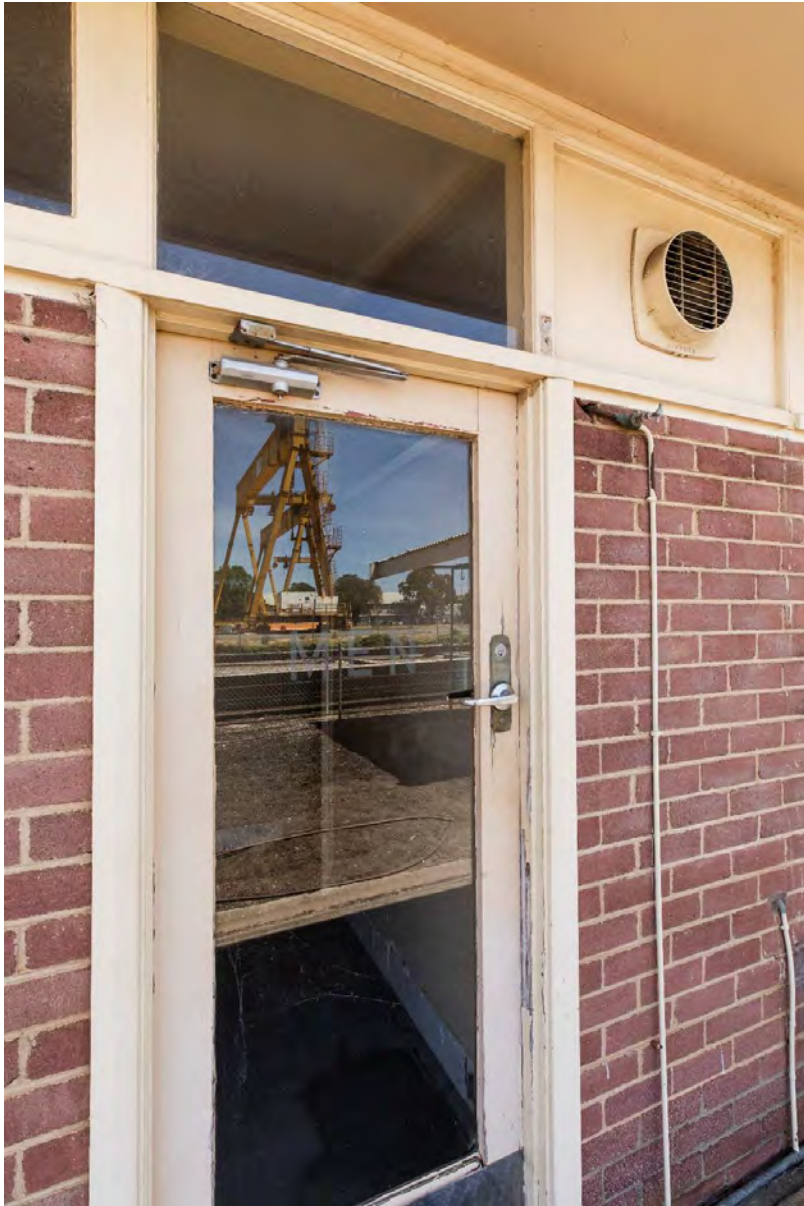
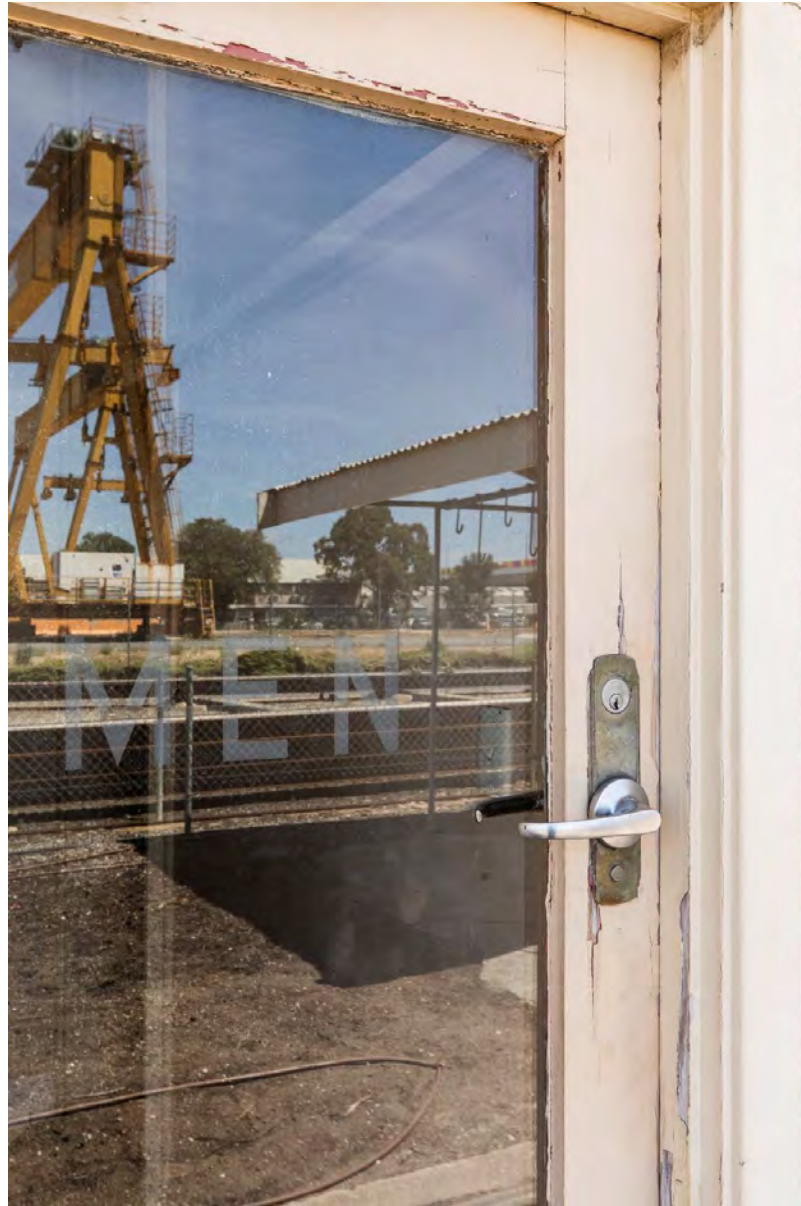
- Original timber framework rot to admin building and amenities.

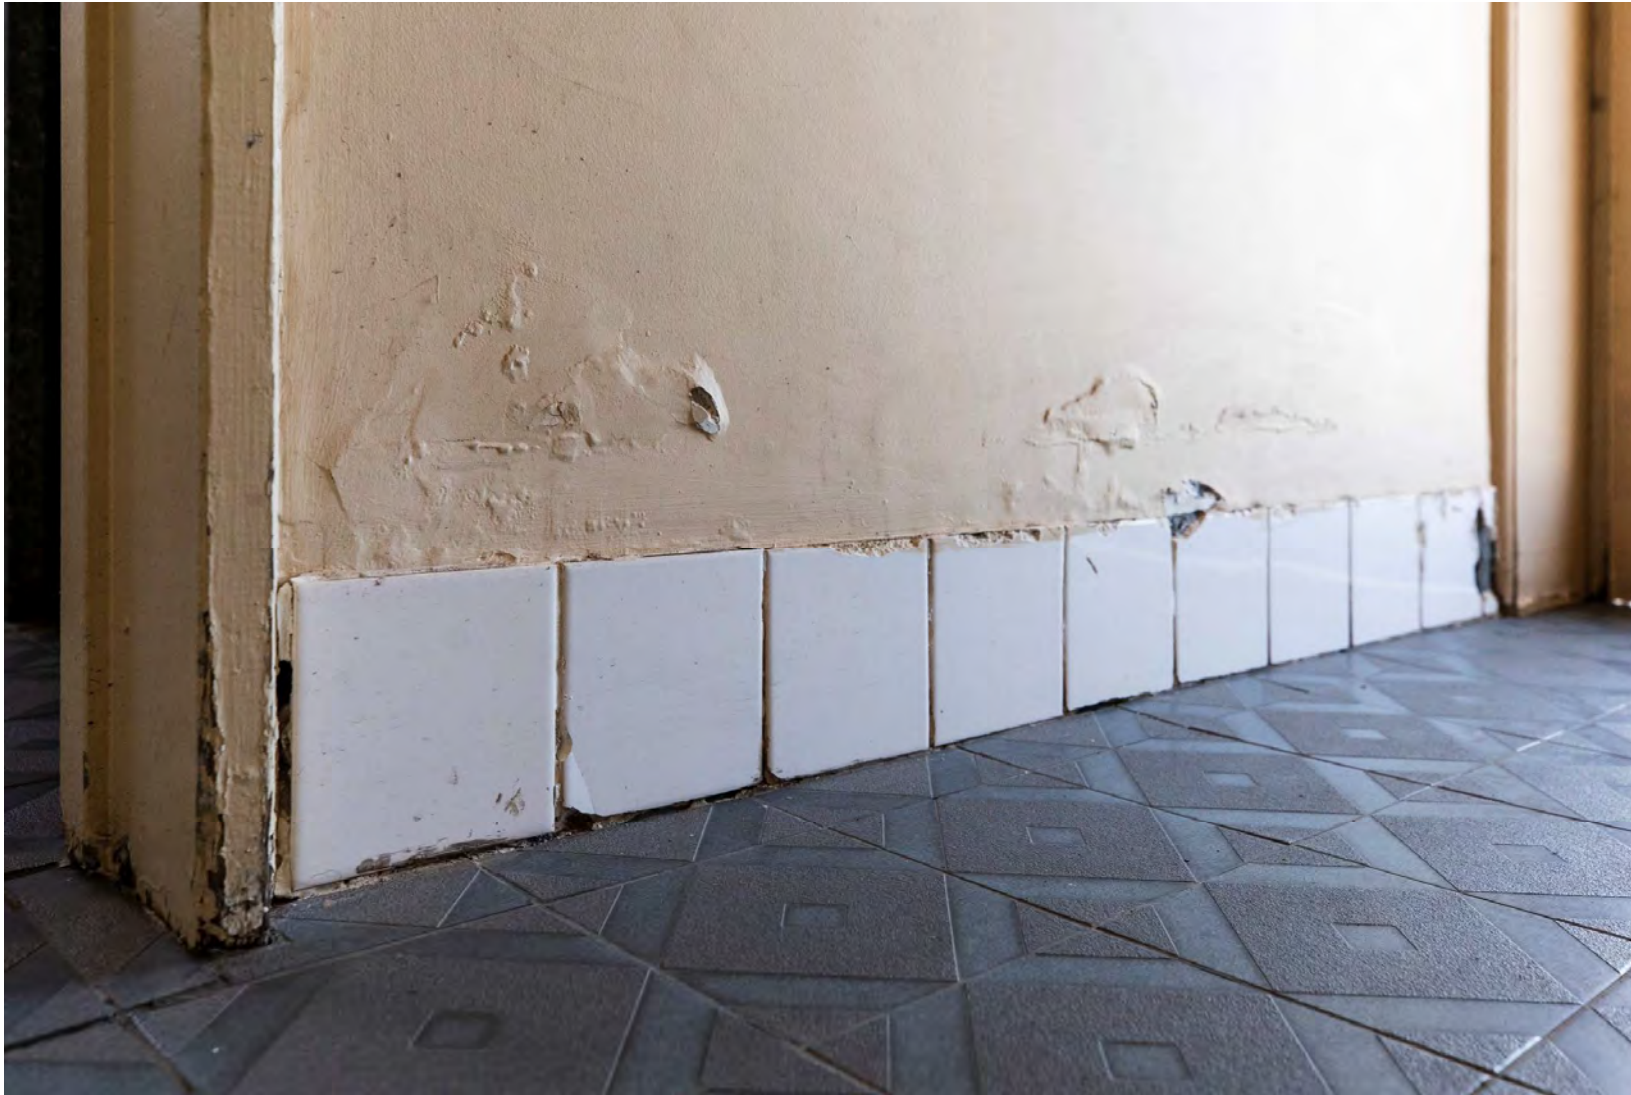
- Rising damp and concrete blockwork degradation

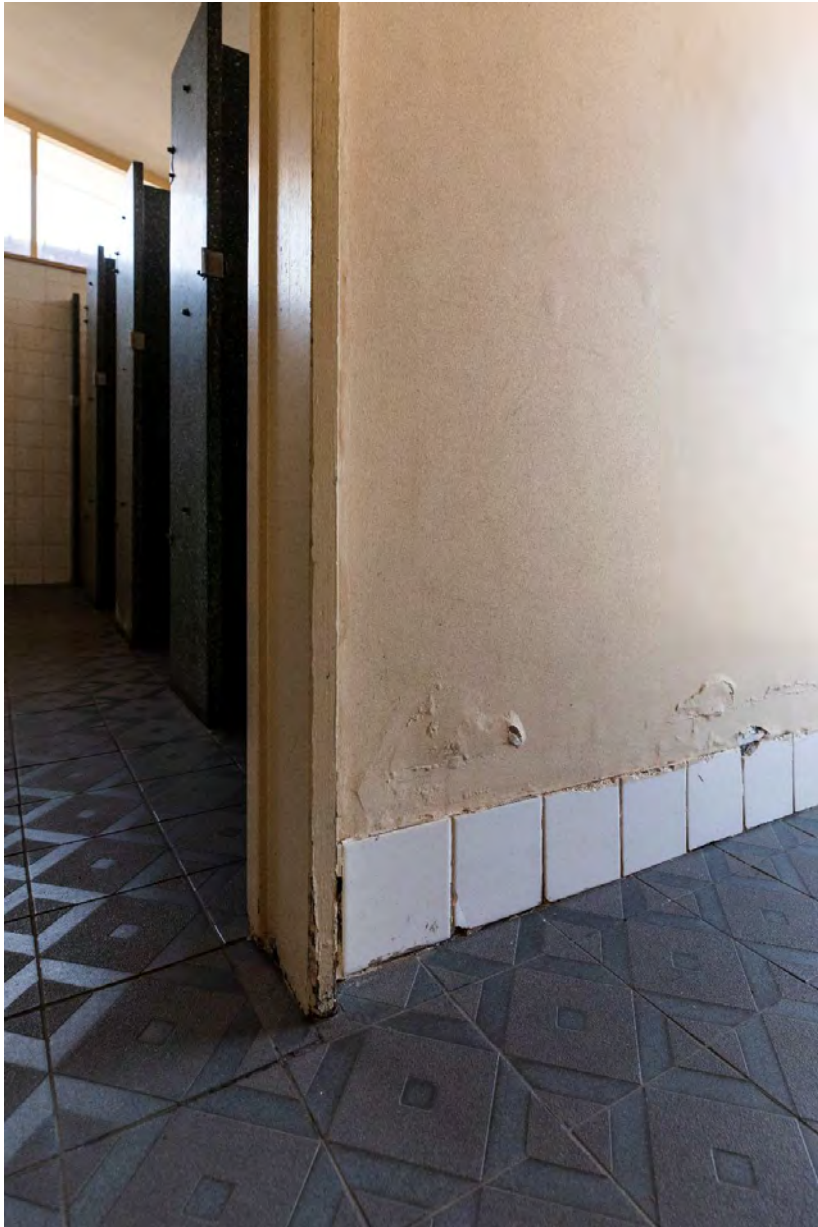
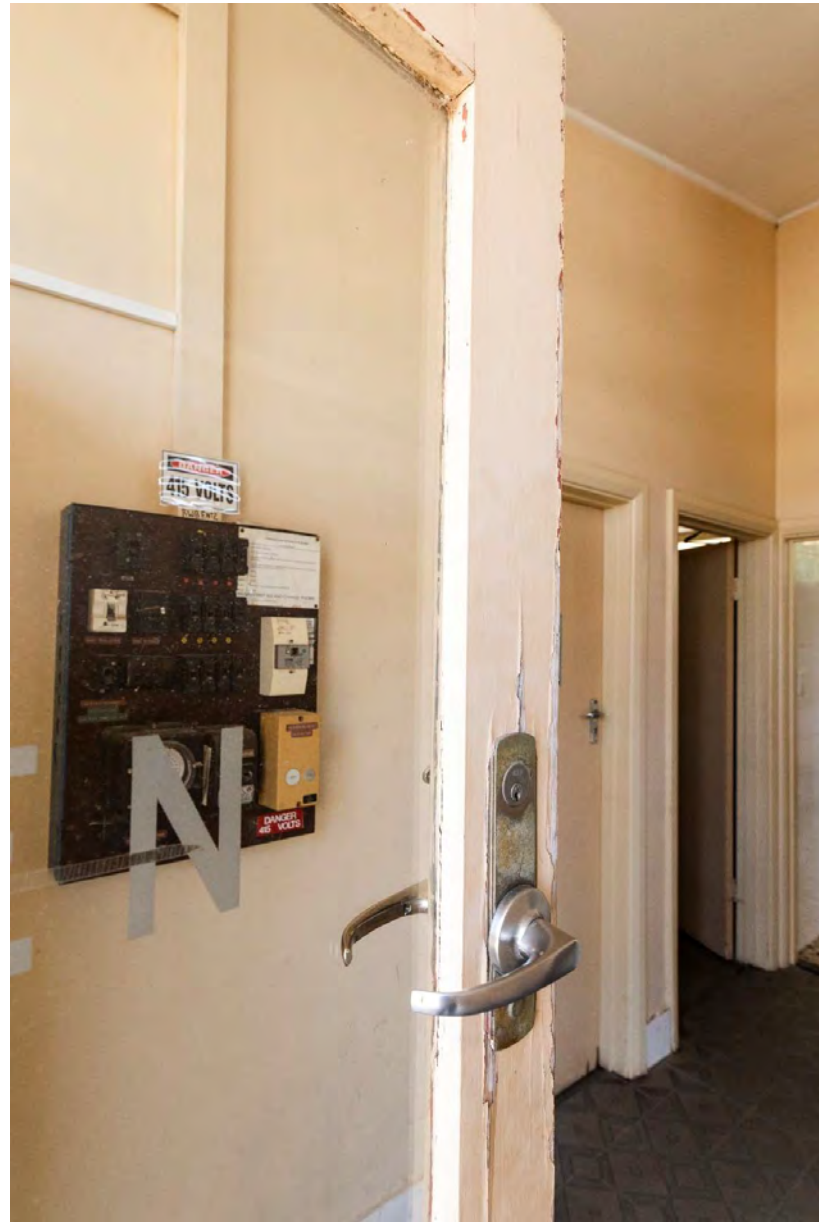
- Original timber framework rot to admin building and amenities and internal blockwork damage
