Supporting
document 5.24.2

St Marys Photographs

2020-25 Revised
Regulatory Proposal
10 December 2019

St Mary's Asset Condition Photographs

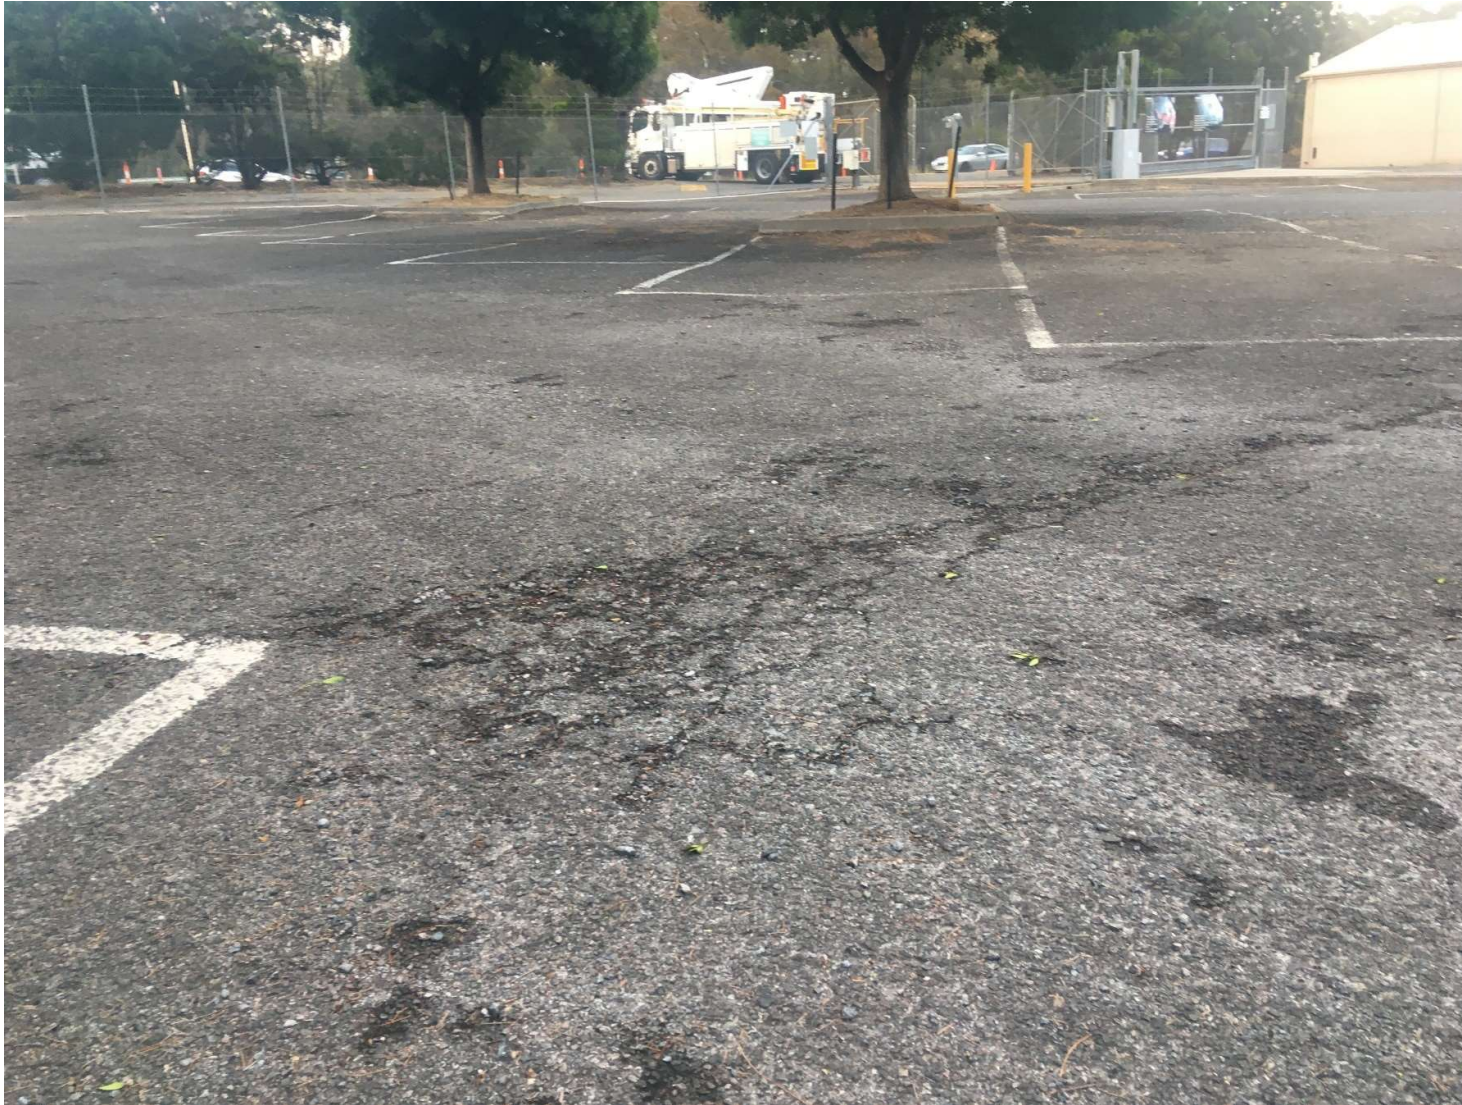
- Bitumen cracking to Light Vehicle Carpark Areas

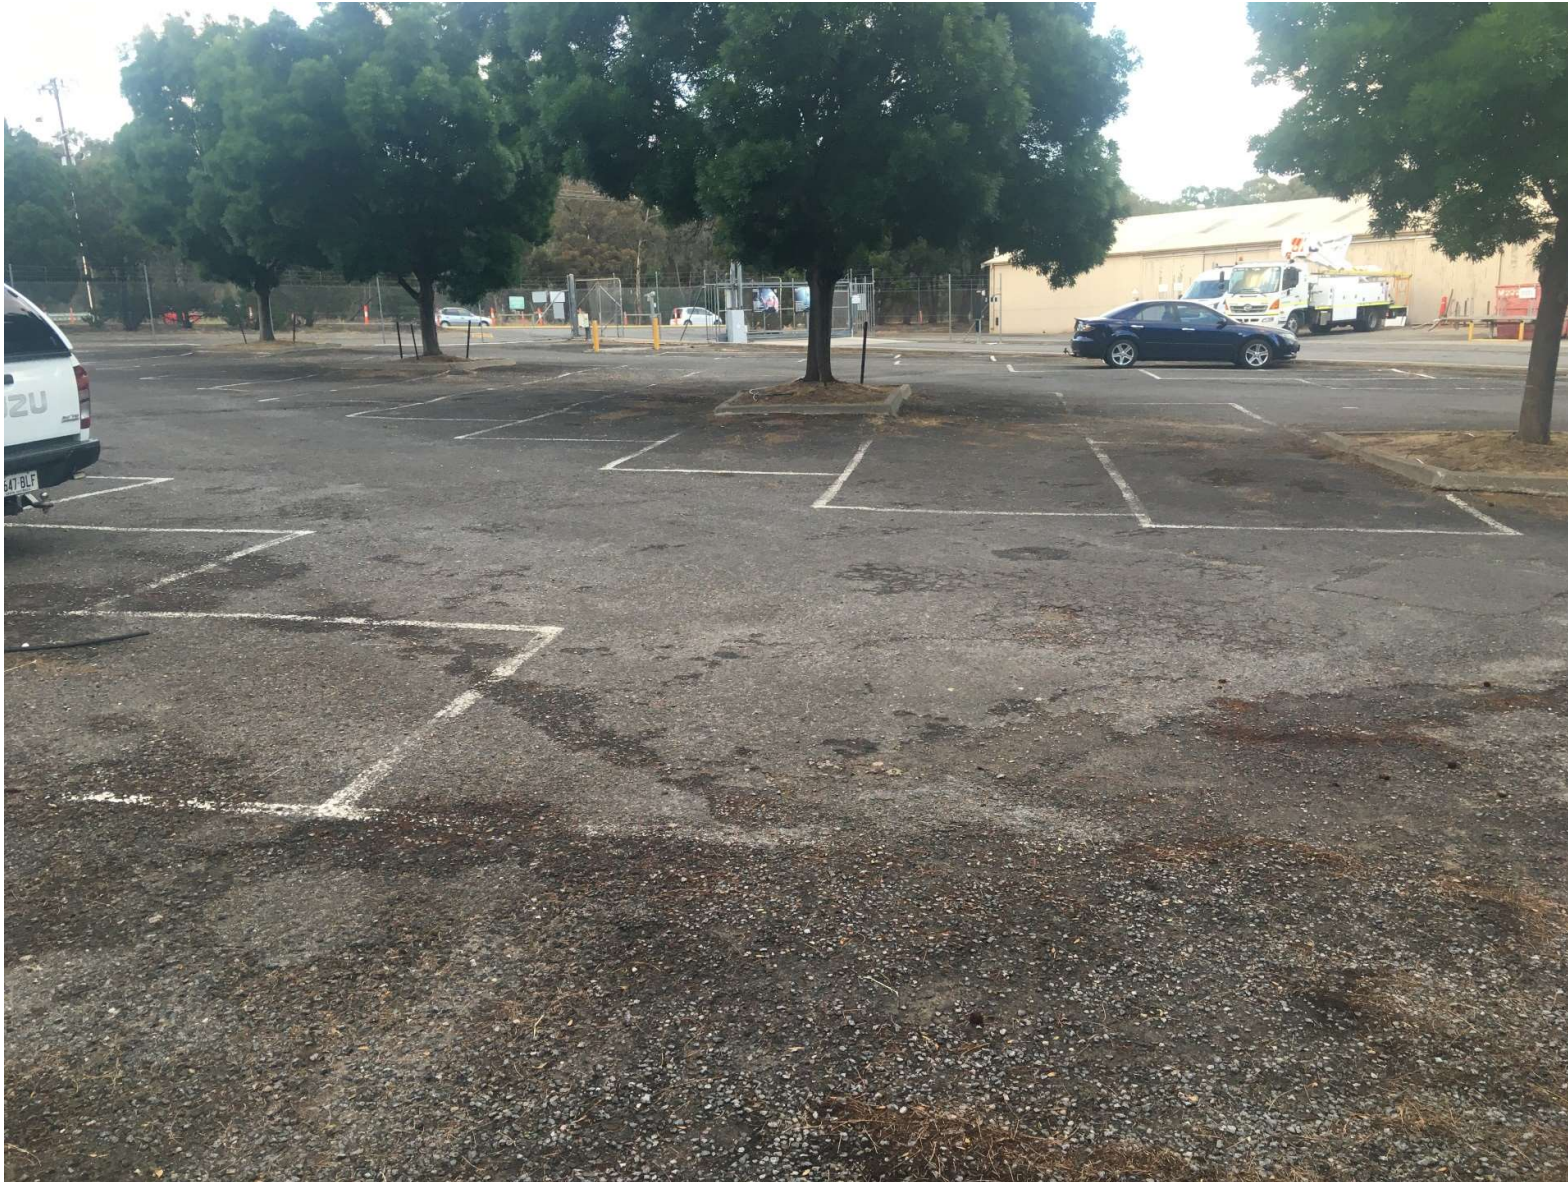
- Complete breakdown of some areas of bitumen to the light vehicle car park and driveways.

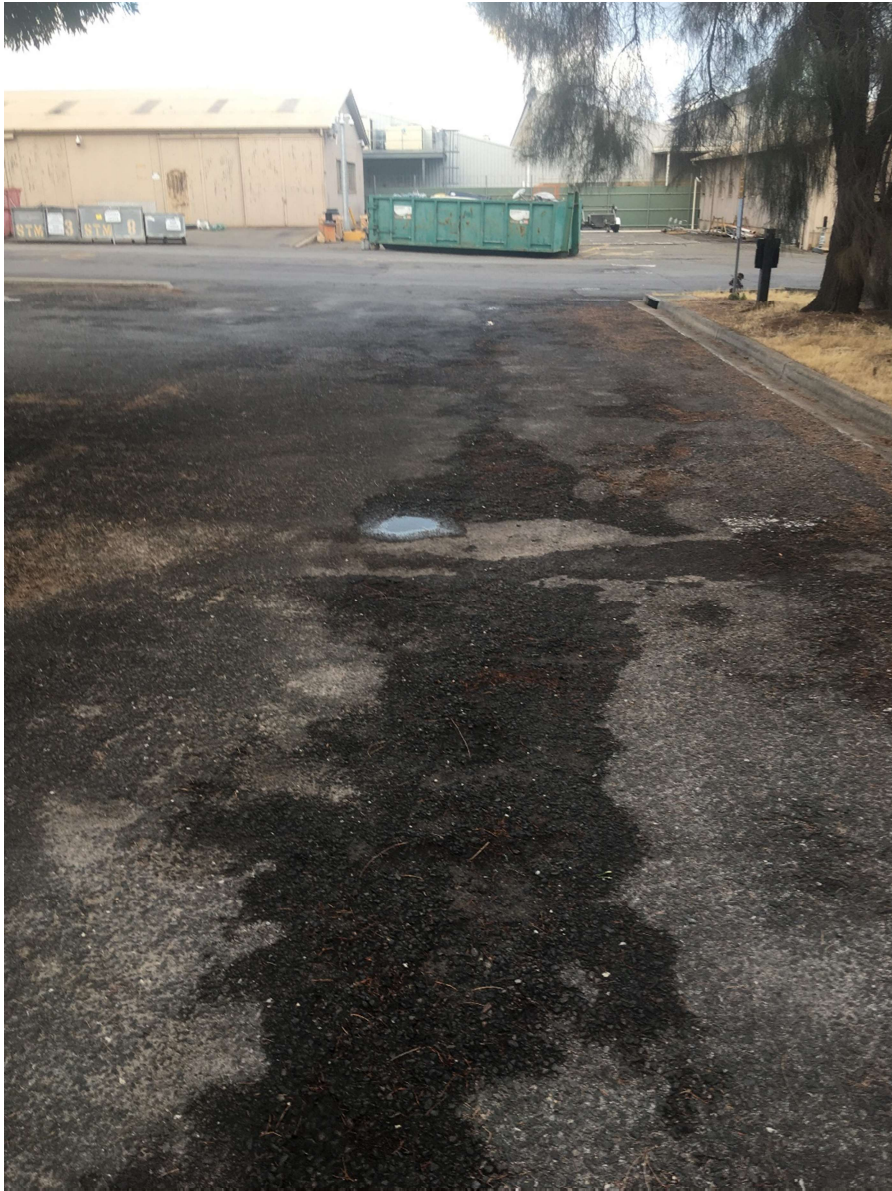
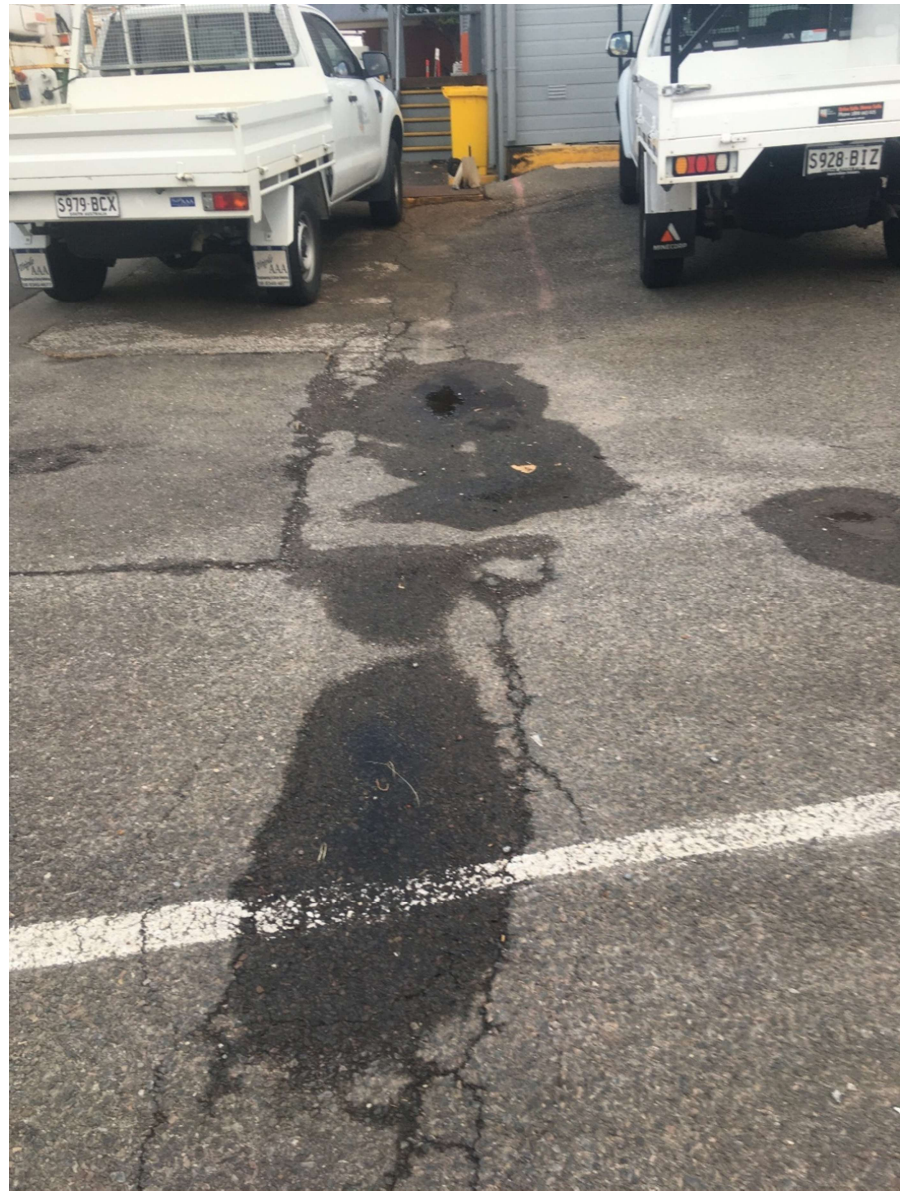
- Full-thickness cracking, subsidence and potholing to main driveway and Car park area

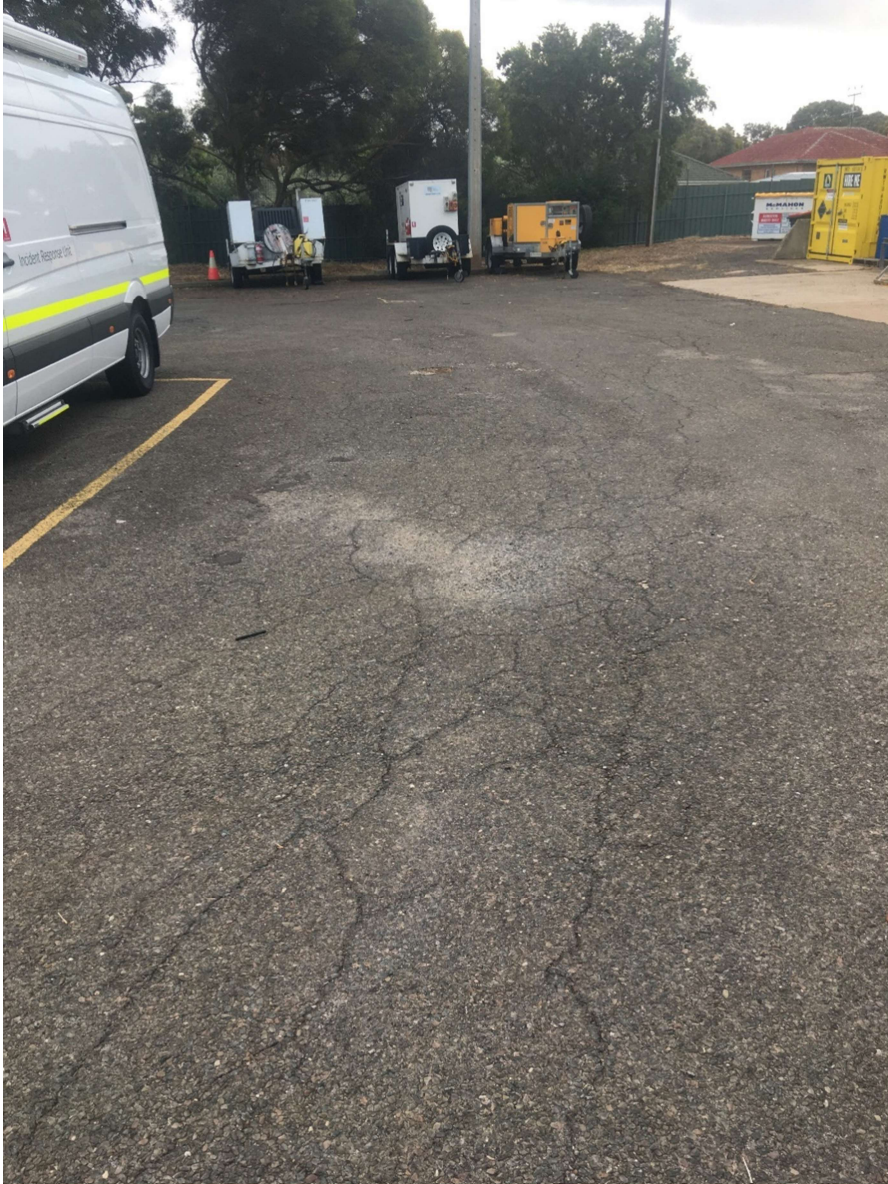
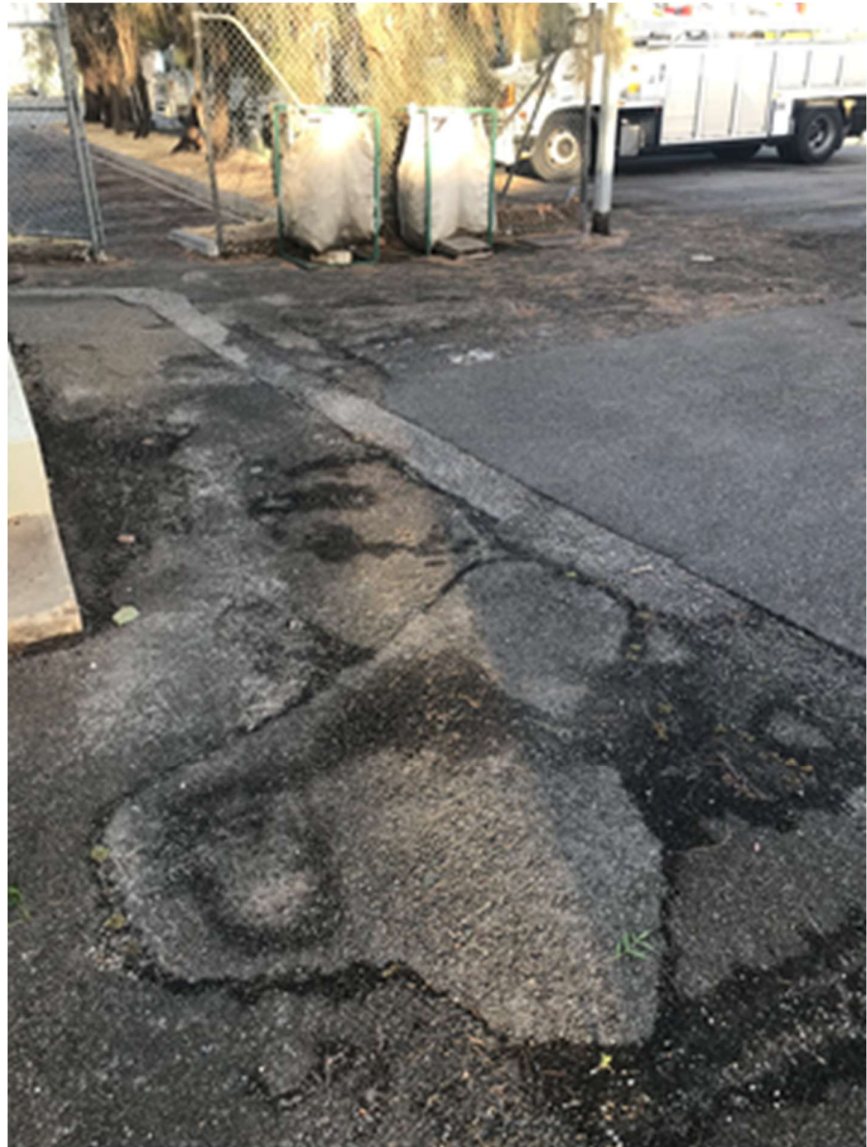
- Full-thickness cracking, subsidence and potholing to commercial vehicle Car park area.

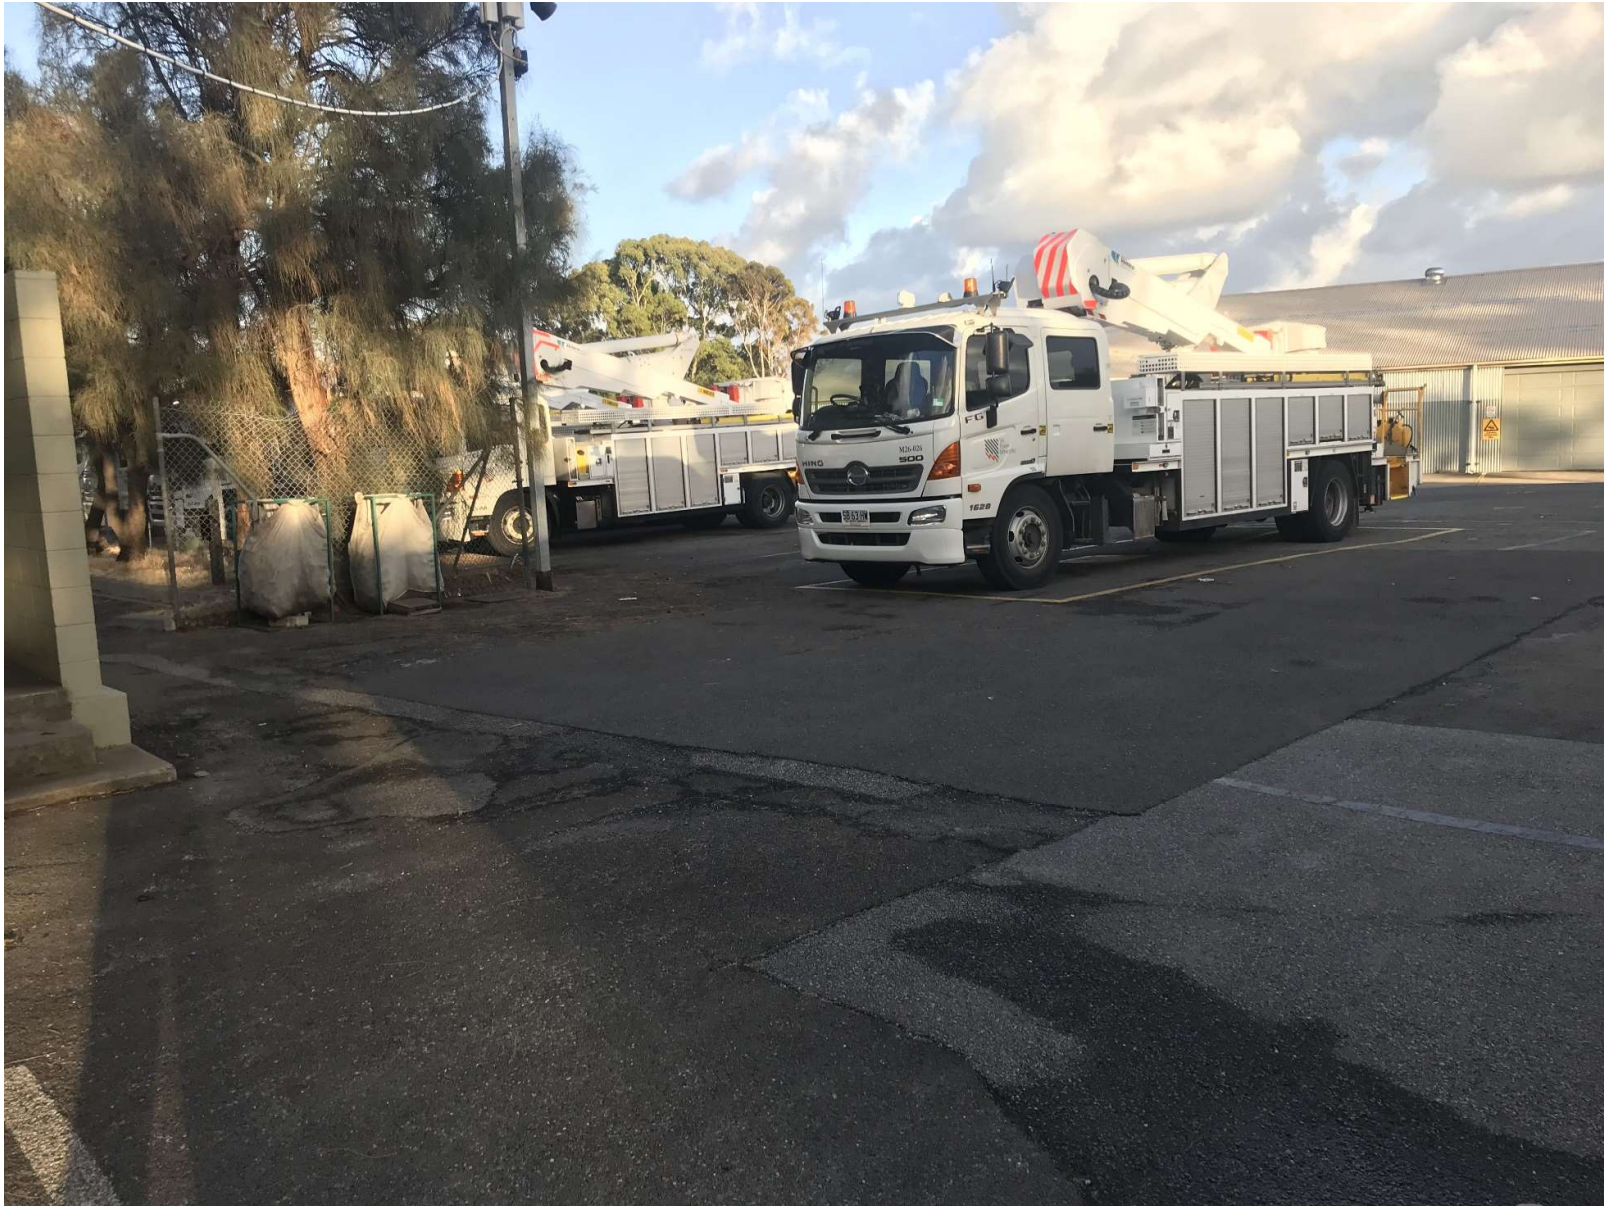
- Areas of cracking and subsidence and previous repair patches.

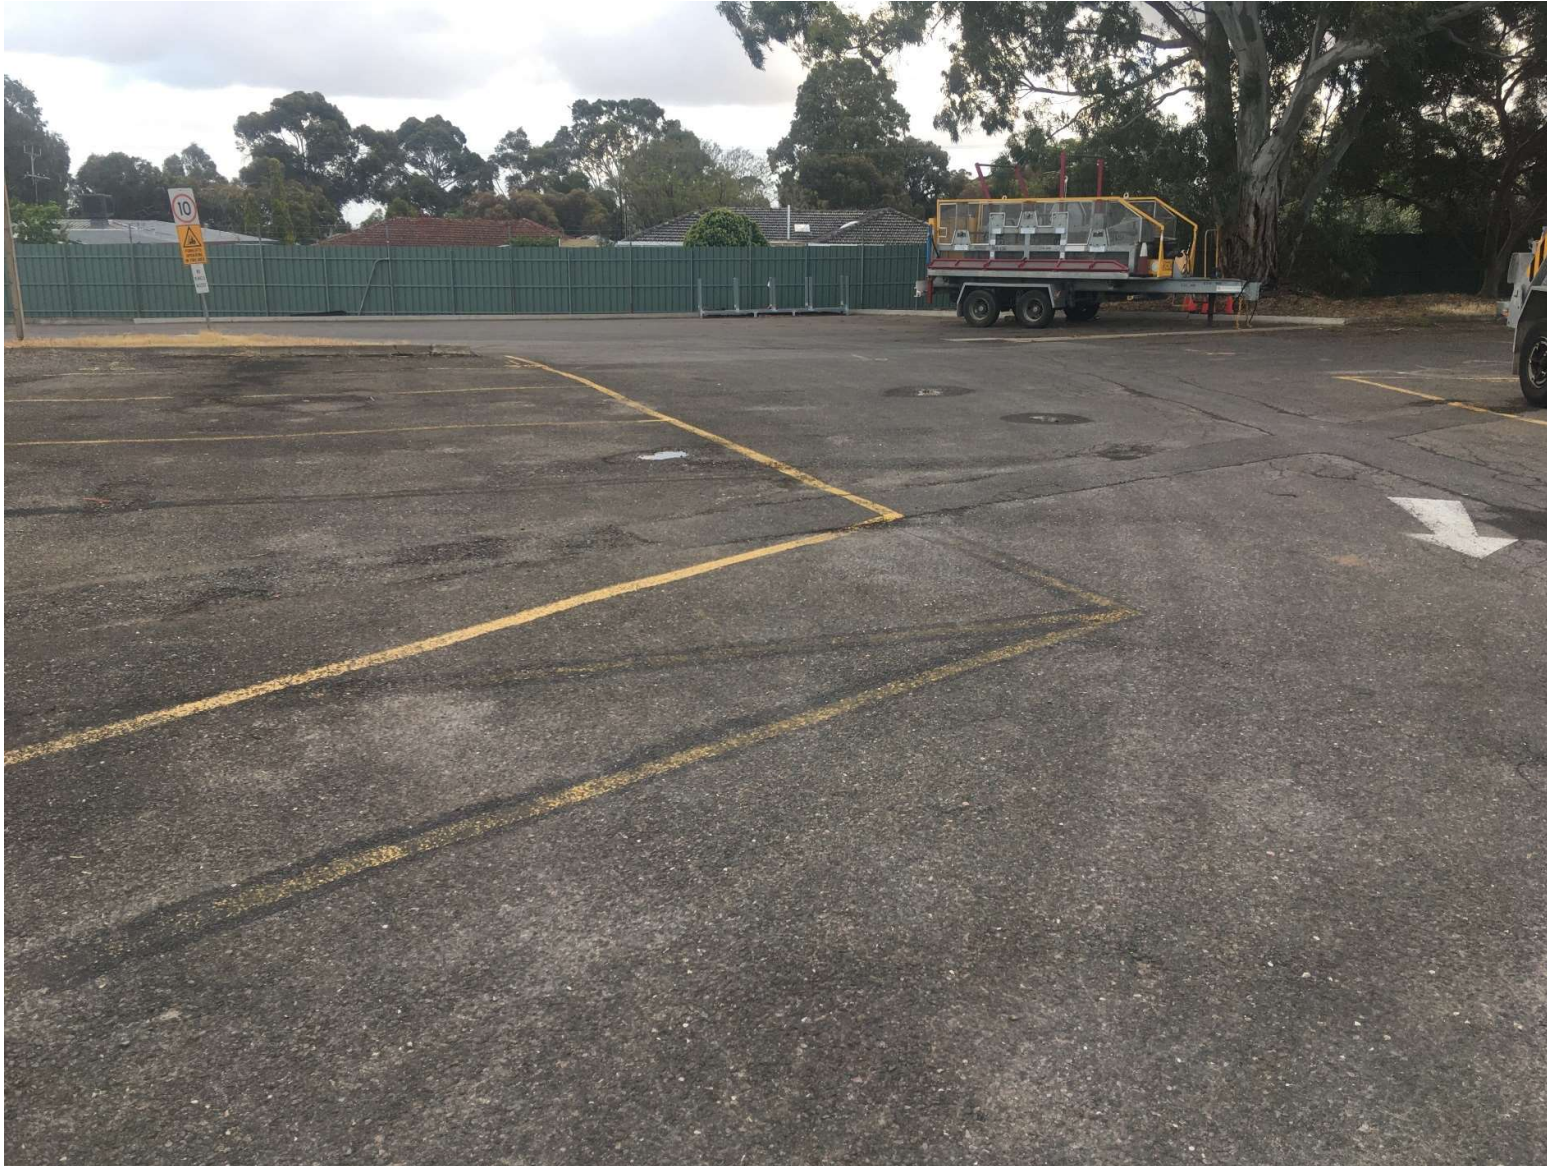
- Areas of cracking and Potholing to heavy vehicle driveway and turning circles.

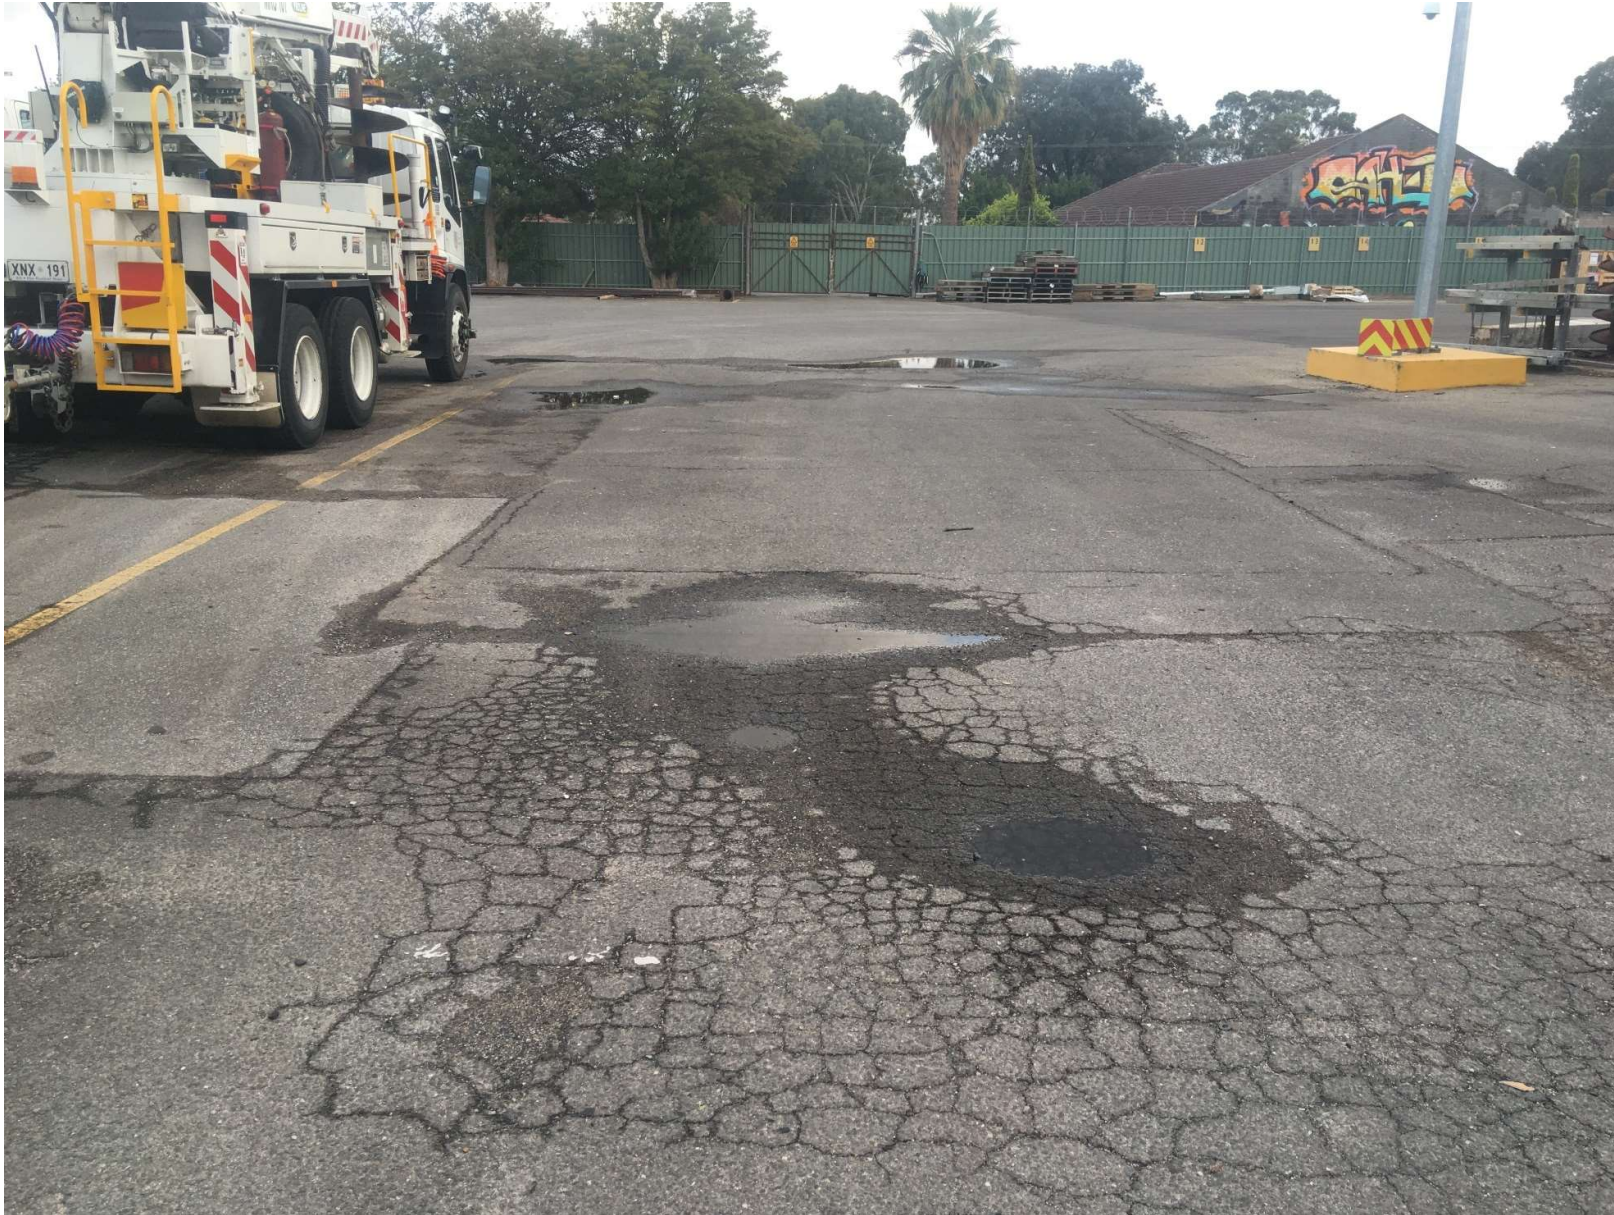
- Full-thickness cracking, potholes and subsidence to heavy vehicle driveway. Also areas of previous repairs.

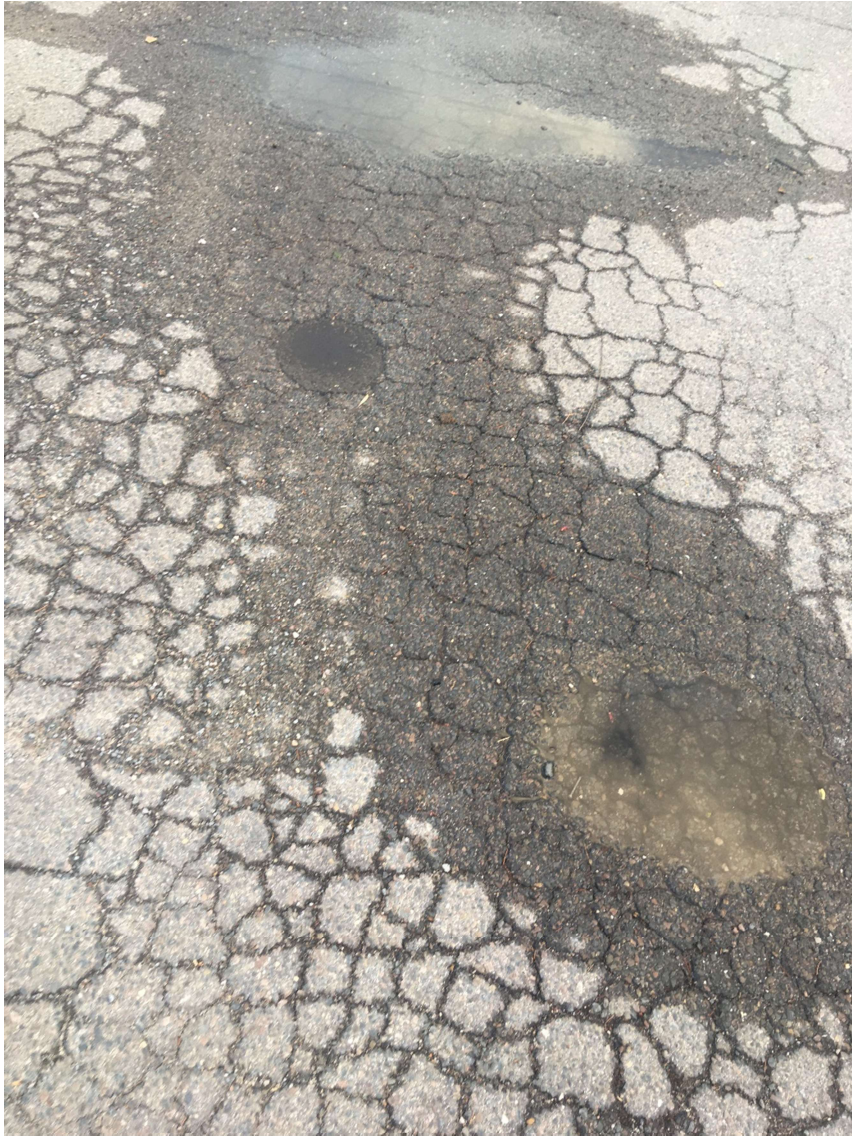
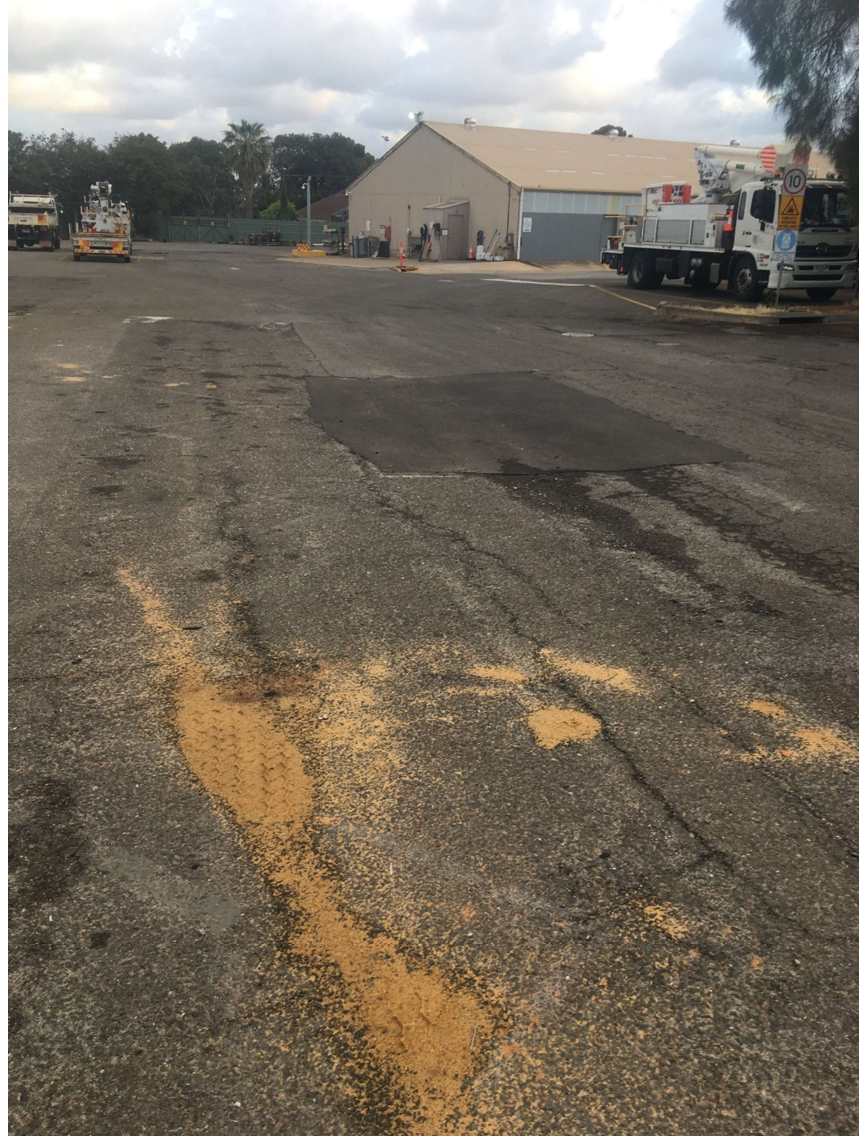
- Full-thickness cracking to main driveway

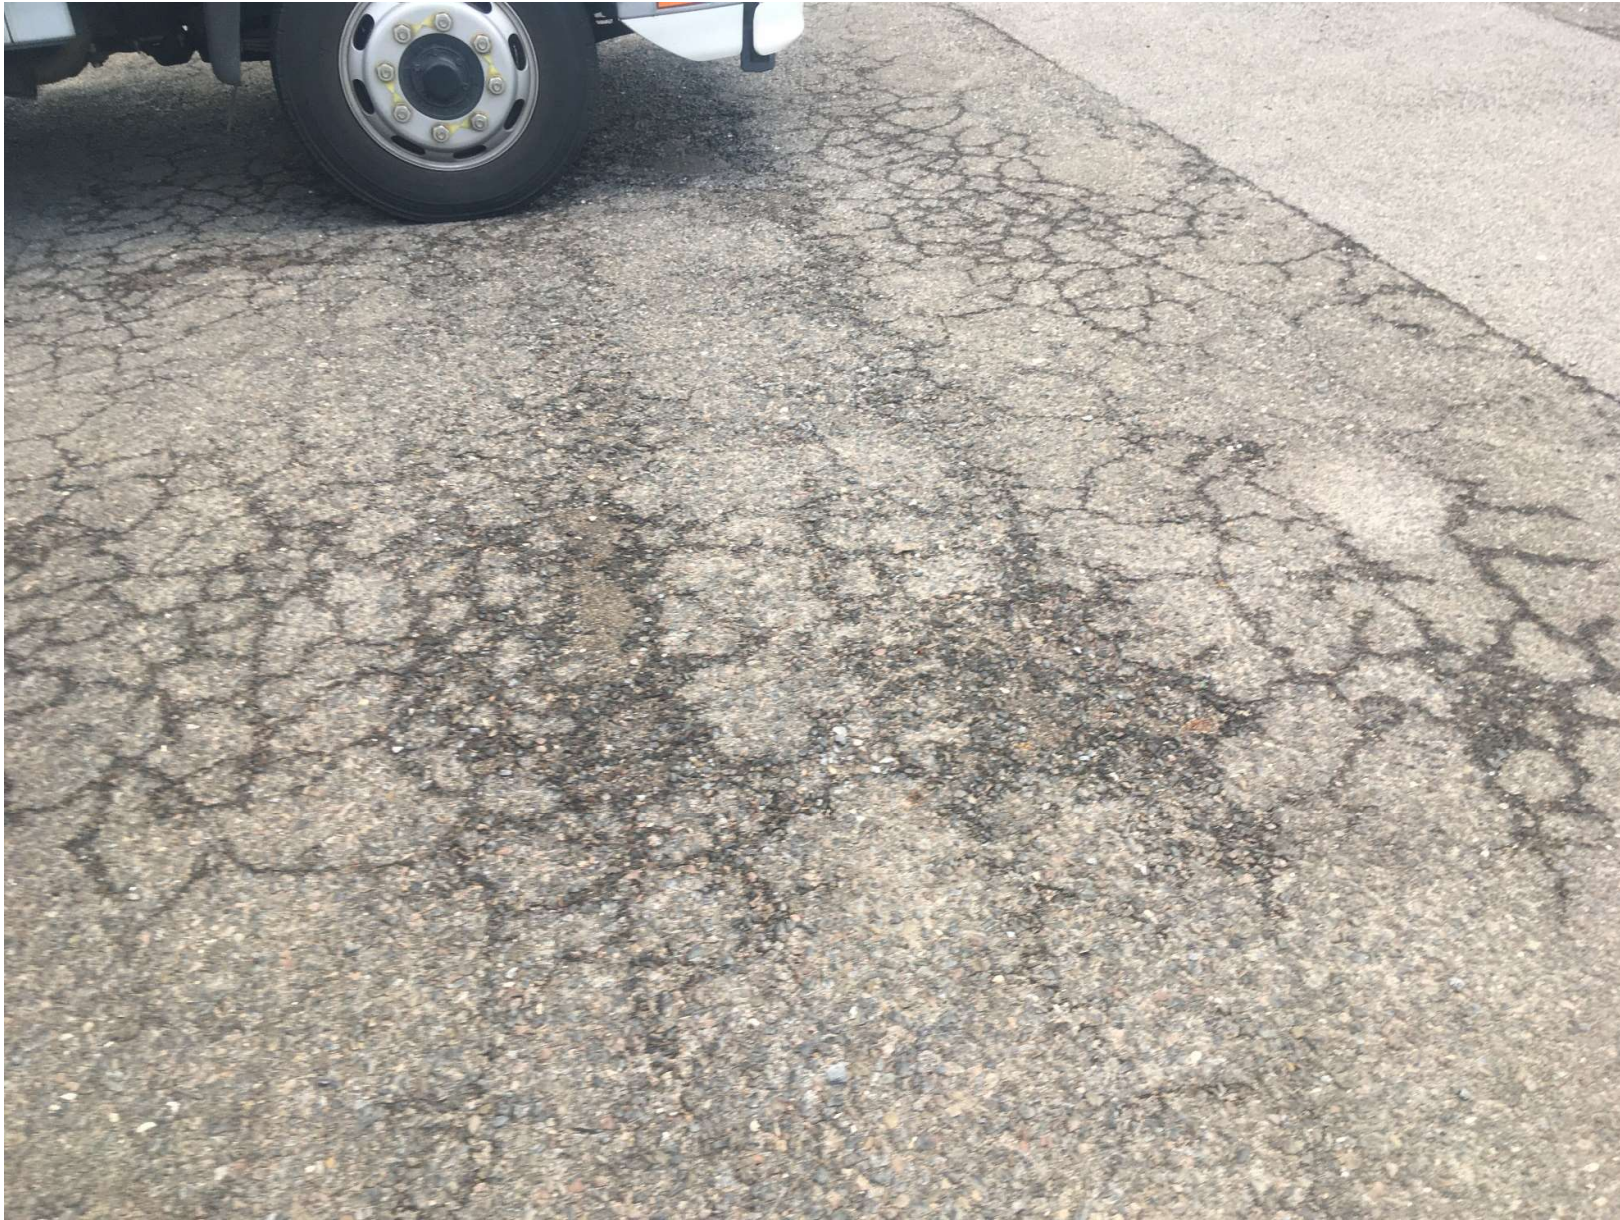
- Full-thickness cracking to main driveway.

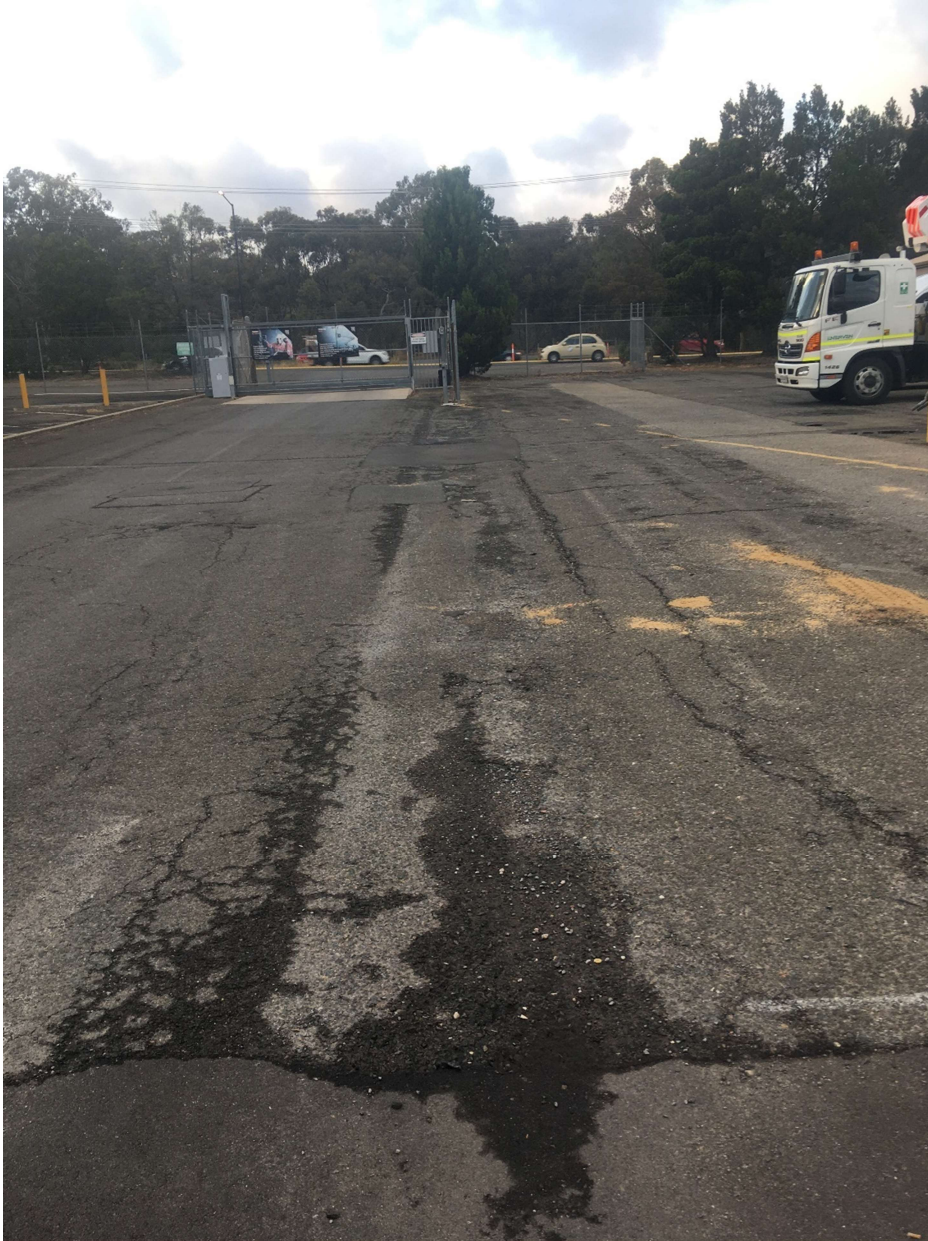
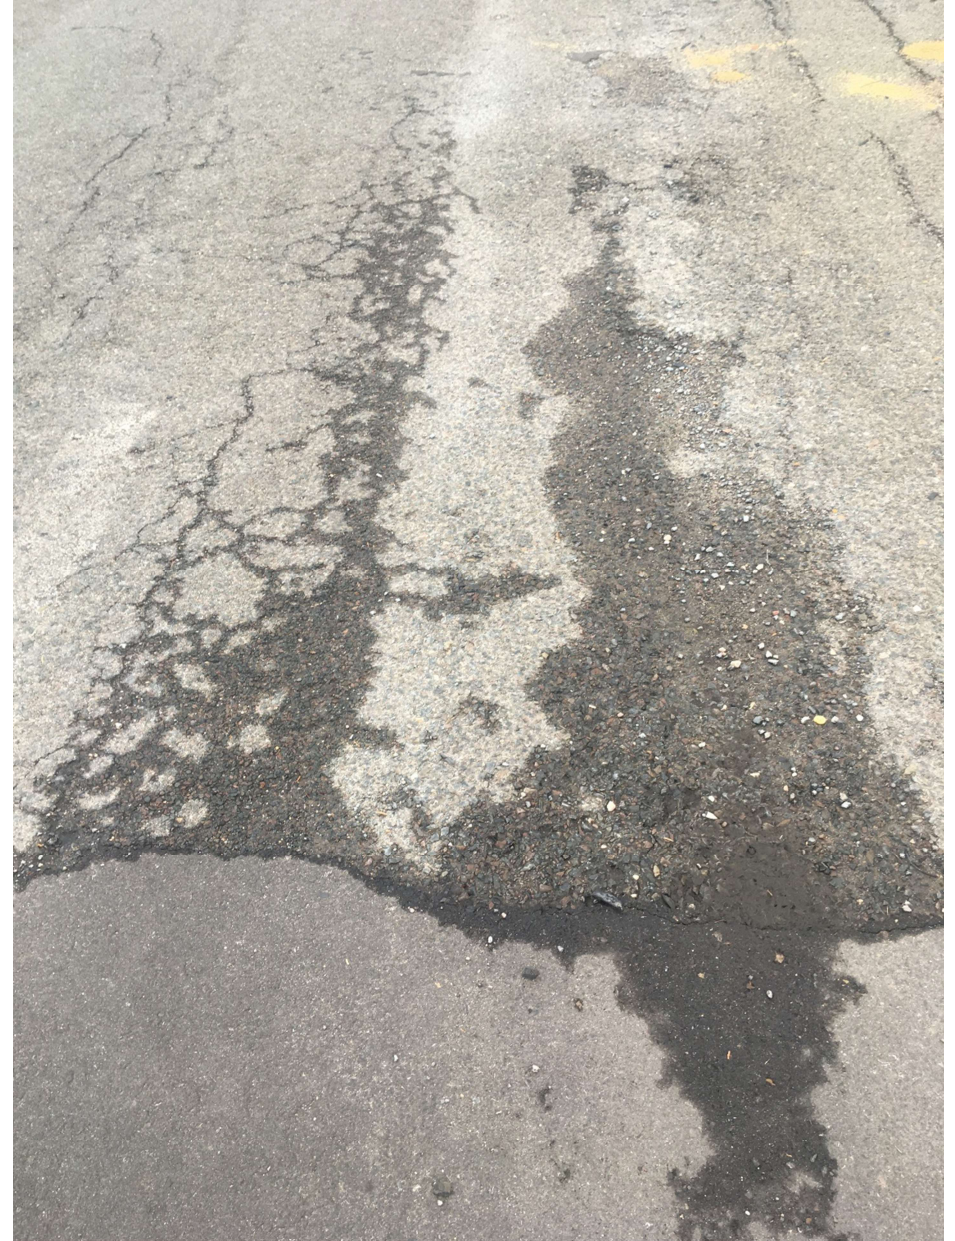
- Full-thickness cracking to main driveway.

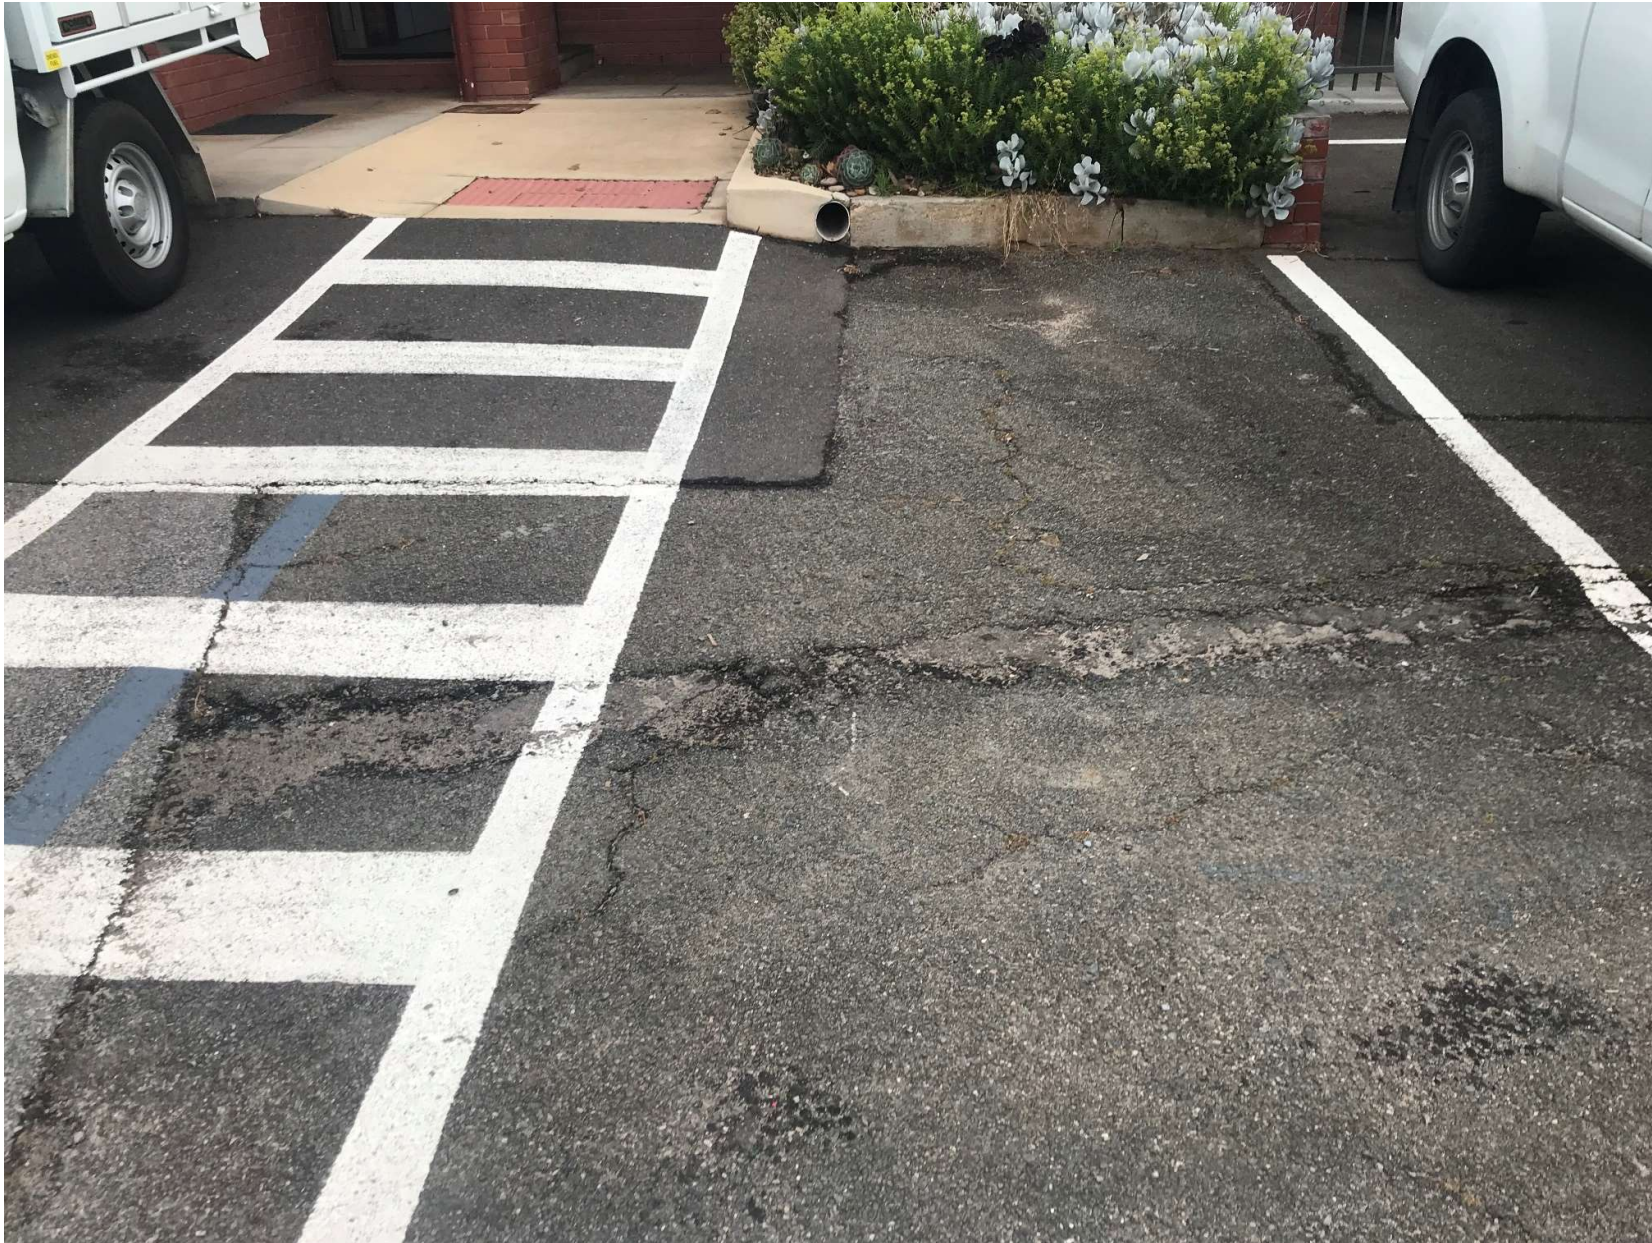
- Cracking around Pedestrian Walkways
