Supporting
document 5.24.2

St Marys Photographs

2020-25 Revised
Regulatory Proposal
10 December 2019

St Mary's Asset Condition Photographs

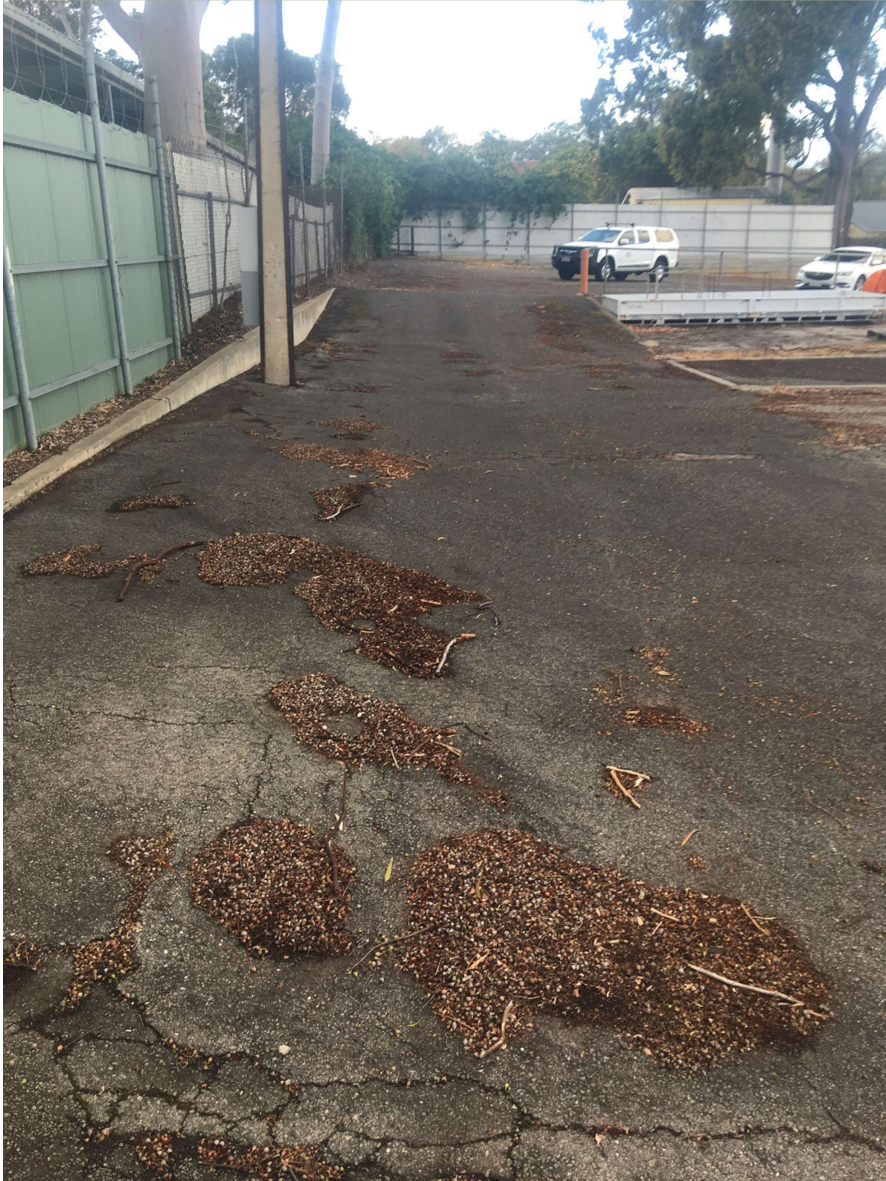
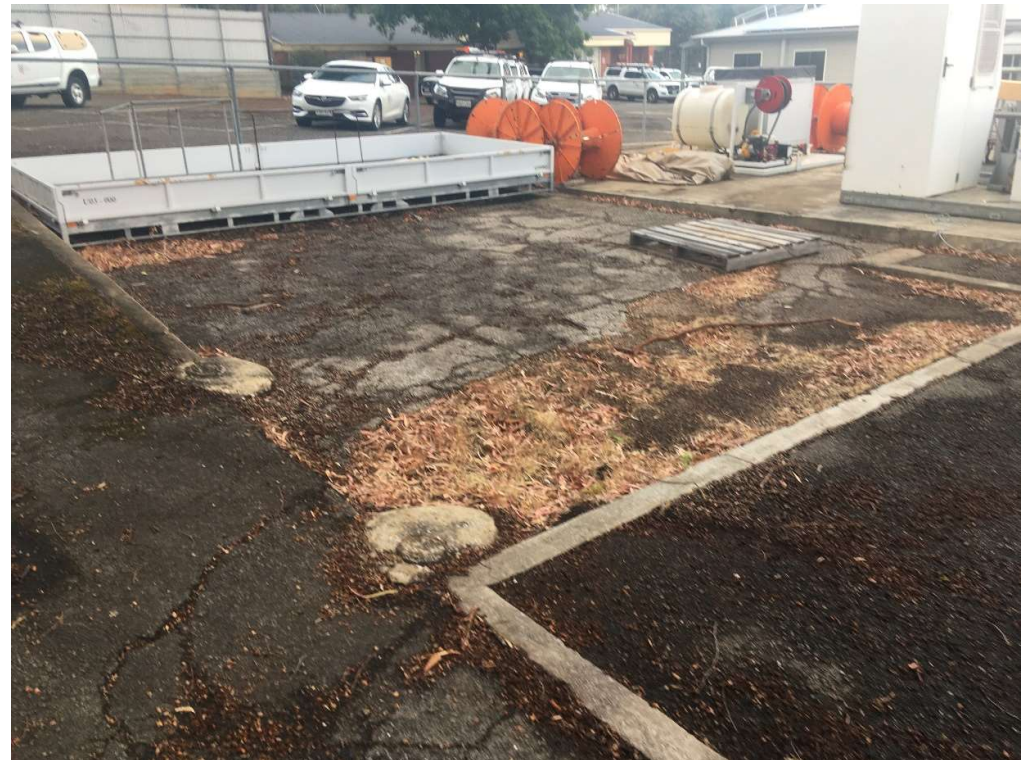
- Cracking, Subsidence and tree root uplift to driveway and storage areas

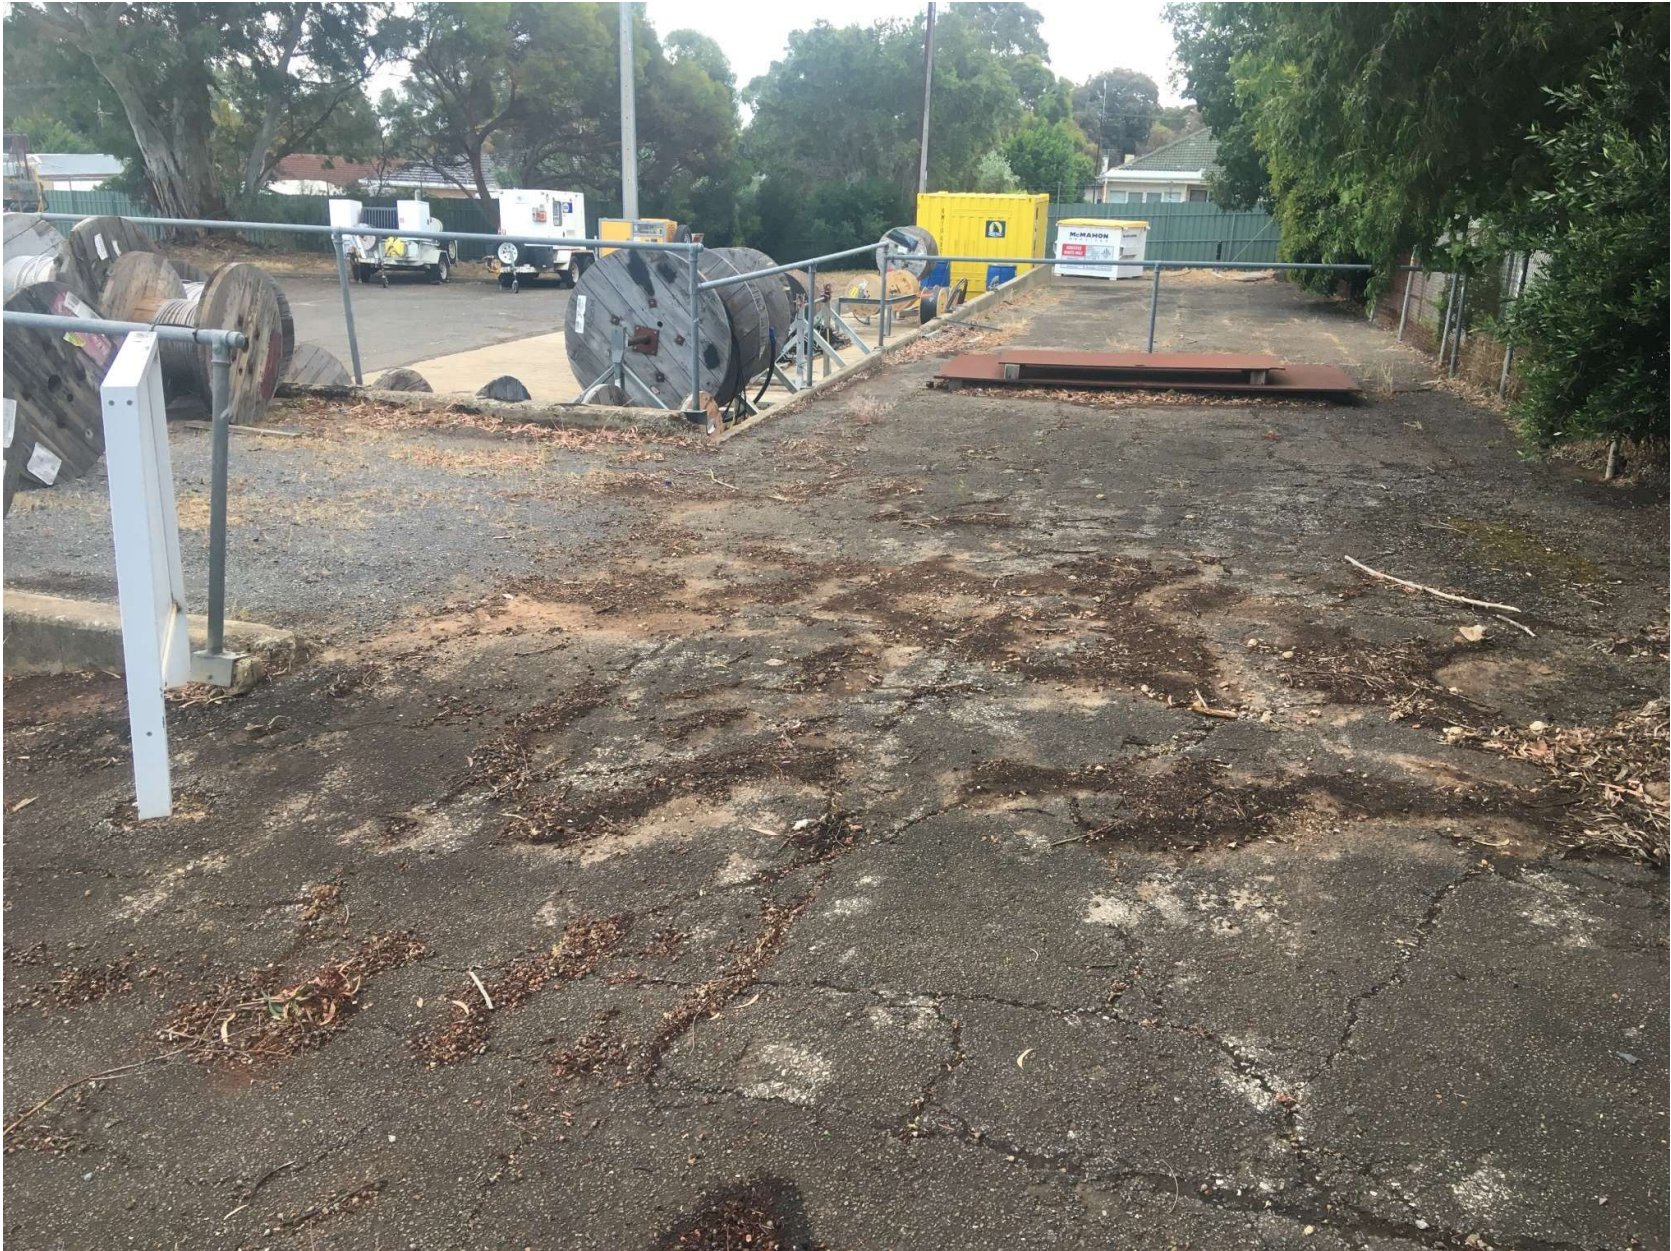
- Cracking, Subsidence and tree root uplift to storage areas.

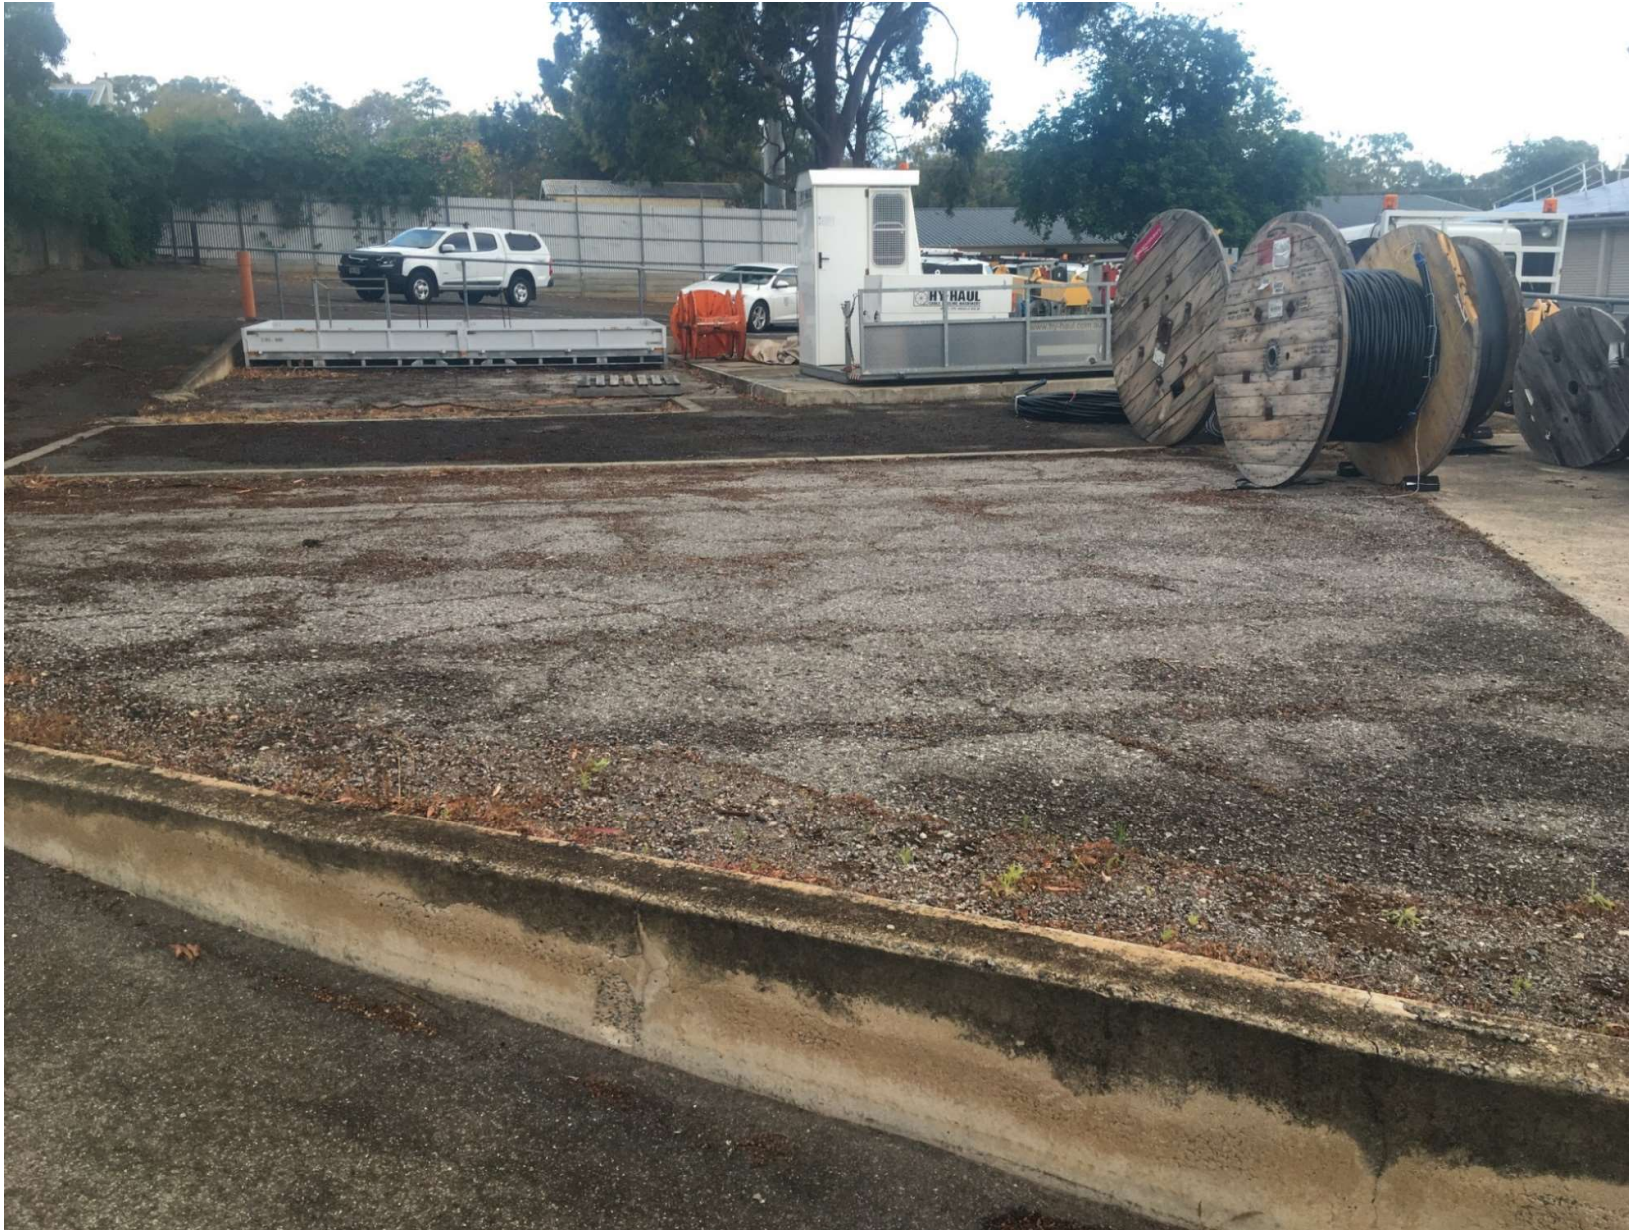
- Cracking, Subsidence and tree root uplift to storage areas.

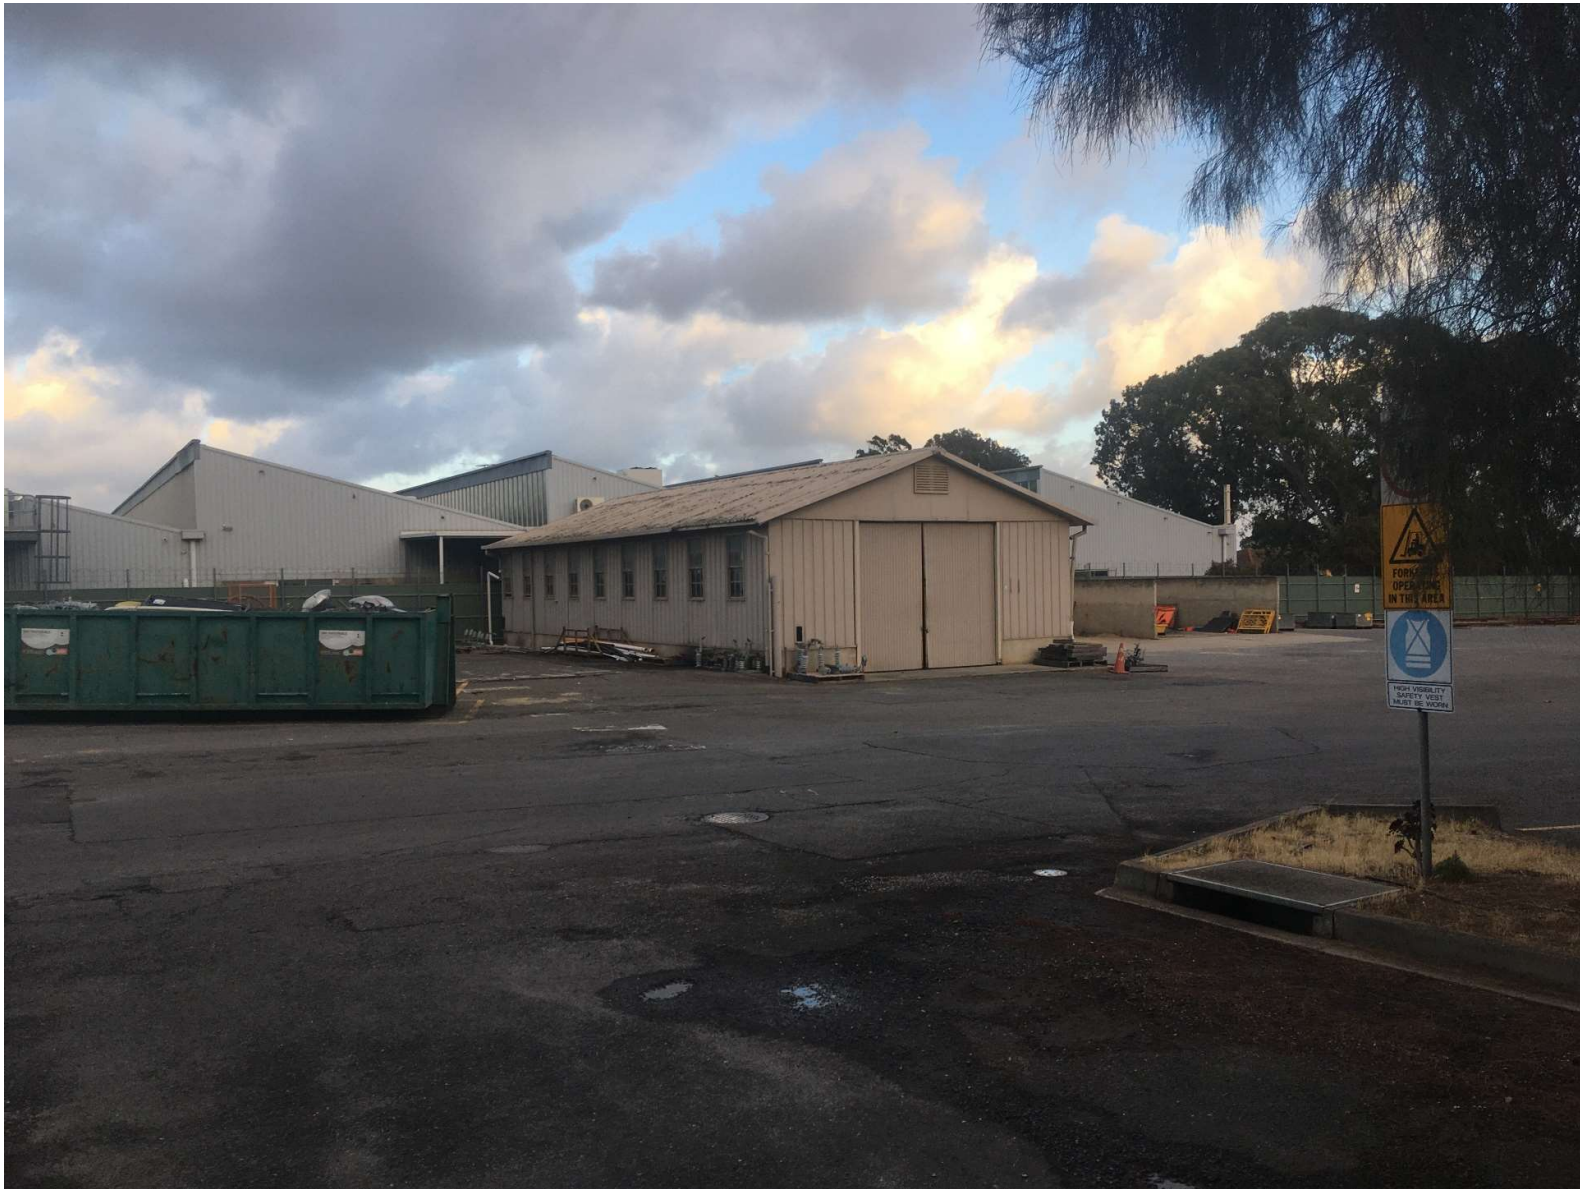
- Shed 1 – Original 1950's corrugated iron in poor condition. Holes in sheets.

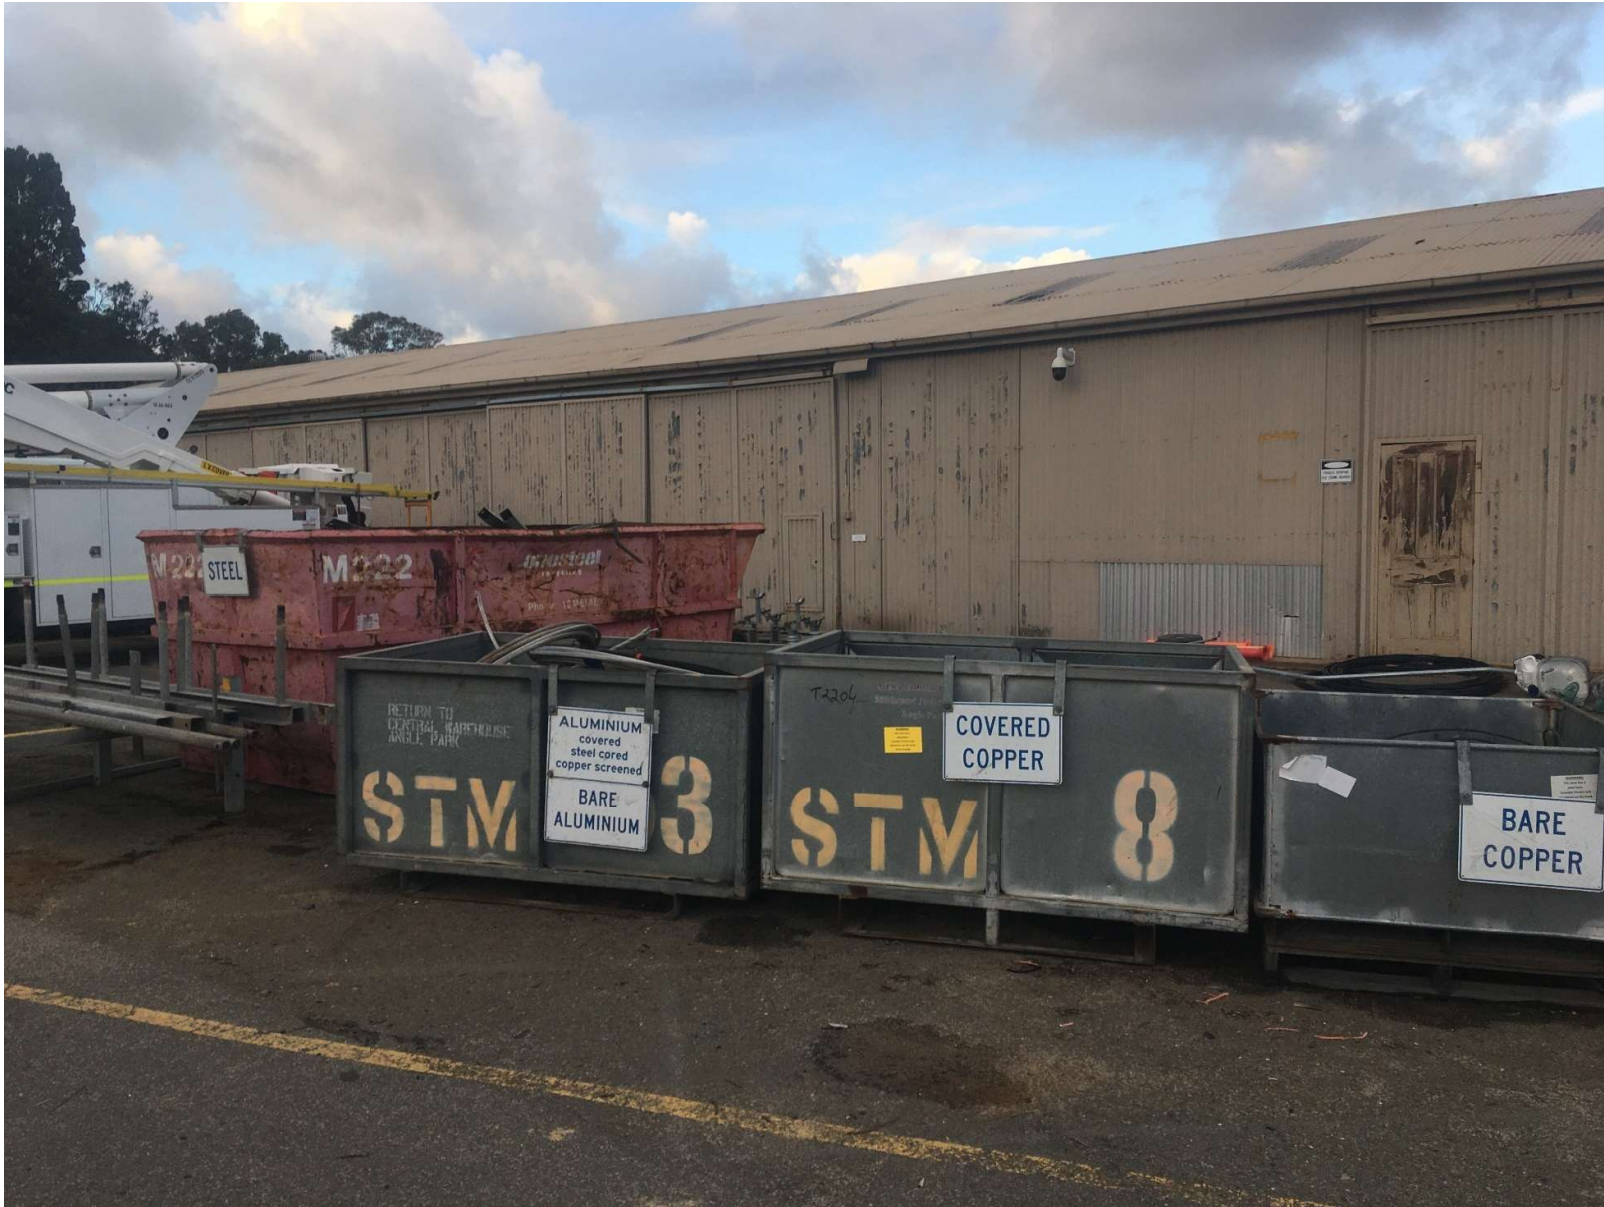
- Shed 1 corrugated iron sheets in poor condition

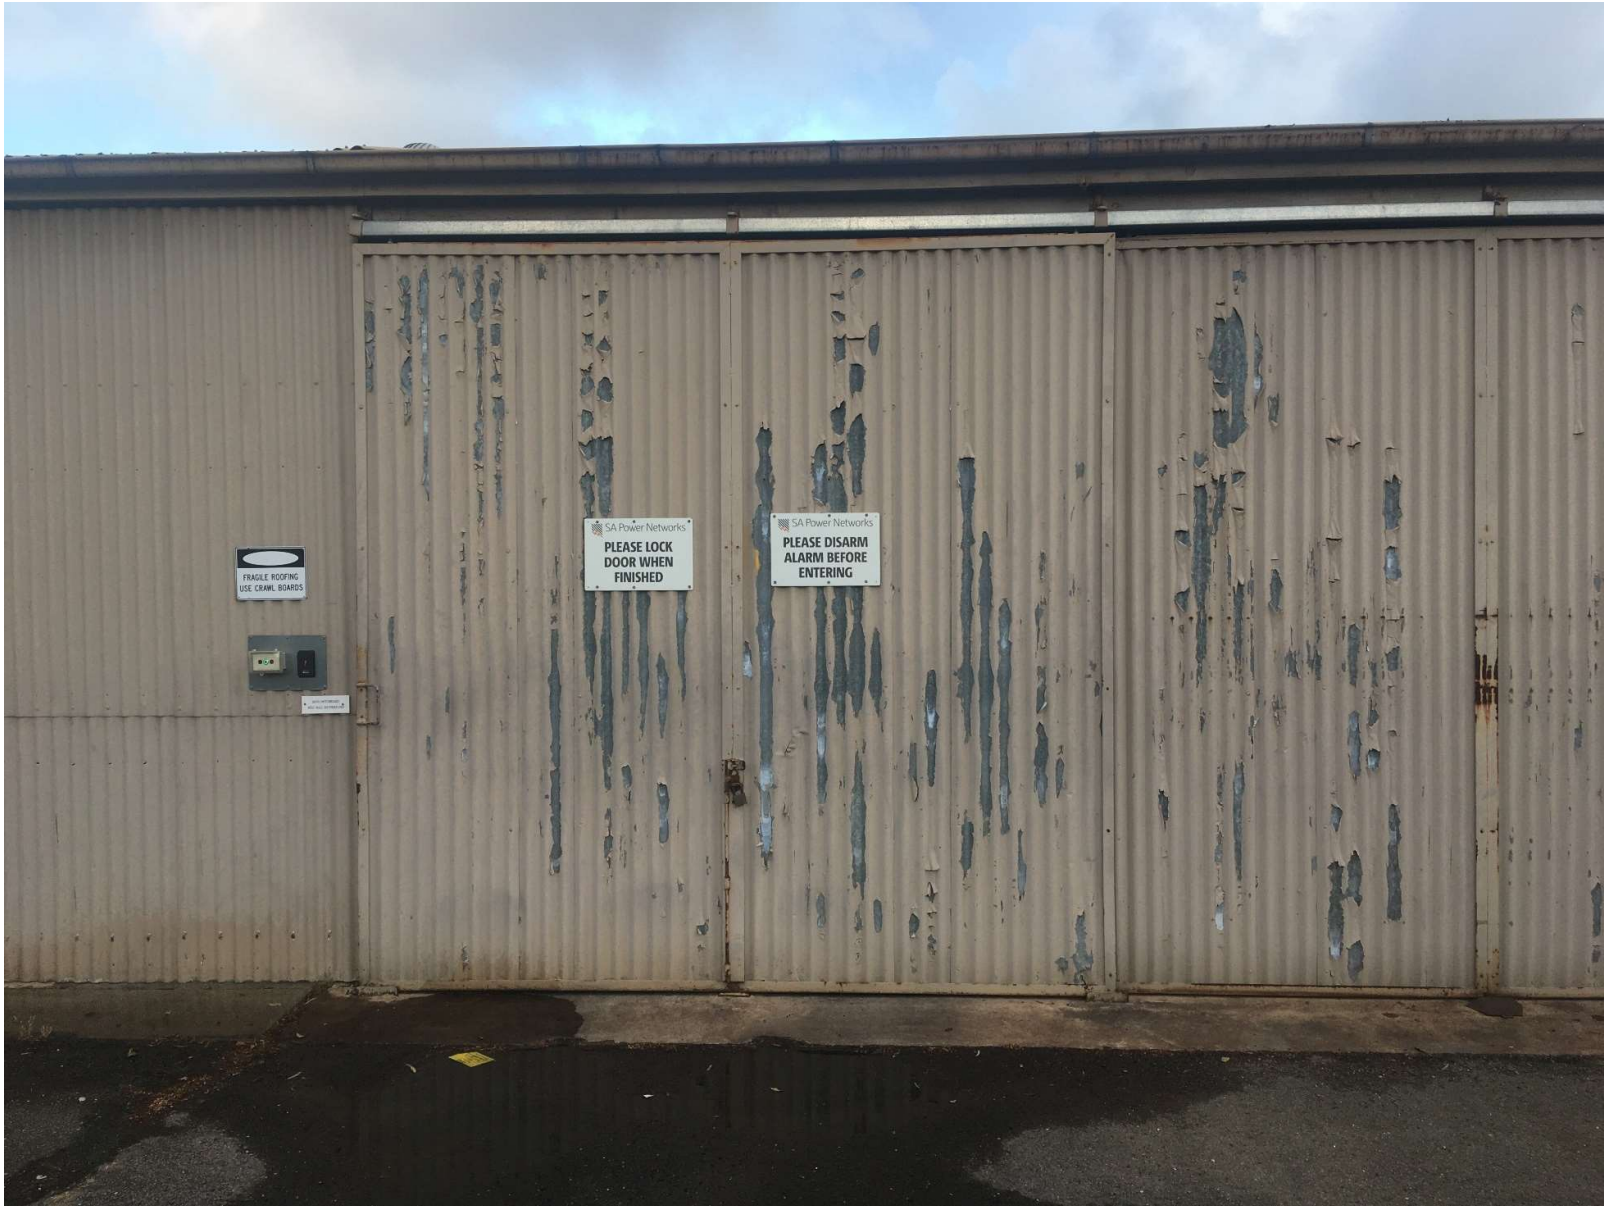
- Rust and corrosion to iron sheets and supporting framing

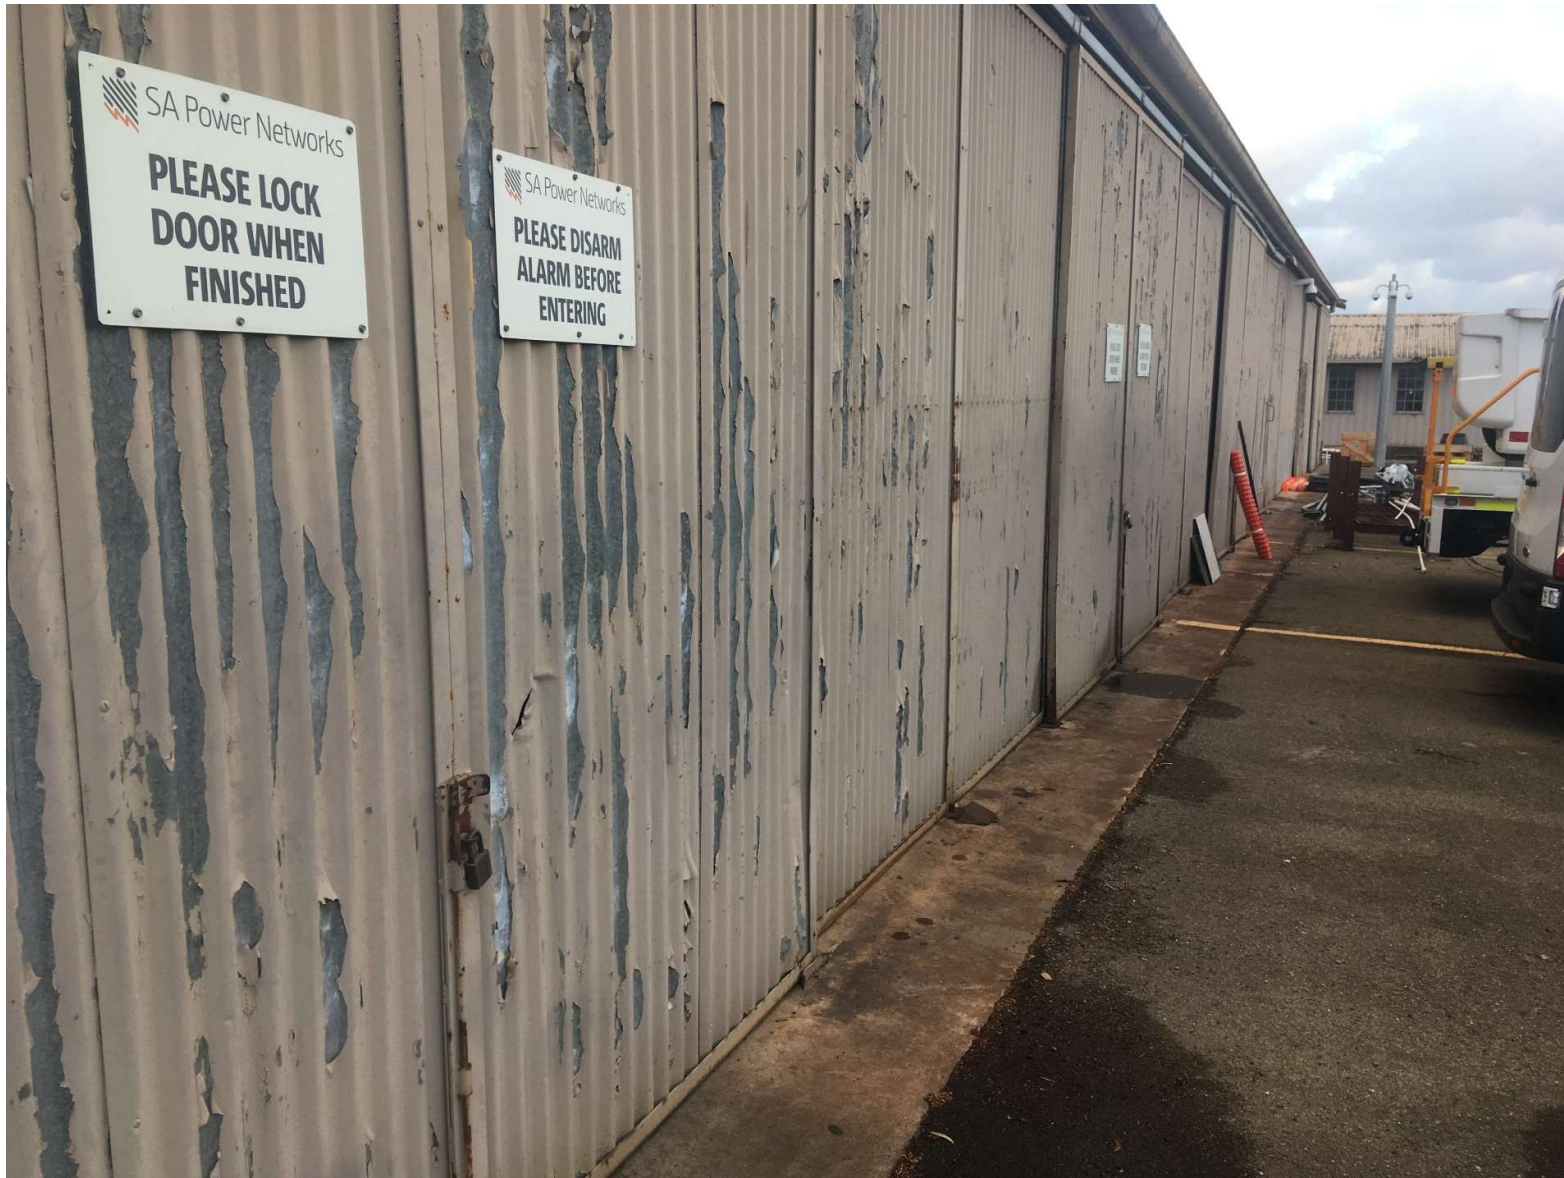
- Shed 1 corrugated iron sheets in poor condition

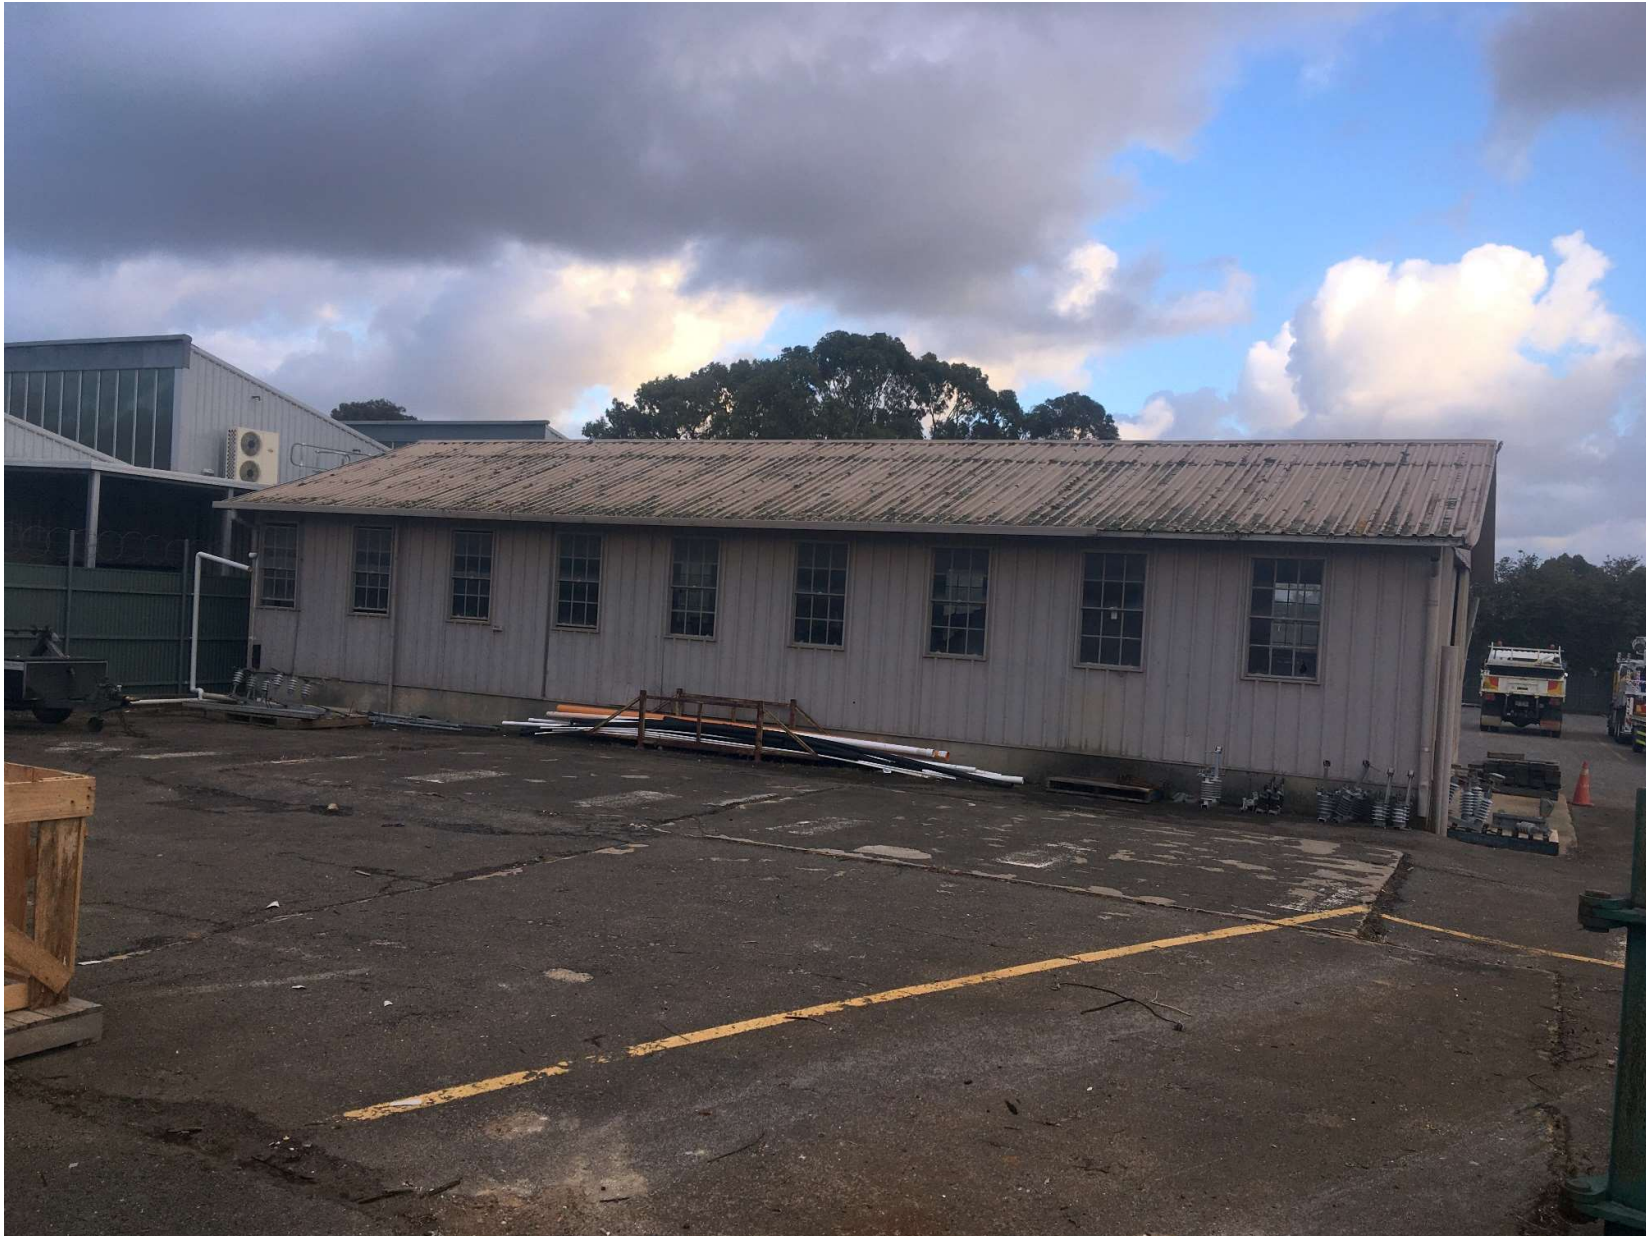
- Shed 2 – Storage. Original 1950's corrugated iron sheets in poor condition

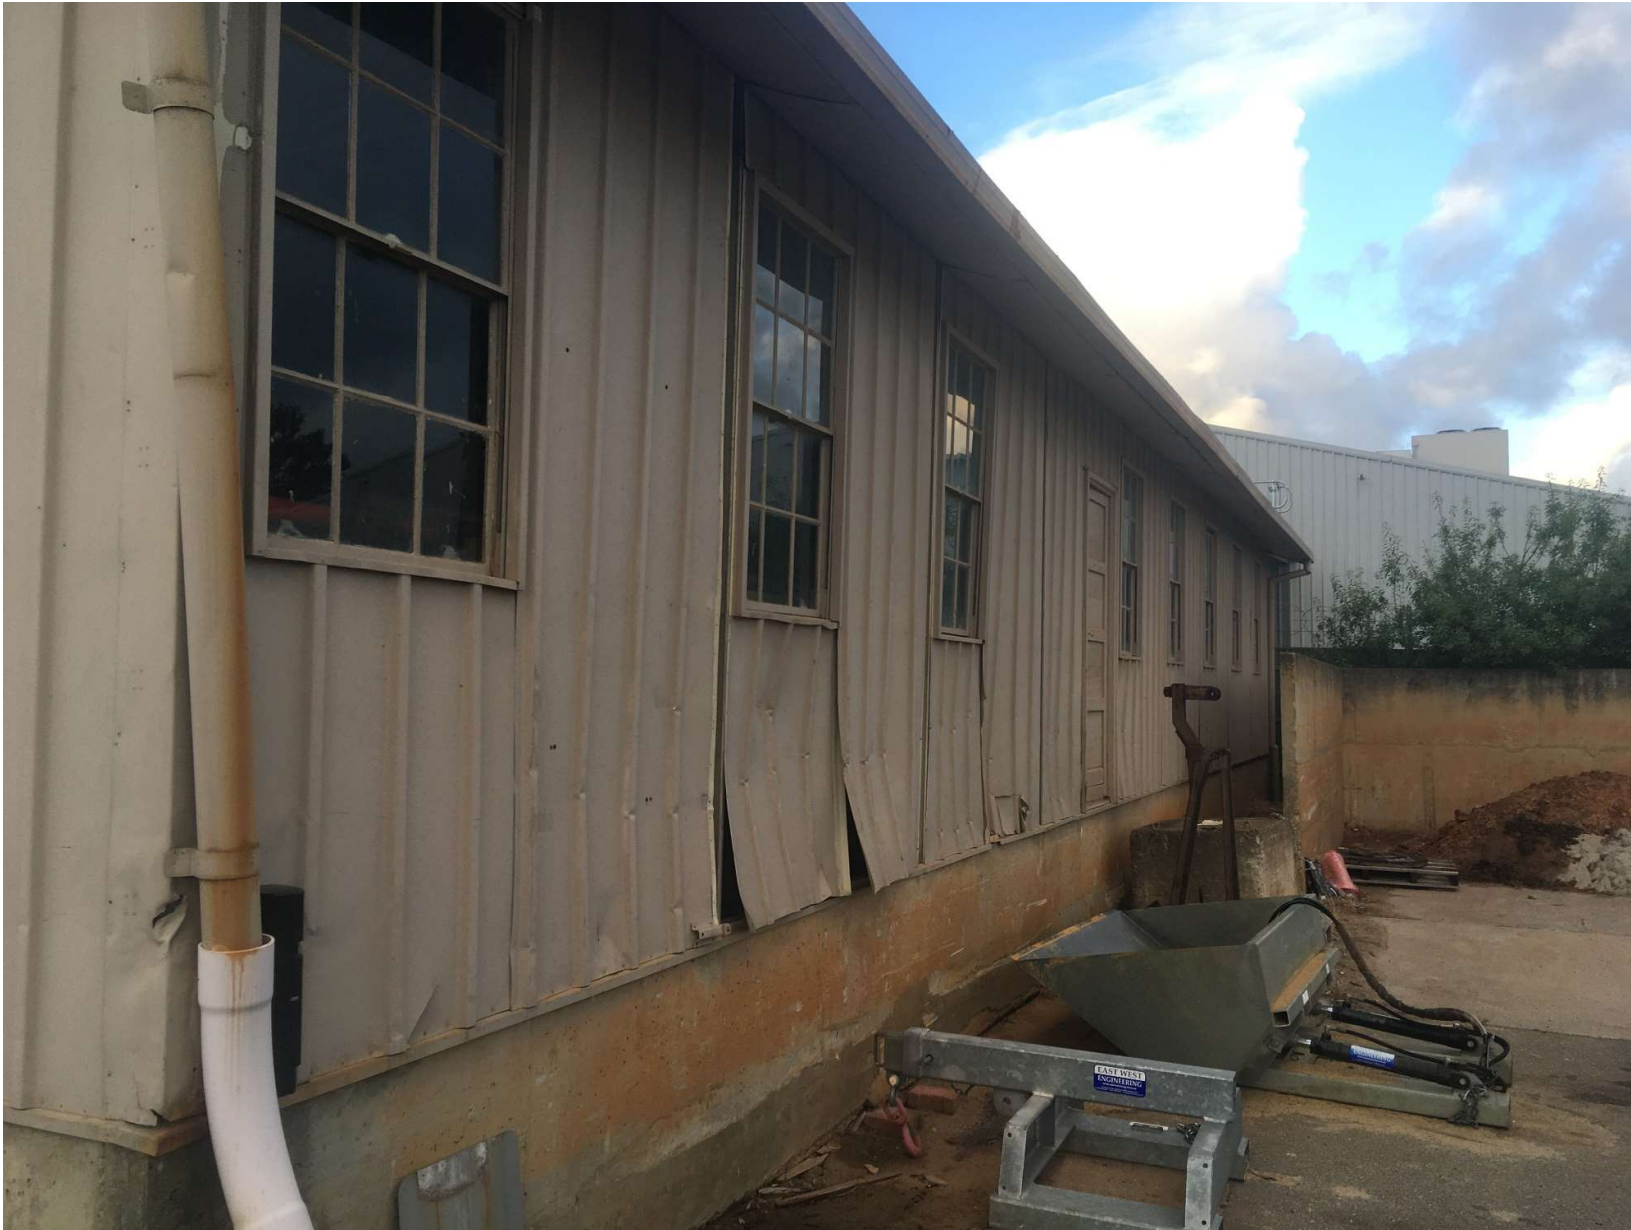
- Shed 2 – damage and sheet corrosion

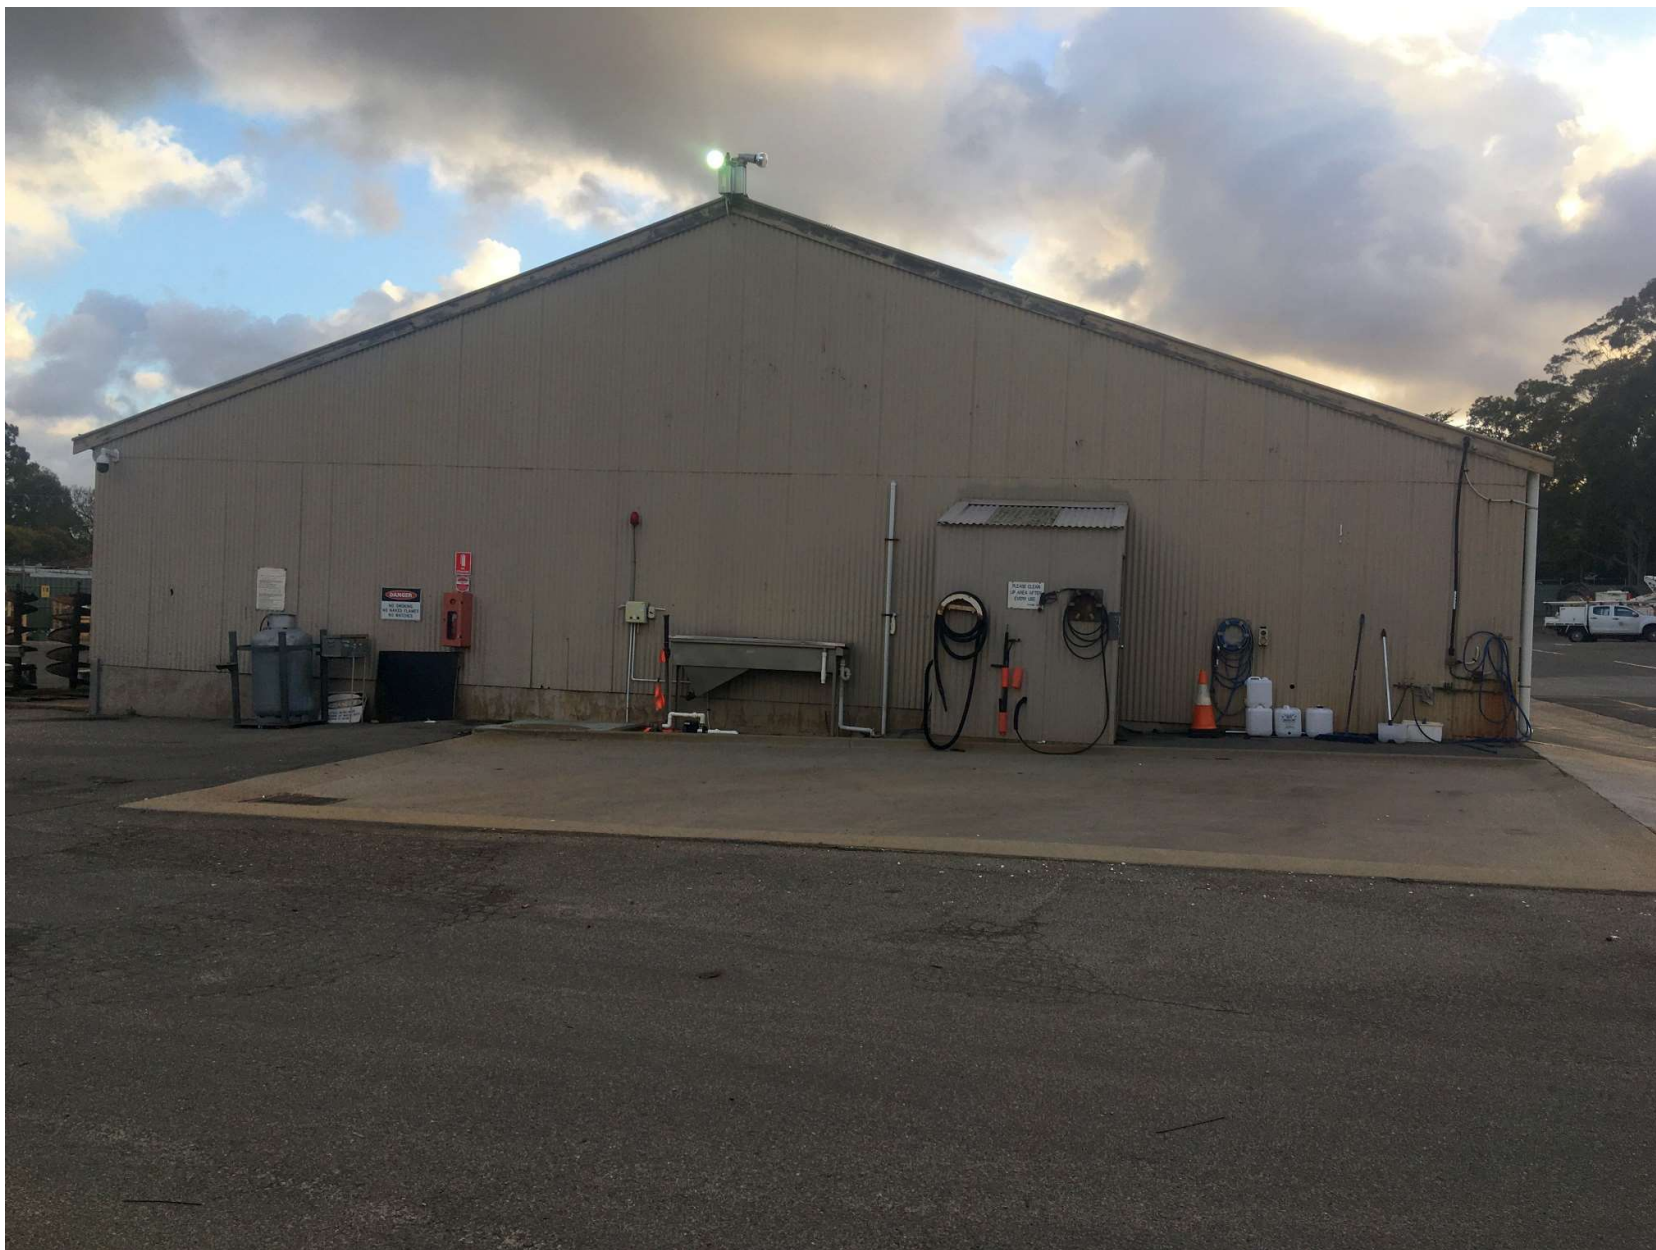
- Shed 3 – Workshop/Warehouse original 1950's corrugated iron sheets in poor condition

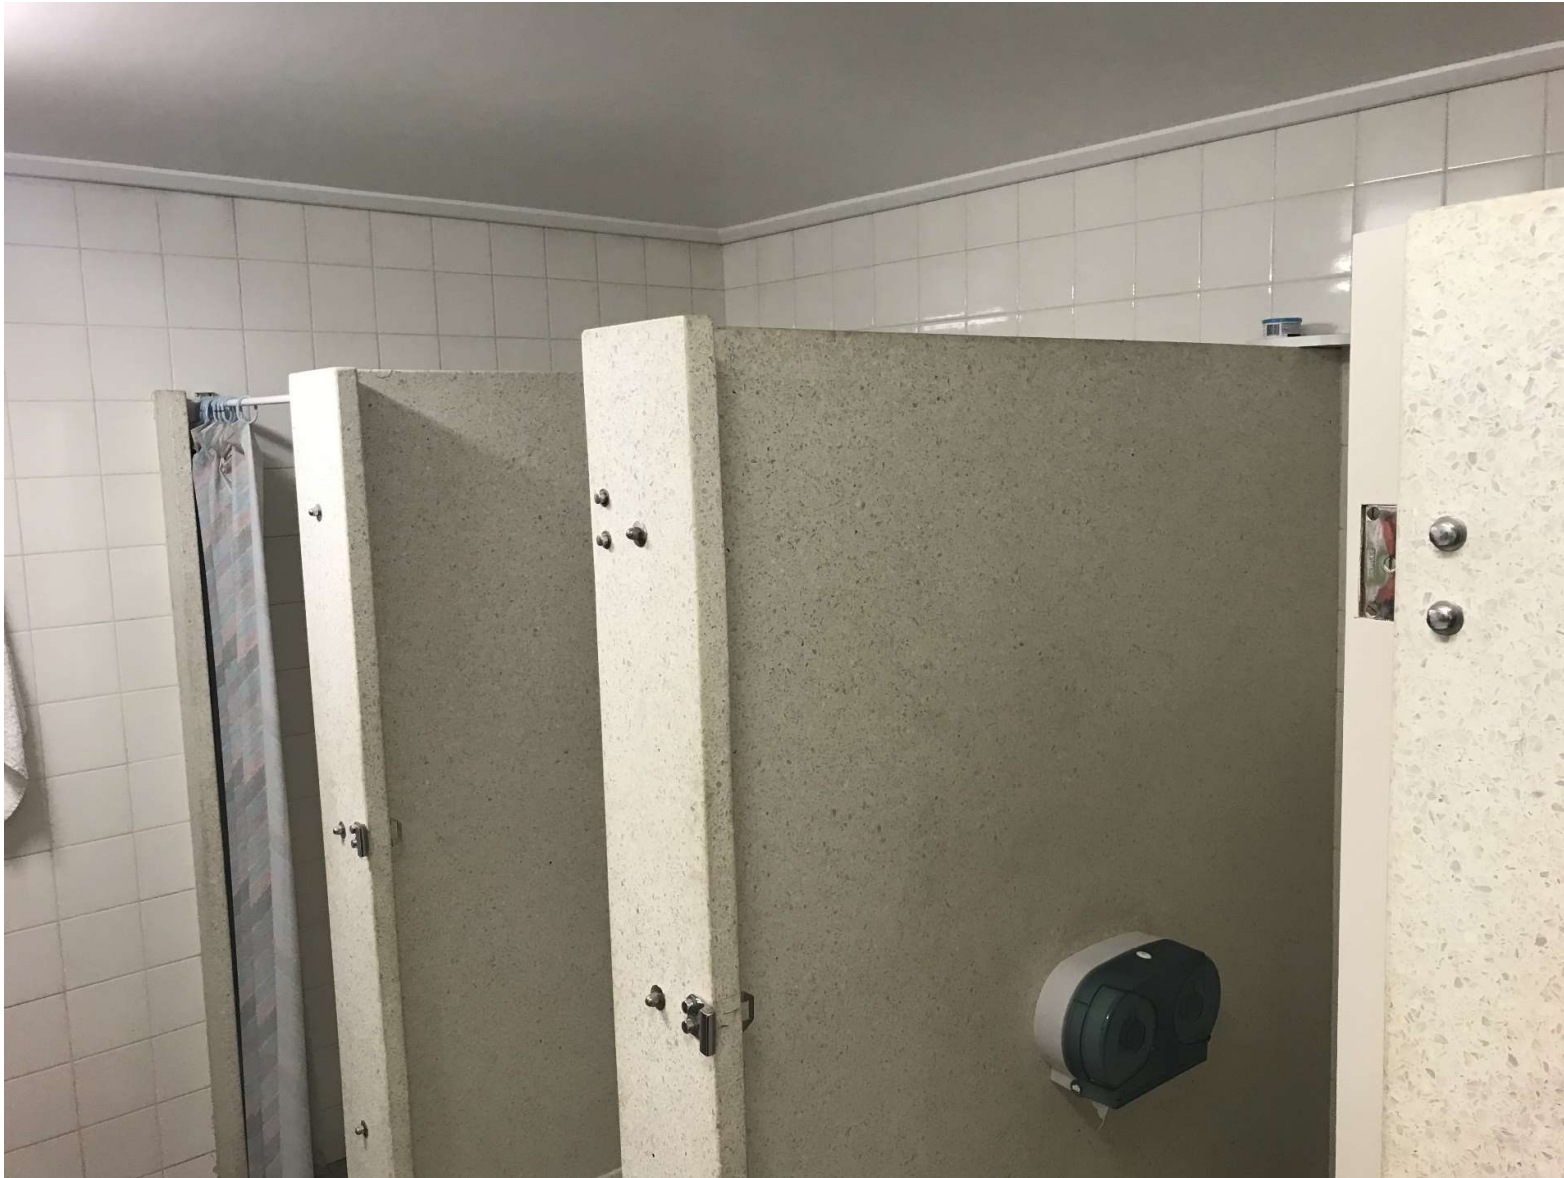
- Original fit-out to shower and toilet cubicles
