Supporting
document 5.24.2

St Marys Photographs

2020-25 Revised
Regulatory Proposal
10 December 2019

St Mary's Asset Condition Photographs

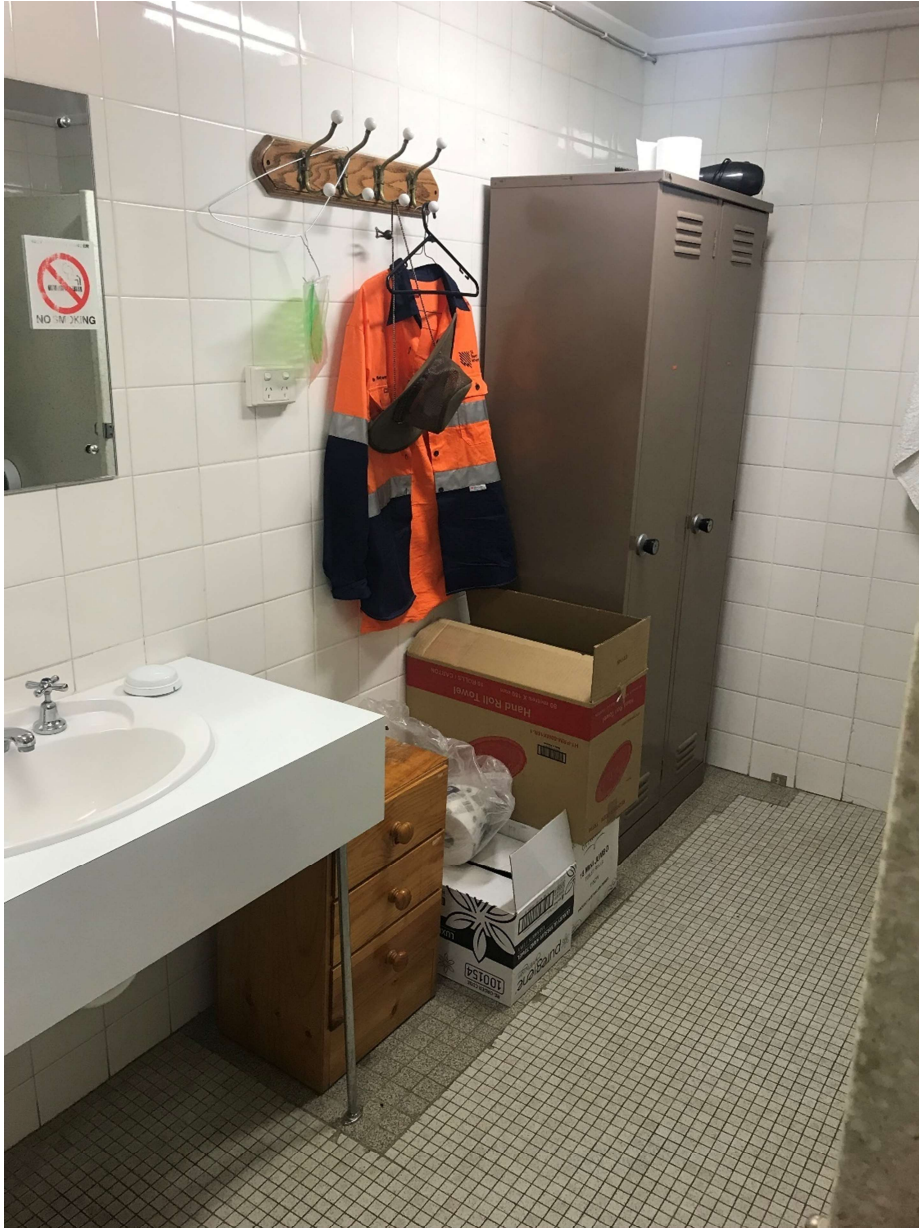
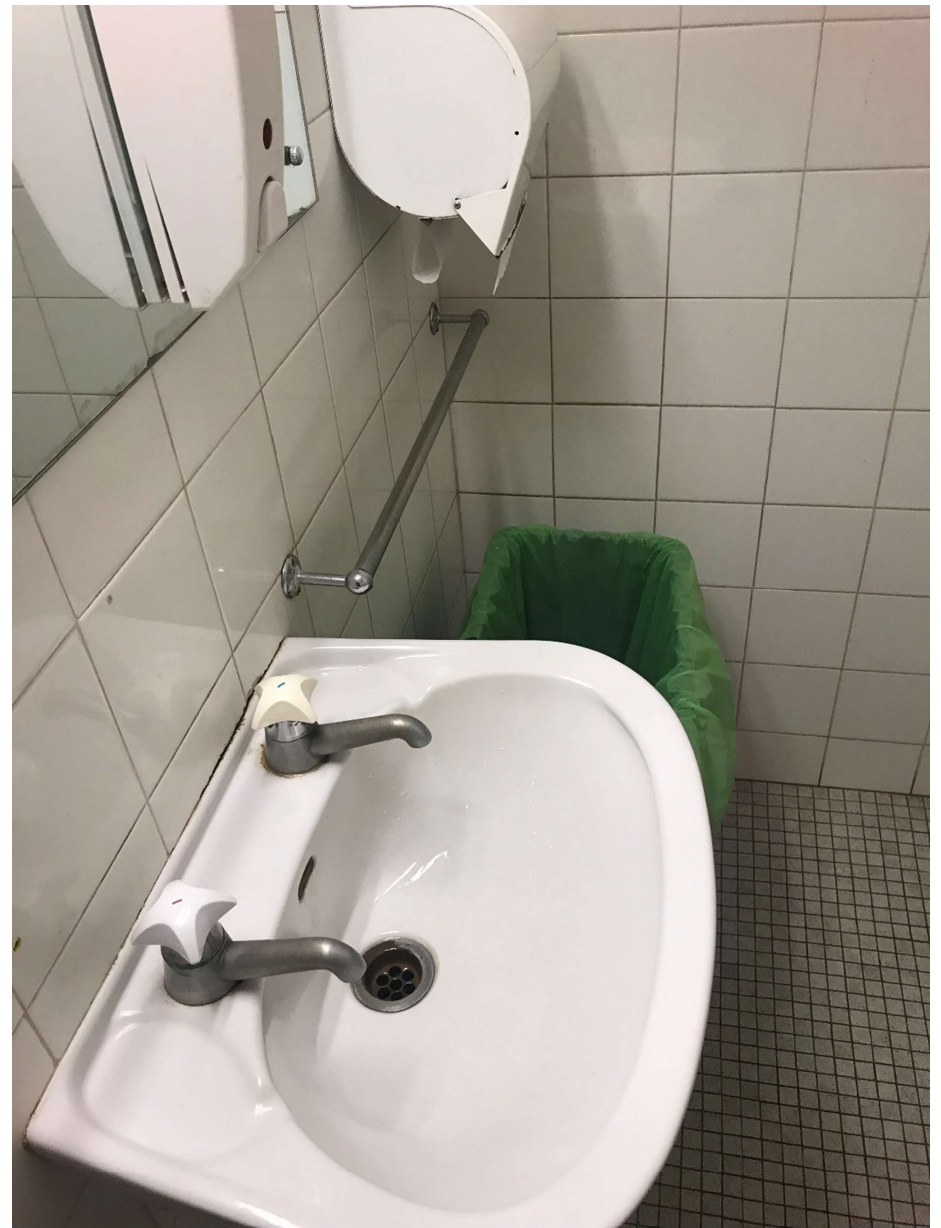
- Original fit-out to shower and toilet cubicles
