Supporting
document 5.25.2

Clare Photographs

2020-25 Revised
Regulatory Proposal
10 December 2019

Clare Depot Asset Condition Photographs

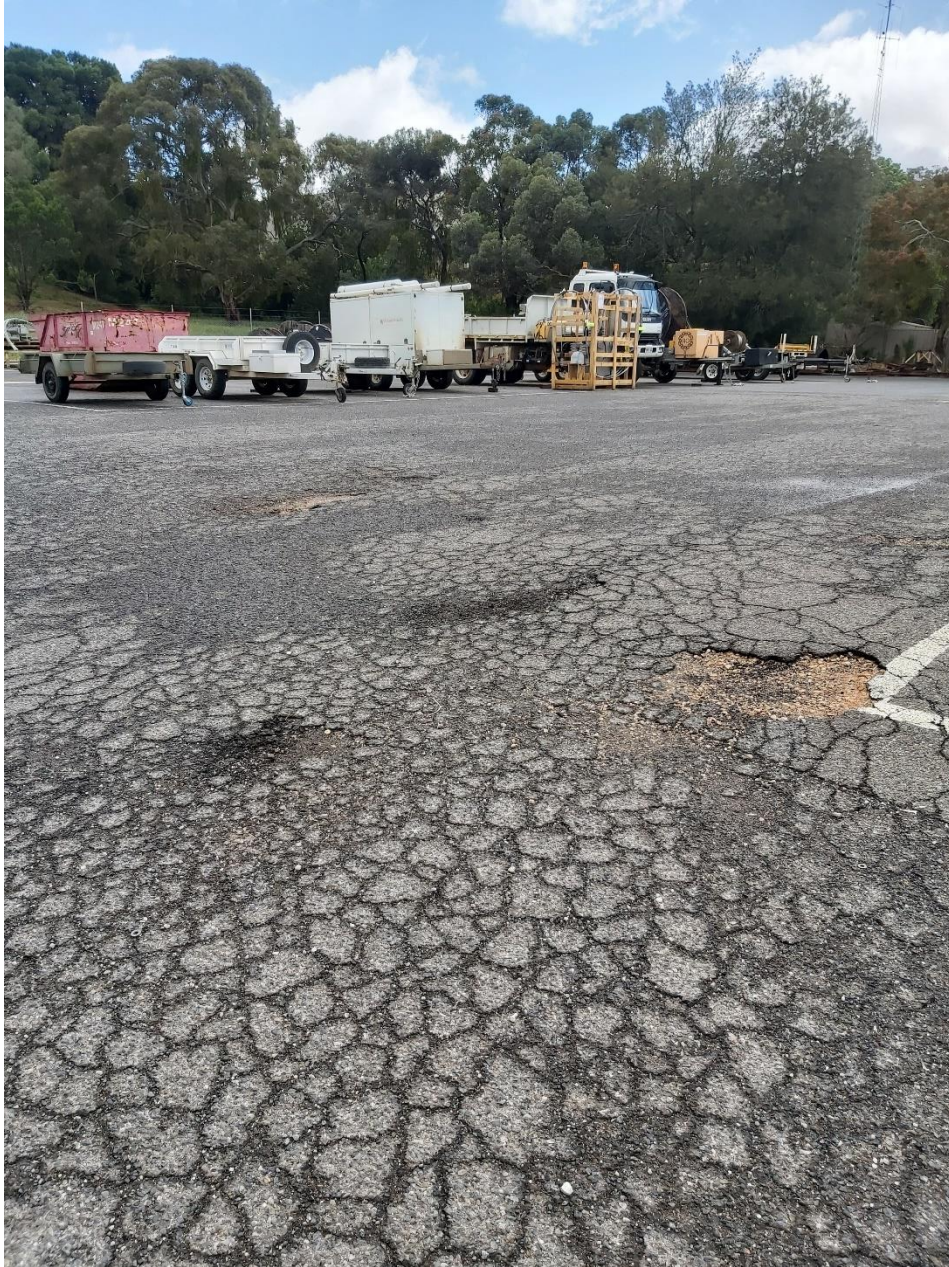
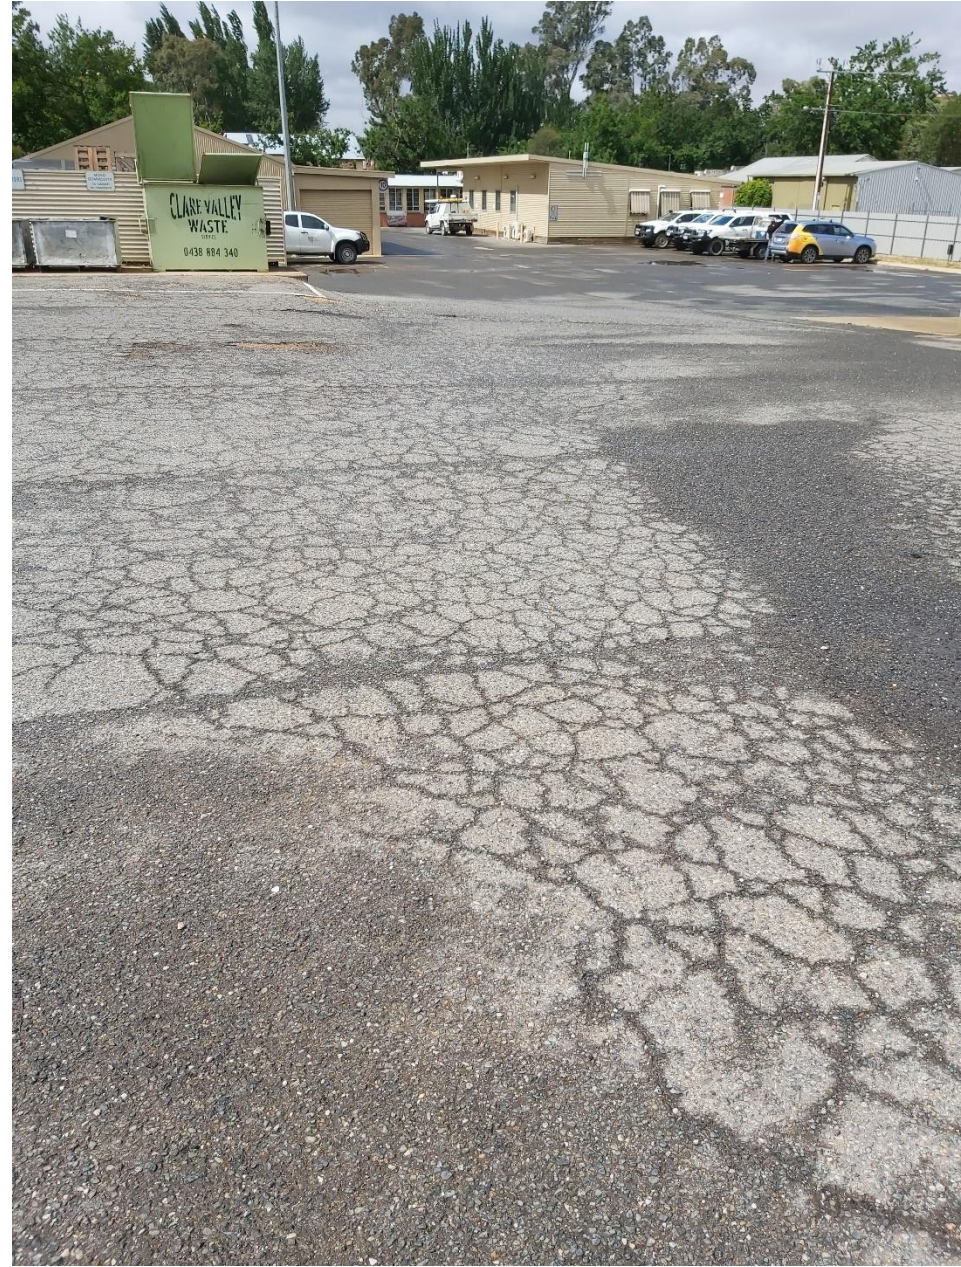
- Large areas of bitumen to the rear of the yard and heavy vehicle driveways in very poor condition with full-thickness cracking, potholing and subsidence.

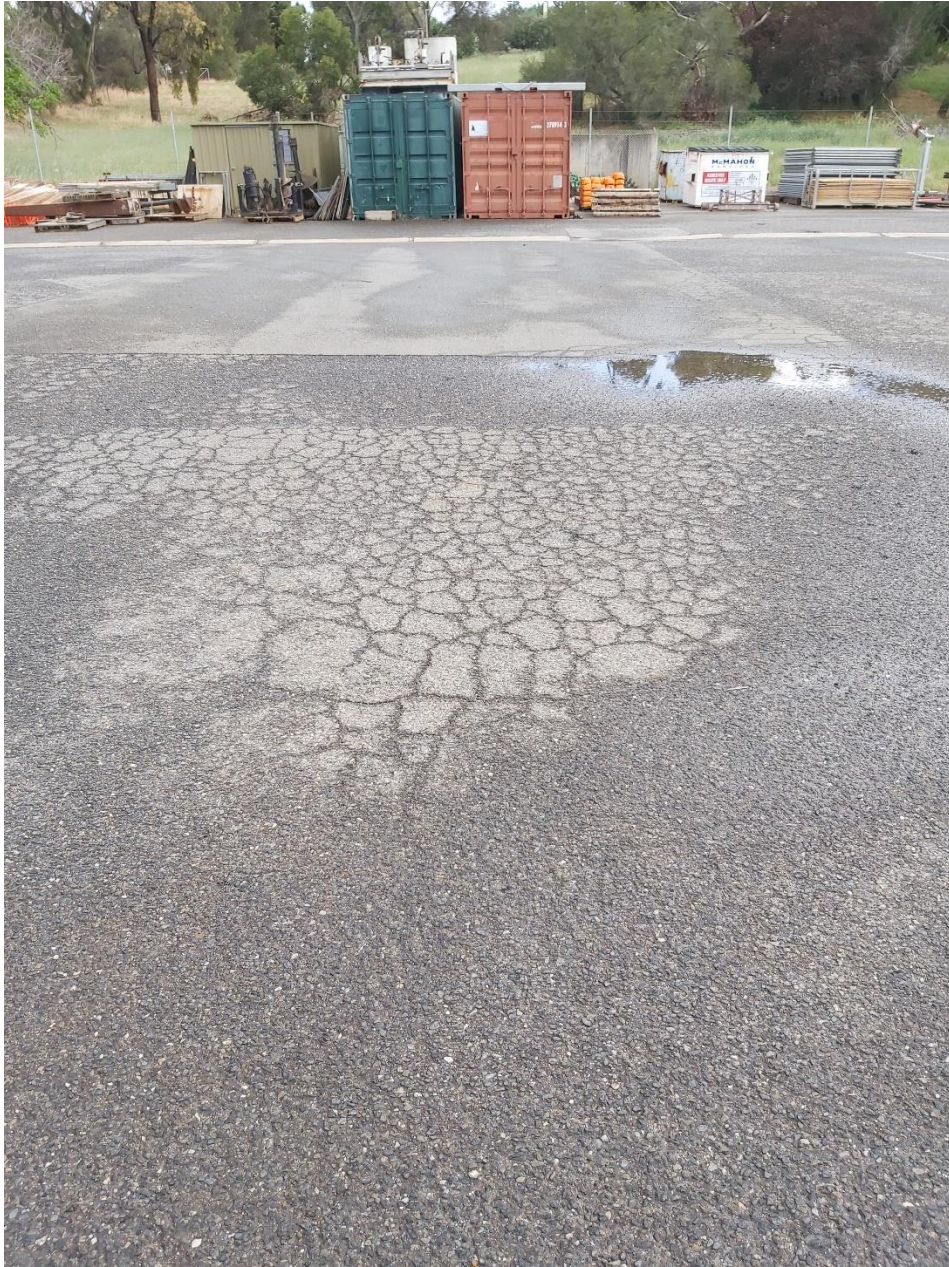
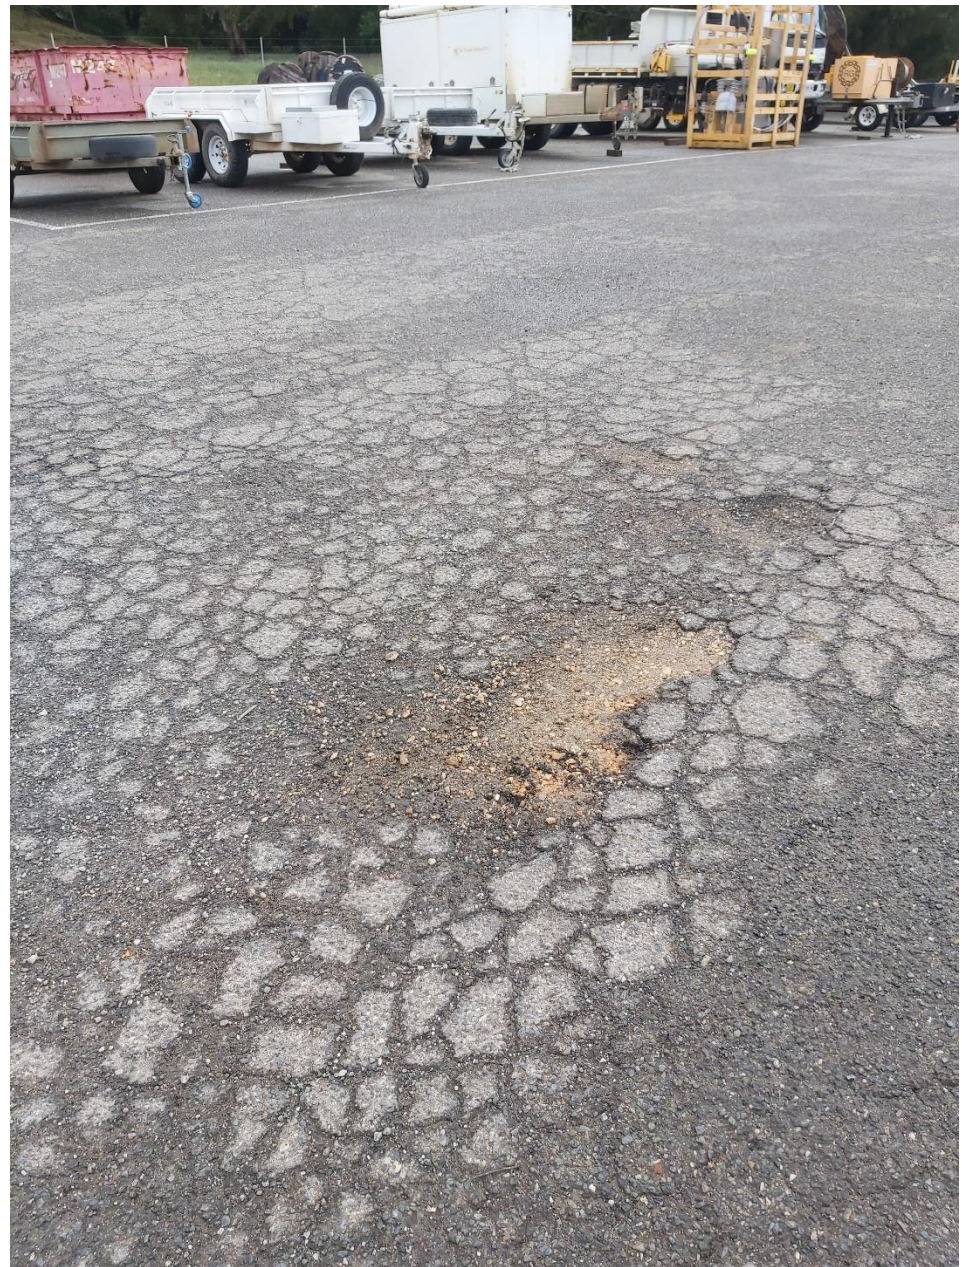
- Large areas of bitumen to the rear of the yard and heavy vehicle driveways in very poor condition with full-thickness cracking and potholing.

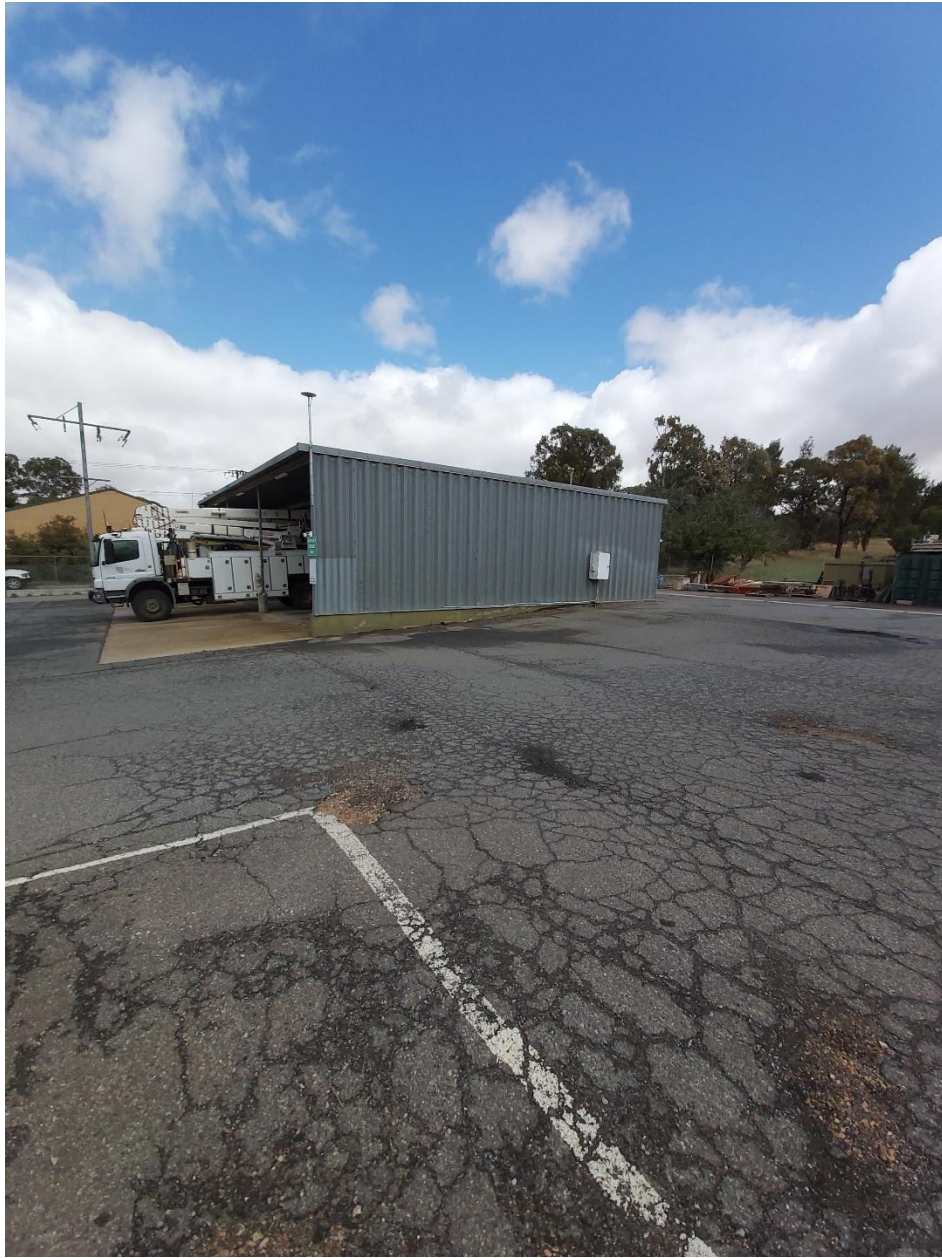
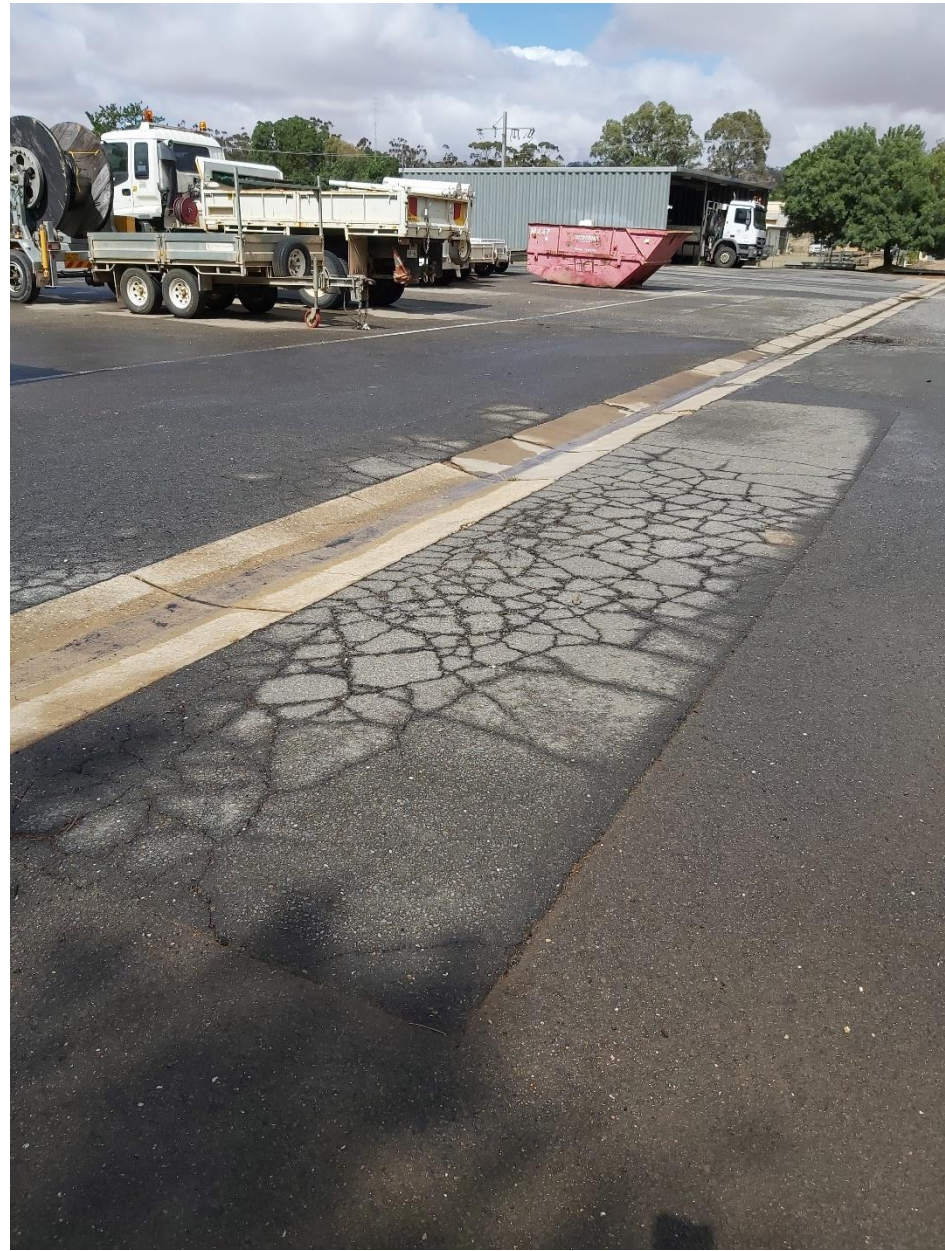
- Large areas of bitumen to the rear of the yard and heavy vehicle driveways in very poor condition.

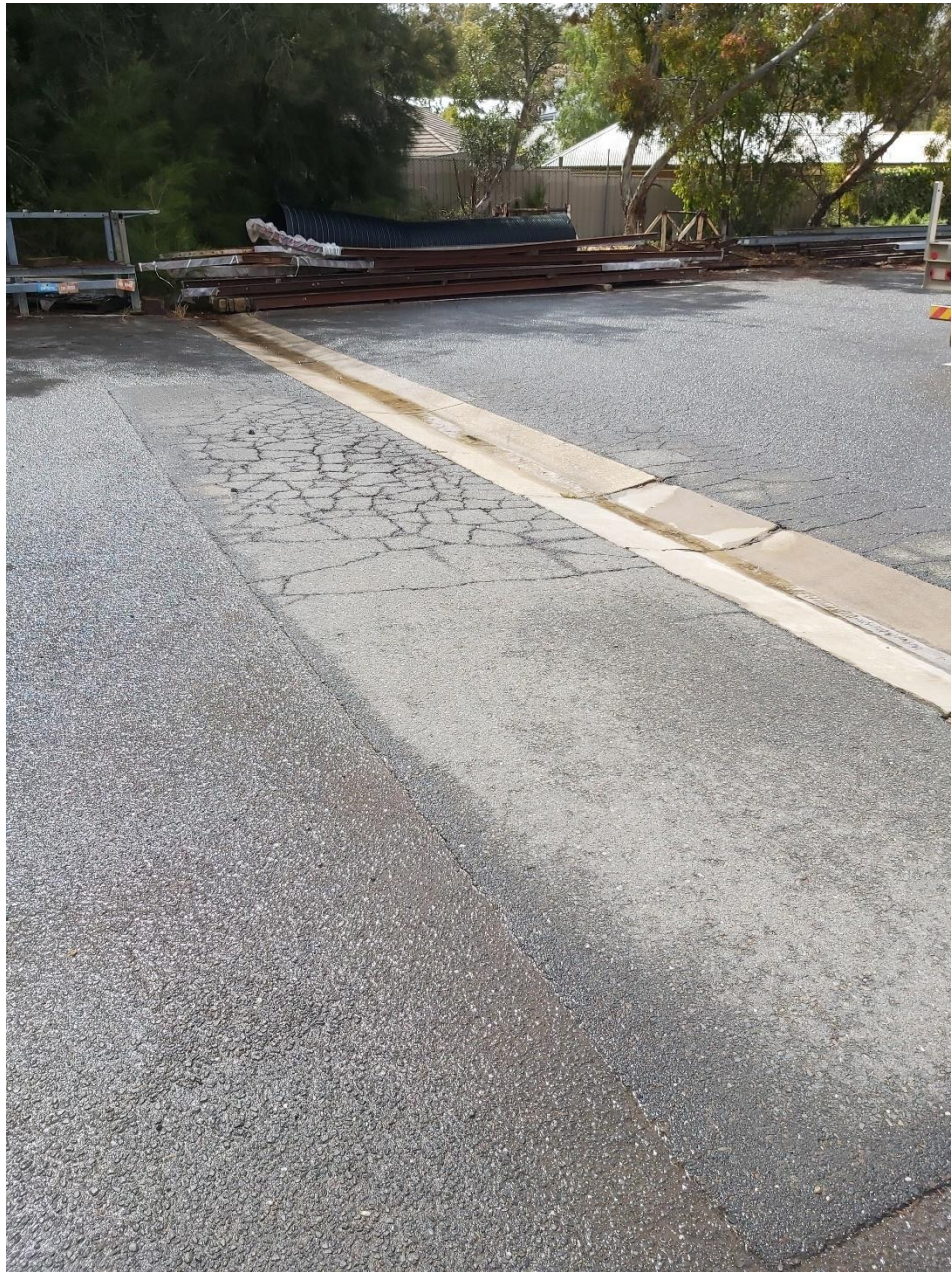
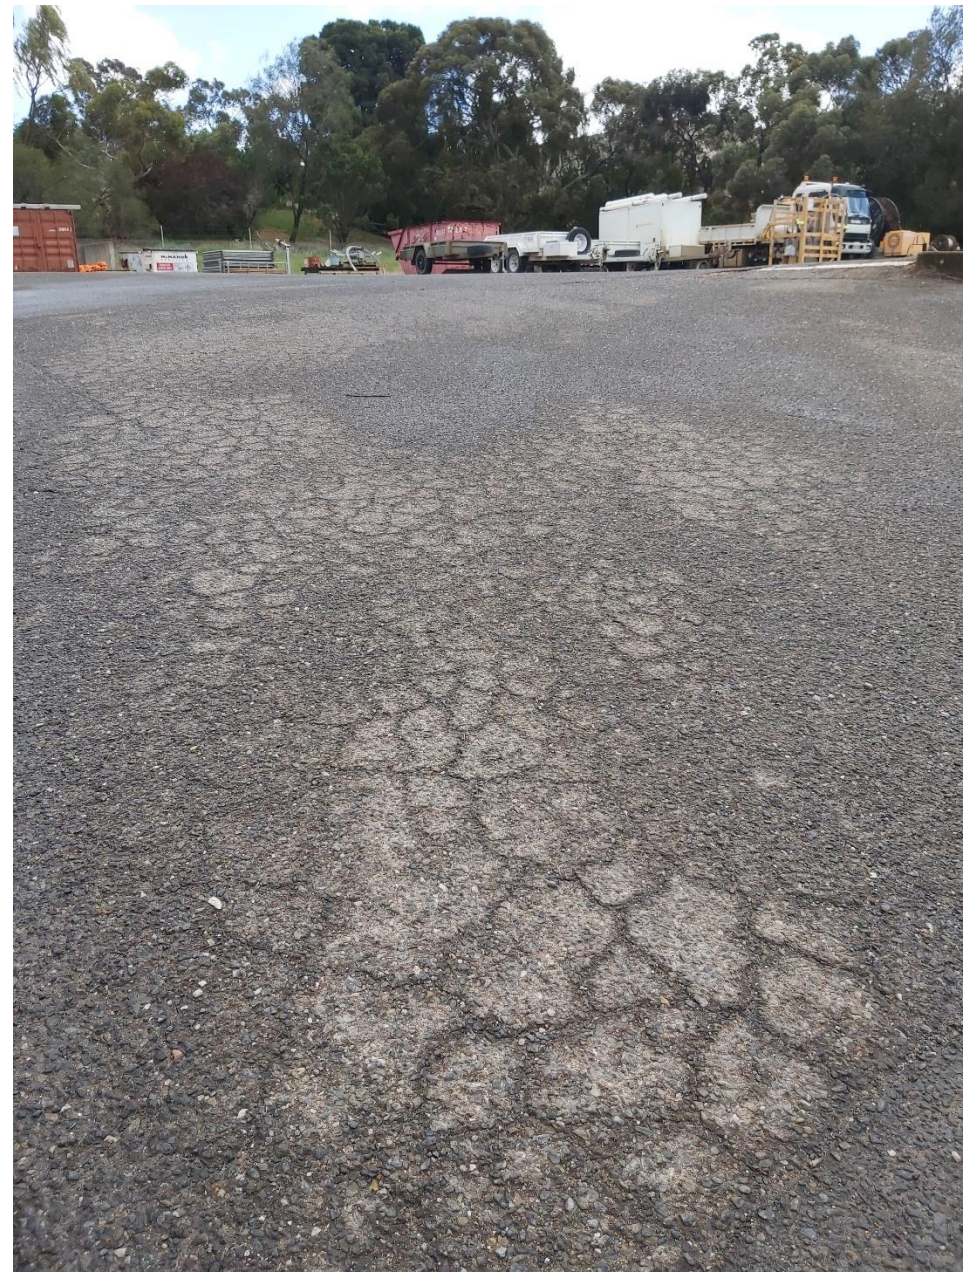
- Deep cracking to bitumen and concrete stormwater drains

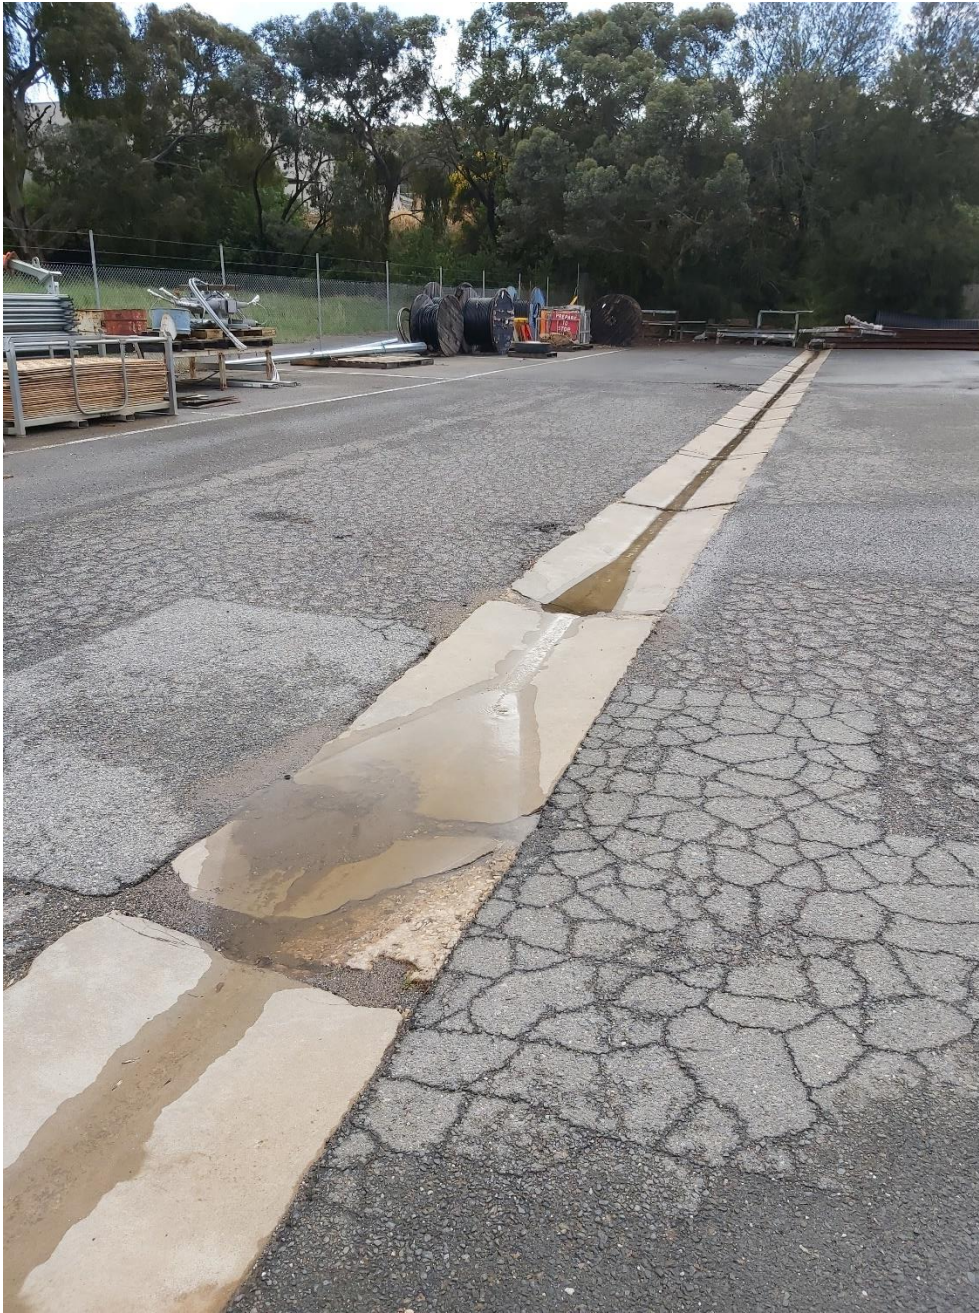
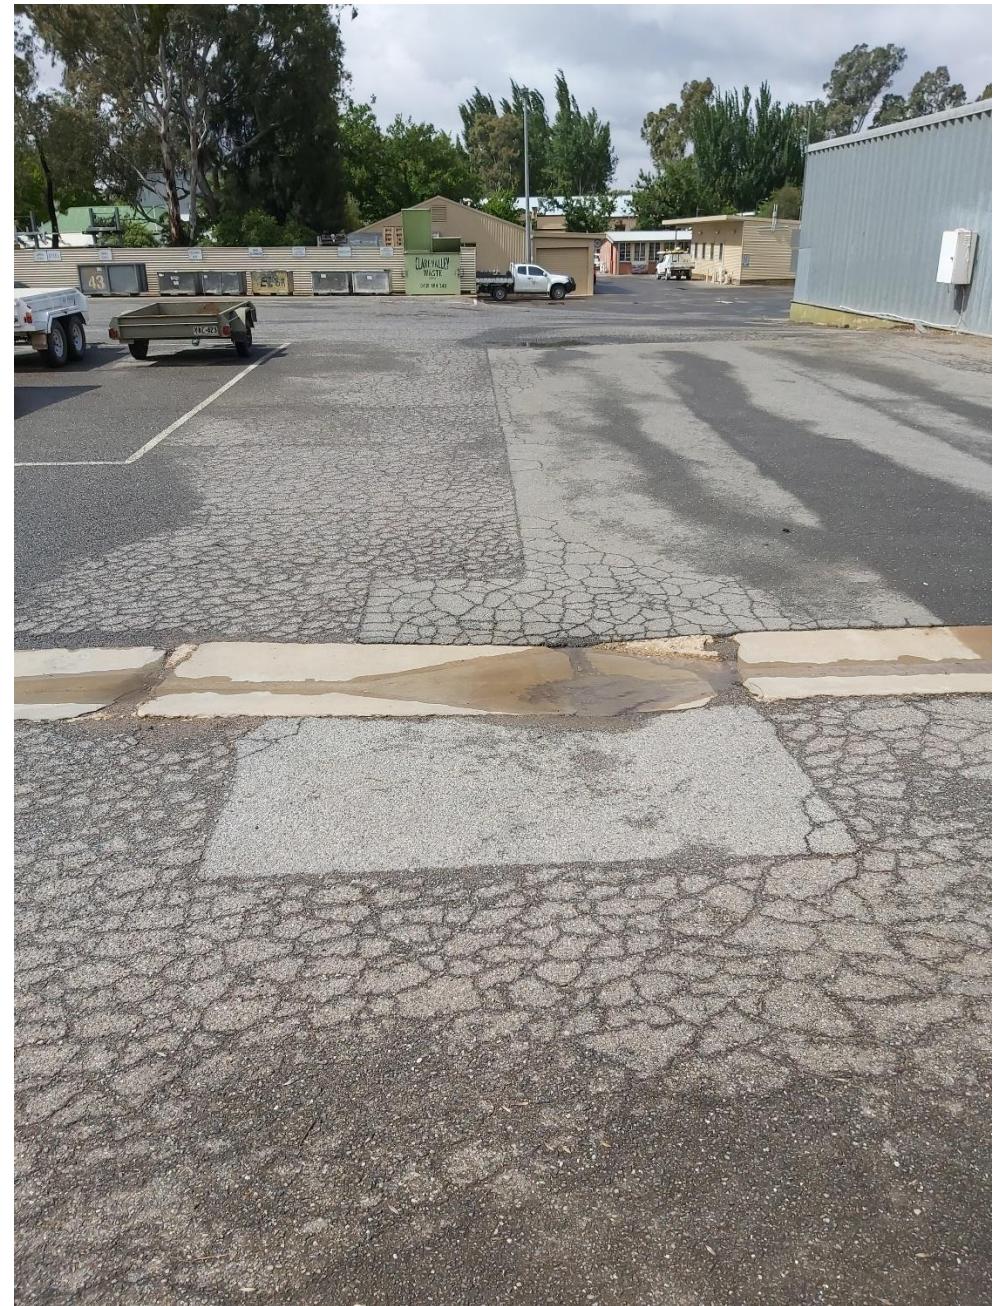
- Full-thickness cracking and breakdown of concrete drain and heavy vehicle driveway

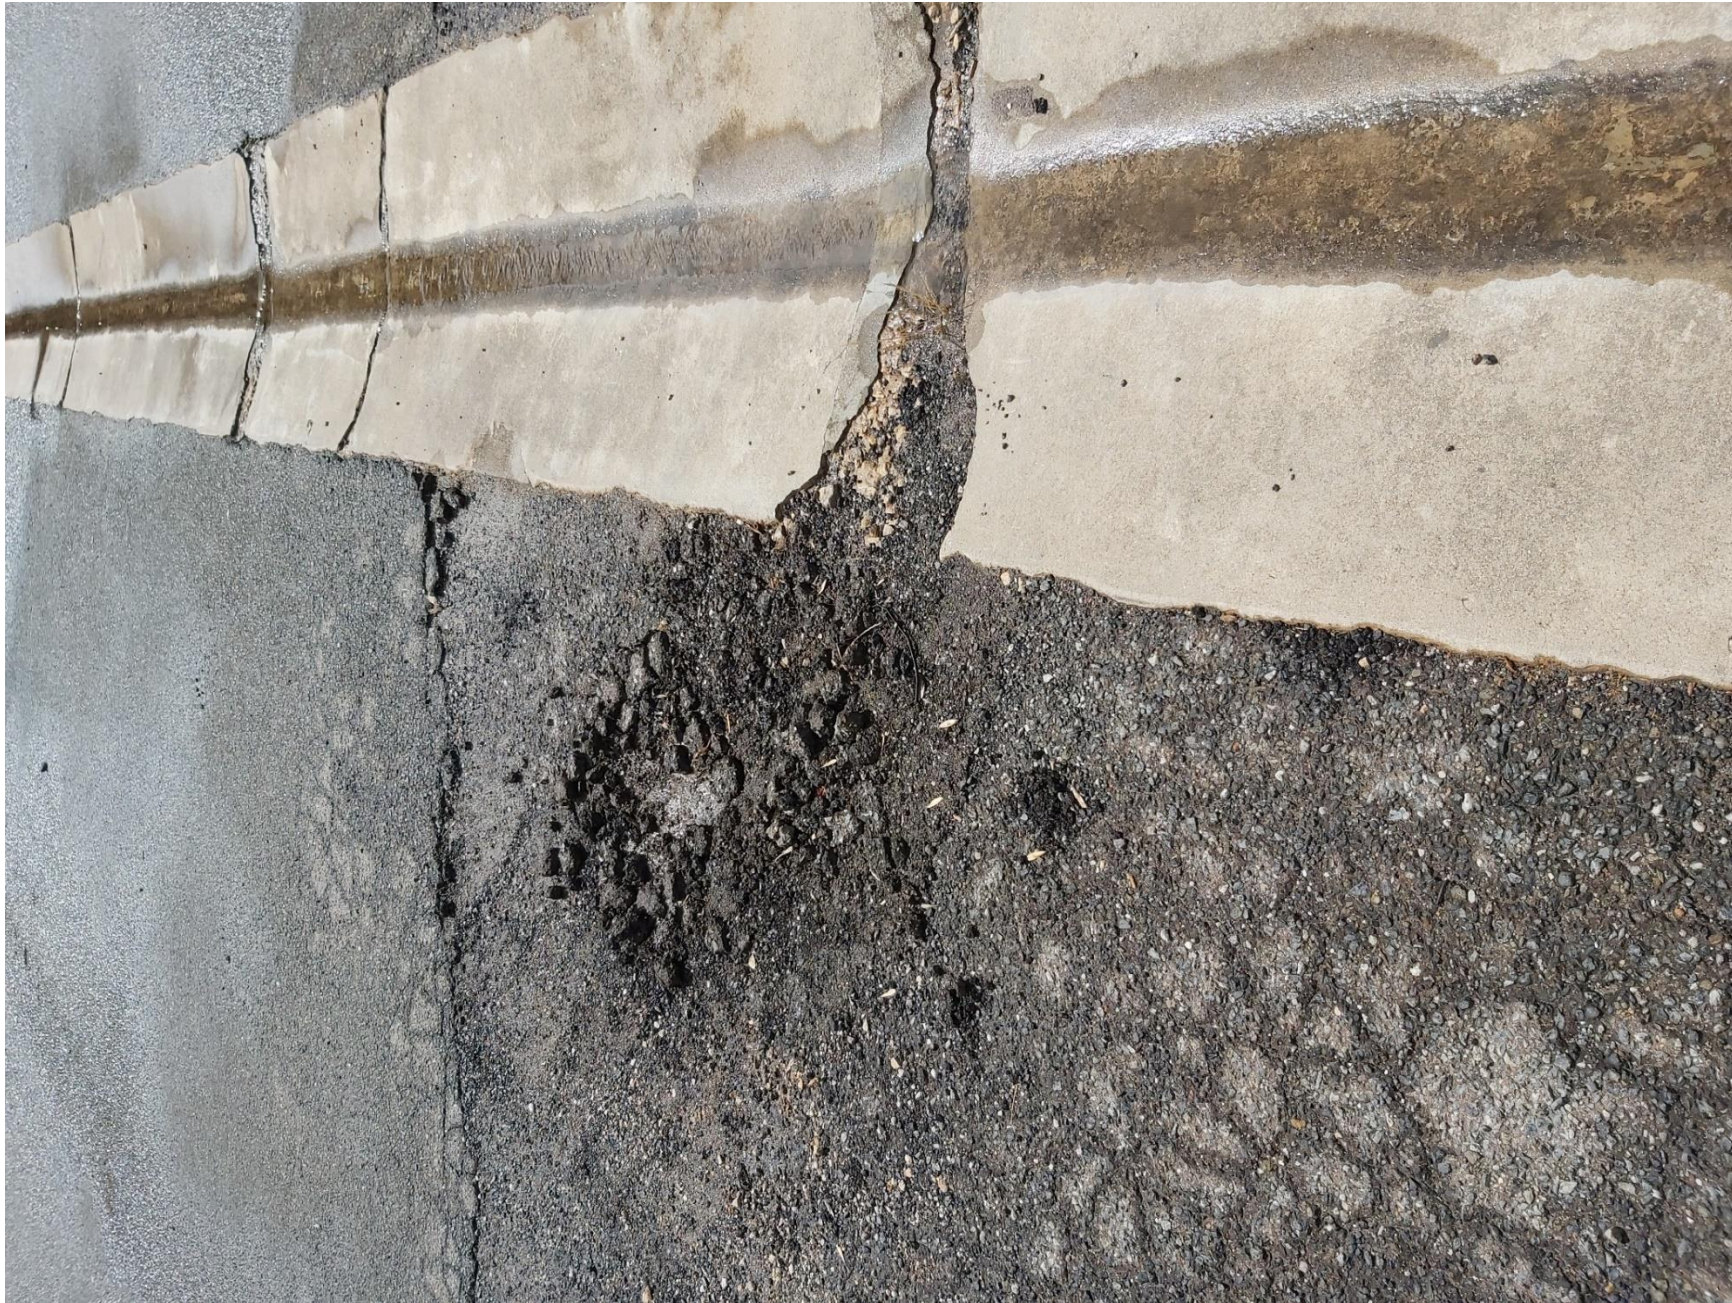
- Breakdown of concrete spoon drain

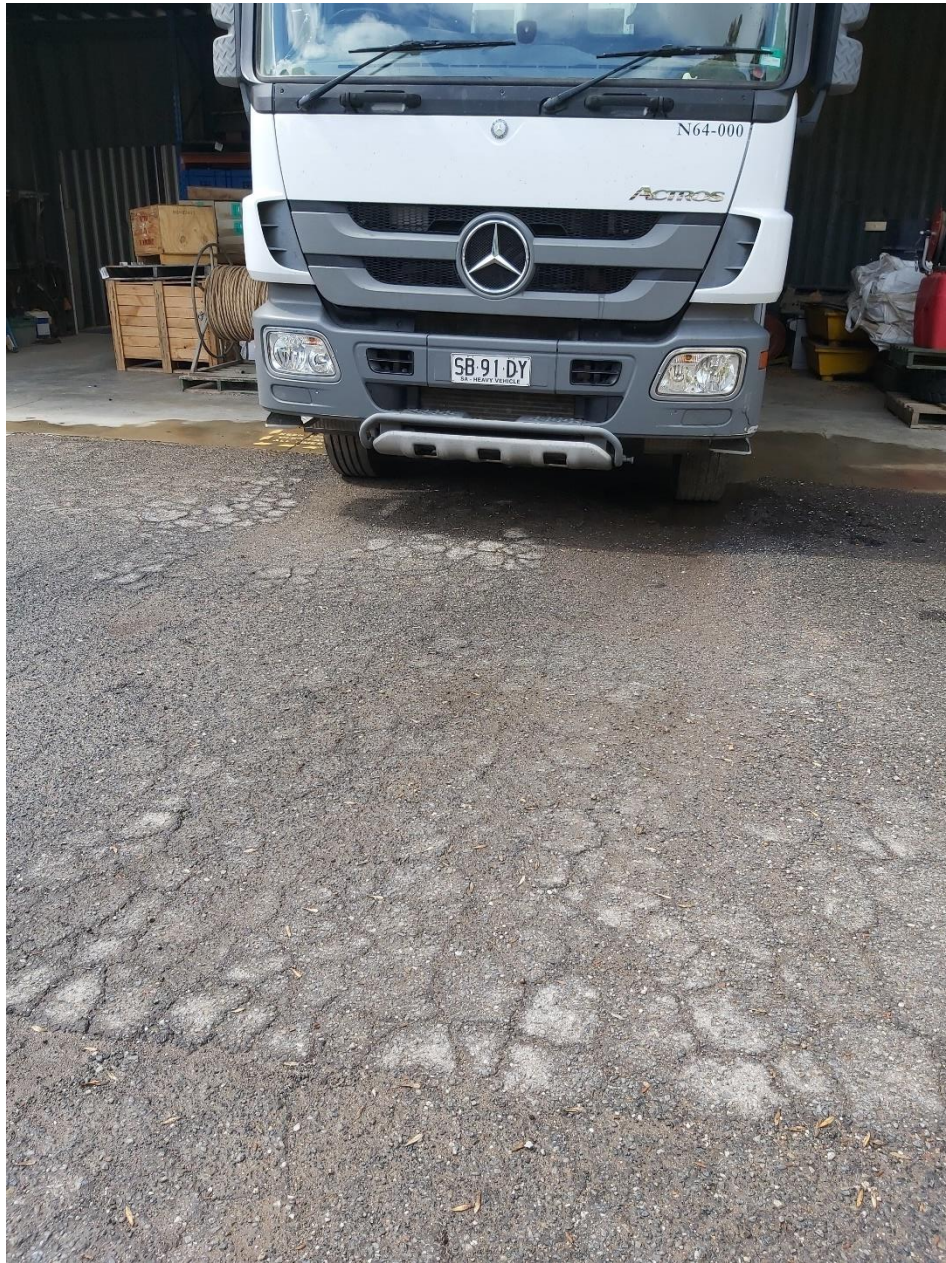
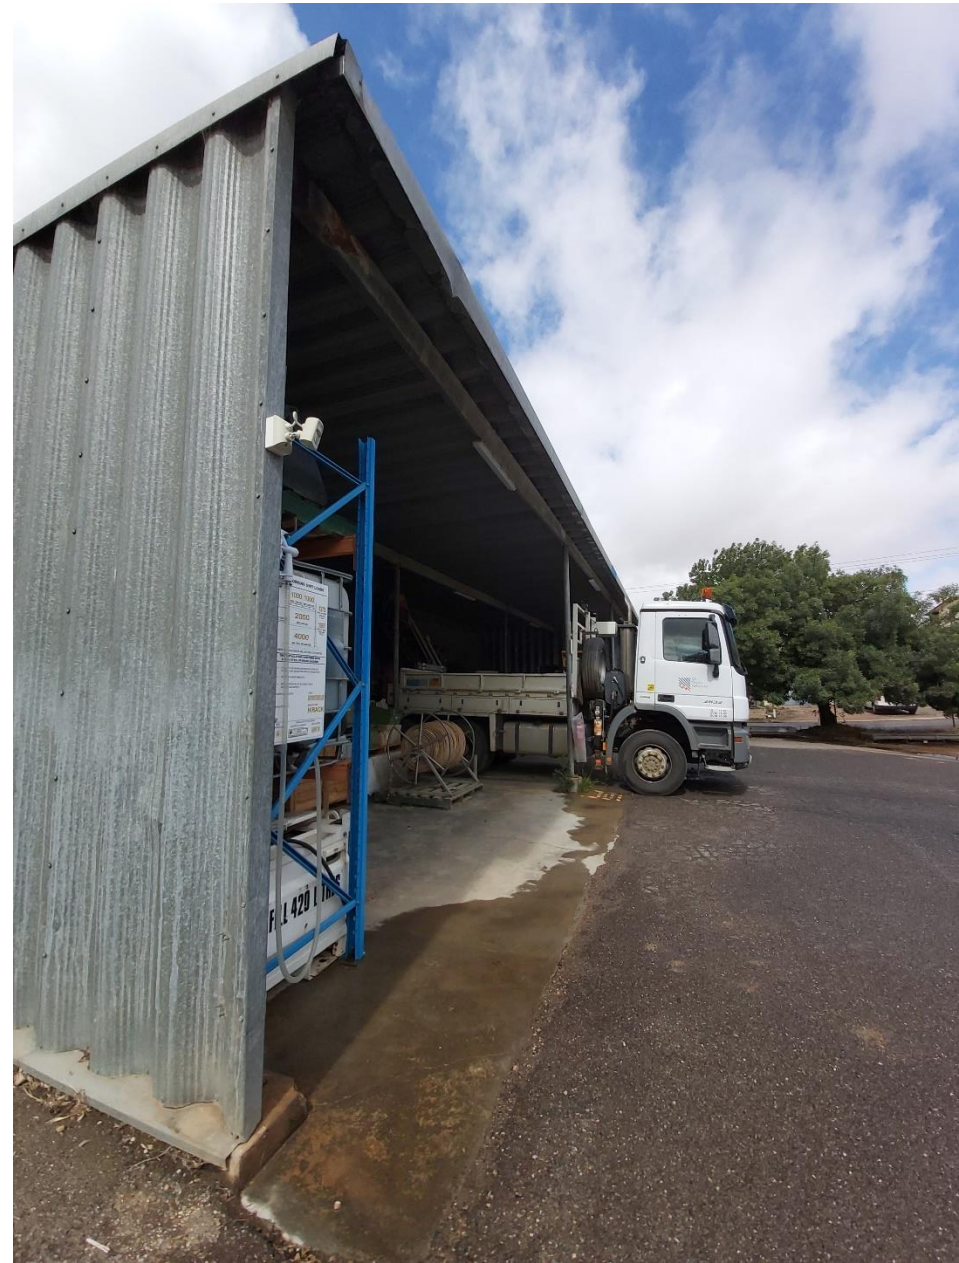
- Broken and degraded pavements to the loading areas of the rear side of the truck store.

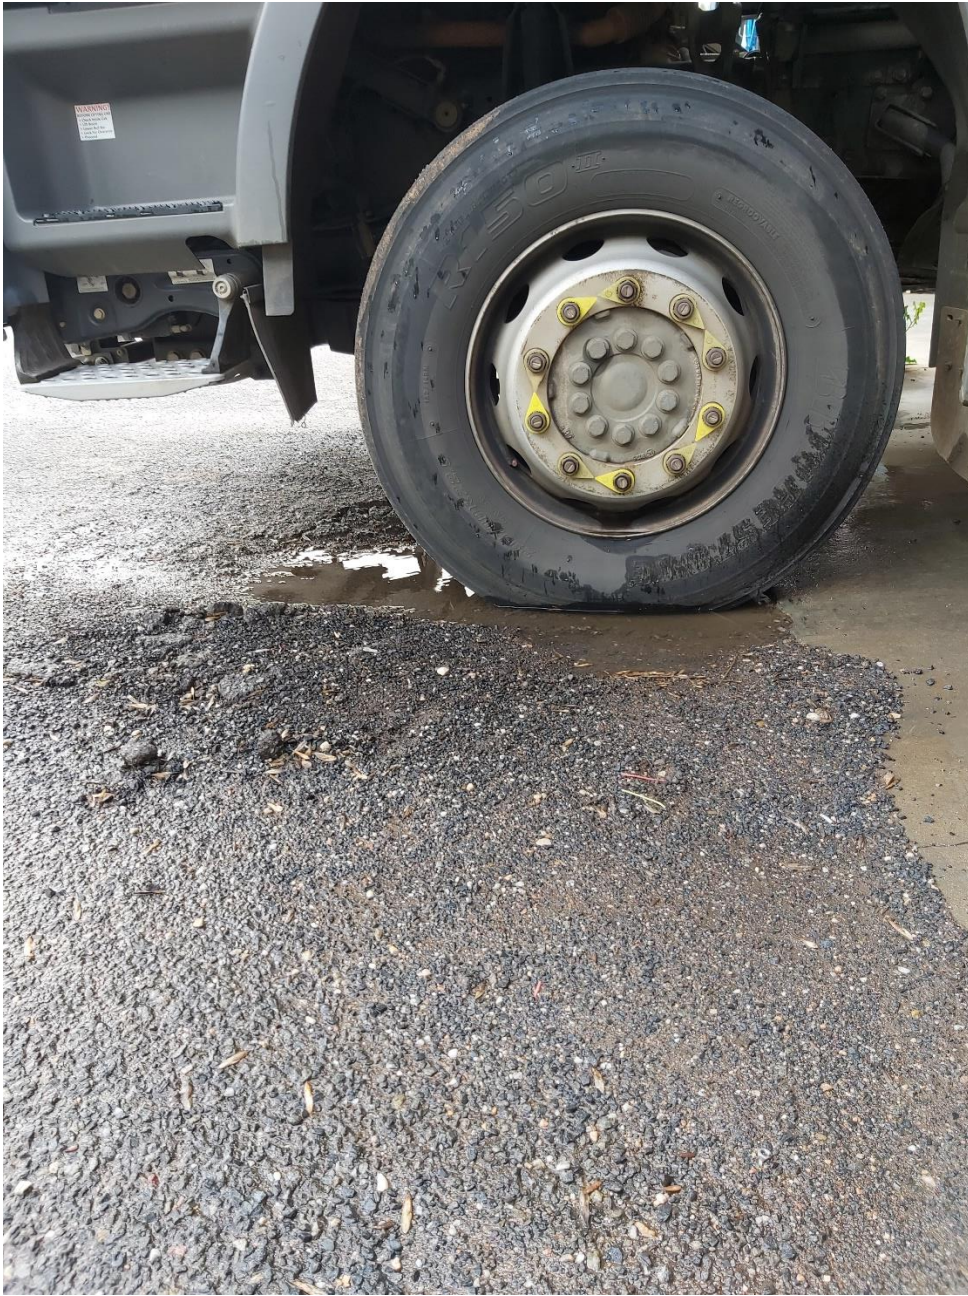
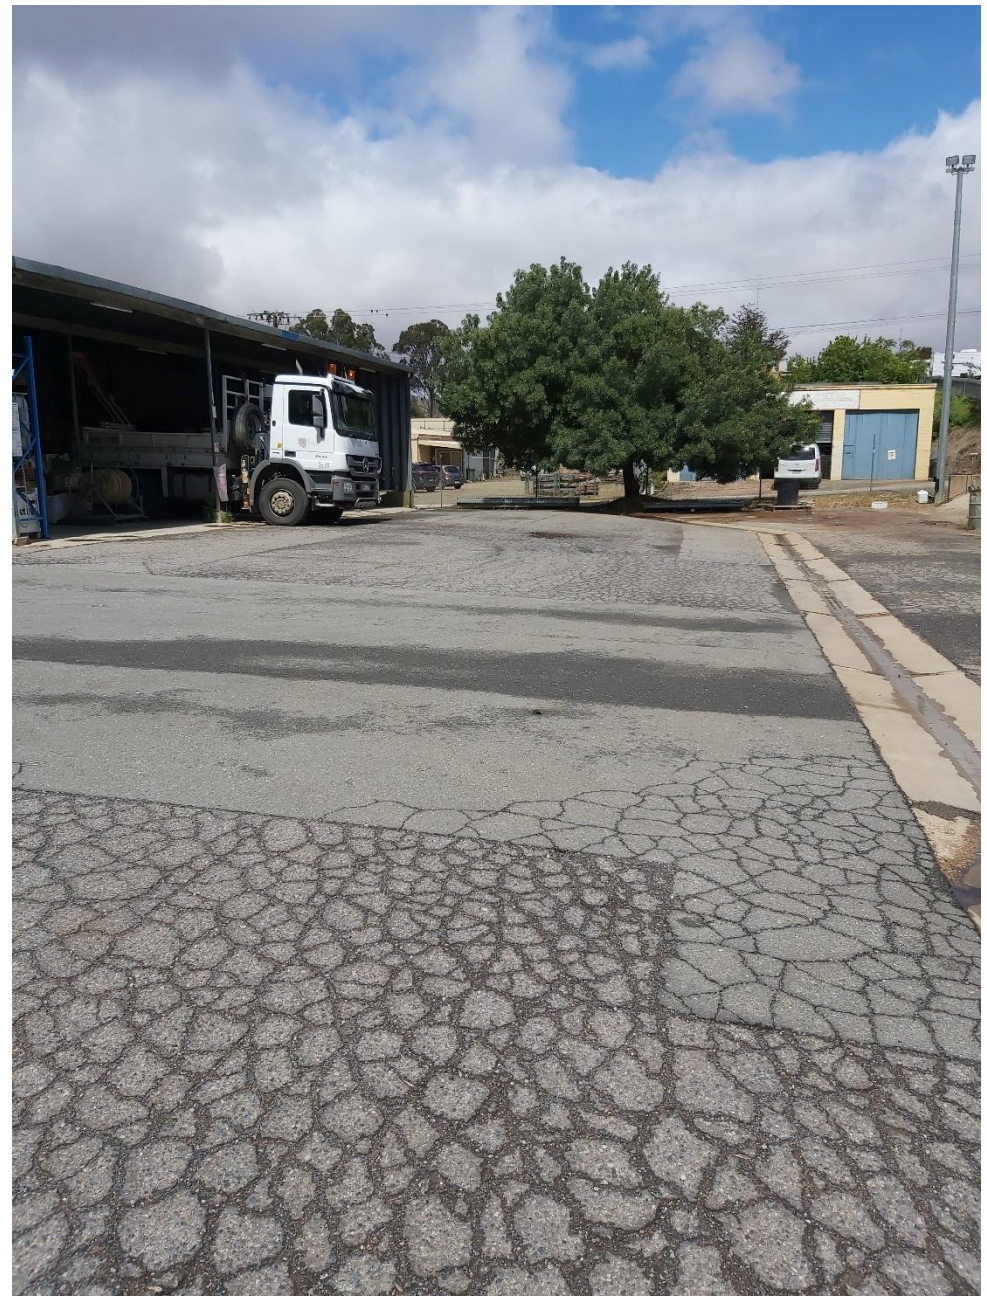
- Broken and degraded pavements to the loading areas of the rear side of the truck store.

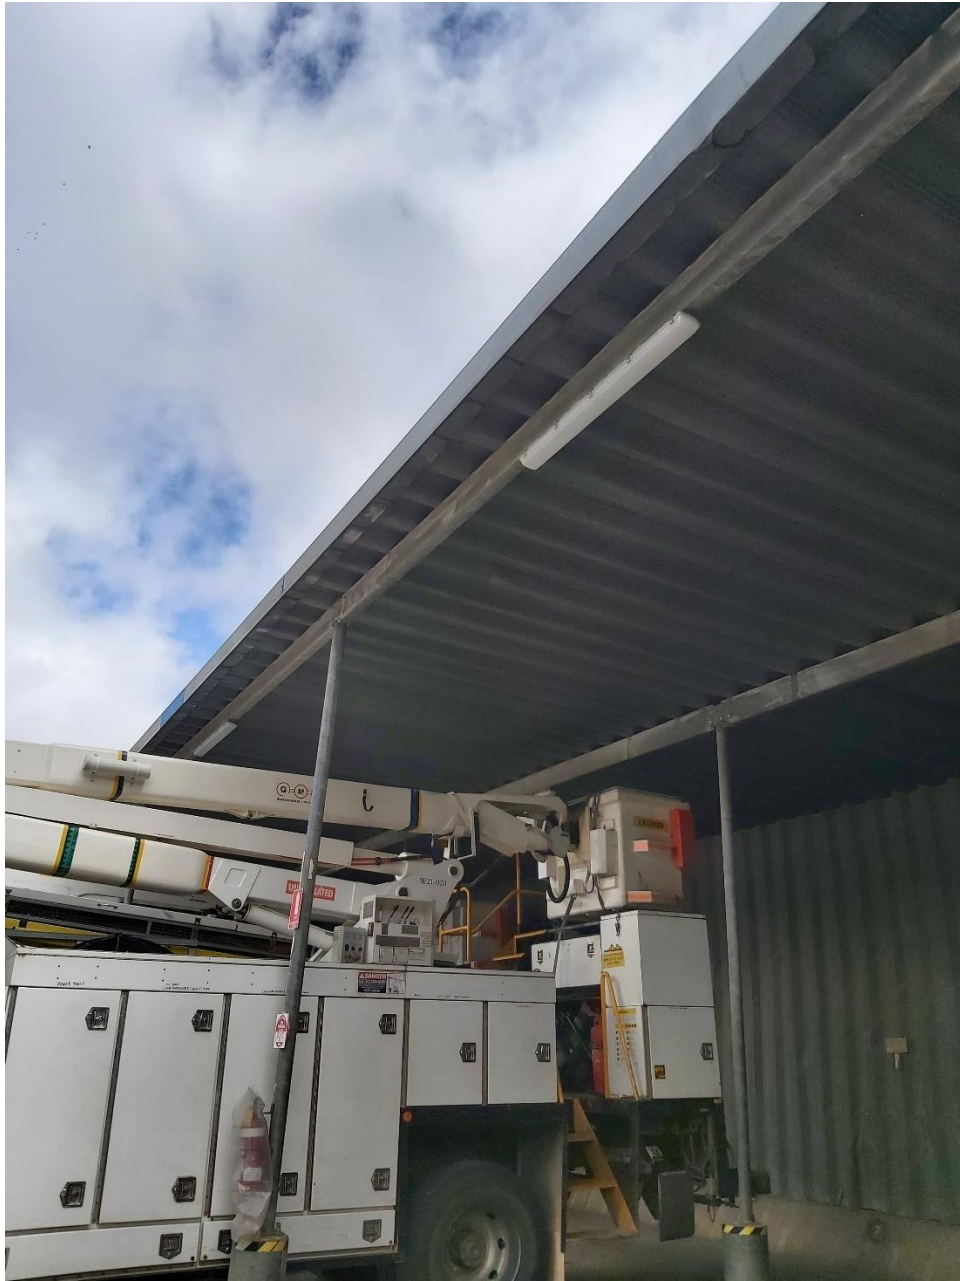
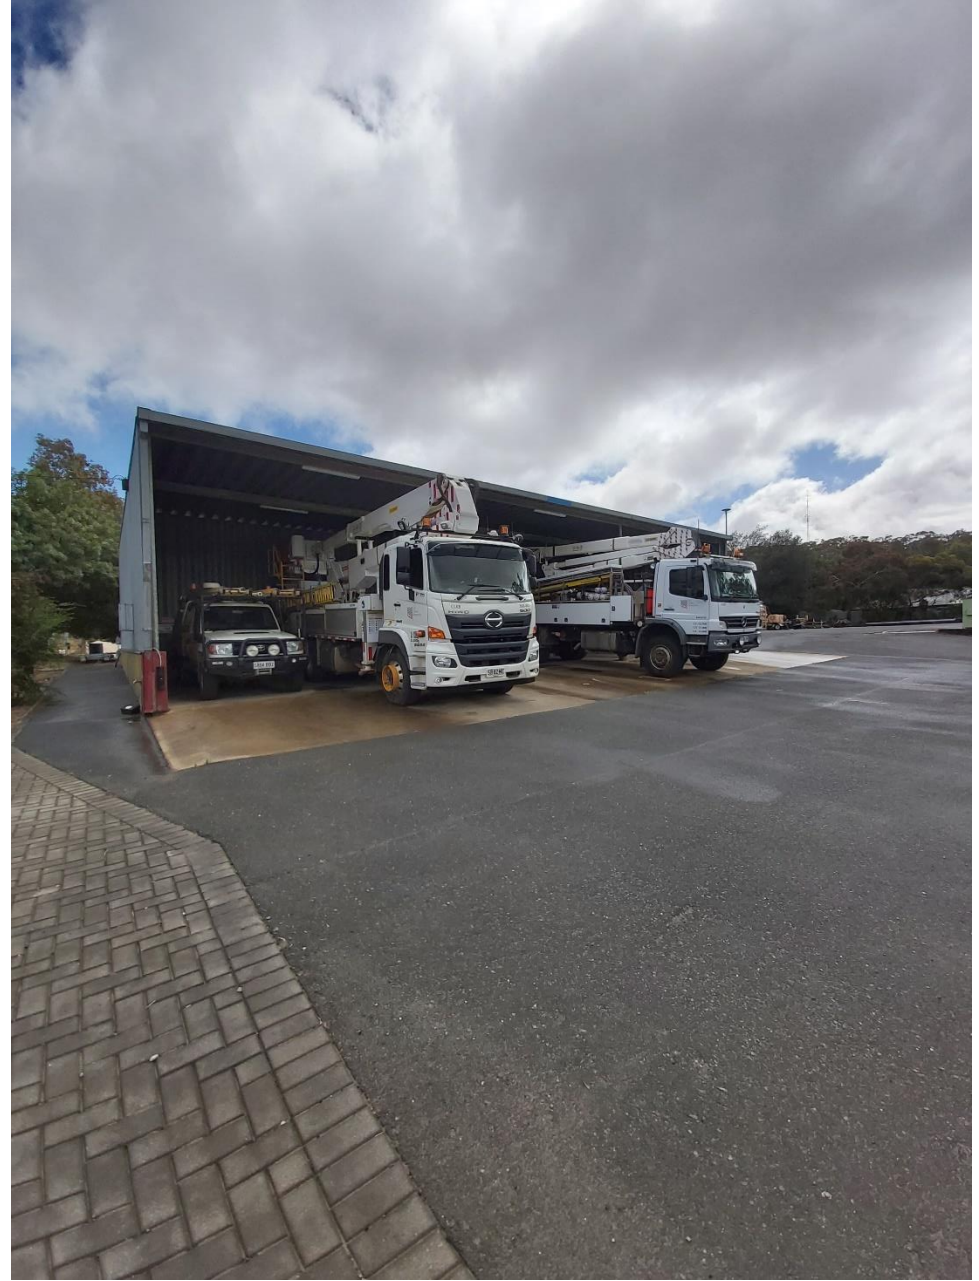
- Current truck store from can only accommodate half the length of an EWP vehicle and other trucks
