Supporting
document 5.25.2

Clare Photographs

2020-25 Revised
Regulatory Proposal
10 December 2019

Clare Depot Asset Condition Photographs

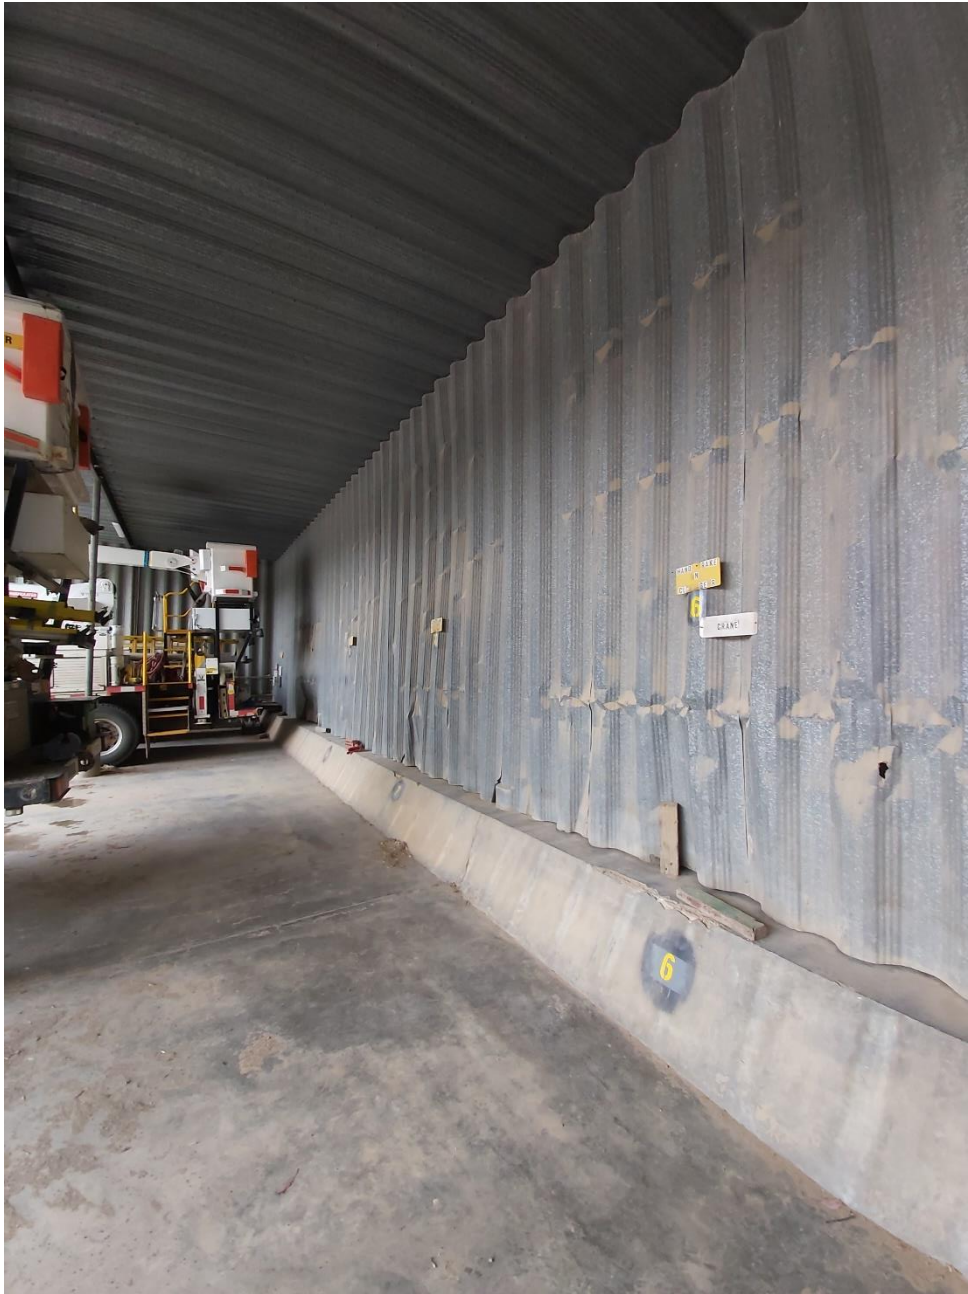
- Damage to internal wall of the front side of the truck store

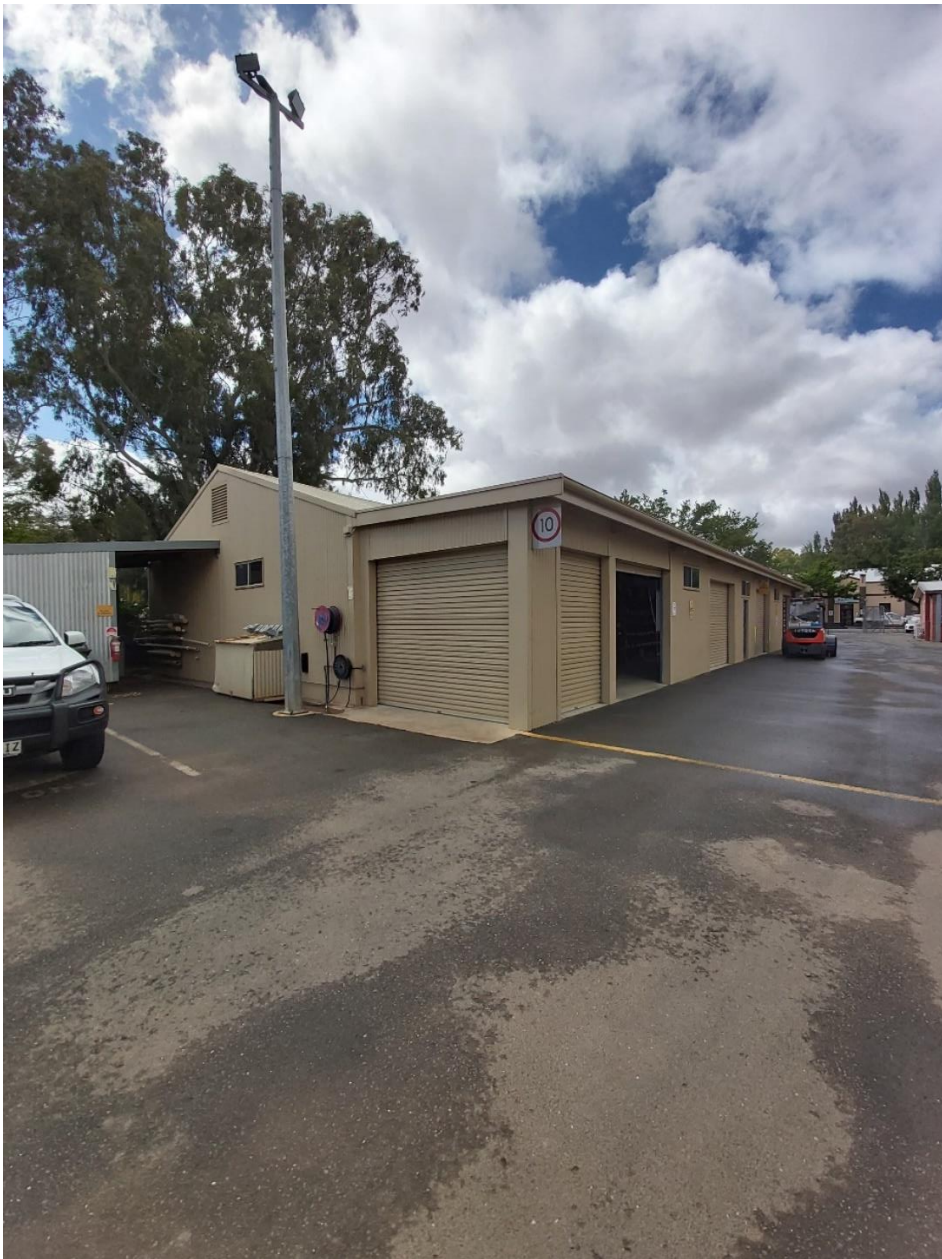
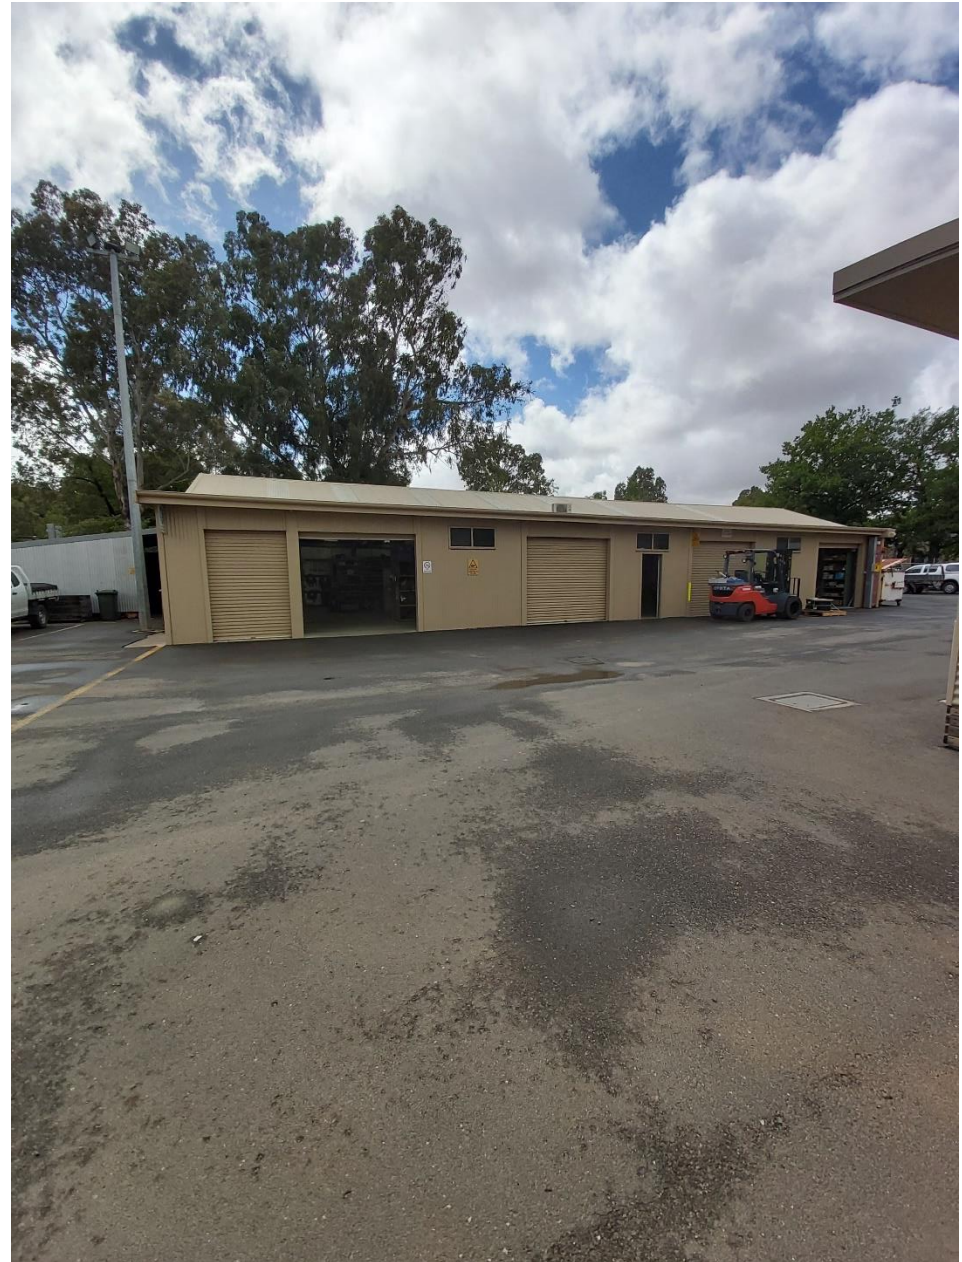
- Original Workshop Building cirqa 1967

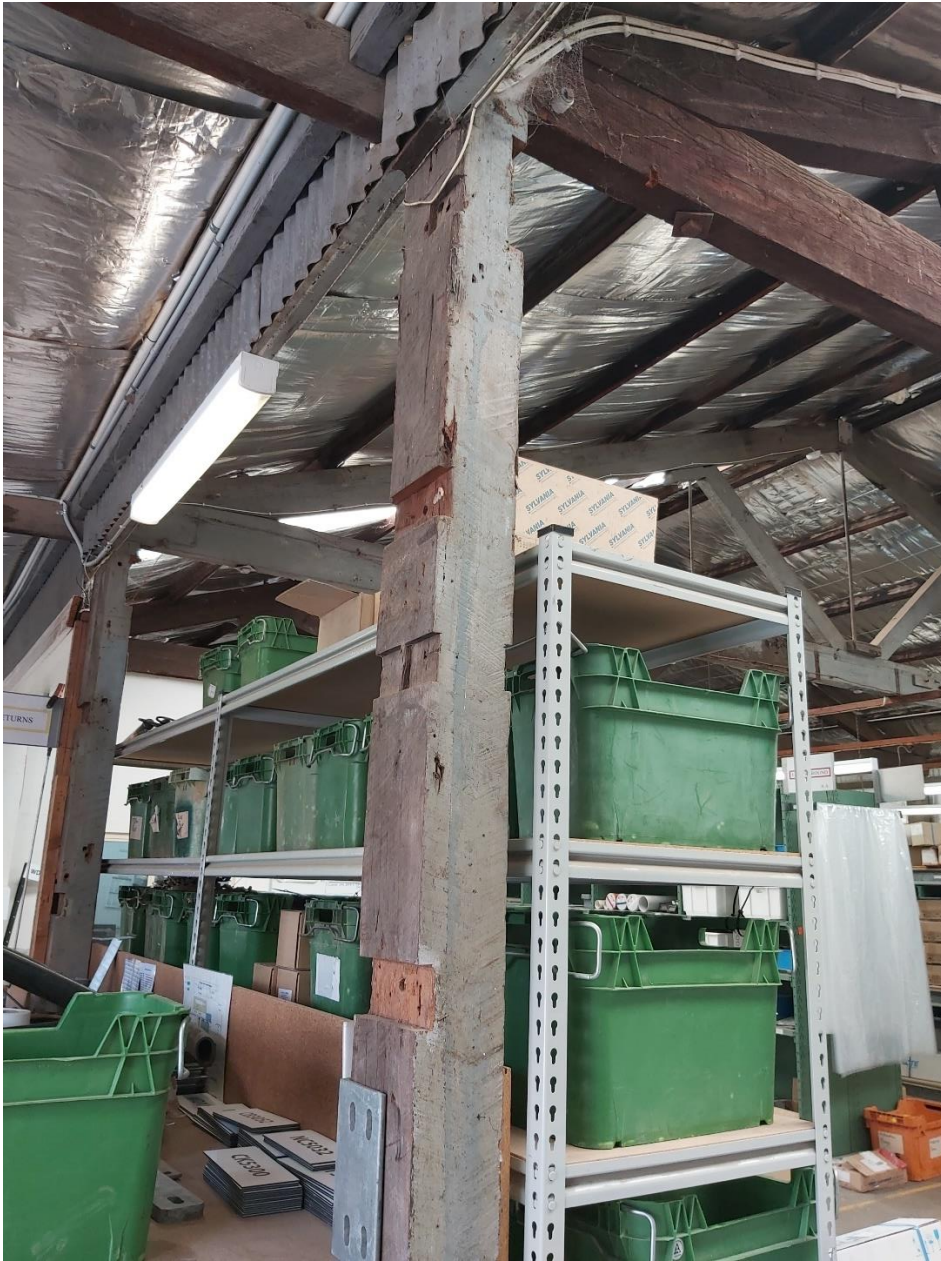
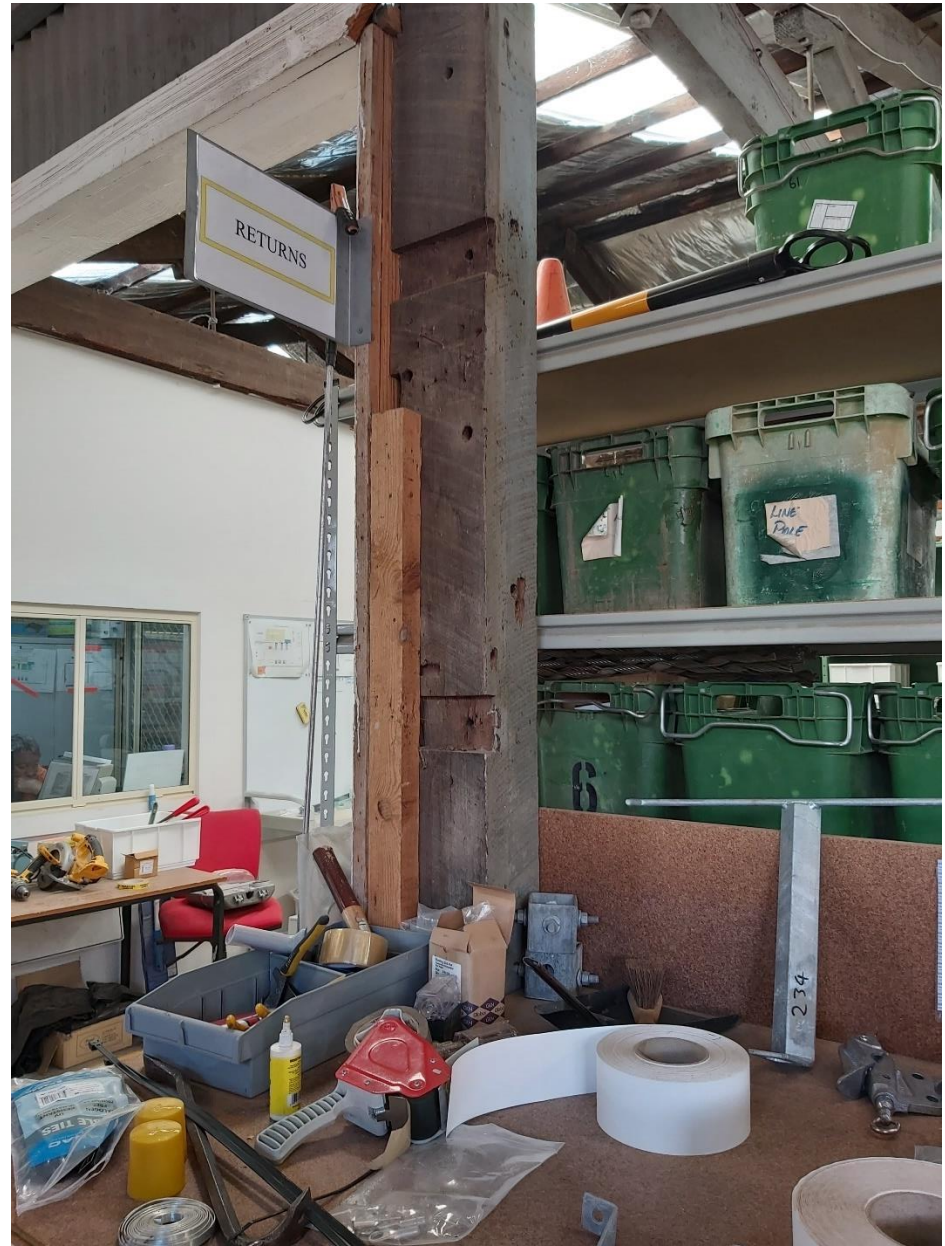
- Original Jarrah Columns and Trusses to Workshop framing starting to show signs of cracking to be replaced by steel members and high level rafters

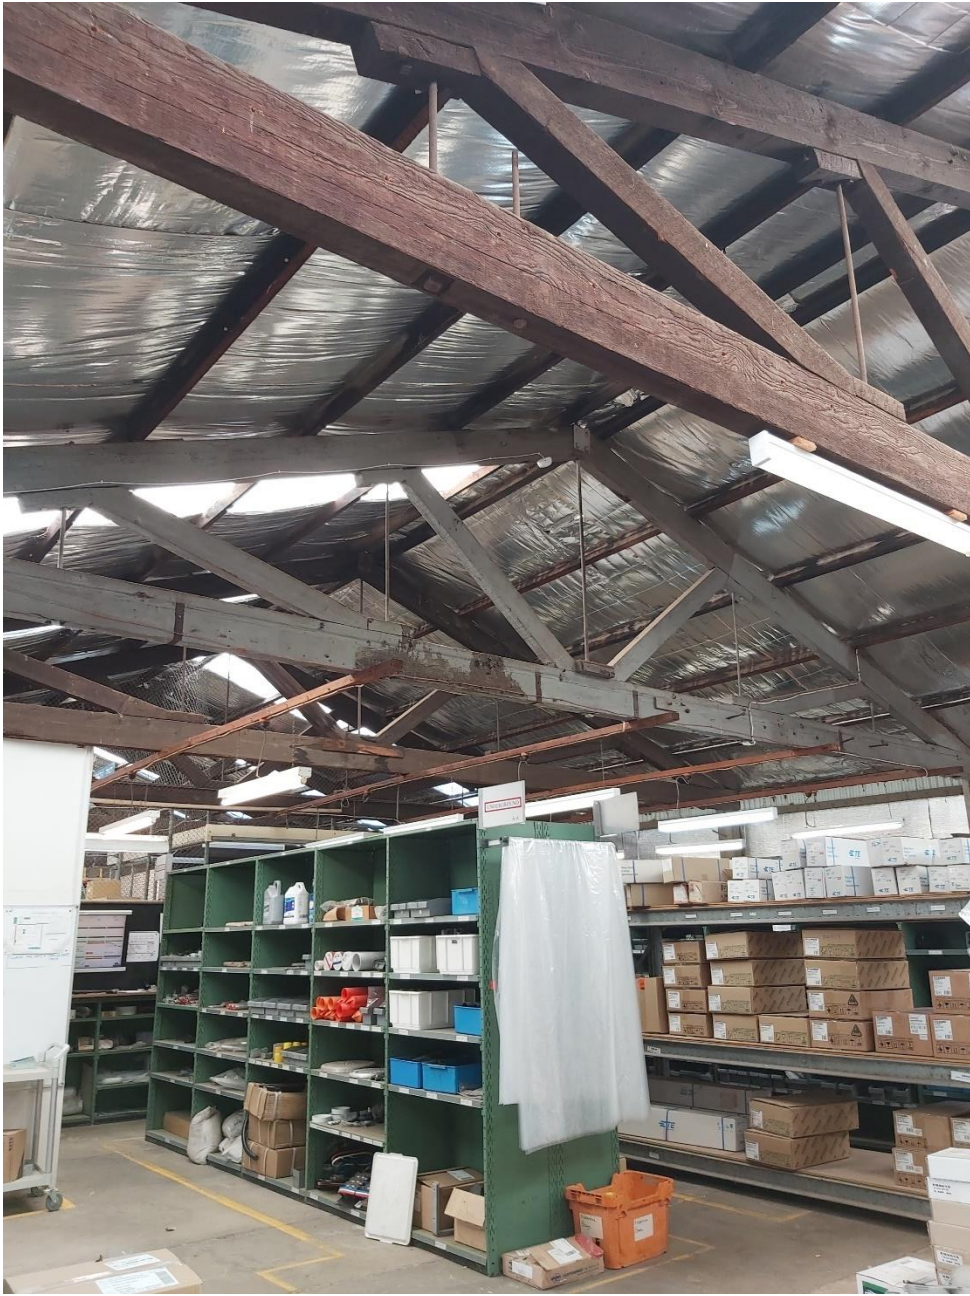
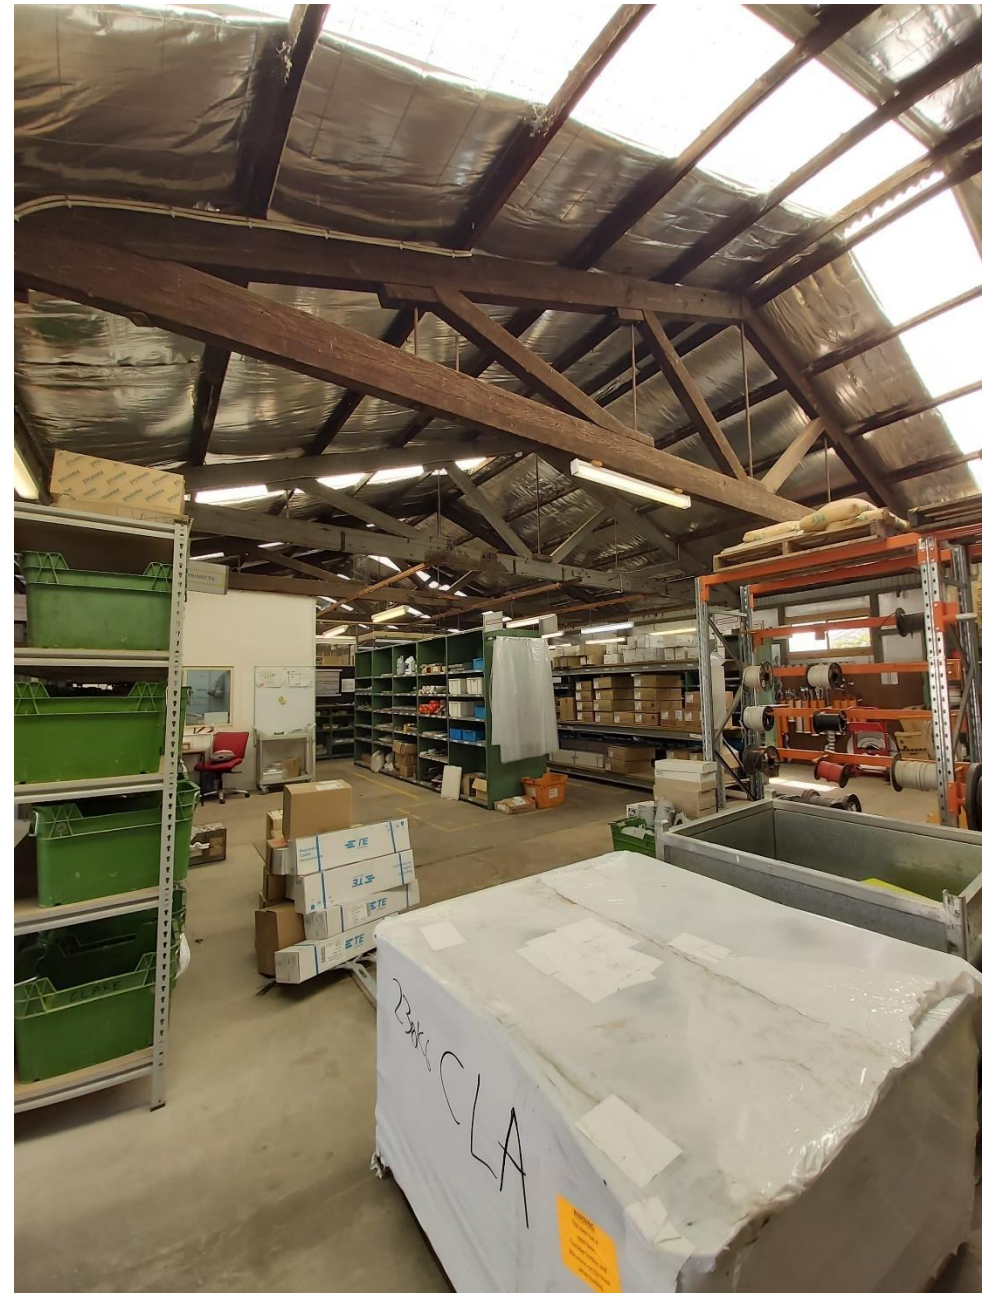
- Storage Height restrictions with Jarrah Trusses

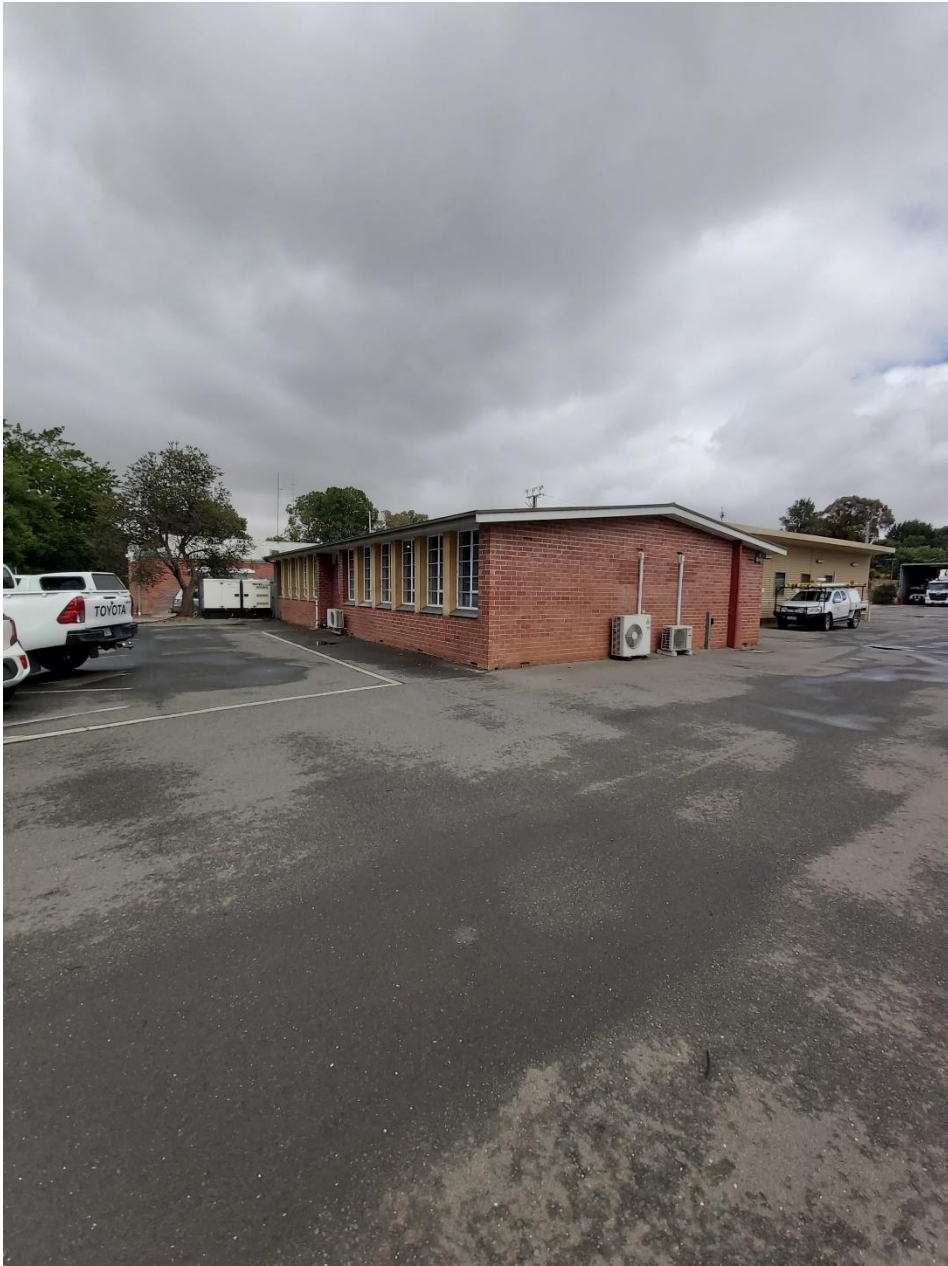
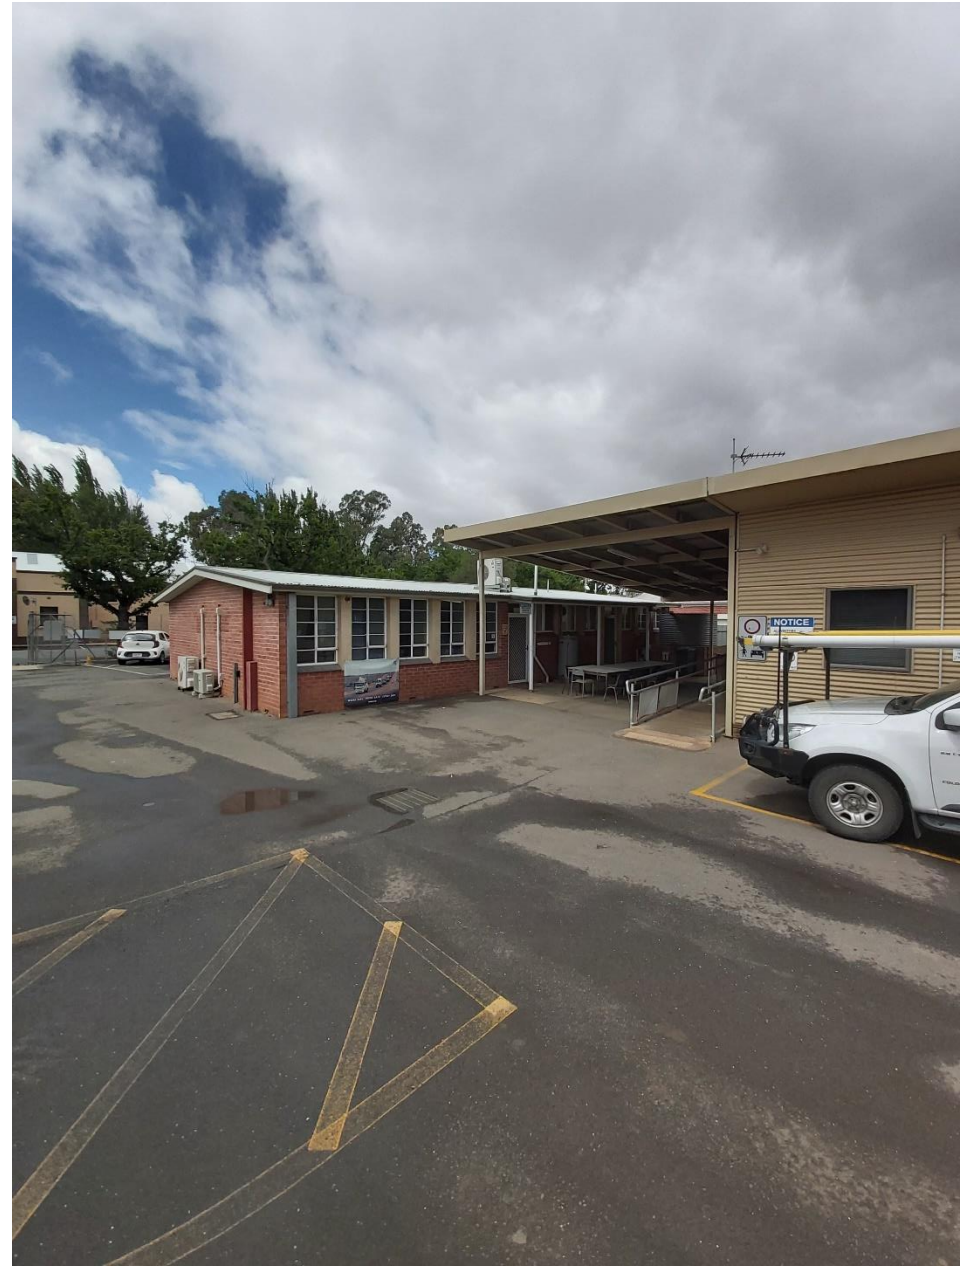
- Brick Admin Building Circa 1967

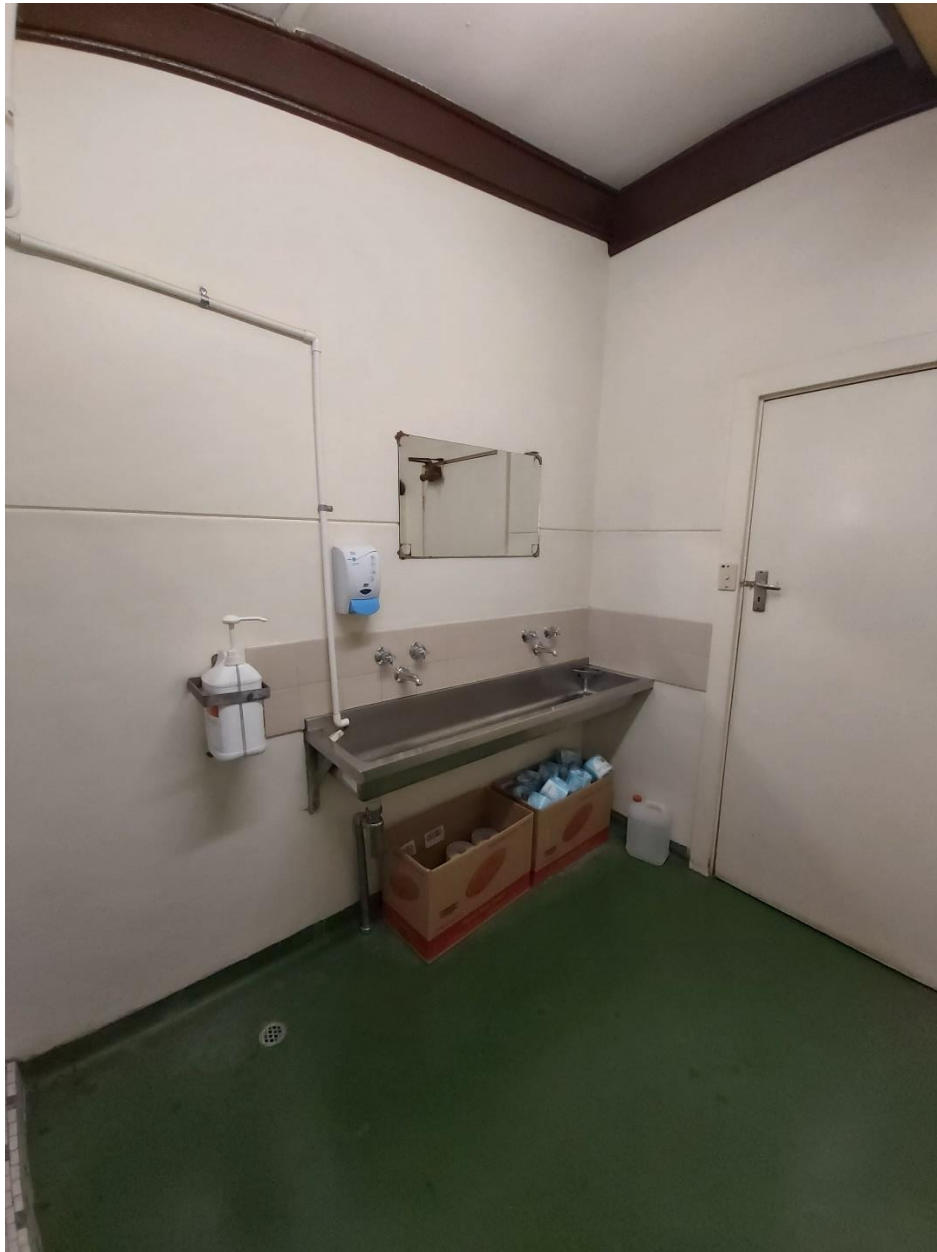
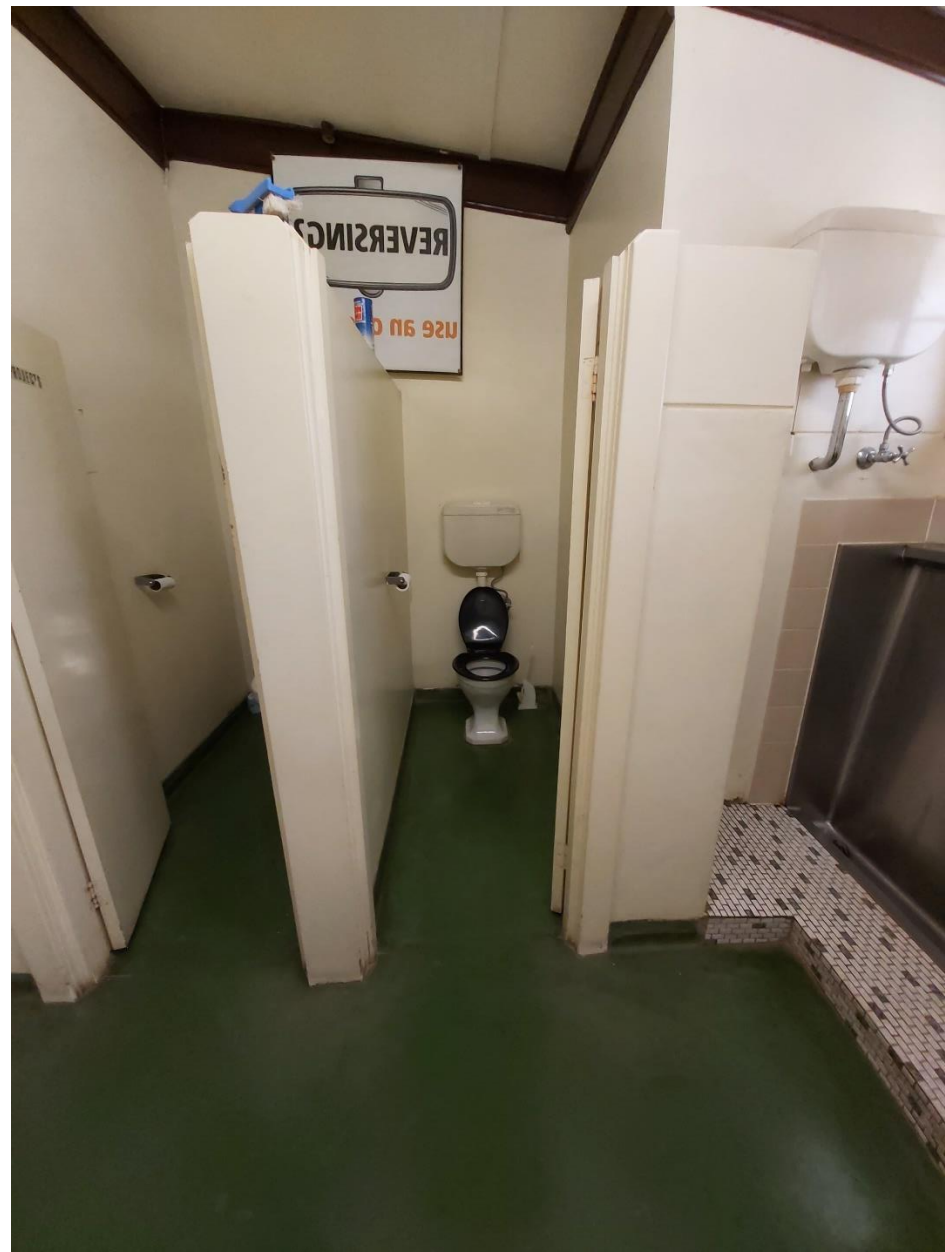
- Male Toilets and showers original fit-out and in poor condition

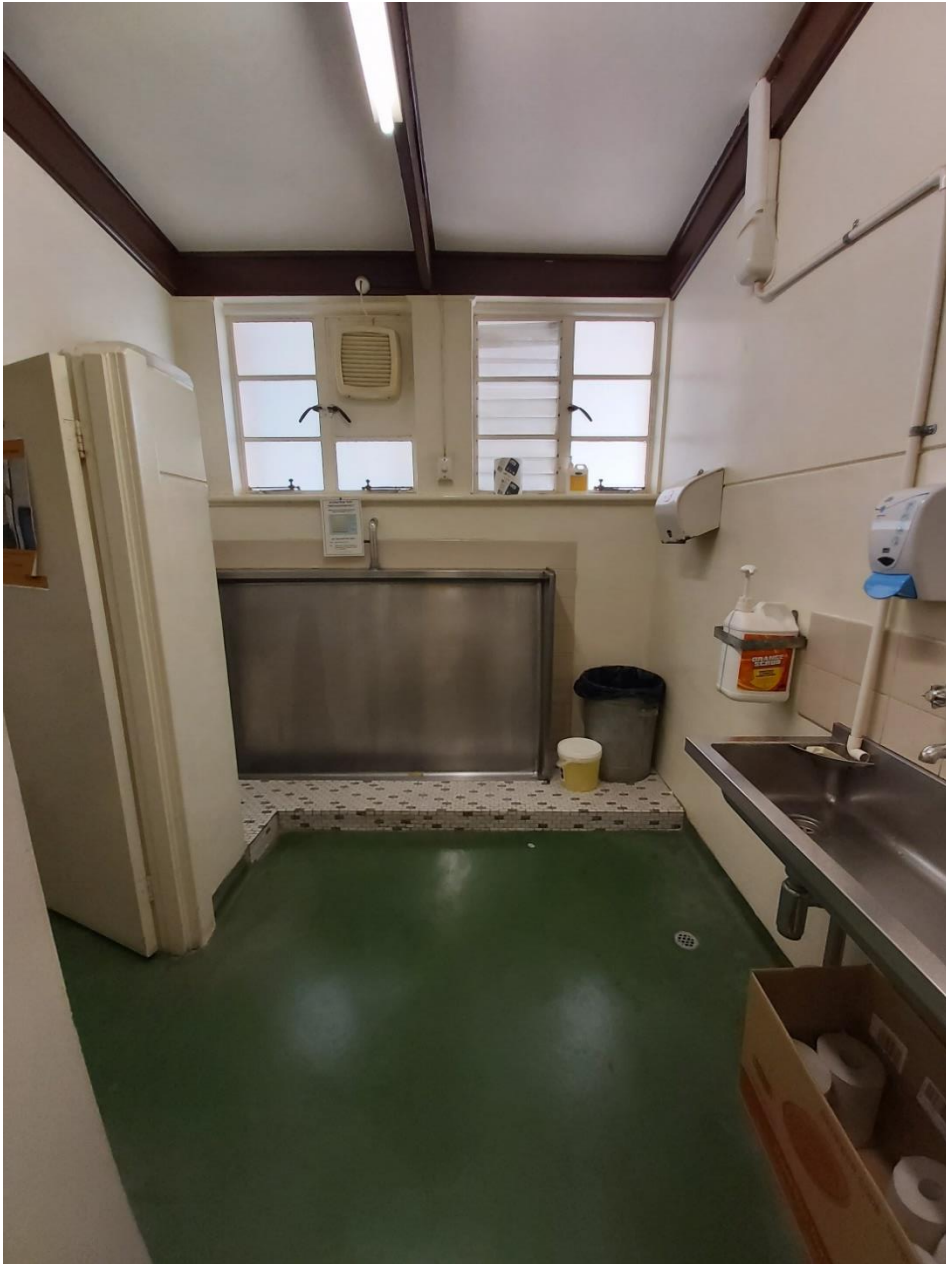
- Mens Urinal – original fit-out

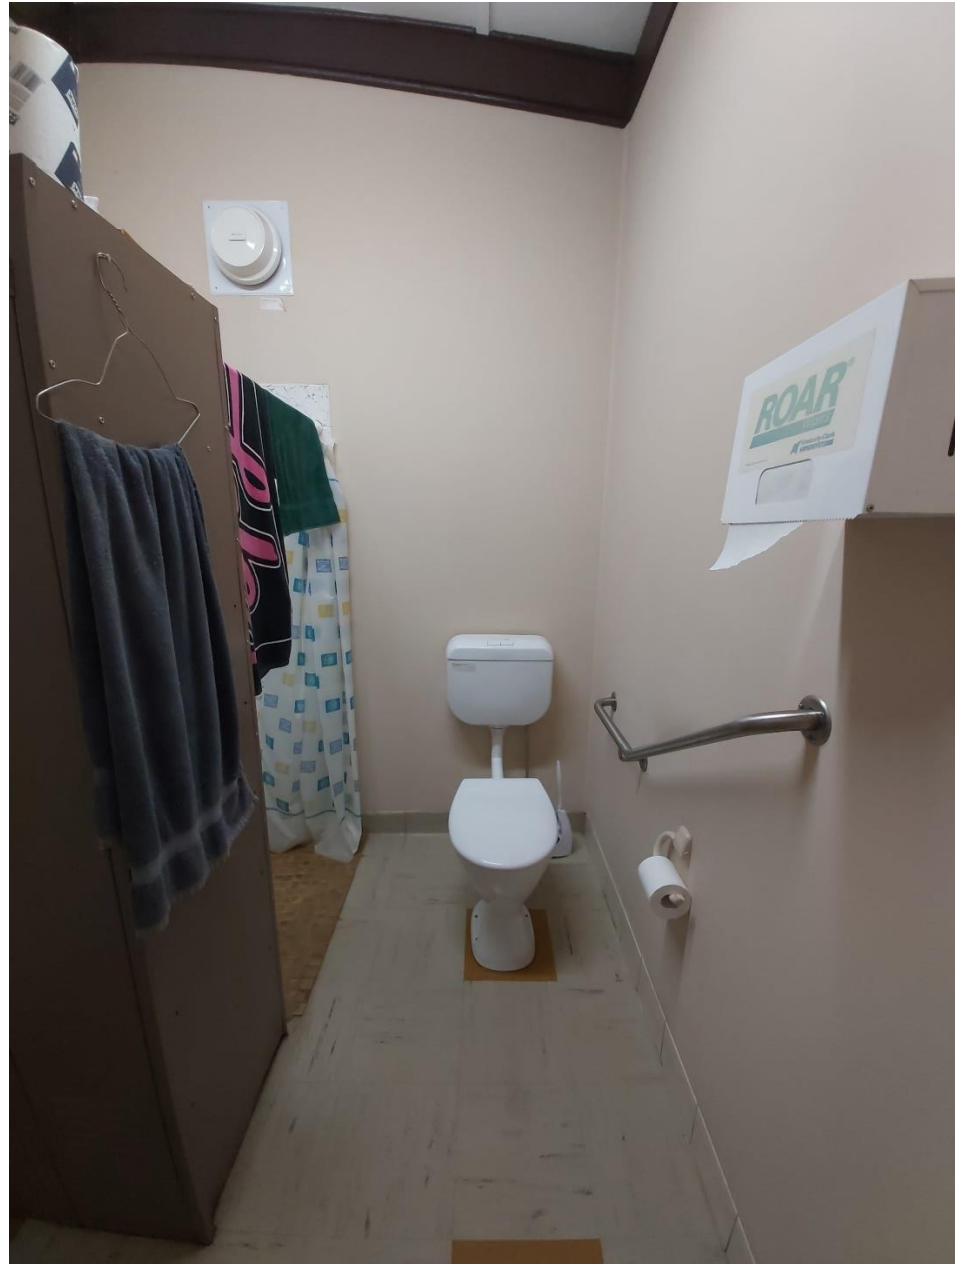
- Ladies toilet and shower all as per original fit out 1967

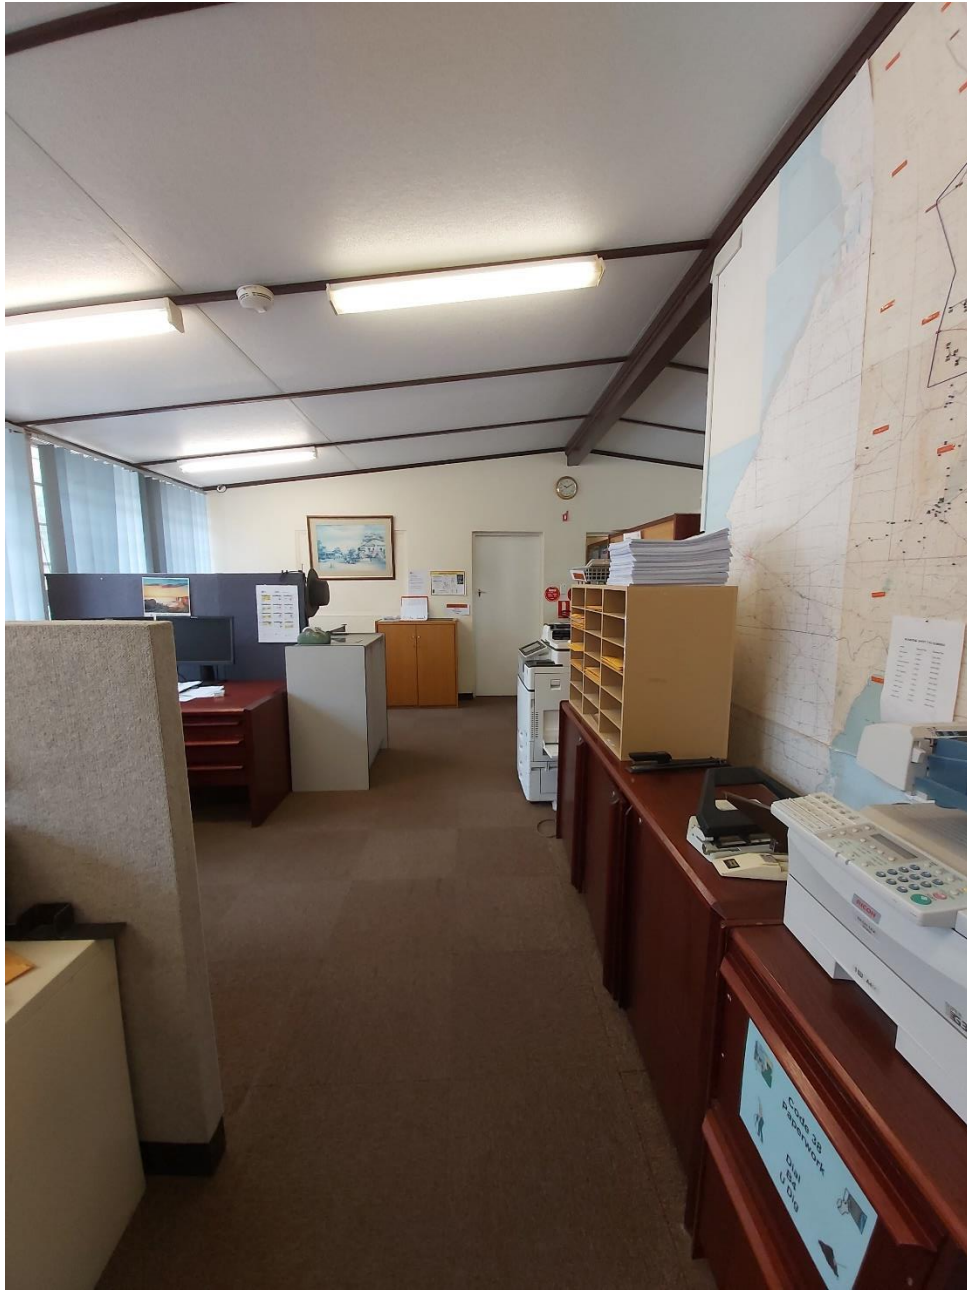
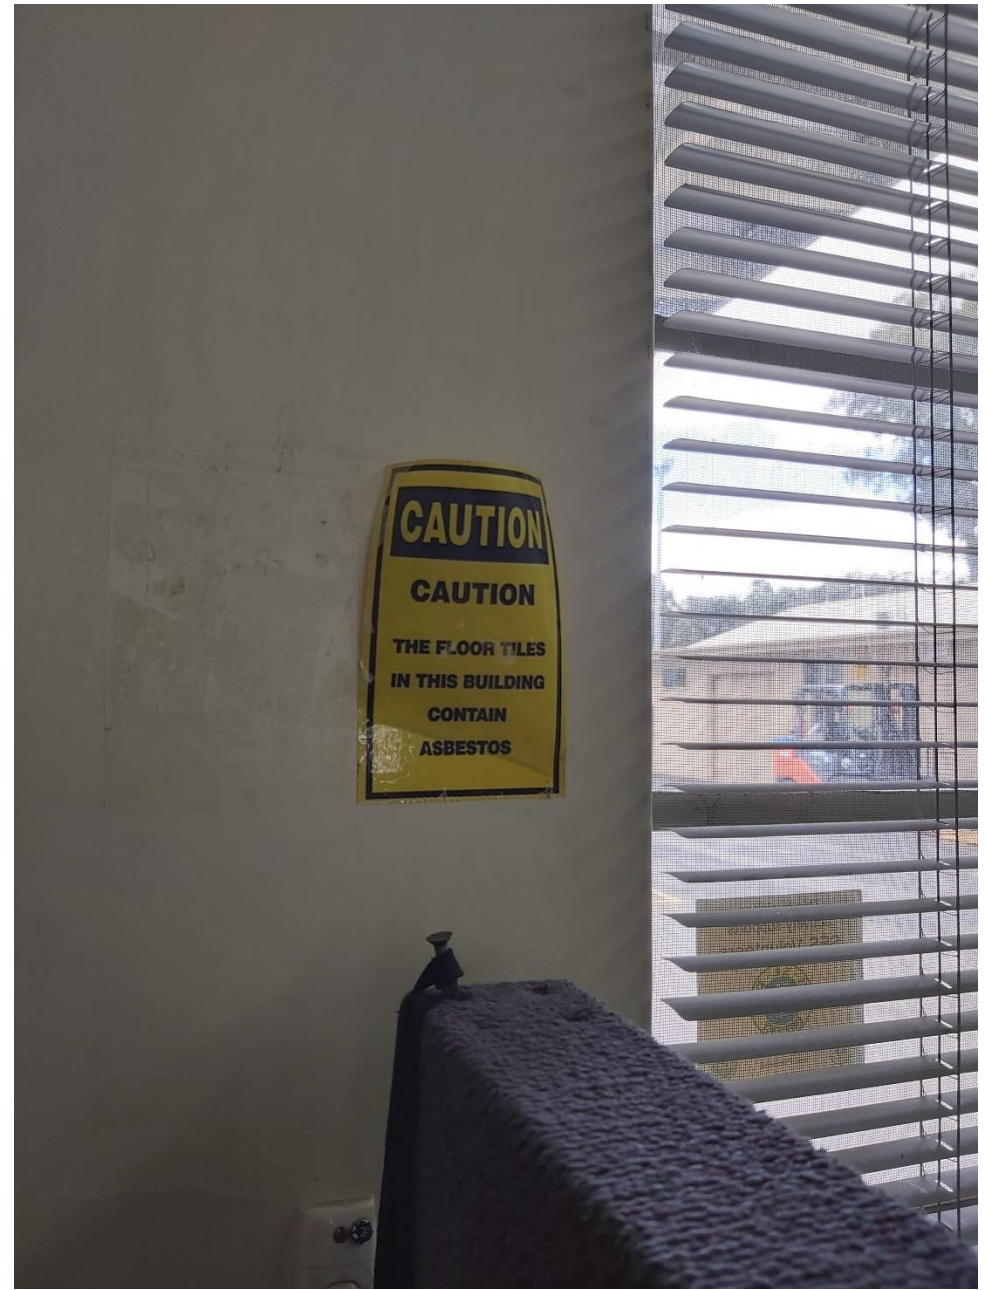
- Admin building internal fit-out as per original and includes asbestos floor tiles underneath

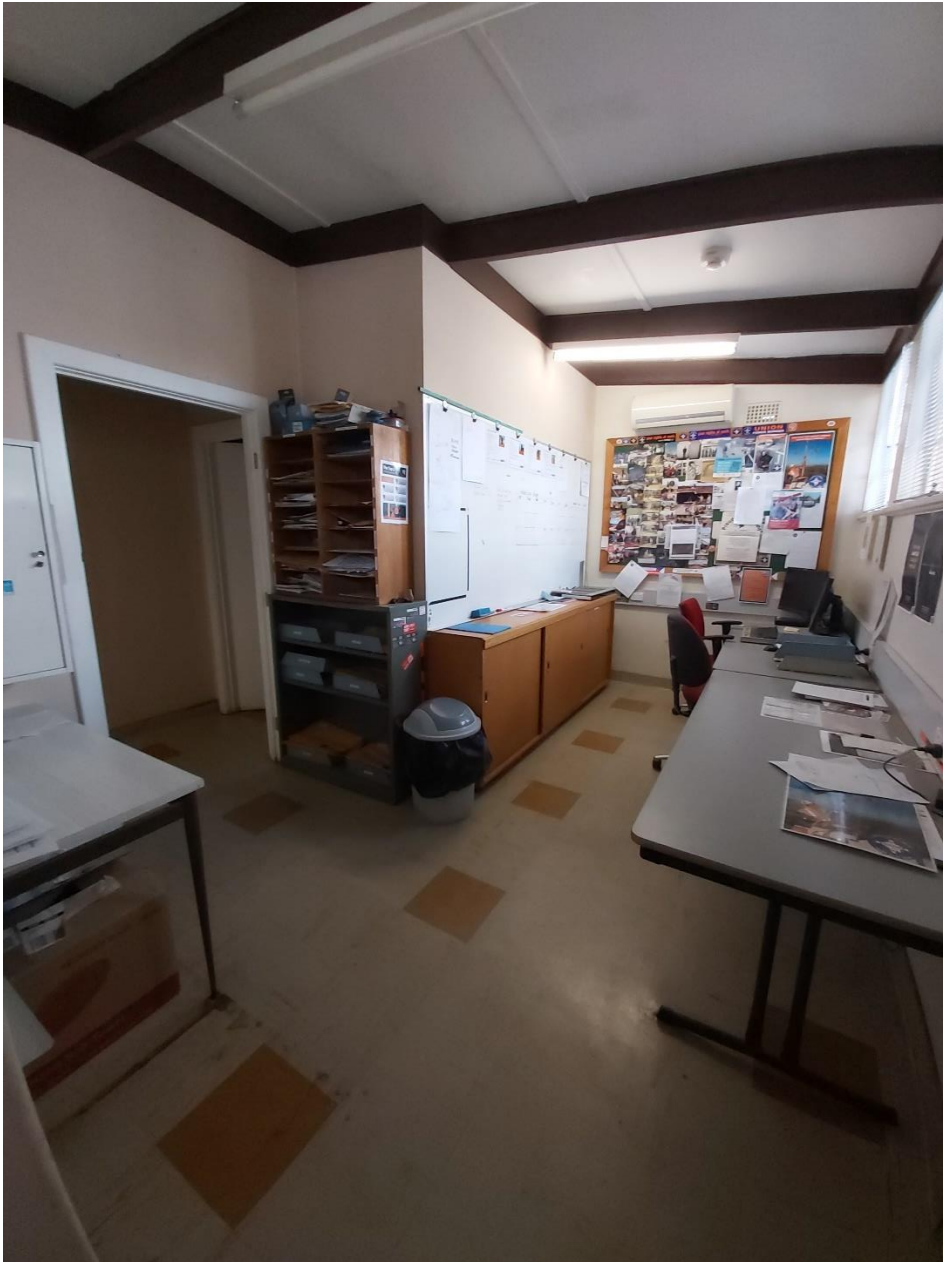
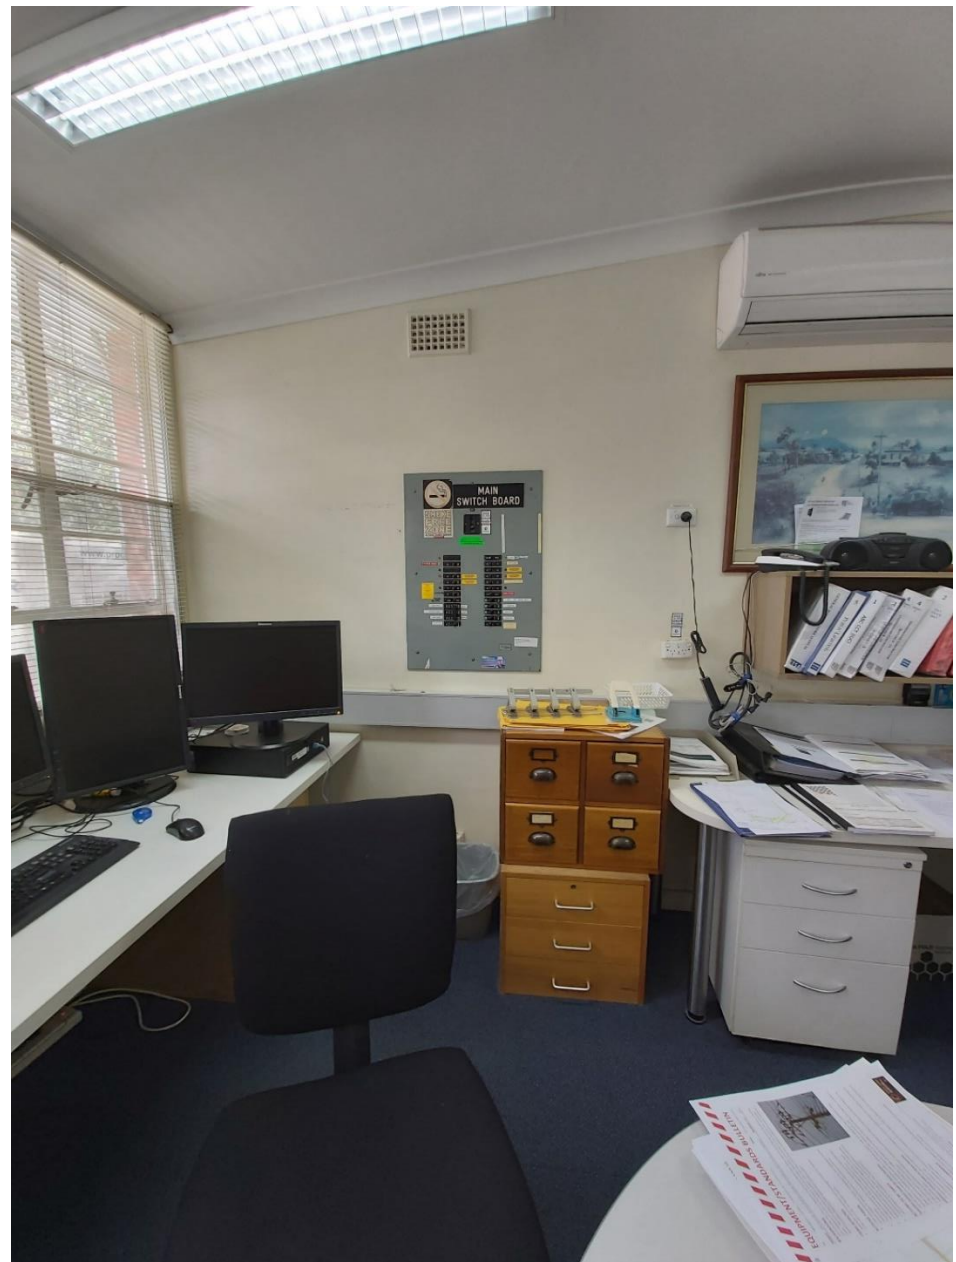
- Admin building internal fit-out as per original and includes asbestos floor tiles underneath.
