# APA GROUP

## LARA SWP CITY GATE

### CONTROL SYSTEM UPGRADE FEED STUDY

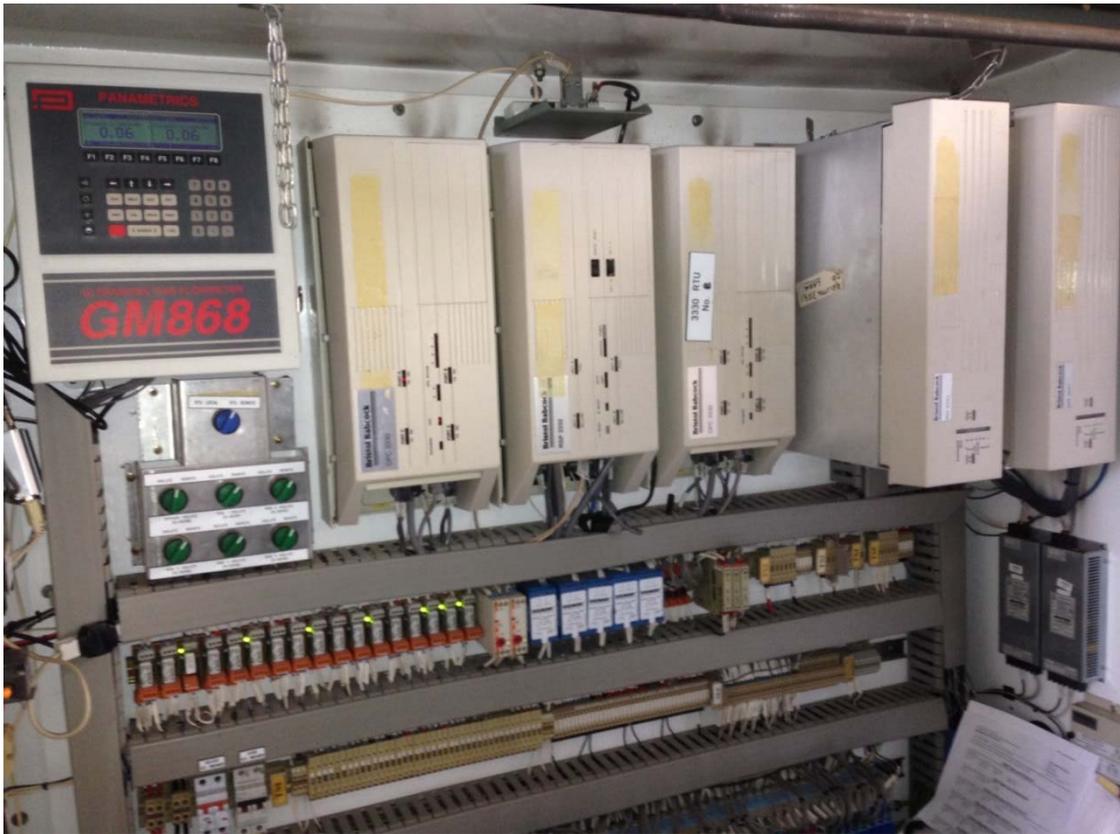
The Bristol 3330 RTU's are past the end of their life cycle and are no longer supported by the manufacturer, they are being phased out throughout APA sites and being replaced by either Control Wave Micro RTUs or if required Triconex/Trident PLC's.

The requirement of changing the existing RTU is of high priority as a failure of the RTU hardware can cause disruption to the operation of the site and restriction of gas supply to customers.

AREA	EQUIPMENT	DETAIL OF WORKS	JUSTIFICATION	PRIORITY LEVEL	APPROX. UPGRADE COST \$
<b>Control Hut</b>	RTU Cabinet Upgrade	<ul style="list-style-type: none"> <li>Upgrade RTU Cabinet with new back plate for new RTU's.</li> <li>Change 3330 Series RTUs to new Bristol Control Wave Micro RTU's.</li> <li>Keep all the existing terminals and barriers where appropriate.</li> </ul>	The existing 3330 series RTU is no longer manufacture and supported. APA are presently executing upgrade projects to replace existing 3300 series RTU's with Control Wave Micro RTUs. This is the standard throughout APA sites.	High	\$100,000
	Battery Charger and Cabinet	Change Battery Charger to new Eaton Battery Charger or similar. The Battery Banks will also be replaced with suitable battery bank arrangement for the proposed new Battery Charger.	The existing Battery Charger Circuitry is obsolete and not supported by the manufacturer. The Battery Charger Compartment is not safe for personnel to work on due to exposed to live terminals etc. The Cabinet has been damaged by rust and environmental factors.	High	\$35000

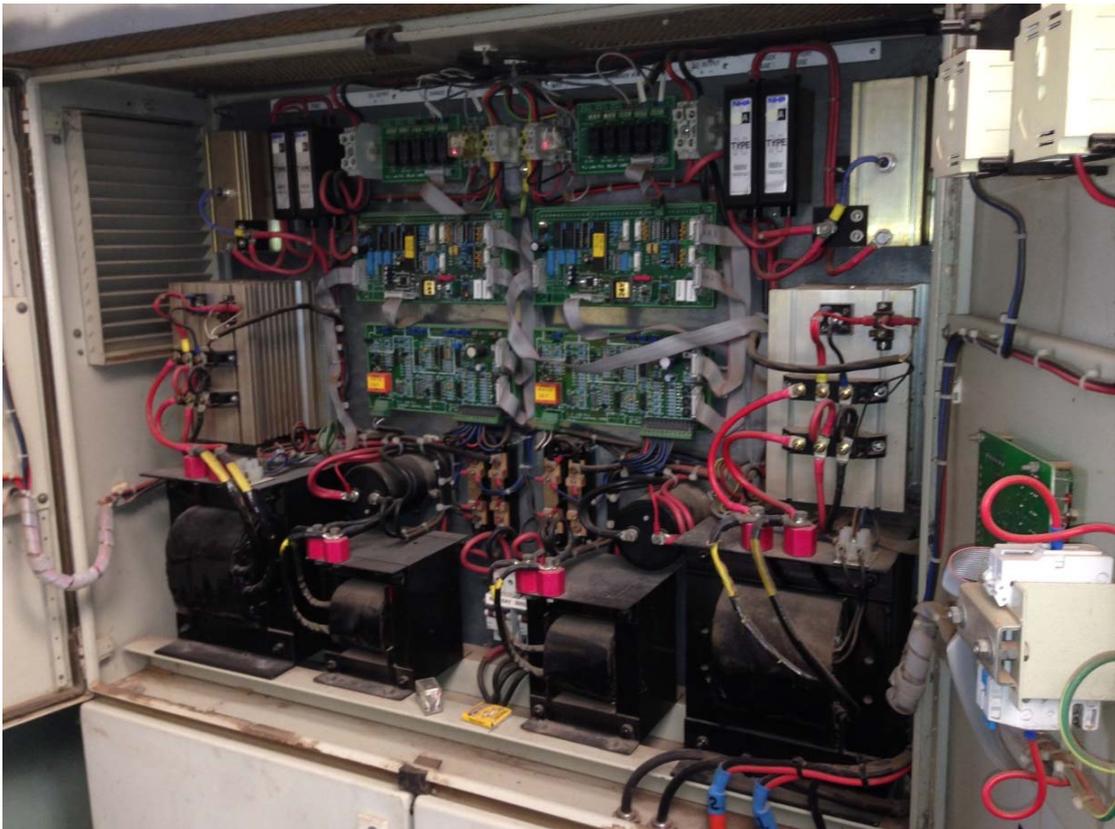
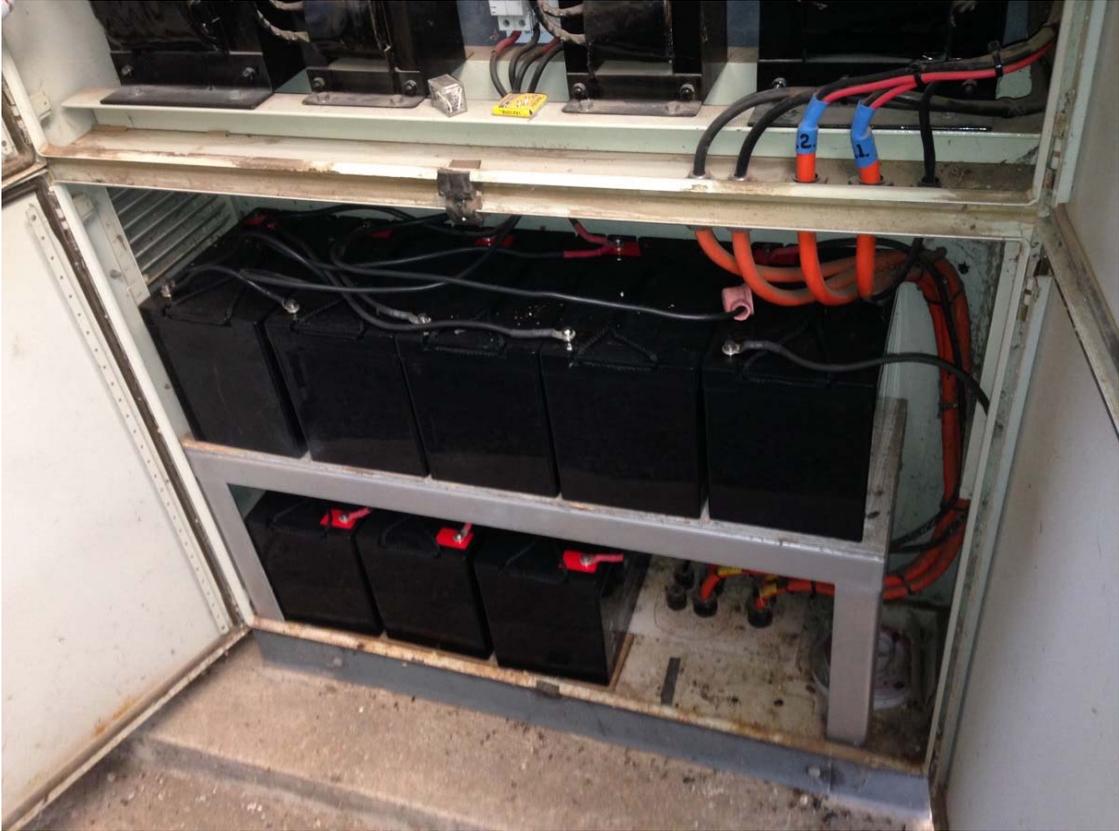
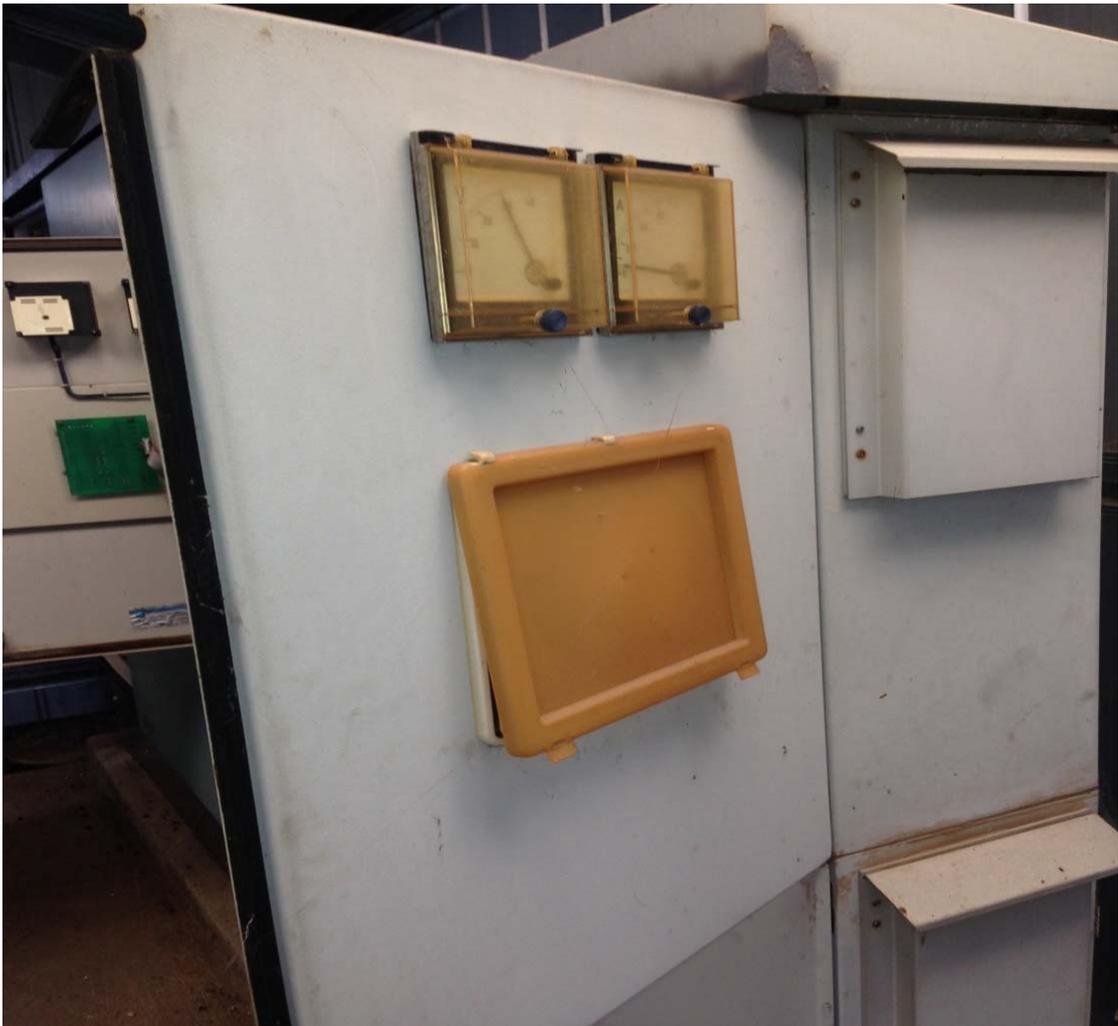
The condition of the existing Battery Chargers has reached its end of life. From visual inspection it is evident that the battery charger cabinet is not safe to maintain due to lack of suitable isolation of live equipment inside the cabinet. There are live terminals exposed and the cabinet shell has rust damage. The circuitry for the battery charger is obsolete and any possible failures cannot be supported by the manufacturer, fault finding within the cabinet is not safe for the maintenance personnel.

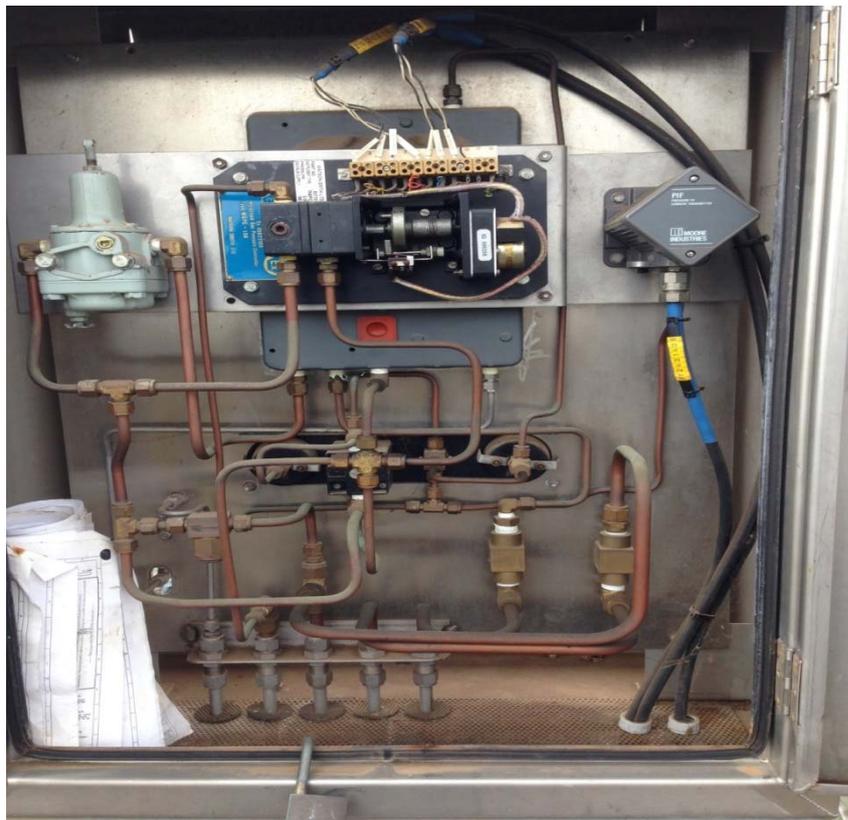
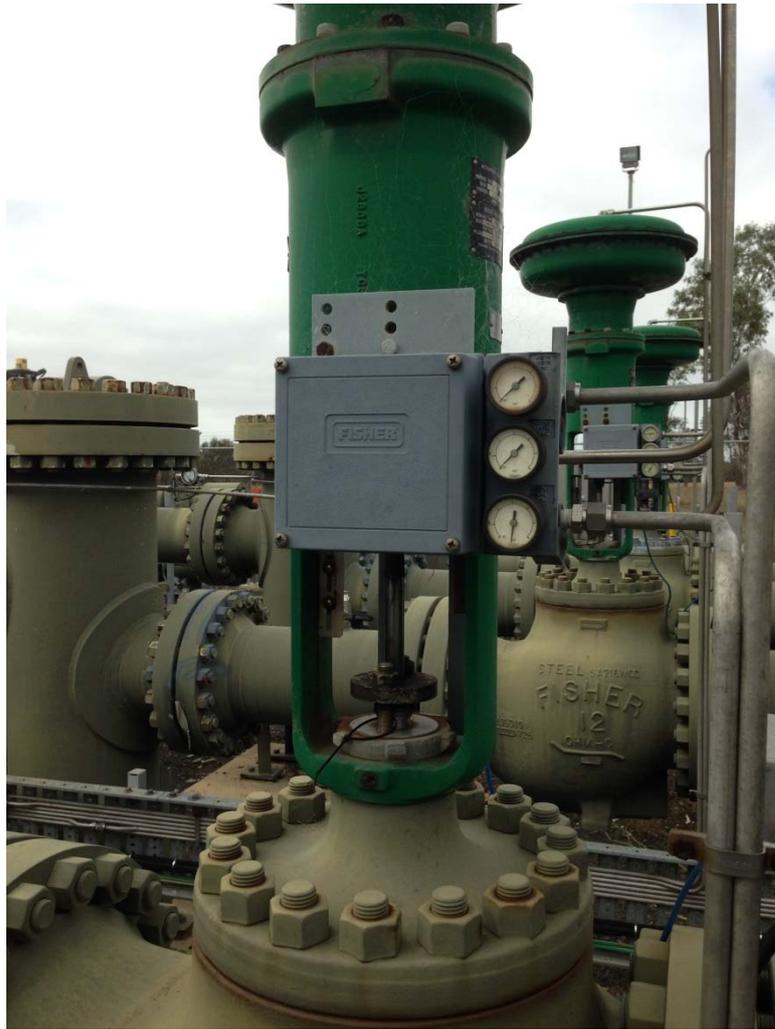
The current controls for the monitor valves on each of the regulator runs feature a “tracking” setpoint for the pneumatic controller, involving a stepper motor to adjust a pressure regulator supplying the setpoint signal to the pressure controller. Although this may be a useful feature, Operations group have reported reliability issues with the equipment, causing interruption to the operation of the regulator runs.

The valve panel also needs to be upgraded to the current APA standards and ensure reliability and hazardous area compliance. The upgrade of these valve panels will include removal of the “tracking” feature presently installed. The present configuration of ‘Fail Open’ needs to be reviewed and the actuator may require change to ‘Fail Close’ to provide suitable level of safety for over pressure protection.

SCADA licence (assuming ClearSCADA).	HMI will allow for improved monitoring and fault finding by maintenance personnel.		
<b>Regulator Runs</b>	Monitor Valves - control	Will involve the change in actuator for the monitor valves and installation of new valve panel.	The controls of the monitor valves needs to be upgraded. The existing control valve panel is not reliable and it has been identified by the operations to be an issue. An upgrade will help make the control of the run more reliable.	High	\$75,000 per valve for five regulator runs.
	Active Valves - control	Replace pneumatic positioner with DVC positioner.	Improved control of the active valves, easier maintenance.	Low	\$75,000
	Slam Shut Panels	Installation of new Slam Shut Panels	The existing Slam Shut Panels are not reliable and do not follow the standard APA Slam Shut Panels. By upgrading the panel to the current standard design, maintenance should be simpler and reliability improved due to use of standard procedures.	Medium	\$120,000

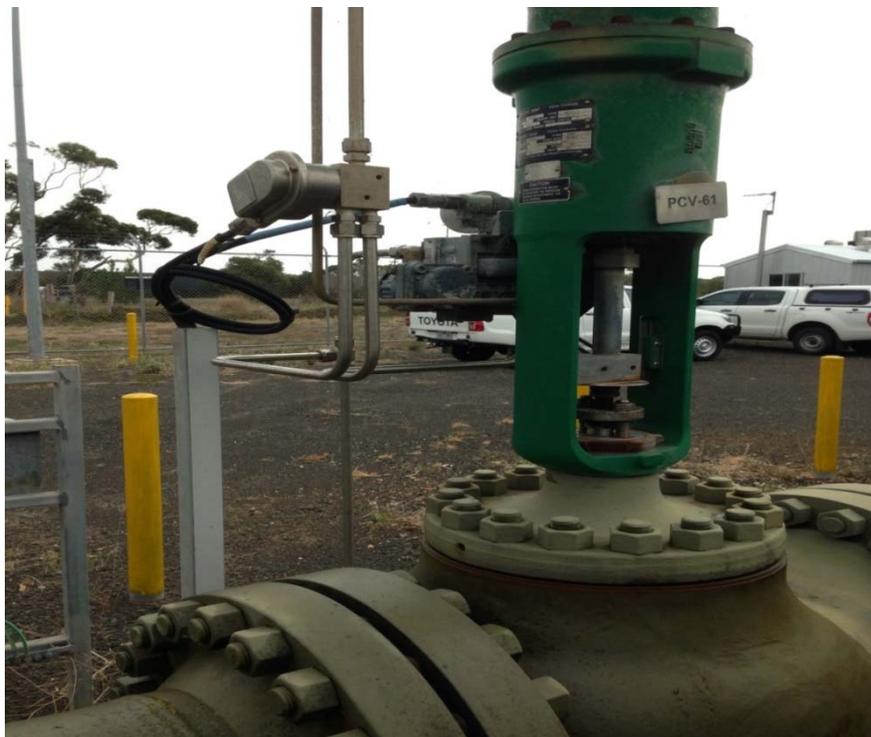
Active Regulator Valve

The Active control valves are fitted with a pneumatic valve positioner and are controlled by the RTU via an I to P converter. A solenoid valve is installed to supply instrument gas pressure directly to the actuator in the event of RTU or control system failure, causing the control valve to close.

A review is required as part of this upgrade to determine if this response to control system failure is appropriate. The review will also consider replacing the existing I to P converter and pneumatic positioner with a new DVC valve positioner to provide improved control of the valve.

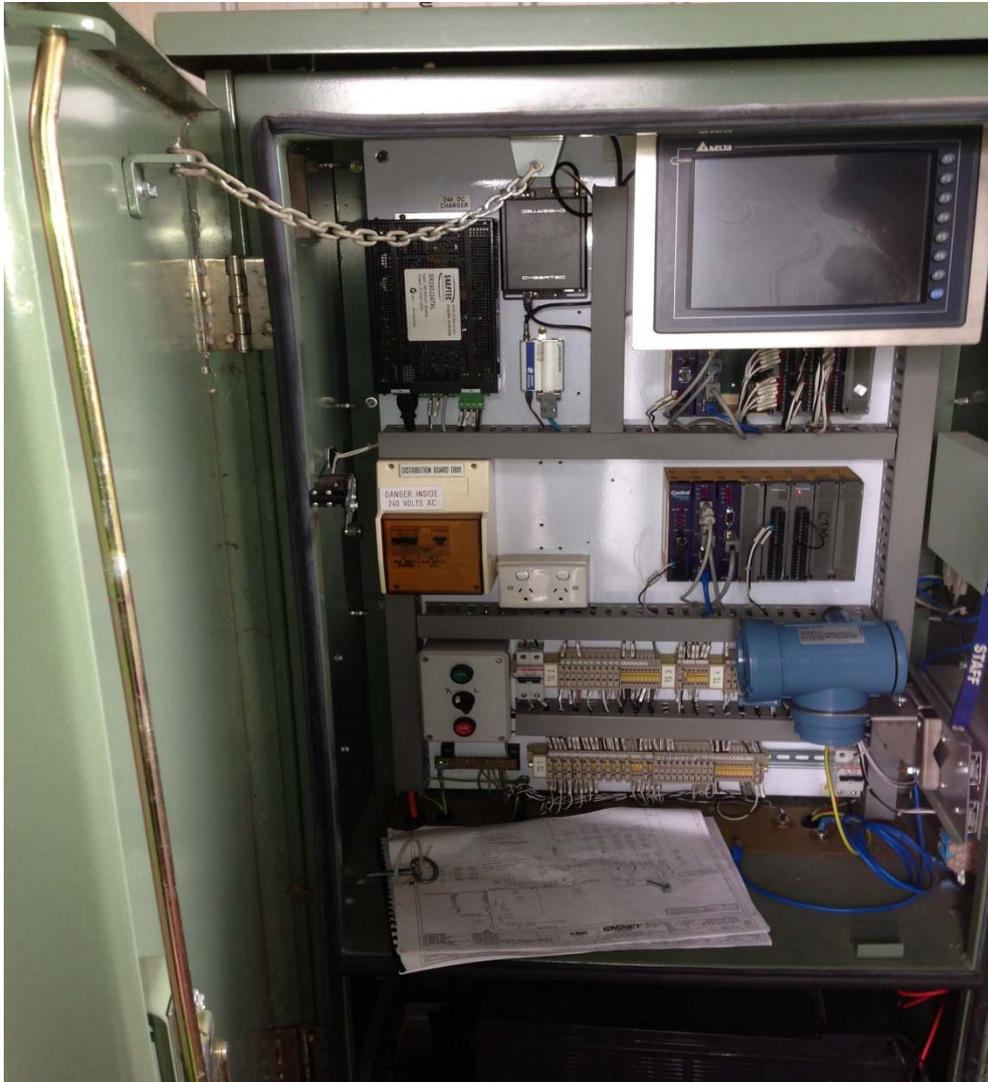
Metering Cabinet

Meter Cabinet	Minimal changes required. Possibly remove HMI screen from inside the cabinet.	HMI screen inside meter cabinet can be removed as it is not generally used and is prone to	Low	\$2,000

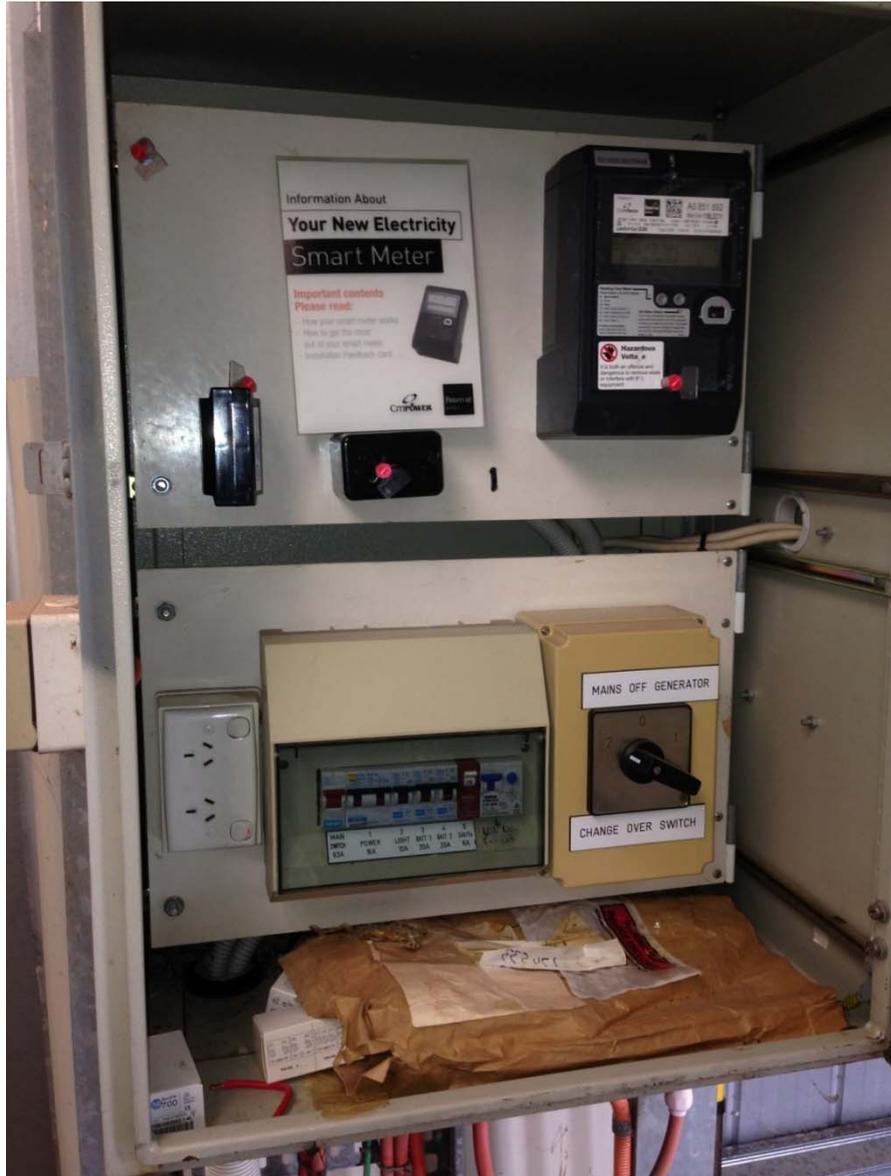
failure. A new HMI may be more appropriate.		
	Distribution Board	Minimal changes required. Possibly install additional circuit breakers for Hut Lighting.	Additional circuit breakers need to be installed if lights are to be provided for the hut.	Low	\$2,000
	Lighting	Install Fluorescent lights and emergency lights for personnel.	Currently there is no lighting provided in the hut, which causes a safety issue for personnel to work in low light conditions.	Low	\$5,000
	Communications	Reconfiguration of communications links to site.	Currently there are multiple communication modes to site. The upgrade will require a change on the communications link and remove redundant links, including conversion to Ethernet IP communications.	High	\$5,000 - \$8,000
	Hut Refurbishment	Refurbish the existing hut	The existing hut needs to be refurbished to provide an adequate work setting for maintenance personnel.	Low	\$20,000

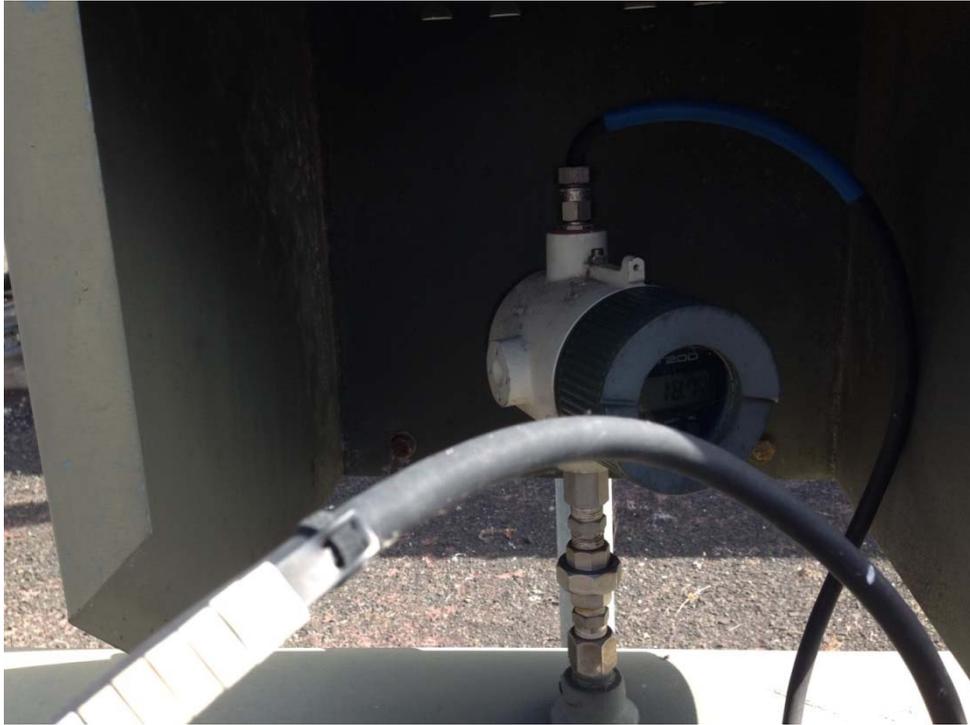
Old Instrumentation

From visual inspection it is evident that some of the equipment, such as instruments and transmitters, are older models that are no longer supported, these may require replacement for ongoing reliability.

Instrumentation	Installation of new instrumentation.	Some of the instrumentation (such as Pressure and Temperature Transmitters) on the regulator runs and general site have been identified to be old models which are no longer supported. New instrumentation will provide improved reliability.	Low	\$10,000
<b>Heater</b>	Control Panel	No works required		Low
