BUILDING CONDITION REPORT

TransGrid

Mt Piper 500KV Sub-Station, via Mt Piper Power Station, Portland Road,
Portland NSW 2847

6 May 2016

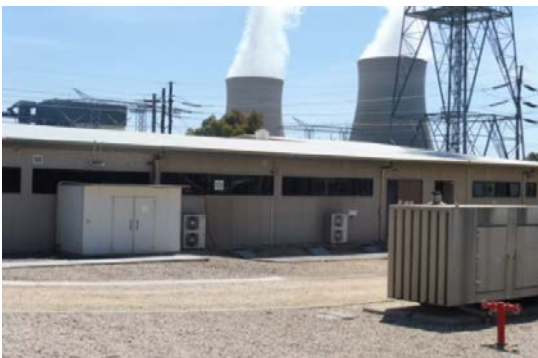
| PREDICTED CAPEX & MAINTENANCE COSTS (\$) excl GST | | | | | | | | | | | | |
|---|---|---|---|---|---|---|---|---|---|---|---|---|
| 1.1.2 | Main Roof Coverings | Steel framed roof structure covered with profile metal sheeting. | In poor to fair overall condition. | The roof sheets to part of the building dates date back to the original construction date (1986) and are suffering from wear and tear with evidence of water ingress. Allow for replacement as required. | CAP | 2 | | \$ | 147,000.00 | \$ | 147,000.00 | |

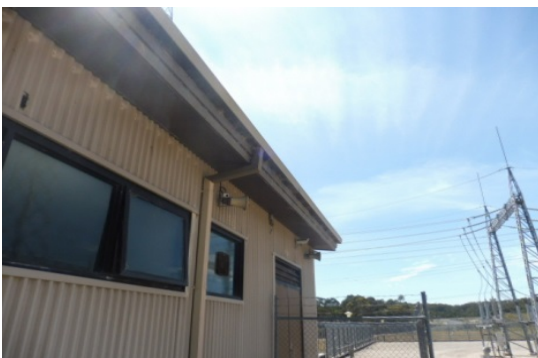
| PREDICTED CAPEX & MAINTENANCE COSTS (\$) excl GST | | | | | | | | | | | | |
|---|---|---|---|---|---|---|---|---|---|---|---|---|
| 1.1.4 | Fascia and Soffits | Metal fascia and soffit boards. | In poor to fair overall condition. | Replace in the short term. | CAP | 2 | | \$ | 5,250.00 | \$ | 5,250.00 | |

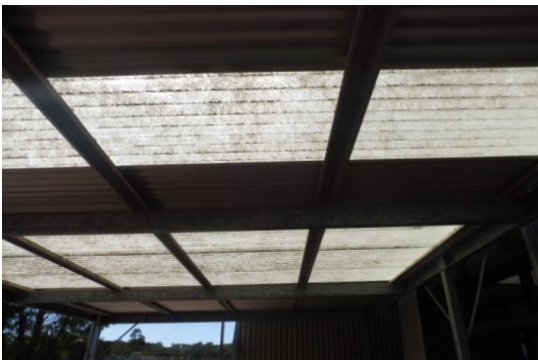
| PREDICTED CAPEX & MAINTENANCE COSTS (\$) excl GST | | | | | | | | | | | | |
|---|---|---|---|---|---|---|---|---|---|---|---|---|
| 1.1.5 | Ancillary Roof Coverings | Steel framed roof structure covered with profile metal sheeting and polycarbonate roof lights. | In poor overall condition. | Replace in the short term. | CAP | 2 | | \$ | 5,000.00 | \$ | 5,000.00 | |

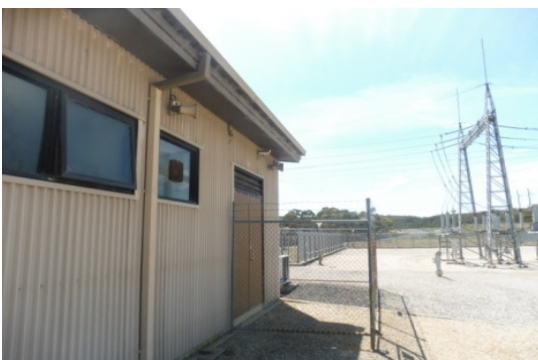
| PREDICTED CAPEX & MAINTENANCE COSTS (\$) excl GST | | | | | | | | | | | | |
|---|---|---|---|---|---|---|---|---|---|---|---|---|
| 1.1.6.2 | Drainage | Metal eaves gutters draining to metal downpipes. | In poor to fair overall condition. | The roof drainage to part of the building dates back to the original construction date (1986) and are suffering from wear and tear with evidence of corrosion. Allow for replacement as required. | CAP | 2 | | \$ | 4,550.00 | \$ | 4,550.00 | |

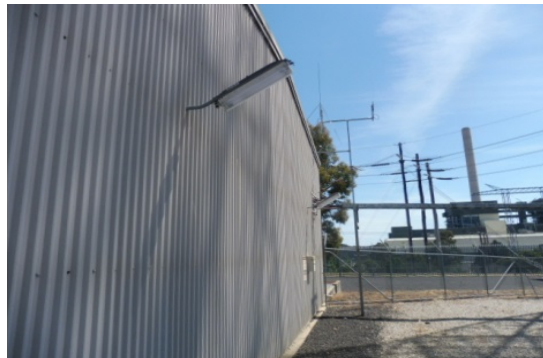
| PREDICTED CAPEX & MAINTENANCE COSTS (\$) excl GST | | | | | | | | | | | | | | |
|---|---|---|---|---|---|---|---|---|---|---|---|---|---|---|
| .2.5.2 | Fixtures & Fittings | Surface fixed strip light fittings. | In poor to fair overall condition. | Aged light fittings. Allow for replacement as part of the cladding replacement works. | CAP | 2 | | | \$ | 900.00 | \$ | 900.00 | | |

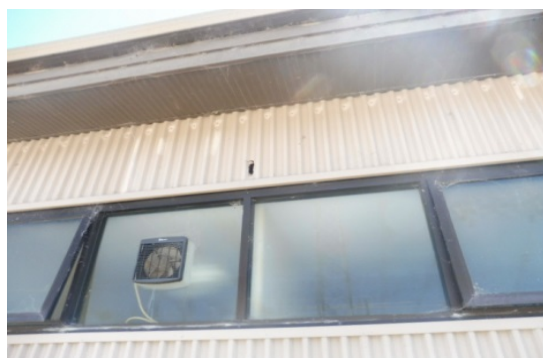
| PREDICTED CAPEX & MAINTENANCE COSTS (\$) excl GST | | | | | | | | | | | | | | | |
|---|---|---|---|---|---|---|---|---|---|---|---|---|---|---|---|
| .2.5.8 | Fixtures & Fittings | Extract fans to WC's window mounted | In poor to fair overall condition. | Replace in the short term. | CAP | 2 | | \$ | 500.00 | | | \$ | 500.00 | | |

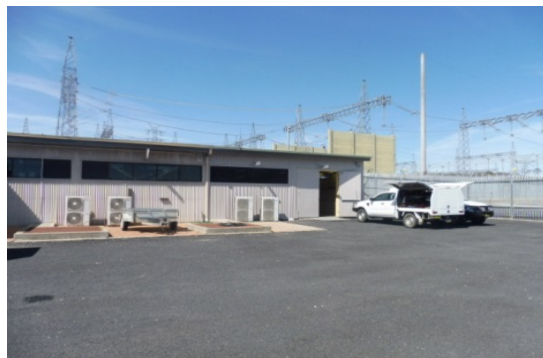
| PREDICTED CAPEX & MAINTENANCE COSTS (\$) excl GST | | | | | | | | | | | | | | | |
|---|---|---|---|---|---|---|---|---|---|---|---|---|---|---|---|
| .3.1.1 | Parking | On-grade unsealed hardcore parking. | In good overall condition. | Allow for sealing the carpark in the reporting period. | CAP | 4 | | | | \$ | 31,350.00 | \$ | 31,350.00 | | |

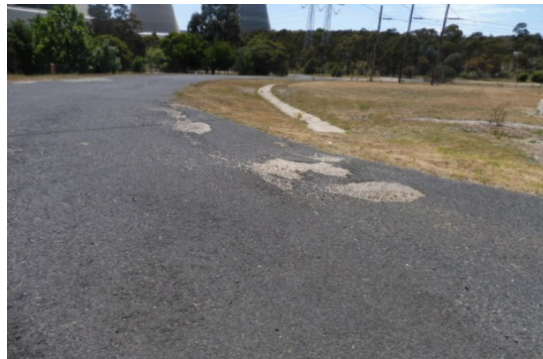
| PREDICTED CAPEX & MAINTENANCE COSTS (\$) excl GST | | | | | | | | | | | | | | | |
|---|---|---|---|---|---|---|---|---|---|---|---|---|---|---|---|
| .3.1.3 | Access Road | On-grade unsealed hardcore parking. | In poor to fair overall condition. | Fill and repair various pothole's and worn areas as required in short term. | R&M | 2 | | \$ | 5,000.00 | | | \$ | 5,000.00 | | |

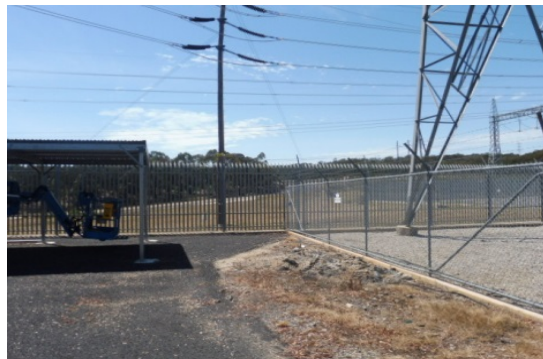
| PREDICTED CAPEX & MAINTENANCE COSTS (\$) excl GST | | | | | | | | | | | | | | | |
|---|---|---|---|---|---|---|---|---|---|---|---|---|---|---|---|
| .3.2.2 | Perimeter Fencing between sub-station and switch yard | Metal post and chain wire fence. | In fair overall condition. | Minor corrosion to sections of fence. Allow for local de-rusting and budget for medium term replacement. | CAP | 3 | | \$ | 500.00 | | \$ | 1,575.00 | \$ | 2,075.00 | |

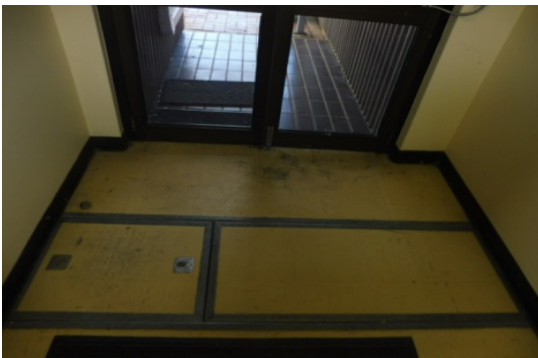
| PREDICTED CAPEX & MAINTENANCE COSTS (\$) excl GST | | | | | | | | | | | | | | | | |
|---|---|---|---|---|---|---|---|---|---|---|---|---|---|---|---|--|
| 2.1.6 | Floors | Concrete floor with vinyl floor tiles laid over. | In poor to fair overall condition. | Allow for replacing the floor covering in the short term. | CAP | 2 | | \$ | 2,520.00 | | \$ | 2,520.00 | | | | |

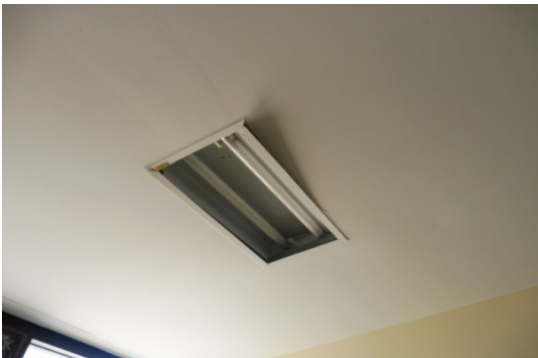
| PREDICTED CAPEX & MAINTENANCE COSTS (\$) excl GST | | | | | | | | | | | | | | | | |
|---|---|---|---|---|---|---|---|---|---|---|---|---|---|---|---|--|
| 2.1.10 | Lighting | Recessed strip light fittings with diffusers. | In fair overall condition. | Aged light fittings with T8 tubes. Allow for replacement of all lights as part of the refurbishment in the short to medium term. | CAP | 2 | | \$ | 1,250.00 | | \$ | 1,250.00 | | | | |

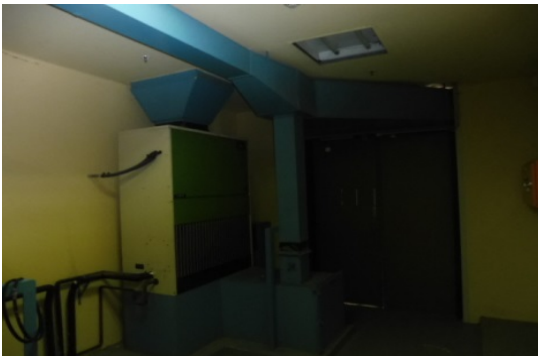
| PREDICTED CAPEX & MAINTENANCE COSTS (\$) excl GST | | | | | | | | | | | | | | | | |
|---|---|---|---|---|---|---|---|---|---|---|---|---|---|---|---|--|
| 2.2.3 | Walls | Painted plasterboard walls and partitions. | In poor overall condition. | Local settlement cracks were noted to 2 no. walls. Repair in the short term. | R&M | 2 | | \$ | 5,000.00 | | \$ | 5,000.00 | | | | |

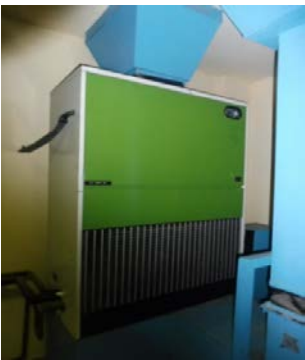
| PREDICTED CAPEX & MAINTENANCE COSTS (\$) excl GST | | | | | | | | | | | | | | |
|---|---|---|---|---|---|---|---|---|---|---|---|---|---|---|
| 2.2.9 | HVAC | 2 no. R22 Carrier Chillers. | In poor overall condition. | Replace in short term. Costs included externally. | CAP | 2 | | | inc. | | \$ | - | | |

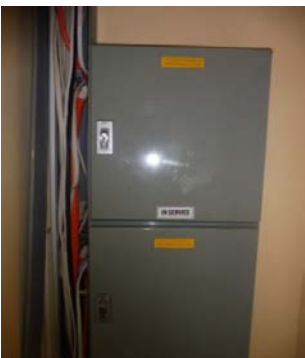
| PREDICTED CAPEX & MAINTENANCE COSTS (\$) excl GST | | | | | | | | | | | | | | |
|---|---|---|---|---|---|---|---|---|---|---|---|---|---|---|
| 2.2.10 | Distribution boards | Air condition switchboard. | In poor to fair overall condition. | Aged and would welcome modernisation as part of the plant and equipment upgrade. | CAP | 2 | | \$ | 10,000.00 | | \$ | 10,000.00 | | |

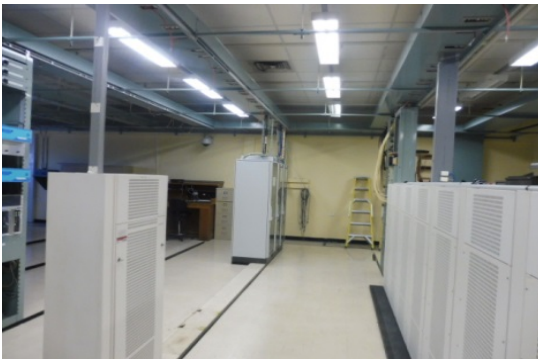
| PREDICTED CAPEX & MAINTENANCE COSTS (\$) excl GST | | | | | | | | | | | | | | |
|---|---|---|---|---|---|---|---|---|---|---|---|---|---|---|
| 2.3.1 | Ceilings | Suspended ceiling with exposed grid and lay-in tiles. | In poor overall condition. | Aged ceilings with damage to a number of tiles. Allow for local replacement of tiles followed by full ceiling replacement in the short term. | CAP | 2 | \$ | 200.00 | \$ | 12,000.00 | | \$ | 12,200.00 | |

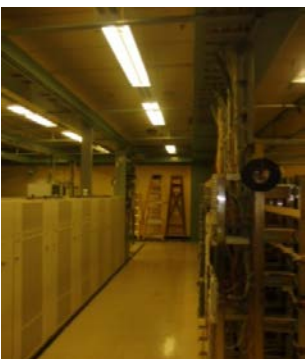
| PREDICTED CAPEX & MAINTENANCE COSTS (\$) excl GST | | | | | | | | | | | | | | |
|---|---|---|---|---|---|---|---|---|---|---|---|---|---|---|
| 2.3.3 | Walls | Painted plasterboard walls with coved skirting. | In fair overall condition. | Allow for repainting works in the short term. | R&M | 2 | | \$ | 2,550.00 | | | \$ | 2,550.00 | |

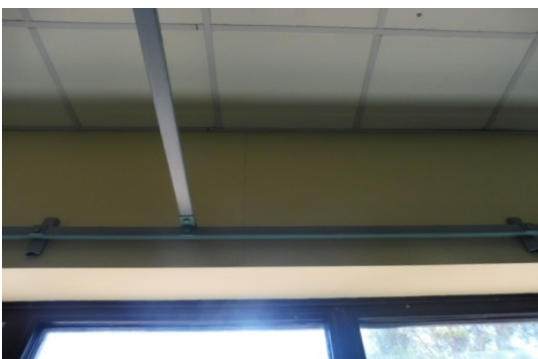
| PREDICTED CAPEX & MAINTENANCE COSTS (\$) excl GST | | | | | | | | | | | | | | |
|---|---|---|---|---|---|---|---|---|---|---|---|---|---|---|
| 2.3.4 | Walls | Painted plasterboard walls with coved skirting. | In poor to fair overall condition. | Local cracking to a number of walls. Undertake local repair works as required. | R&M | 1 | \$ | 3,500.00 | | | | \$ | 3,500.00 | |

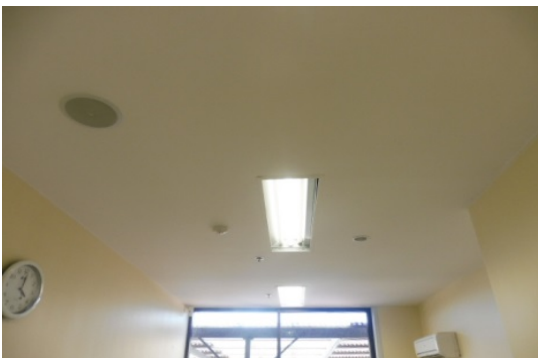
| PREDICTED CAPEX & MAINTENANCE COSTS (\$) excl GST | | | | | | | | | | | | | | |
|---|---|---|---|---|---|---|---|---|---|---|---|---|---|---|
| 2.4.2 | Ceilings | Suspended plasterboard ceiling with paint finish. | In fair overall condition. | Allow for repainting works in the short term. | R&M | 2 | | \$ | 360.00 | | | \$ | 360.00 | |

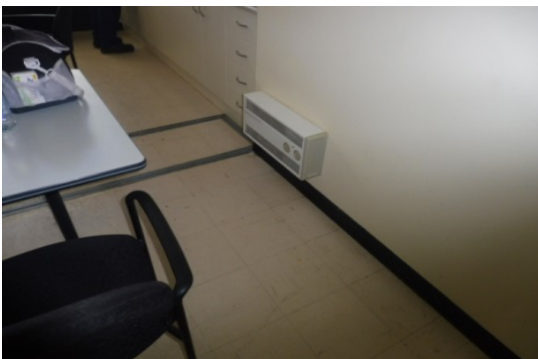
| PREDICTED CAPEX & MAINTENANCE COSTS (\$) excl GST | | | | | | | | | | | | | | |
|---|---|---|---|---|---|---|---|---|---|---|---|---|---|---|
| 2.4.6 | Floors | Concrete floor with vinyl floor tiles laid over. | In fair overall condition. | Allow for replacement in the medium to long term. | CAP | 3 | | | \$ | 1,350.00 | | \$ | 1,350.00 | |

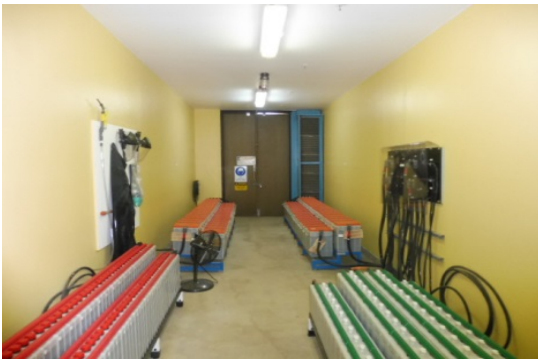
| PREDICTED CAPEX & MAINTENANCE COSTS (\$) excl GST | | | | | | | | | | | | | | |
|---|---|---|---|---|---|---|---|---|---|---|---|---|---|--|
| 2.5.6 | Floors | Exposed concrete floor. | In fair overall condition. | Allow for installing a waterproof membrane as required and include for bunded walls. | R&M | 1 | \$ | 3,500.00 | | | \$ | 3,500.00 | | |

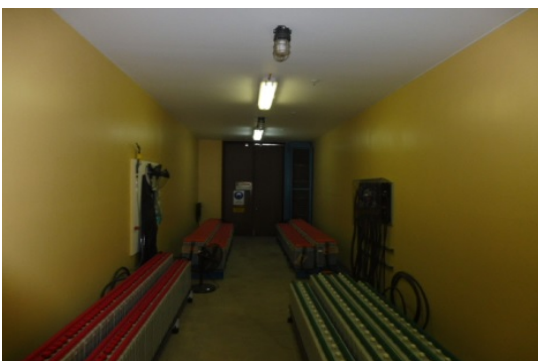
| PREDICTED CAPEX & MAINTENANCE COSTS (\$) excl GST | | | | | | | | | | | | | | |
|---|---|---|---|---|---|---|---|---|---|---|---|---|---|--|
| 2.5.11 | Ventilation | Louvre wall panels. | In poor to fair overall condition. | Replace ventilation in medium term as required. | CAP | 2 | | | \$ | 1,500.00 | \$ | 1,500.00 | | |

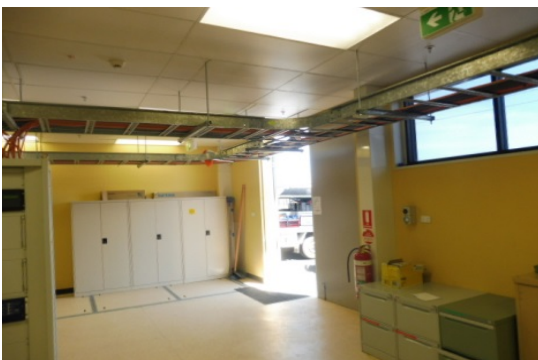
| PREDICTED CAPEX & MAINTENANCE COSTS (\$) excl GST | | | | | | | | | | | | | | |
|---|---|---|---|---|---|---|---|---|---|---|---|---|---|--|
| 2.6.2 | Ceilings | Suspended ceiling with exposed grid and lay-in tiles. | In poor to fair overall condition. | A number of tiles were damaged or missing and should be patched repaired in the short term. | R&M | 1 | \$ | 500.00 | | | \$ | 500.00 | | |

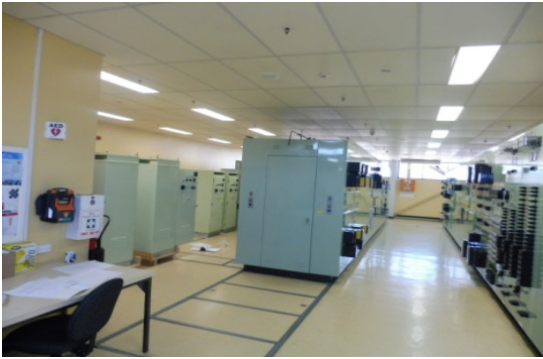
| PREDICTED CAPEX & MAINTENANCE COSTS (\$) excl GST | | | | | | | | | | | |
|---|---|---|---|---|---|---|---|---|---|---|---|
| 2.6.4 | Walls | Painted rendered walls with coved skirting. | In fair overall condition. | Allow for repainting works in the medium term. | R&M | 2 | | | \$ 3,111.00 | \$ 3,111.00 | |

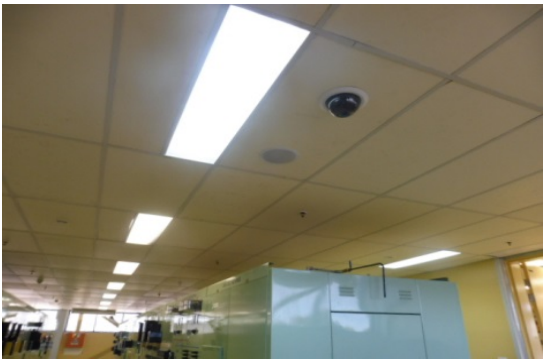
| PREDICTED CAPEX & MAINTENANCE COSTS (\$) excl GST | | | | | | | | | | | |
|---|---|---|---|---|---|---|---|---|---|---|---|
| 2.6.8 | Lighting | Recessed strip light fittings with diffusers. | In fair overall condition. | Allow for light replacement works in the medium term with energy efficient lights. | CAP | 3 | | \$ 6,000.00 | | \$ 6,000.00 | |

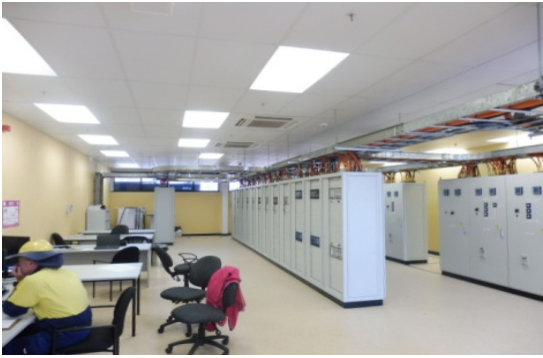
| PREDICTED CAPEX & MAINTENANCE COSTS (\$) excl GST | | | | | | | | | | | |
|---|---|---|---|---|---|---|---|---|---|---|---|
| 2.7.1 | Ceilings | Suspended ceiling with exposed grid and lay-in tiles. | In good overall condition. | Newly installed as part of the extension works. No works envisaged in reporting period. | CAP | 4 | | | | \$ - | |

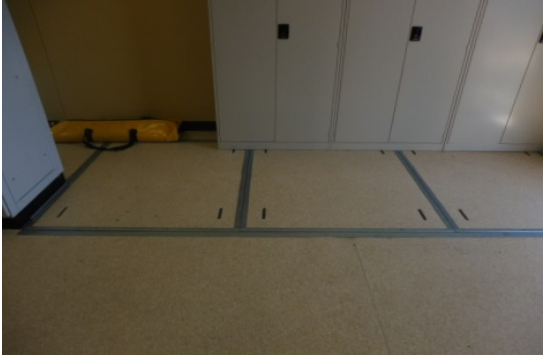
| PREDICTED CAPEX & MAINTENANCE COSTS (\$) excl GST | | | | | | | | | | | |
|---|---|---|---|---|---|---|---|---|---|---|---|
| 2.7.4 | Floors | Concrete floor with vinyl sheet laid over. | In good overall condition. | Allow for replacement of vinyl in long term. | CAP | 3 | | | \$ 12,525.00 | \$ 12,525.00 | |

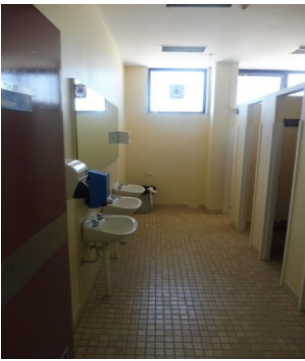
| PREDICTED CAPEX & MAINTENANCE COSTS (\$) excl GST | | | | | | | | | | | |
|---|---|---|---|---|---|---|---|---|---|---|---|
| 2.8.2 | Ceilings | Suspended plasterboard ceiling with paint finish. | In fair overall condition. | Allow for repainting works in the short term. | R&M | 2 | | \$ 300.00 | | \$ 300.00 | |

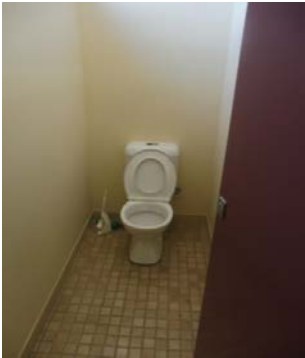
| PREDICTED CAPEX & MAINTENANCE COSTS (\$) excl GST | | | | | | | | | | | |
|---|---|---|---|---|---|---|---|---|---|---|---|
| 2.8.4 | Walls | Painted plasterboard walls with tiled skirting. | In fair overall condition. | Allow for repainting works in the short term. | R&M | 2 | | \$ 731.00 | | \$ 731.00 | |

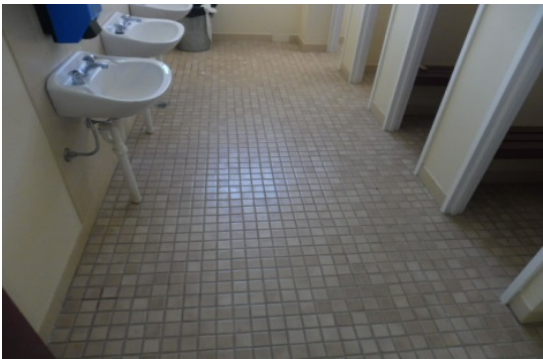
| PREDICTED CAPEX & MAINTENANCE COSTS (\$) excl GST | | | | | | | | | | | |
|---|---|---|---|---|---|---|---|---|---|---|---|
| 2.8.7 | Floors | Concrete floor with ceramic tile floor covering. | In fair overall condition. | Tiles are dated and would welcome replacement in the medium term. | CAP | 2 | | \$ 1,275.00 | | \$ 1,275.00 | |

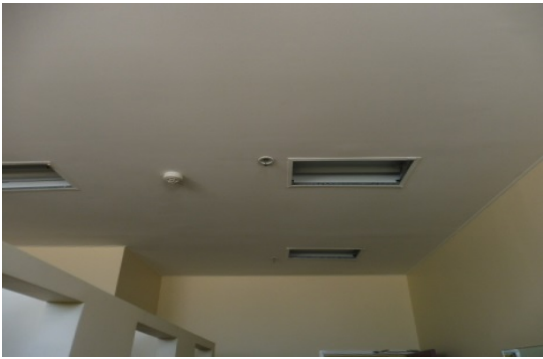
| PREDICTED CAPEX & MAINTENANCE COSTS (\$) excl GST | | | | | | | | | | | |
|---|---|---|---|---|---|---|---|---|---|---|---|
| 2.8.10 | Lighting | Recessed strip light fittings with diffusers. | In fair overall condition. | Aged light fittings with T8 tubes. Allow for replacement of all lights as part of the refurbishment in the short to medium term. | CAP | 2 | | \$ 750.00 | | \$ 750.00 | |

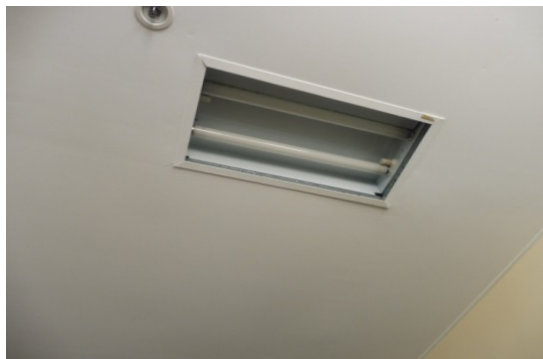
| PREDICTED CAPEX & MAINTENANCE COSTS (\$) excl GST | | | | | | | | | | | | | |
|---|---|---|---|---|---|---|---|---|---|---|---|---|---|
| 2.8.11 | Lighting | Recessed strip light fittings with diffusers. | In fair overall condition. | A number of tubes were not working at the time of inspection. Replace as required. | R&M | 1 | \$ | 100.00 | | | \$ | 100.00 | |

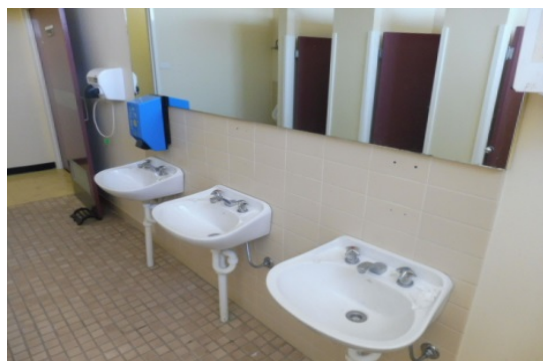
| PREDICTED CAPEX & MAINTENANCE COSTS (\$) excl GST | | | | | | | | | | | | | |
|---|---|---|---|---|---|---|---|---|---|---|---|---|---|
| 2.8.12 | Fixtures and Fittings | Vitreous china WHBs, WCs, urinals and shower units. | In poor to fair overall condition. | The sanitaryware is aged and would welcome replacement in the short term. | CAP | 2 | | \$ | 10,000.00 | | \$ | 10,000.00 | |

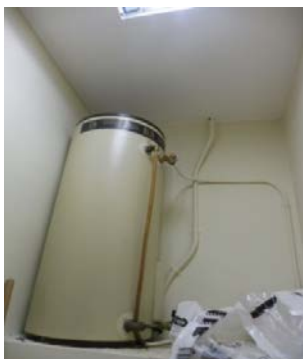
| PREDICTED CAPEX & MAINTENANCE COSTS (\$) excl GST | | | | | | | | | | | | | |
|---|---|---|---|---|---|---|---|---|---|---|---|---|---|
| 2.8.13 | Hot water heater | 250 litre HW tank. | In fair overall condition. | HWU is over 10 years old and will require replacement in the short term. | CAP | 2 | | \$ | 5,000.00 | | \$ | 5,000.00 | |

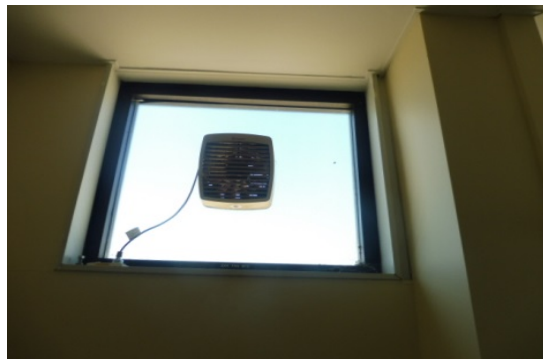
| PREDICTED CAPEX & MAINTENANCE COSTS (\$) excl GST | | | | | | | | | | | | | |
|---|---|---|---|---|---|---|---|---|---|---|---|---|---|
| 2.8.14 | Extract fans | Mechanical extract fan window mounted. | In poor to fair overall condition. | Aged extract fans. Replace in the short term. | CAP | 2 | | \$ | 350.00 | | \$ | 350.00 | |

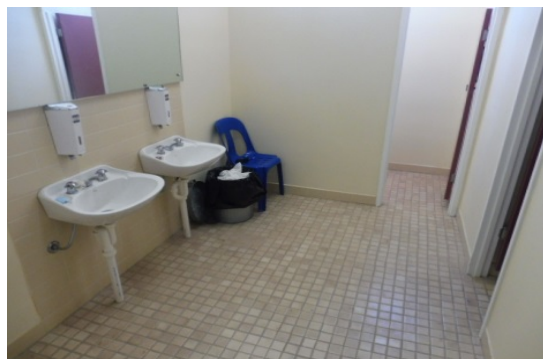
| PREDICTED CAPEX & MAINTENANCE COSTS (\$) excl GST | | | | | | | | | | | | | |
|---|---|---|---|---|---|---|---|---|---|---|---|---|---|
| 2.9.4 | Walls | Painted plasterboard walls with tiled skirting. | In fair overall condition. | Allow for repainting works in the short term. | R&M | 2 | | \$ | 884.00 | | \$ | 884.00 | |

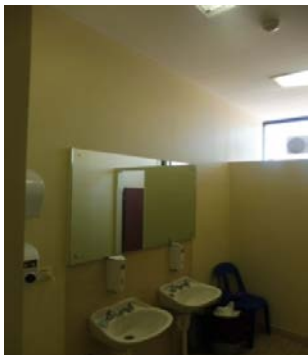
| PREDICTED CAPEX & MAINTENANCE COSTS (\$) excl GST | | | | | | | | | | | | | |
|---|---|---|---|---|---|---|---|---|---|---|---|---|---|
| 2.9.6 | Walls | Tiled splashback walls. | In fair overall condition. | Previous fixings to tiles. Works covered in above replacement. | R&M | 2 | | | inc. | | \$ | - | |

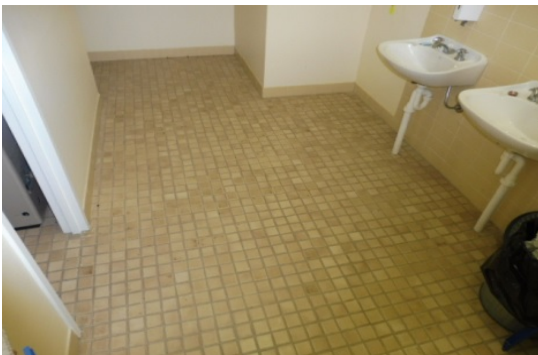
| PREDICTED CAPEX & MAINTENANCE COSTS (\$) excl GST | | | | | | | | | | | | | |
|---|---|---|---|---|---|---|---|---|---|---|---|---|---|
| 2.9.7 | Floors | Concrete floor with ceramic tile floor covering. | In fair overall condition. | Tiles are dated and would welcome replacement in the medium term. | CAP | 2 | | \$ | 14,625.00 | | \$ | 14,625.00 | |

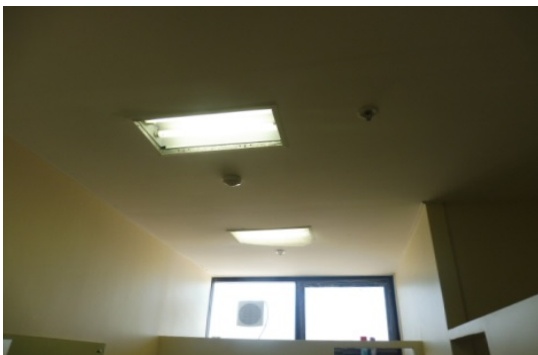
| PREDICTED CAPEX & MAINTENANCE COSTS (\$) excl GST | | | | | | | | | | | | | |
|---|---|---|---|---|---|---|---|---|---|---|---|---|---|
| 2.9.10 | Lighting | Recessed strip light fittings with diffusers. | In fair overall condition. | Aged light fittings with T8 tubes. Allow for replacement of all lights as part of the refurbishment in the short to medium term. | CAP | 2 | | \$ | 750.00 | | \$ | 750.00 | |

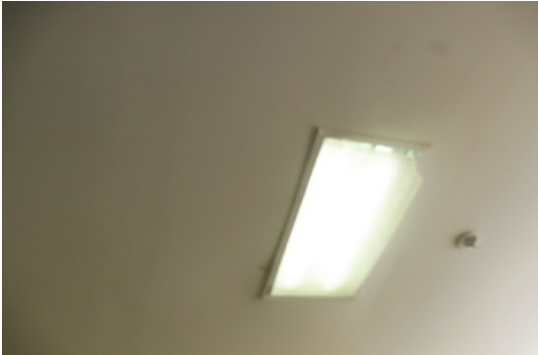
| PREDICTED CAPEX & MAINTENANCE COSTS (\$) excl GST | | | | | | | | | | | | | |
|---|---|---|---|---|---|---|---|---|---|---|---|---|---|
| 2.9.11 | Lighting | Recessed strip light fittings with diffusers. | In fair overall condition. | A number of tubes were not working at the time of inspection. Replace as required. | R&M | 1 | | \$ | 100.00 | | \$ | 100.00 | |

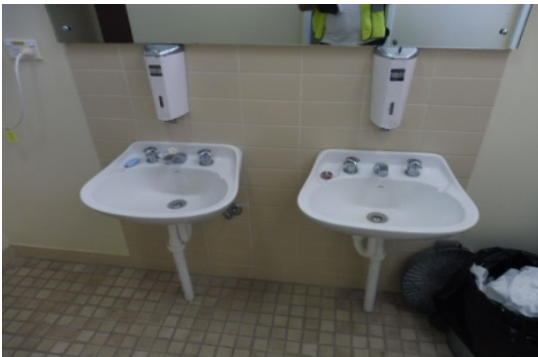
| PREDICTED CAPEX & MAINTENANCE COSTS (\$) excl GST | | | | | | | | | | | | | |
|---|---|---|---|---|---|---|---|---|---|---|---|---|---|
| 2.9.12 | Fixtures and Fittings | Vitreous china WHBs, WCs and shower units. | In poor to fair overall condition. | The sanitaryware is aged and would welcome replacement in the short term. | CAP | 2 | | \$ | 10,000.00 | | \$ | 10,000.00 | |

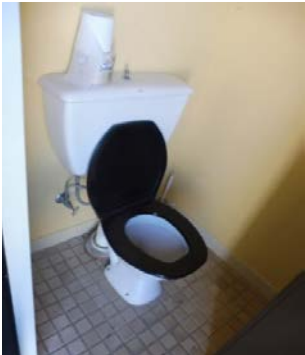
| PREDICTED CAPEX & MAINTENANCE COSTS (\$) excl GST | | | | | | | | | | | |
|---|---|---|---|---|---|---|---|---|---|---|---|
| 2.10.5 | Floors | Concrete floor with ceramic tile floor covering. | In fair overall condition. | Allow for replacement in medium term. | CAP | 4 | | \$ 500.00 | | | \$ 500.00 |

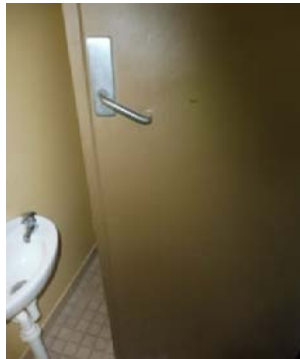
| PREDICTED CAPEX & MAINTENANCE COSTS (\$) excl GST | | | | | | | | | | | | | | | | | |
|---|---|---|---|---|---|---|---|---|---|---|---|---|---|---|---|---|---|
| 2.10.7 | Joinery- Doors | Timber access doors with paint finish. | In poor to fair overall condition. | Replace ironmongery in the medium term as part of the upgrade works to the toilet. | R&M | 2 | | | \$ | 150.00 | \$ | 150.00 | | | | | |

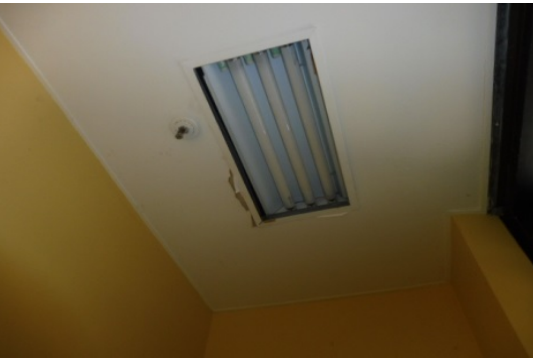
| PREDICTED CAPEX & MAINTENANCE COSTS (\$) excl GST | | | | | | | | | | | | | | | | | |
|---|---|---|---|---|---|---|---|---|---|---|---|---|---|---|---|---|---|
| 2.10.8 | Lighting | Recessed strip light fittings with diffusers. | In poor to fair overall condition. | Aged light fittings with T8 tubes. Allow for replacement of all lights as part of the refurbishment in the short to medium term. | CAP | 3 | | | \$ | 250.00 | \$ | 250.00 | | | | | |

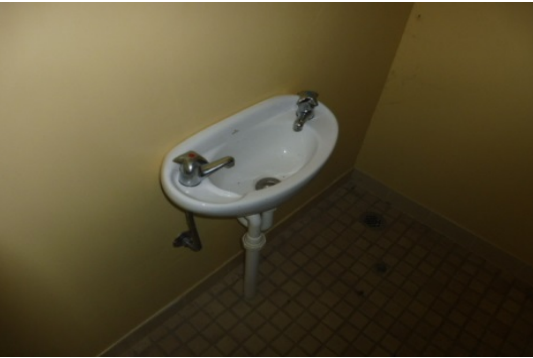
| PREDICTED CAPEX & MAINTENANCE COSTS (\$) excl GST | | | | | | | | | | | | | | | | | |
|---|---|---|---|---|---|---|---|---|---|---|---|---|---|---|---|---|---|
| 2.10.9 | Fixtures and Fittings | Vitreous china WHBs and WCs. | In poor to fair overall condition. | Aged fittings. Replace in short to medium term. | CAP | 2 | | | \$ | 1,500.00 | \$ | 1,500.00 | | | | | |

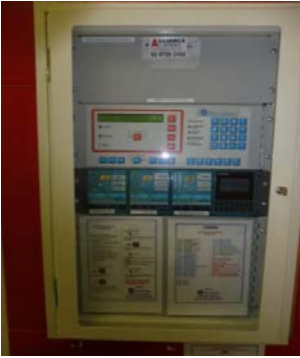
| PREDICTED CAPEX & MAINTENANCE COSTS (\$) excl GST | | | | | | | | | | | | | | | | | |
|---|---|---|---|---|---|---|---|---|---|---|---|---|---|---|---|---|---|
| 3.4 | Building Services Generally | Fire indicator panel - Digital | In good overall condition. | We don't envisage any major replacement works in the reporting period. Maintain annually. | R&M | 1 | | inc. | | inc. | | inc. | | inc. | \$ | - | |

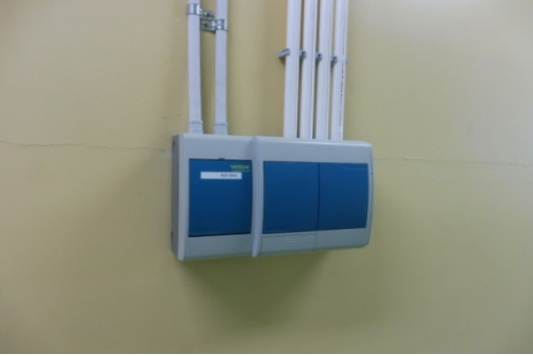
| PREDICTED CAPEX & MAINTENANCE COSTS (\$) excl GST | | | | | | | | | | | | | | | | | |
|---|---|---|---|---|---|---|---|---|---|---|---|---|---|---|---|---|---|
| 3.5 | Building Services Generally | VESDA system. | In good overall condition. | We don't envisage any major replacement works in the reporting period. Maintain annually. | R&M | 2 | \$ | 5,000.00 | \$ | 10,000.00 | \$ | 15,000.00 | \$ | 25,000.00 | \$ | 55,000.00 | |

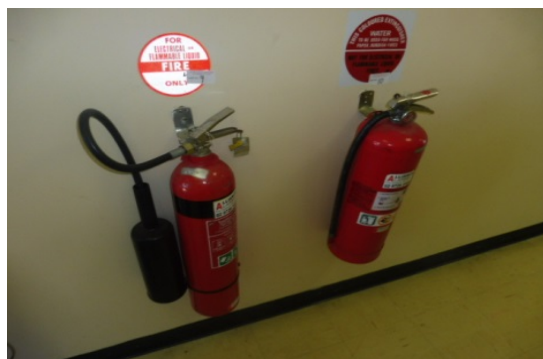
| PREDICTED CAPEX & MAINTENANCE COSTS (\$) excl GST | | | | | | | | | | | | |
|---|---|---|---|---|---|---|---|---|---|---|---|---|
| 3.7 | Building Services Generally | Fire extinguishers and fire hose reels within the building. | In fair overall condition. | Allow for statutory testing and tagging as required. | R&M | 1 | \$ 2,000.00 | \$ 4,000.00 | \$ 6,000.00 | \$ 10,000.00 | \$ 22,000.00 | |

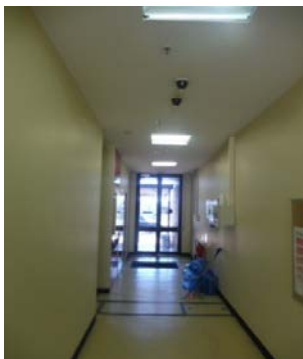
| PREDICTED CAPEX & MAINTENANCE COSTS (\$) excl GST | | | | | | | | | | | | |
|---|---|---|---|---|---|---|---|---|---|---|---|---|
| 3.10 | Building Services Generally | Fire exit signs and directional signs. | In poor overall condition. | Aged and not BCA complaint. Allow for upgrades and installation in the short term as required. | BCA | 1 | | \$ 5,000.00 | | | \$ 5,000.00 | |

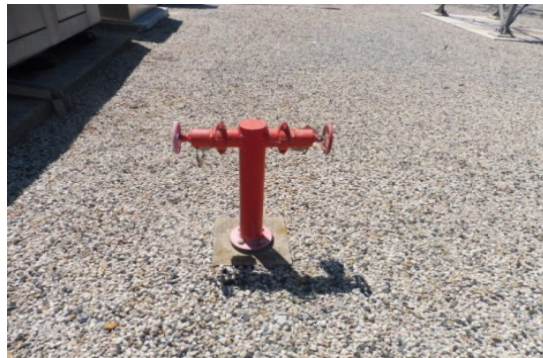
| PREDICTED CAPEX & MAINTENANCE COSTS (\$) excl GST | | | | | | | | | | | | |
|---|---|---|---|---|---|---|---|---|---|---|---|---|
| 3.12 | Building Services Generally | Fire Hydrants site wide. | In fair overall condition. | Allow for repainting and testing and tagging as required. | R&M | 1 | \$ 2,000.00 | \$ 4,000.00 | \$ 6,000.00 | \$ 10,000.00 | \$ 22,000.00 | |

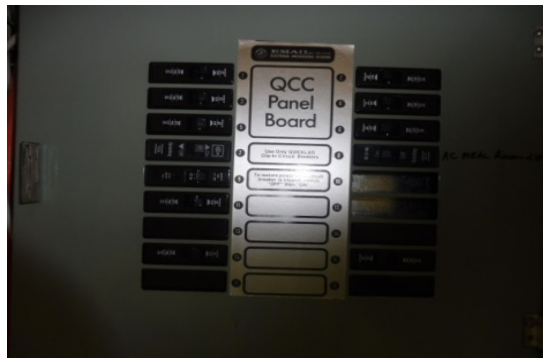
| PREDICTED CAPEX & MAINTENANCE COSTS (\$) excl GST | | | | | | | | | | | | |
|---|---|---|---|---|---|---|---|---|---|---|---|---|
| 3.13 | Building Services Generally | Mains Distribution board and switchboards. | In poor to fair overall condition. | Aged but still performing. There are no RCDs on the lighting circuits and parts are becoming obsolete. Allow for short term replacement of the boards. | CAP | 2 | | \$ 10,000.00 | | | \$ 10,000.00 | |
