BUILDING CONDITION REPORT

TransGrid

Tumut 132/66Kv Substation, Adelong Road, Tumut, NSW

6 May 2016

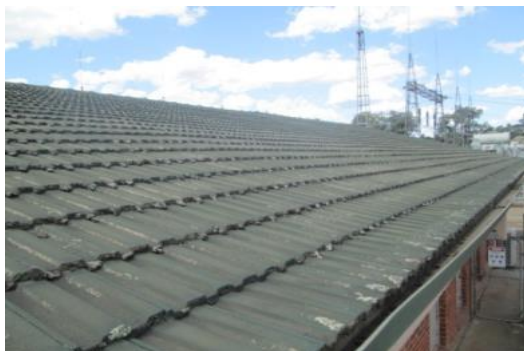
1.1	Roof														
1.1.1	Main Roof Coverings - Control Building	Timber framed roof structure covered with tiled roof coverings.	In fair overall condition.	Aged with moss growth, though no evidence of water penetration internally. Allow for cleaning of concrete tiles and isolated repairs during the reporting period.	R&M	2	\$	1,000.00	\$	2,000.00	\$	4,000.00	\$	7,000.00

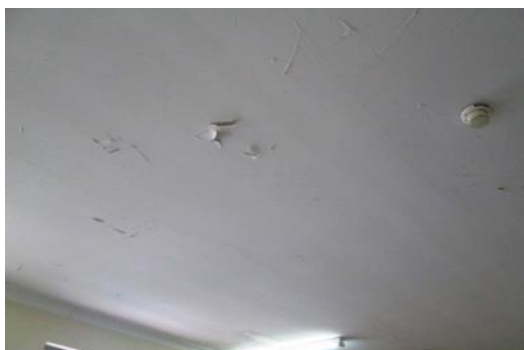
1.1.2	Main Roof Coverings - Control Building	Timber framed roof structure covered with tiled roof coverings.	In fair overall condition.	Potential issue with lack of ventilation and condensation within the roof space evident by peeling paint to all plasterboard ceilings internally and blistering to eaves soffits externally. Allow for investigation and repair works as required.	R&M	1	\$	3,000.00					\$	3,000.00

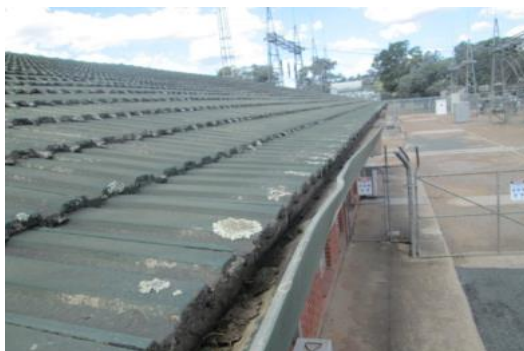
1.1.3	Roof Drainage														
1.1.3.1	Drainage	Metal eaves gutters draining to metal downpipes.	In fair overall condition.	The roof drainage gutters to part of the building are suffering from wear and tear with evidence of impact. Allow for replacement of damaged sections as required.	R&M	2	\$	450.00					\$	450.00

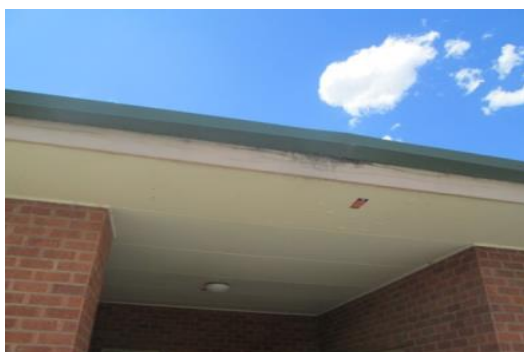
1.1.3.2	Fascia and Soffits	Timber fascia boards with suspect asbestos clad soffits.	In fair overall condition.	Decay to timber fascia below damaged gutter. Repair as required.	R&M	2	\$	600.00					\$	600.00

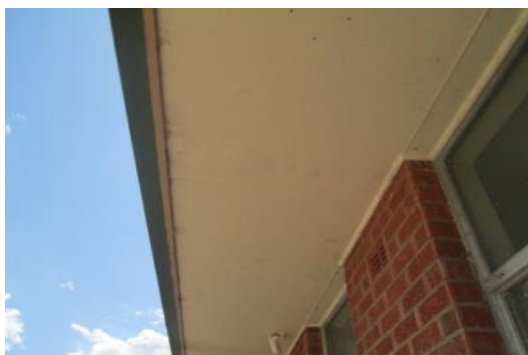
1.1.3.4	Fascia and Soffits	Suspect asbestos cladding panels.	In poor to fair overall condition.	Asbestos sheet cladding to fascia's and soffits aged and blistered. Unable to scrap back paint to asbestos material. Allow to replace all soffit boards in the short term. Includes entrance porch soffit.	R&M	2		\$	18,750.00		\$	18,750.00

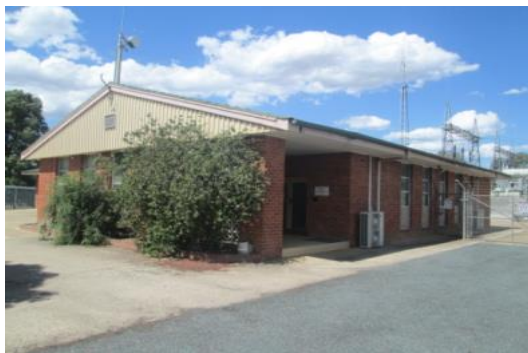
1.2.1	Façades	Fair faced cavity brick elevations.	In fair to good overall condition.	No major issues noted or any major capital works envisaged in the reporting period.	CAP	4					\$	-

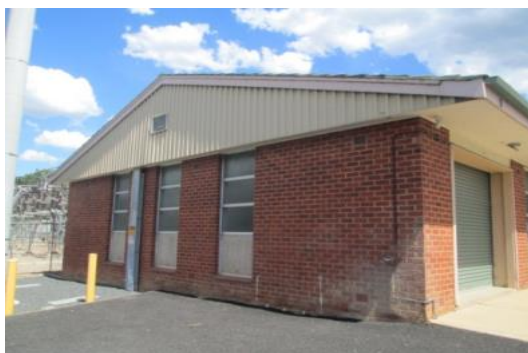
1.2.3	Façades	Profiled metal sheet cladding.	In fair overall condition.	Suspect asbestos metal profiled cladding to gables. Aged and friable asbestos coating. Allow to replace cladding in the short term.	R&M	2		\$	7,500.00		\$	7,500.00

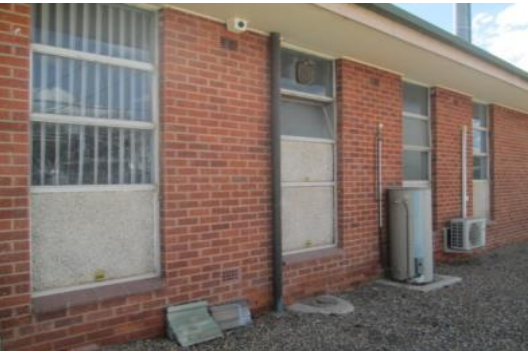
1.2.4	Windows & Doors											
1.2.4.1	Windows	Metal framed single glazed windows with suspect asbestos panels.	In poor to fair overall condition.	Aged. Windows have suspect asbestos concrete pebblecrete panels and asbestos mastic seals. Degraded reflective film to several windows. Allow for replacement of all units in the short to medium term.	CAP	3			\$ 11,400.00		\$ 11,400.00

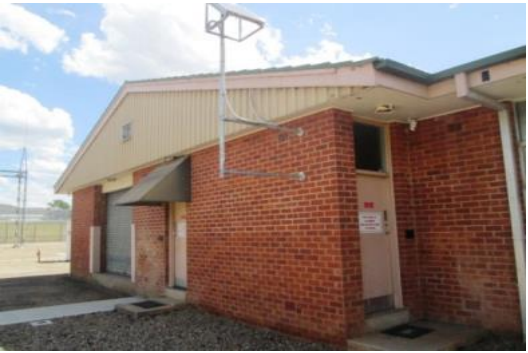
1.2.4.3	Joinery - Doors	Timber access doors with paint finish.	In fair overall condition.	Allow an overhaul of switchyard timber door units, including new seals and replace ironmongery.	R&M	2		\$ 300.00			\$ 300.00

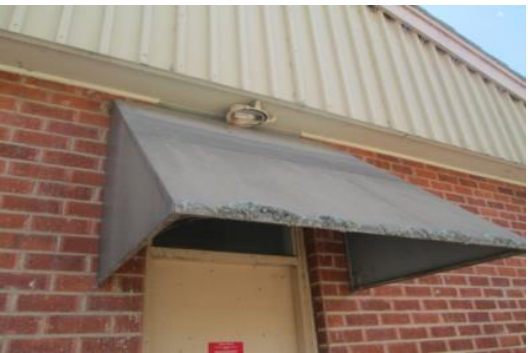
1.2.4.4	Joinery - Doors	Metal awning.	In fair overall condition.	Surface corrosion to metal awning above control room switchyard door. Awning obscuring light fitting above door opening. Allow to remove and dispose in medium term and install blackout film to glazing in lieu.	CAP	3		\$ 500.00			\$ 500.00

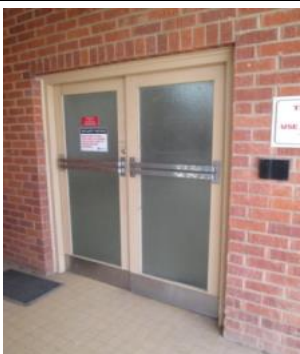
1.2.4.5	Joinery - Doors	Timber framed glazed doors to main entrance.	In fair overall condition.	Front door does not close properly. Security issue. Allow an overhaul of door unit, including new seals and replace ironmongery.	R&M	1	\$ 300.00				\$ 300.00

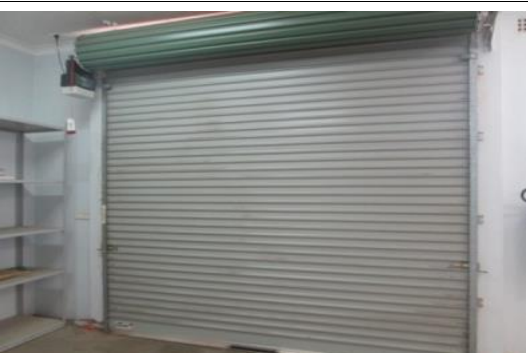
1.2.4.6	Joinery - Doors	Metal roller shutter doors.	In fair to good overall condition.	2no electric motorized roller shutter doors to workshops. Allow for ongoing testing and maintenance during the reporting period.	R&M	2		\$ 500.00	\$ 500.00	\$ 1,000.00	\$ 2,000.00

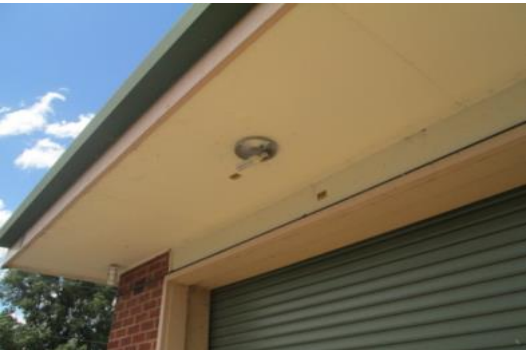
1.2.5 Fixtures & Fittings												
1.2.5.1	Fixtures & Fittings	Surface fixed strip light fittings.	In poor overall condition.	Aged light fittings to soffits above all door openings. Allow for replacement as part of the soffit replacement works.	CAP	2		\$ 1,500.00			\$ 1,500.00

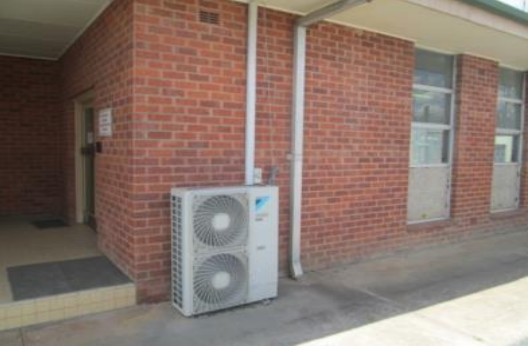
1.2.5.2	Fixtures & Fittings	Split System A/C units located to elevations.	In fair to good overall condition.	2no double Daikin units should be replaced in the long term due to life expectancy.	CAP	4				\$ 14,000.00	\$ 14,000.00

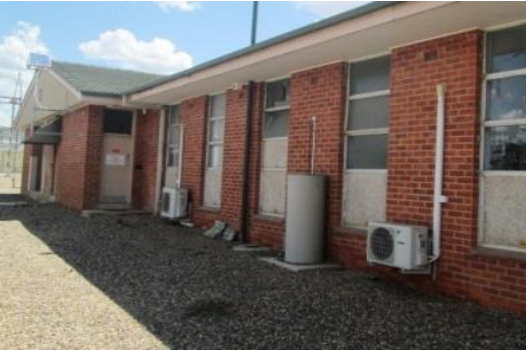
1.2.5.3	Fixtures & Fittings	Split System A/C units located to elevations.	In fair overall condition.	1no small Diakin A/C unit supplying the office should be replaced in the long term due to life expectancy.	CAP	4				\$ 3,500.00	\$ 3,500.00

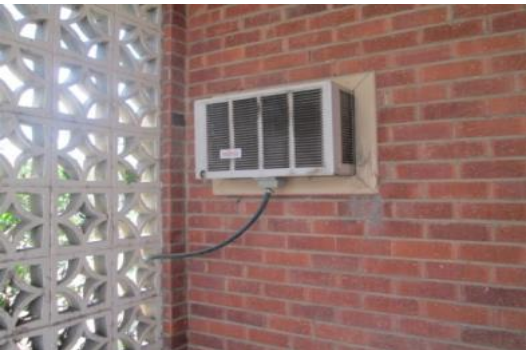
1.2.5.5	Fixtures & Fittings	Split System A/C units located to elevations.	In poor overall condition.	2no wall mounted Fujitsu A/C units to comms room require replacing in the short term.	CAP	2		\$ 7,000.00			\$ 7,000.00

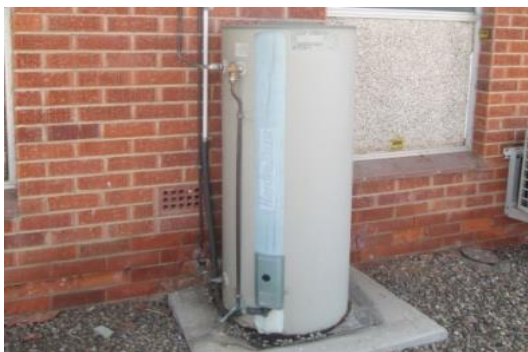
1.2.5.6	Fixtures & Fittings	Electric Hot Water tank.	In poor to fair overall condition.	HWU is over 10 years old and will require replacement in the short term.	CAP	2		\$	5,000.00		\$	5,000.00

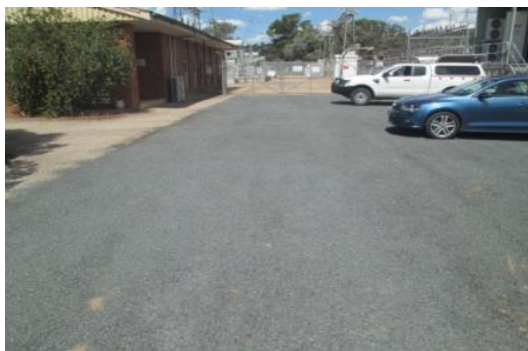
1.3 External Areas															
1.3.1 External Surfaces															
1.3.1.1	Parking and Access Roads - Control Building	Combination of reinforced concrete hard stand areas and on-grade tarmacadam road surfaces.	In fair to good overall condition.	No action required, ongoing maintenance as required.	CAP	4					\$	-

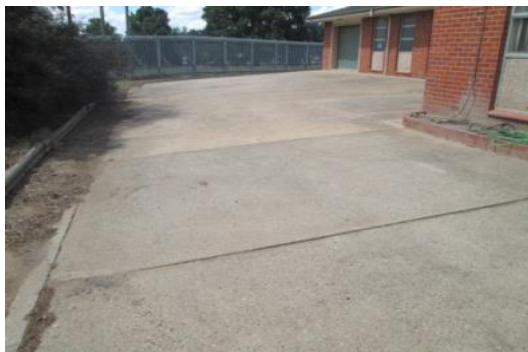
1.3.1.2	Parking and Access Roads - Control Building	Combination of reinforced concrete hard stand areas and on-grade tarmacadam road surfaces.	In fair to good overall condition.	No action required, ongoing maintenance as required.	CAP	4					\$	-

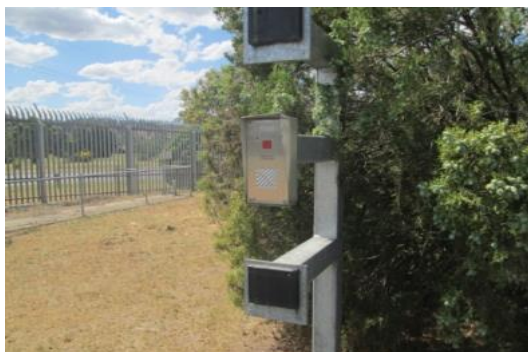
1.3.2.3	Site Entry Gates	Mechanically operated sliding metal entry gate and control.	In fair overall condition.	Impact damage to entry gate access control post. Repair as required.	R&M	2		\$	250.00			\$	250.00

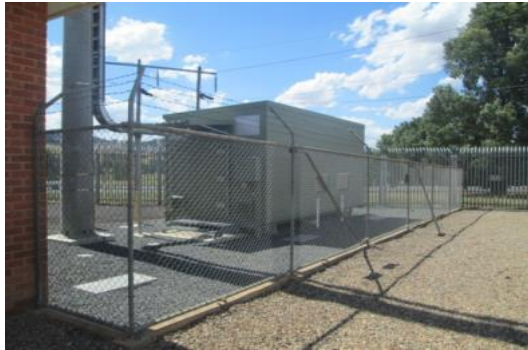
1.3.2.4	Switchyard Perimeter Fencing	Metal post and chain wire fence.	In fair overall condition.	Minor corrosion to sections of fence. Allow for local de-rusting and repairs for medium term.	R&M	3				\$	500.00		\$	500.00

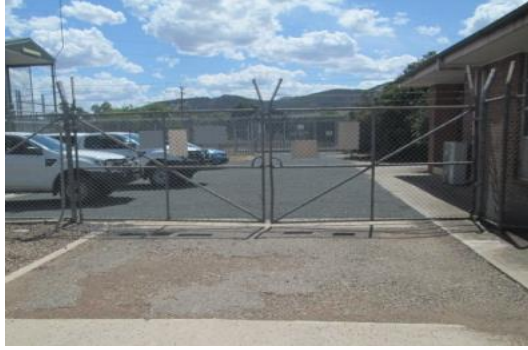
1.3.2.5	Switchyard Entry Gates	Metal swing entry gates.	In fair overall condition.	Minor corrosion to metal swing gates and chain / padlock. Allow for local de-rusting and repairs in the medium term.	R&M	3				\$	500.00		\$	500.00

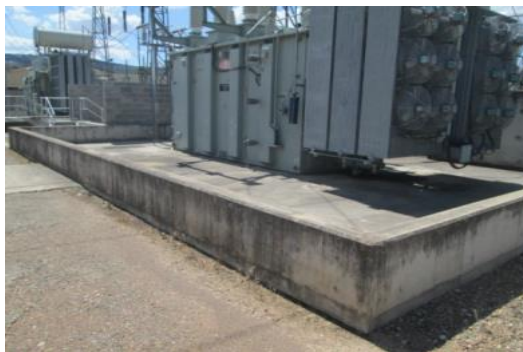
1.3.3.5	Bunding - Transformers	Bunded areas to transformers and switchyard equipment.	In good overall condition.	Concrete bunded areas but no waterproof membrane. Subject to requirement.	CAP	4					\$ -

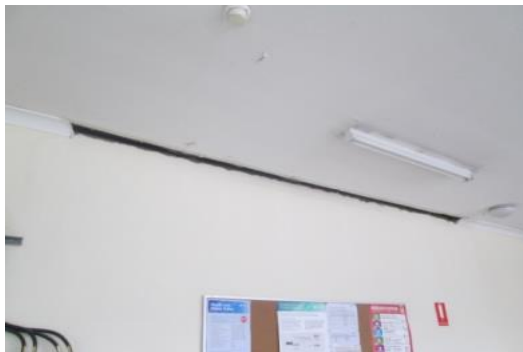
2.1	Relay Room											
2.1.1	Ceilings	Suspended plasterboard ceiling with paint finish.	In poor to fair overall condition.	Allow to investigate and repair section of dropped ceiling where coving missing.	R&M	2		\$ 600.00			\$ 600.00

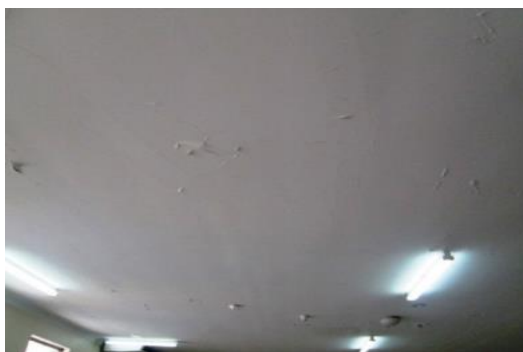
2.1.2	Ceilings	Suspended plasterboard ceiling with paint finish.	In poor to fair overall condition.	Significant peeling paint. Allow to burn off and repaint ceiling surfaces. Consideration should be given to renewing plaster ceiling in the long term.	R&M	2		\$ 5,040.00			\$ 5,040.00

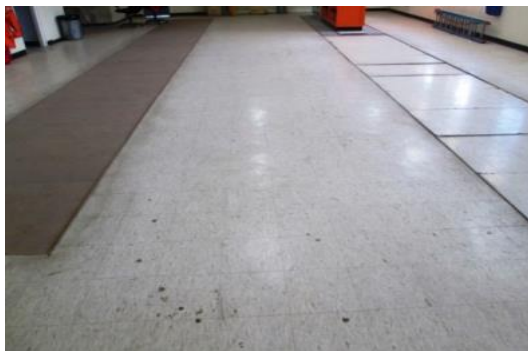
2.1.5	Floors	Concrete floor with vinyl sheet laid over.	In fair to good overall condition.	Allow to replace vinyl flooring in the short term.	R&M	2		\$	10,080.00		\$	10,080.00

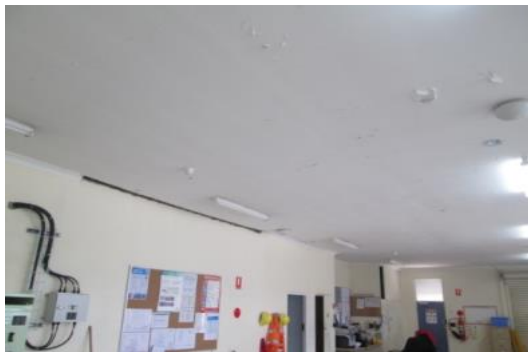
2.1.7	Lighting	Recessed strip light fittings with diffusers.	In poor to fair overall condition.	Row of 4no lights not working. Allow to repair circuit / tubes.	R&M	2		\$	250.00		\$	250.00

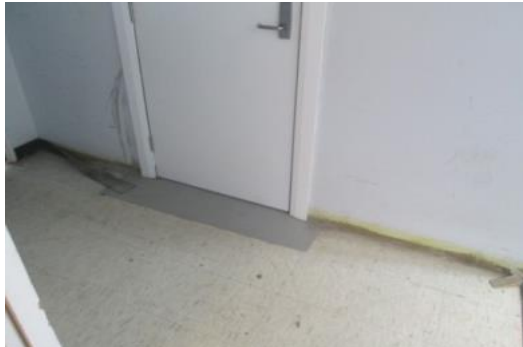
2.5.3	Walls	Painted rendered walls with flush vinyl skirting.	In poor to fair overall condition.	Vinyl skirting debonded and missing in places. Allow to replace as part of refurbishment works.	R&M	2		\$	100.00		\$	100.00
