K-BIK Power Pty Ltd

SUBSTATION COMMON FAILURES ASSESSMENT REVIEW

Site: United Energy - Victoria

Report Reference Number: VIC-UE-001-R1|V1.4

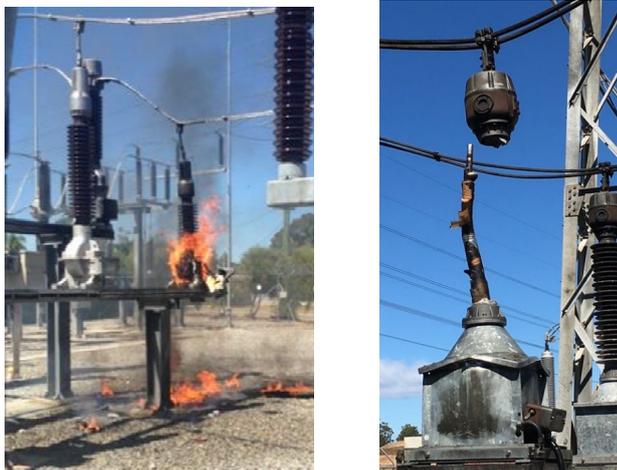
Figure 1| 132kV Voltage Transformer Failures (different substations)

These voltage transformers (Figure 1 above) had a weakness with the oil quality and as a result the dielectric strength deteriorated over time and cause internal flash-overs under switching and lightning events.

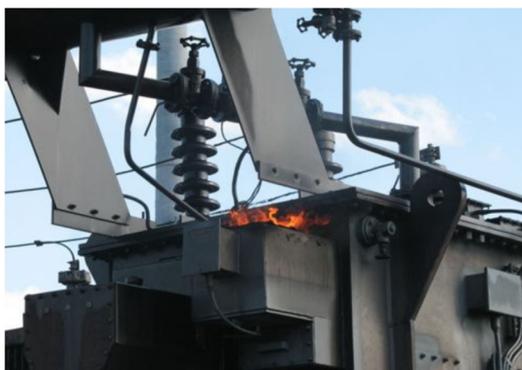
The Voltage Transformer (VT Figure 2) that was connected to this transformer had a lightning impulse level of 75kV where as the main transformer 11kV side had 95kV. The failure occurred after a lightning strike at the substation and the VT failed and caused a fire. When sister units were investigated the issue was then discovered. During factory impulse testing the VT was disconnected and so the issue remained undetected until the lightning event.

Figure 2| VT on Fire in Transformer Cable Box.

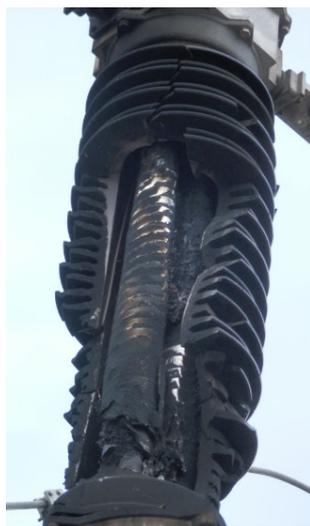
Figures 3 and 4 below show the remnants of failed CTs. These were 2 of 9 separate failures. All failures had a common-cause being they were over filled and created internal pressures during the daily load cycles. The internal pressures generated hydrogen gas from the insulation which then formed a tracking path along the stem of the CT. With an increase in system voltage in the early hours of the morning there would be an internal flashover from the line side head to the DLA tap which was the only earth point internally.

The utility had several hundred units in service and when all were checked it was found that only a batch of units made in one calendar year had the problem and was caused by a change in manufacturing process. This is an example of a common-cause failure that cannot be detected without a trend of failures developing and then the root cause being exhaustively investigated.

Figure 3| 132kV Current Transformer Explosive Failures

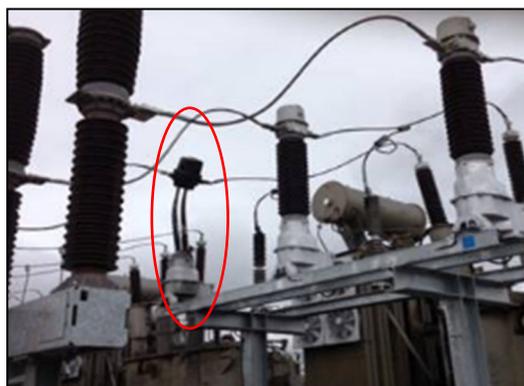
Figure 4| 132kV Current Transformer Explosive Failures

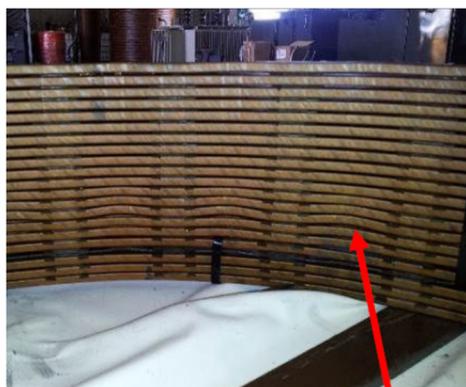
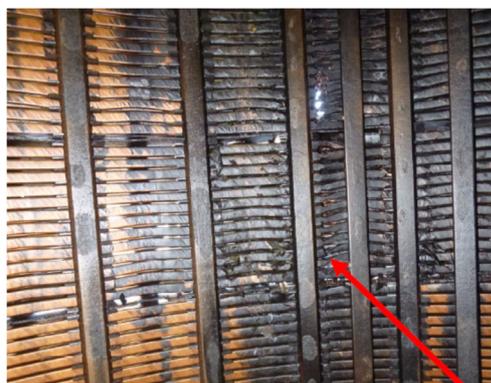
In Figure 5 below the windings of the transformer had suffered a number of through faults that were of low magnitude. This transformer then suffered a close in fault where the fault level rose to almost the substation fault rating. The transformer had been specified with a fault rating on this winding and should have withstood all the faults. The failure occurred after a number of local lightning storms and the winding flashed over between turns then carried on through the winding. The winding had been damaged by the through faults and local fault and was evidenced by the buckling of the windings. When the design was checked for strength during the failure investigation it was discovered that the fault rating was in fact half of the specified fault rating. Upon discussion with the OEM it was found that they had had an error (of a factor of 2) in their fault calculations and consequently the transformer was constructed with a weak winding. The utility had 7 transformers of this design in service and was forced to install fault current limiting devices and change the protection to faster trip speeds to ensure the transformers could remain in service as far as possible. These units were made in 1978 which was during a period where the design of some power transformers had design and manufacturing weaknesses.

Figure 5| Transformer buckled winding resulting in internal damage then failure

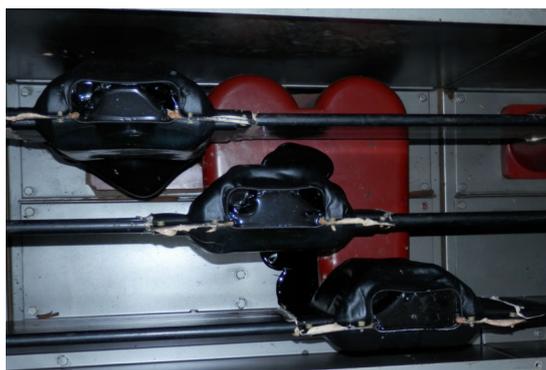
Figure 6| Old Pitch-Insulated Busbar Joints with Voids

Figure 6 shows a top view of a 3 phase busbar arrangement where the joints were originally encased in pitch to improve the lightning impulse level. Over a period of more than 40 years the hardener in the pitch decomposed and the pitch slowly leaked leaving large voids and exposed bar busbars. The investigation found that many utilities within Australia and the UK had the same problem. As the busbars are in a continuous chamber an whole of switchboard outage is required for any inspection or repair. Complete loss of the pitch caused phase to phase failures and so extensively damaged the switchboards.

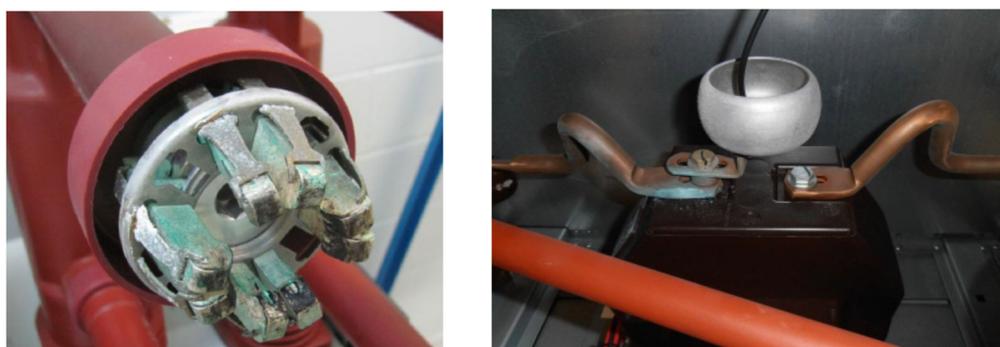
Figure 7| Contact Partial Discharge due to corrosion.

Figures 7 show a circuit breaker cluster and a fixed switchboard CT both with green coloured corrosion on the copper contacts. The ingress of moisture can cause the corrosion and that in turn produces the PD. Whilst this can happen in high humidity areas it is not common in dry environments such as in this switchboard. The investigation showed that the humidity was less than 50% over the entire year and so the cause was not moisture. It was found that the supplier had changed the type of surface treatment to the contacts and this had a reaction with copper. The issue was found in 8 switchboards in one utility and it was advised that other utilities had had the same problem without knowledge of the underlying cause.
