# AusNet

## Transmission Line Structures

Asset Management Strategy

| Document number: | AMS 10-77 |

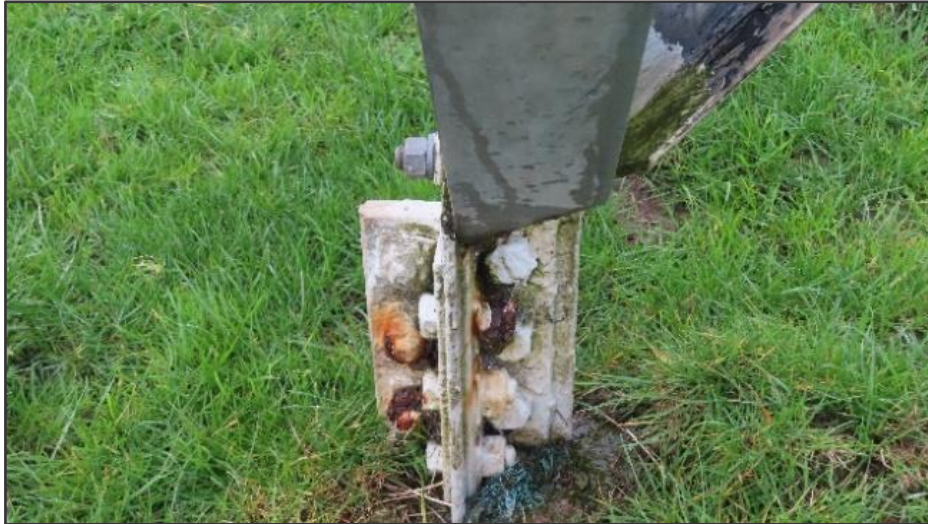
Upon closer inspection of towers scored in Poor and Very Poor condition, it was found that over 80% of C4 towers and over 30% (7) of C5 towers relate to the condition of the corrosion protection painting on the legs of these towers, known as SOXS. The SOXS is a protective layer and not a load bearing component, its purpose is to preserve the underlying condition of the tower legs. In all these towers the SOXS condition has been raised as a defect however it does not represent the condition of the tower legs. Rectification is part of the ongoing corrective maintenance program, including legs re-blasted, bolts replaced as needed, and coatings reapplied. An example of a tower leg with C5 bolts and damaged SOXS before repair is shown below.

**Fig 18: Damaged SOXS, T197 MLTS-TGTS 220kV**

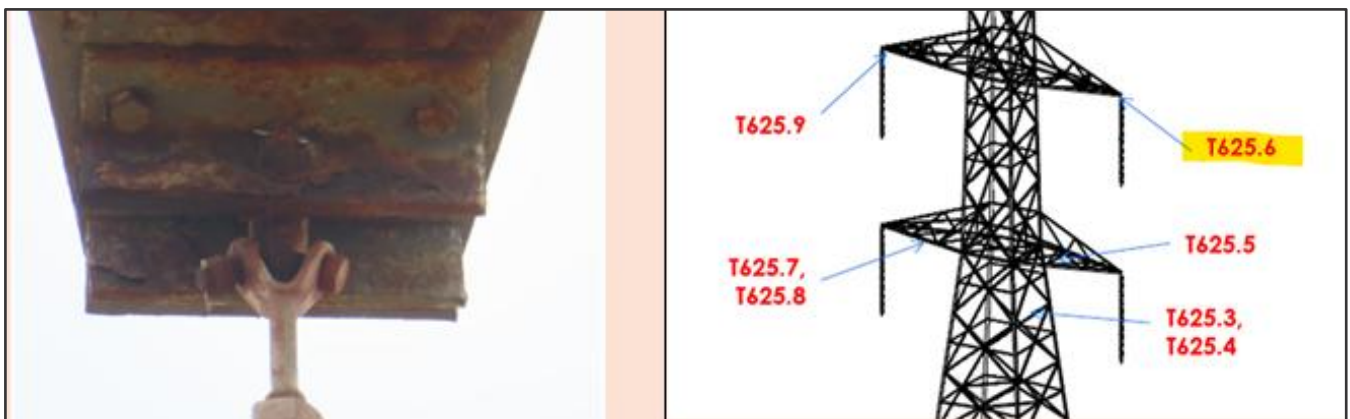
Figures 24 and 25 show examples of C5 members/bolts/plates which require offloading of conductors and ground wires from the structure due to their interconnected nature with other members.

**Figure 24: T625 suspension plates, middle phase**

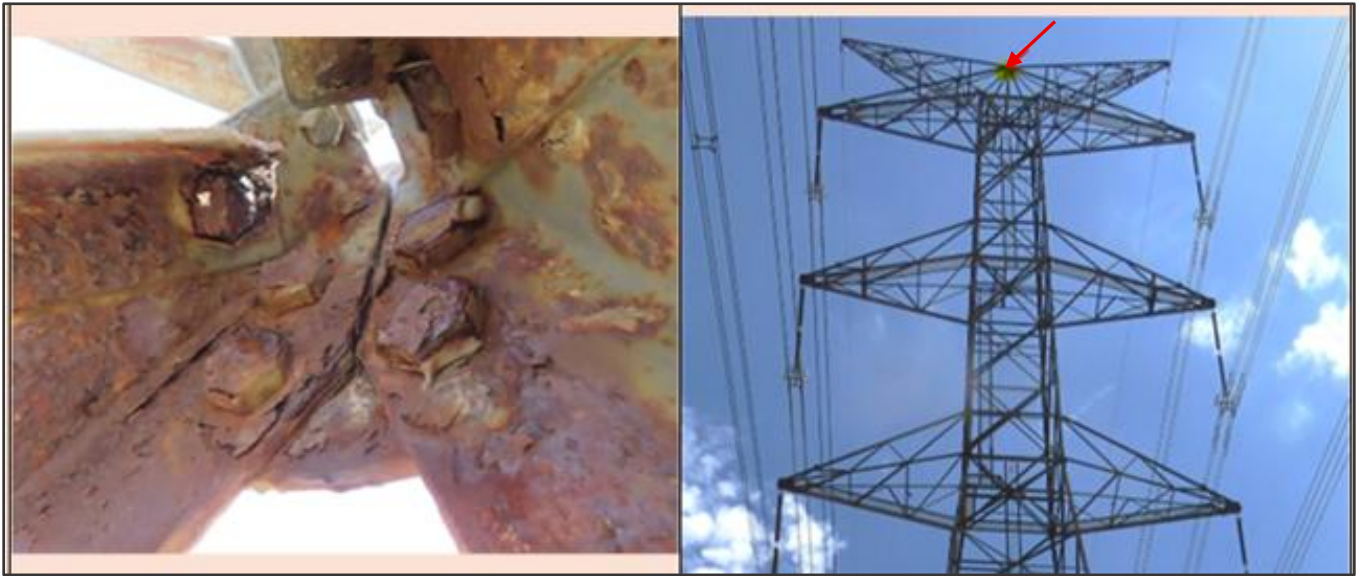
**Figure 25: T609 gusset plate and member of the earth peak top chord and top crossarm**

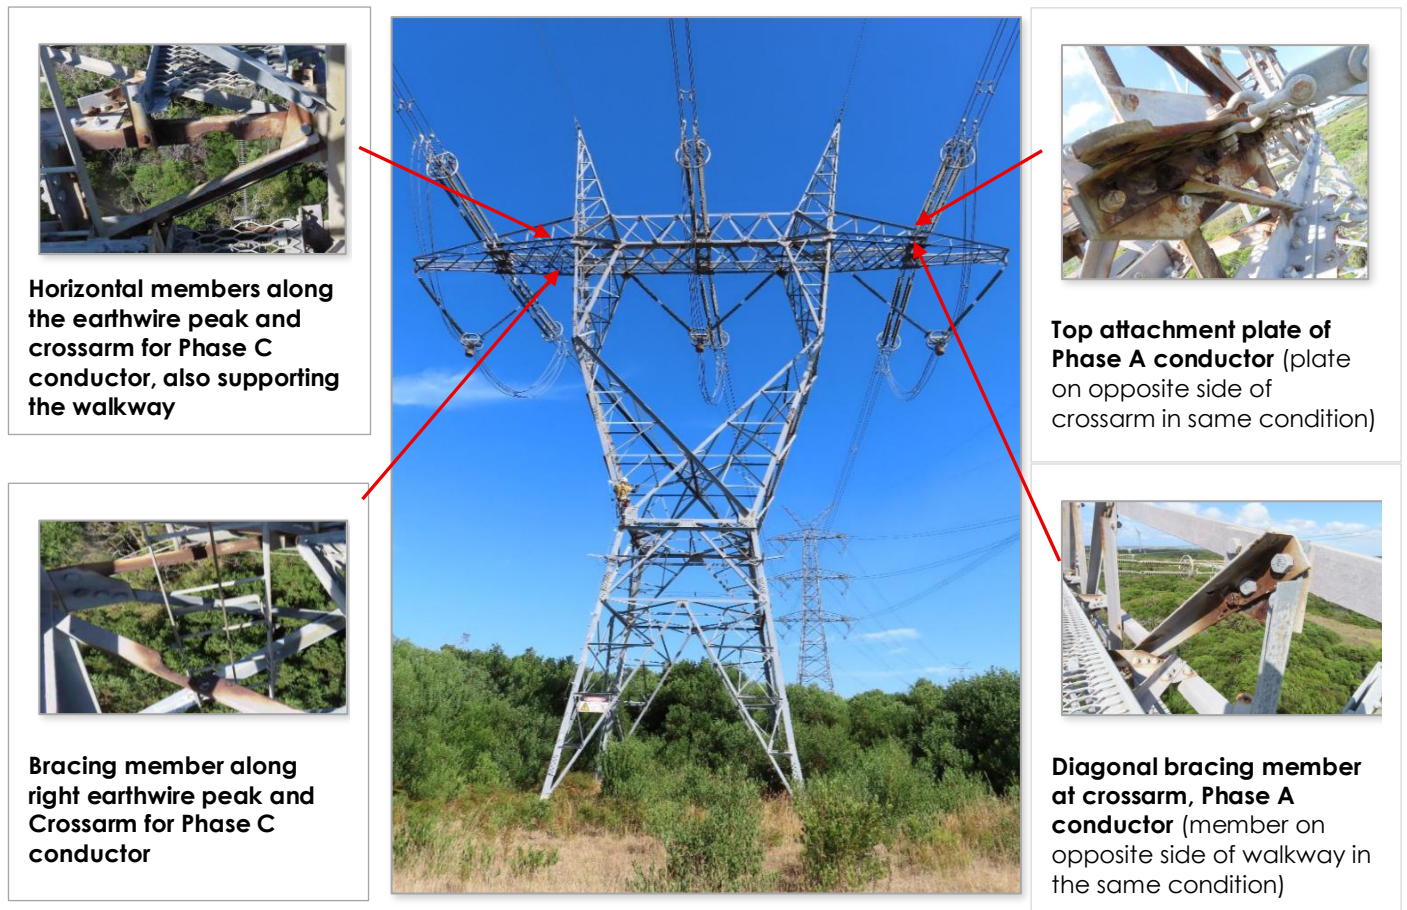
T628B and T628A are the termination towers supporting the circuits going into the [C.I.C] switchyard. Both circuits cross an arterial road that adds to the consequence of a tower failure, due to the potential for motorists being harmed.

**Figure 26: T628B, corrosion of plates and interconnected members**

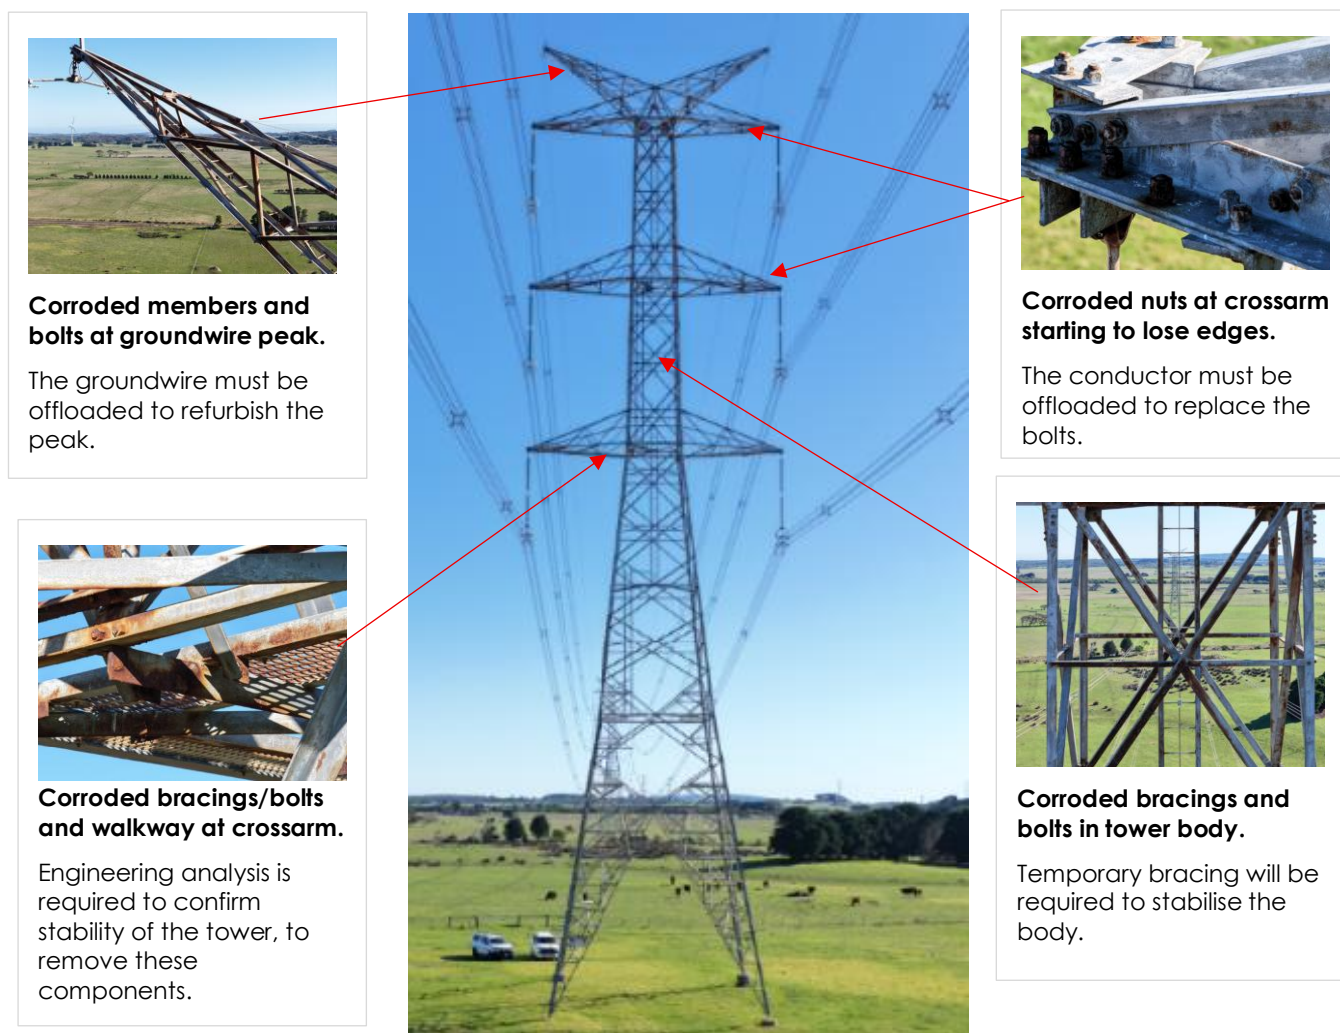
**Figure 27: T610, showing corroded members, bolts and walkway on the tower**

Due to the extent of poor condition members and bolts, refurbishment would require extensive temporary bracings to stabilise the body, with the conductors and ground wires needing to be offloaded to lessen the load on the structure. *These complex requirements and the inherent risks associated with refurbishment activities point to tower replacement as a better option – both in terms of worker safety and cost effectiveness.*

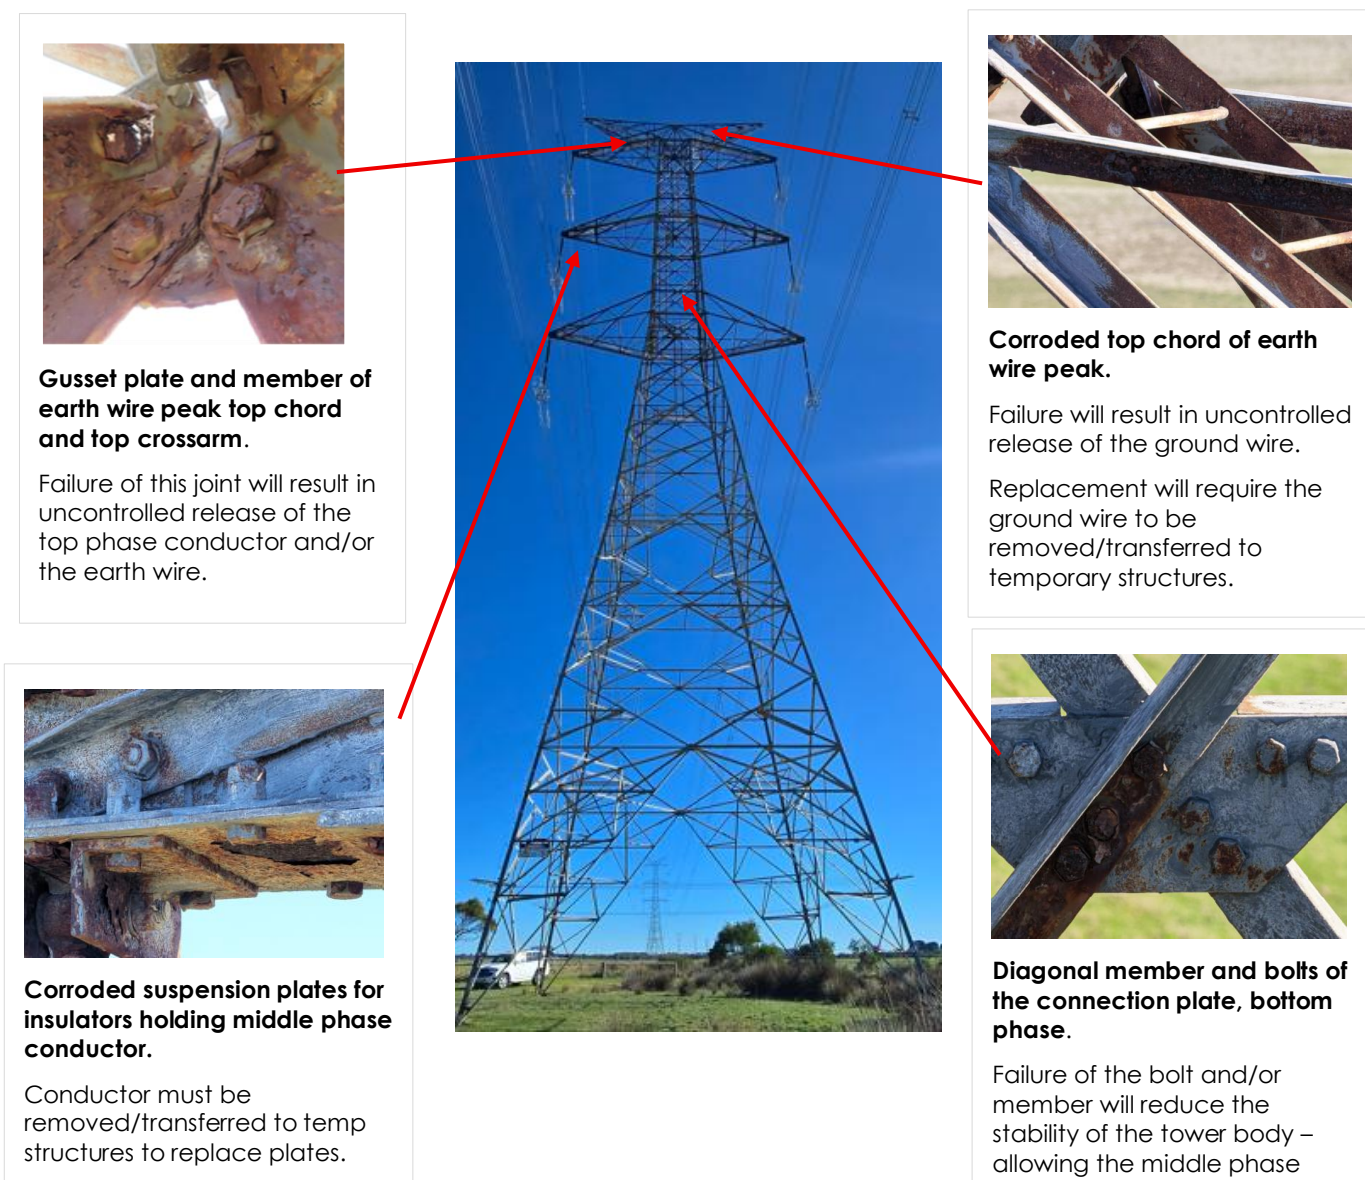
**Figure 28: T609, corrosion of interconnected members, bolts, and plates**

Being an intermediate tower that will require offloading, it is more cost efficient and much safer for line workers to replace the structure rather than have it refurbished and perform regular maintenance on the structure over its lifetime.

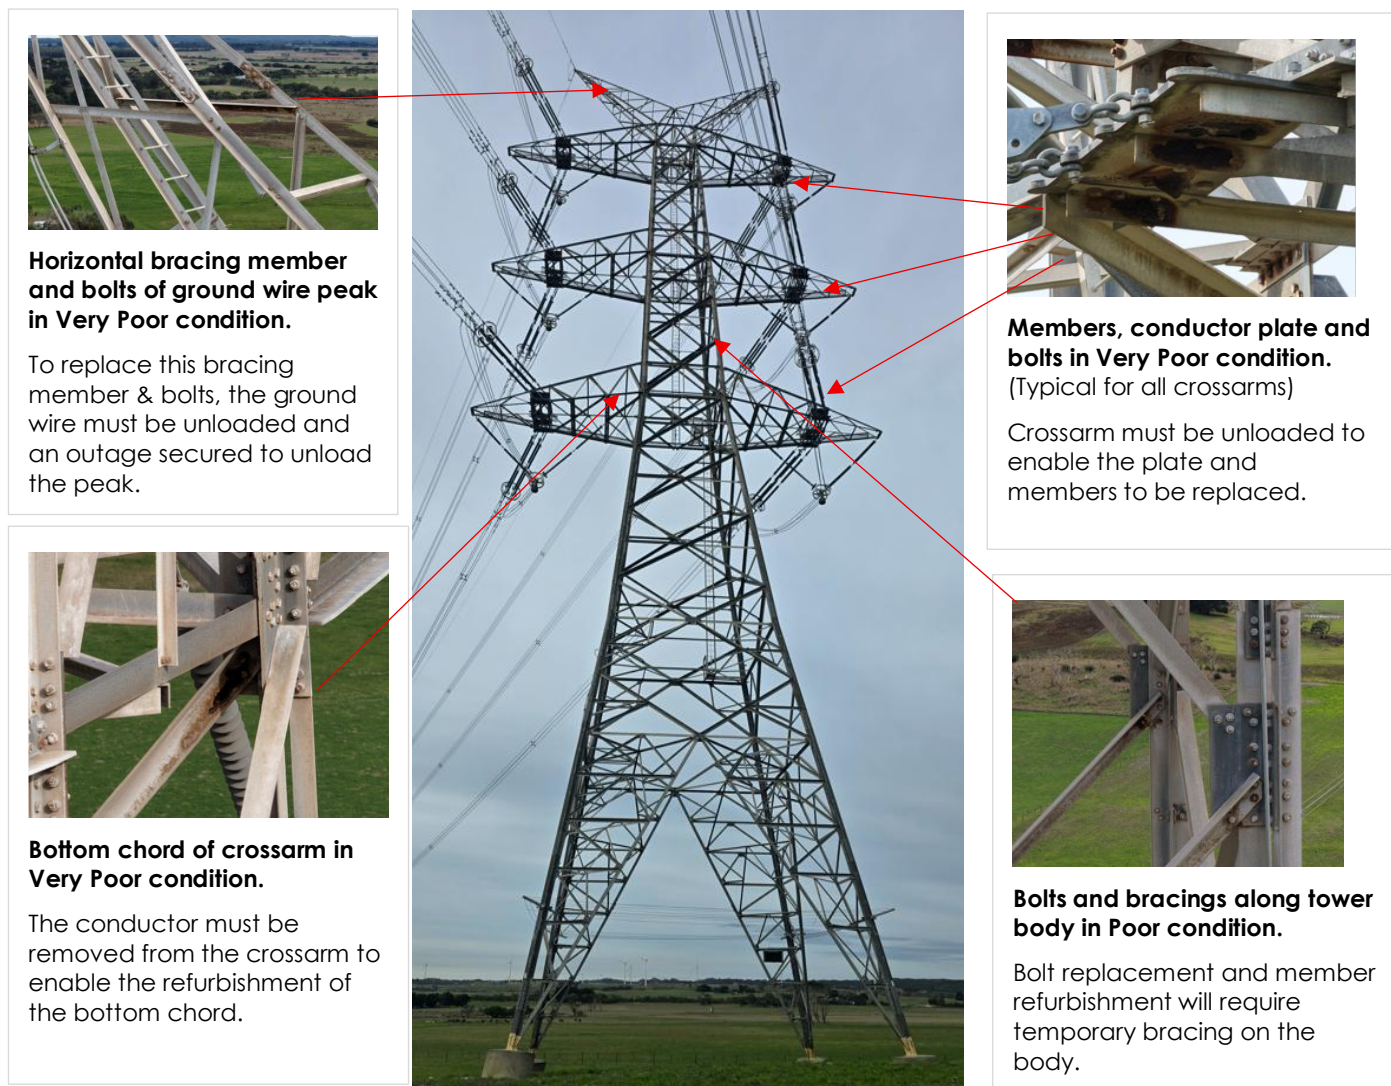
The photos below illustrate the current condition of the members and bolts on the tower.

**Figure 29: T603, corrosion of conductor plates & members, bracing members, crossarm bottom chord & bolts**

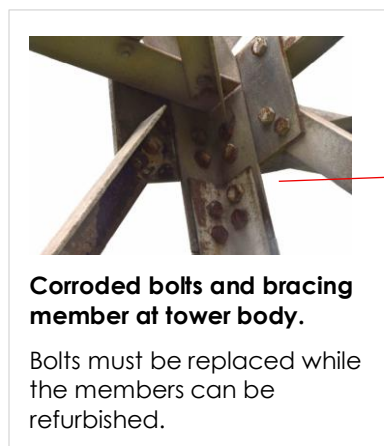
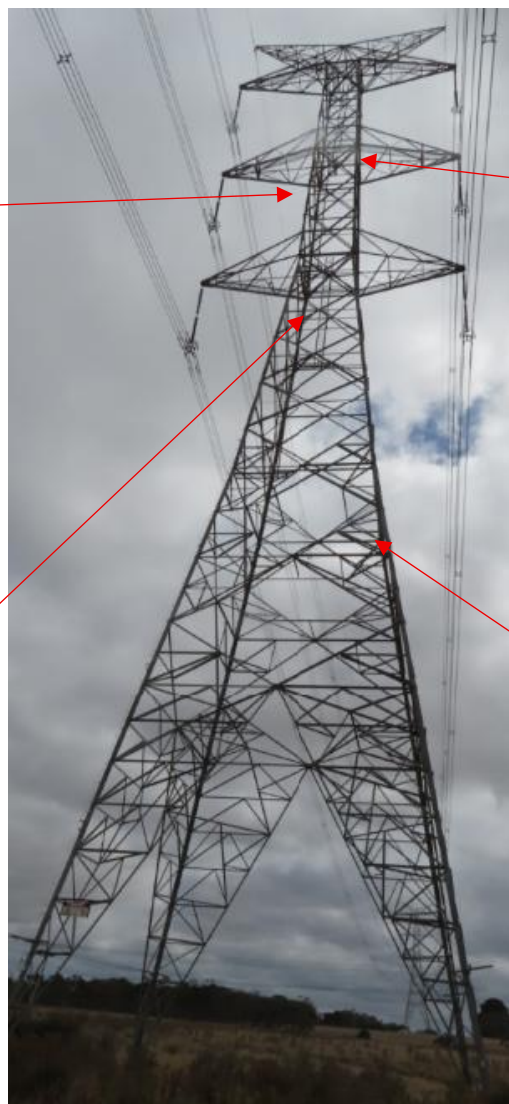
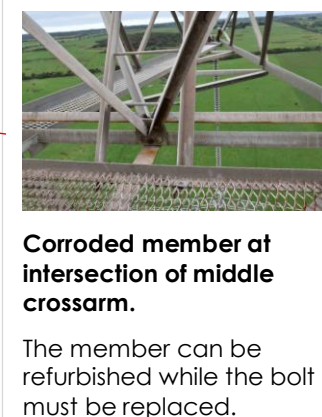
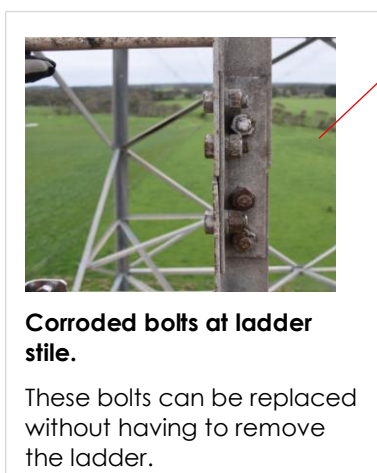
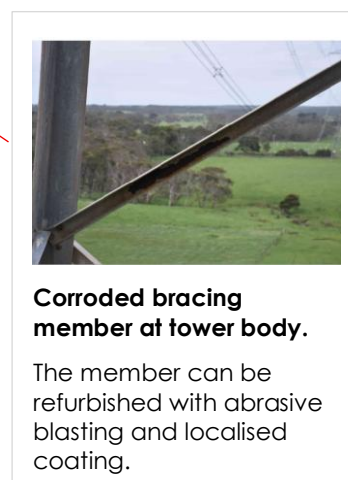
**Figure 30: T598, corrosion of plates and interconnected members**

Being an intermediate tower with only a few corroded components needing replacement, and without the need to offload the conductors and ground wire, *tower refurbishment is an economic solution with the following images illustrating tower condition.*

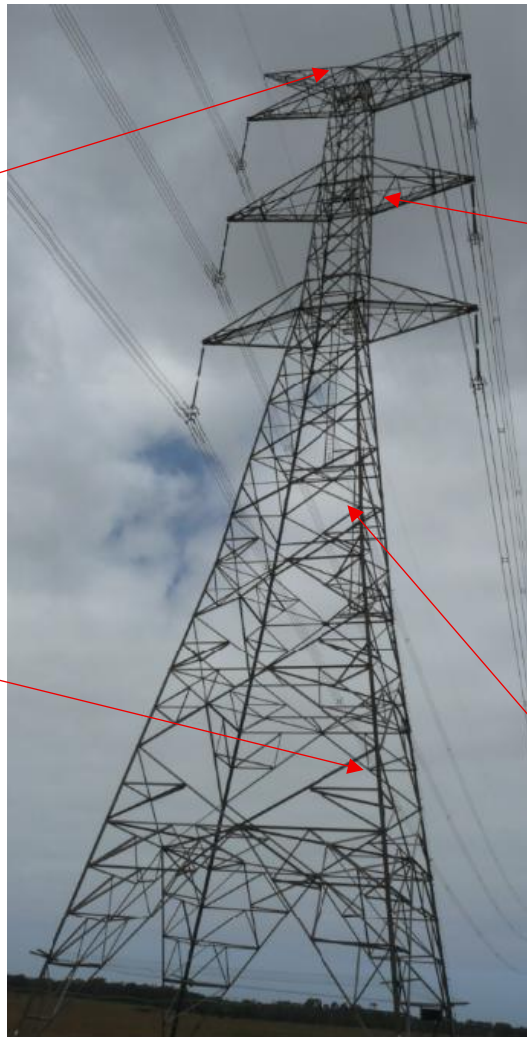
**Corroded bolts and plates at junction of crossarm and body.**

The bolt can be replaced while the leg needs to be cleaned and coated.
