Attachment 3 - Use of polygons to identify affected areas and assets

ENERGEX COST PASS THROUGH APPLICATION

TROPICAL CYCLONE ALFRED - COST ANALYSIS APPROACH

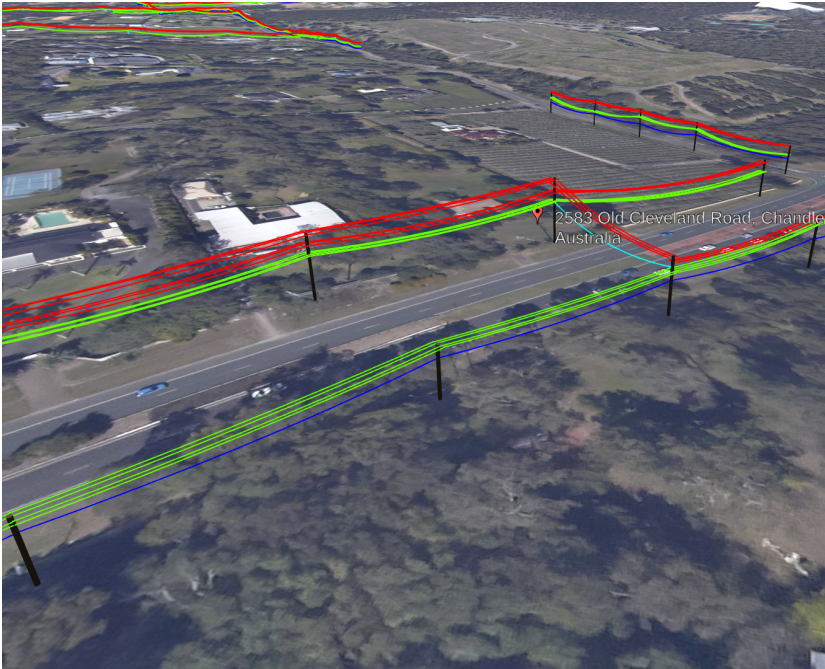
<p data-bbox="531 1283 1359 1406">Two phases 11kV down across drive way of no. 583 old Cleveland road. Pin pole either side ok. 2nd 11kV feeder above CL5 is ok. P71114-C</p>

Lv mains broken and on ground. -To required. -Busy round about-	COMPLETED	4 Recorded	M0040 Tree S-NSPOLE	M0001 Broken S-NSPOLE	M0010 Bare Cu Conductor S-NSPOLE	COND Conductor Conductive S-NSPOLE	0.24	P43335-C
New 11LBSPTFFIS required-11kv currently earthed. --New LVP required and conductors 3 spans. --UG terms and cable appear ok. -MEN cable supports on cross arm broken. LV service wires disconnected and hanging at head height	COMPLETED	4 Recorded	M0040 Tree S-NSPOLE	M0001 Broken S-NSPOLE	M0204 Switch, Unknown S-NSPOLE	Sw Switch S-NSPOLE	11	X74198-A
Two phases 11kV down across drive way of no. 583 old Cleveland road. Pin pole either side ok. 2nd 11kV feeder above CL5 is ok.	COMPLETED	4 Recorded	M3999 Unknown S-NSPOLE	M0001 Broken S-NSPOLE	M0404 LV Cable S-NSPOLE	COND Conductor Conductive S-NSPOLE	0.24	P62238-B
Tree branch on 11kV mains and air break.	COMPLETED	4 Recorded	M0040 Tree S-NSPOLE	M0001 Broken S-NSPOLE	M0009 Bare Al. Conductor S-NSPOLE	COND Conductor Conductive S-NSPOLE	11	P71114-C
