# AusNet

## Transmission Line Structures

Asset Management Strategy

**Document number:** AMS 10-77

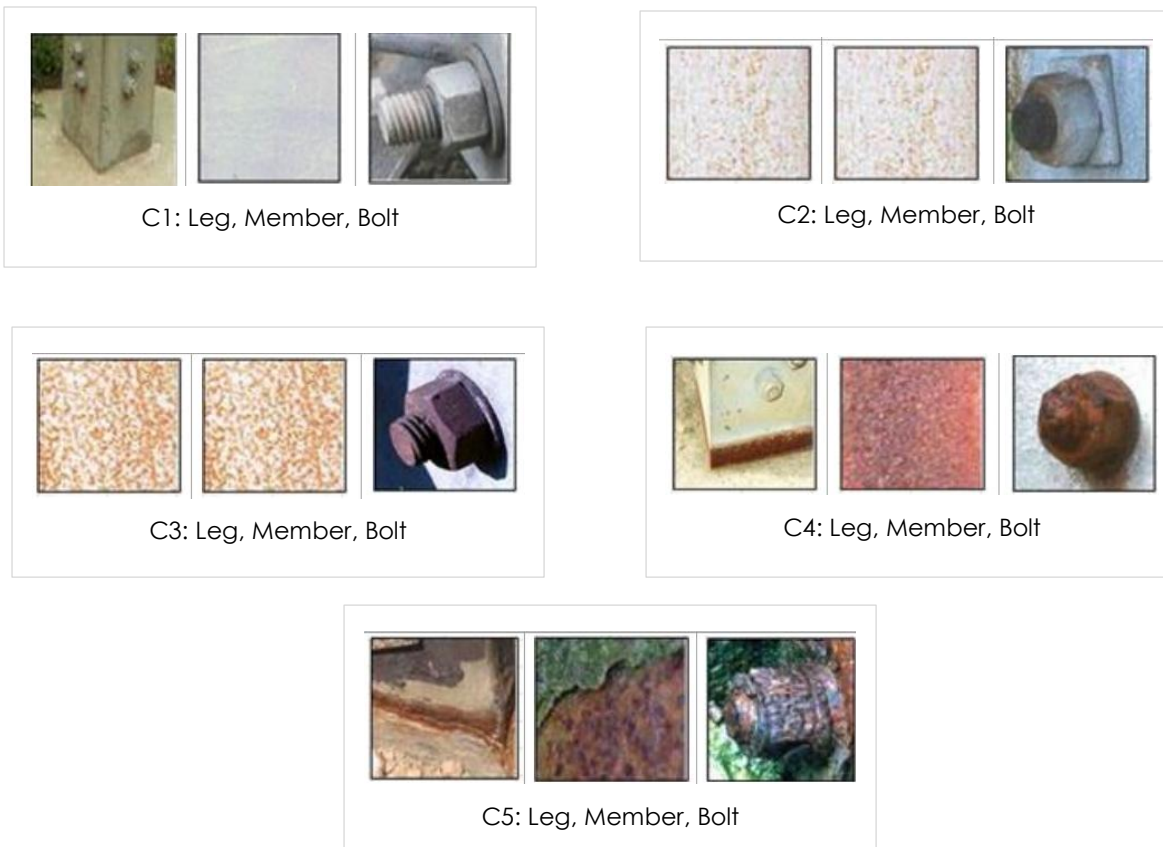
**Figure 15: Condition Scores Examples**

Figure 15 below provides visual examples of condition scores for legs, members, and bolts, illustrating how each component is assessed during inspections.

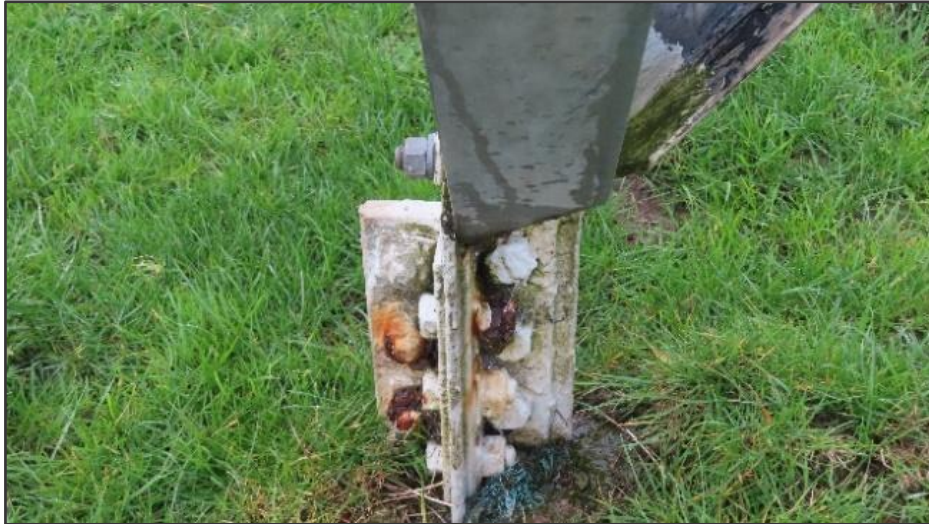
**Fig 18: Damaged SOXS, T197 MLTS-TGTS 220kV**

Upon closer inspection of towers scored in Poor and Very Poor condition, it was found that over 80% of C4 towers and over 30% (7) of C5 towers relate to the condition of the corrosion protection painting on the legs of these towers, known as SOXS. The SOXS is a protective layer and not a load bearing component, its purpose is to preserve the underlying condition of the tower legs. In all these towers the SOXS condition has been raised as a defect however it does not represent the condition of the tower legs. Rectification is part of the ongoing corrective maintenance program, including legs re-blasted, bolts replaced as needed, and coatings reapplied. An example of a tower leg with C5 bolts and damaged SOXS before repair is shown below.

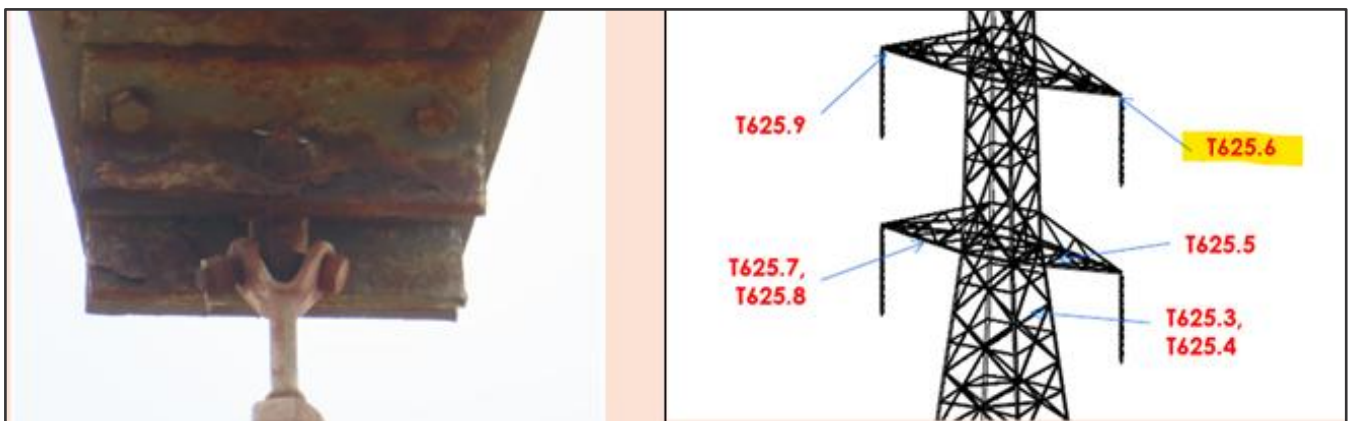
**Figure 24: T625 suspension plates, middle phase**

Figures 24 and 25 show examples of C5 members/bolts/plates which require offloading of conductors and ground wires from the structure due to their interconnected nature with other members.

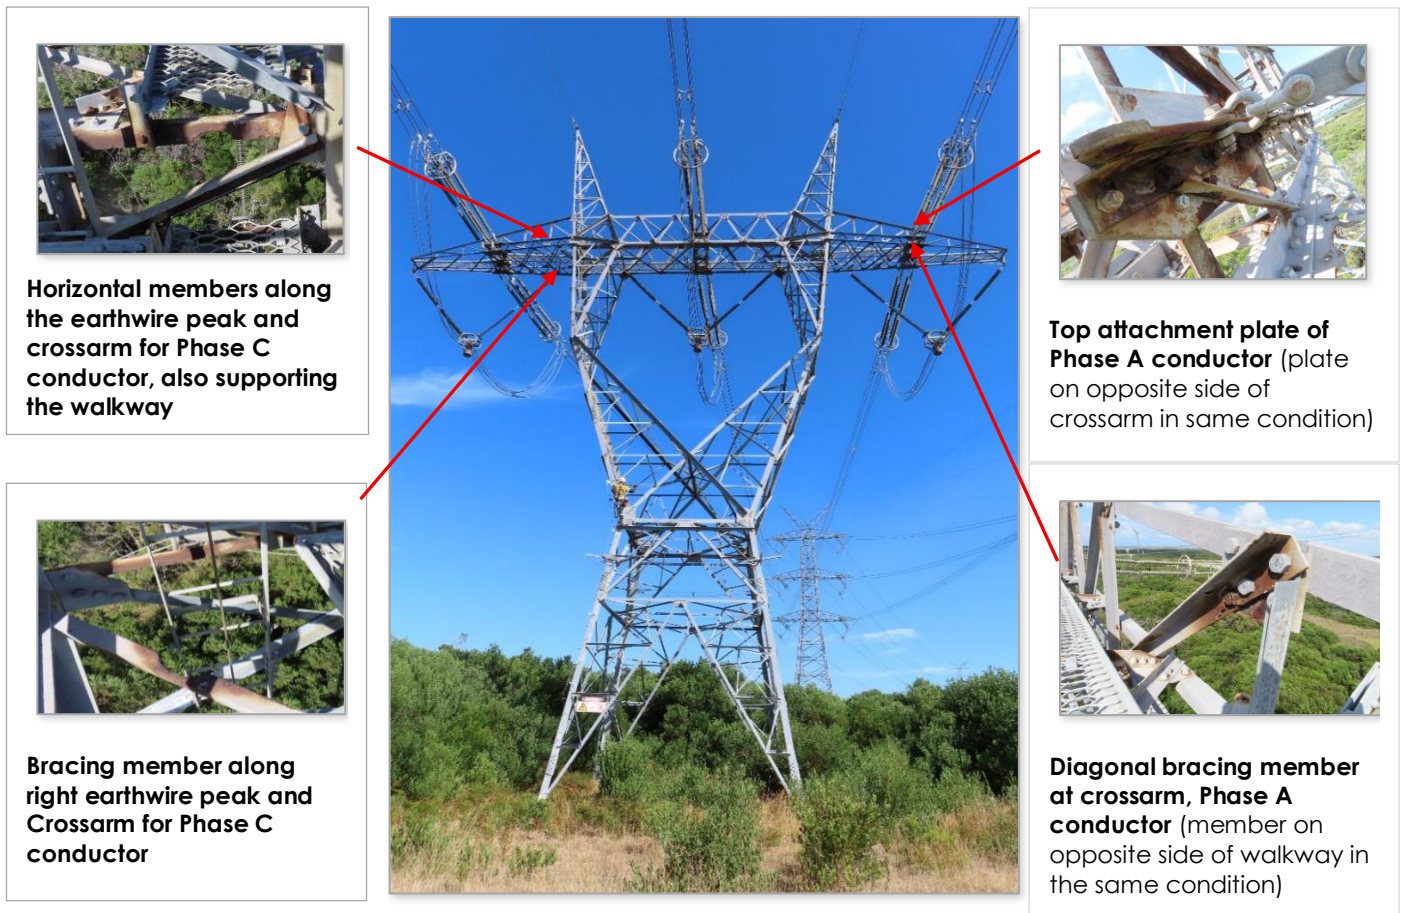
**Figure 26: T628B, corrosion of plates and interconnected members**

T628B and T628A are the termination towers supporting the circuits going into the [C.I.C] switchyard. Both circuits cross an arterial road that adds to the consequence of a tower failure, due to the potential for motorists being harmed.

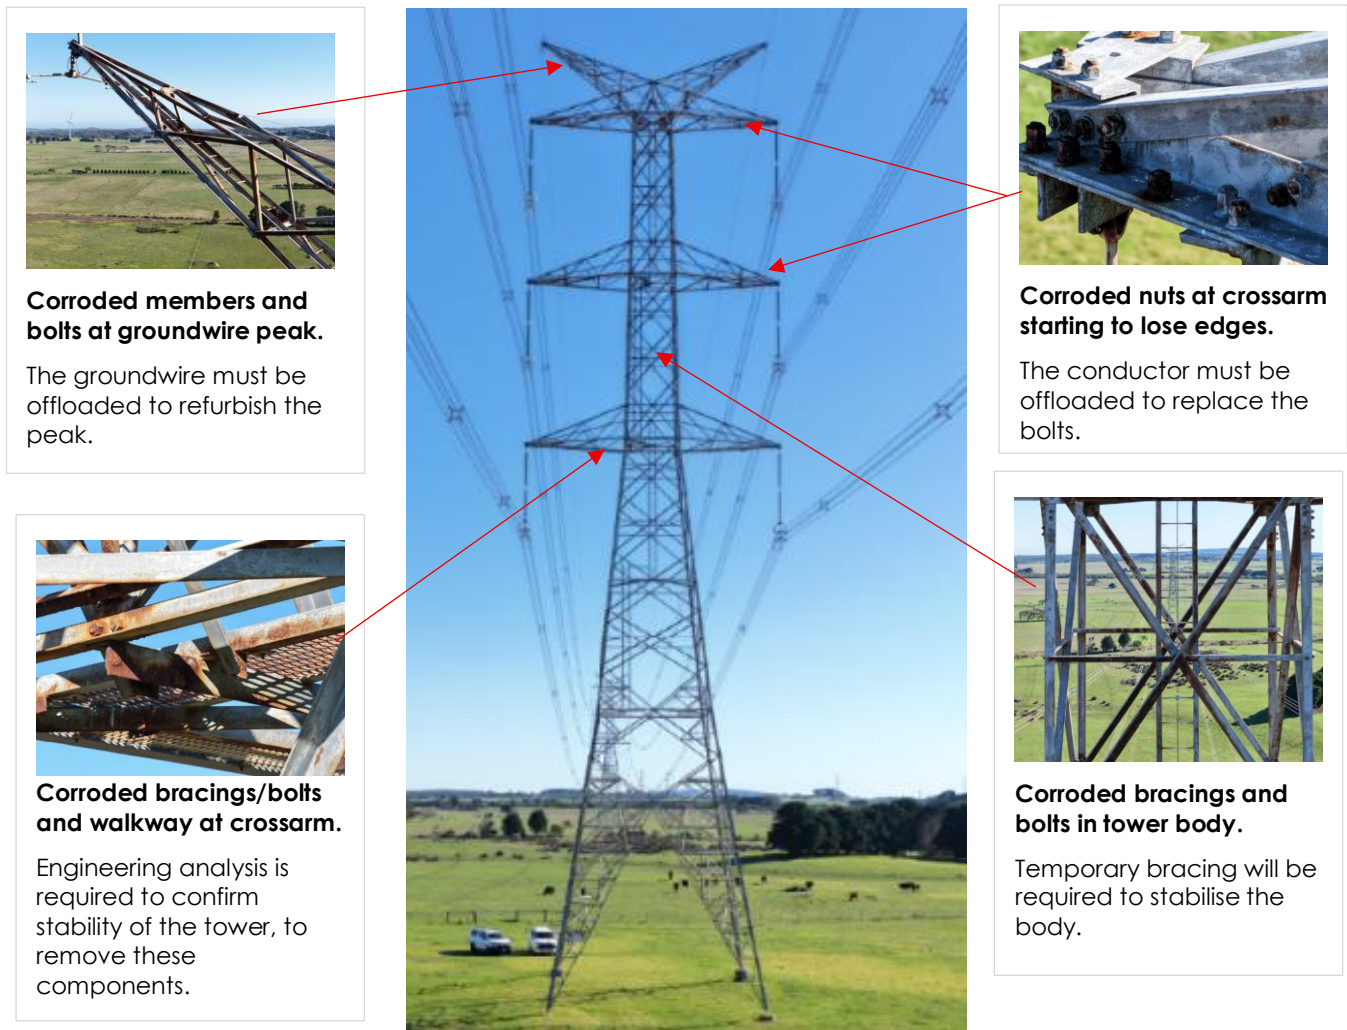
**Figure 27: T610, showing corroded members, bolts and walkway on the tower**

Due to the extent of poor condition members and bolts, refurbishment would require extensive temporary bracings to stabilise the body, with the conductors and ground wires needing to be offloaded to lessen the load on the structure. *These complex requirements and the inherent risks associated with refurbishment activities point to tower replacement as a better option – both in terms of worker safety and cost effectiveness.*

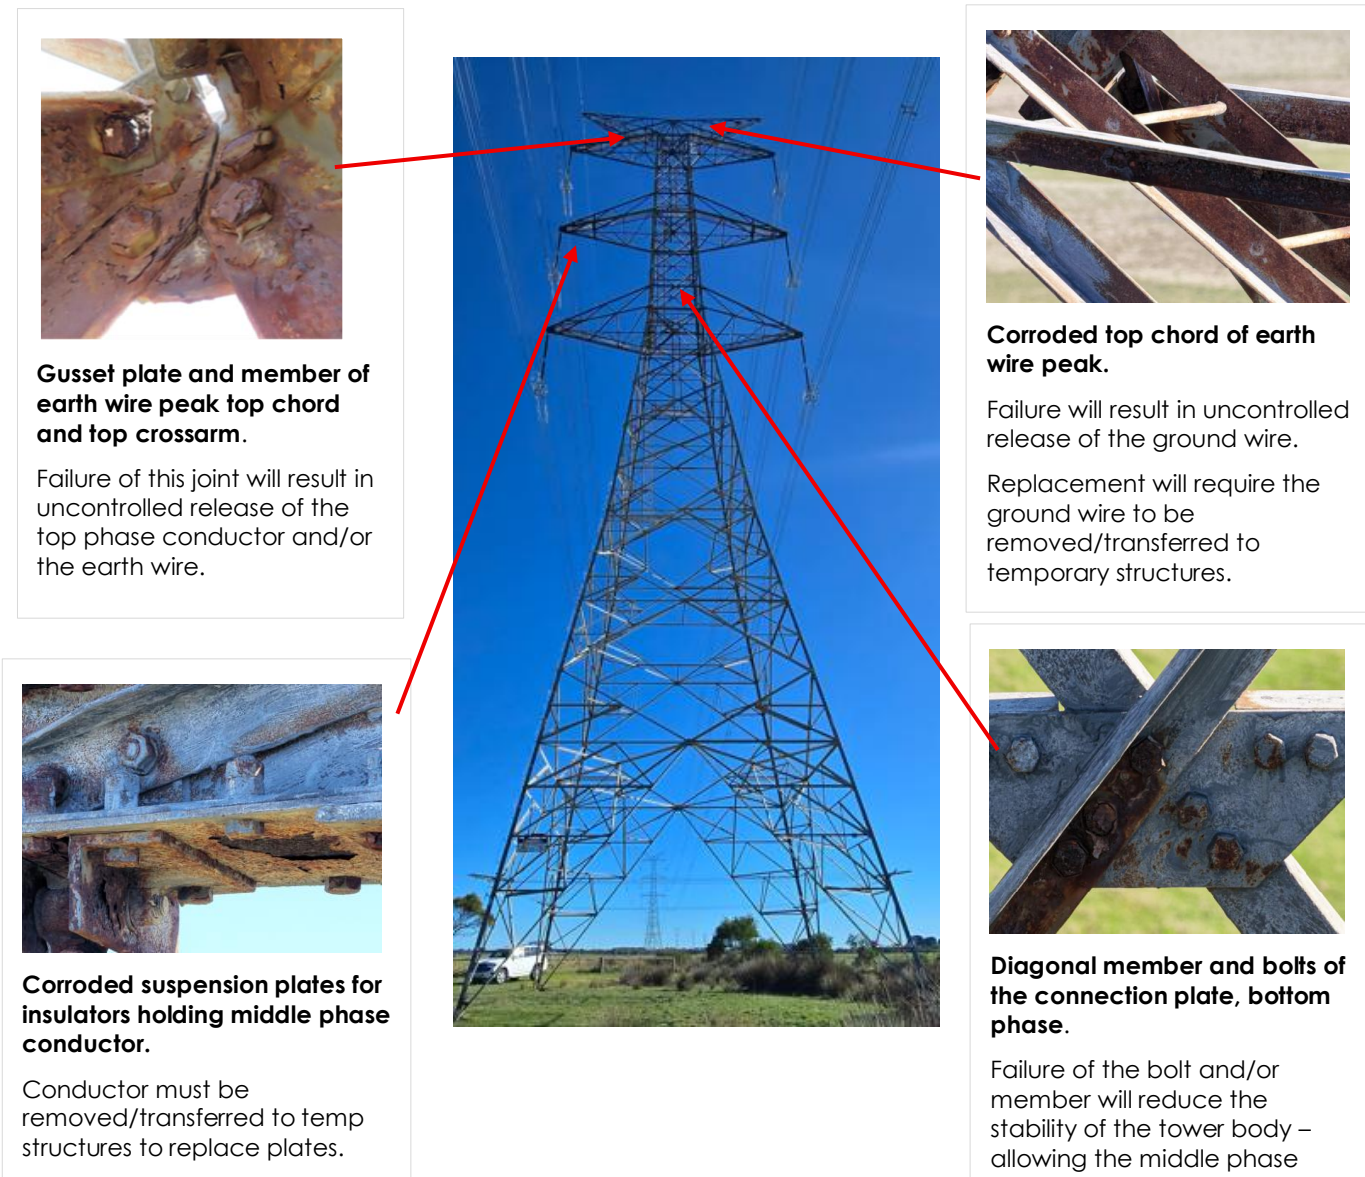
**Figure 28: T609, corrosion of interconnected members, bolts, and plates**

Being an intermediate tower that will require offloading, it is more cost efficient and much safer for line workers to replace the structure rather than have it refurbished and perform regular maintenance on the structure over its lifetime.

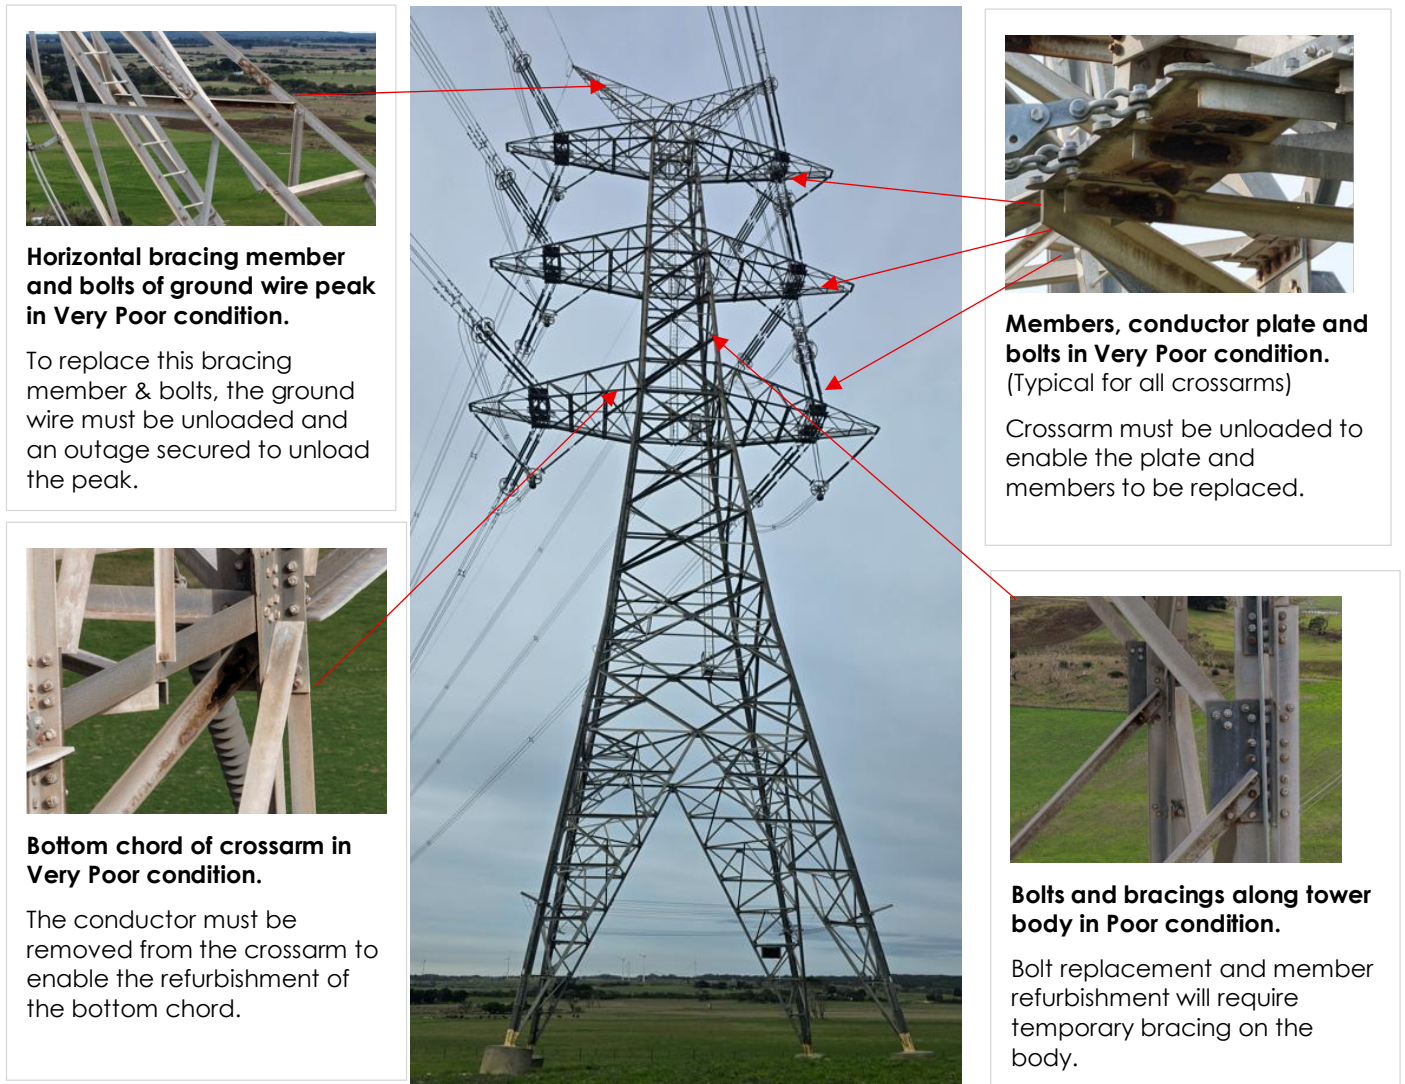
The photos below illustrate the current condition of the members and bolts on the tower.

**Horizontal bracing member and bolts of ground wire peak in Very Poor condition.**

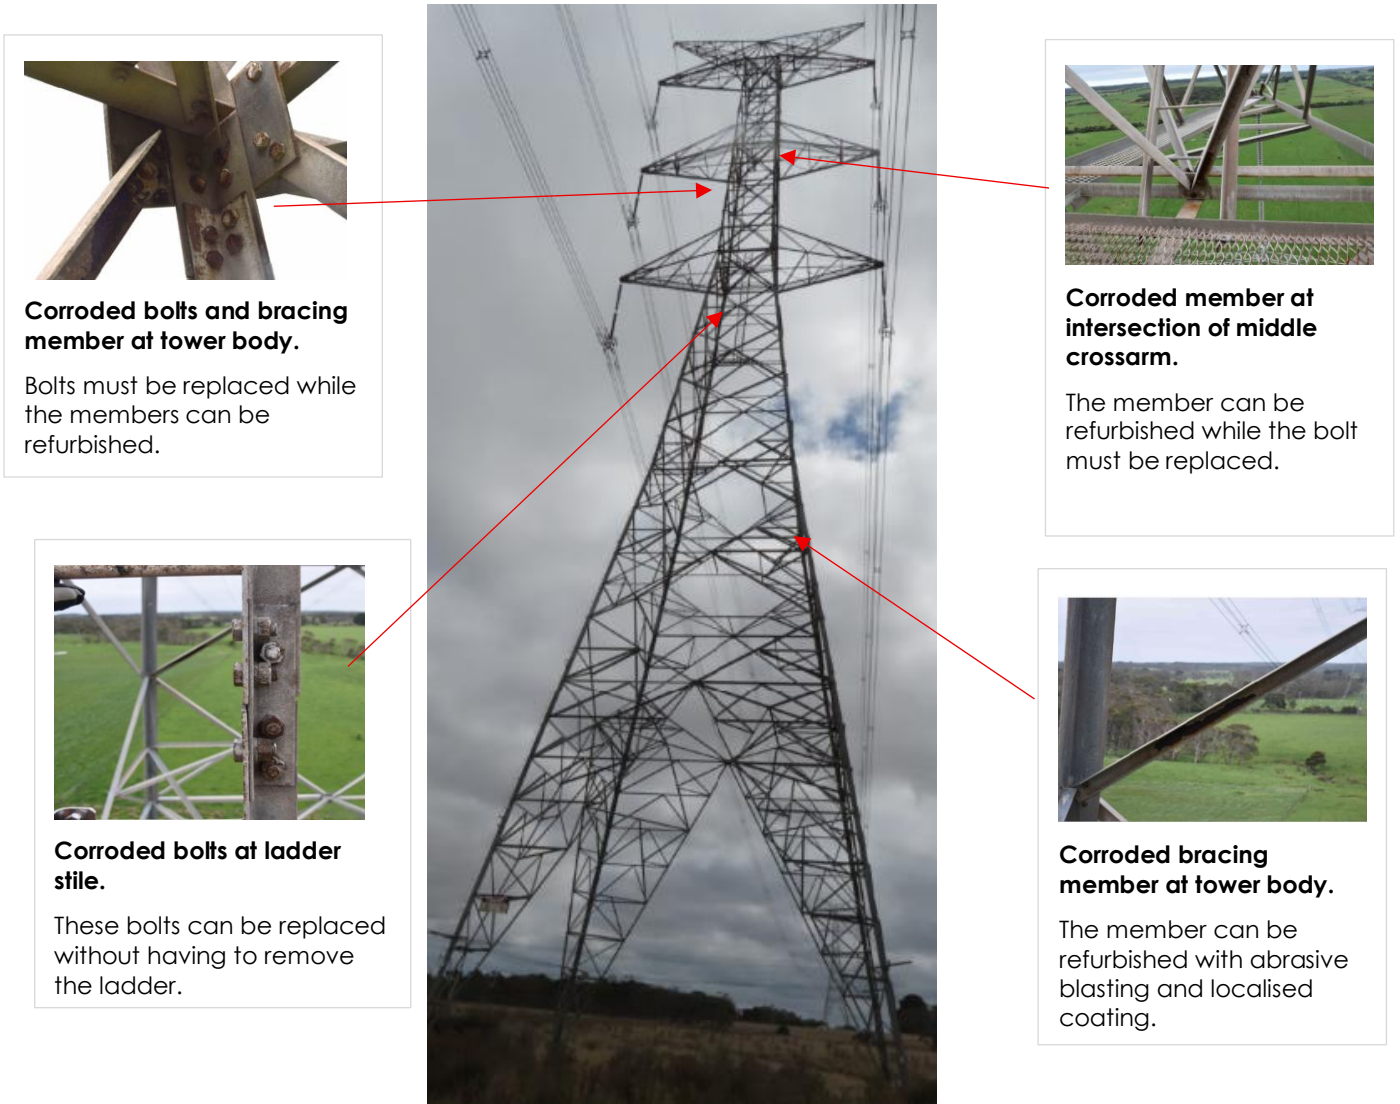
**Figure 30: T598, corrosion of plates and interconnected members**

Being an intermediate tower with only a few corroded components needing replacement, and without the need to offload the conductors and ground wire, *tower refurbishment is an economic solution with the following images illustrating tower condition.*

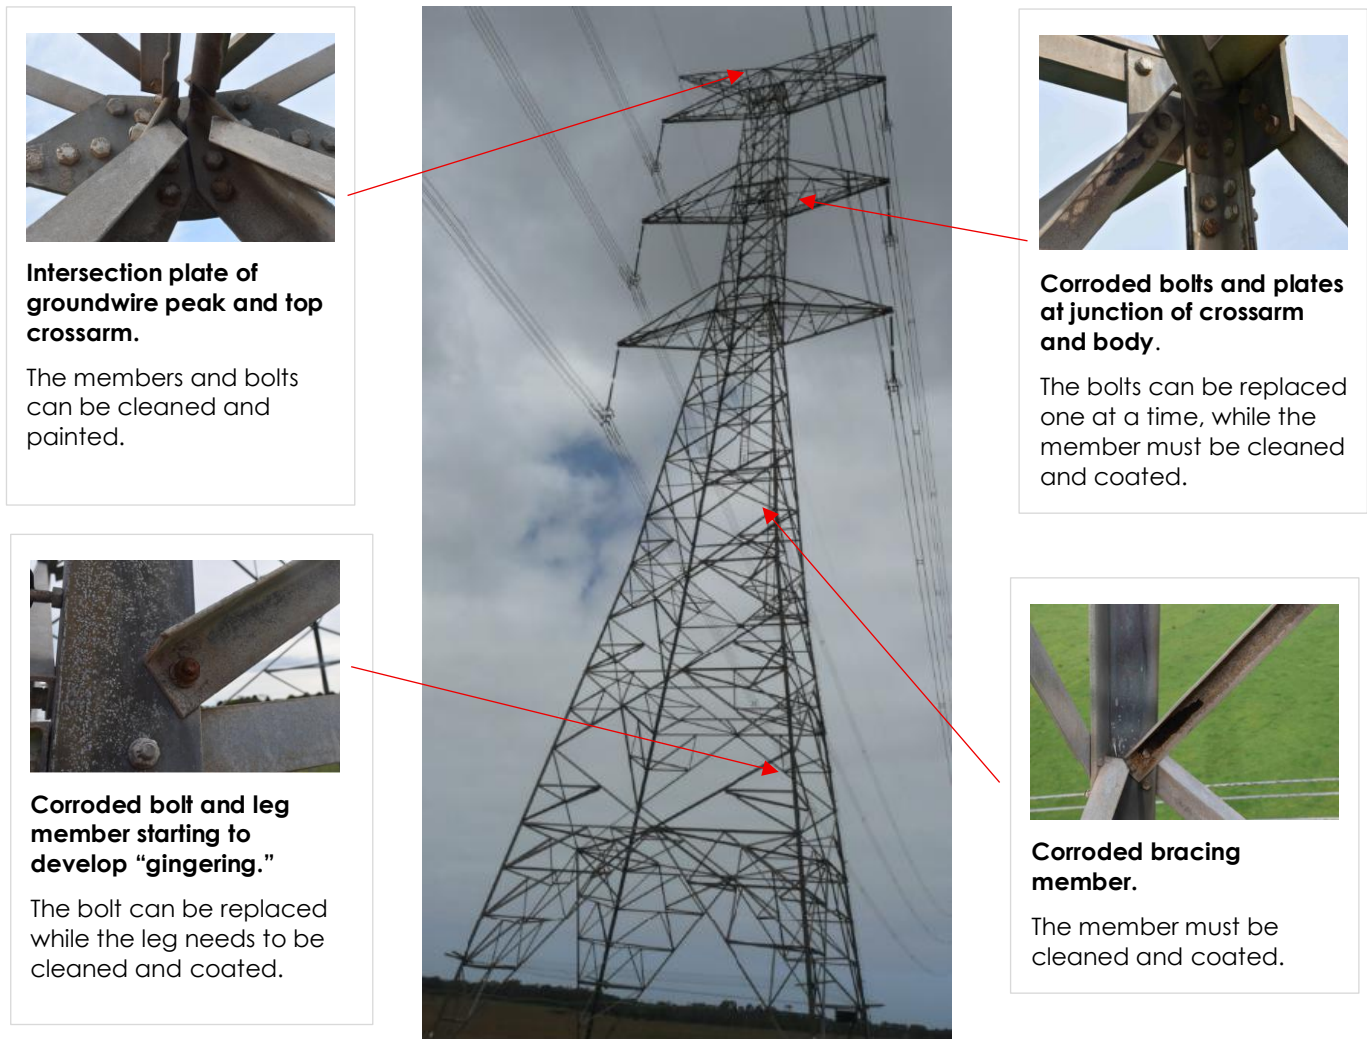
**Figure 31: T592, corrosion of plates and interconnected members**

The following images illustrates the condition of the tower.
