AMS – Victorian Electricity Transmission Network

Power Transformers and Oil-Filled Reactors (PUBLIC VERSION)

Document number	AMS 10-67
Issue number	10
Status	Approved
Approver	J. Dyer
Date of approval	28/08/2015

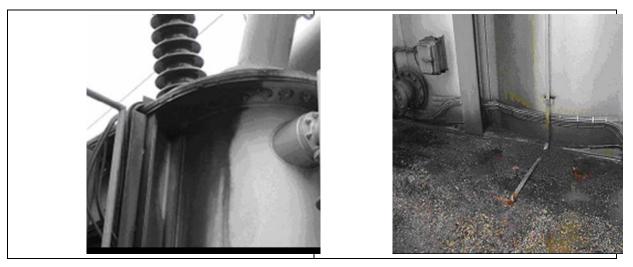
Figure 31 – Significant Transformer Oil Leaks

One of the major types of oil leak and most difficult to repair, is a leak from the main tank-to-tank cover joint on older transformers. Replacement of these gaskets is a major task requiring removal of bushings, turrets, wiring, etc. before the tank cover can be removed. Furthermore, this does not necessarily cure the problem. A lower cost process of welding a steel strip across the flanges of the cover and the tank, and replacing the bolts with dome nuts and 'O' rings (or similar) to seal the bolt holes, has been reasonably successful. Welded lids have been specified for new transformers for some time.

Oil leaks on transformers, particularly old transformers are not being resolved by normal maintenance and for heavily loaded transformers the long outages needed to repair these leaks are difficult to arrange for reasons of load at risk and network security. These leaks do not pose an immediate risk of transformer failure, but can result in environmental and health and safety issues. An audit in 2011, identified more than 30% of the fleet had significant (> 100 litres per year) and there is renewed focus and approved projects to fix major leaks over the next 2 years or have plans to replace the transformer.

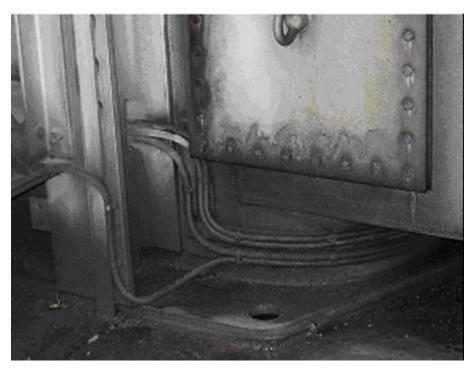
Figure 32 – Oil Leaks and Secondary Cables

Oil leaking from secondary terminals in CT terminal boxes has flowed down cables, resulting in deterioration of the insulation as illustrated in Figure 32 below.

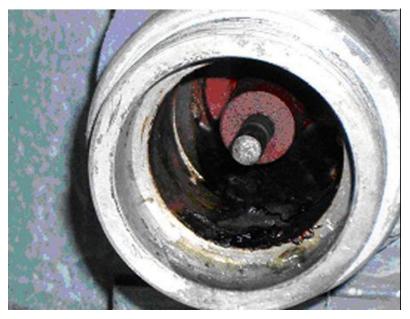
Figure 33 – Corrosion of Bushing Test Tap

The test and voltage tappings on bushings have been found with various problems, mainly as a result of corrosion (incorrect metal surfaces) and water entry. It is important that these are checked on a regular basis. These problems have been exacerbated when the tapping has a cable connection for a CVT or other monitoring equipment. An example of corrosion of a bushing test tap is shown in Figure 33.
