RIN Supporting Information

EDPR 2016-20

Bushfire Mitigation Audit SP AusNet (D)

**Final Audit
Report 2013**

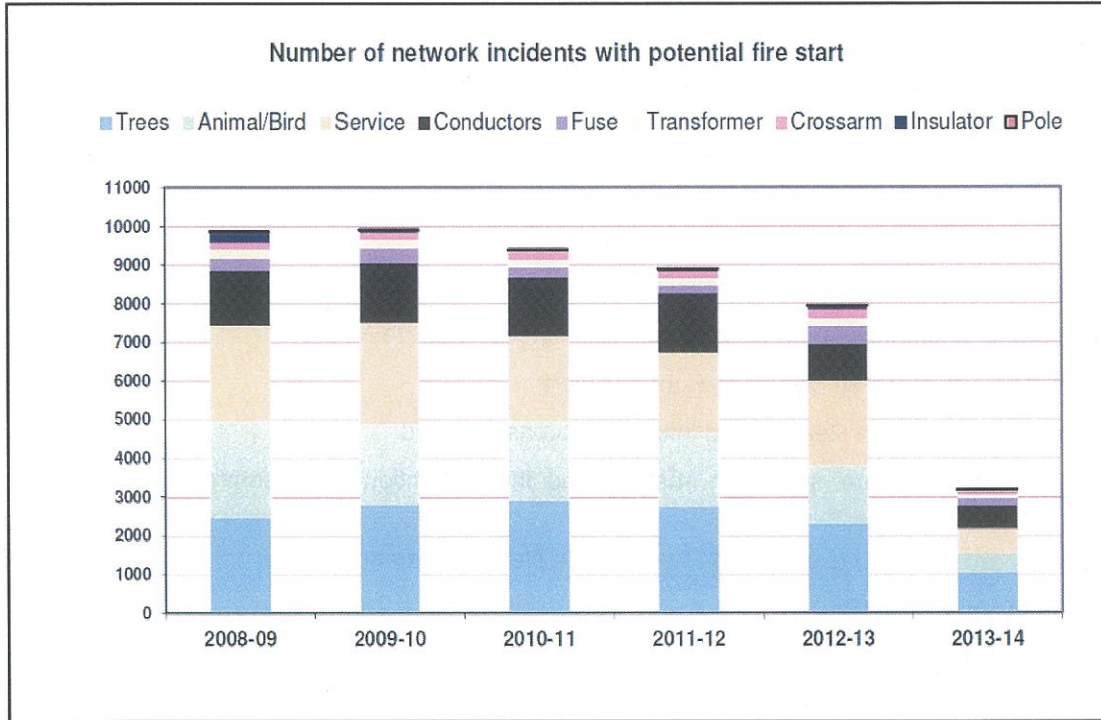
Network Safety Report – September 2013 Figure 3.1.8 Potential HBRA Incidents Financial Years

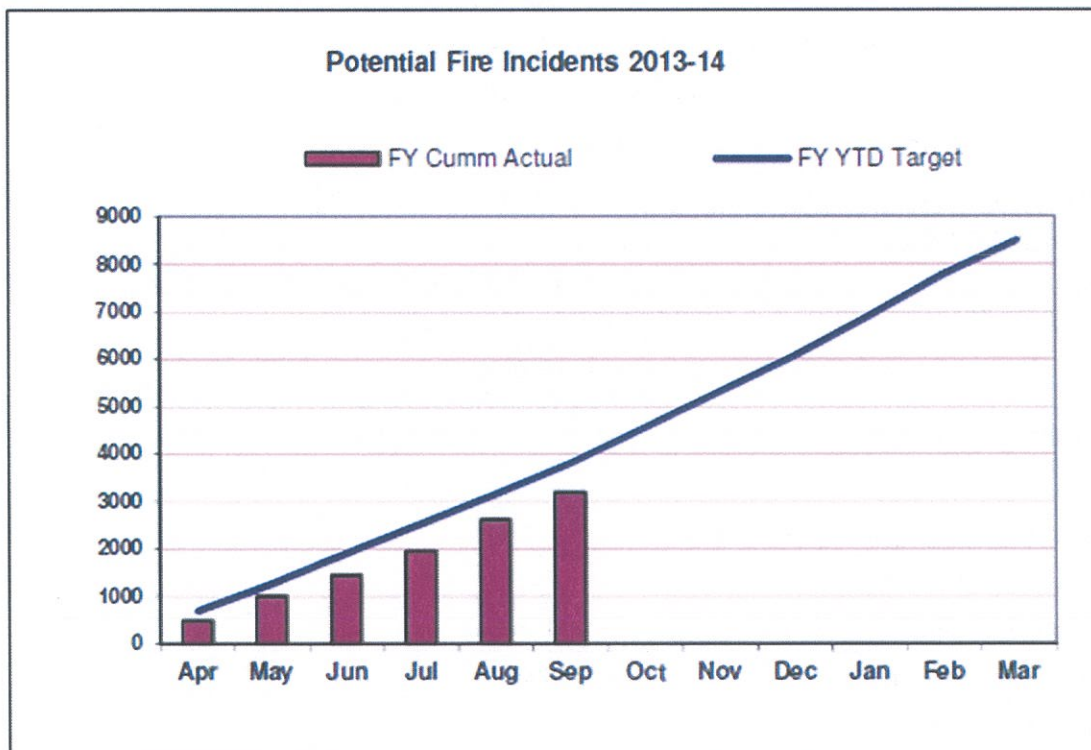
Network Safety Report – September 2013 Figure 3.1.9 Potential HBRA Incidents 2013 YTD
