HV DISTRIBUTION STEEL MAINS REPLACEMENT PROGRAM

Project DS011.18 2017/18 business case

Prepared by Asset Strategy and Planning

January 2017

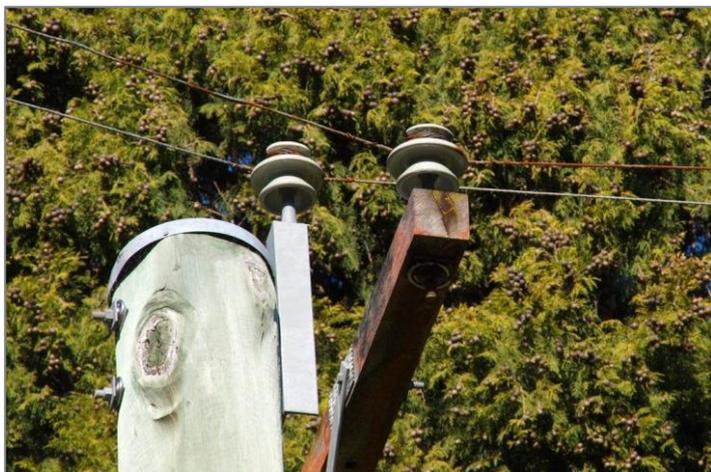
Figure 1 below shows an example of 7/0.064 steel conductor in service at 11kV at Leura. The outer phases are more effected by corrosion than the inner phase and all are showing more corrosion at the pin insulator.

FIGURE 1 - CORRODED 7/0.064 SC/GZ CONDUCTOR IN SERVICE AT LEURA

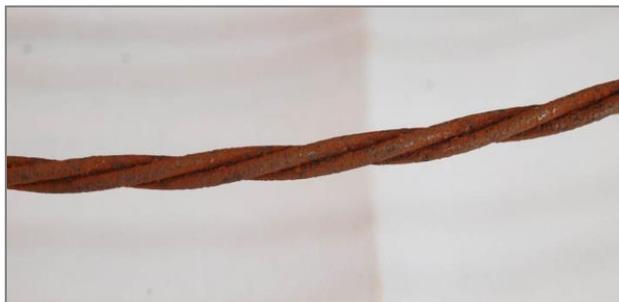
Figure 2 shows a piece of 3/0.104 SC/GZ conductor which was removed from Lowther Siding in the Good Forest area in March 2015. This conductor shows widespread corrosion and some loss of section and would be considered to be at high risk of failure, both due to the corrosion damage it has suffered and also due to its very small diameter. Figure 3 shows a 7/0.064 SC/GZ conductor which failed on top of its pin insulator at Mount Irvine in 2012.

FIGURE 2 - CORRODED 3/0.104 SC/GC CONDUCTOR

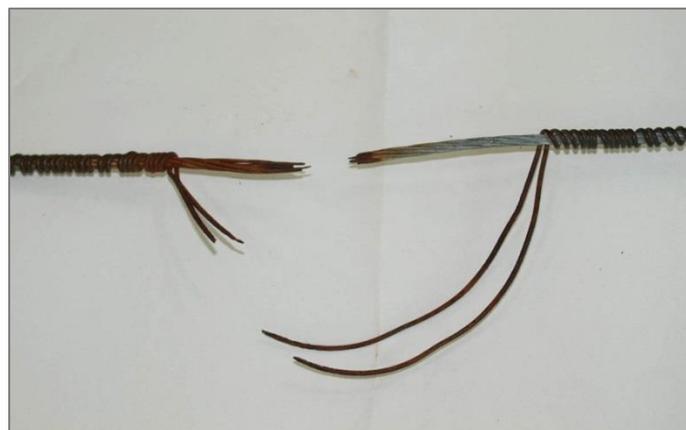
FIGURE 3 - FAILED 7/0.064 SC/GZ CONDUCTOR

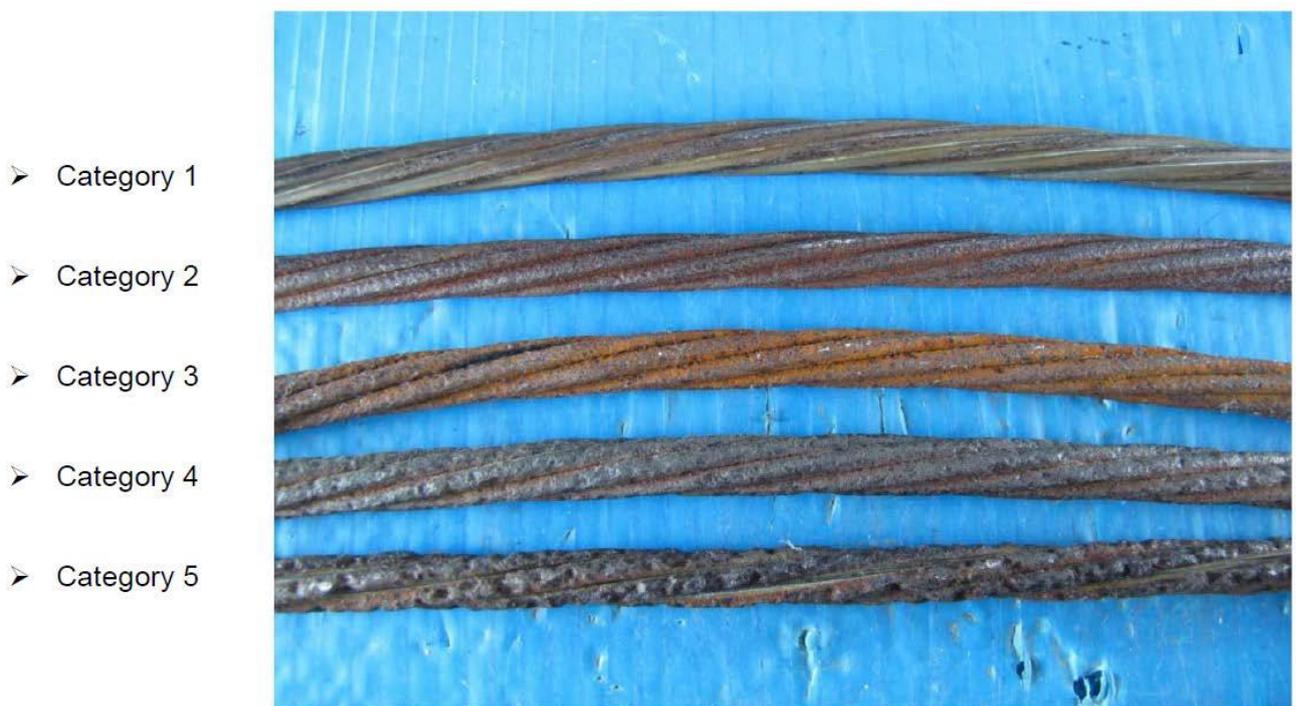
FIGURE 4 – VISUAL COMPARISON OF CONDUCTOR CORROSION CATEGORIES

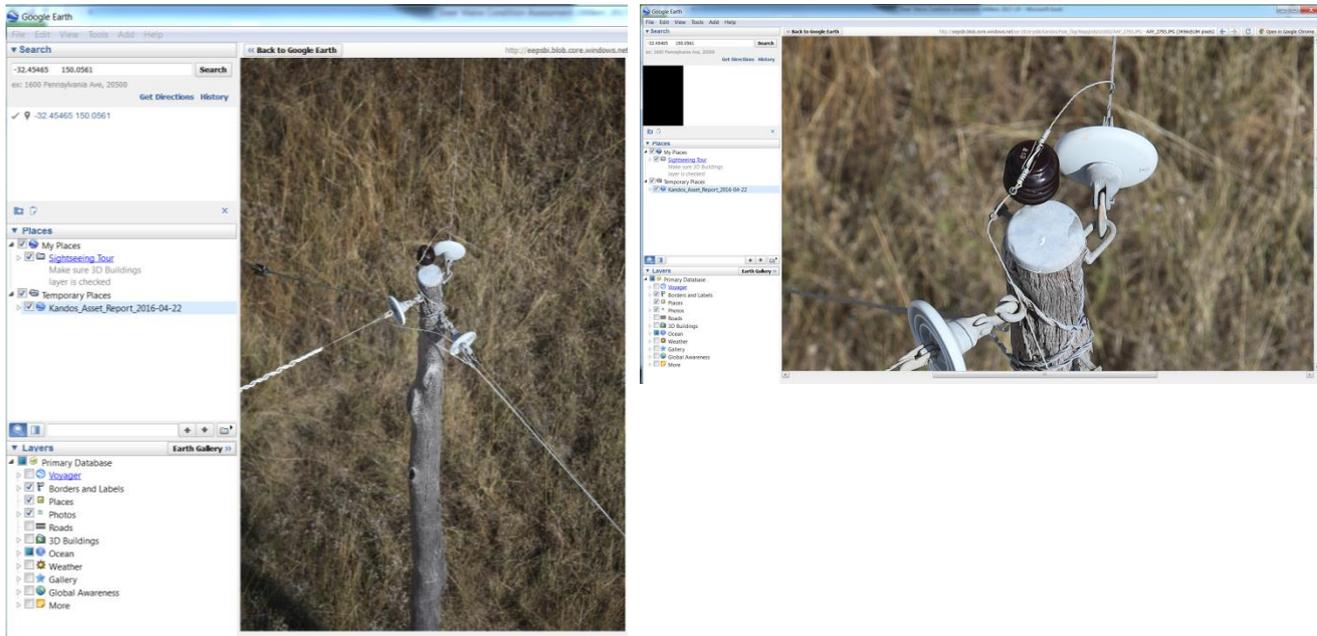
Closer inspection of FIGURE 2 below, in places where moisture builds up in and around the dead-ends and heading out along the conductor, indicates limited evidence for any significant corrosion at this site.

FIGURE 2- CATEGORY 2 RATING

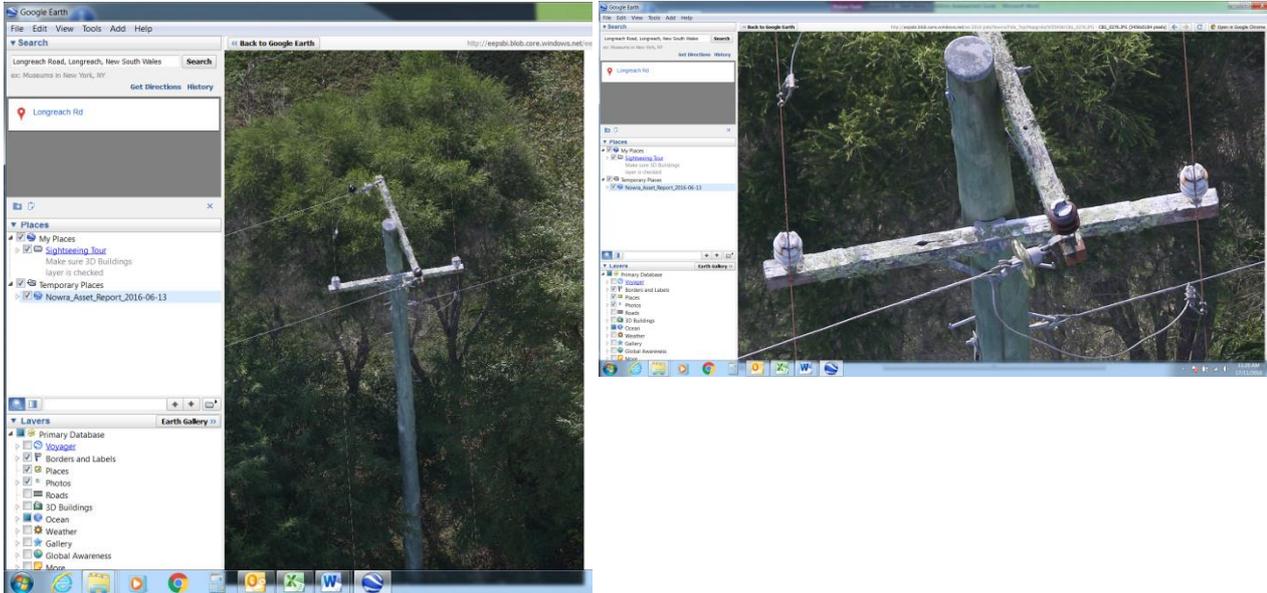
A Category 4 or 5 site would show heavy surface corrosion with mild to heavy pitting, annealing or thinning of the conductor, broken, frayed or split conductors under tension. These sites are to be prioritised for replacement.

Visual inspection of FIGURE 3 below shows obvious signs of darker areas in and around the insulators and out along the length of the conductor that indicates higher levels of corrosion reflected in a higher priority category ranking.

FIGURE 3 - CATEGORY 4 OR 5 RATING

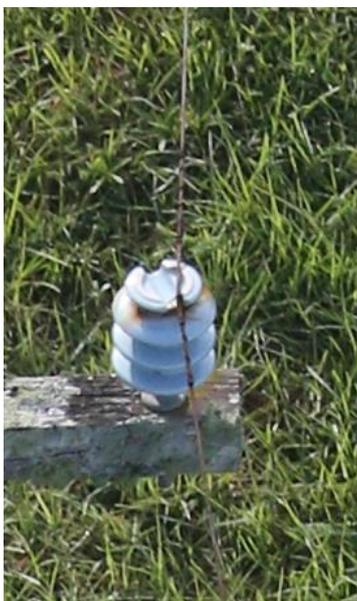
Significant defects could include missing tie-wires or obvious broken strands. The example in FIGURE 4 below shows the steel mains conductor at risk of coming free from the pin insulator. This site would need to be flagged back to AS&P as requiring urgent attention.

FIGURE 4 – EXAMPLE OF A HIGH PRIORITY DEFECT

In the event that a significant defect is identified during the image review process that may potentially result in a failure of the conductor or present a safety risk, the site must be flagged back to AS&P prior to the completion of the scoping study.
