Unmodelled repex: Business cases for “other” repex

Reactive Asset Replacement Program

Reactive Asset Replacement Program 2015/16 - 2019/20

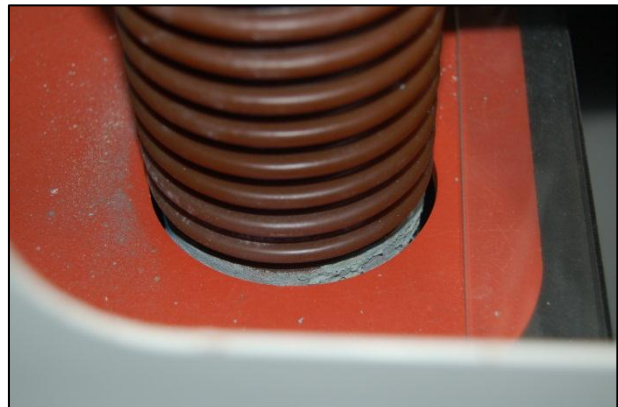
SSMGL CB1022 badly detached screen

SSMGL CB1022 screen detachment in air gap

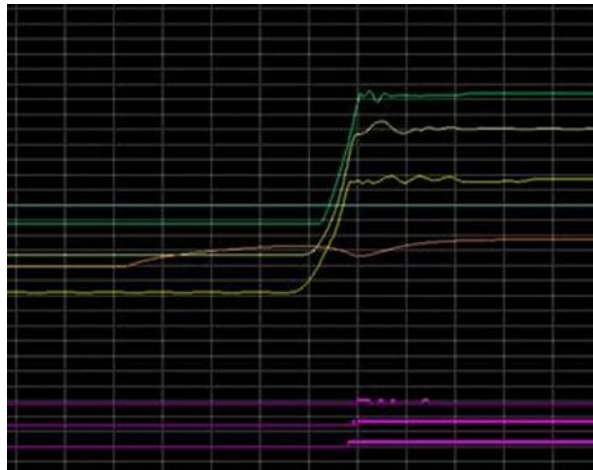
The dislodging of the bearing in the Eclipse CB can be attributed to the design and manufacture of the drive shaft. The consequence of this is that the drive to the three vacuum interrupters is unbalanced and one of the outer phases does not close. In the case of a bearing failure, the loss of travel is approximately 5mm which means the CB is only just open when in the closed position. In a faulty CB the contacts will be open circuit in phase after closing, but during the closing stroke they will overtravel and make momentary contact through a small bounce period. This can be seen in the diagram below in which the first phase (with a dislodged bearing) is bouncing during closing for approximately 15ms. In this time current will be initiated and the interrupter will attempt interruption at each rebound open. As this will occur during the initial making at the time the DC component may be high, the CB may actually fail during this time. Such a failure could result in the welding of the interrupter or actual physical failure resulting in an external arcing event within the CB cubicle.

Closing contact bounce with displaced bearing

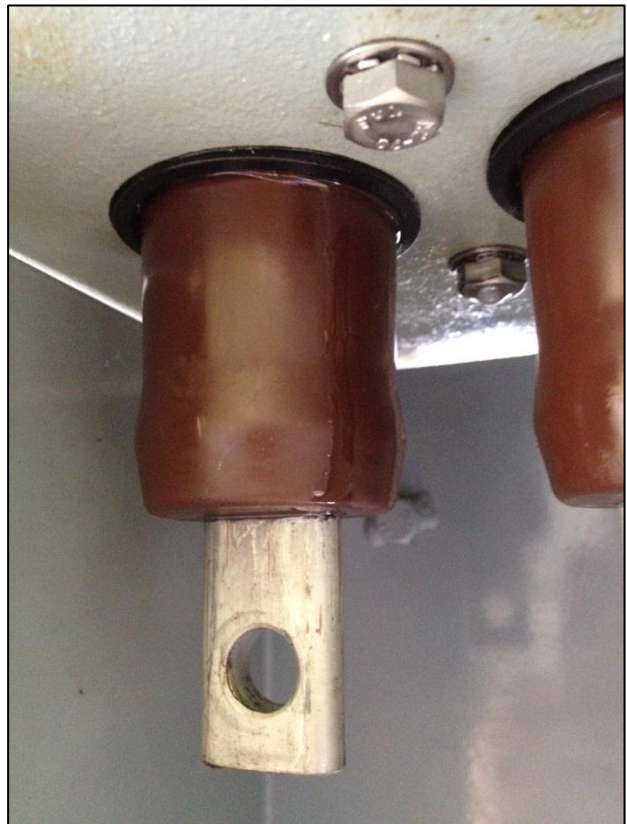
An issue has been found with [REDACTED] series oil RMUs in which the tank may leak oil, usually after invasive maintenance. This problem was brought to the attention of Energex after several leaking units were discovered by Ergon Energy. Energex has conducted checks and has found some leaks from a small quantity of RMUs. Investigations have suggested that the leak only occurs in later models in which a change of gasket design with less fixings is not providing an effective seal. Evidence has shown that the unit may be more susceptible to leaking after switching operations during maintenance without oil in the tank. The practice of switching without oil has been ceased but it is not known how many units may leak in the future as a result of these conditions.

As the leak is usually from the bottom of the unit, inside the HV cable boxes, it is not easy to check for this leak other than checking the oil level on the sight glass. Operating restrictions are in place to manage this and prevent energised operation without oil. Once a leaking unit is discovered, it cannot be repaired either onsite or economically in the workshop and the only viable action is to replace the unit with a new SF₆ insulated RMU. At this time there is no accurate data to forecast the numbers affected or the likely locations.

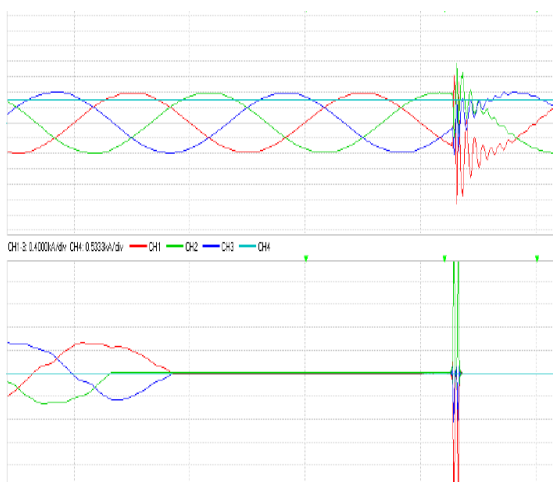
SSRVW Late restrikes on [redacted]

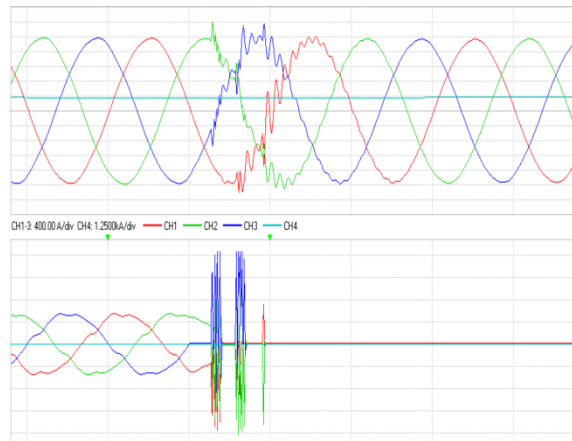
SSBBS Multiple restriking activity on HS Horizon

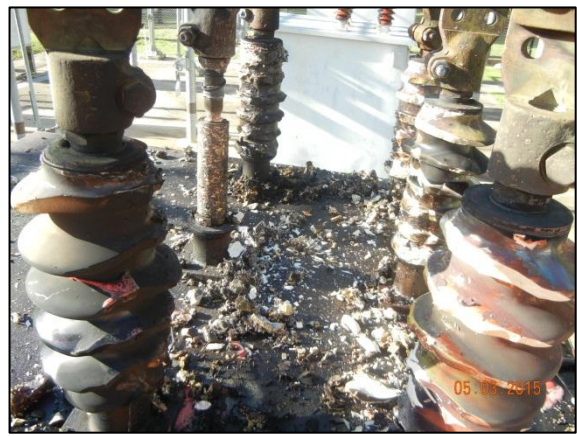
SSLTN Destruction of bushings

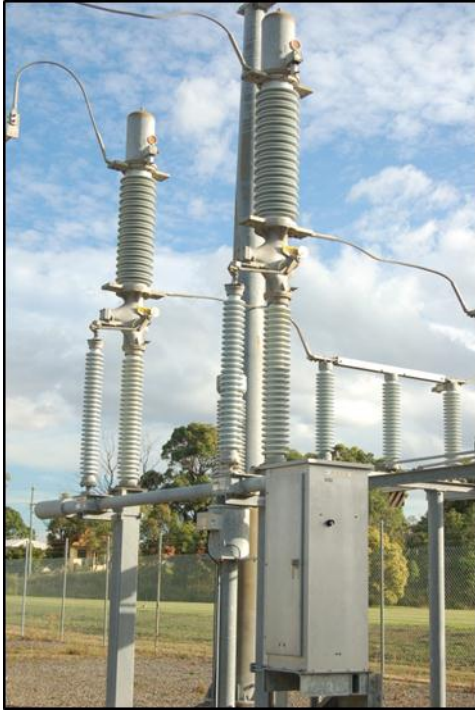
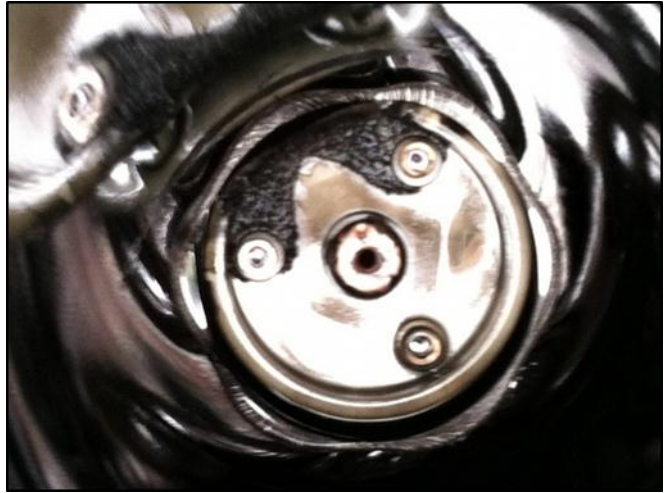
The second failure involved an outdoor live tank 110kV OCB at substation SST114 (refer photos below). During routine switching on an adjacent device the operator heard discharging sounds from within and the unit was immediately isolated. Until examination severe tracking damage was found inside the porcelain chamber. Despite regular maintenance, this CB had become unserviceable, most likely due to moisture ingress thus affecting the integrity of the internal insulation.

SST114 110kV OCB failure exterior

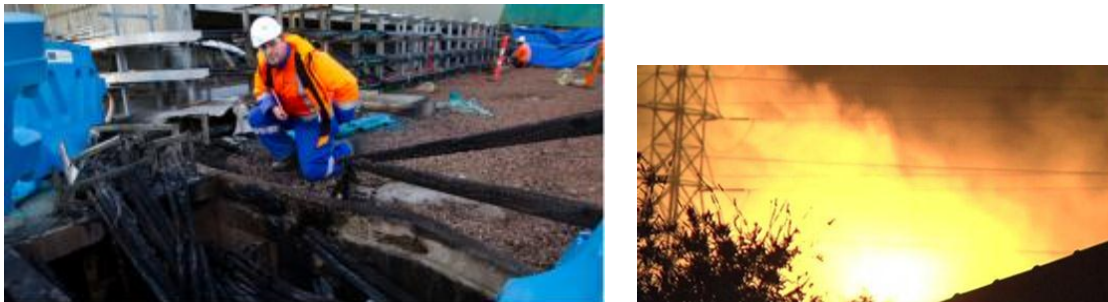
There is a reasonable probability that if one of the cables fails, that the adjacent feeder in the same route with minimum separation will also sustain damage. An incident in Auckland - New Zealand saw multiple transmission cables damaged from a single fault.

Figure 9: Penrose Substation – New Zealand 2014 – fire and damage following an oil filled cable fault within a substation⁷

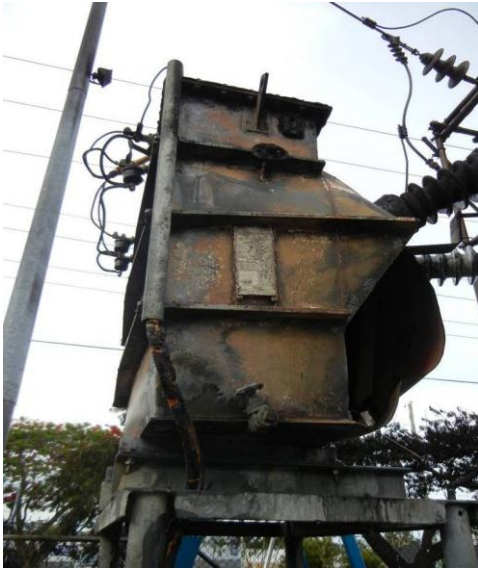
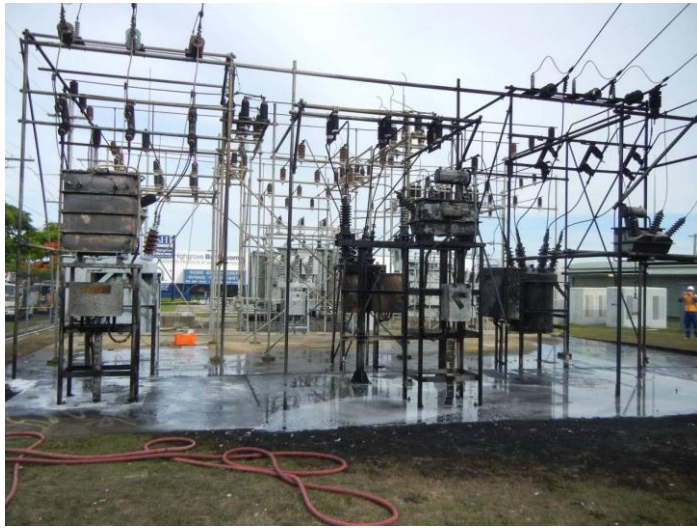
Figure 11: Station Transformer TR8 exploded and expelled 400L of hot insulating oil igniting spontaneous fires

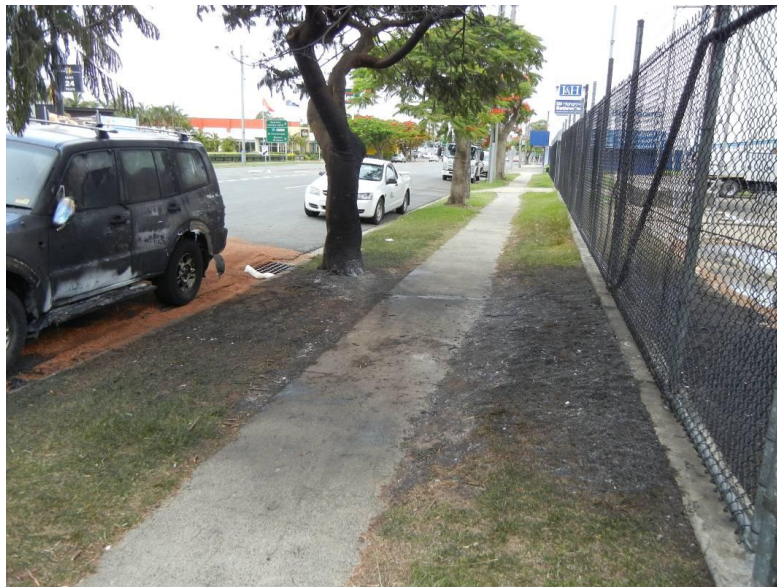
Figure 12: Ignited oil sprayed approximately 10m from the transformer, across the foot path onto the Vehicle

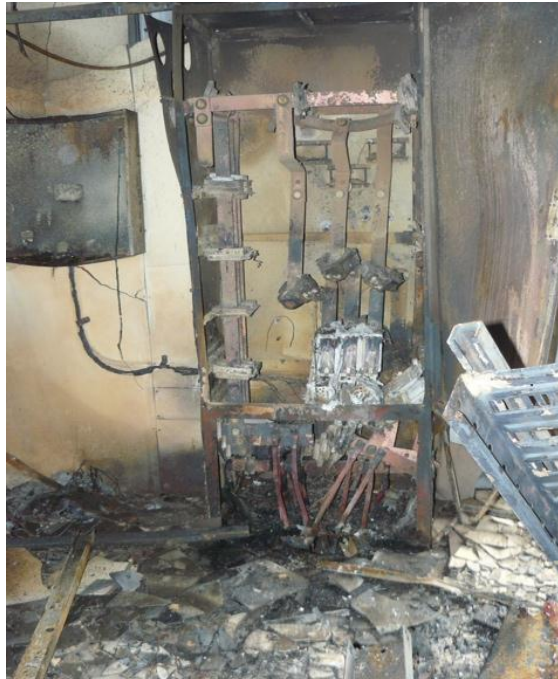
Figure 18: Entry point of LV cables to customer’s switchboard following an incident in the Energex Network

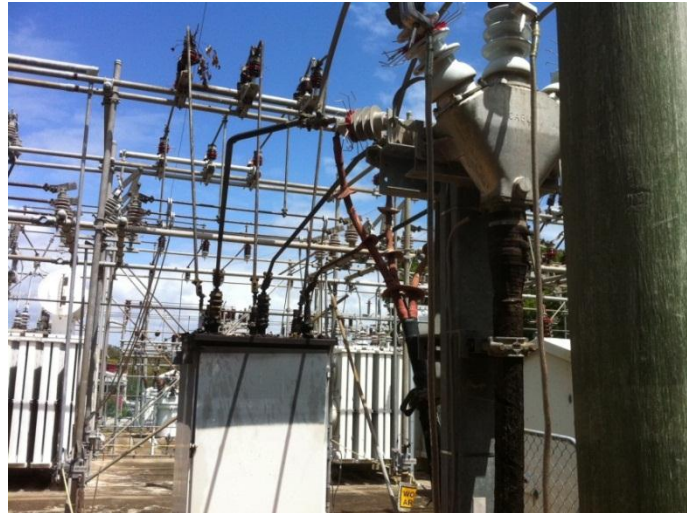
Figure 20: Extent of damage insitu

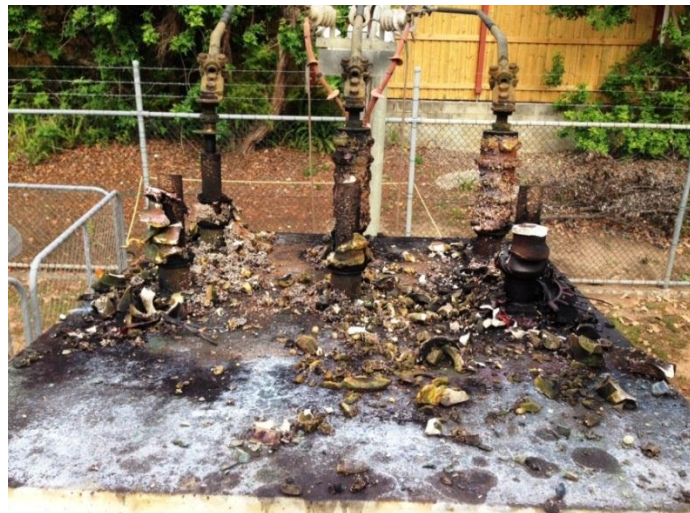
Figure 21: Extent of damage to all 6 bushings of the failed circuit breaker

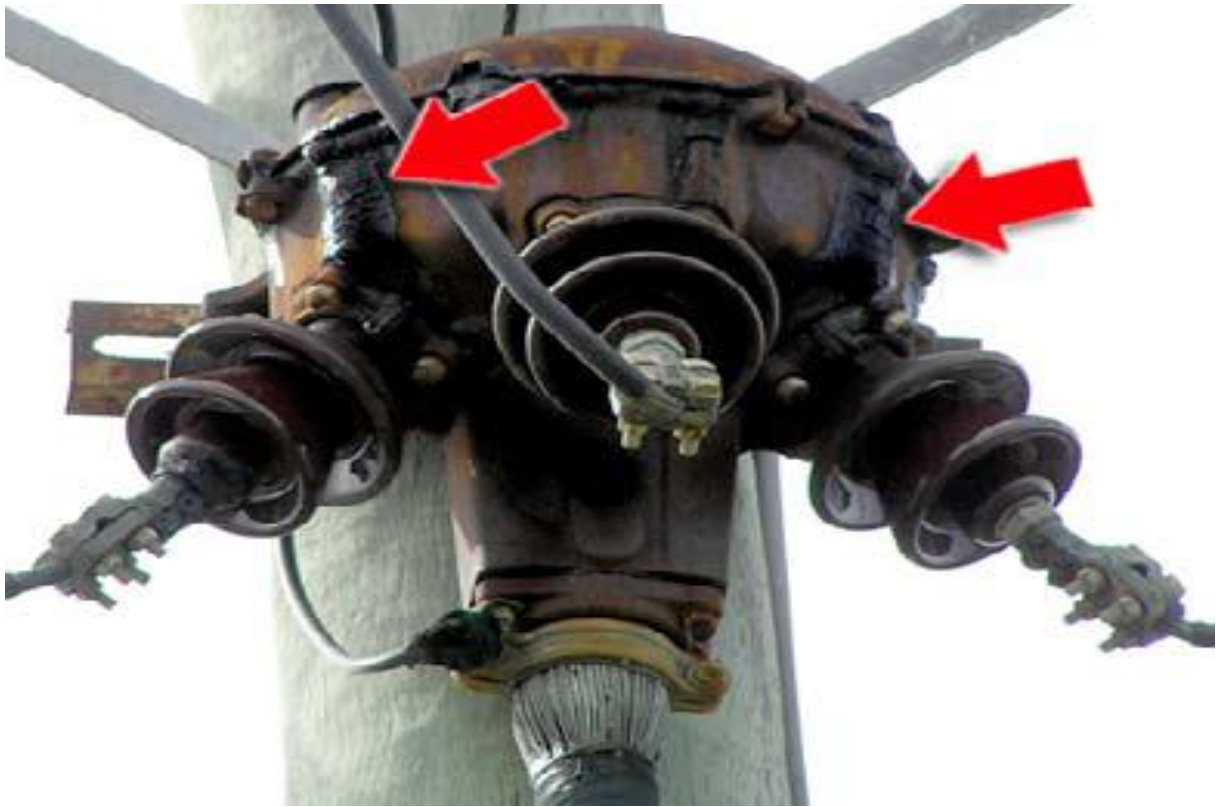
The photographs below show a cast iron 11kV pothead in service (Figure 2), one that has evidence of a pitch/fluid leak (Figure 3), the remnants of one that has suffered an explosive failure (Figure 4), and an example of leaking bitumen on an 11kV pothead (Figure 5).

Figure 3 - 11kV Pot Head with fluid leaks

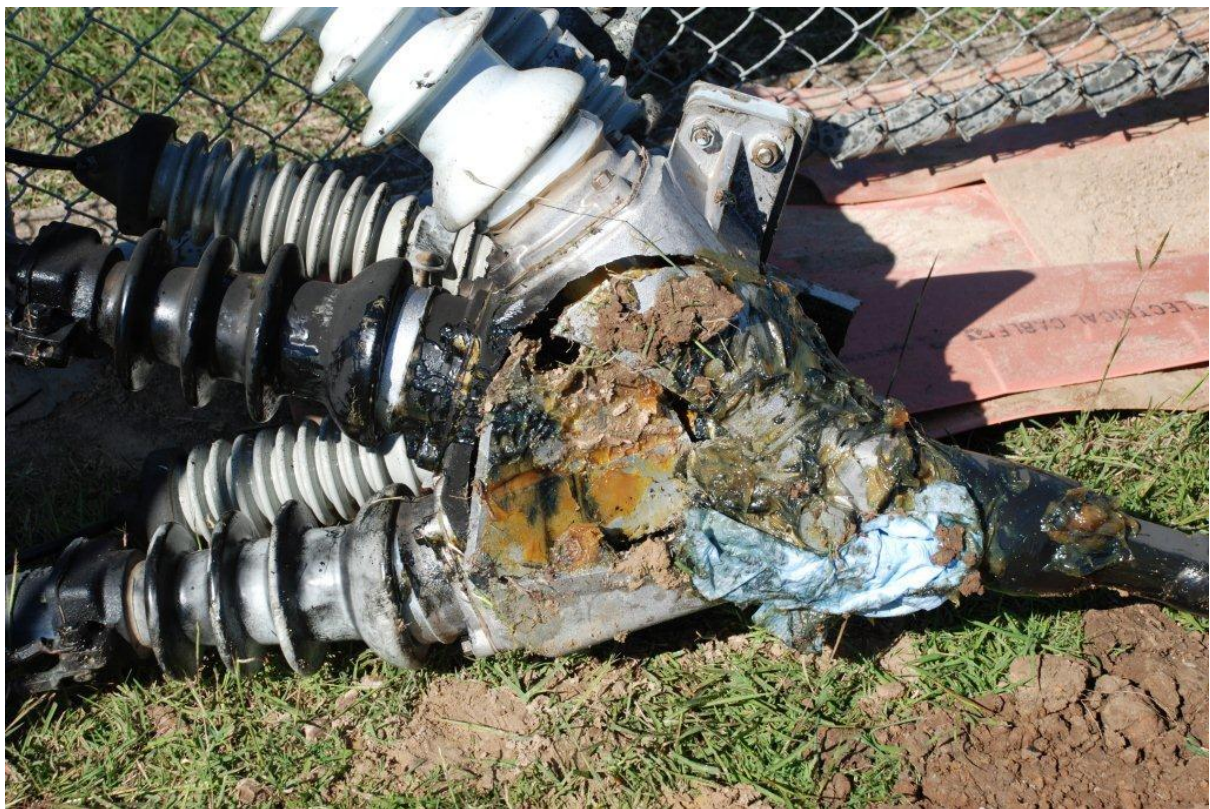
Figure 4 - Explosive Failure - 11kV Pot Head

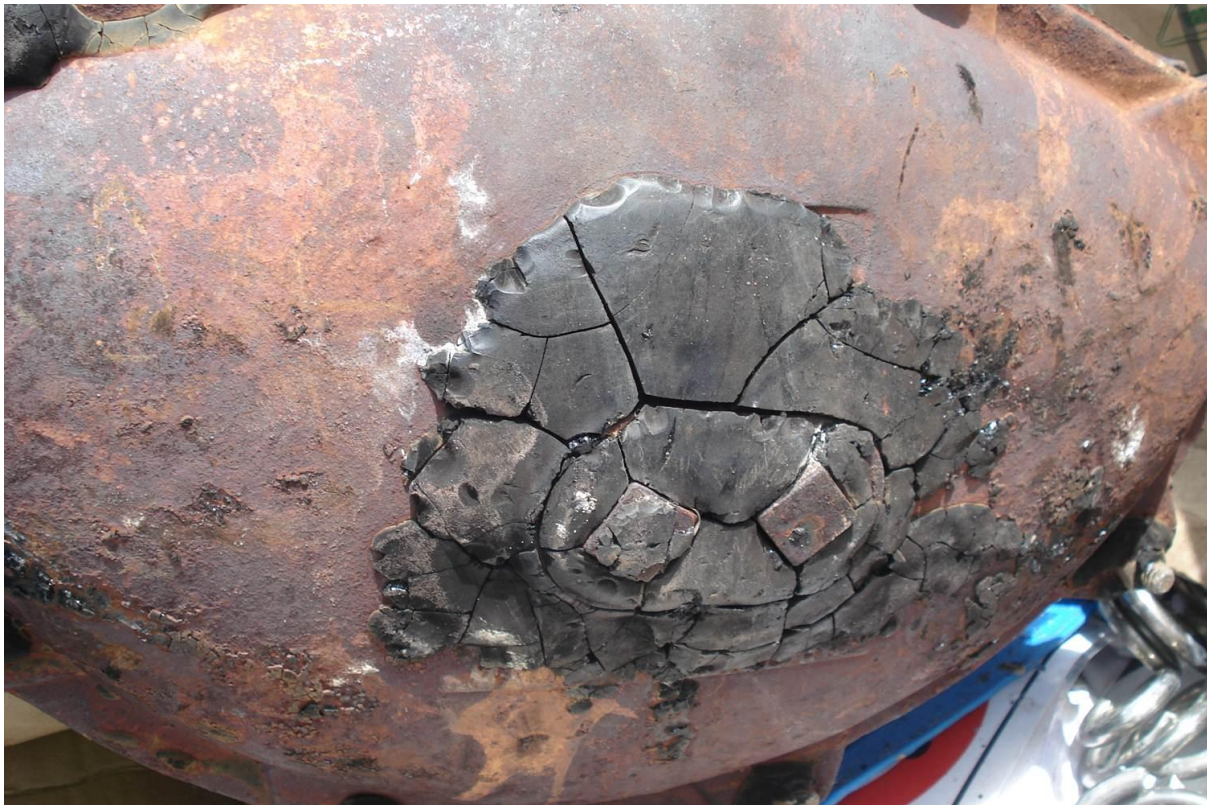
Figure 5 - 11kV Pot Head Leaking Bitumen

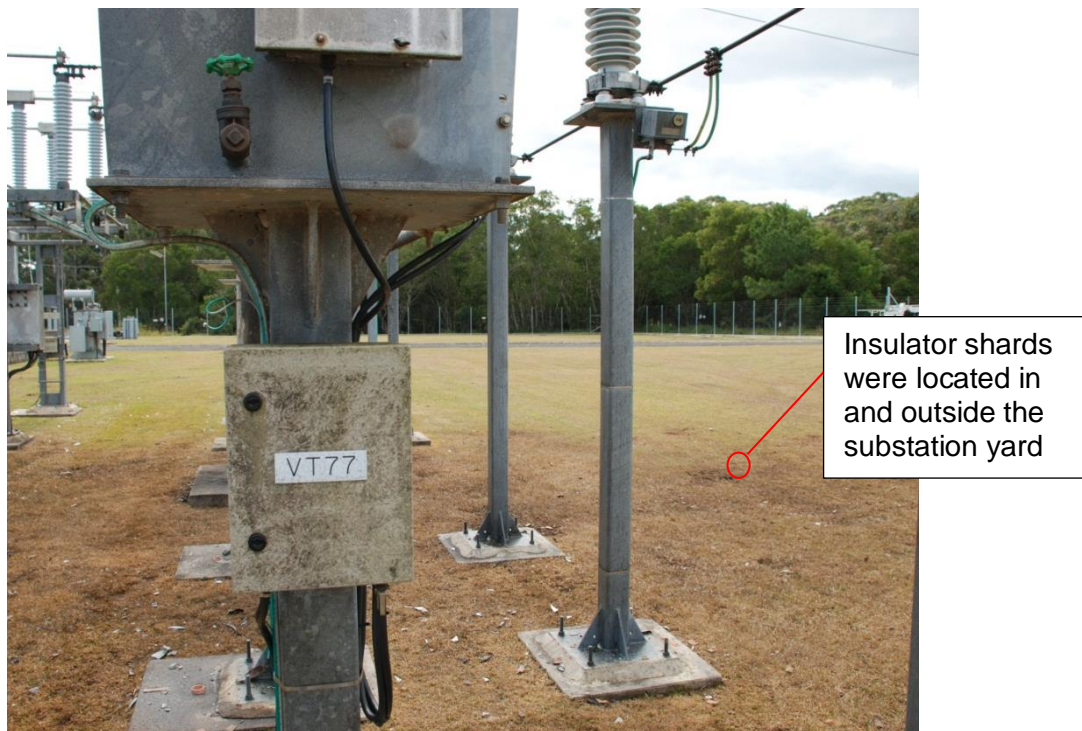
Figure 2: VT Failure at Mooloolaba – Insulator Shards Covering the Yard

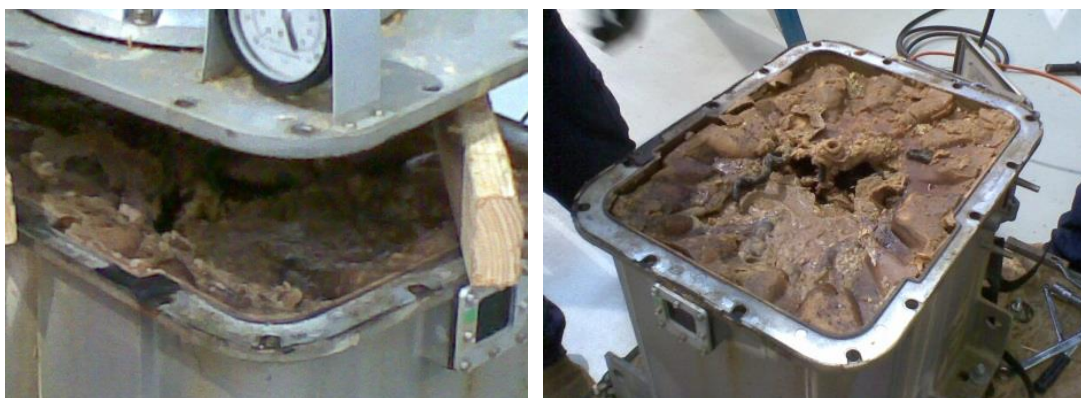
Figure 6: Poor Condition CVT¹

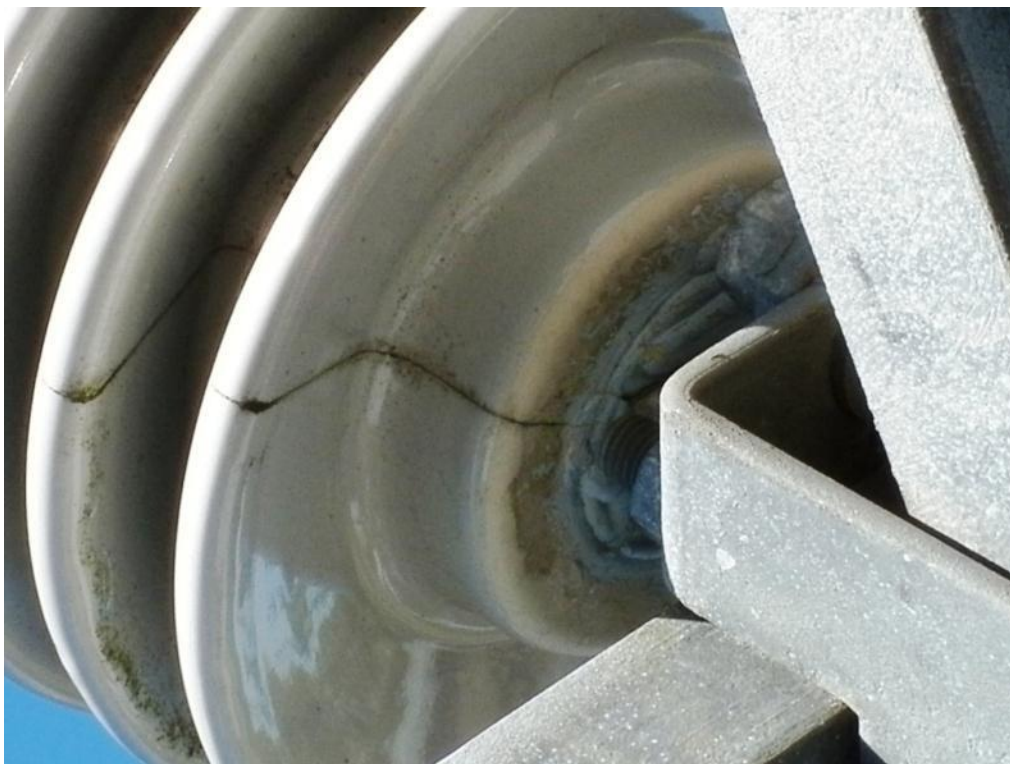
Figure 2: Large Crack on the Underside of an ABS Insulator from SST16

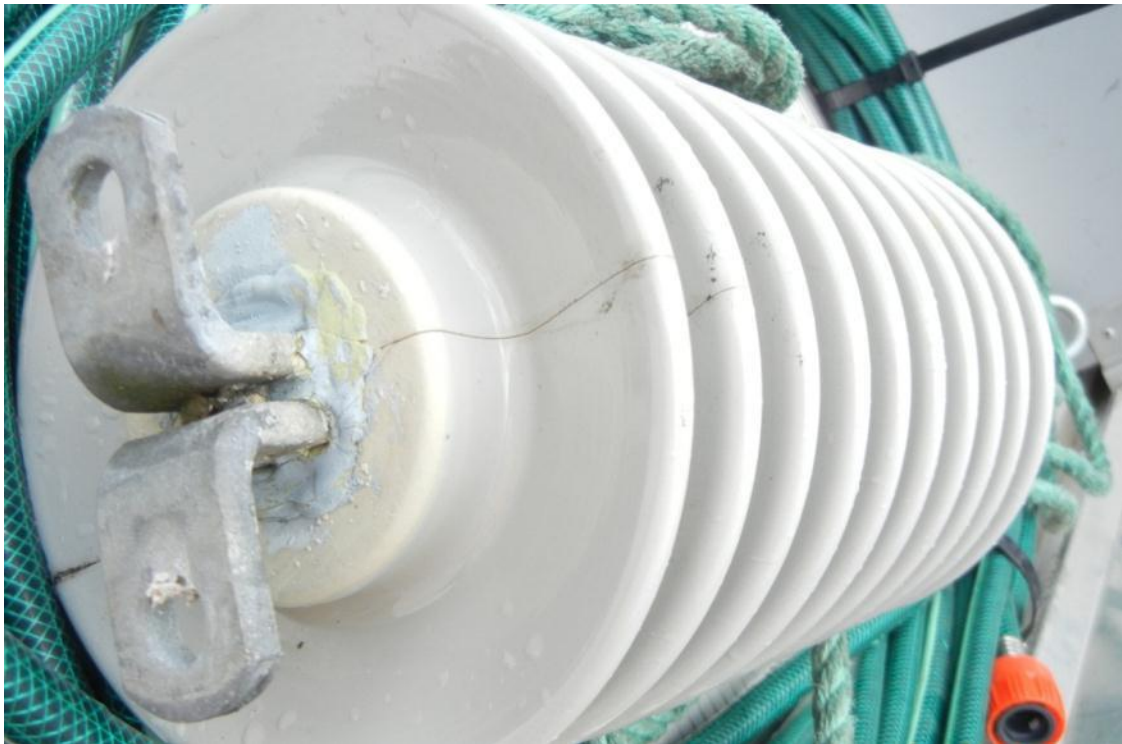
Figure 3: Hairline Crack and the Sealant on the Insulator ABS Insulator from SST16 (Nambour Substation)

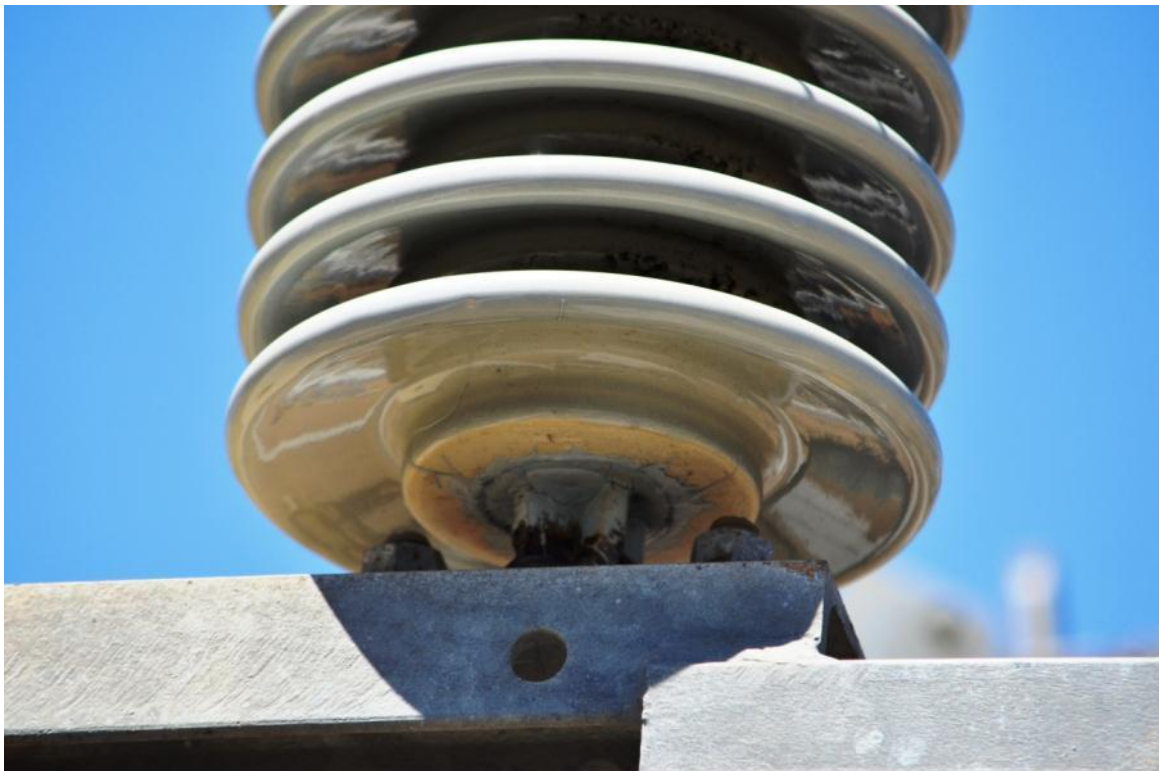
Figure 4: Signs of Pin Corrosion on the Bottom Side of the Isolator Insulator – T136 (Abermain Substation)

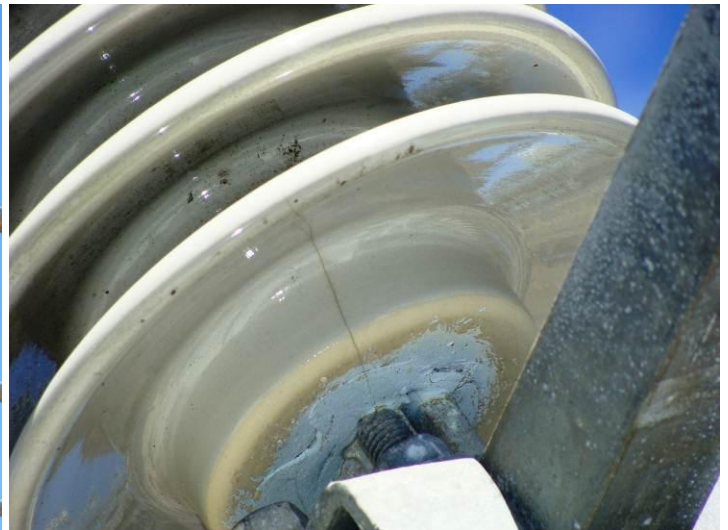
Fig 1- A typical 33 kV [REDACTED] isolator in switchyard Figure 2- Hairline crack on the support insulator.
