Jemena Electricity Networks (Vic) Ltd

Replace Coburg North (CN) Zone Substation Switchgear

2022 and 2023 Business Case

31 January 2020

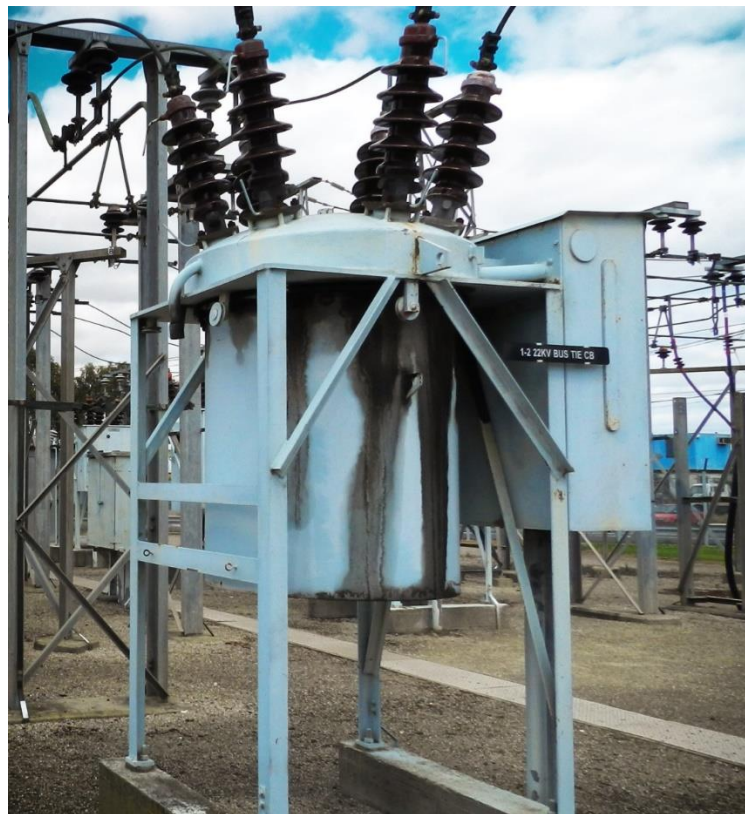
Figure 2–2: CN 22kV Switchgear

There have been 26 recorded defects associated with the CN Email 345GC 22kV switchgear and recorded in JSAP (JEN's Maintenance Management System). In addition, 32 defects have occurred at ZSS AW (Airport West) and 24 defects have been reported for ZSS BD (Broadmeadows). AW, BD and CN all have the Email 345GC switchgear on the JEN Network. However, the CB replacement at CN is being considered a priority and the CB replacements at AW and BD will be addressed in separate subsequent business cases. AW also has the Crompton Greaves 30-SFGP-25A CBs. Neither AW nor BD has the Siemens 3AF CBs. These defects are shown in Table 2-2,

It has been found that the 345GC CBs suffer from several issues. The predominant issue is bushing defects. The bushings have been found to be leaking pitch and a program was initiated to refurbish all bushings on the 345GC CBs on the JEN. In recent years the main contact pull rods have experienced failures. These pull rods were made from Permalin wood, which is no longer available. These pull rods have been replaced with fibre glass pull rods. In 2014 a project was initiated to replace pull rods with fibre glass pull rods on all transformer and cap bank CBs on JEN.

There has been no recorded defects on the Siemens 3AF CBs. However, due to excessive switching duties, on the cap bank CBs in particular, some of the Siemens 3AF cap bank CBs have had their interrupters replaced.

The Crompton Greaves CBs have a history of ongoing issues. The main issue was related to SF6 leaks from the interrupter poles. A number of CBs on JEN have had their interrupters refurbished. This is an ongoing issue and will only be resolved with the replacement of the CBs.

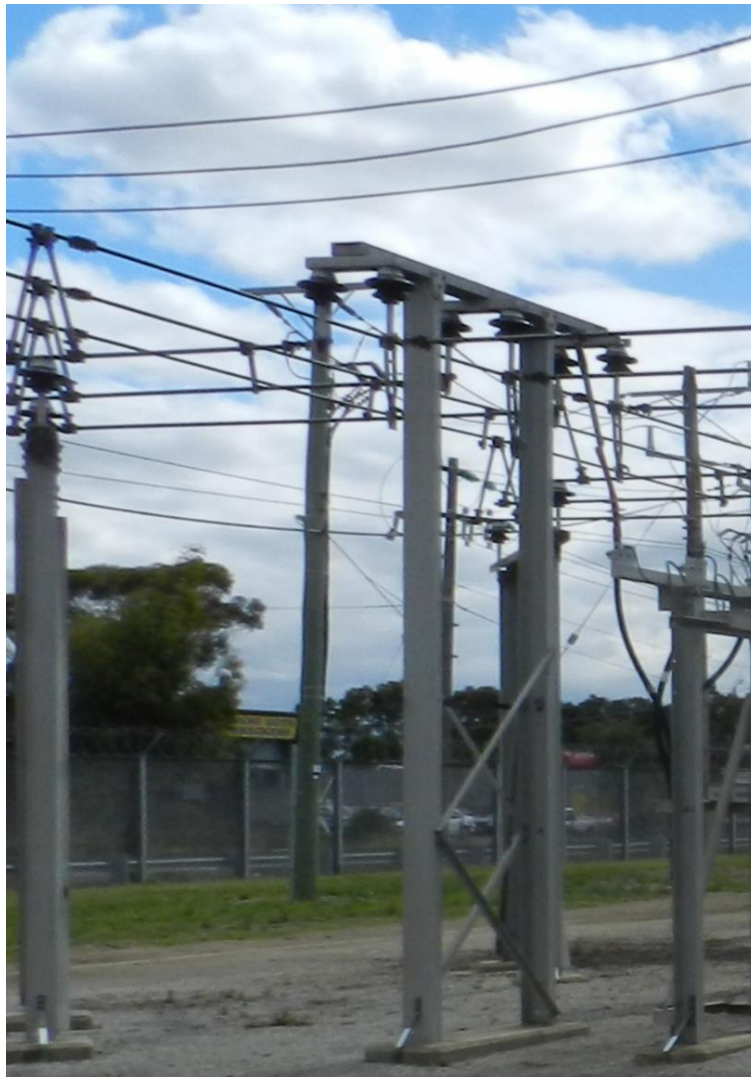
Figure 2–3: CN 22 kV Transfer Bus

There have been two recent incidents associated with the failure of 22 kV pin and cap type insulators within Victoria as follows:

1. In circumstances similar to the arrangement in Figure 2–3, an insulator had sheared from the pin and resulted in the bus dropping to 1 m above ground level. The bus remained alive and was found by an employee.
2. An isolator was opened using a HV switch stick when an insulator had sheared from the pin. The live conductor then fell onto an employee's shoulder.

These insulators consist of a galvanised steel pin cemented into the porcelain and over time as moisture corrodes the pin, the expansion of the rust causes the porcelain to crack and shear. Although various means are used to detect a possible failure such as visual inspection, maintenance and off line PD detection, this defect may still remain undetected until an isolator is operated and the insulator shears off completely.

If the Transfer buses were to remain in-service, the 22 kV pin and cap insulators will be replaced to mitigate a known safety risk.

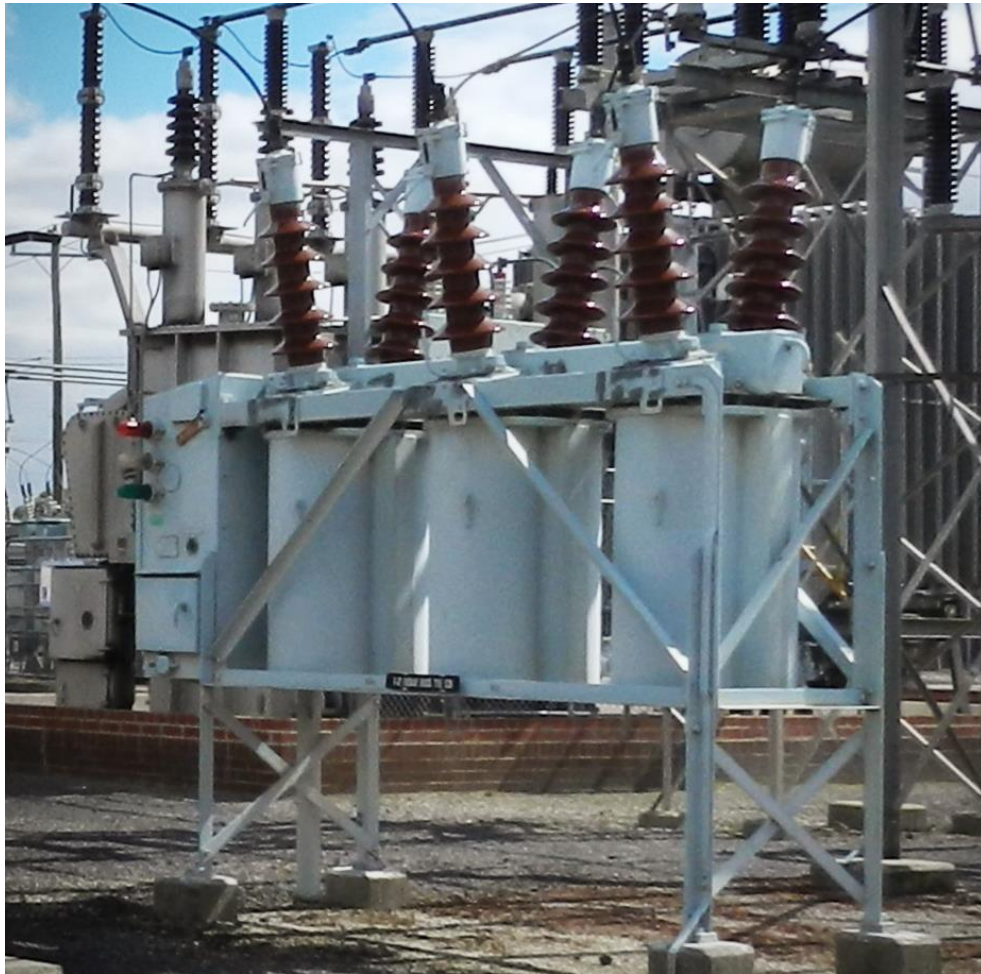
Figure 2–4: CN 1-2 66kV Bus Tie CB

There have been no recorded defects on the 1-2 66 kV Bus Tie CB on the JEN network; however, there are records of this type of CB, in the Victorian Electricity Industry, with a history of defects and catastrophic failures. Please refer to Section 2.2.1, dot point 5 for further details.

There were two catastrophic failures of this type of CB at Brooklyn and one at West Melbourne Terminal Stations in the late 1990's and early 2000's and these failures related to the 66 kV bushings as the bushing DLA (Dielectric Loss Angle) had deteriorated to the point of failure.

These CBs are no longer supported by the manufacturer and consequently, spare components such as 66 kV bushings, turbulators, solenoids and mechanism components are no longer available. The failure of 66 kV bushings is a risk to the safety of field crews. Continued maintenance and testing will not prevent the failure of a bushing as the DLA and PD continues to deteriorate. The cost of engineering new replacement bushings, procurement and installation would be comparable to a new CB installed. Replacement of the bushings alone does not address the mechanical wear and lack of spare parts.

There has been a defect identified in the mechanism of these CBs involving the retaining of a shaft by a washer that is peened on the end of the shaft. This indicates component failure due to mechanical wear and has resulted in damage to the mechanism. New component, a pin, was designed and manufactured, costing in excess of \$5,000 to develop, as original spare parts were not available. An inspection of all of these CBs has been undertaken and a plant defect notice issued. This shows that the CBs are entering a wear out phase and due to lack of spare parts, components are being re-engineered independently outside of the original equipment manufacturer specification which takes time and is costly.
