Power and Water Corporation Preliminary Business Case

PRA34420 Alice Springs Corroded Poles

PRA34420 - ASP Corroded Poles

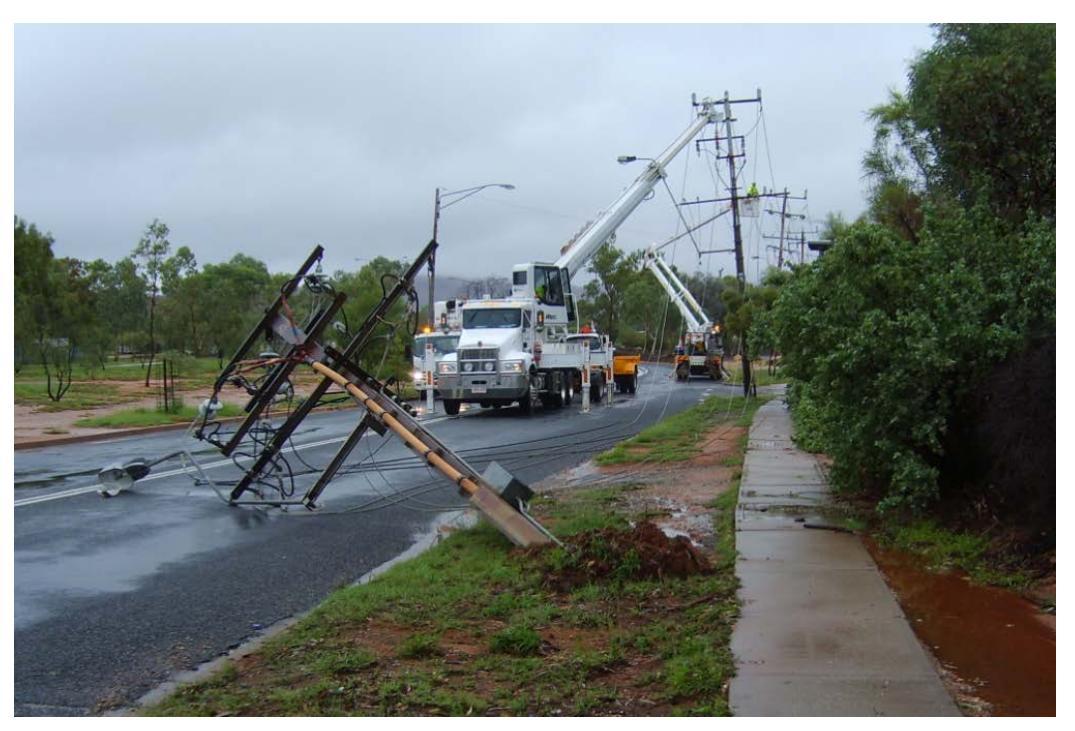
The failure of a steel power pole due to corrosion of the pole footing in Alice Springs in January 2015 drew concern regarding the condition of pole assets in the Alice Springs area. The pole had been in service for approximately 40 years before it failed, which is considerably less than the expected service life for steel poles of 60 years and the average life in the NEM of 53 years. In the days up to and including the failure, the area had received 130mm of rain, double the average rainfall for January¹. This incident triggered an investigation into the condition of pole footings for poles of similar design in the Alice Springs region and specifically in the High Salinity Area (HSA), as this was considered to be a significant contributing factor to the failure.

Figure 1 - Undoolya Rd Pole Failure 10/01/2015 Due to Footing Corrosion

The investigation of the failed pole in 2015 identified that in addition to high soil salinity, the type of footing construction was a key factor. Typically poles are either direct buried or "top-and-toe". Since the early 1990's full concrete encasement for highly loaded poles became more common. The high soil salinity was deemed to have accelerated the corrosion of the unprotected steel below the ground between the "top-and-toe" which led to the pole failure.

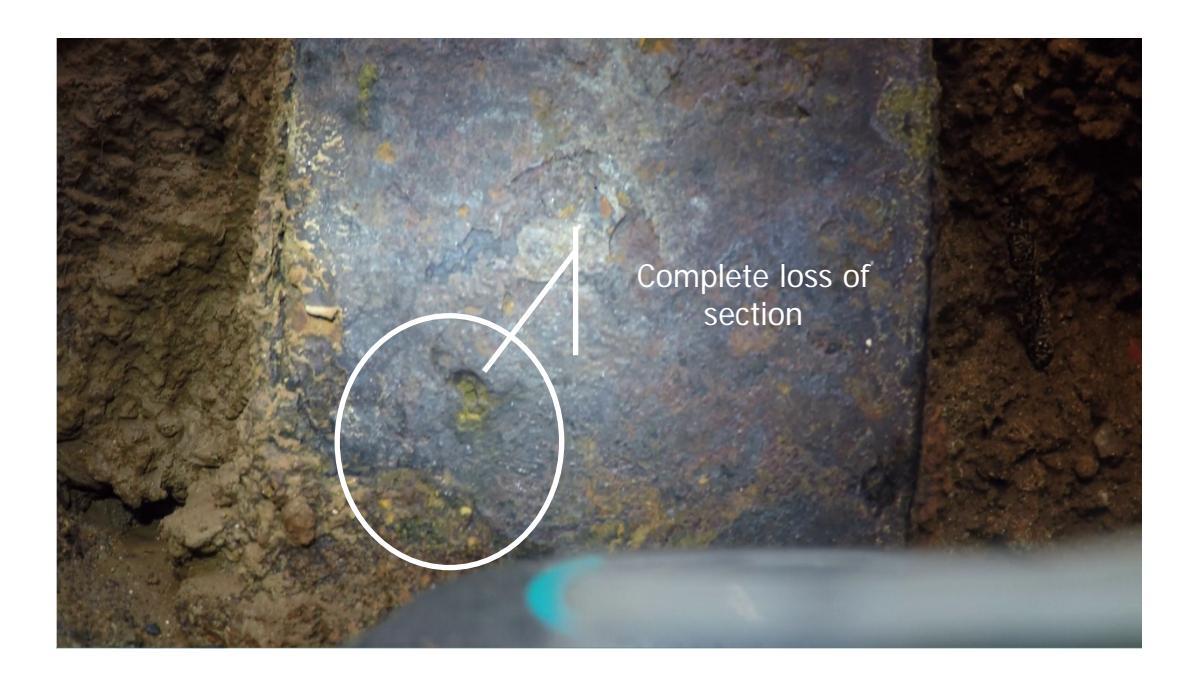
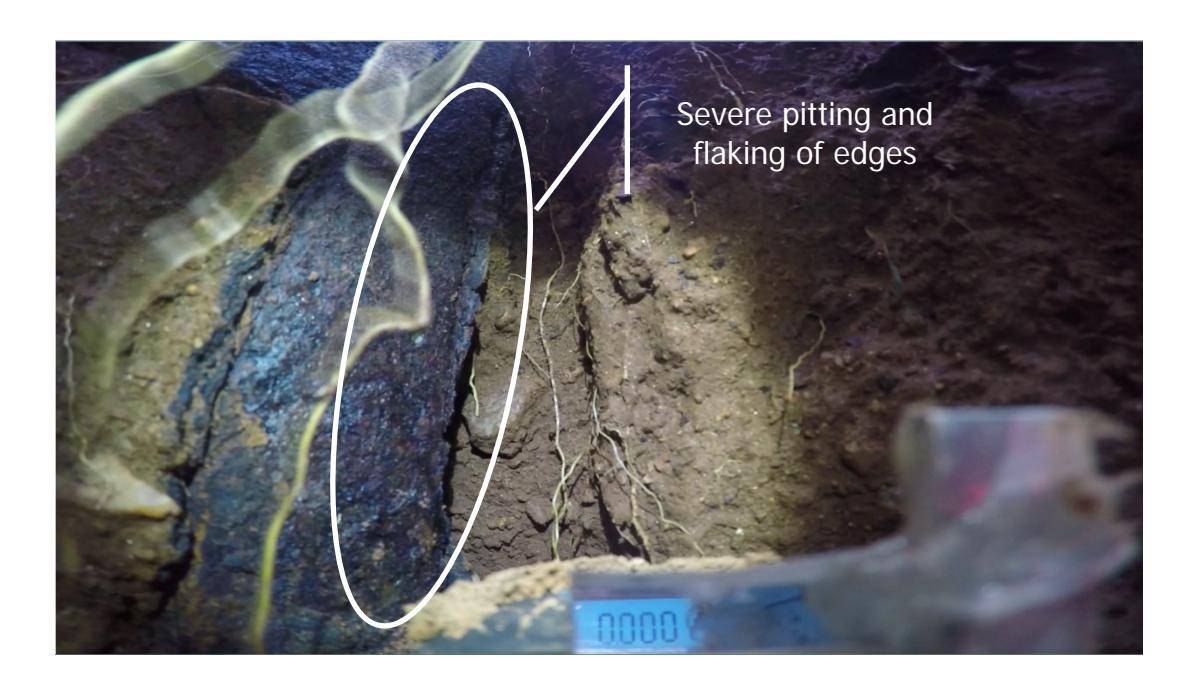
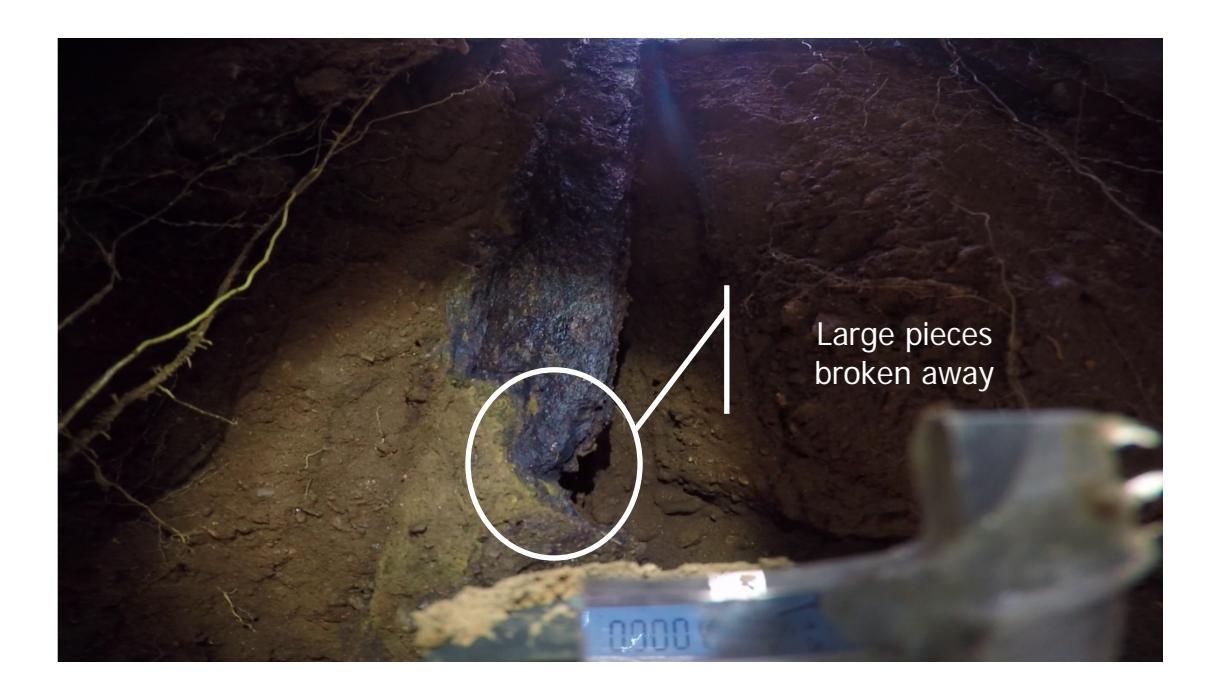
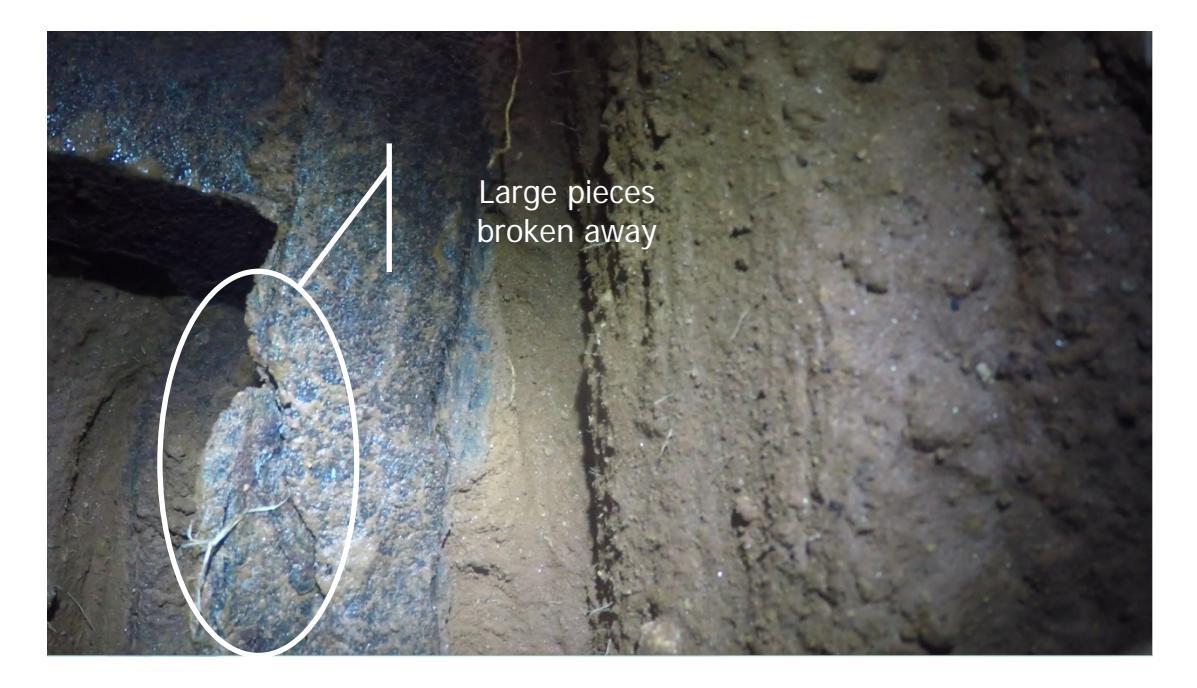
SAMPLE OF PHOTOS FROM INSPECTION VIDEOS

Investigations to date have shown that simple visual inspections of the footing cannot provide a reliable assessment of footing condition. They can provide indication if corrosion is consistent in an area by identifying only the most severe corrosion, and only in circumstances where sections of pole have fallen away. Sections of pole that look in reasonable condition have also been found to deteriorate quickly in sections covered by concrete i.e. in top and toe footings. A combination of visual inspections and sample intrusive tests is proposed to assess each inspection area and determine treatment requirements.

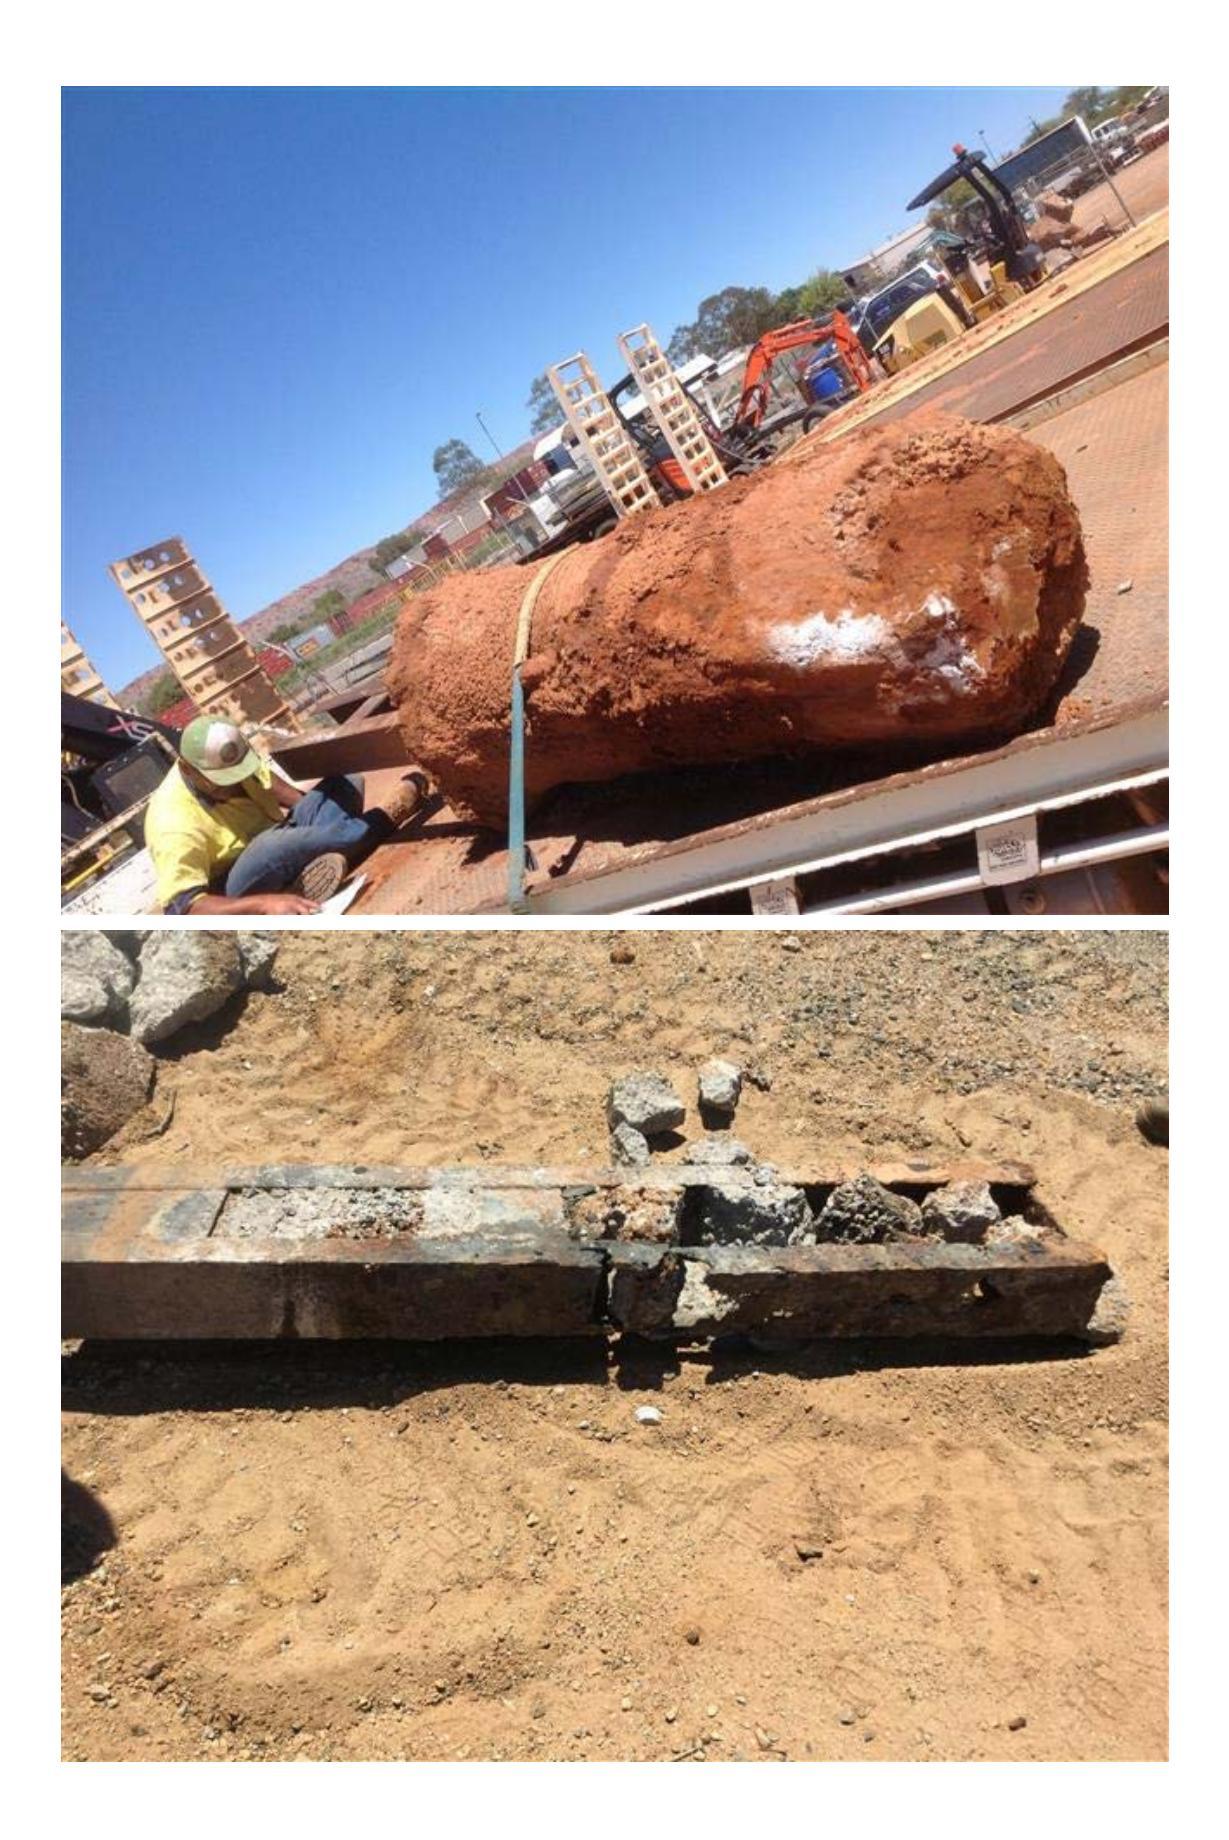
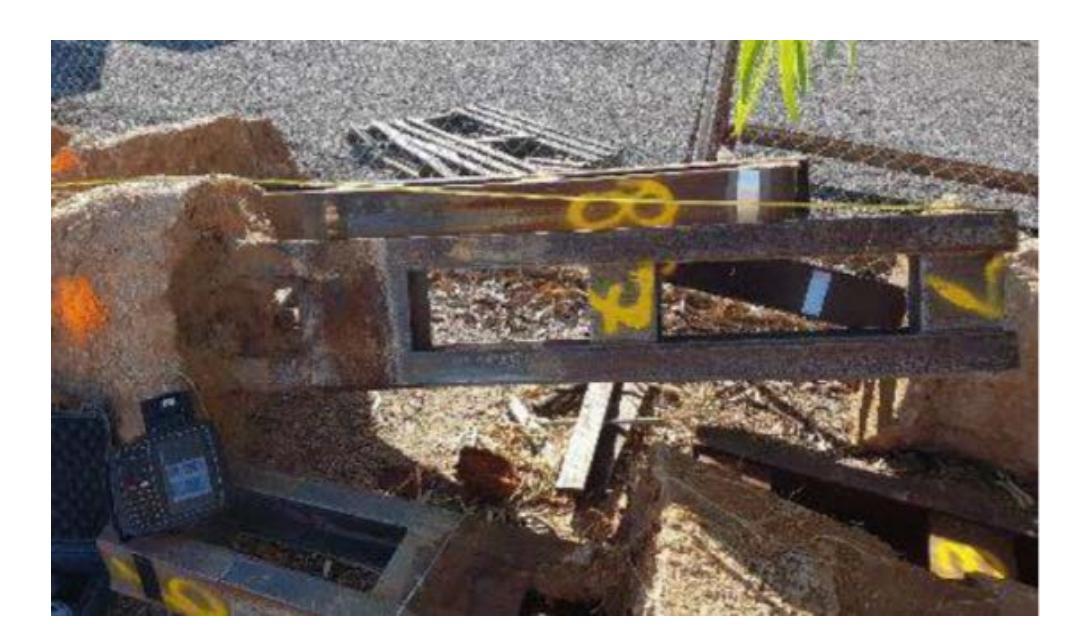
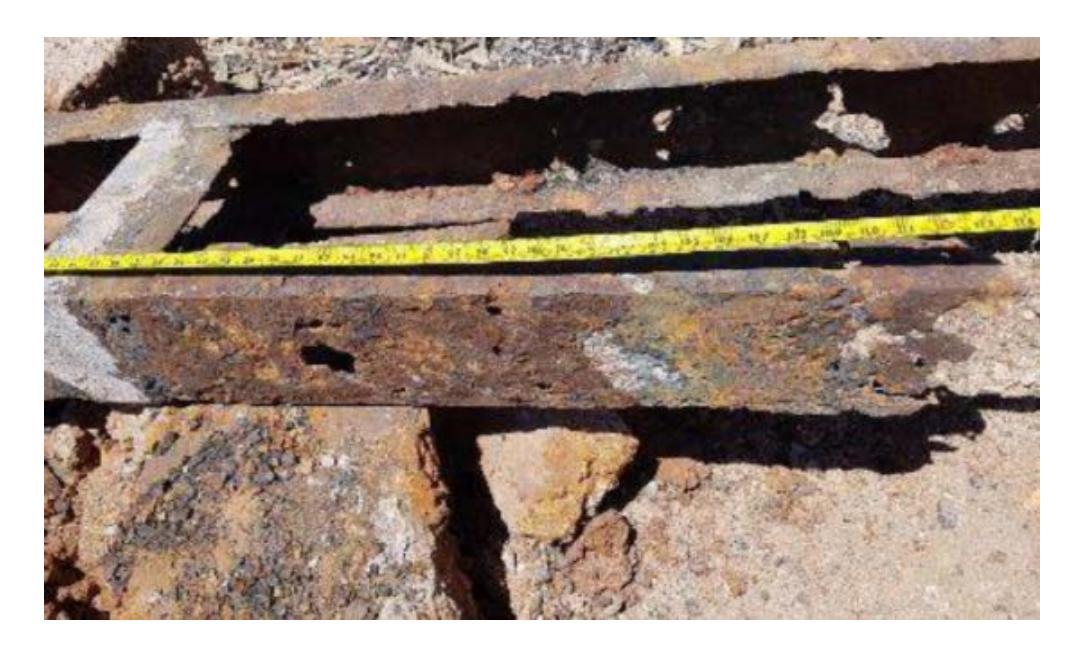
SAMPLE OF PHOTOS OF CORROSION OF CONCRETED FOOTINGS

It was also thought that pole footings with full depth concrete footings would be at least partially protected from the corrosion mechanism; however sample inspections have since confirmed that no protection was provided. While concrete can provide corrosion protection, this was not its purpose and installation procedures reflected this.
