Program Business Need Identification

Power and Water Corporation

NMP5 (PRD33435)

Lake Bennet Feeder Conductor Clearance Rectification

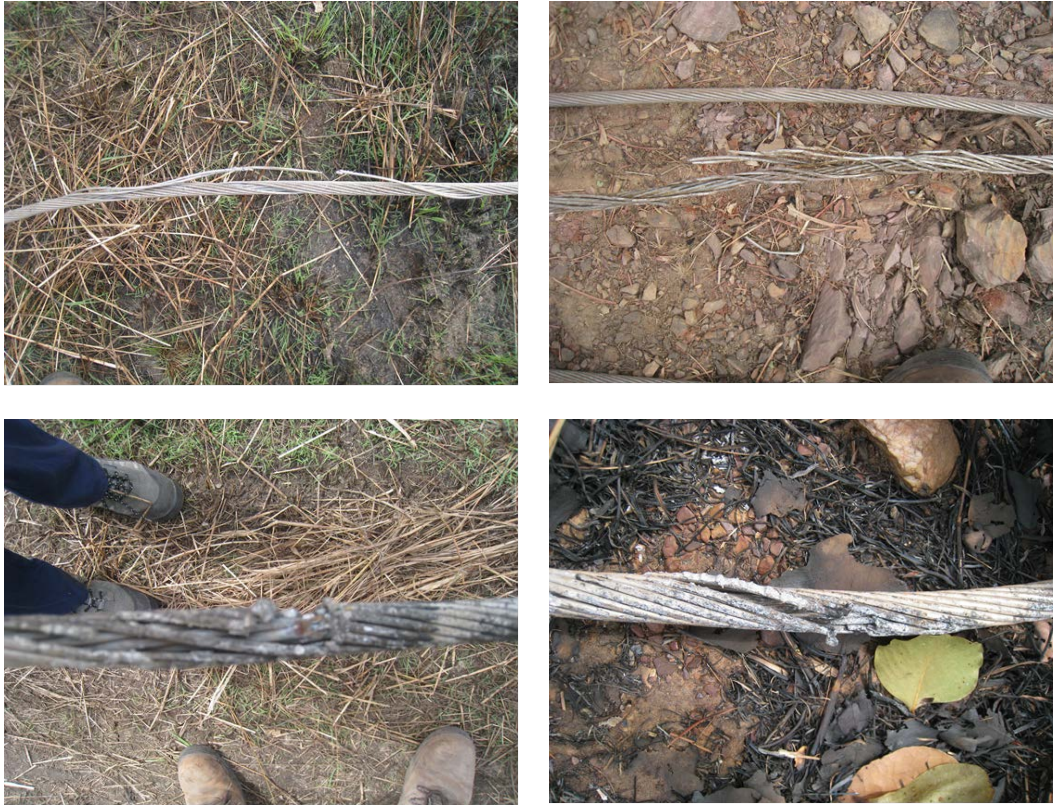
There is a history of defects found on the Cockatoo conductor on the Lake Bennett feeder, including:

- Burnt conductor
- Broken strands
- Conductor corrosion

The widespread presence of these defects was confirmed during recent maintenance and repair works undertaken on the feeder. Figure 1 shows some photos taken during these works.

Figure 1 – Cockatoo conductor photos showing broken strands, burning and corrosion

The program will re-conductor the Cockatoo portion of the Lake Bennett feeder install mid-span poles to ensure that ground safety clearance are met. The program will be undertaken during the next regulatory period, 2019/20 to 2023/24. It is expected to cost █████ million over the 5 year period, and the strategy will bring the Lake Bennett feeder up to acceptable standards within the regulatory period.

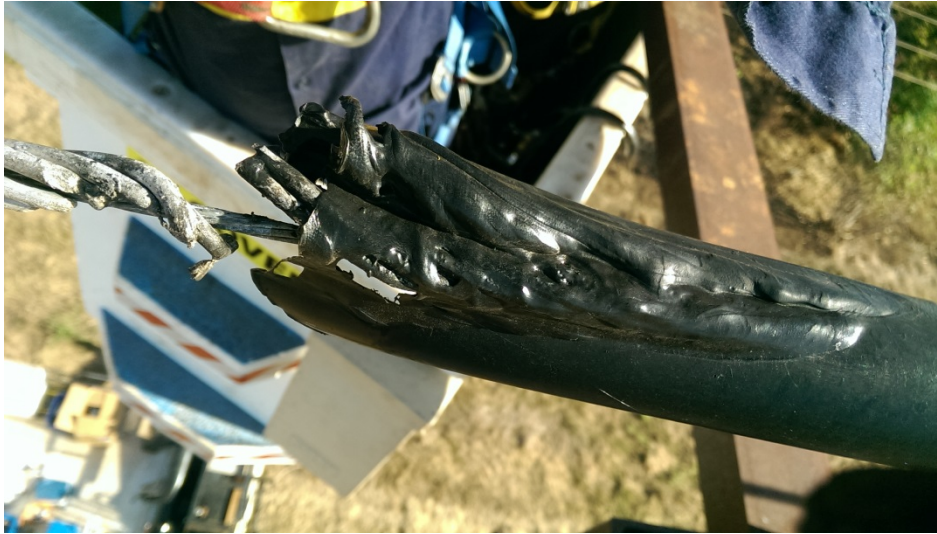
The Lake Bennett feeder is also affected by the “poly-pipe” corrosion issue. Widespread damage to overhead conductors has been identified where “poly-pipe” style bat protection has been used. This style of protection is used widely in the Katherine region and sporadically in Darwin’s rural area. The risk associated with this damage is conductor failure and wires dropping onto the ground. Anecdotal evidence suggests that the Cockatoo conductor type is not affected as badly as other conductor types but this has not been comprehensively tested.

Figure 2 shows an example of severely corroded conductor caused by the “poly-pipe” bat guards.

Figure 2 – Damaged conductor Due to “poly-pipe” bat guards
