Cockatoo Conductor Replacement Program

Regulatory Business Case (RBC) 2024-29

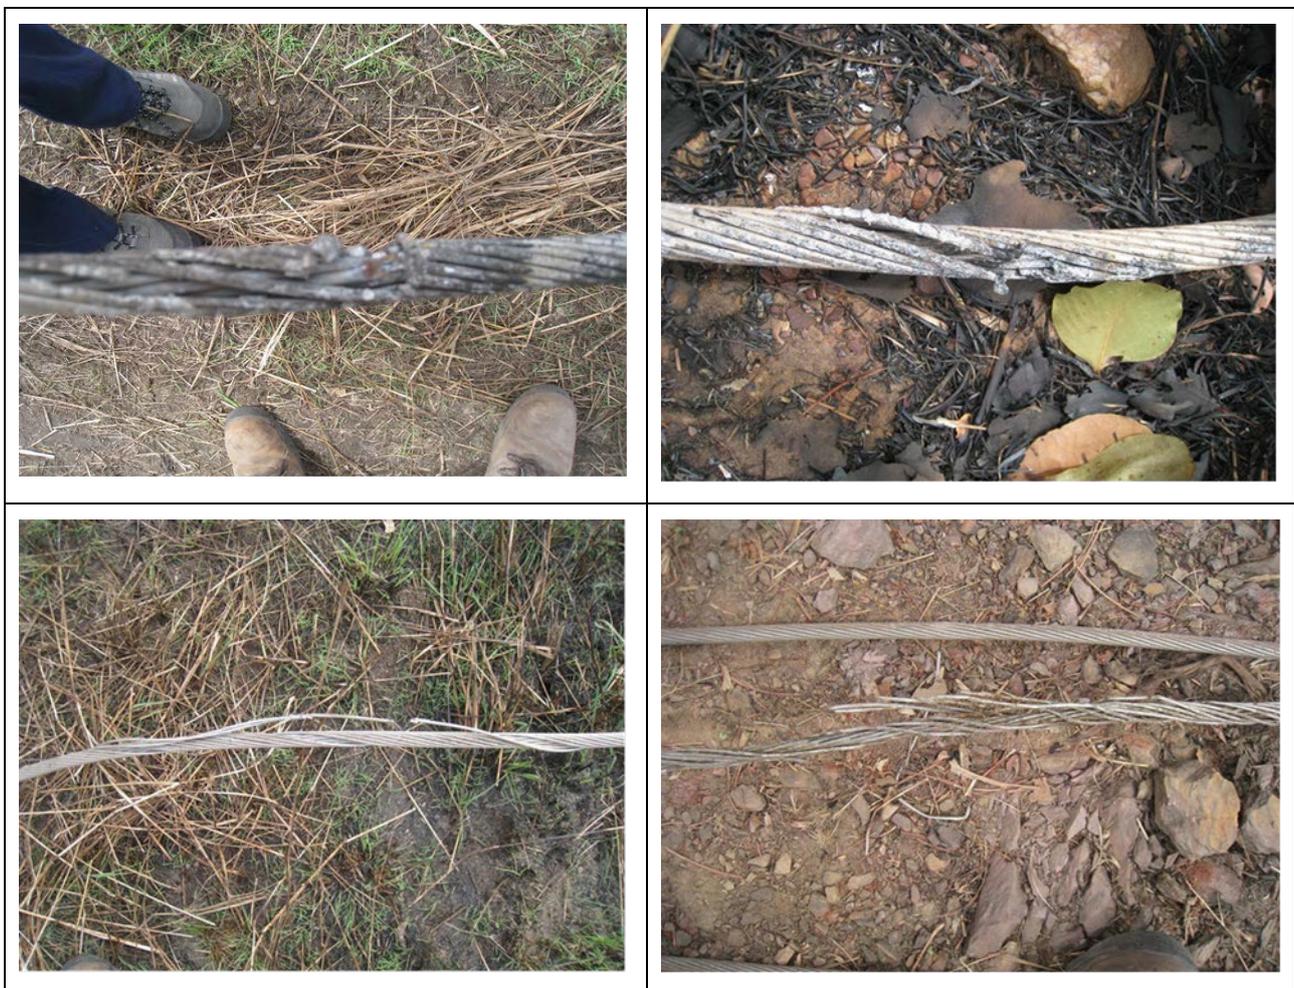
There are various issues affecting the operational performance of this feeder that demonstrate it has reached the end of its serviceable life. The major issues are conductor damage, failure of conductor strands and corrosion. The conductor has been reported by field crew as fatigue failing, meaning it is failing due to deteriorated condition.

Figure 4 Cockatoo conductor photos showing broken strands, burning and corrosion

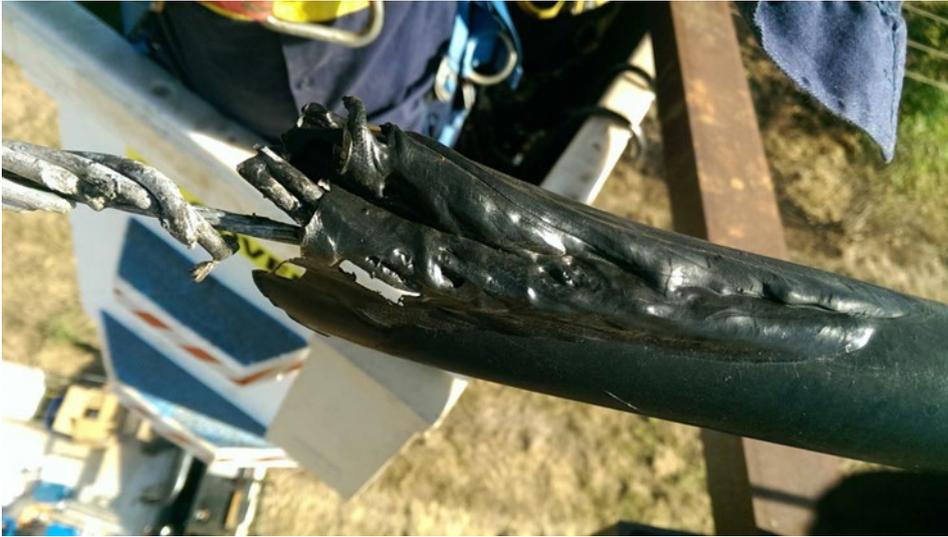
The deterioration of the cockatoo conductor is also accelerated by the “poly-pipe” style bat protection that has been installed. The Poly-pipe bat guards provide a physical barrier and prevent bats causing a short circuit between phases, however, the pipes can allow water ingress which remains in contact with the conductor and accelerates corrosion. Eventually the corrosion results in failure of the conductor.

Figure 5 Damaged conductor Due to “poly-pipe” bat guards
