## Angle Park North Business Case

2020-25 Revised  
Regulatory Proposal  
10 December 2019

# Angle Park North Business Case

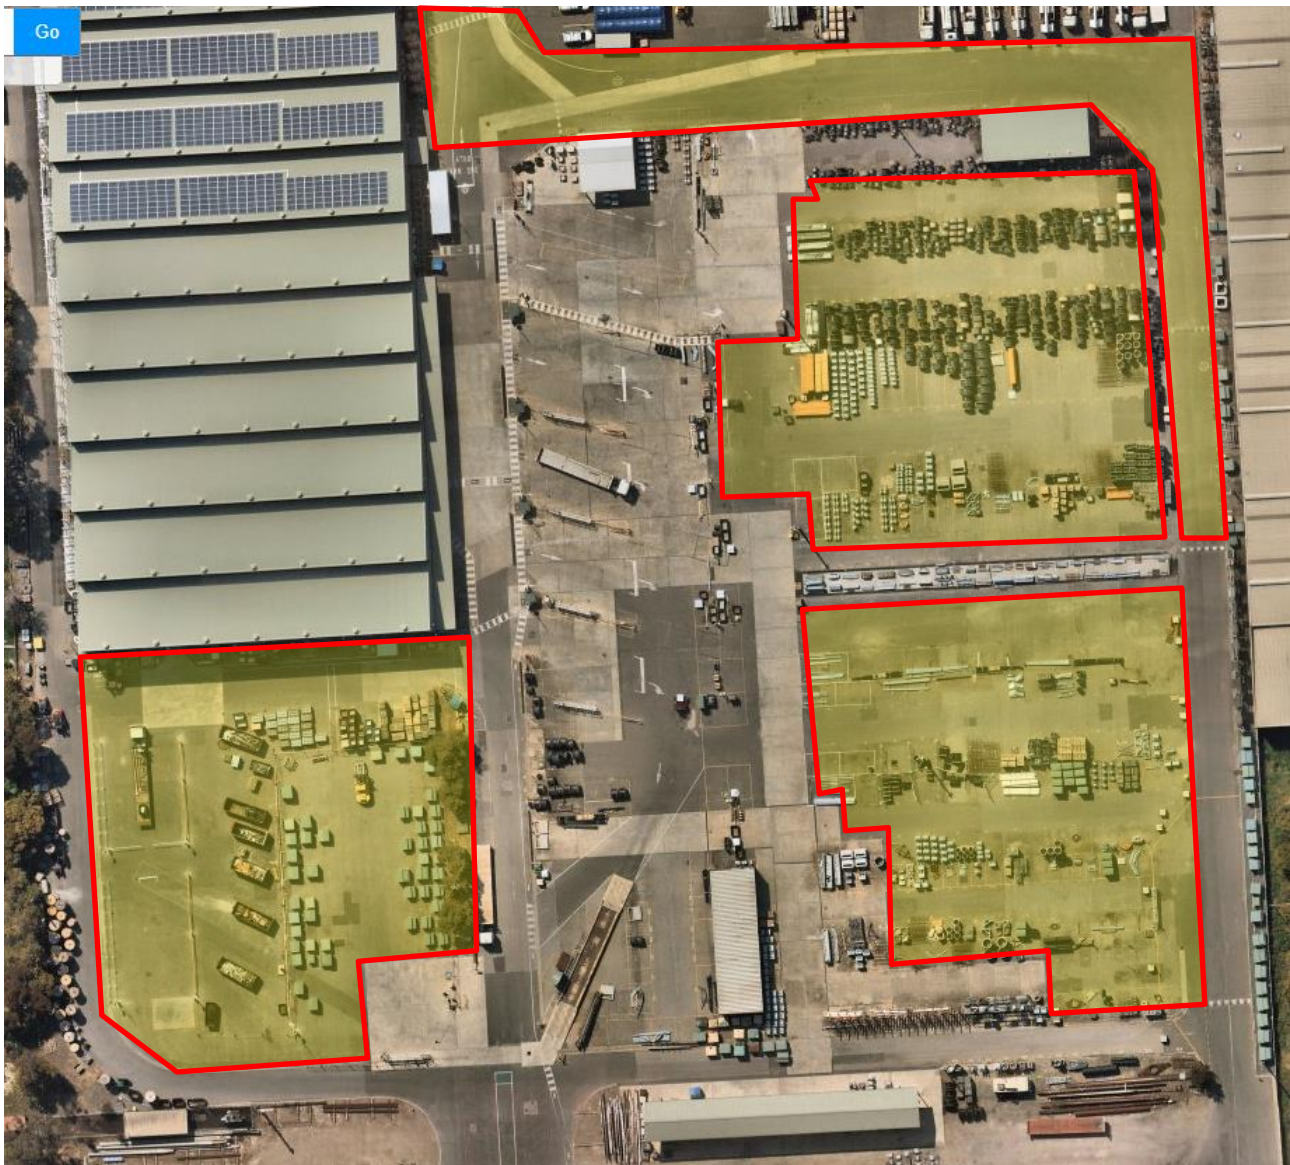
**Figure 6 Diagram indicating areas of pavement in poor condition**

The diagram above indicates the areas across the pavement in the worst condition, including the salvage area, the various outdoor storage zones and the main roadway into the logistics facility. These areas of very poor condition affect various activities on the pavements, including:

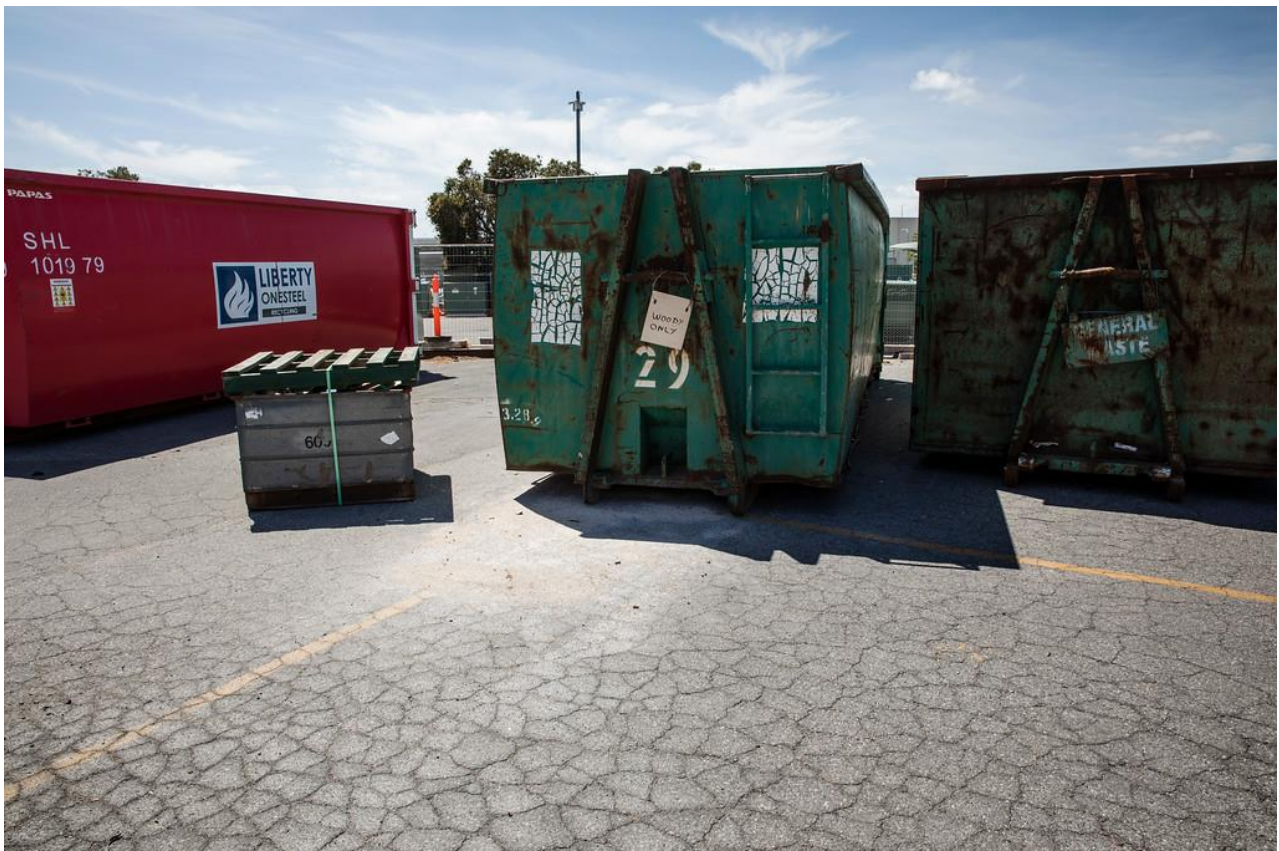
**Figure 7 Example of extensive full-thickness bitumen cracking to salvage bin storage, loading and unloading areas (9m storage bins can be over 3 tonne in weight).**

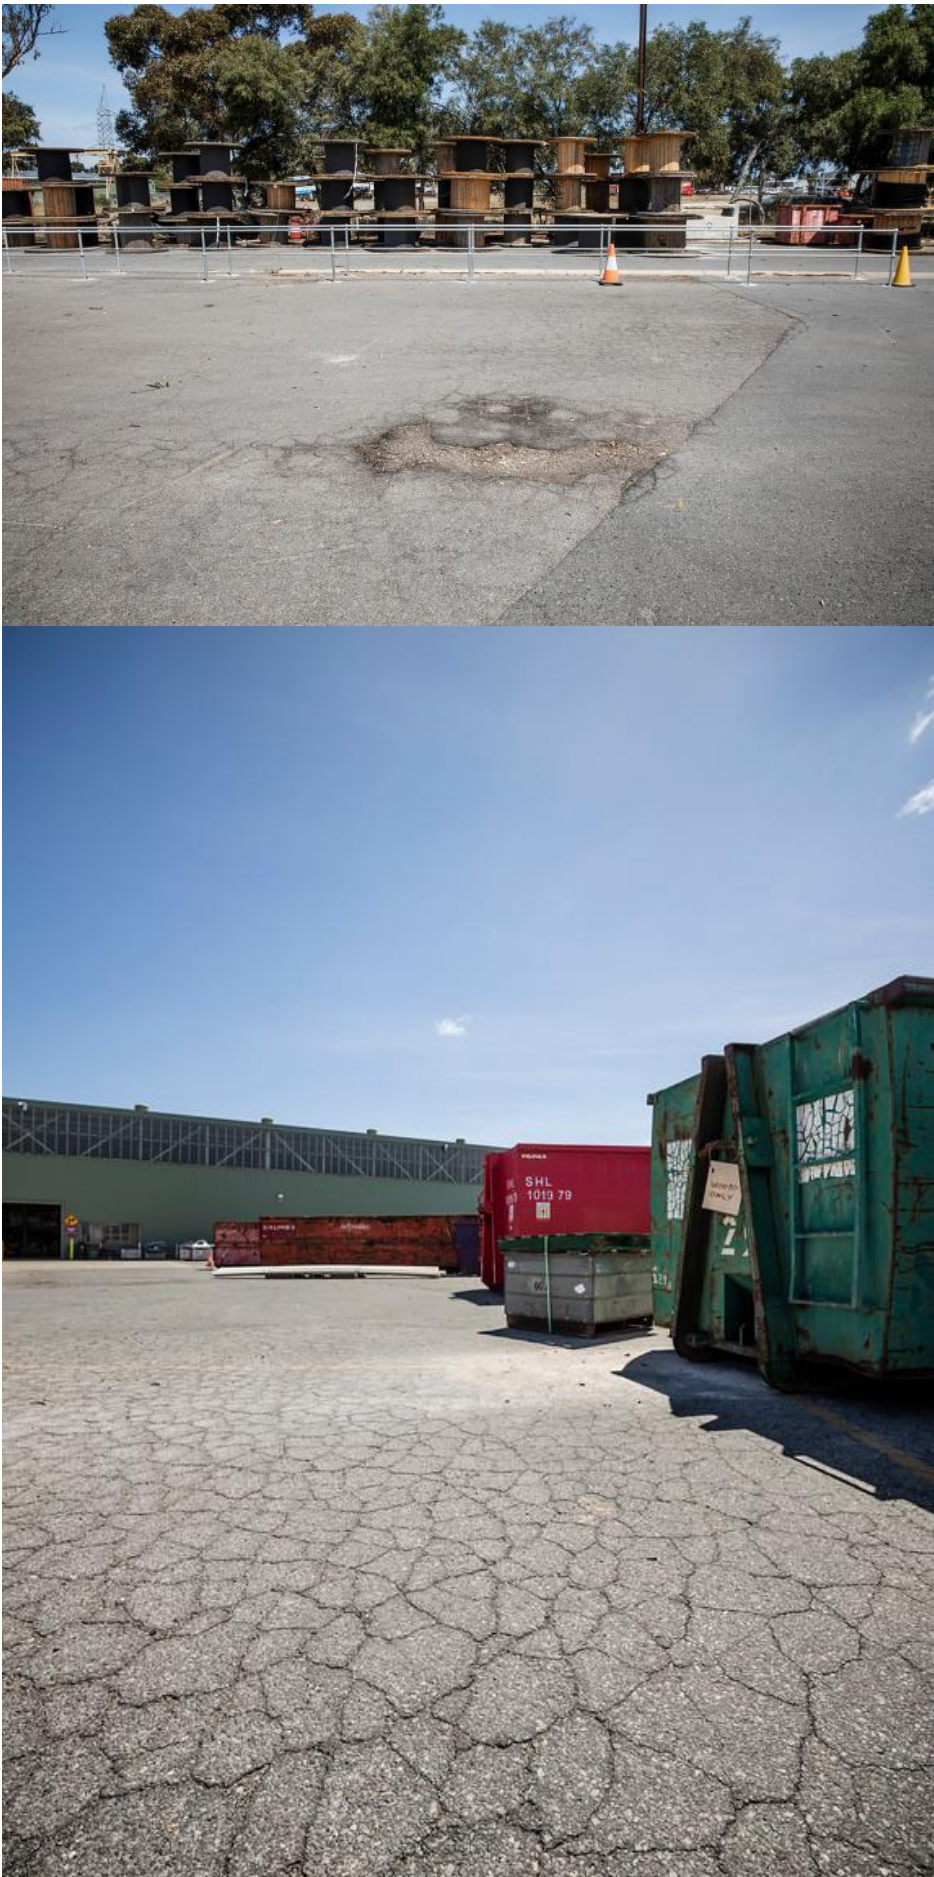
Figure 8 Further examples of cracking and potholing and subsidence of sub-grade to logistics salvage area.

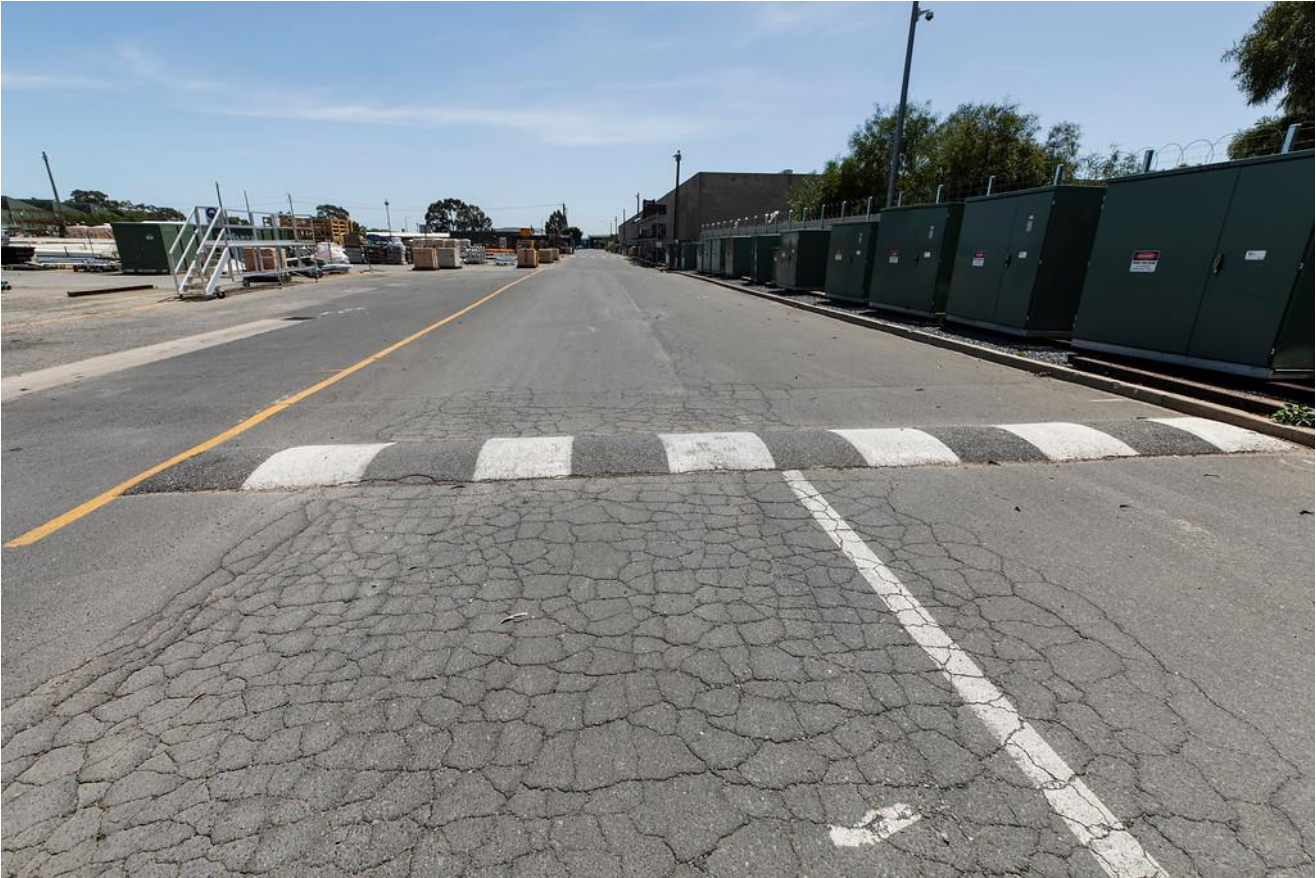
Figure 9 Example of significant full-thickness crack and subsidence to main driveway route for heavy vehicles.

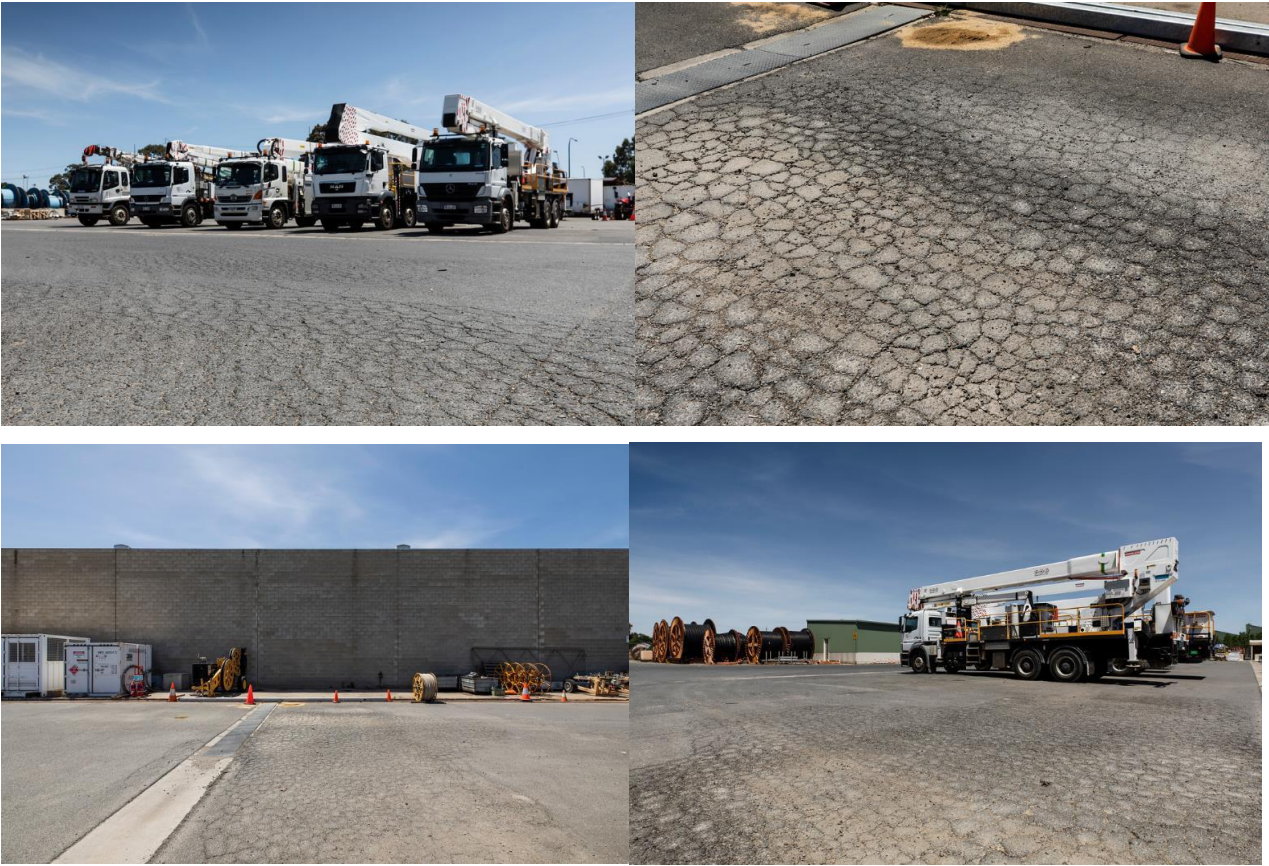
Figure 10 Examples of significant bitumen damage to semi-trailer route and turning circles and Transmission Heavy Vehicle Parking and Storage areas

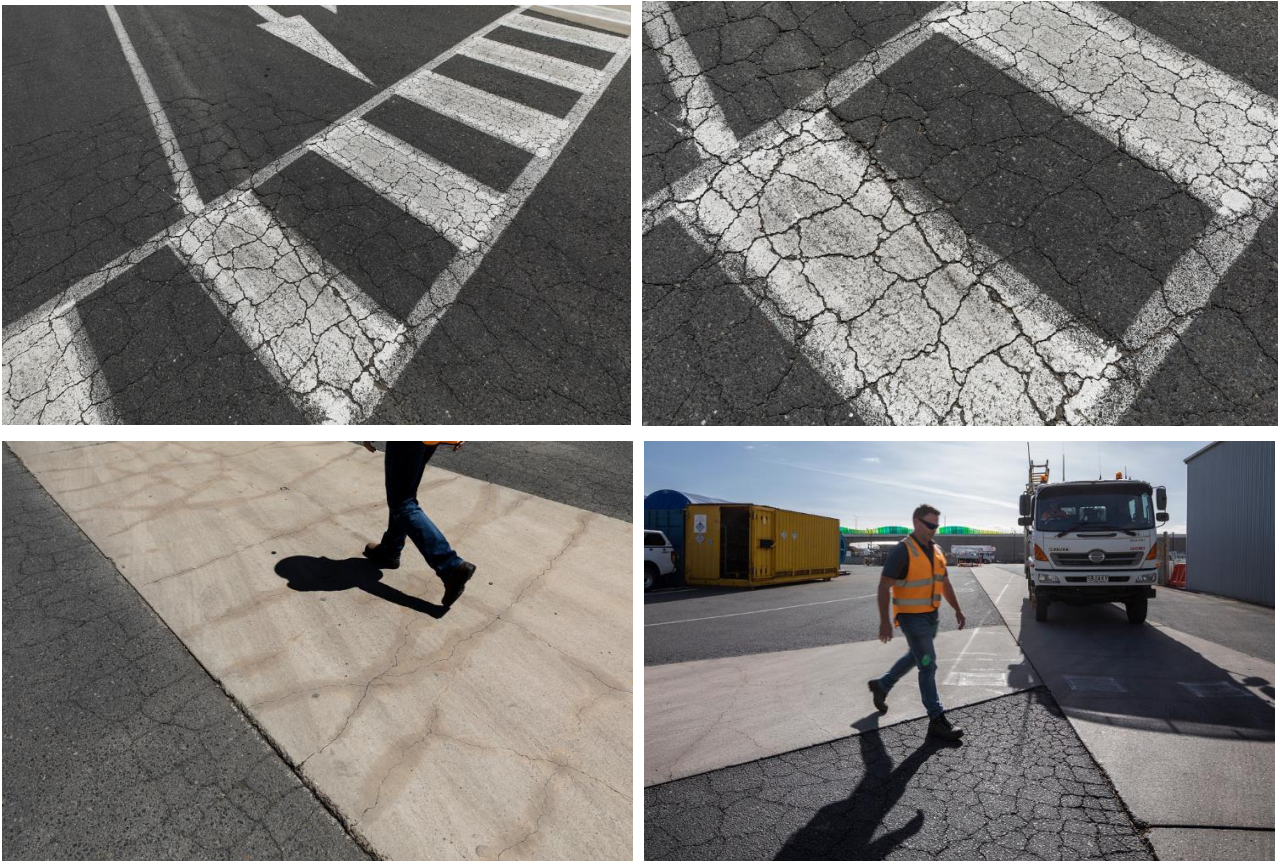
Figure 11 Examples of cracking and damage to pedestrian walkways, thoroughfares and concrete drainage areas. Also showing previous glue repair failures.

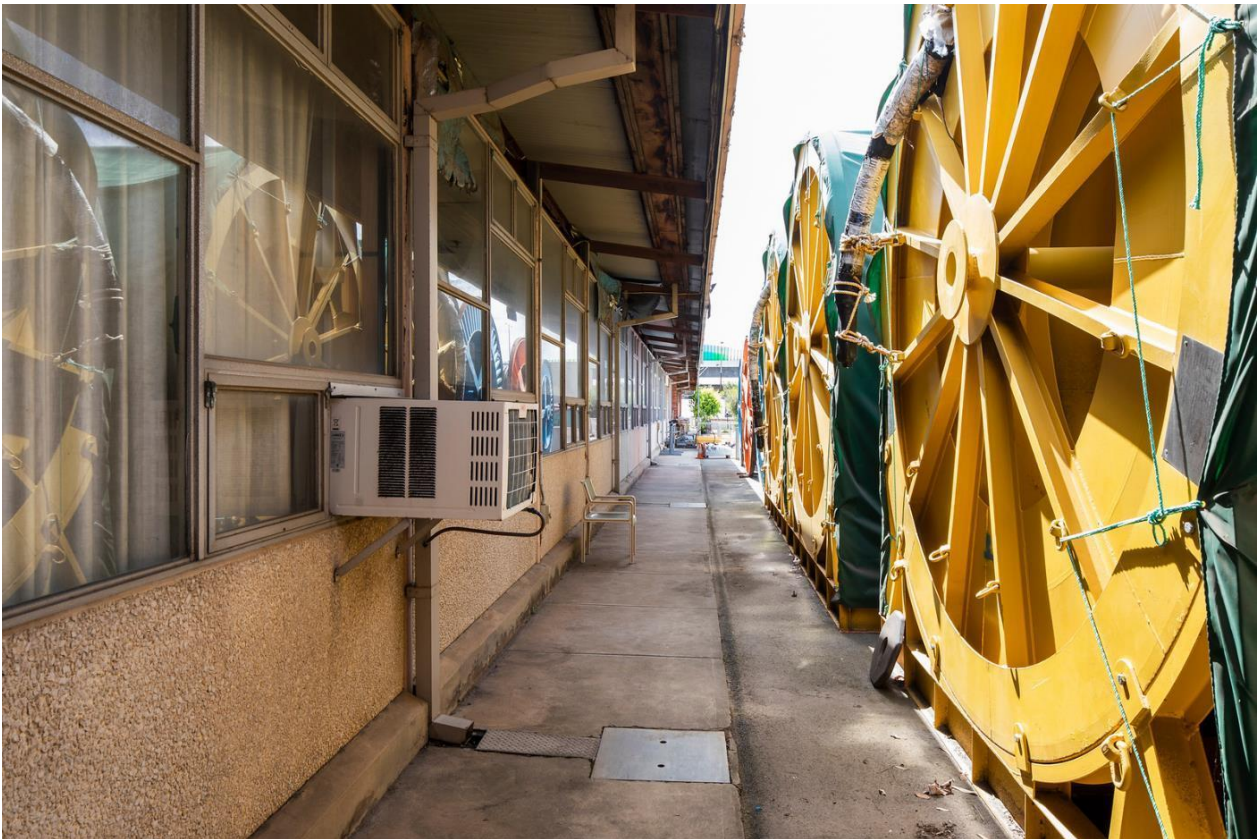
**Figure 13 Gutters and down-pipes in very poor condition, rising damp and concrete cancer to floor and wall foundations, timber rot to roofing beams.**

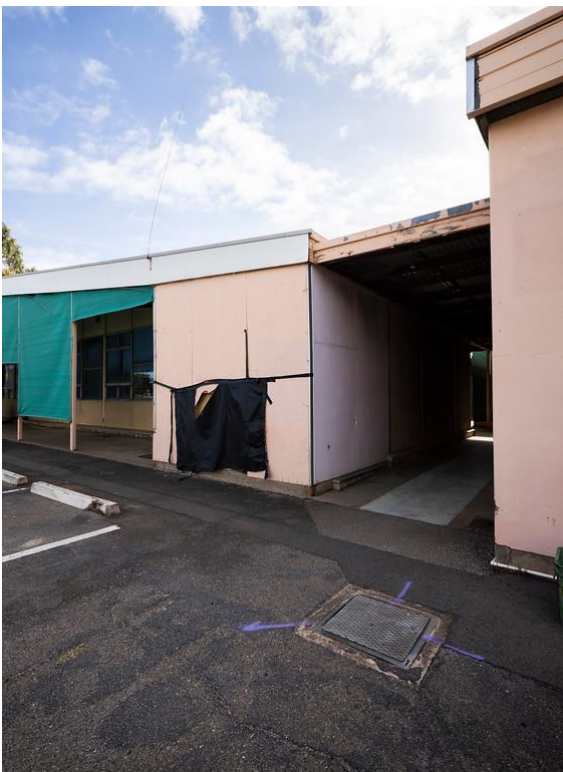
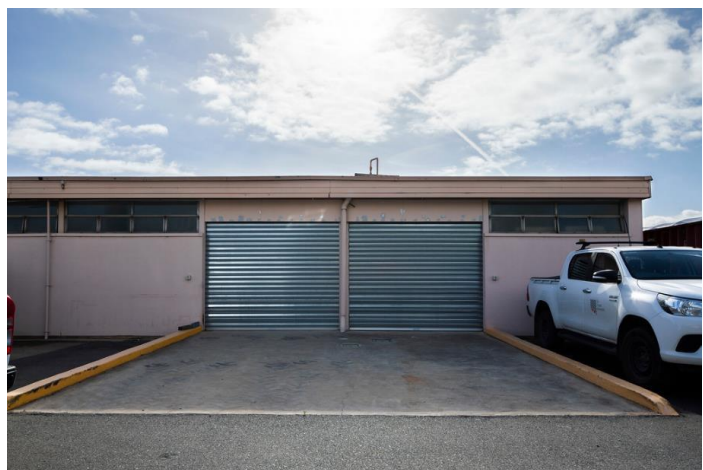
**Figure 14 Cement fibre cladding in various states of rot and disrepair and damage.**

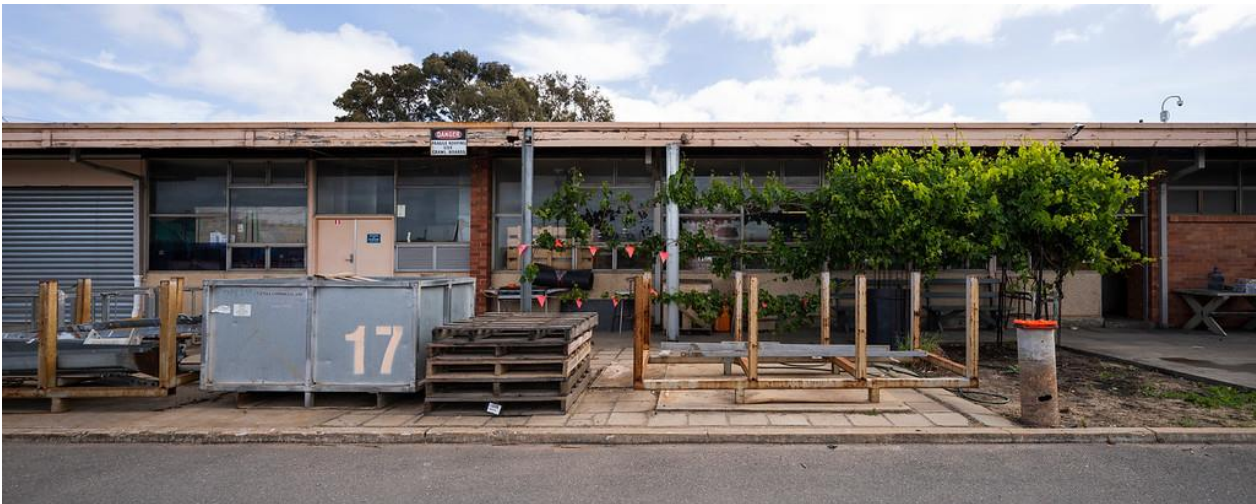
**Figure 15** Transmission area in the rear of the old admin guttering and timbers in very poor condition.

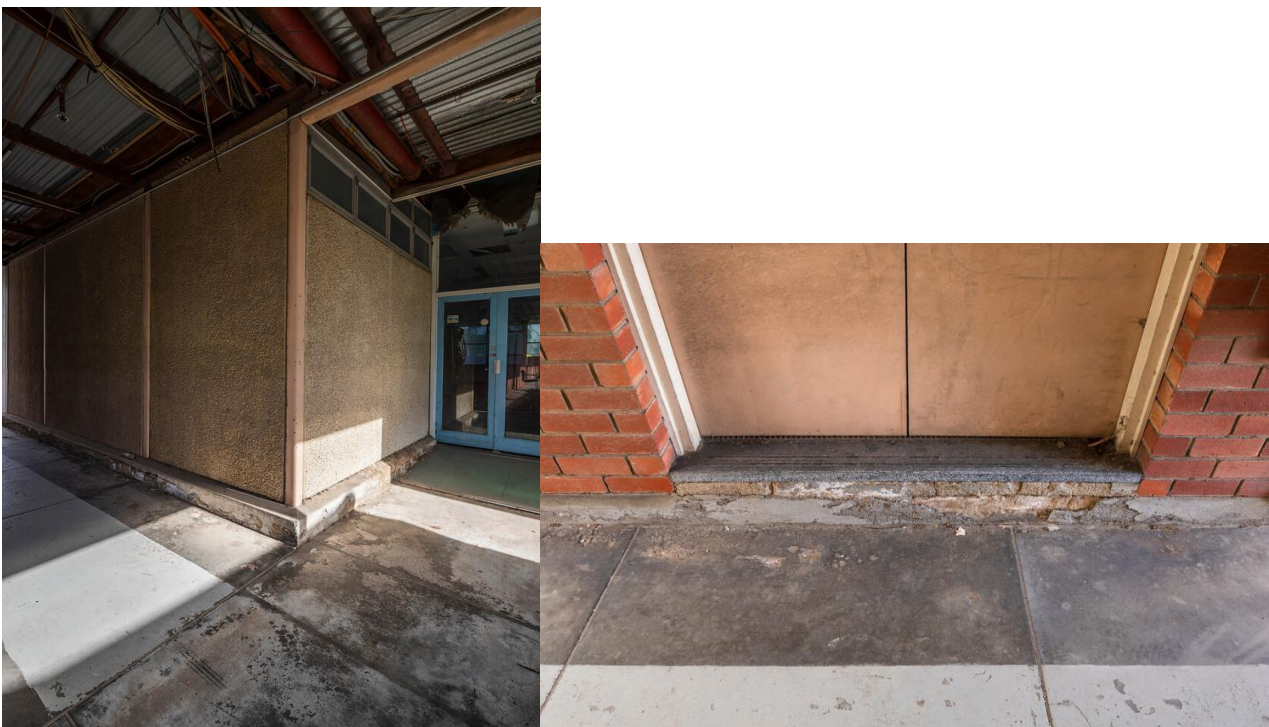
**Figure 16** Examples of extensive rising damp and concrete cancer to wall foundations and damage to amenities block brick work and foundations

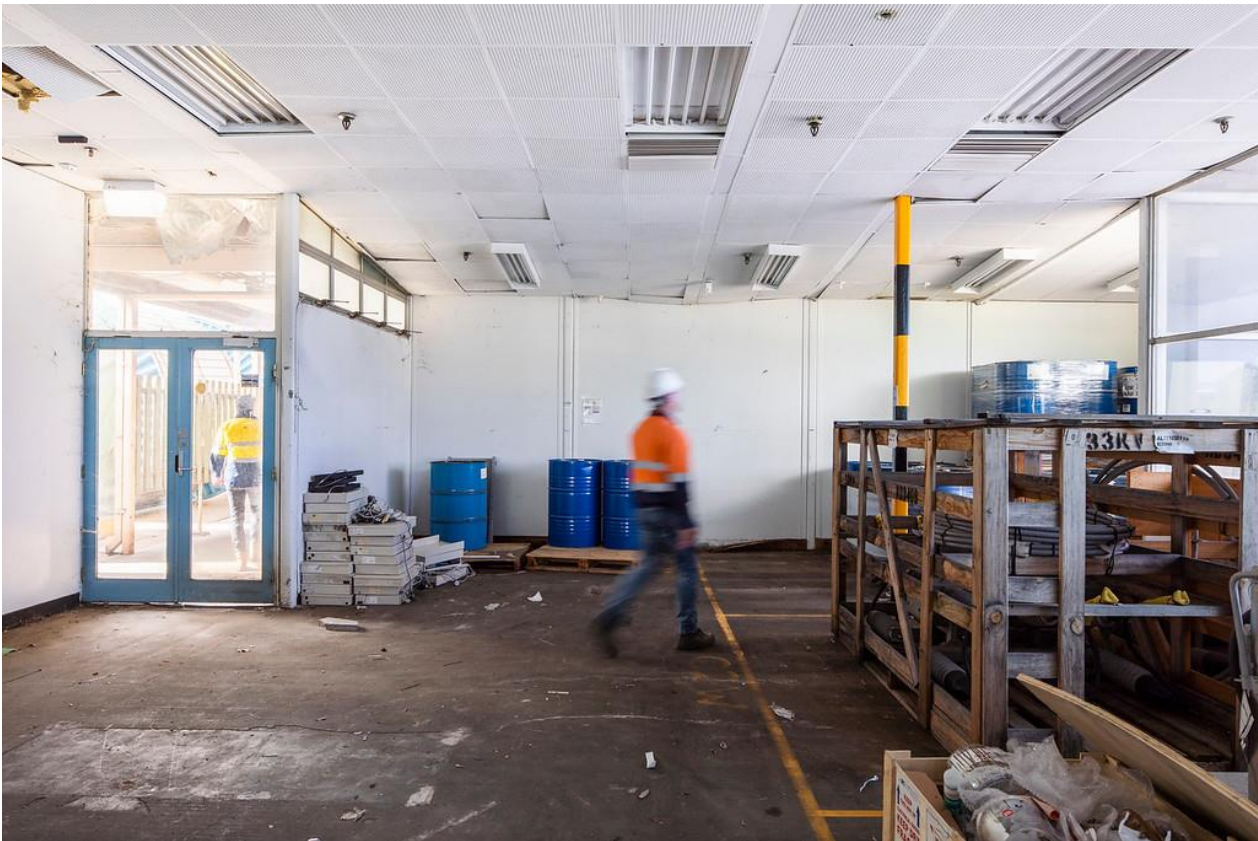
Figure 17 Collapsed ceiling sections, wall damage and floor condition inside storage area of old admin building.

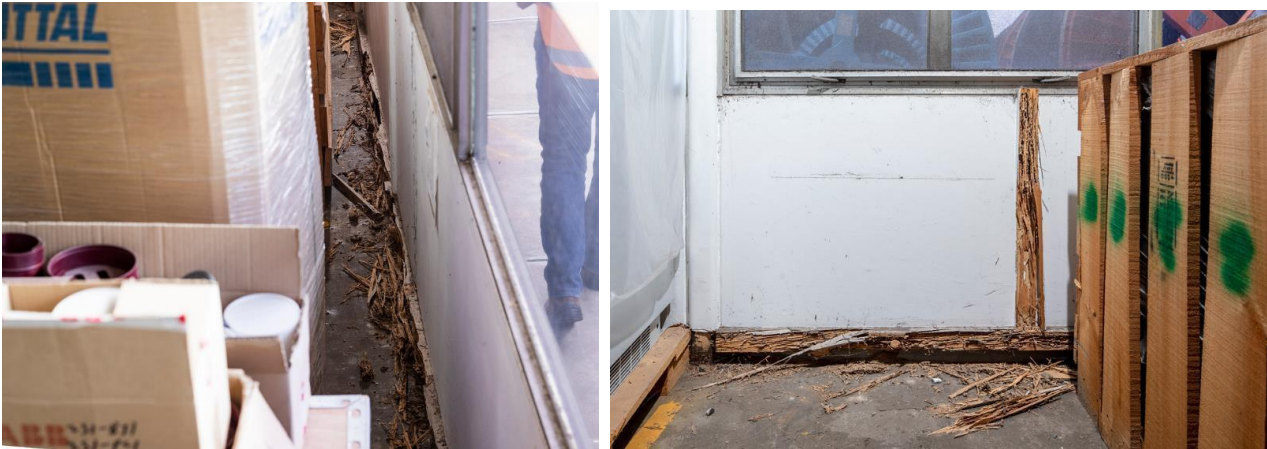
Figure 18 Example of significant termite damage to internal timberwork in old admin building.

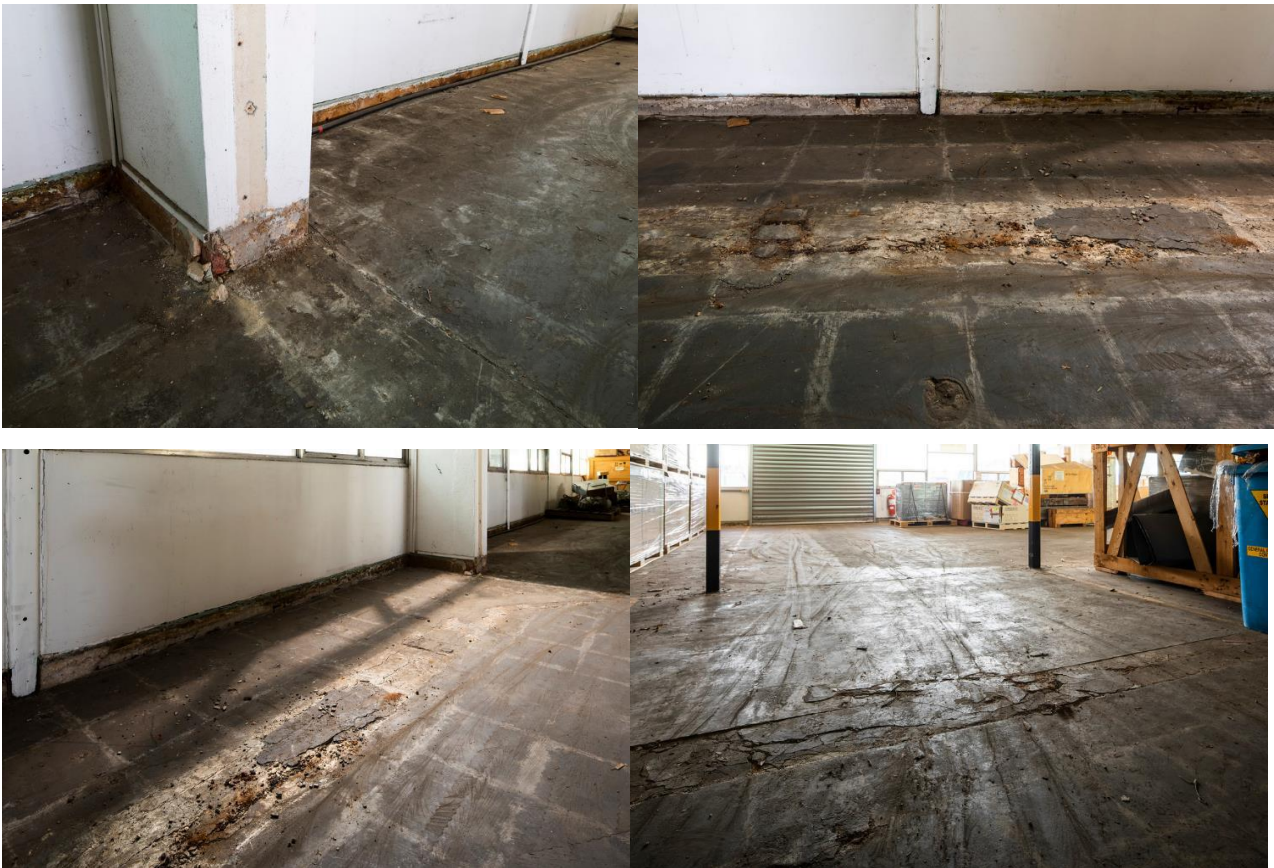
Figure 19 Example of extensive floor cracking, rising damp and concrete cancer throughout interior of the old admin building.

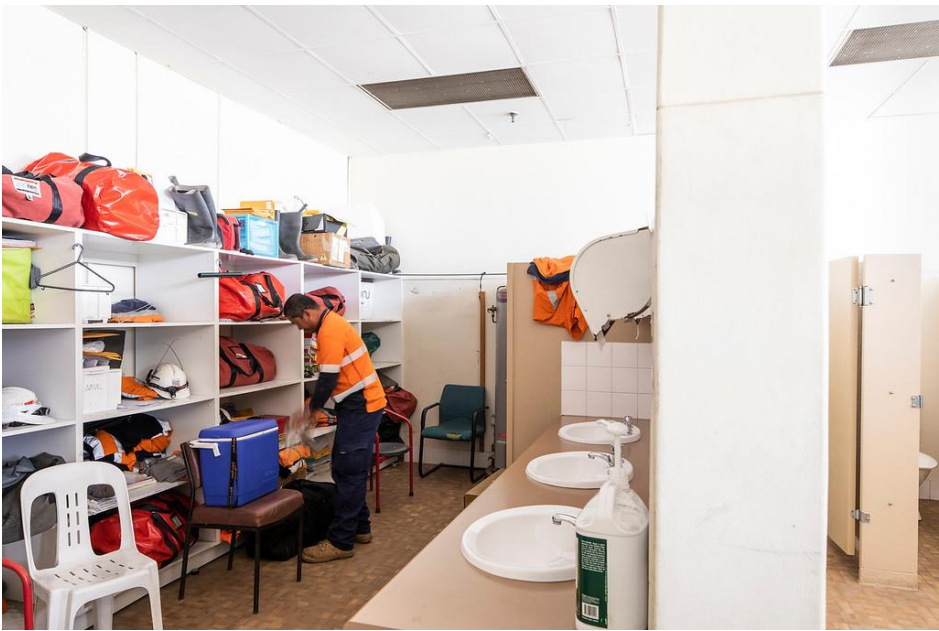
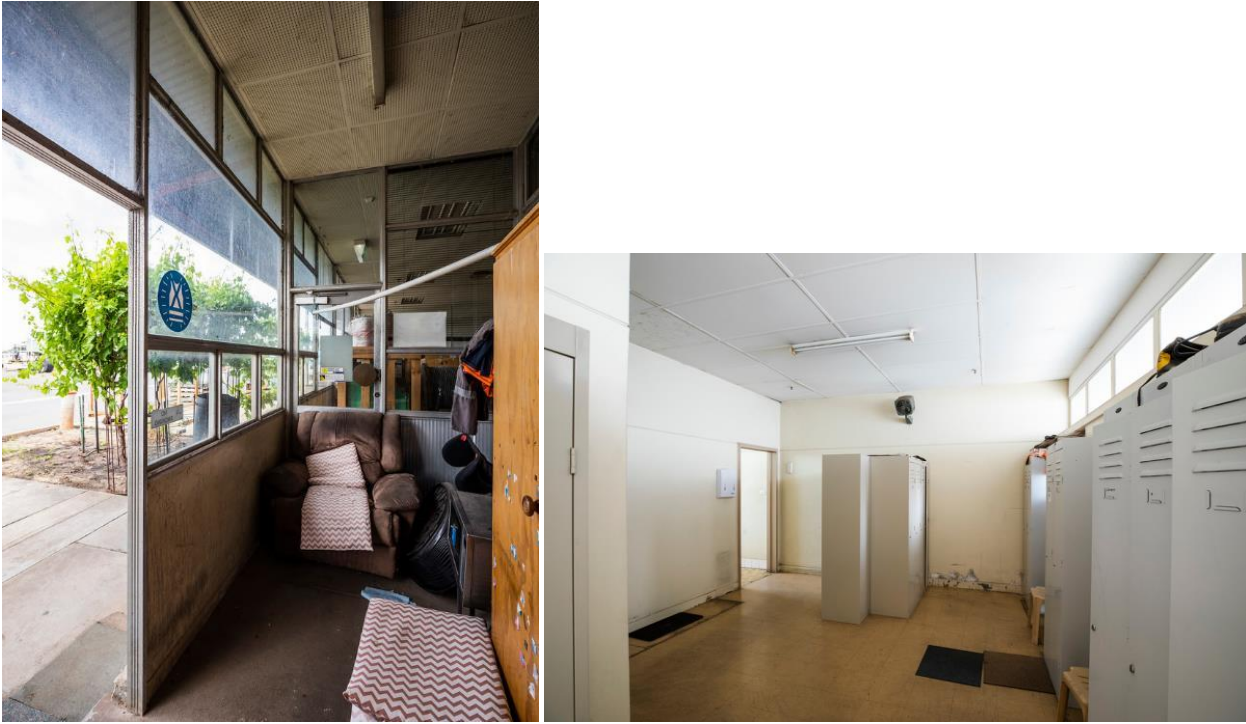
**Figure 20** sub-transmission group amenities, locker Rooms and break out areas, including transmission breakout area, bag storage and toilets all in the same area with no dedicated female facilities. All aged and in poor condition.

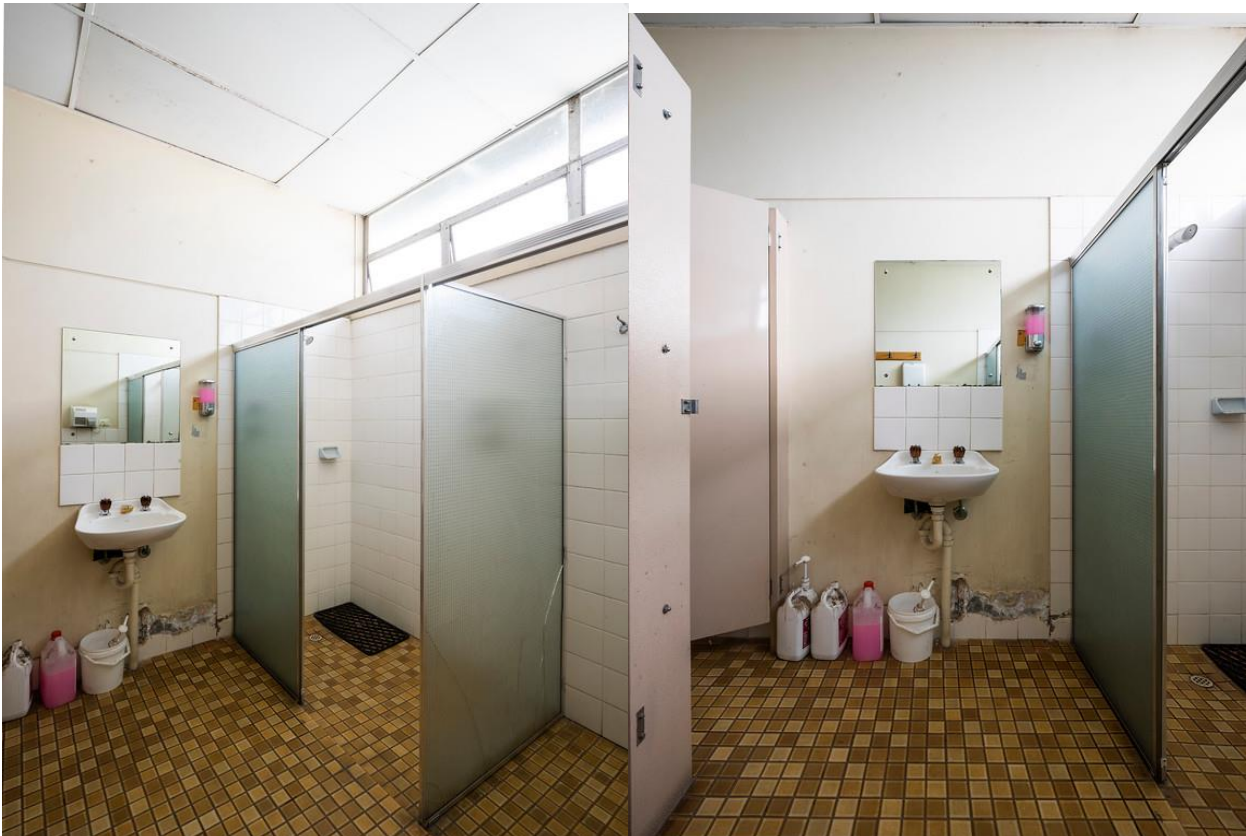
**Figure 21** Toilet and shower cubicles all original 1950's fit-out in very poor condition.

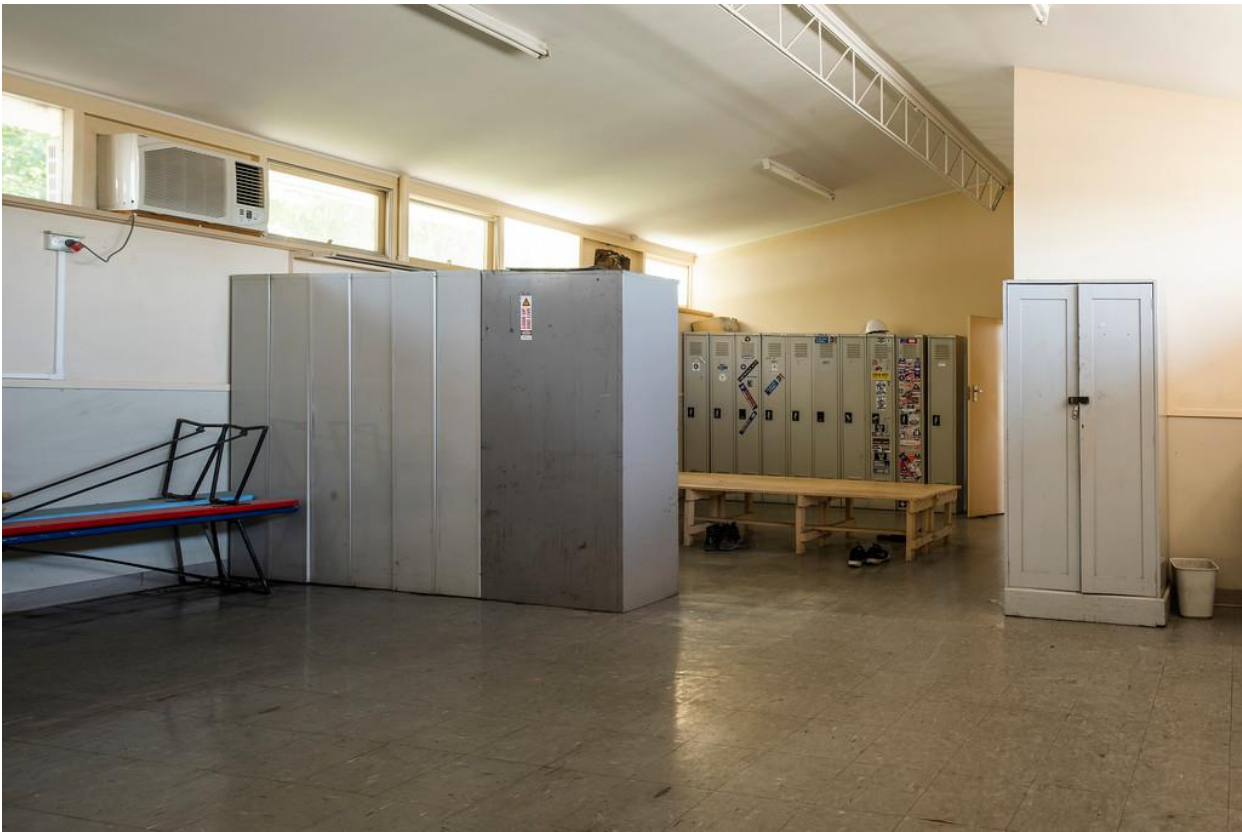
Figure 23 Pole Construction Locker Room – Original 1950’s fit-out

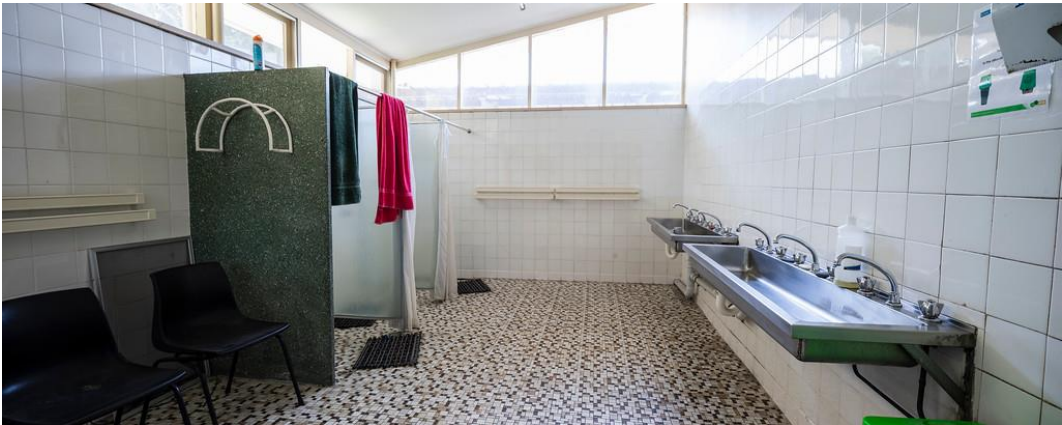
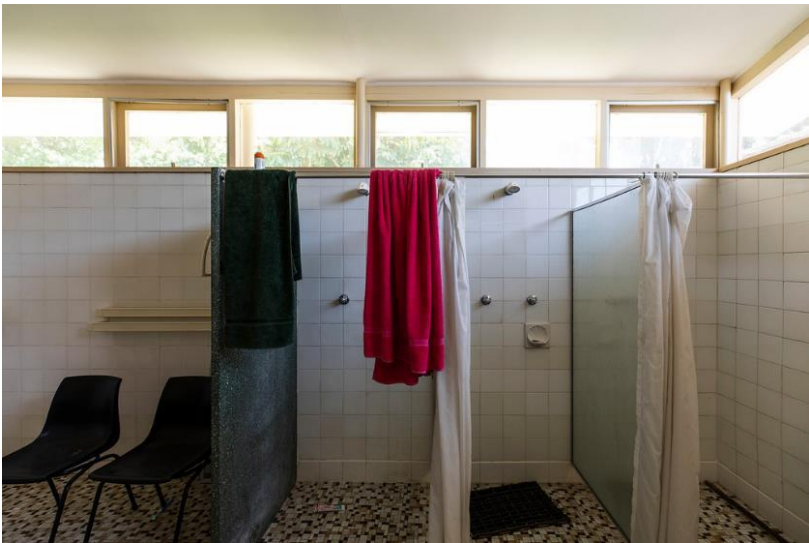
Figure 24 Pole construction showers all in very poor condition and original fit-out

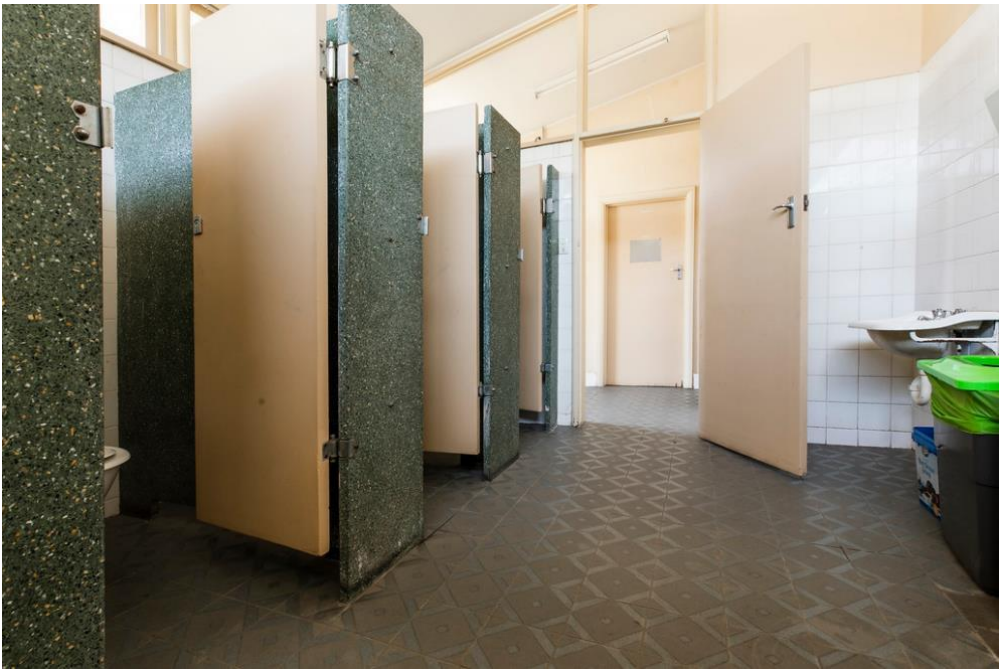
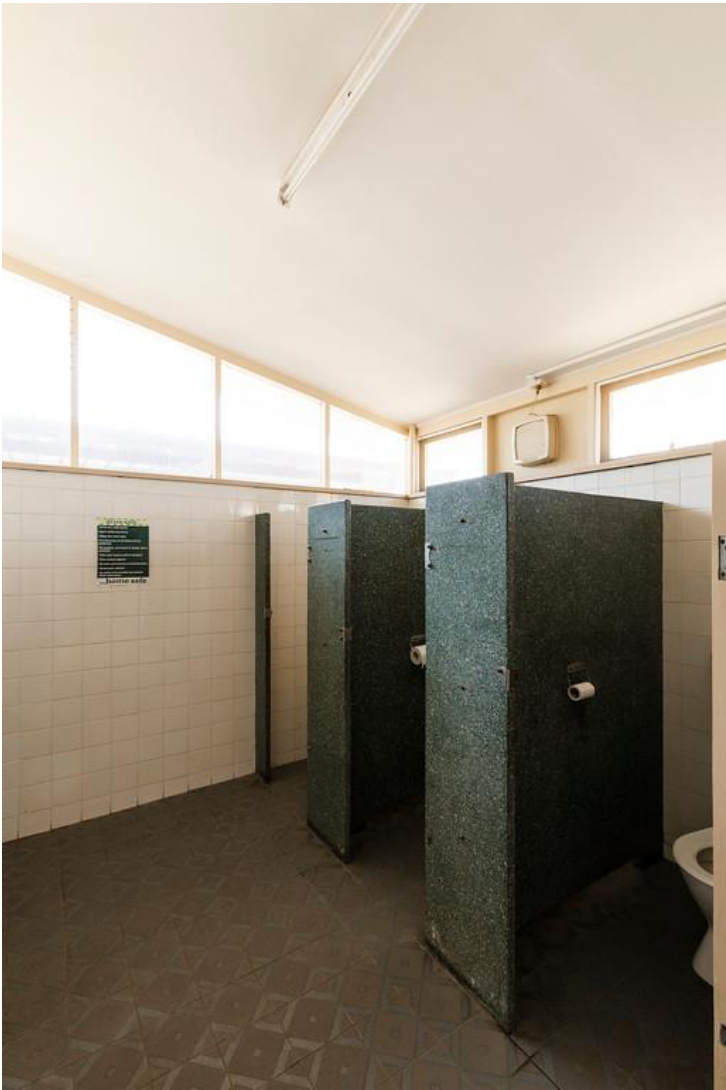
Figure 25 Pole construction toilets all in very poor condition and original fit-out

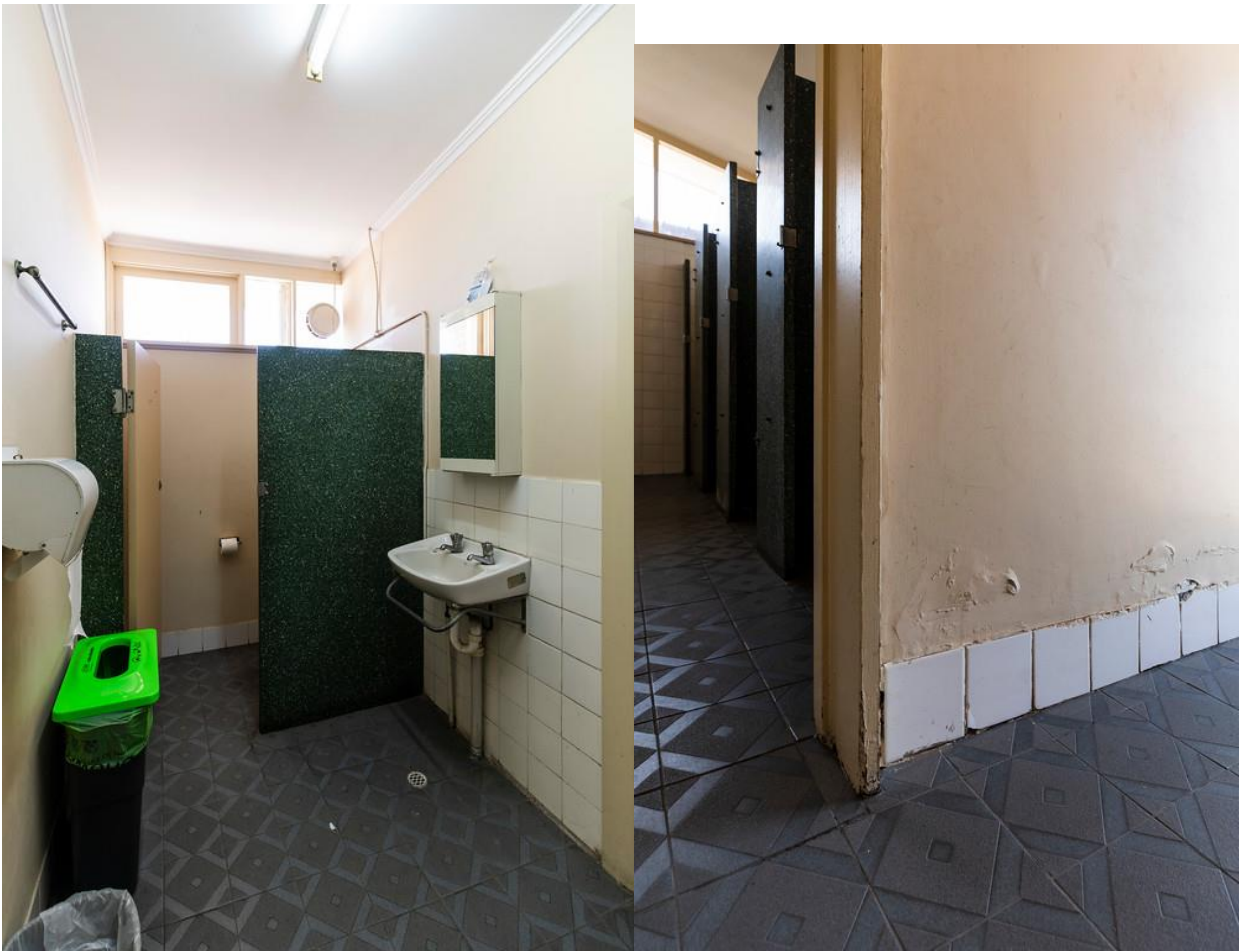
Figure 26 Pole Construction Ladies Toilet – No Female Shower, rising damp and concrete degradation

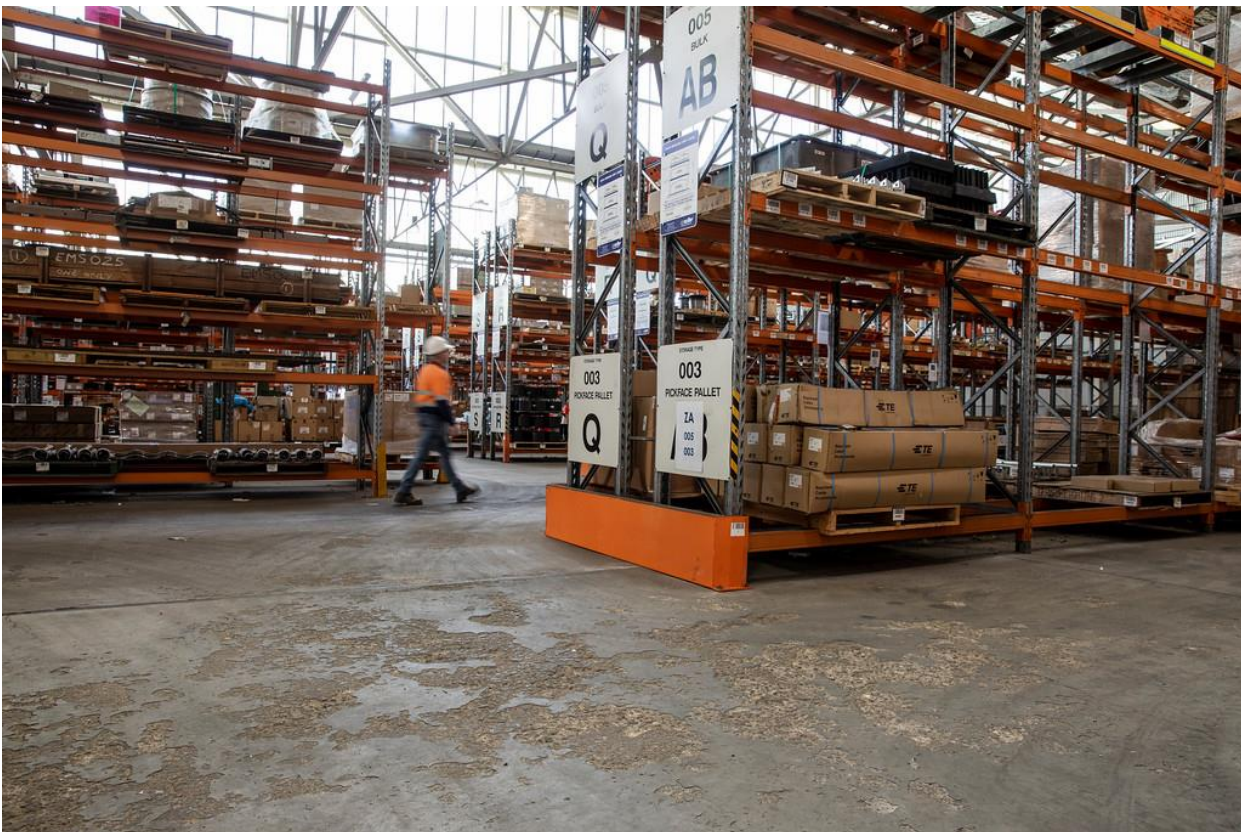
Figure 27 Example concrete cracking and de-lamination to large areas of the logistics warehouse floor.
