## Angle Park North Business Case

2020-25 Revised  
Regulatory Proposal  
10 December 2019

# Angle Park North Business Case

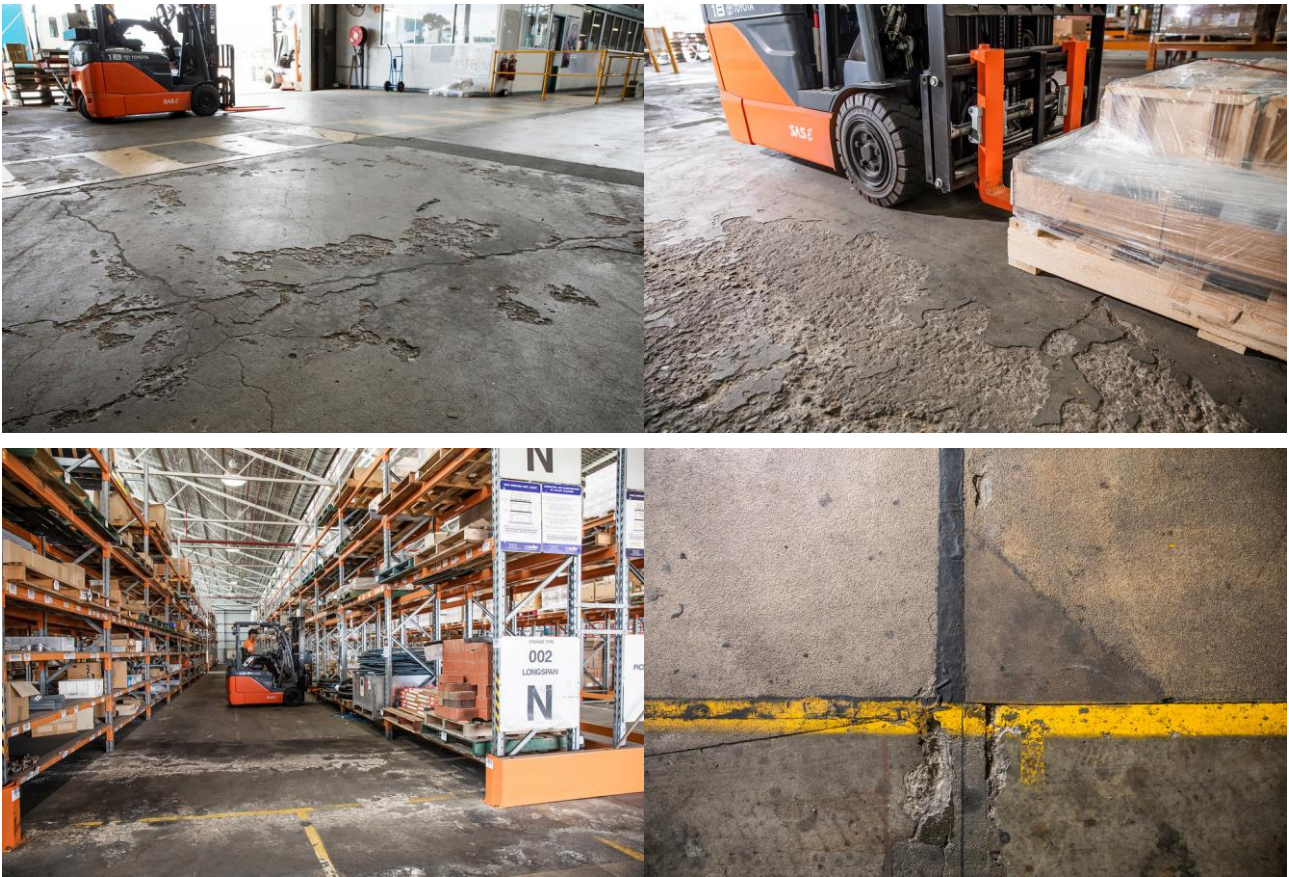
**Figure 28 Detailed views of cracking and de-lamination of the logistics warehouse floor, including previous repairs with levelling compounds and epoxy/composite coverings**
