Supporting document 5.23 Marleston North Business Case

2020-25 Revised Regulatory Proposal 10 December 2019

Marleston North Business Case

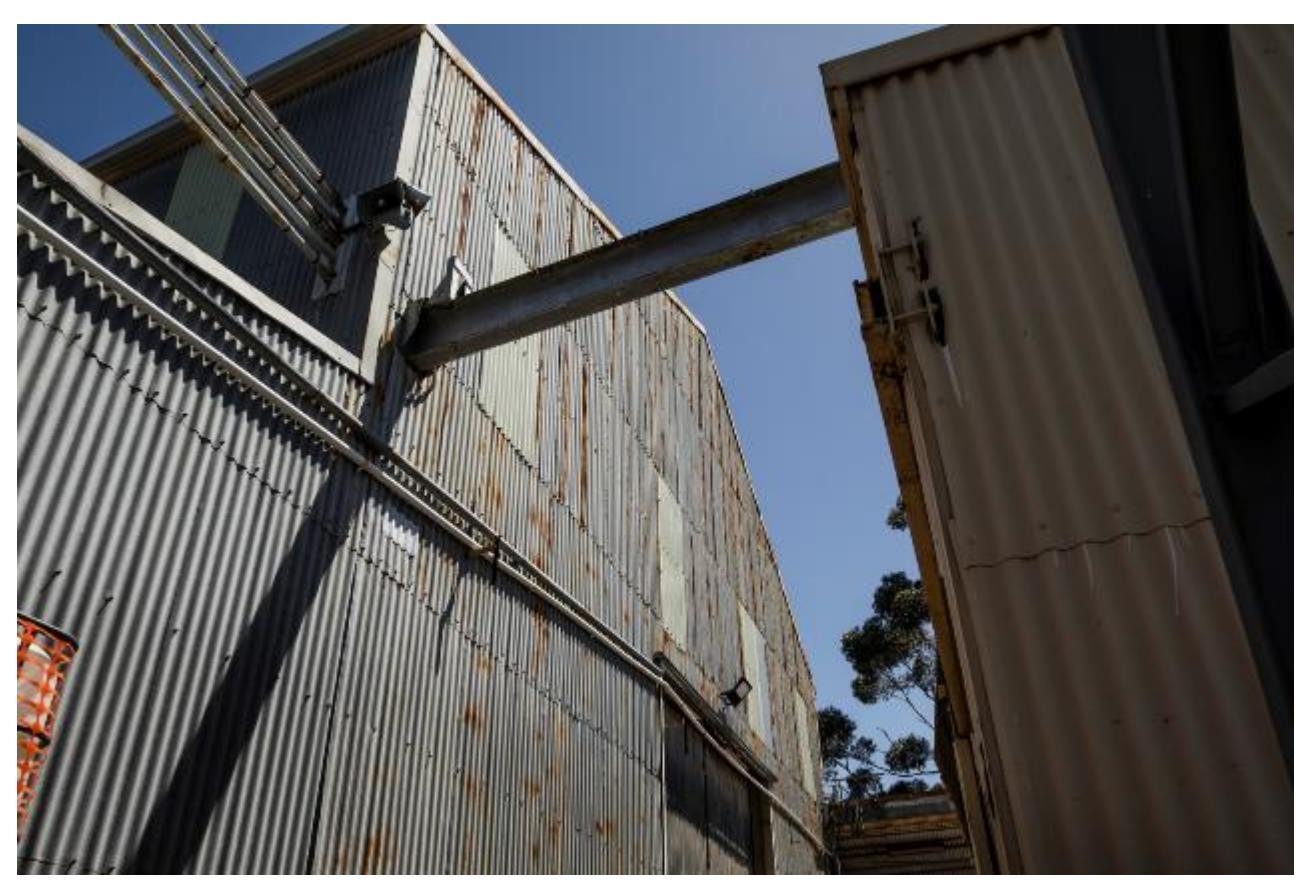
- Aged and poor condition non-structural elements and systems There are a range of nonstructural elements and systems associated with these four buildings that are aged, in a poor condition and well below current standards – most notably:
 - Transformer workshop and substation store external iron sheeting The main transformer workshop and substation store walls and some parts of their roof are original corrugated iron sheets and have extensive rusting and pitting through the full thickness of the sheets and need replacing. The roofs also have no hot air extraction or insulation.

Figure 5 Example of rusted corrugated iron sheets to the rear wall of the transformer workshop – original 1950's sheets.

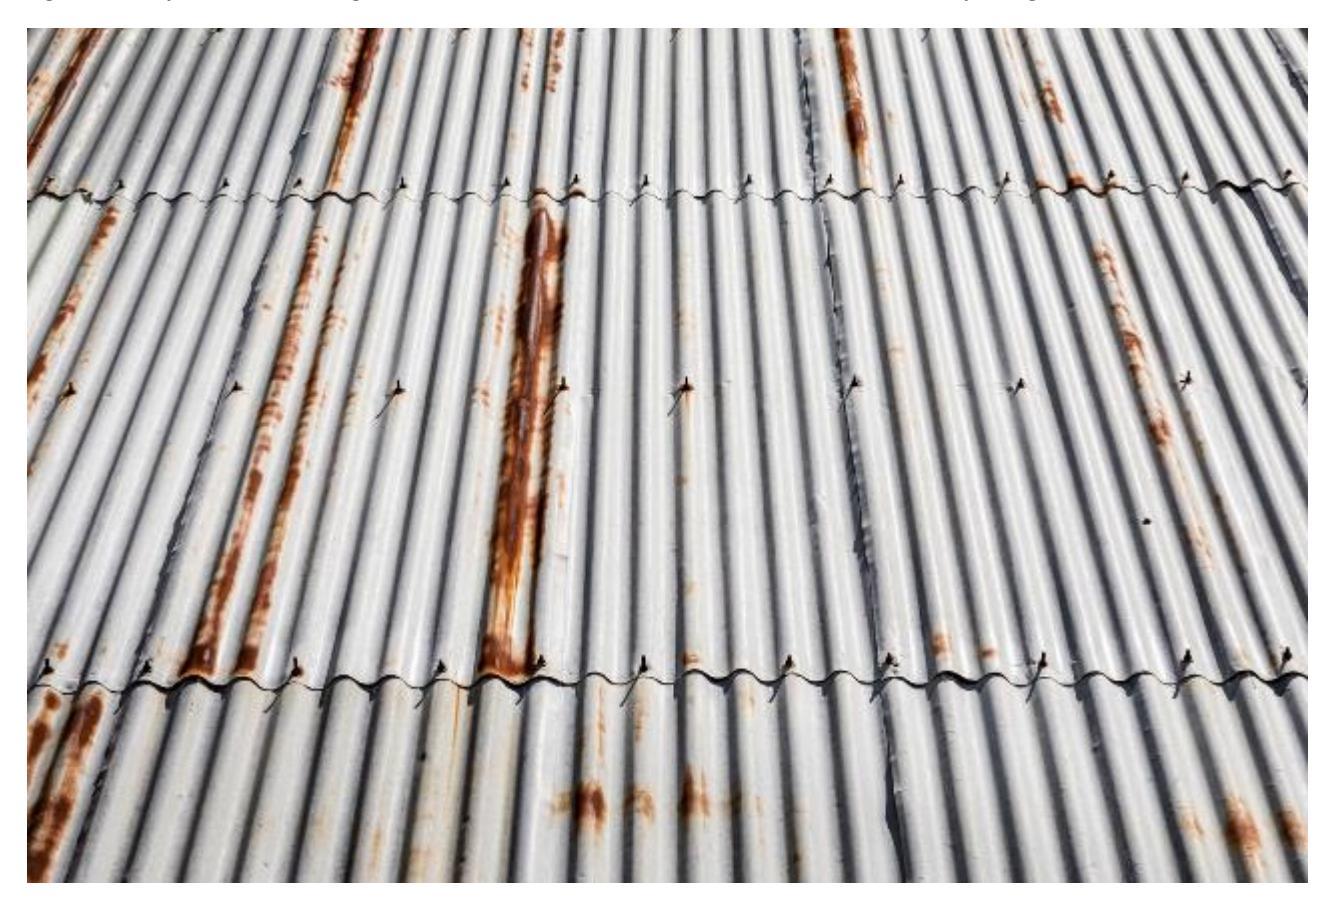
Figure 6 Example of rusted corrugated iron sheets to the rear wall of the transformer workshop - original 1950's sheets.

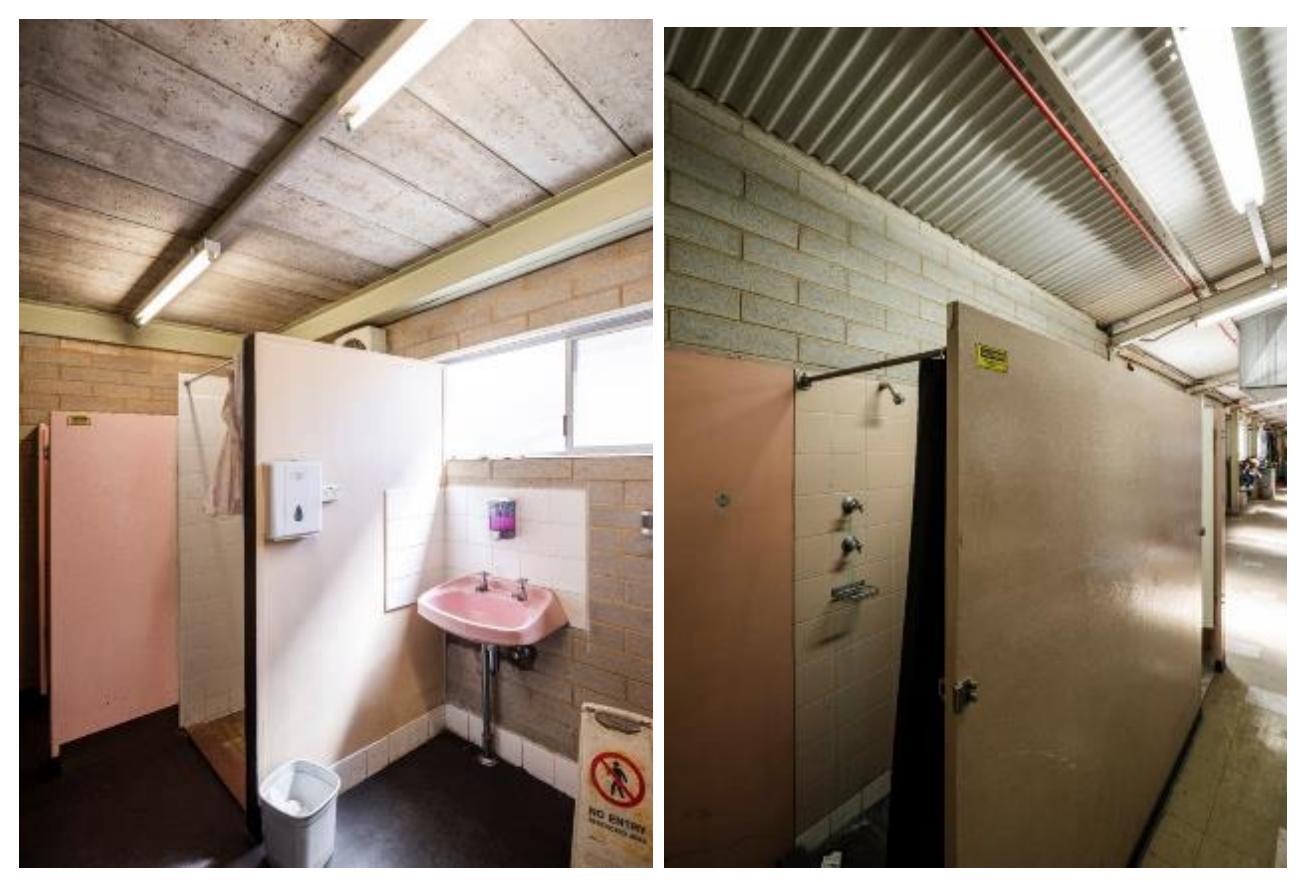
- **Toilets, showers and amenities** These are the original toilets and showers from the early 1950's and are in a poor condition and in need of refurbishment. Cubicle doors and walls are original asbestos panels.

Figure 7 Ladies toilets and shower – Transformer Workshop. Original 1950's fit out in very poor condition with asbestos cubicle panels.

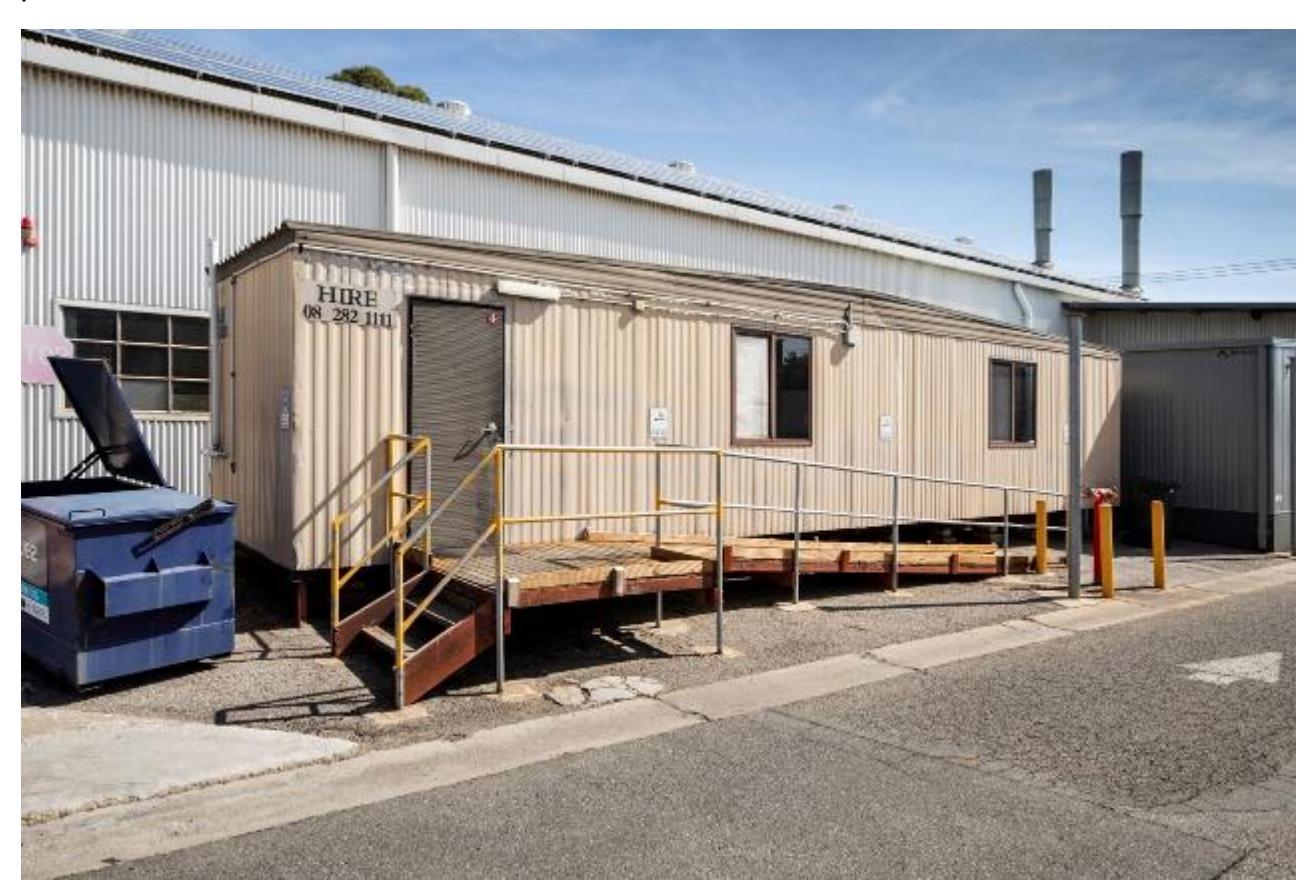
- Lunchroom building The modular lunchroom building is over 30 years old and is in a significant state of degradation and needs replacing and upsizing for the amount of people now housed at this site.

Figure 8 Substation Construction Modular Lunchroom – Very Poor Condition – Beyond Repair.

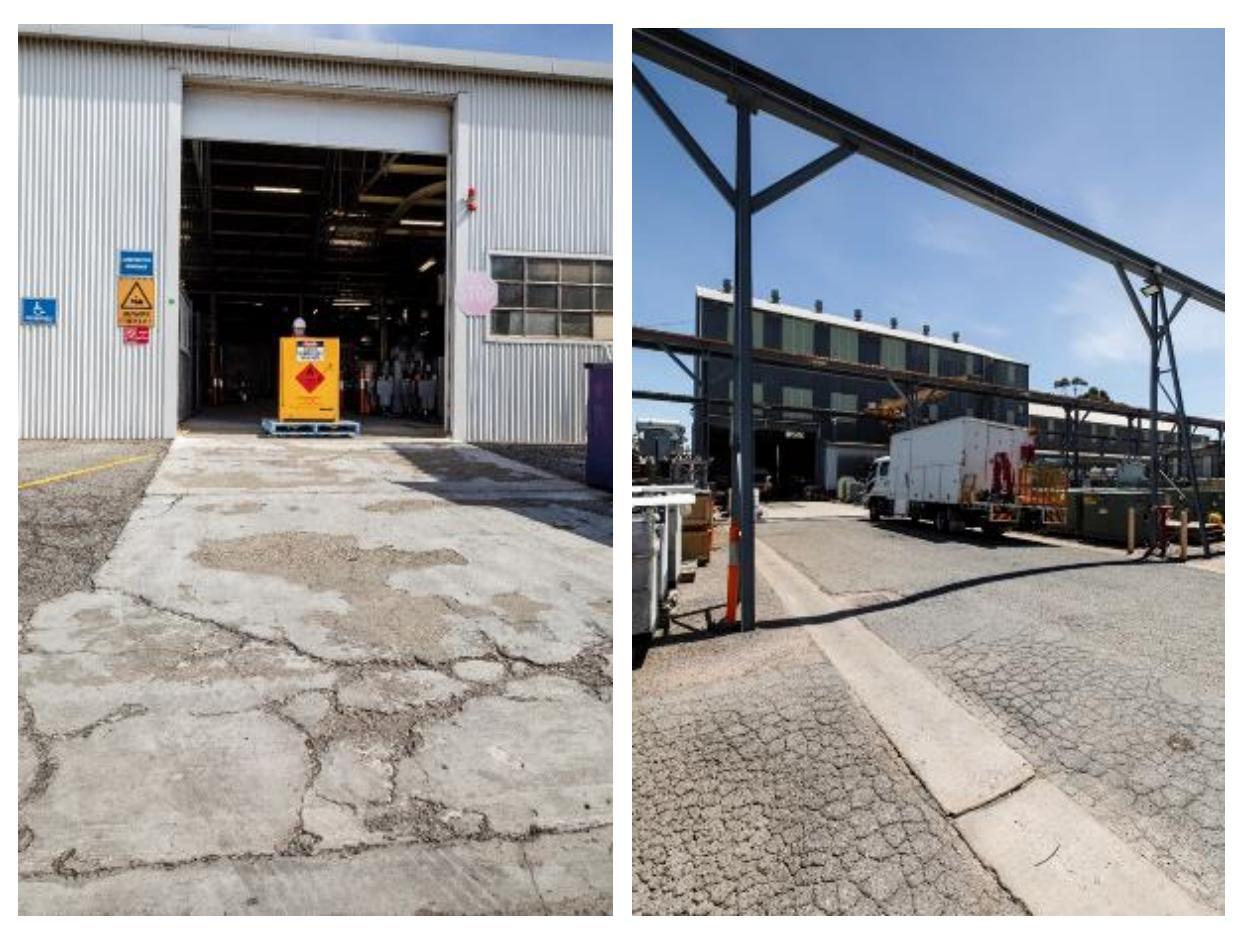
- **Substation workshop and substation store concrete floor** The concrete floor/pavement areas are in poor condition, with significant cracks forming.

Figure 9 Example of deep cracking to concrete forklift loading ramp. Bitumen cracking to transformer workshop truck loading bay

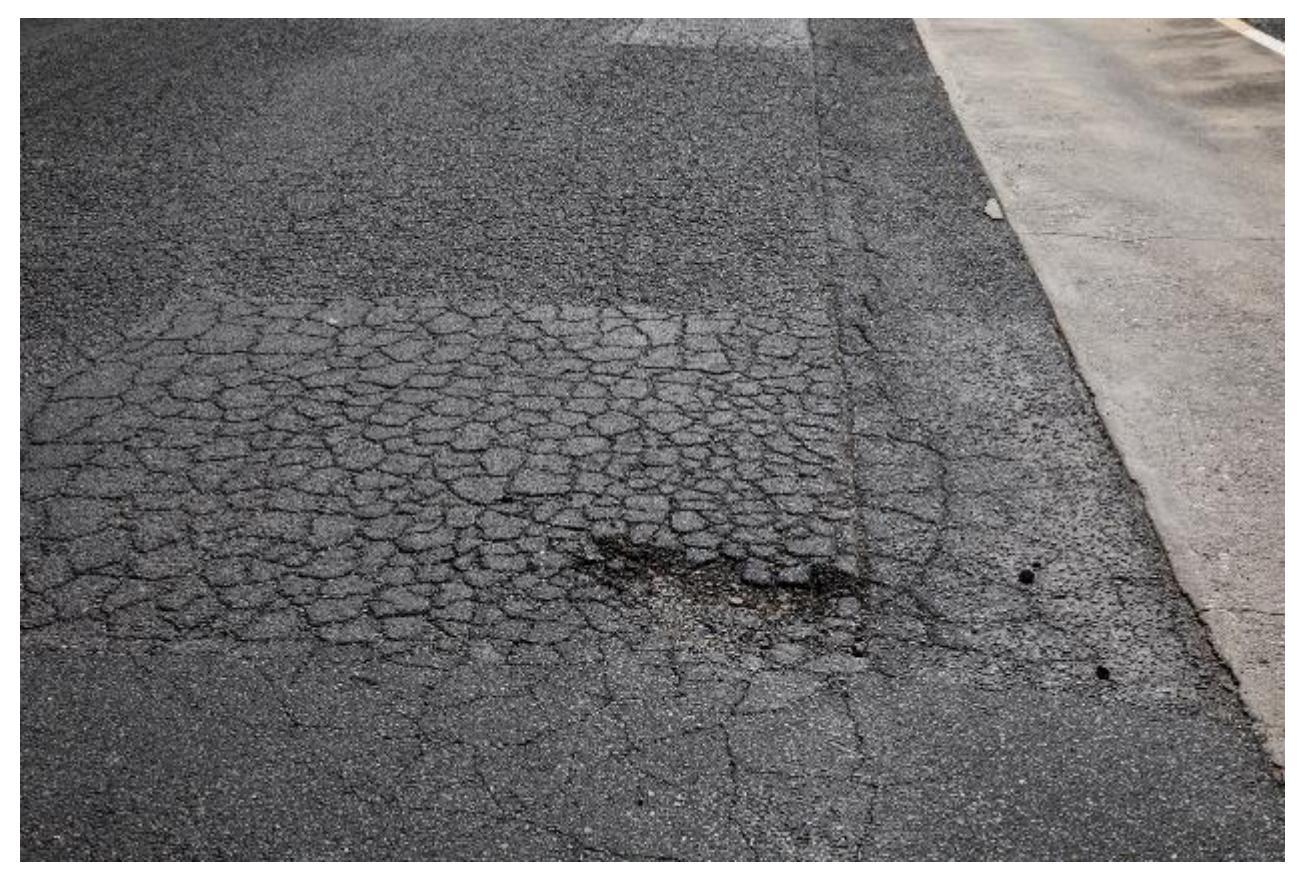
Figure 11 Example of full-thickness cracking and potholing to main driveway and Car park area

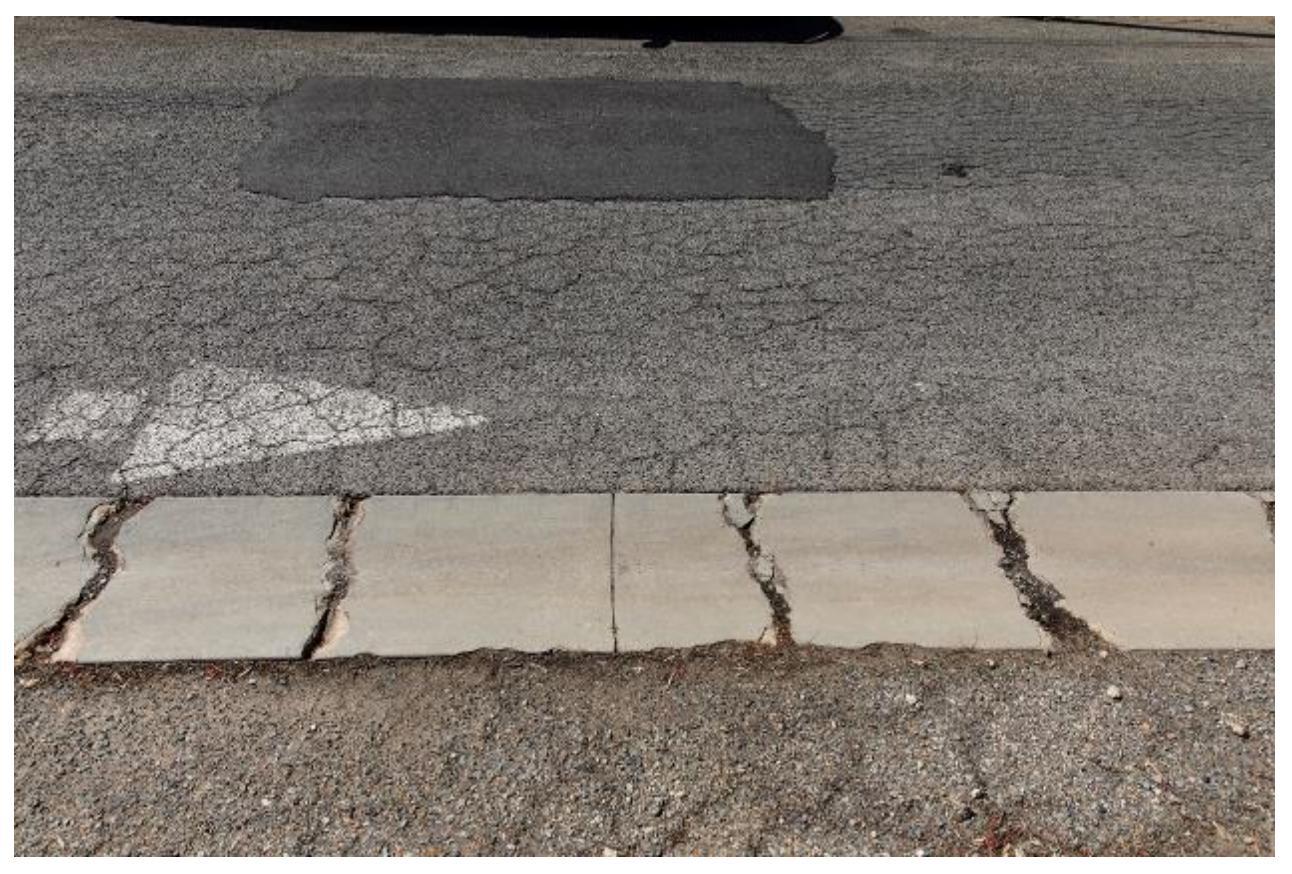
Figure 12 Example of deep cracking and movement to concrete spoon drain, full-thickness cracking to bitumen pavement, area of previous repair.

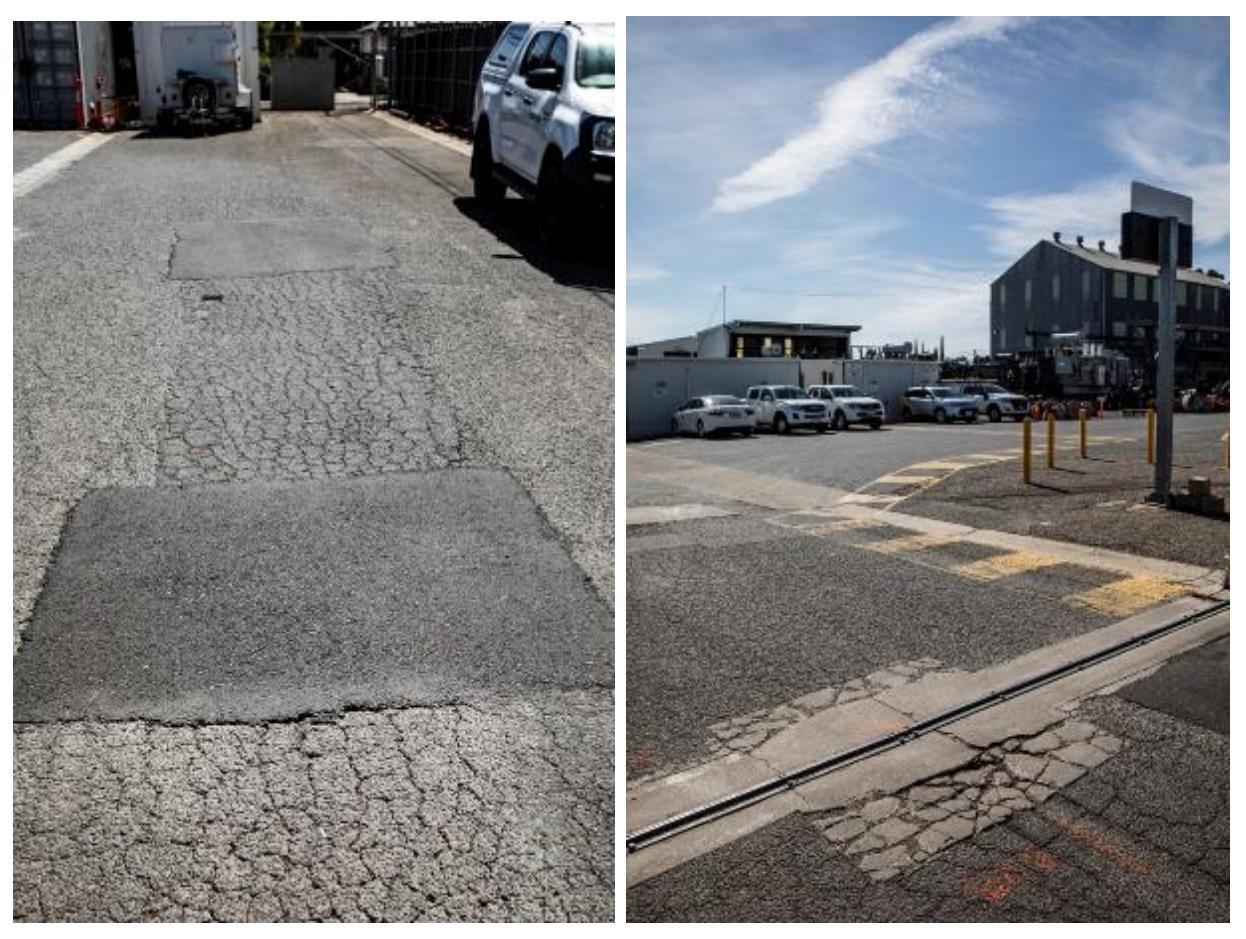
Figure 13 Examples of full-thickness bitumen cracking and subsidence, recent repair patches and previous repair patch cracking

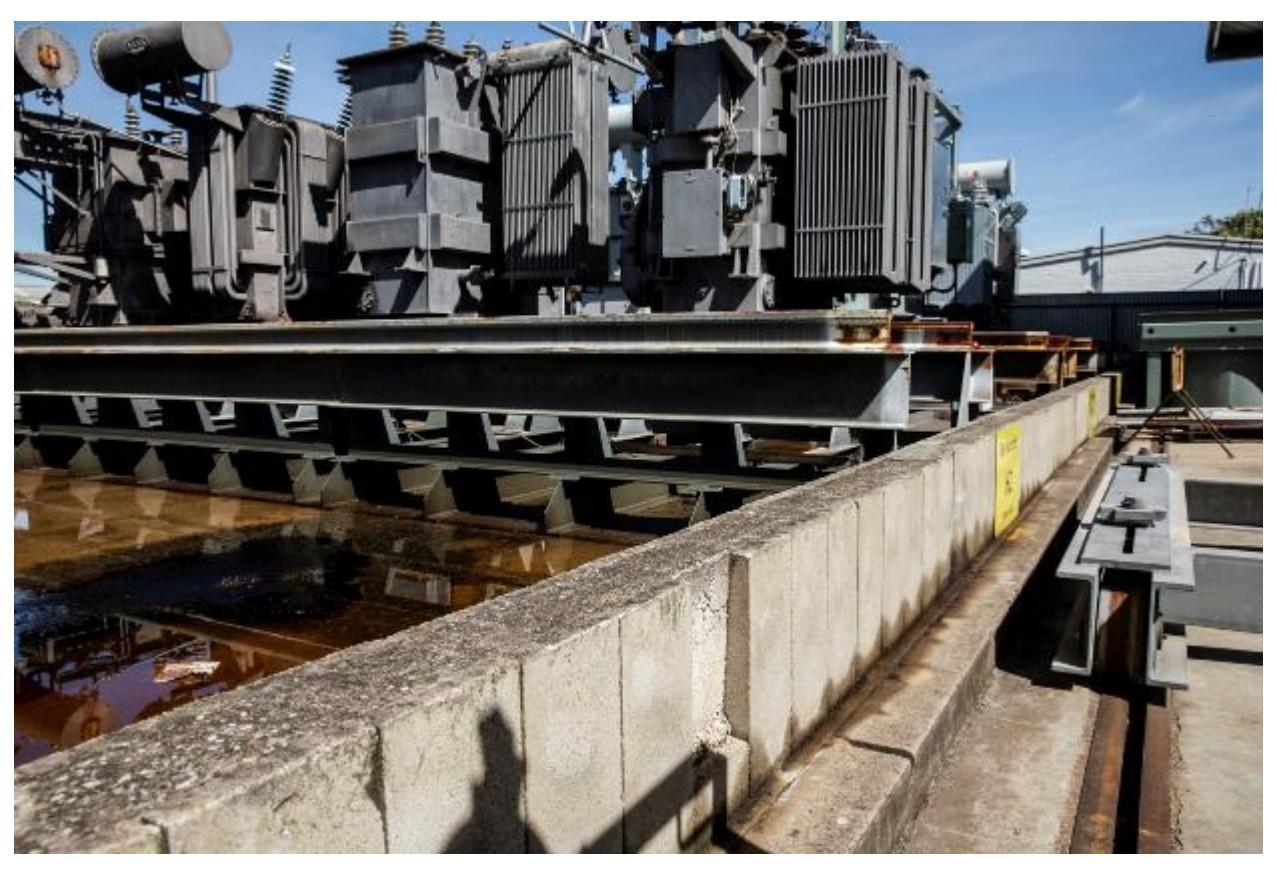
Figure 14 Heavy Transformer containment bund (besser block) – cracking, movement and leaking transformer oil through bund wall

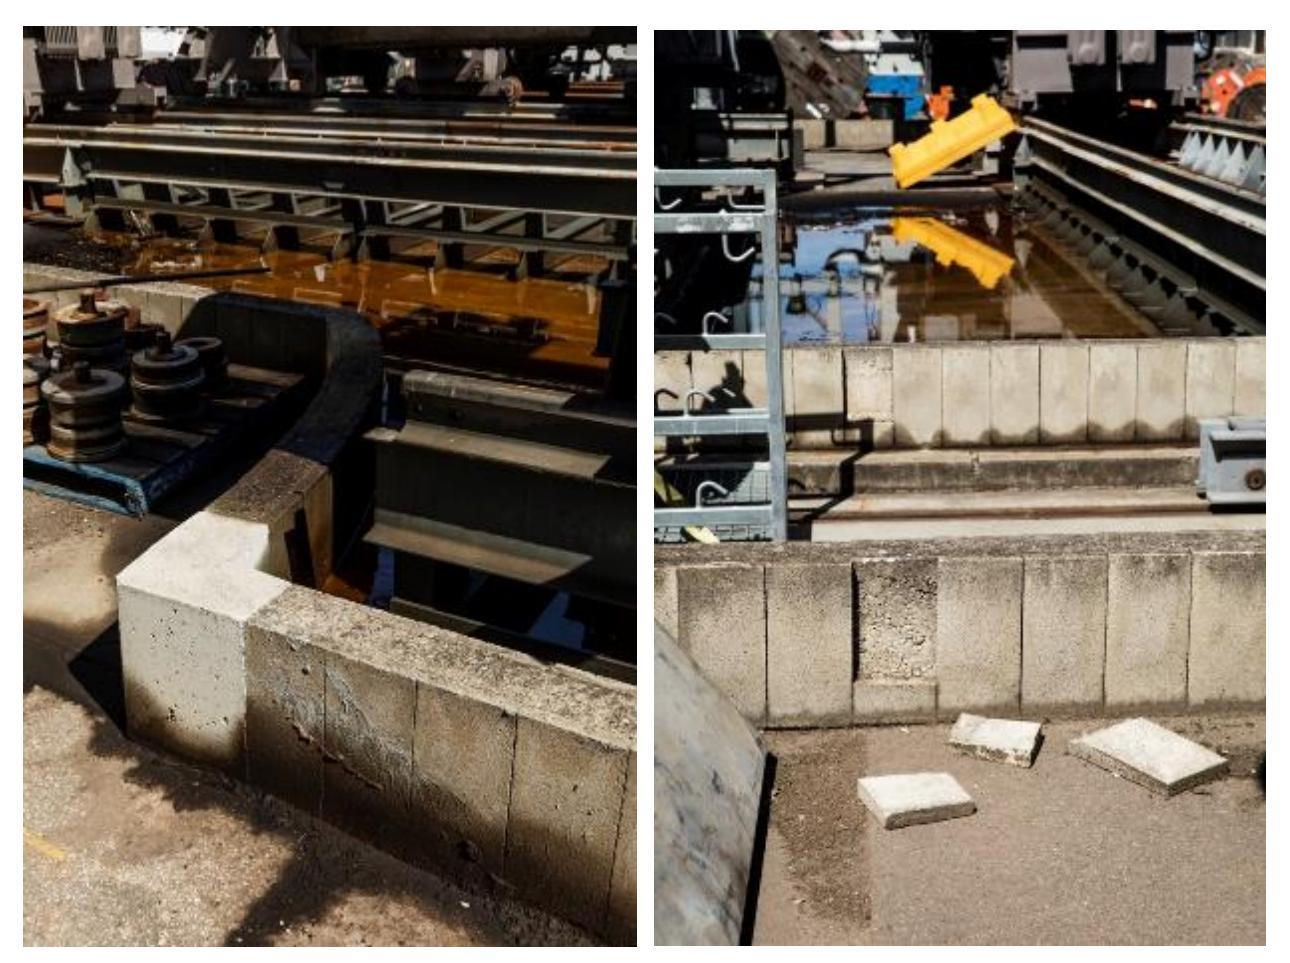
Figure 15 Heavy Transformer containment bund (besser block) – cracking, movement and leaking transformer oil through bund wall; Previous bund repair section.
