Supporting document 5.23.2 Marleston North Photographs

2020-25 Revised Regulatory Proposal 10 December 2019

Marleston North Asset Condition Photographs

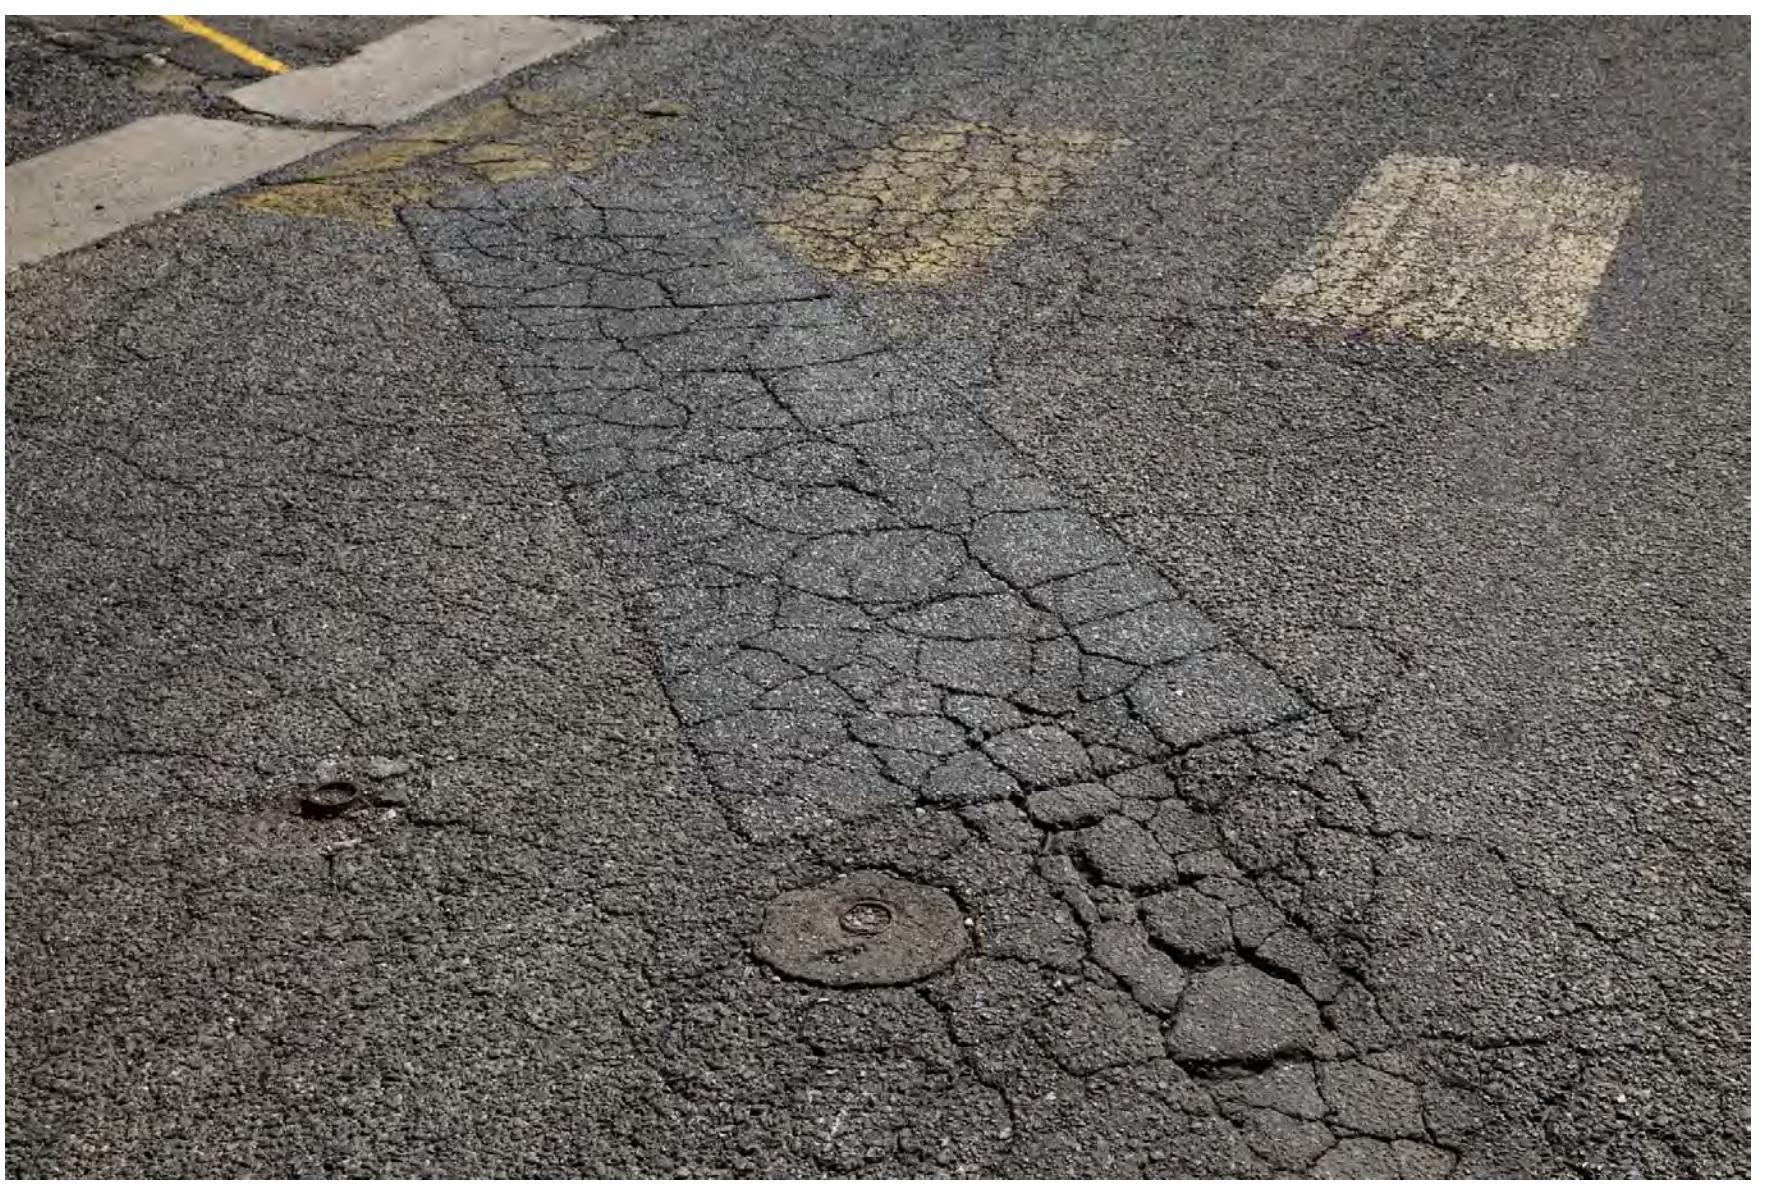
Full-thickness cracking and subsidence to driveway and pedestrian walkway

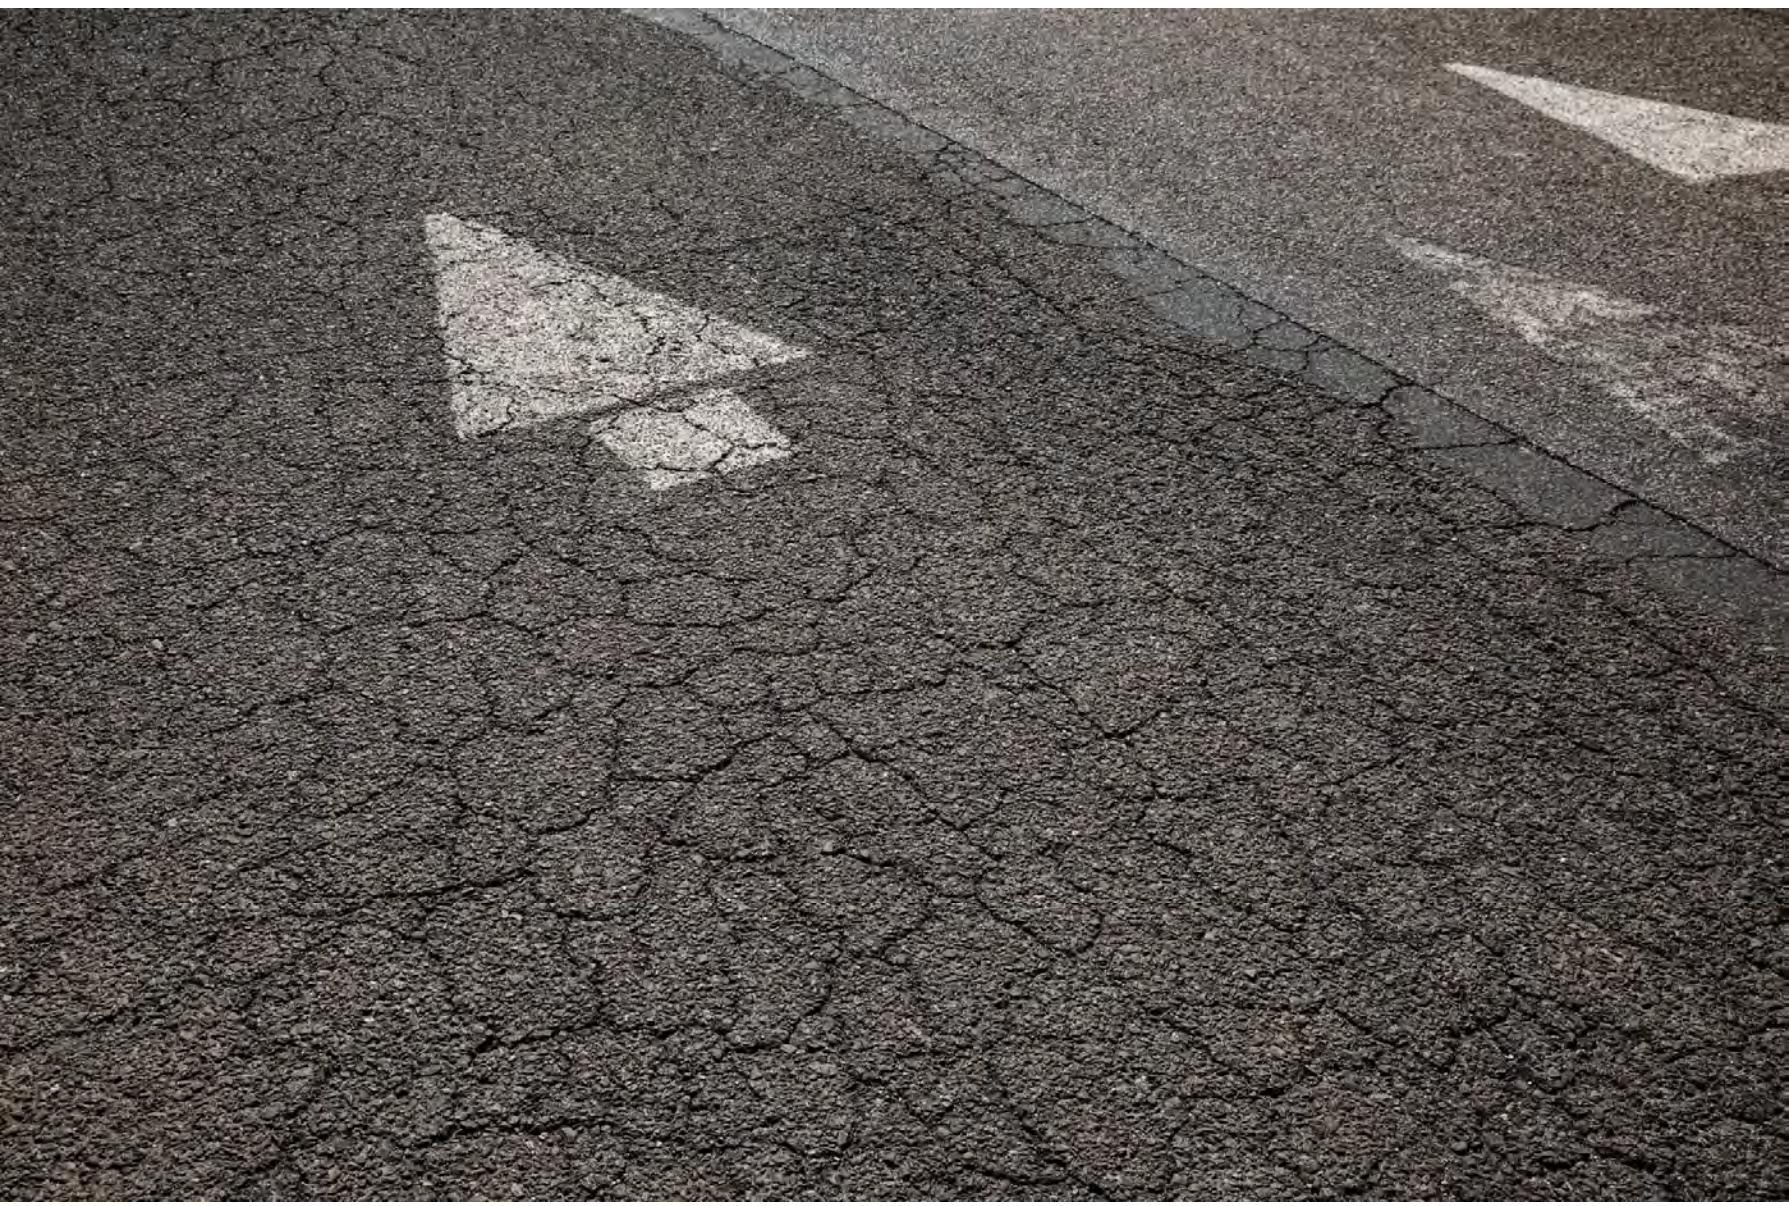
Full-thickness cracking to main driveway

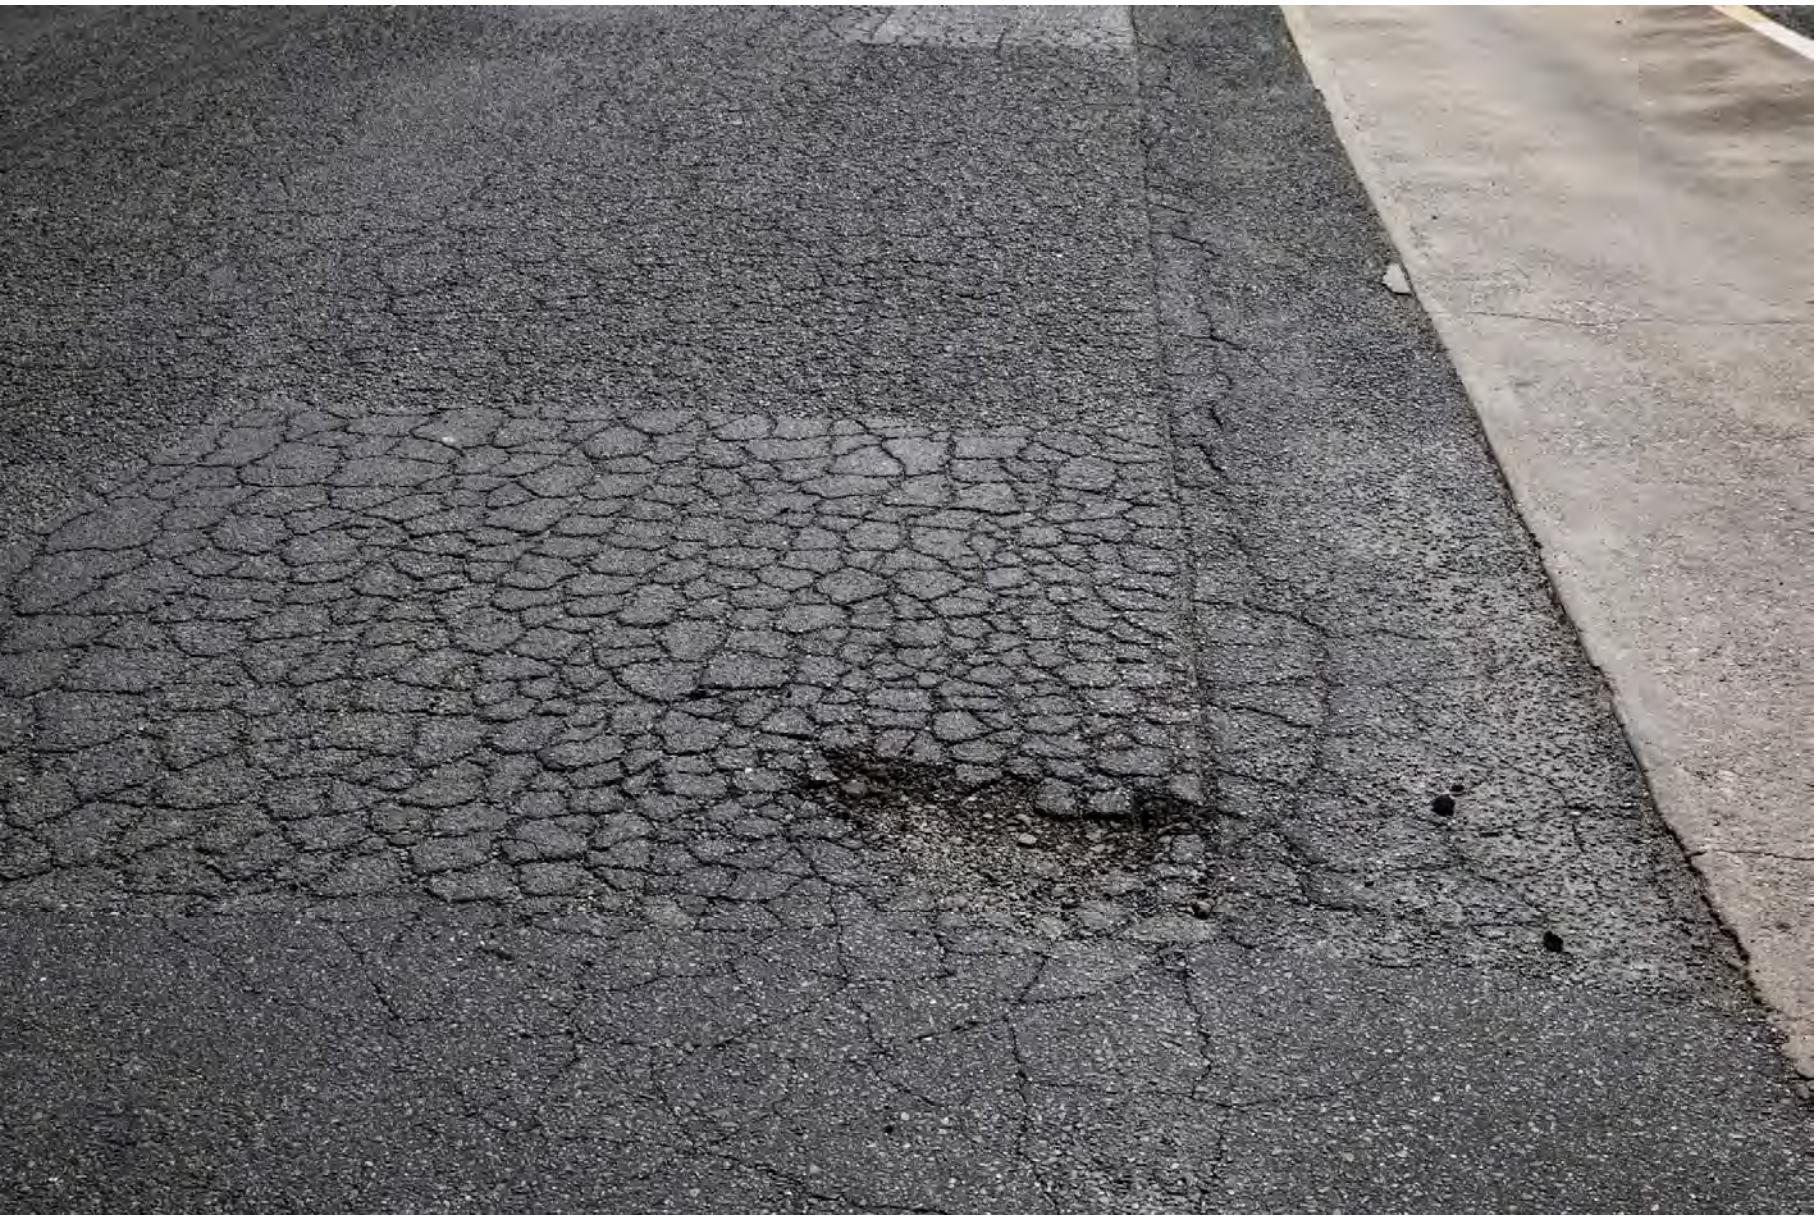
Full-thickness cracking and potholing to main driveway and Car park area

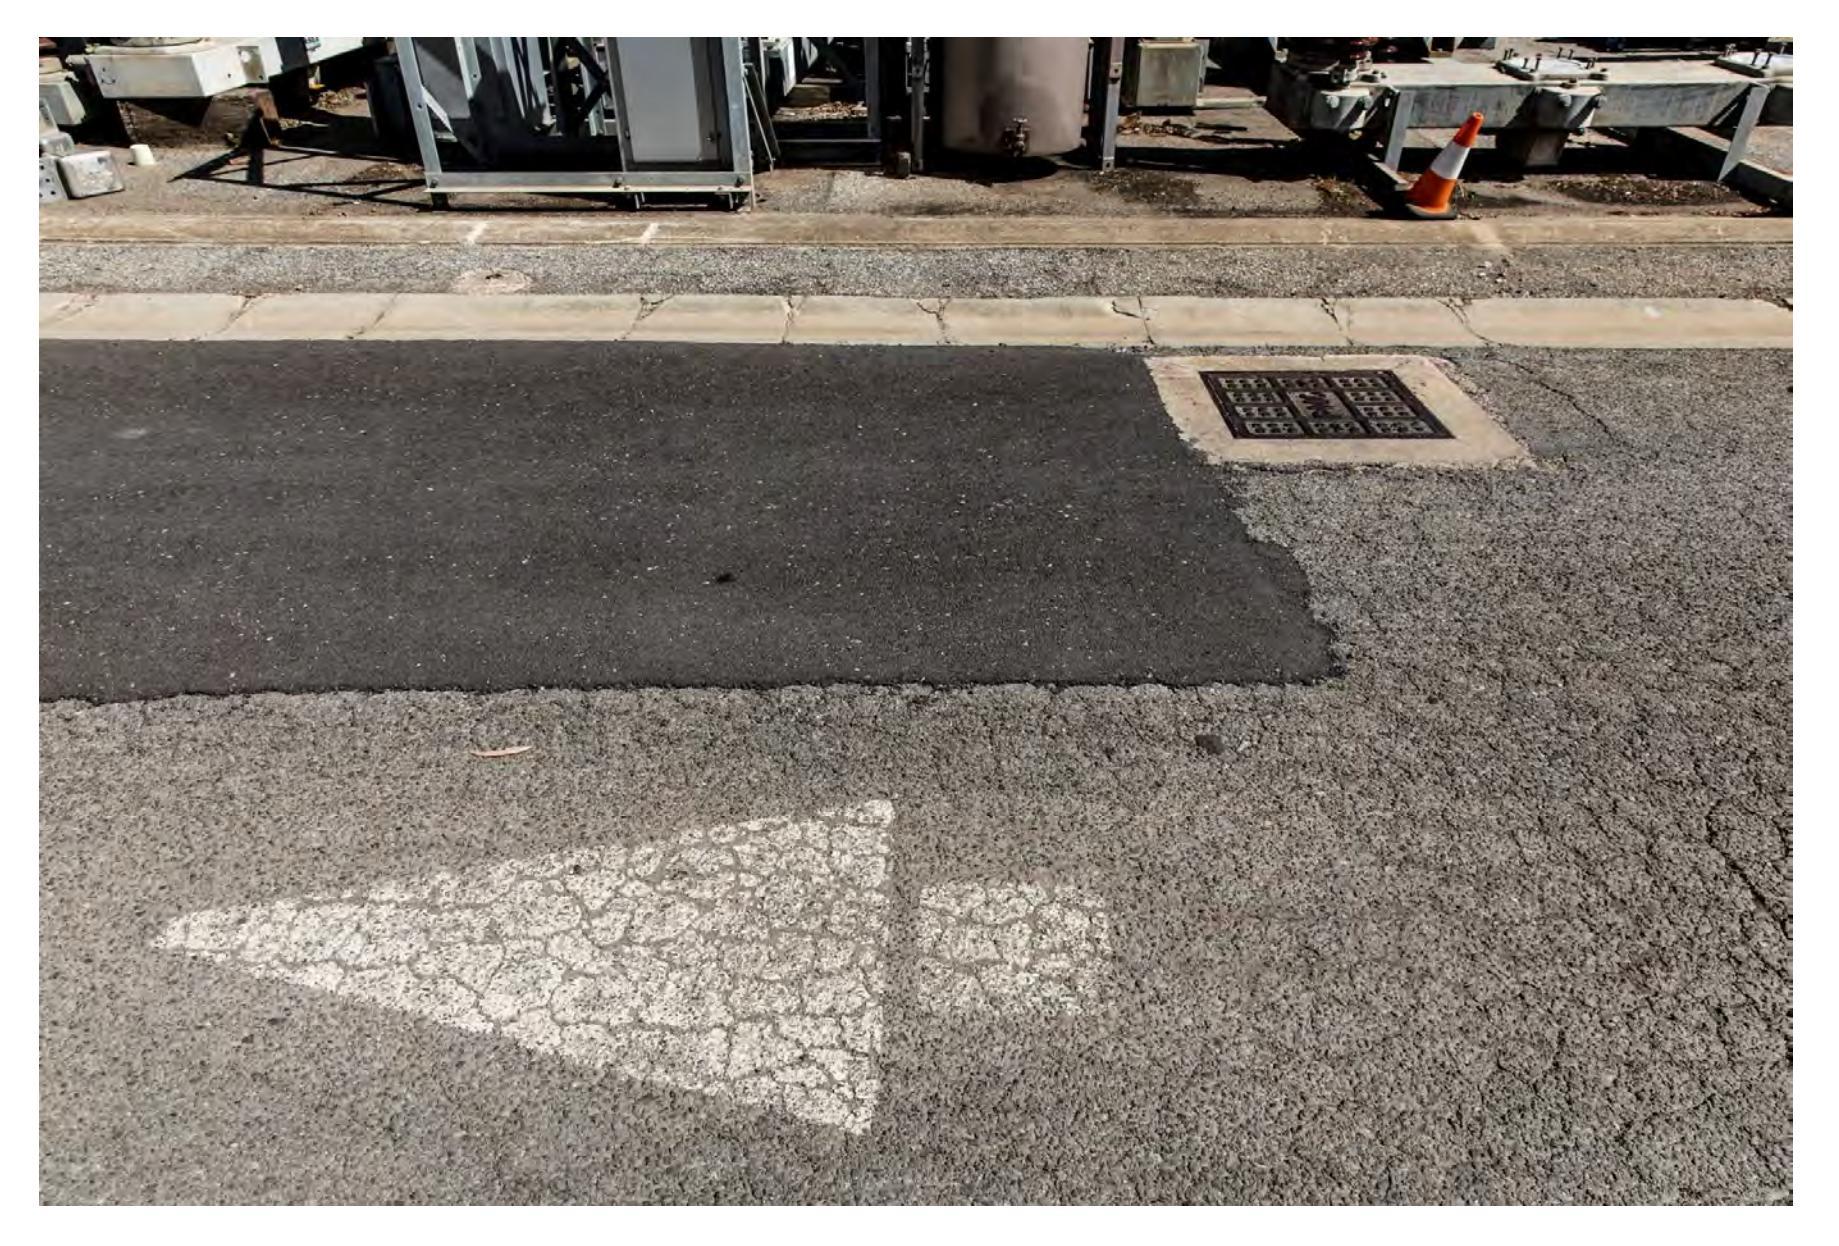
• Deep cracking to concrete spoon drain, full-thickness cracking to bitumen pavement, area of previous repair and low roll-over bund

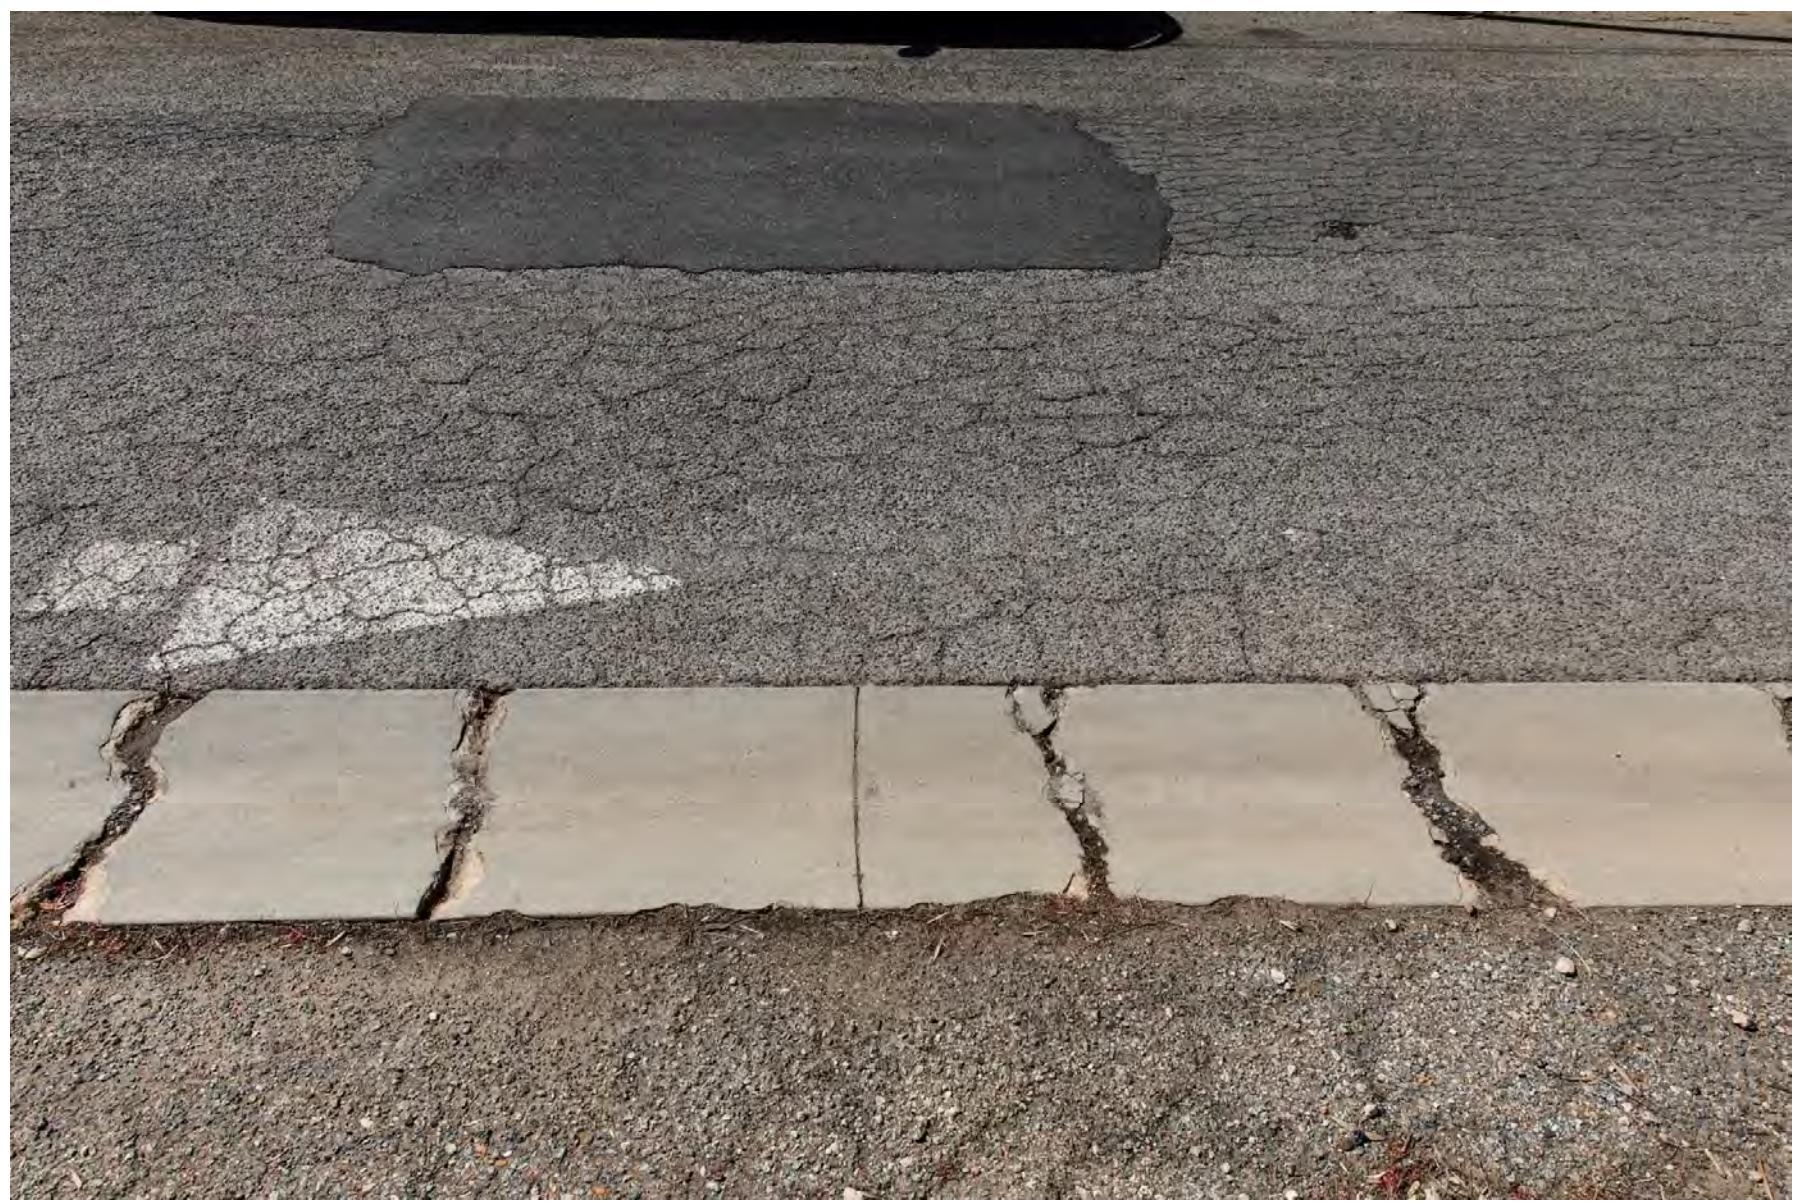
• Deep cracking and movement to concrete spoon drain, full-thickness cracking to bitumen pavement, area of previous repair.

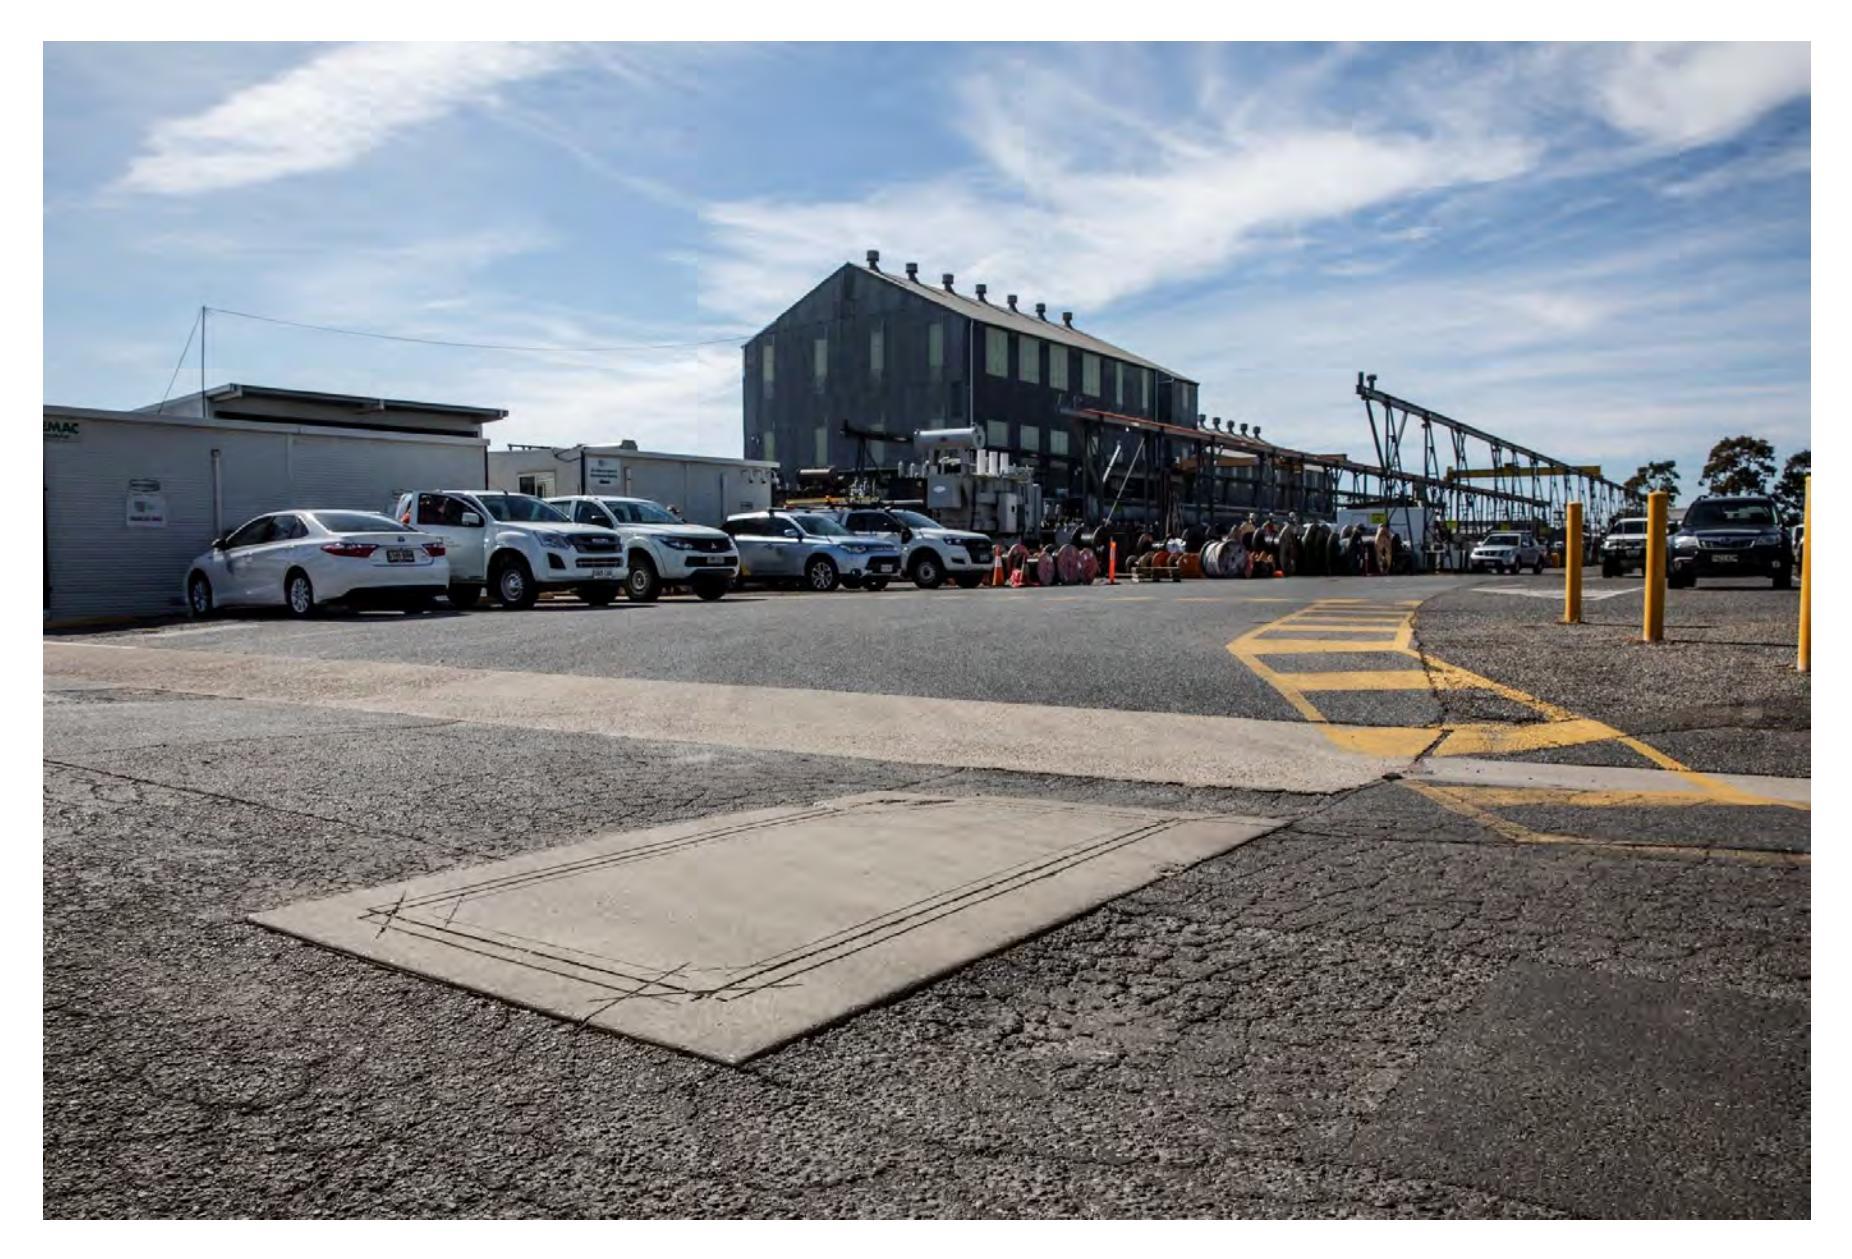
• Full-thickness bitumen cracking and subsidence to main gate entranceway and heavy vehicle turning circle

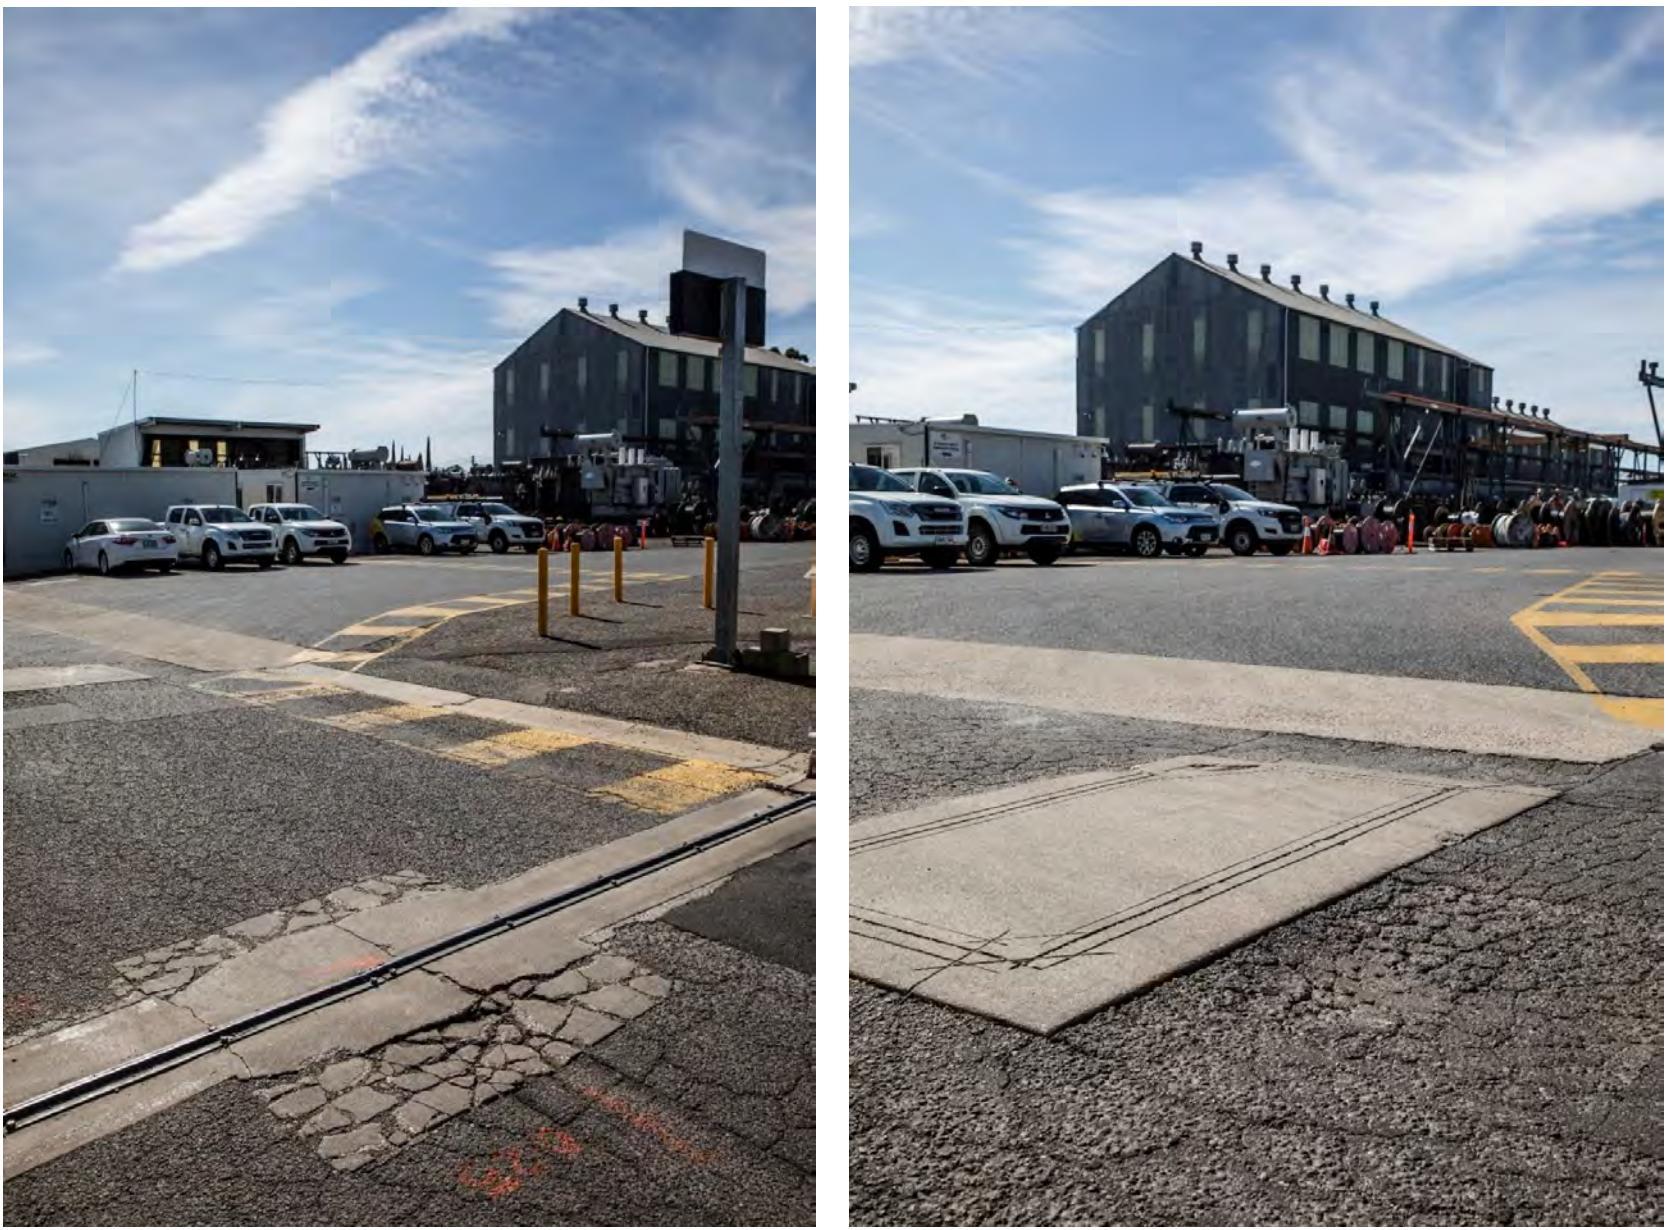
• Full-thickness bitumen cracking and subsidence to main gate entranceway, concrete gate rail cracking and subsidence.

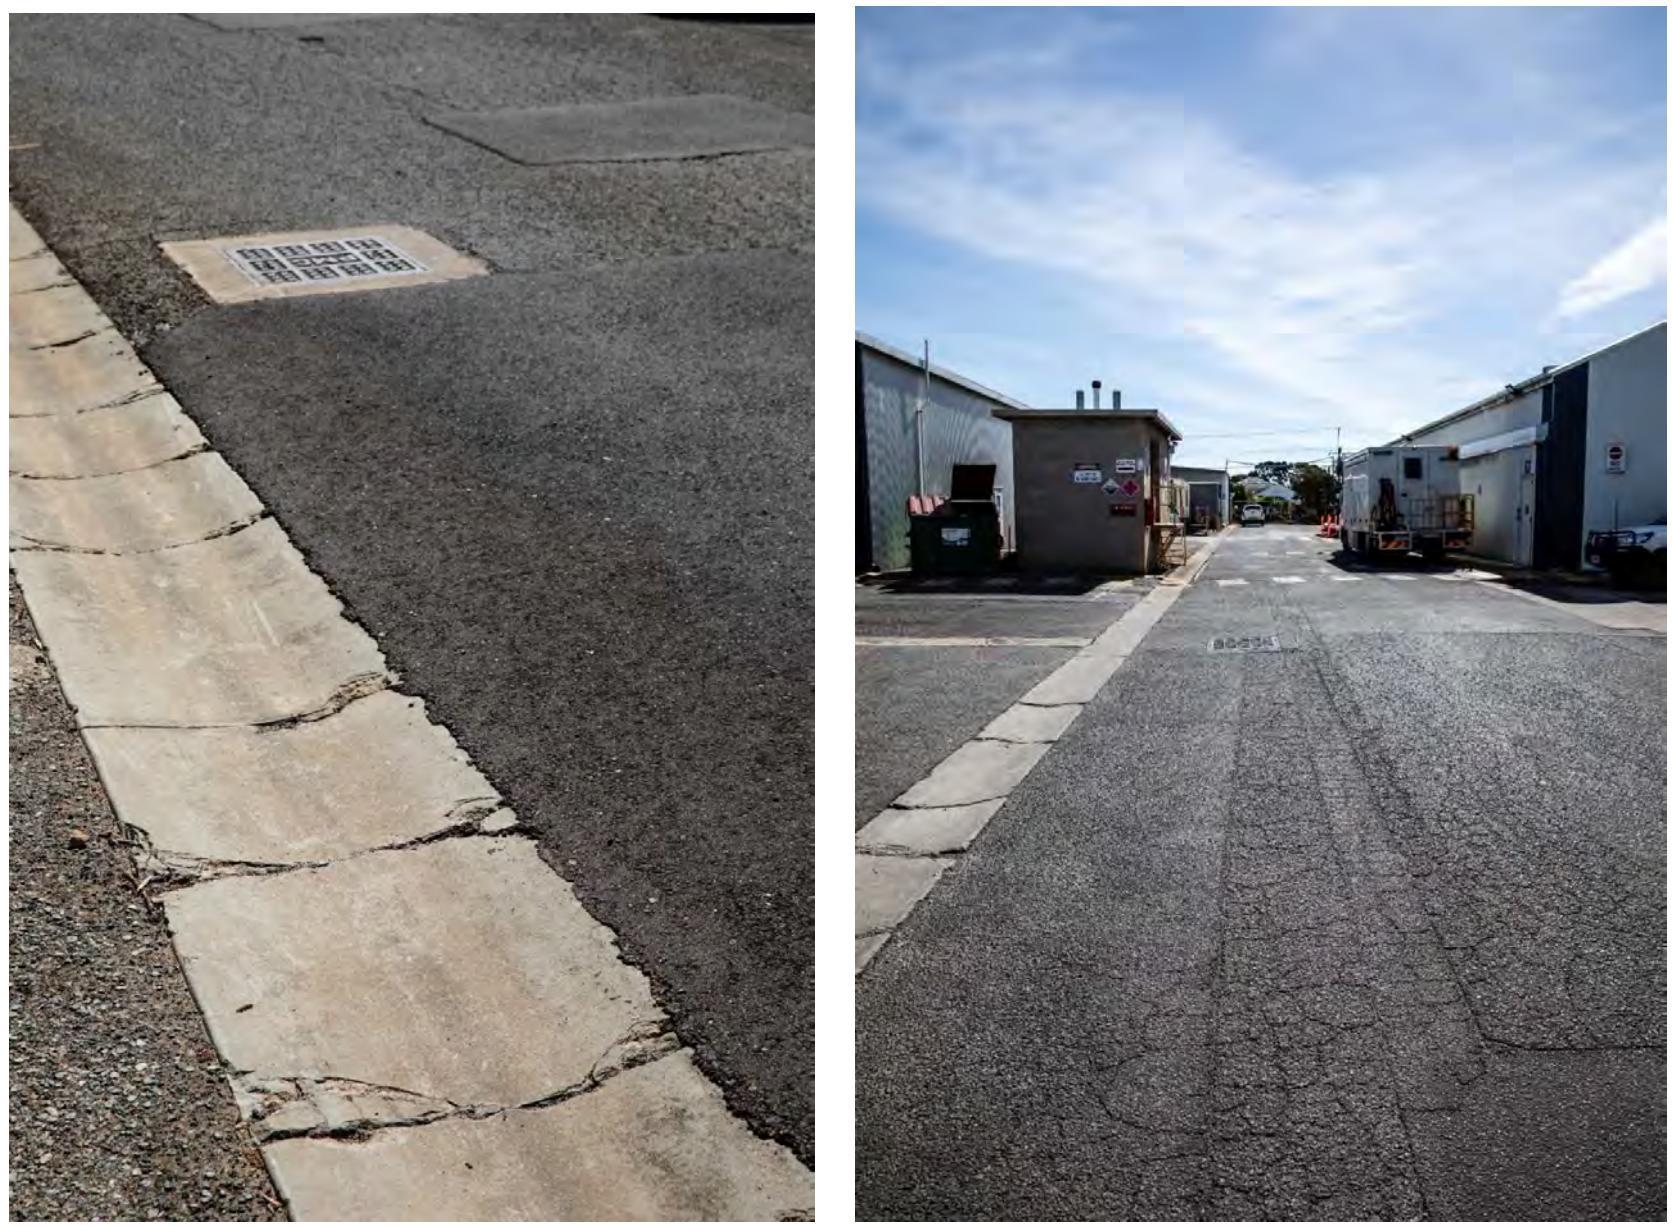
• Spoon drain cracking and instability, previous repair patches and extent of bitumen cracking to substation store driveway

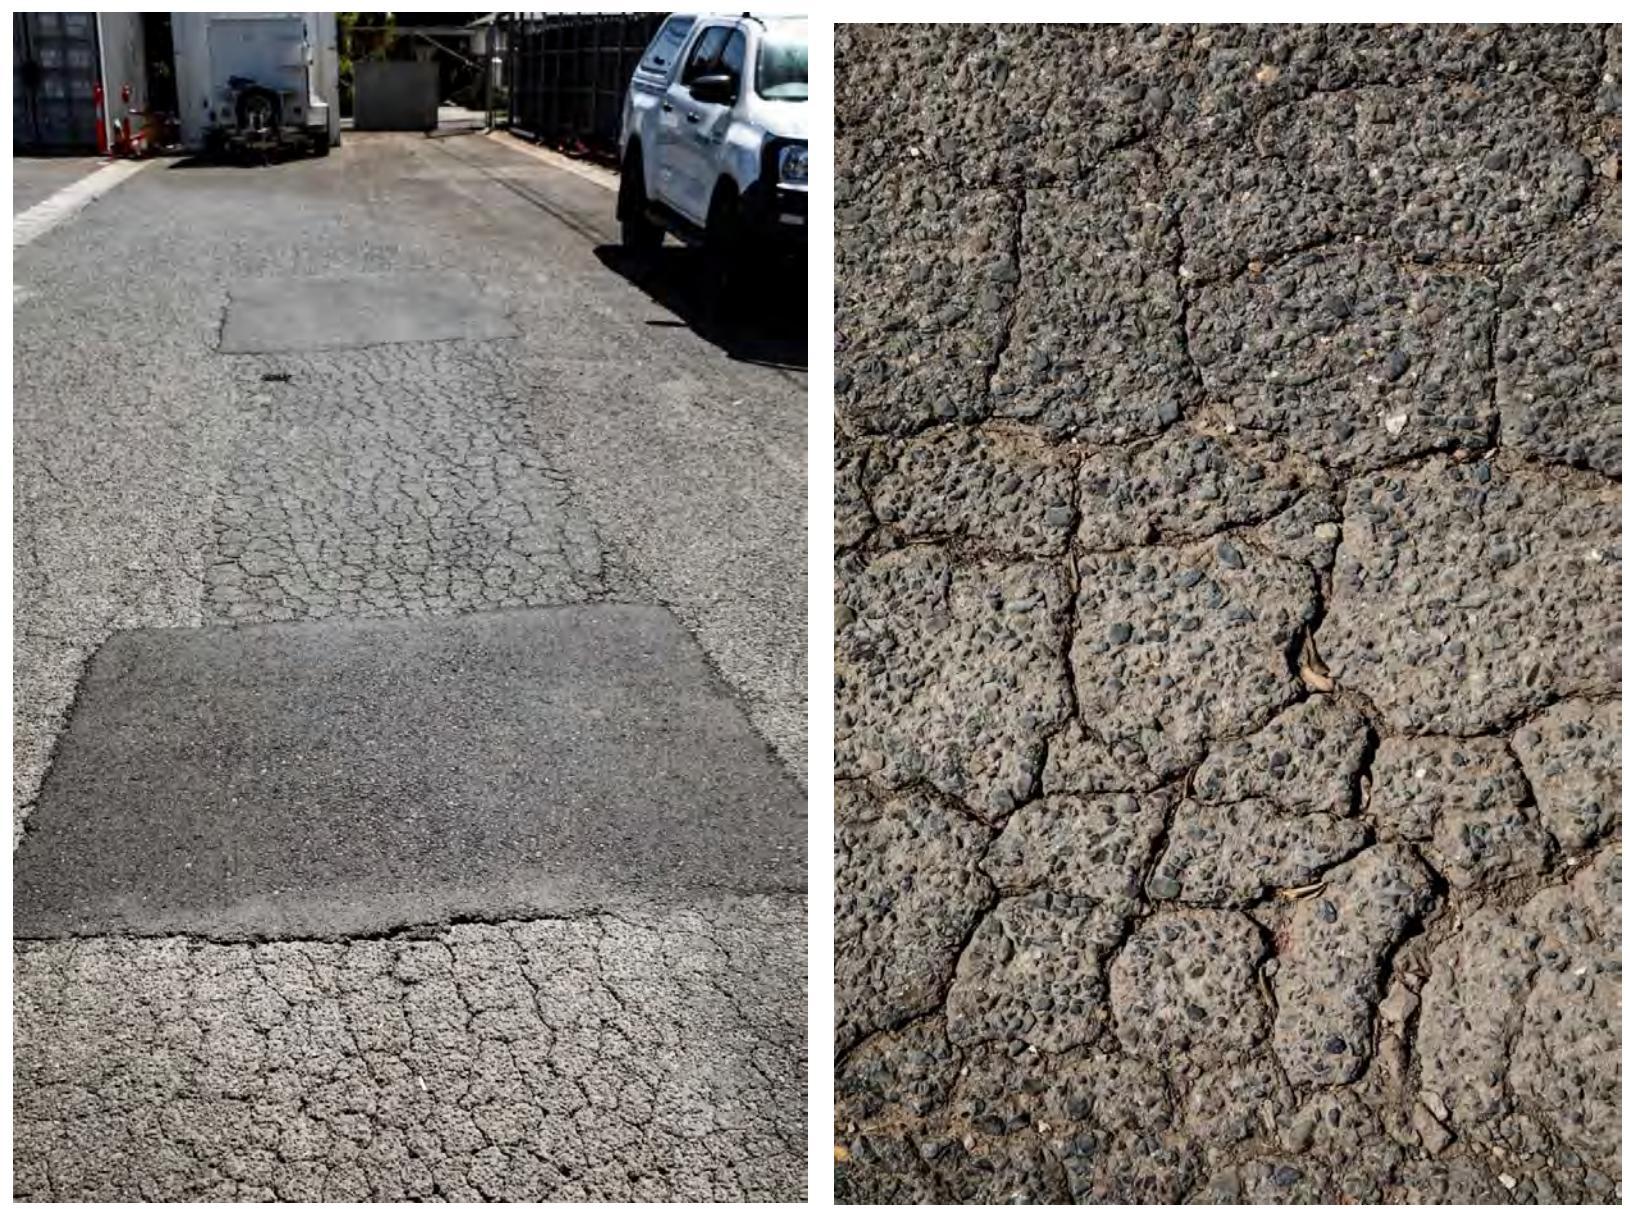
• Full-thickness bitumen cracking and subsidence, recent repair patches and previous repair patch cracking

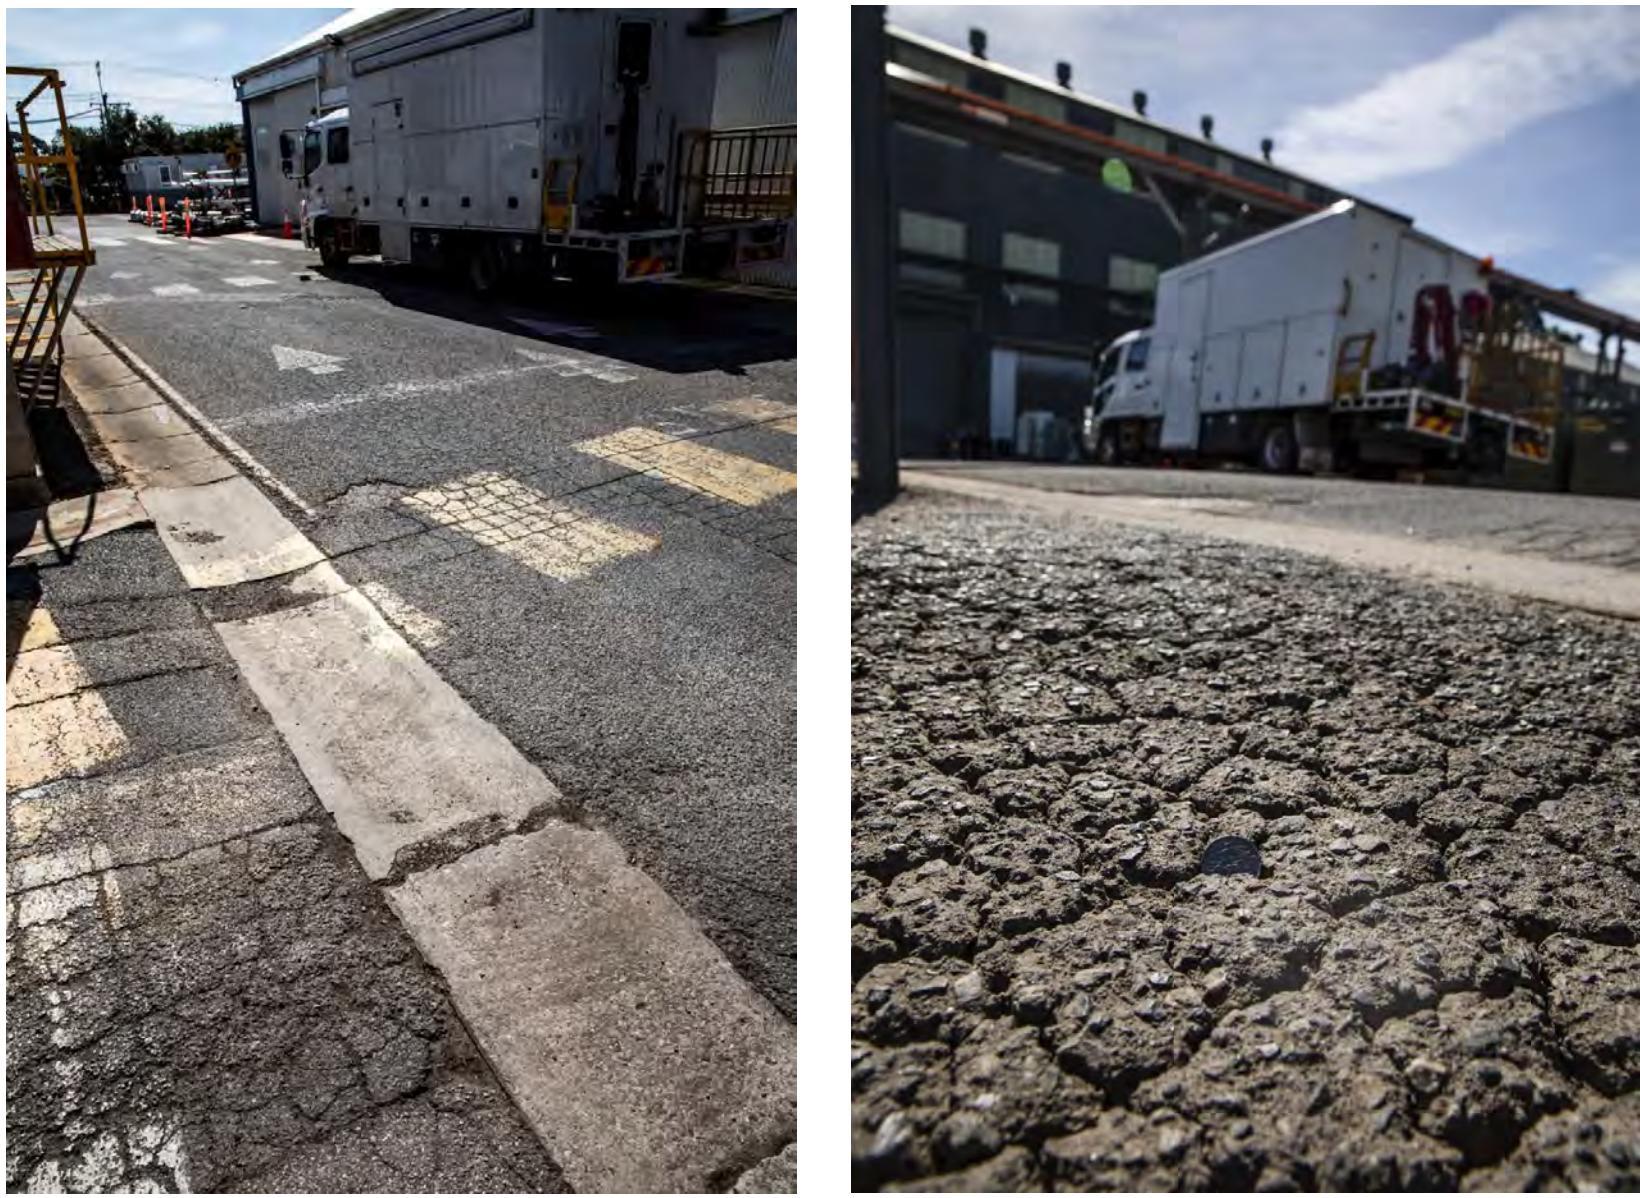
• Deep cracking to concrete spoon drain and main driveway to transformer workshop
