Supporting document 5.23.2 Marleston North Photographs

2020-25 Revised Regulatory Proposal 10 December 2019

Marleston North Asset Condition Photographs

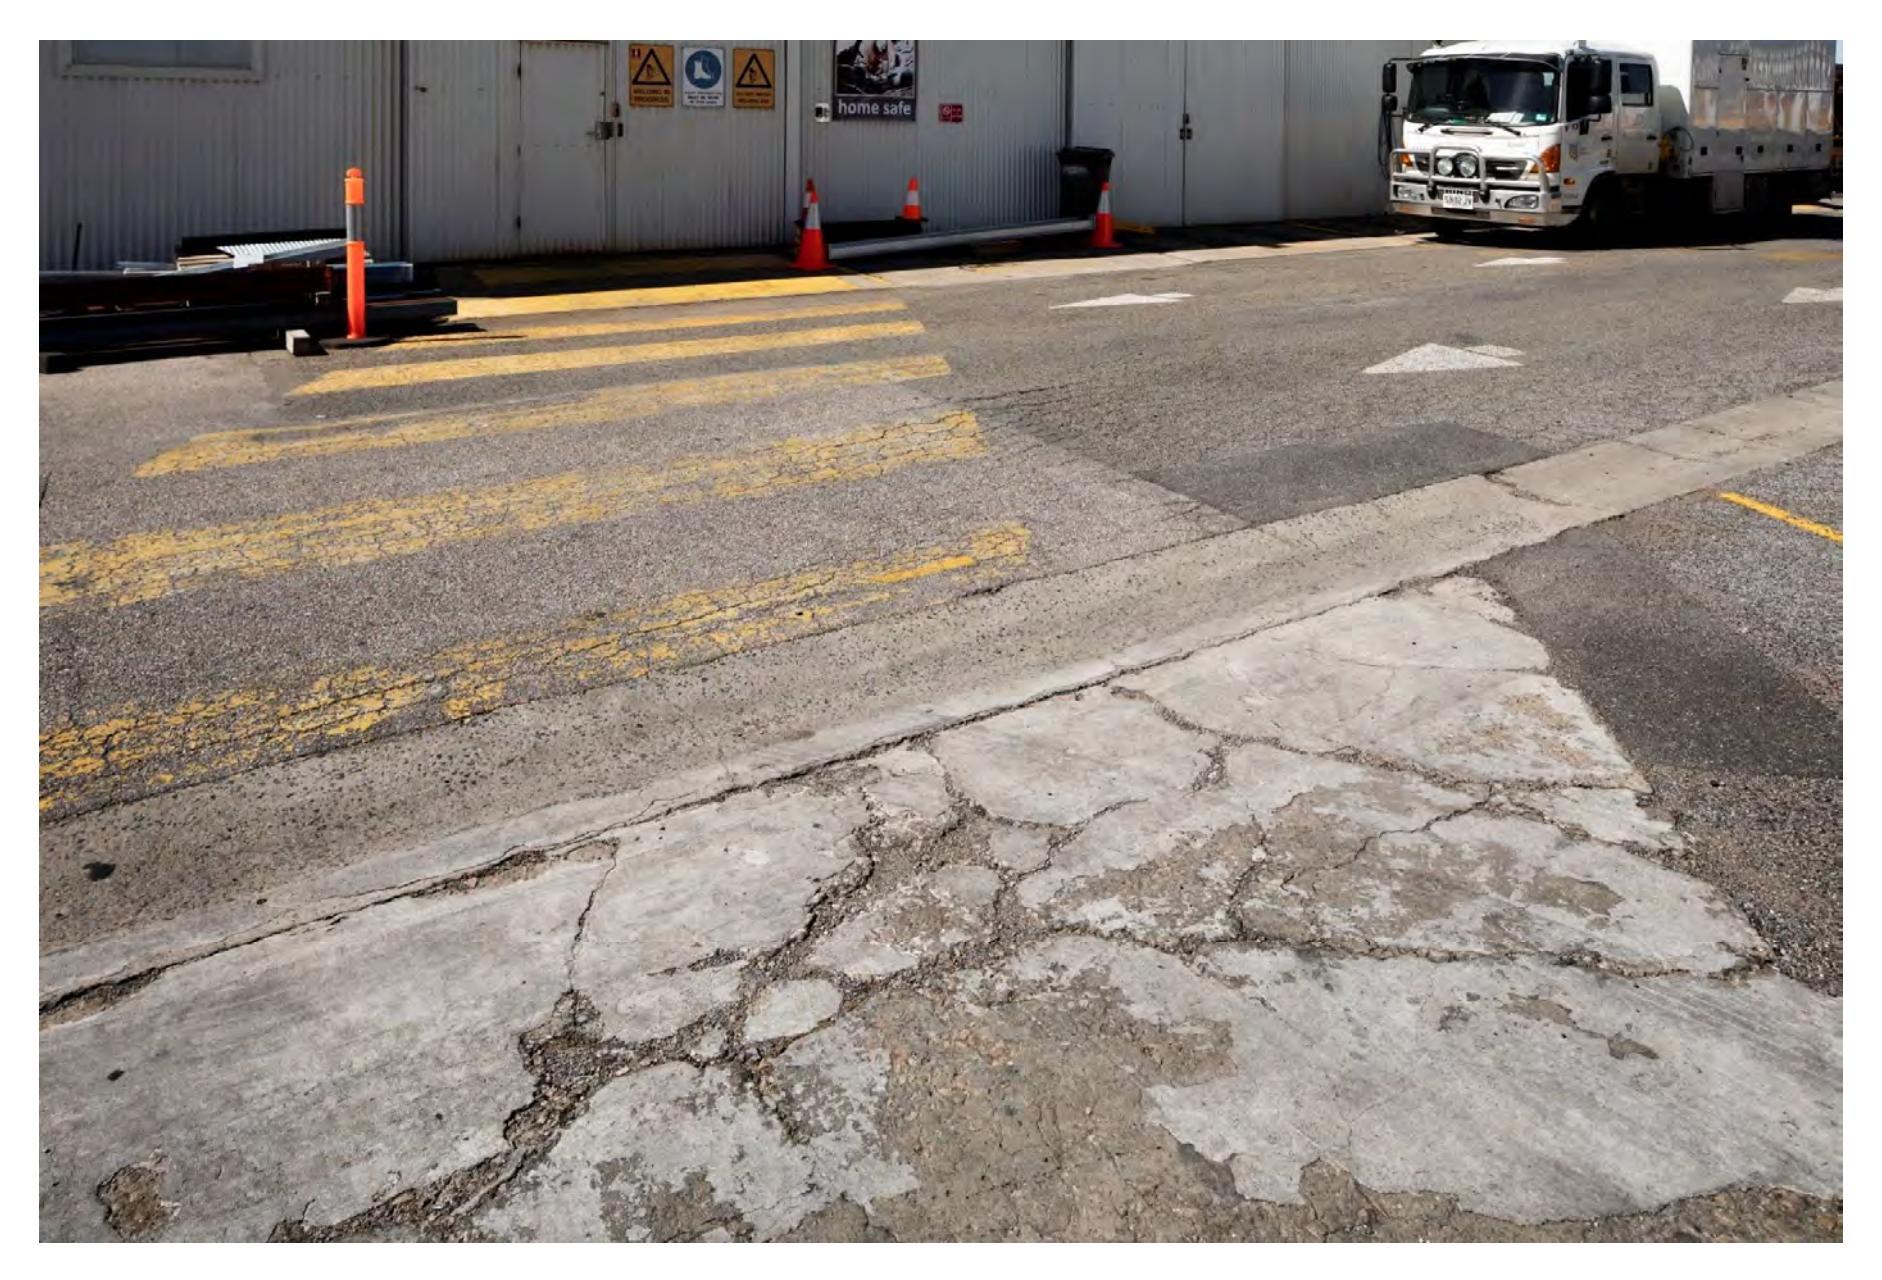
• Deep cracking to concrete forklift loading ramp to substation workshop and bitumen cracking to main roadway

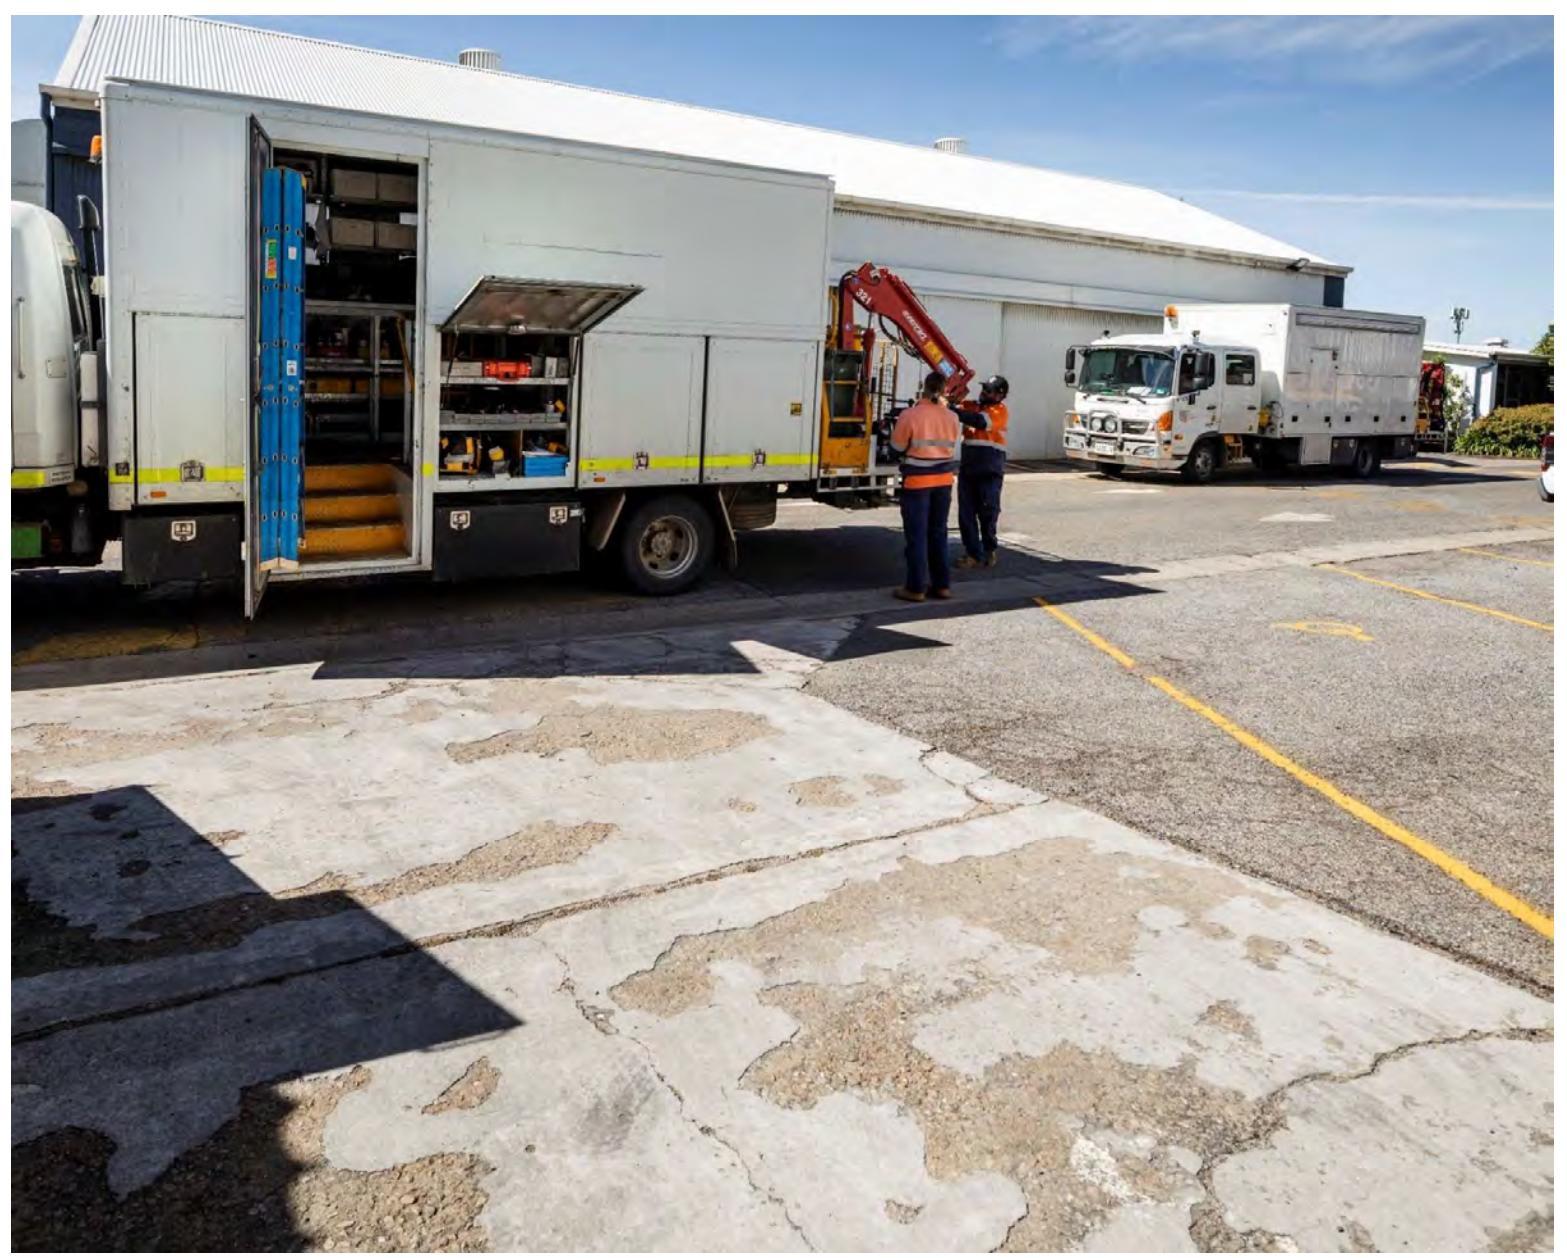
Deep cracking and movement to concrete forklift loading ramp – substation workshop

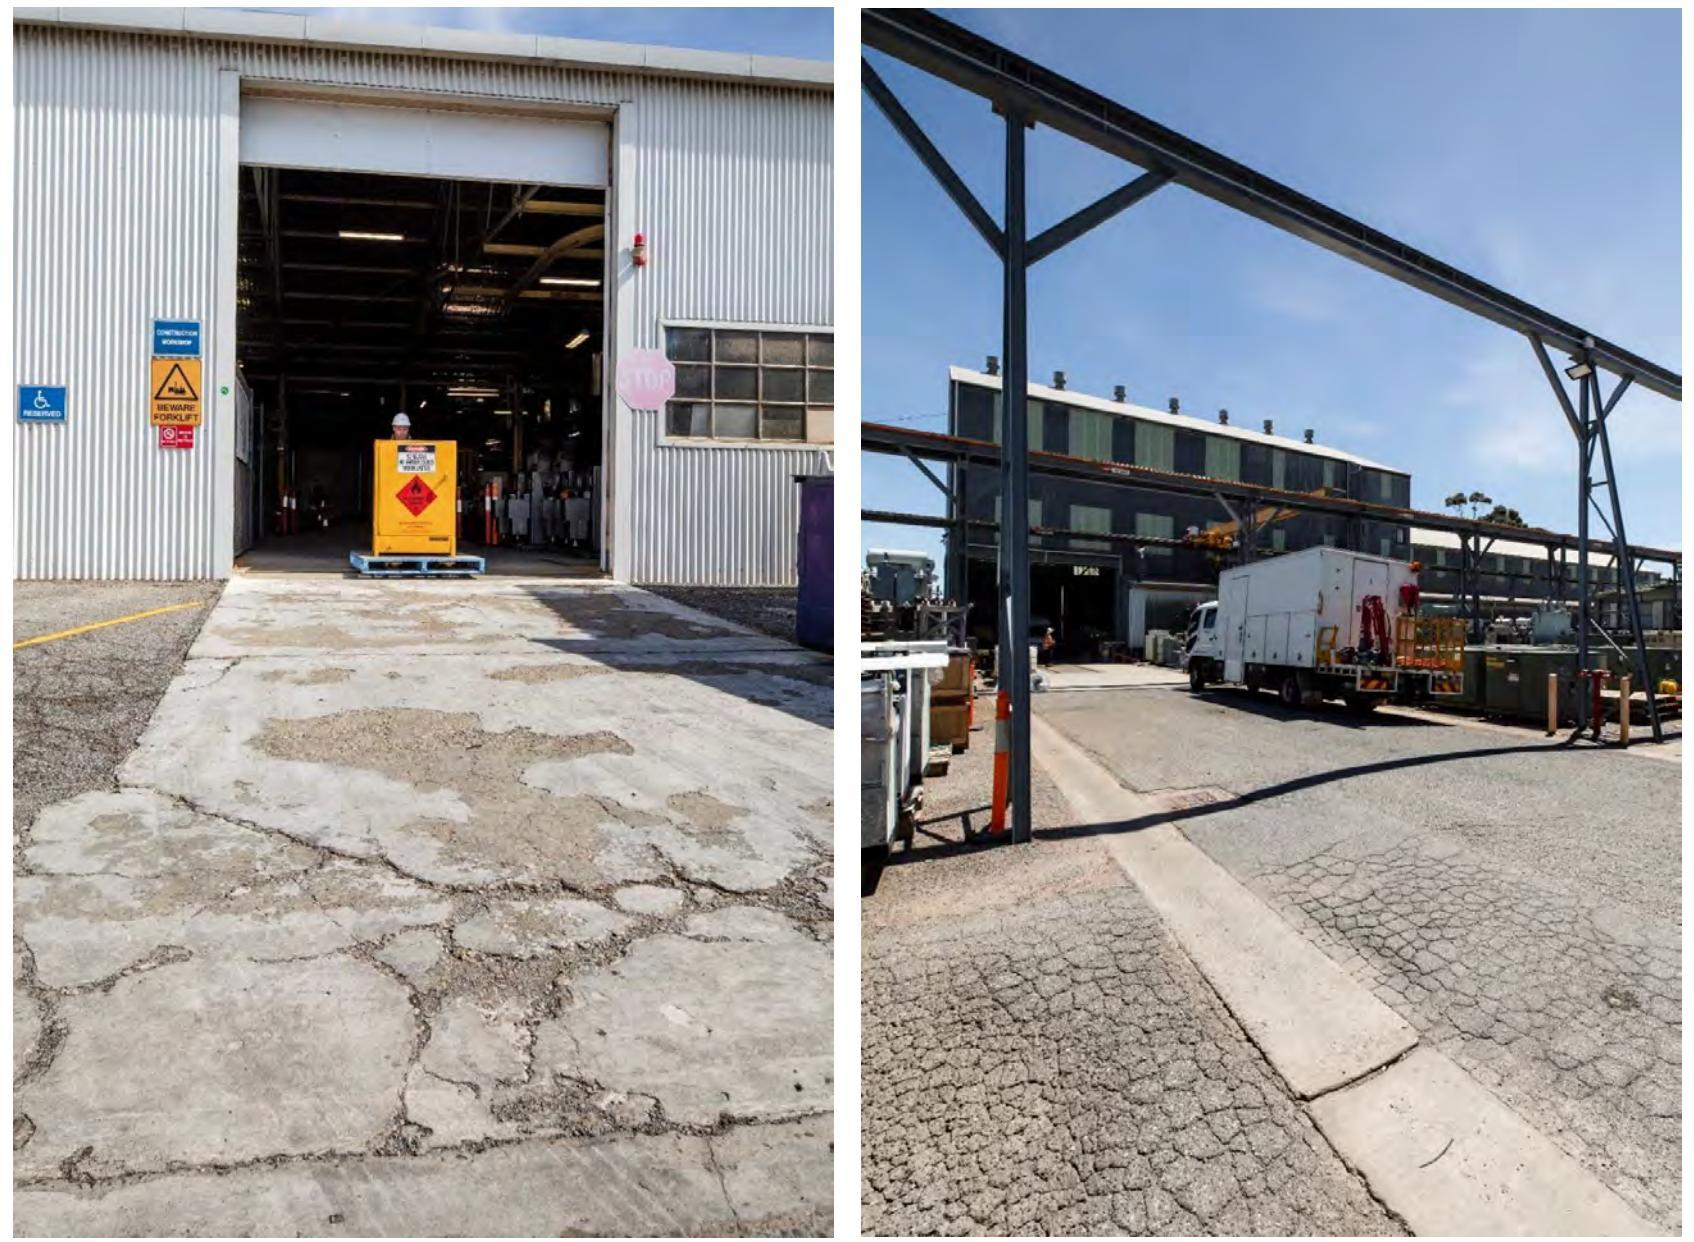
Deep cracking and movement to concrete forklift loading ramp – substation workshop. Bitumen cracking to transformer workshop truck loading bay

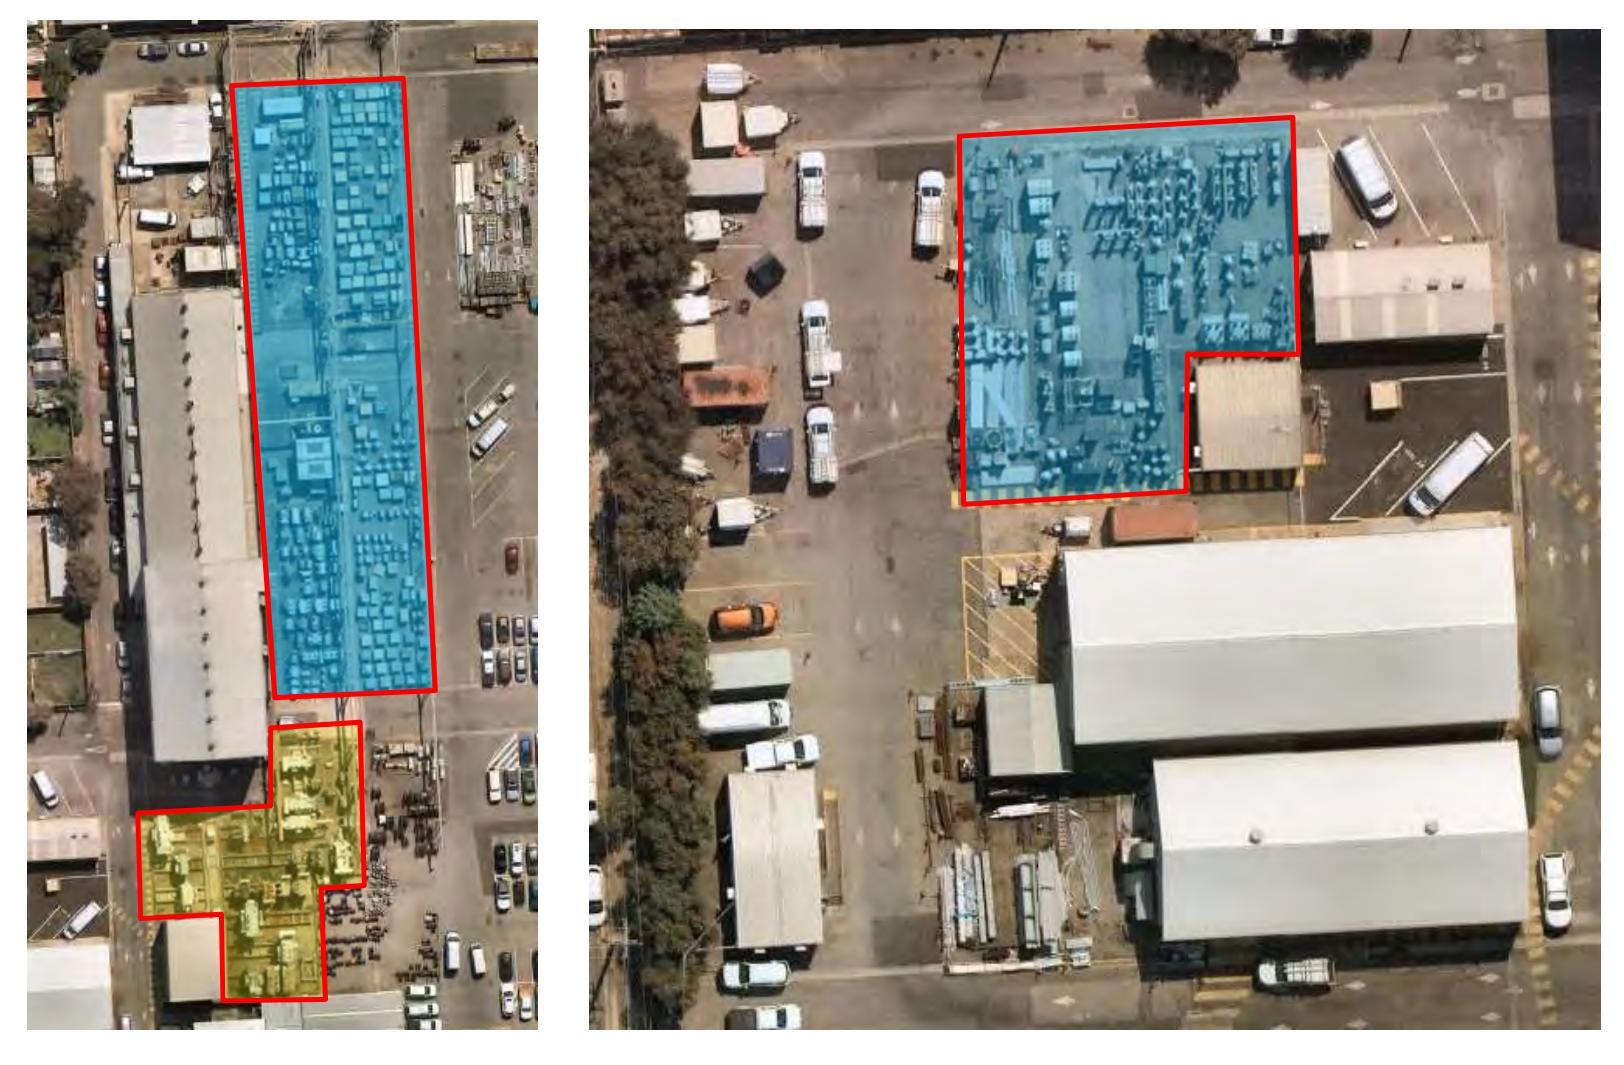
- Yellow area is Heavy Transformer Oil Containment Concrete Bund unmortared besser block design cracked and leaking.
- Blue area is Bitumen oil containment bund Smaller Transformers low bitumen roll-over bund.

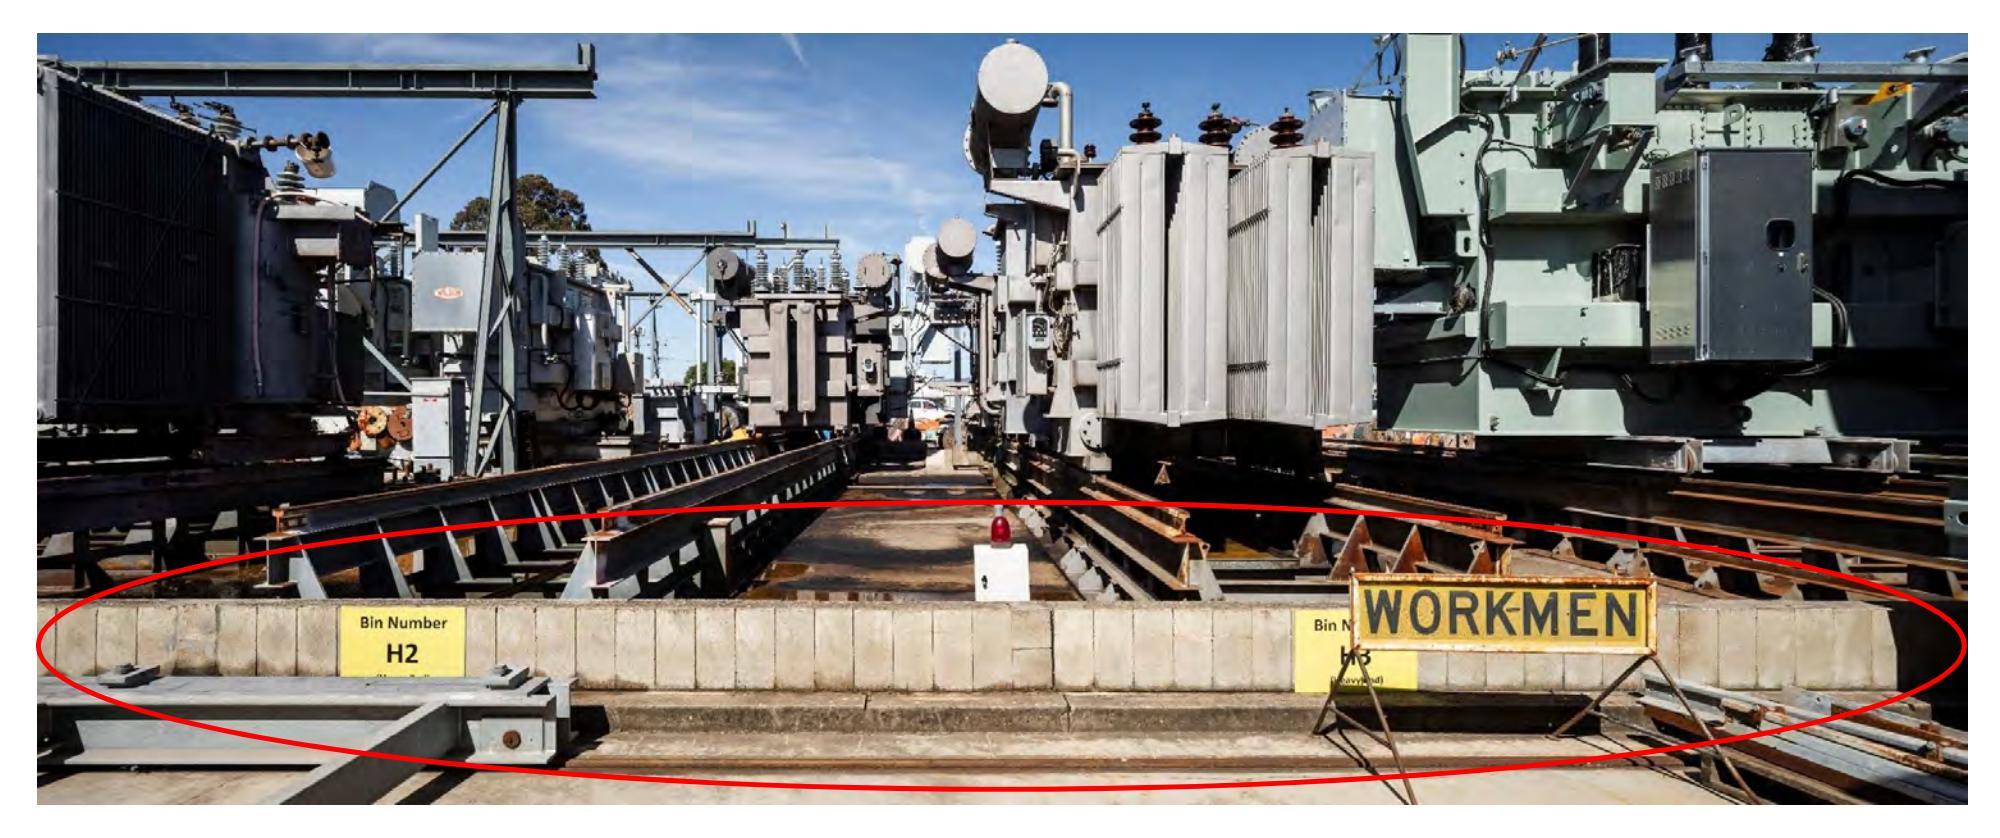
- Heavy Transformer containment bund (besser block) cracking, movement and leaking transformer oil through bund wall;
- Original transformer rail system no longer operational and tagged out of service due to ground subsidence.

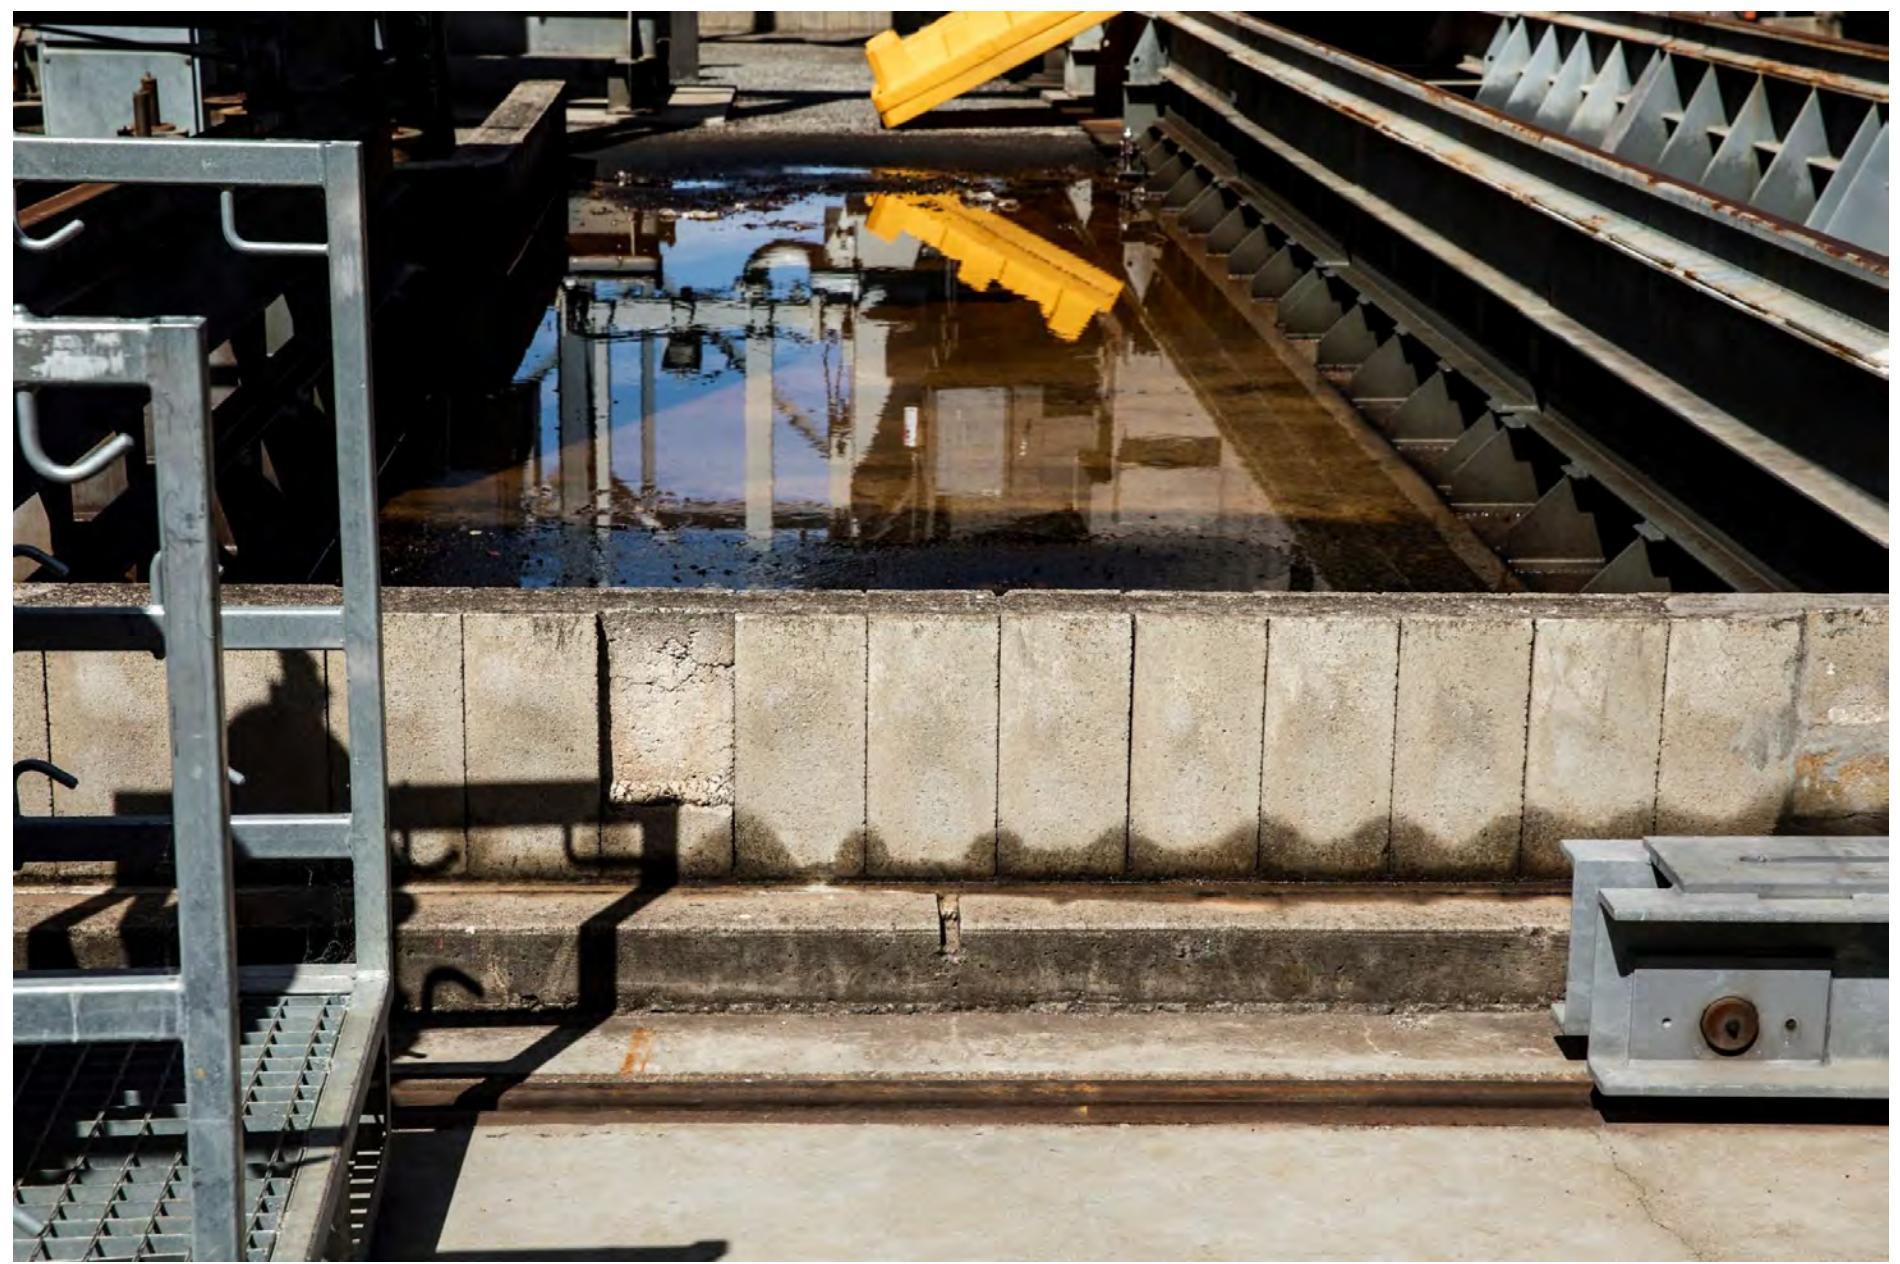
Heavy Transformer containment bund (besser block) – cracking, movement and leaking transformer oil through bund wall.

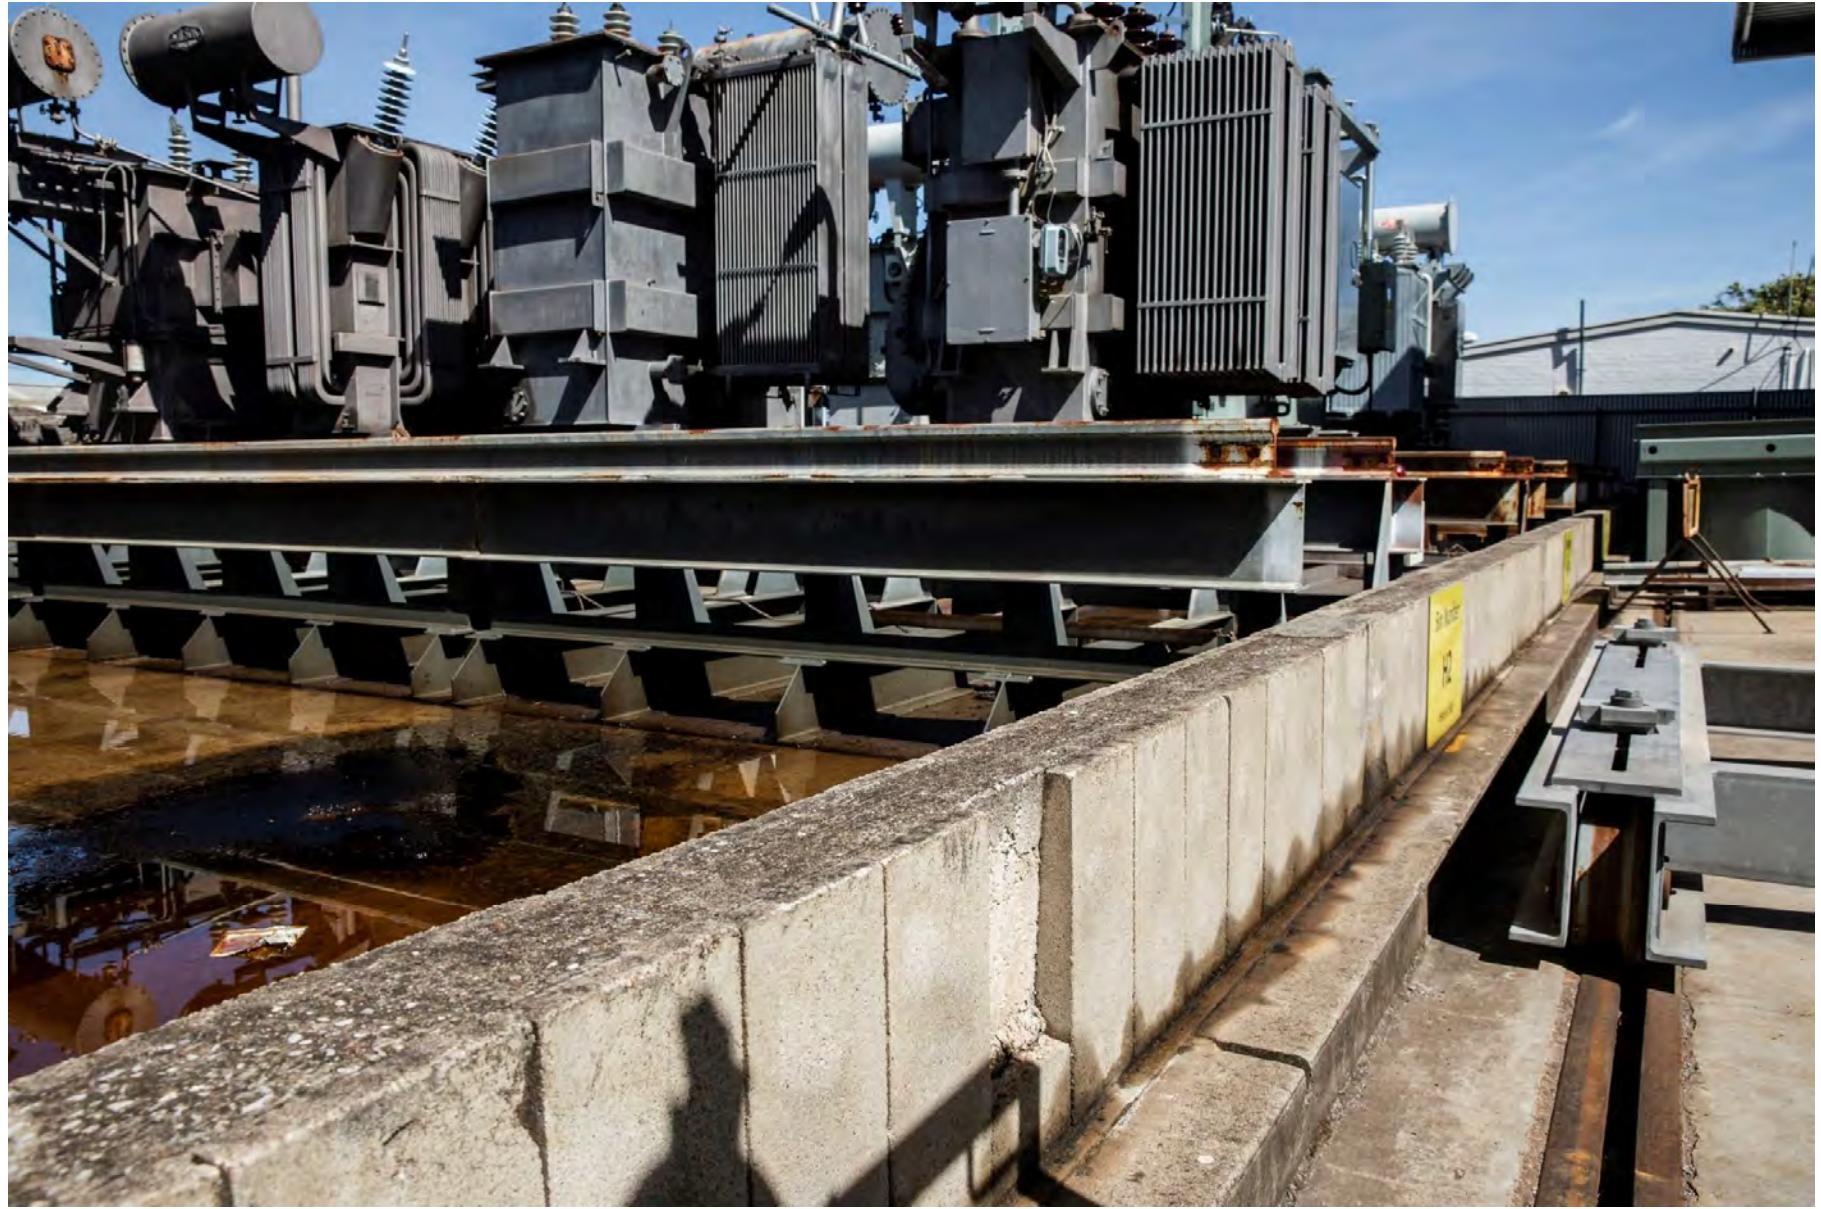
• Heavy Transformer containment bund (besser block) – cracking, movement and leaking transformer oil through bund wall;

• Original transformer rail system no longer operational and tagged out of service due to ground subsidence.

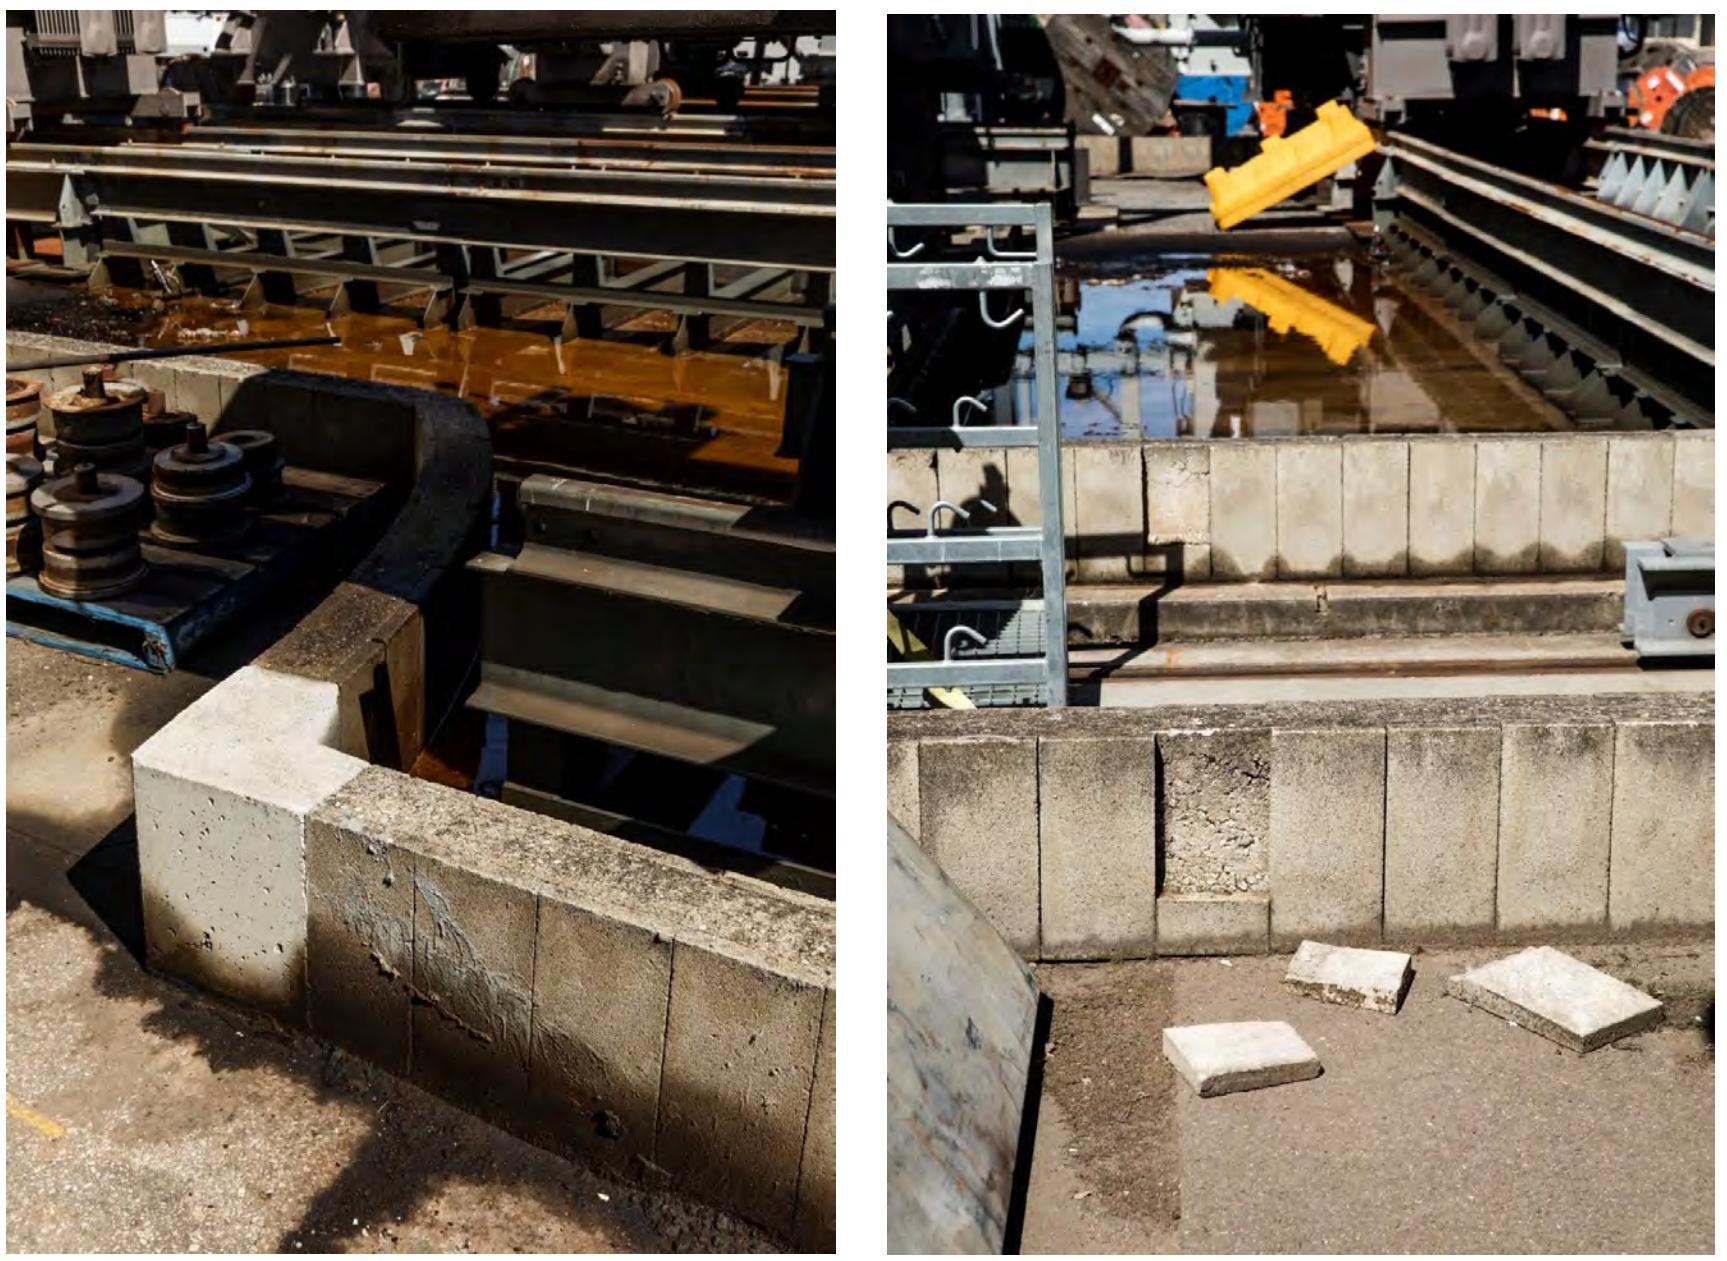
Heavy Transformer containment bund (besser block) – cracking, movement and leaking transformer oil through bund wall; Previous bund repair section.

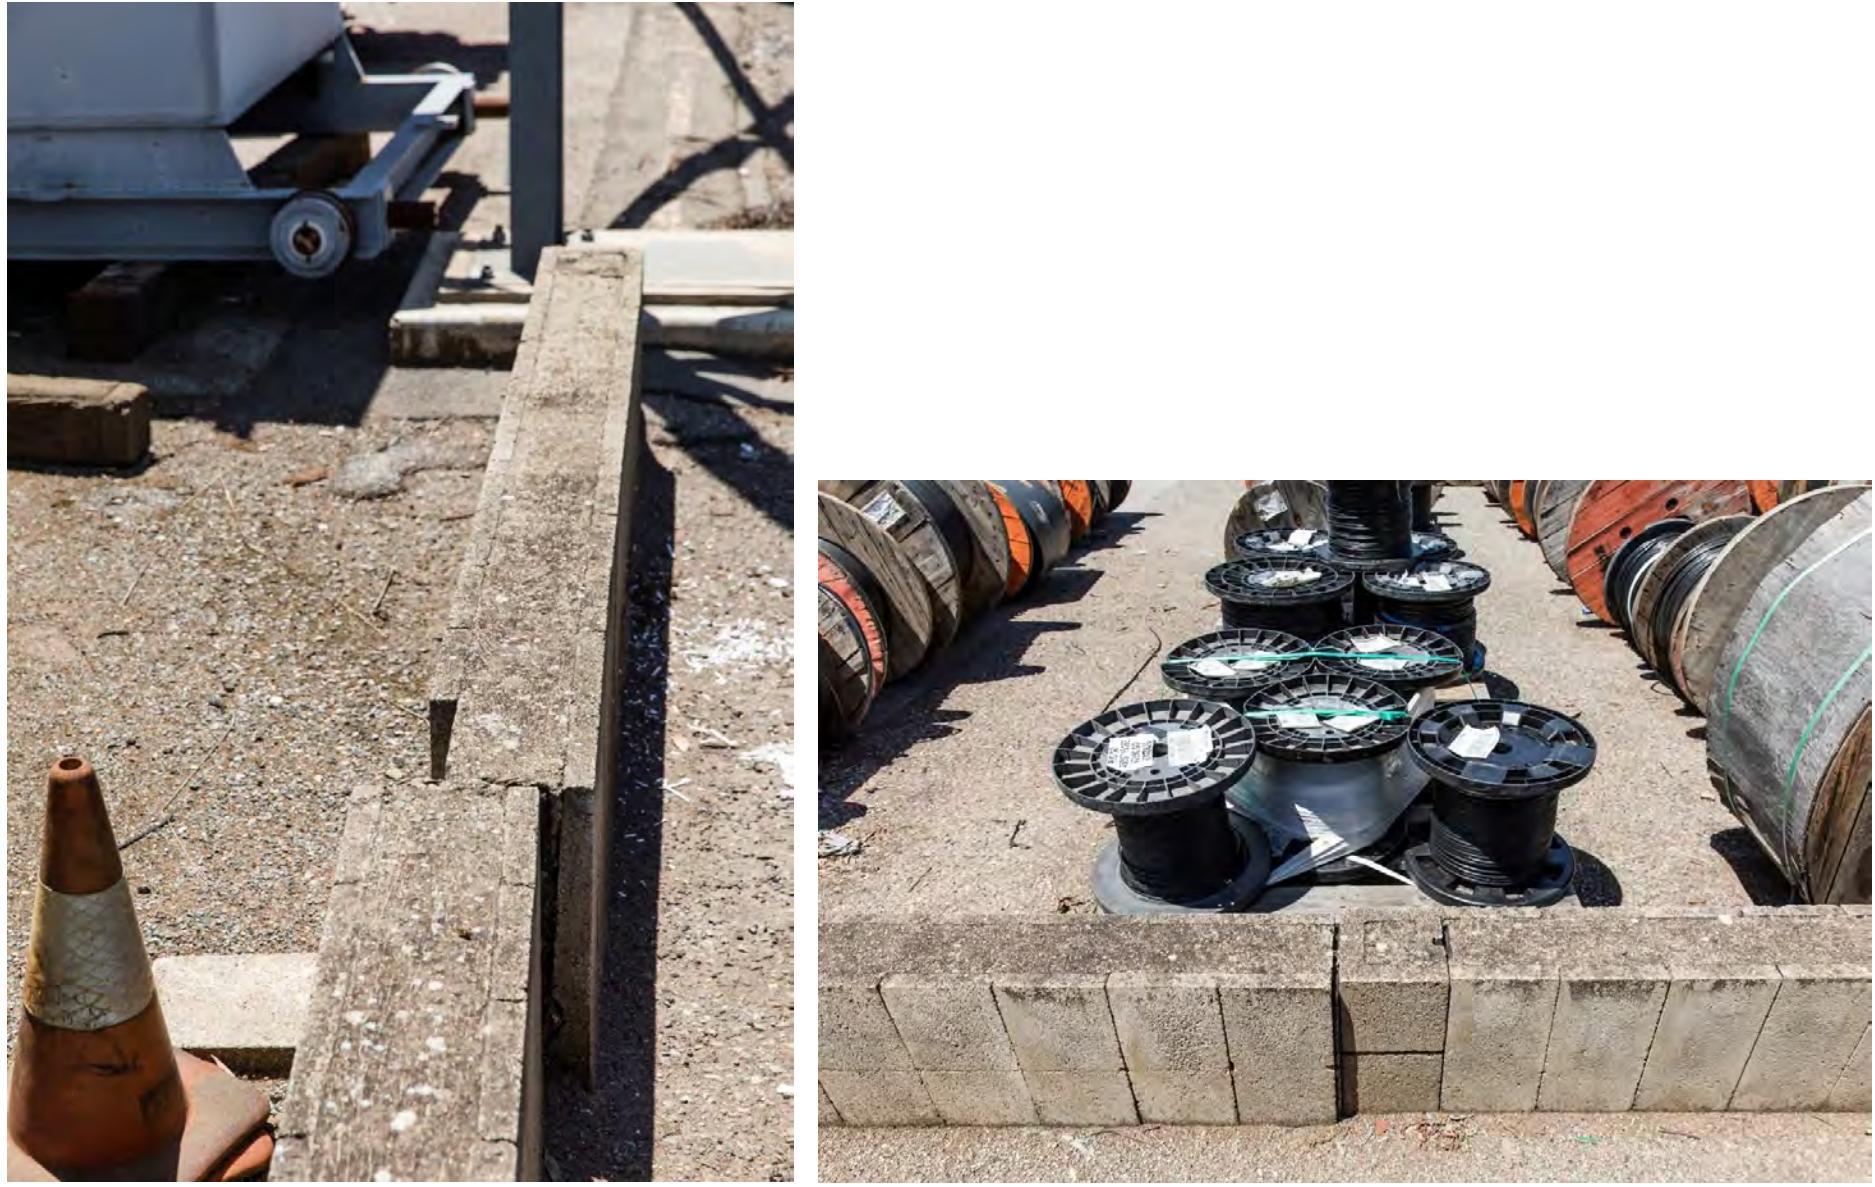
Heavy Transformer containment bund (besser block) – cracking, movement.

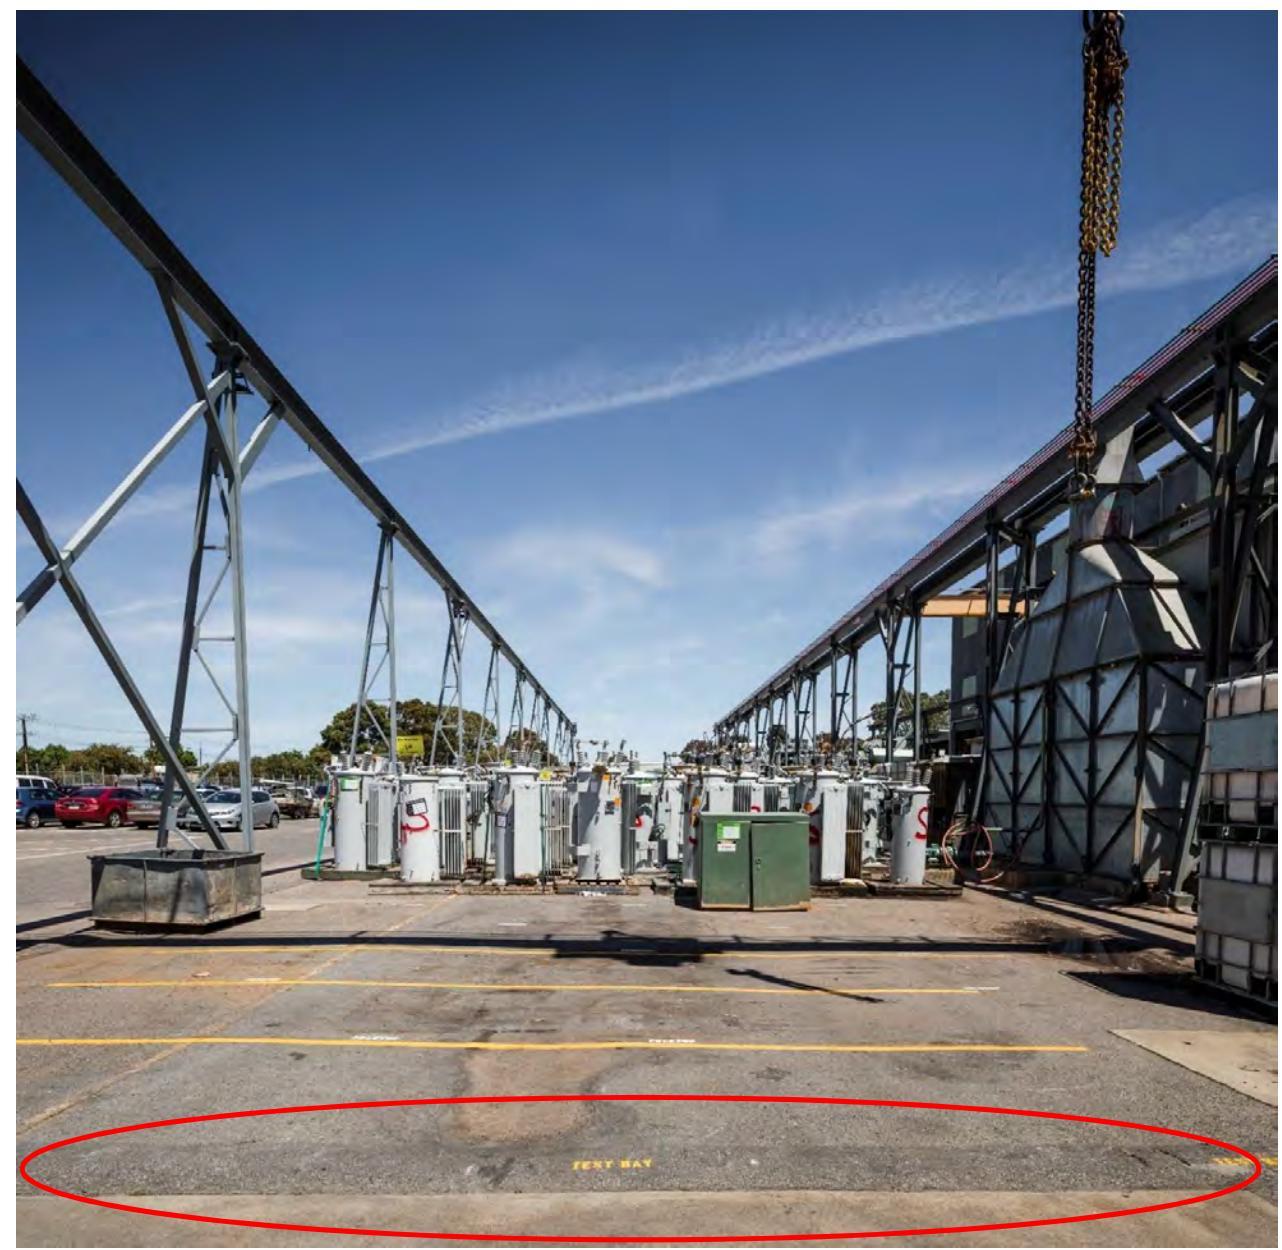
• Smaller Transformer storage area with bitumen roll-over bund compressed flat over time, no longer complies to EPA bunding requirements.

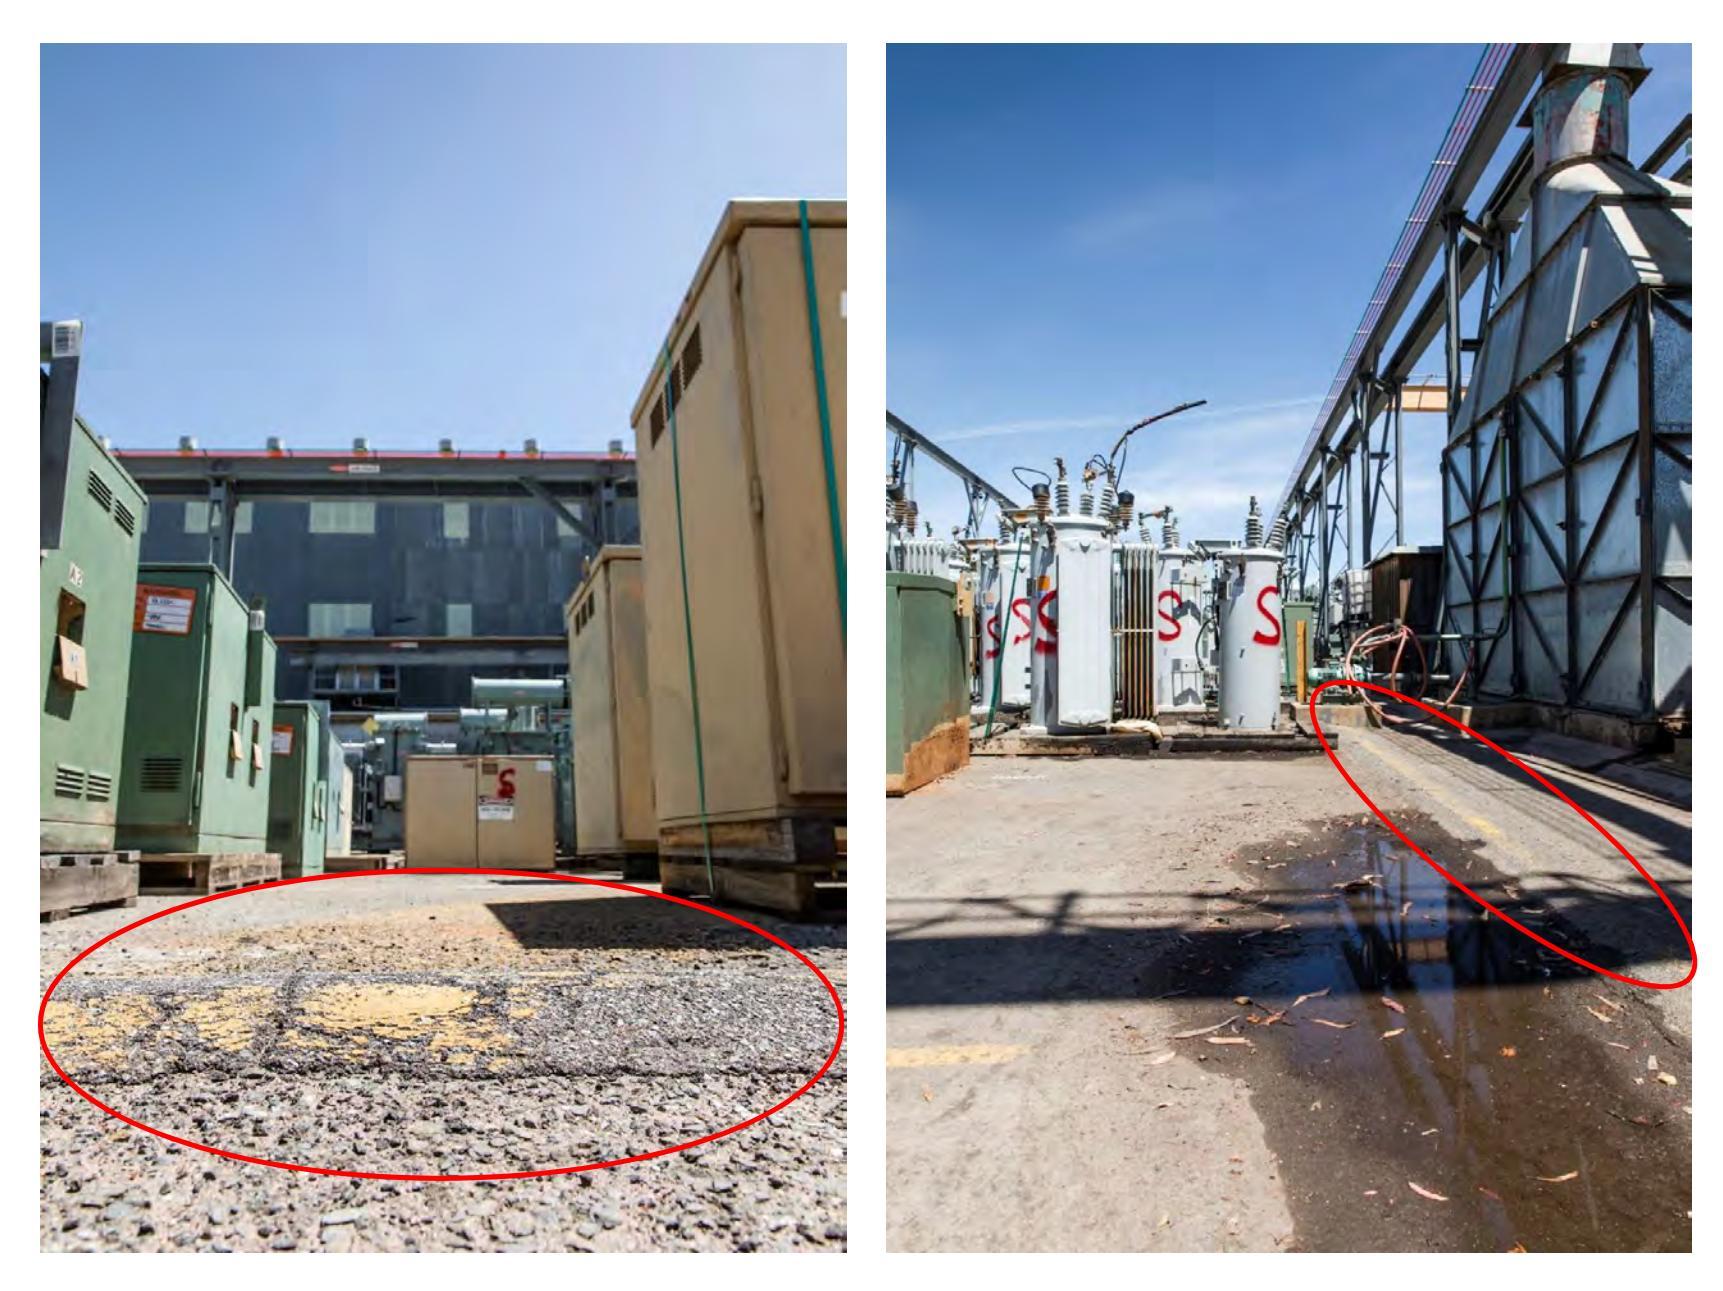
Smaller Transformer storage area with bitumen roll-over bund compressed flat over time, no longer complies to EPA bunding requirements.
