Supporting document 5.23.2 Marleston North Photographs

2020-25 Revised Regulatory Proposal 10 December 2019

Marleston North Asset Condition Photographs

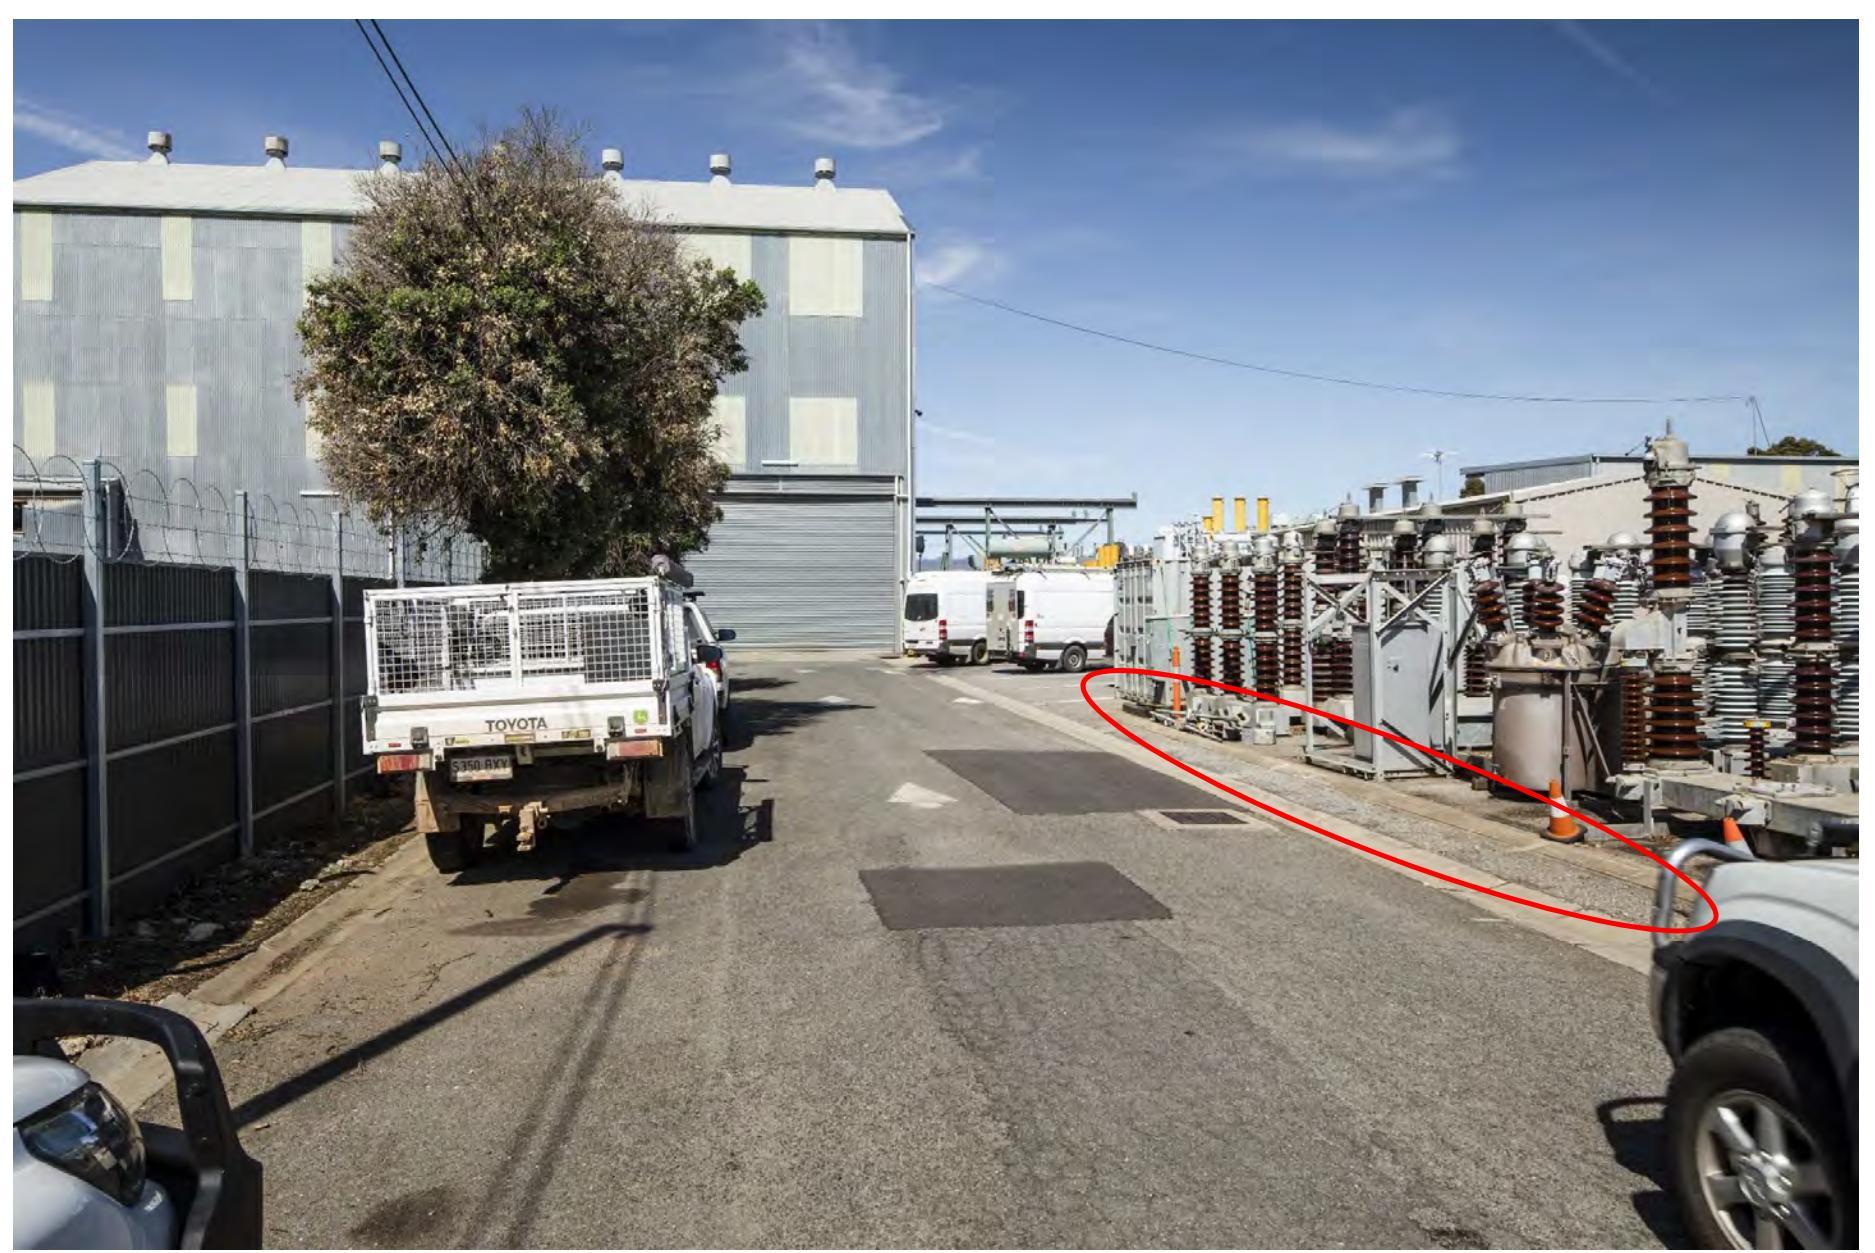
• Substation Maintenance – Oil filled equipment bunded area with bitumen roll-over bund flattened over time, bitumen cracking to driveway and repairs.

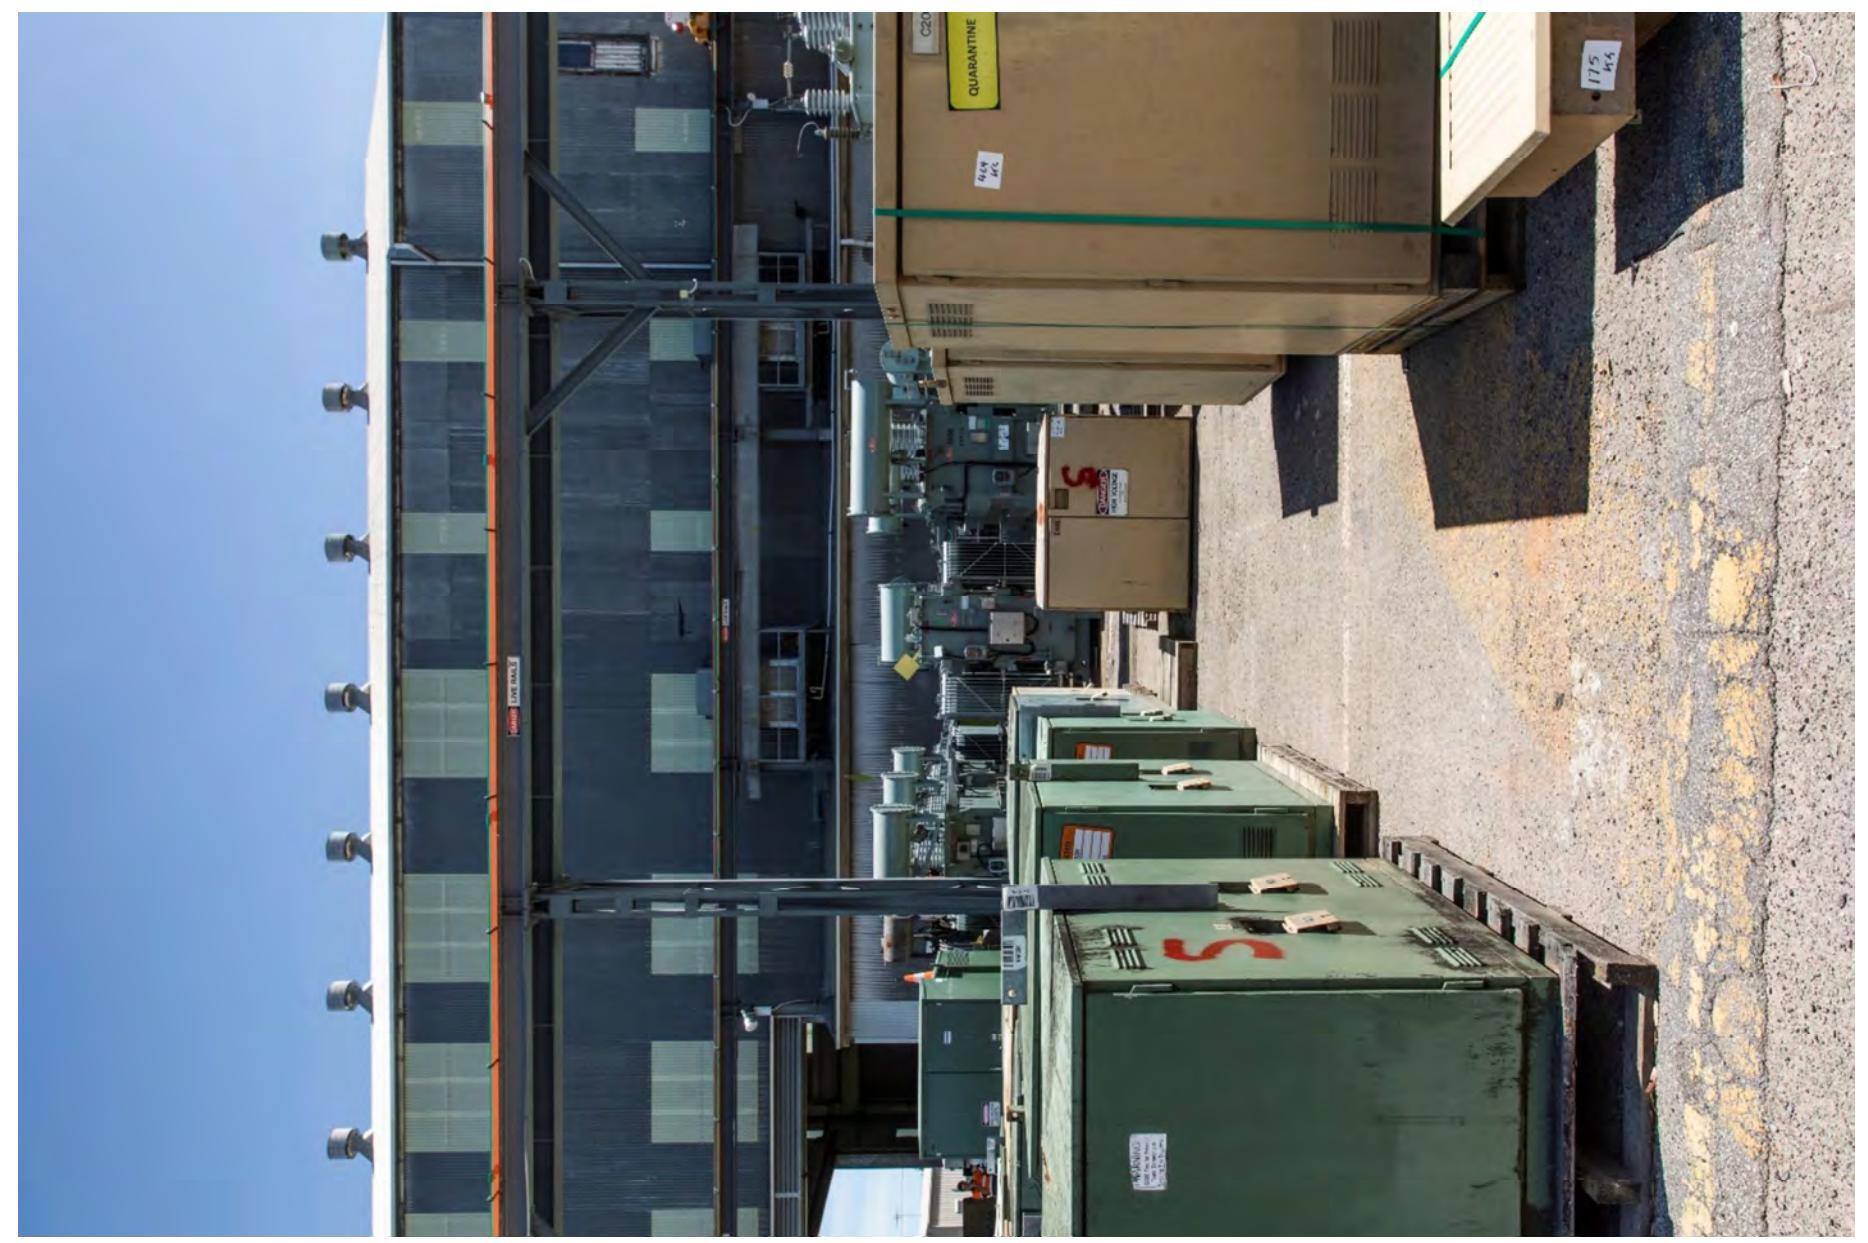
• Smaller Transformer storage area with bitumen roll-over bund compressed flat over time, no longer complies to EPA bunding requirements.

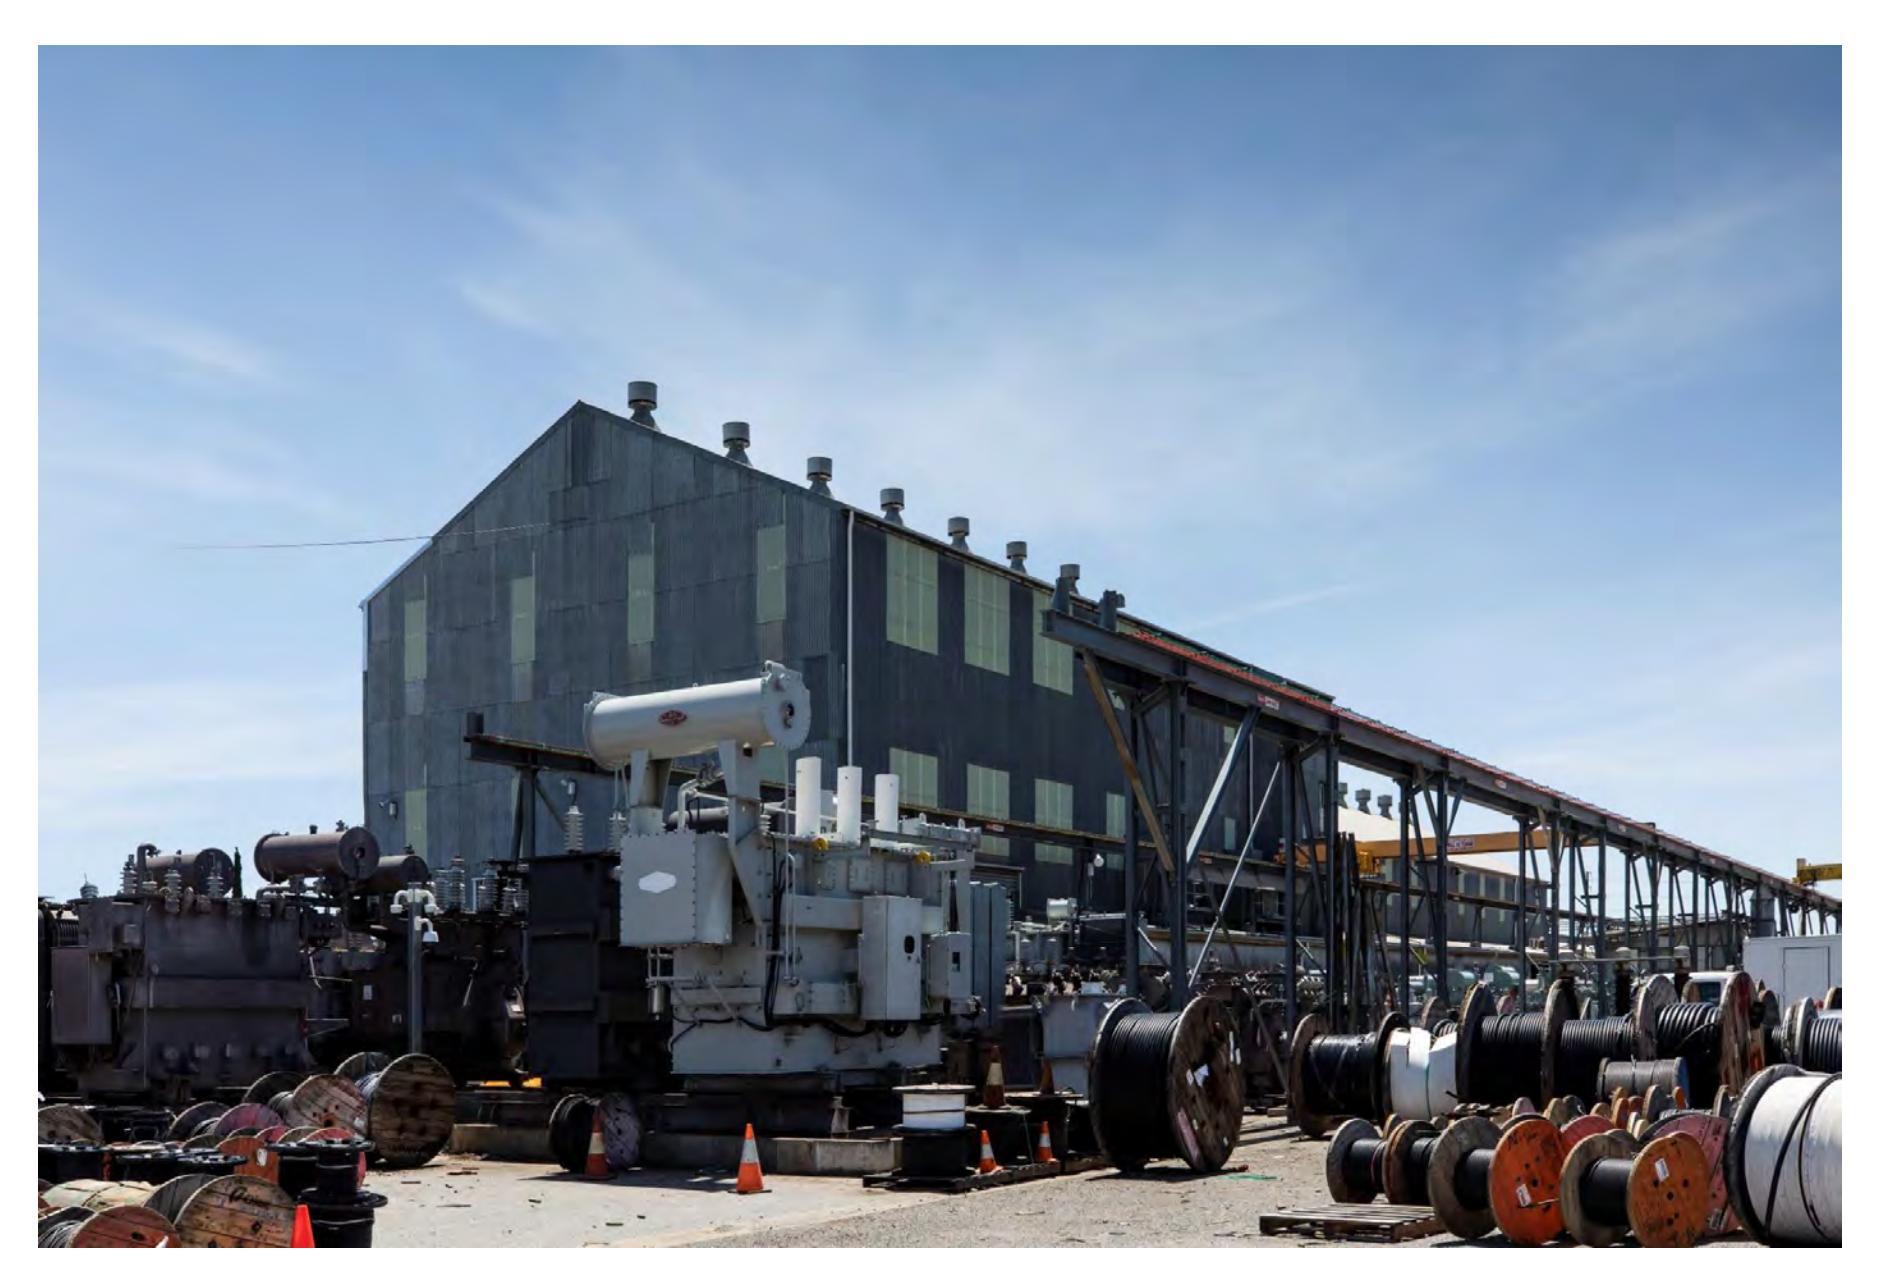
• Original 1950's corrugated iron sheets

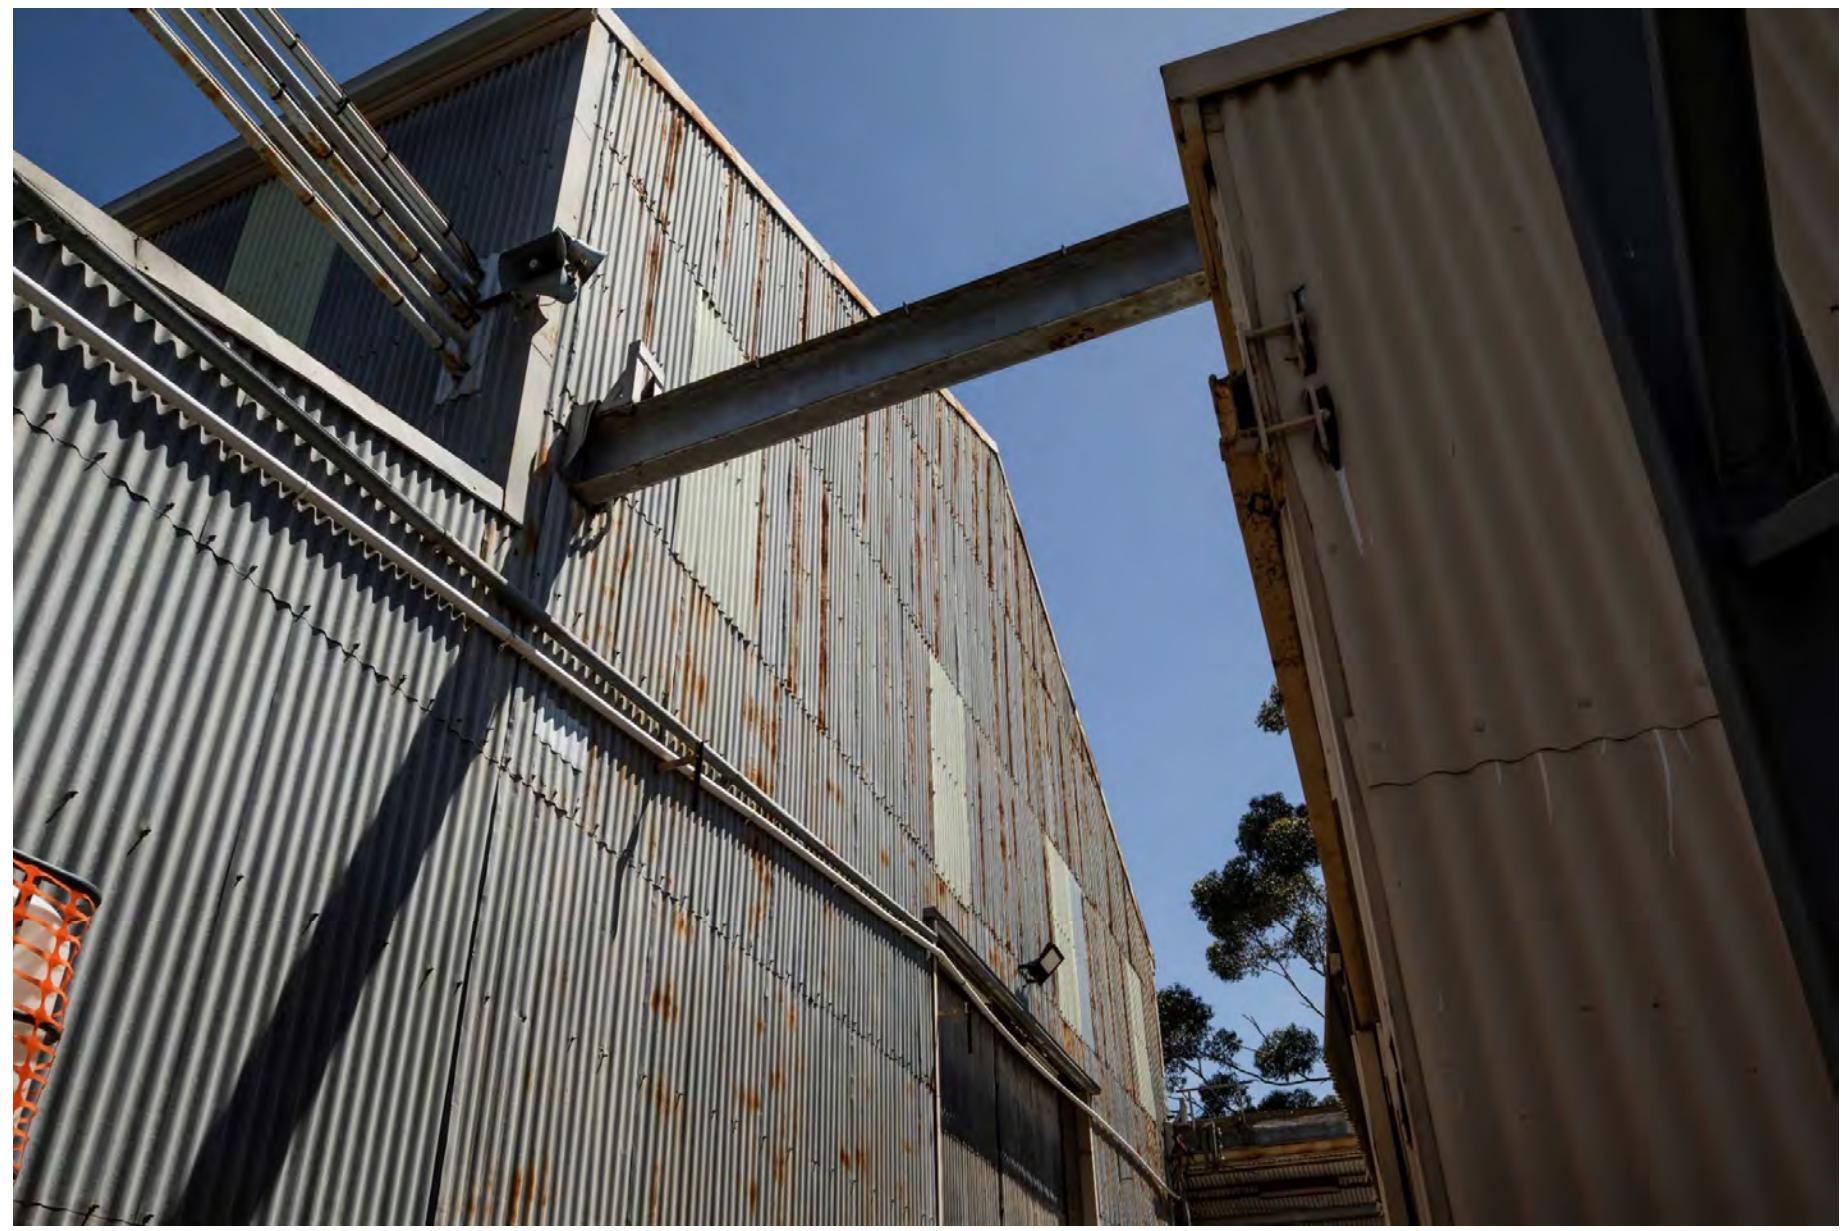
• Rusted corrugated iron sheets to the rear wall of the transformer workshop – original 1950's sheets.

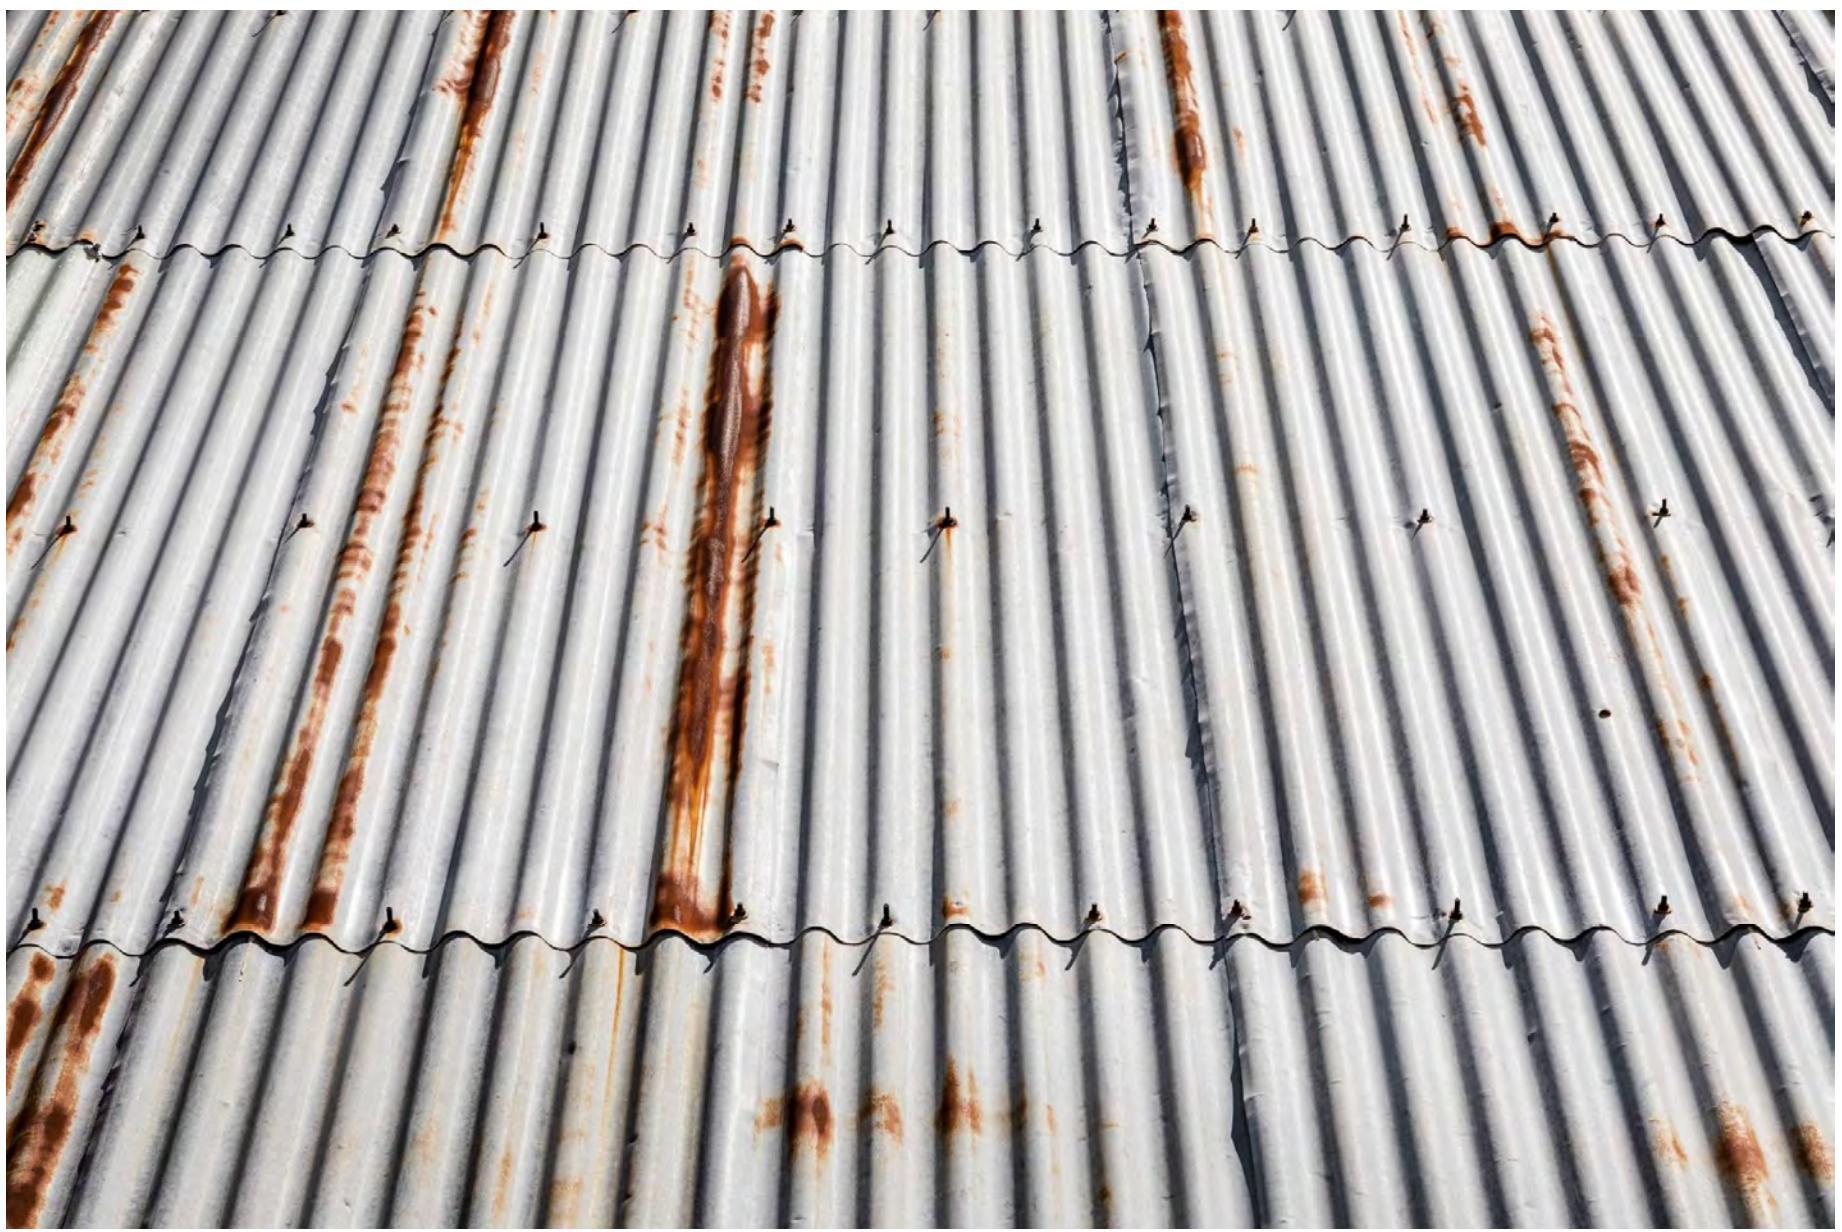
Rusted corrugated iron sheets to the rear wall of the transformer workshop – original 1950's sheets.

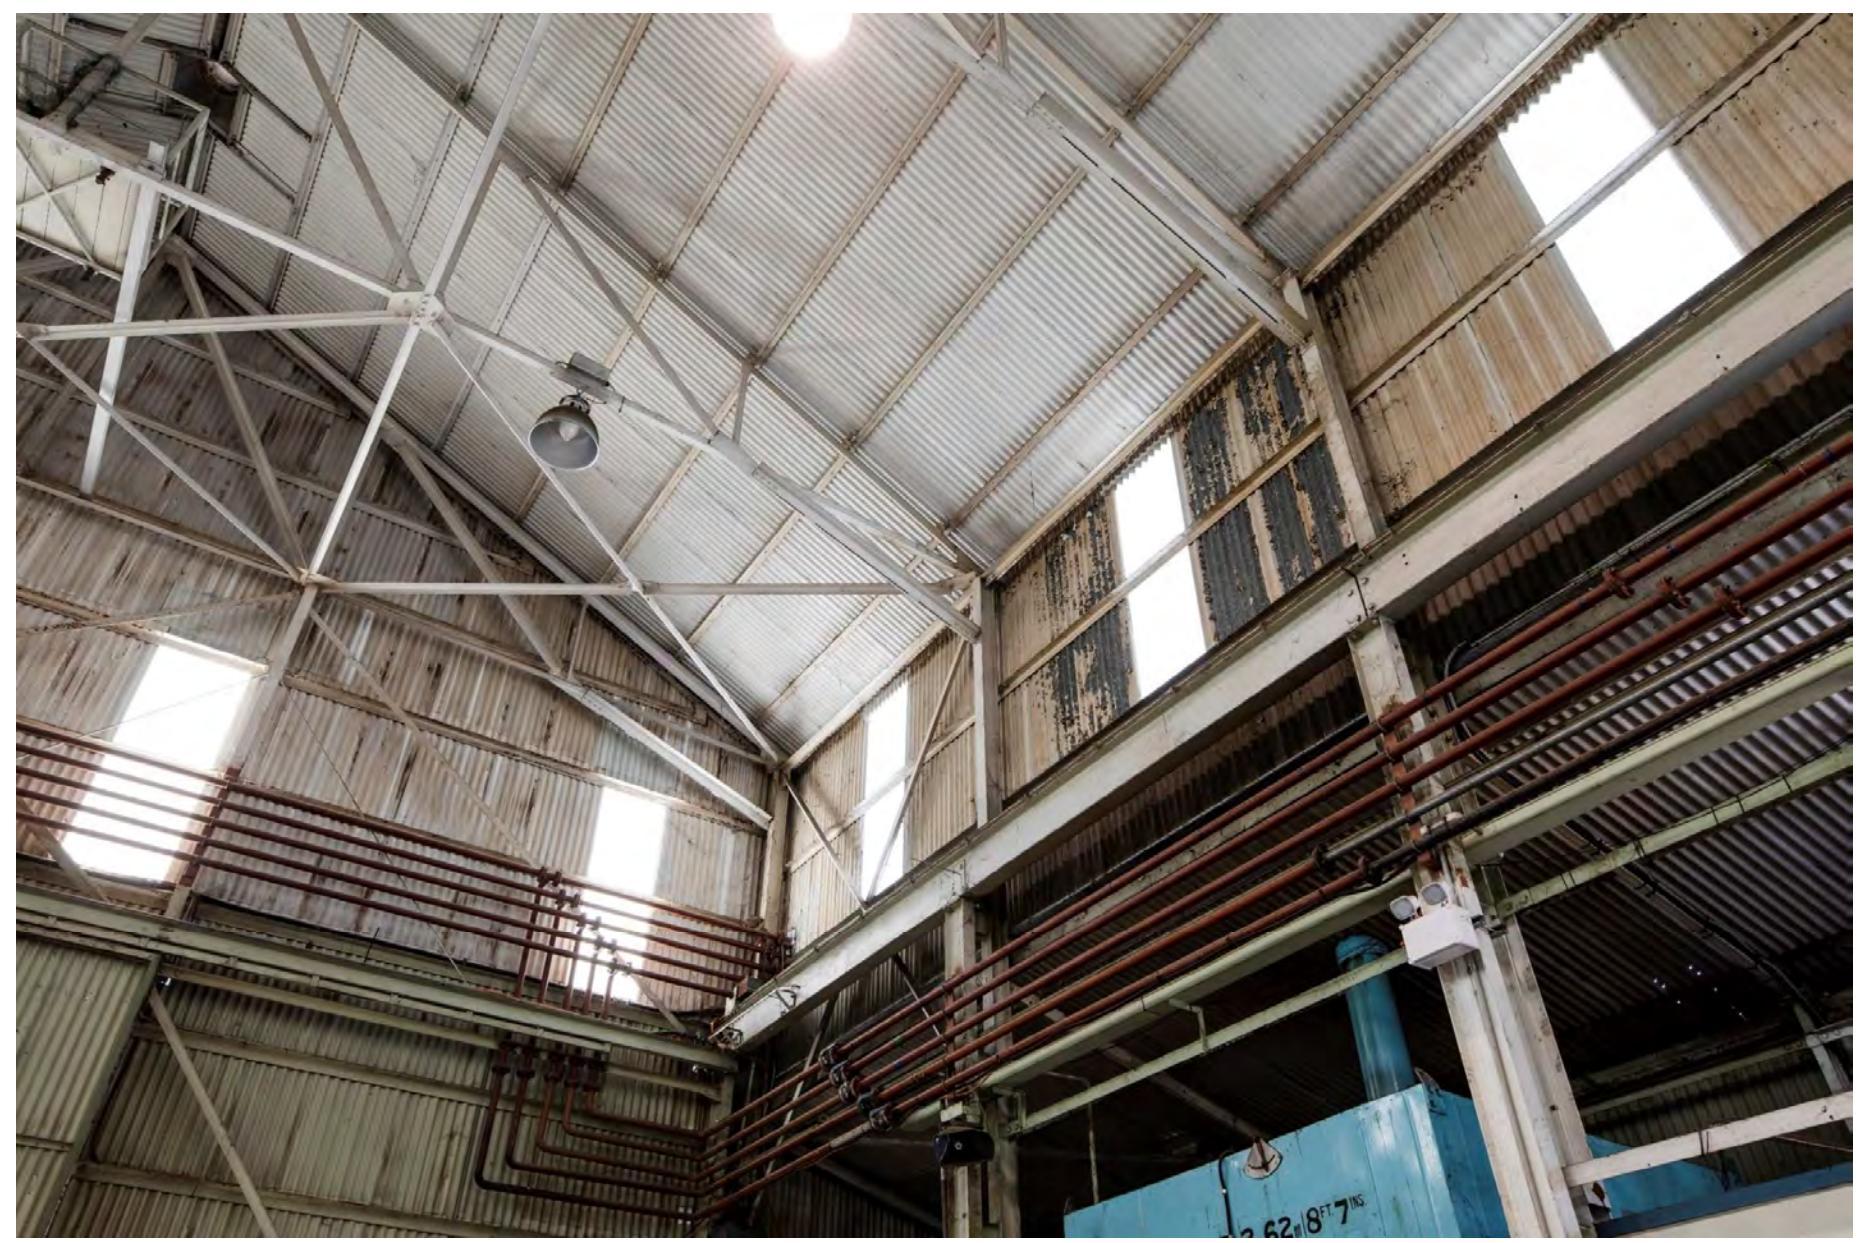
• Internal view of Transformer Workshop walls – Corrugated iron sheets, no insulation to workshop.

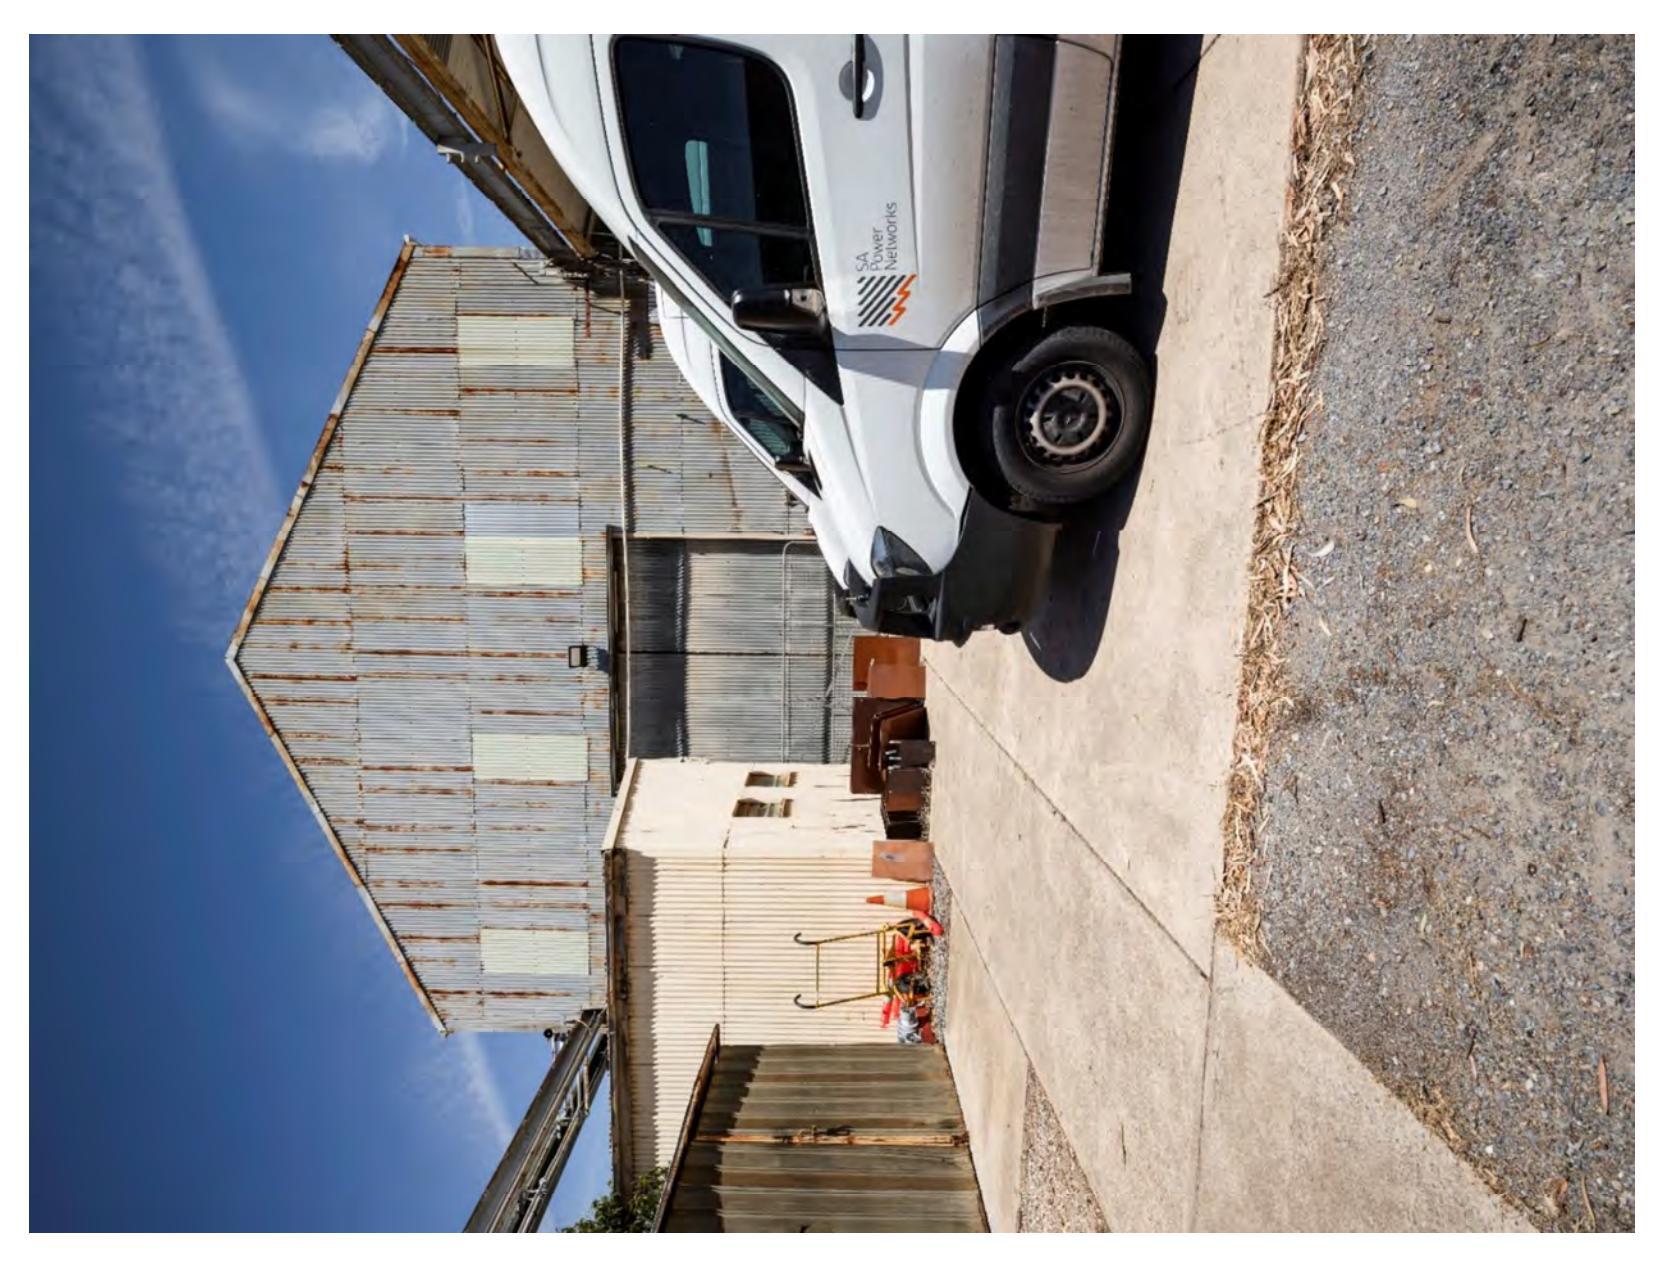
• Rusted corrugated iron sheets to the rear wall of the transformer workshop – original 1950's sheets.

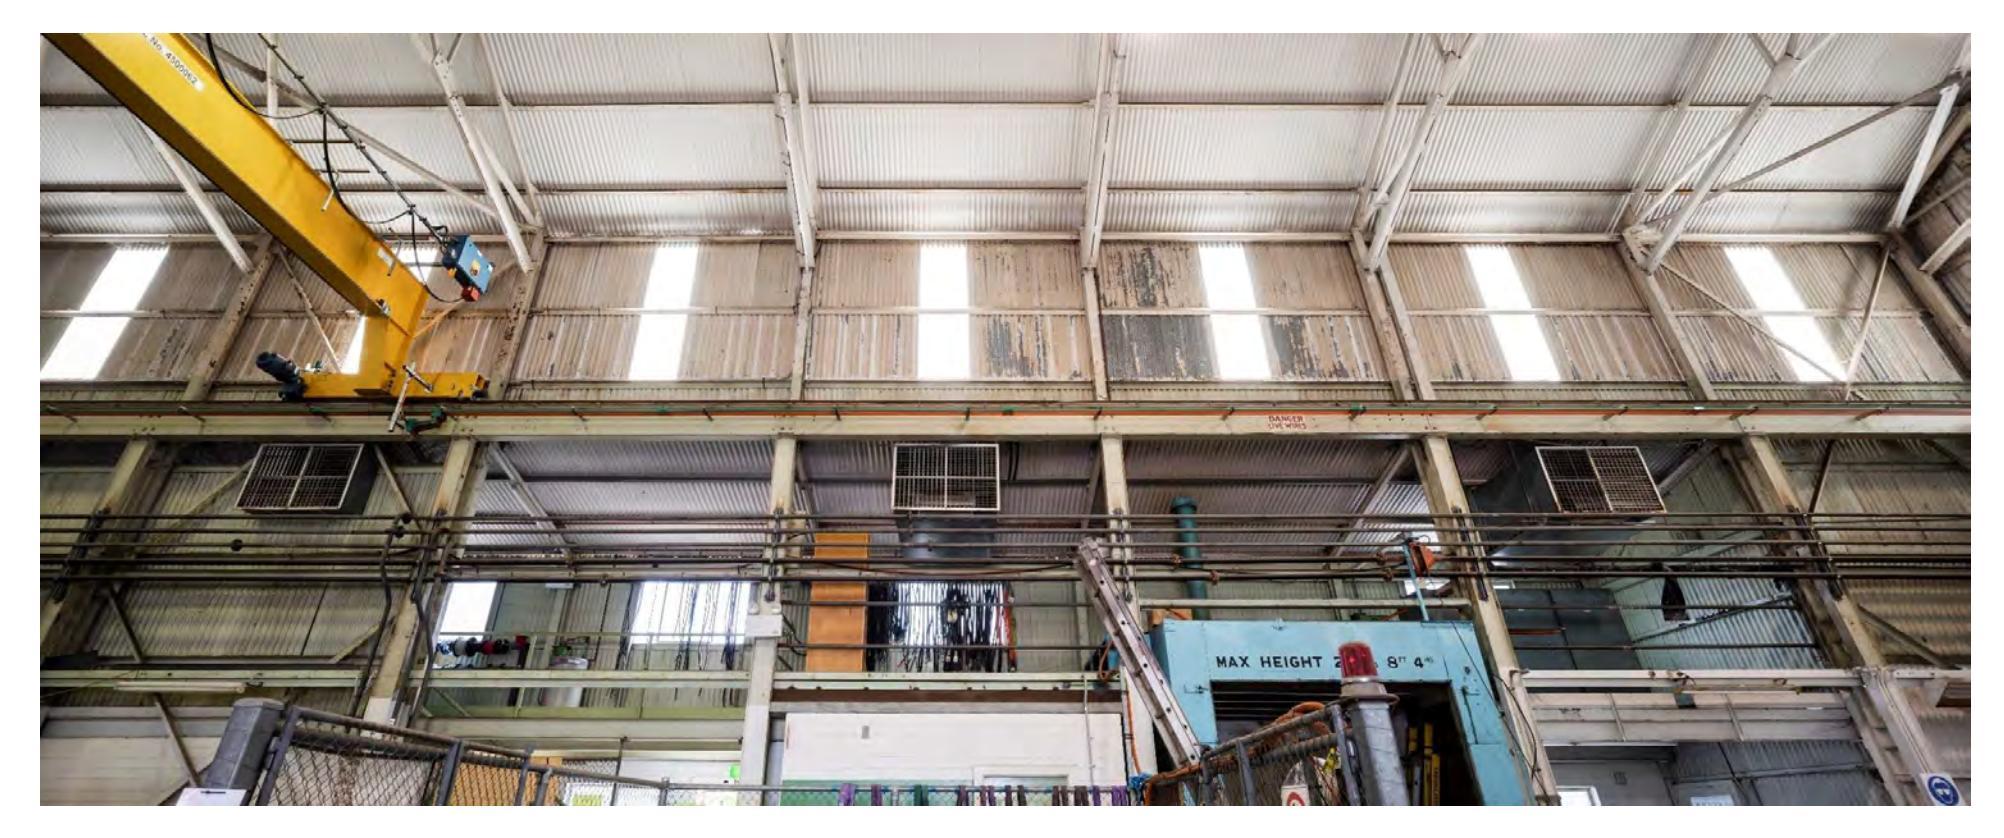
- Internal view of Transformer Workshop walls Corrugated iron sheets, no insulation to workshop.
- Evap air-conditioning units tagged out of service, now beyond repairable life.

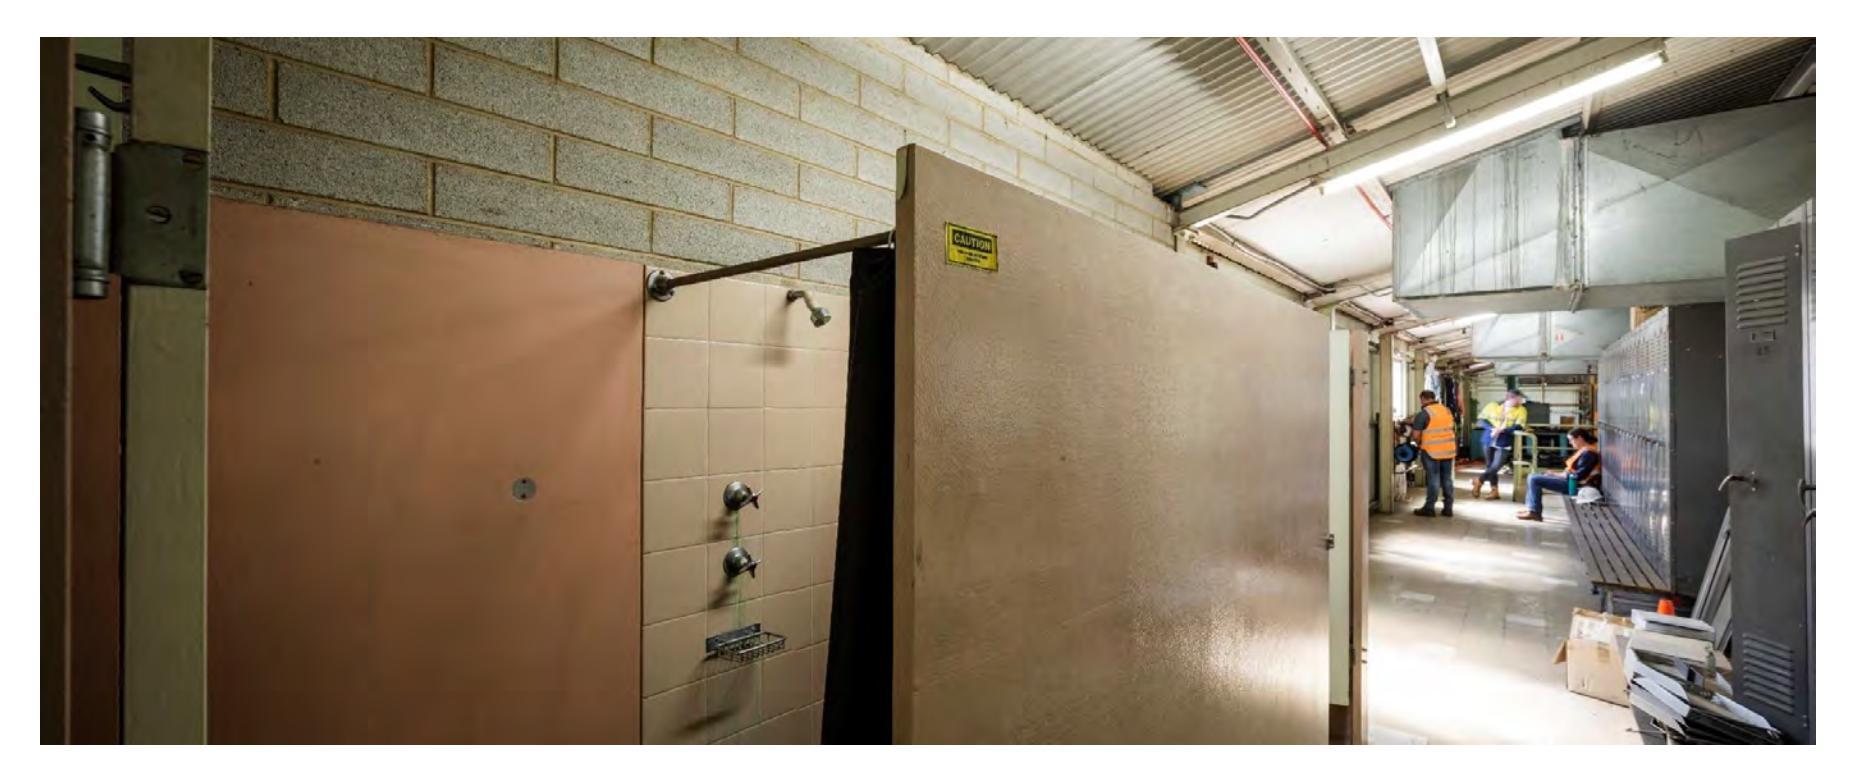
• Transformer Workshop Locker Room and Shower in very poor condition (asbestos cubicle walling).

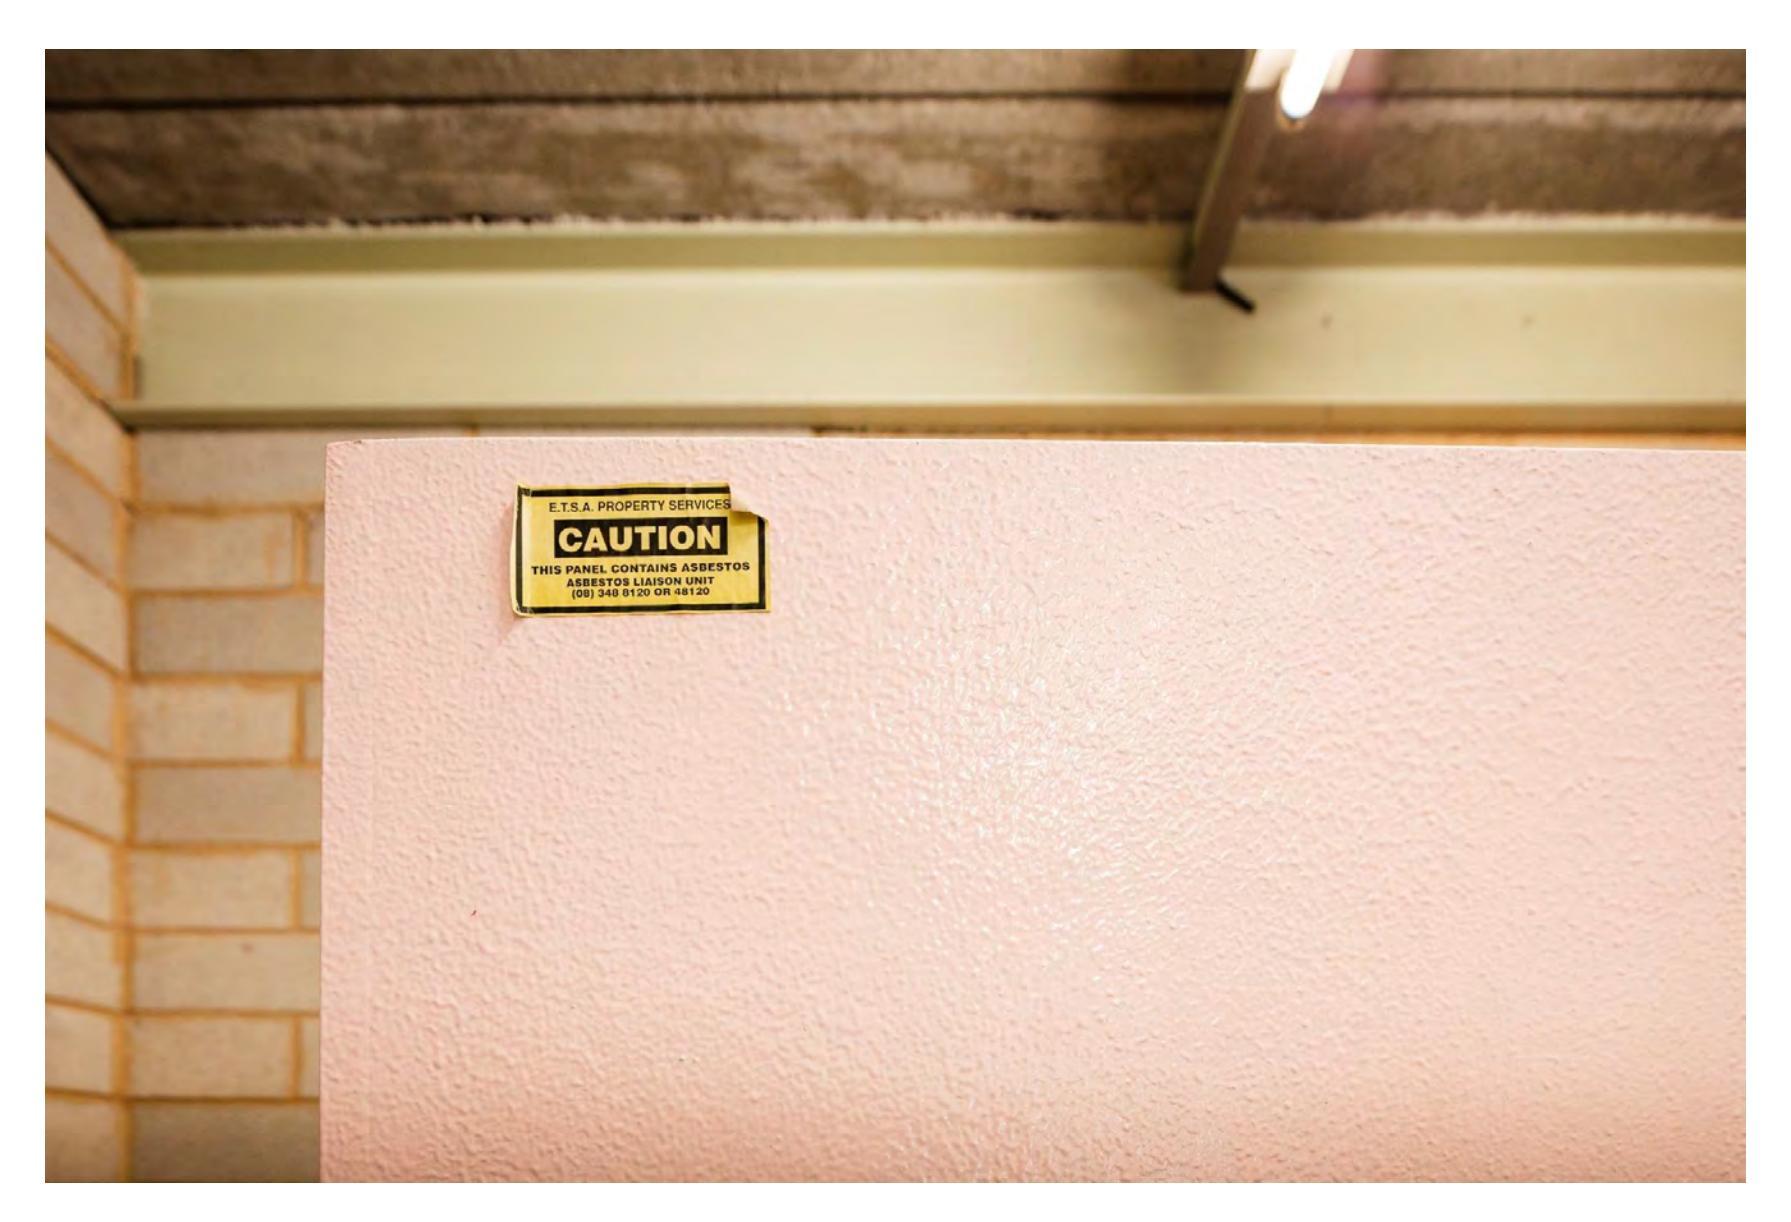
• Transformer Workshop Locker Room and Shower in very poor condition (asbestos cubicle walling).
