Supporting document 5.23.2 Marleston North Photographs

2020-25 Revised Regulatory Proposal 10 December 2019

Marleston North Asset Condition Photographs

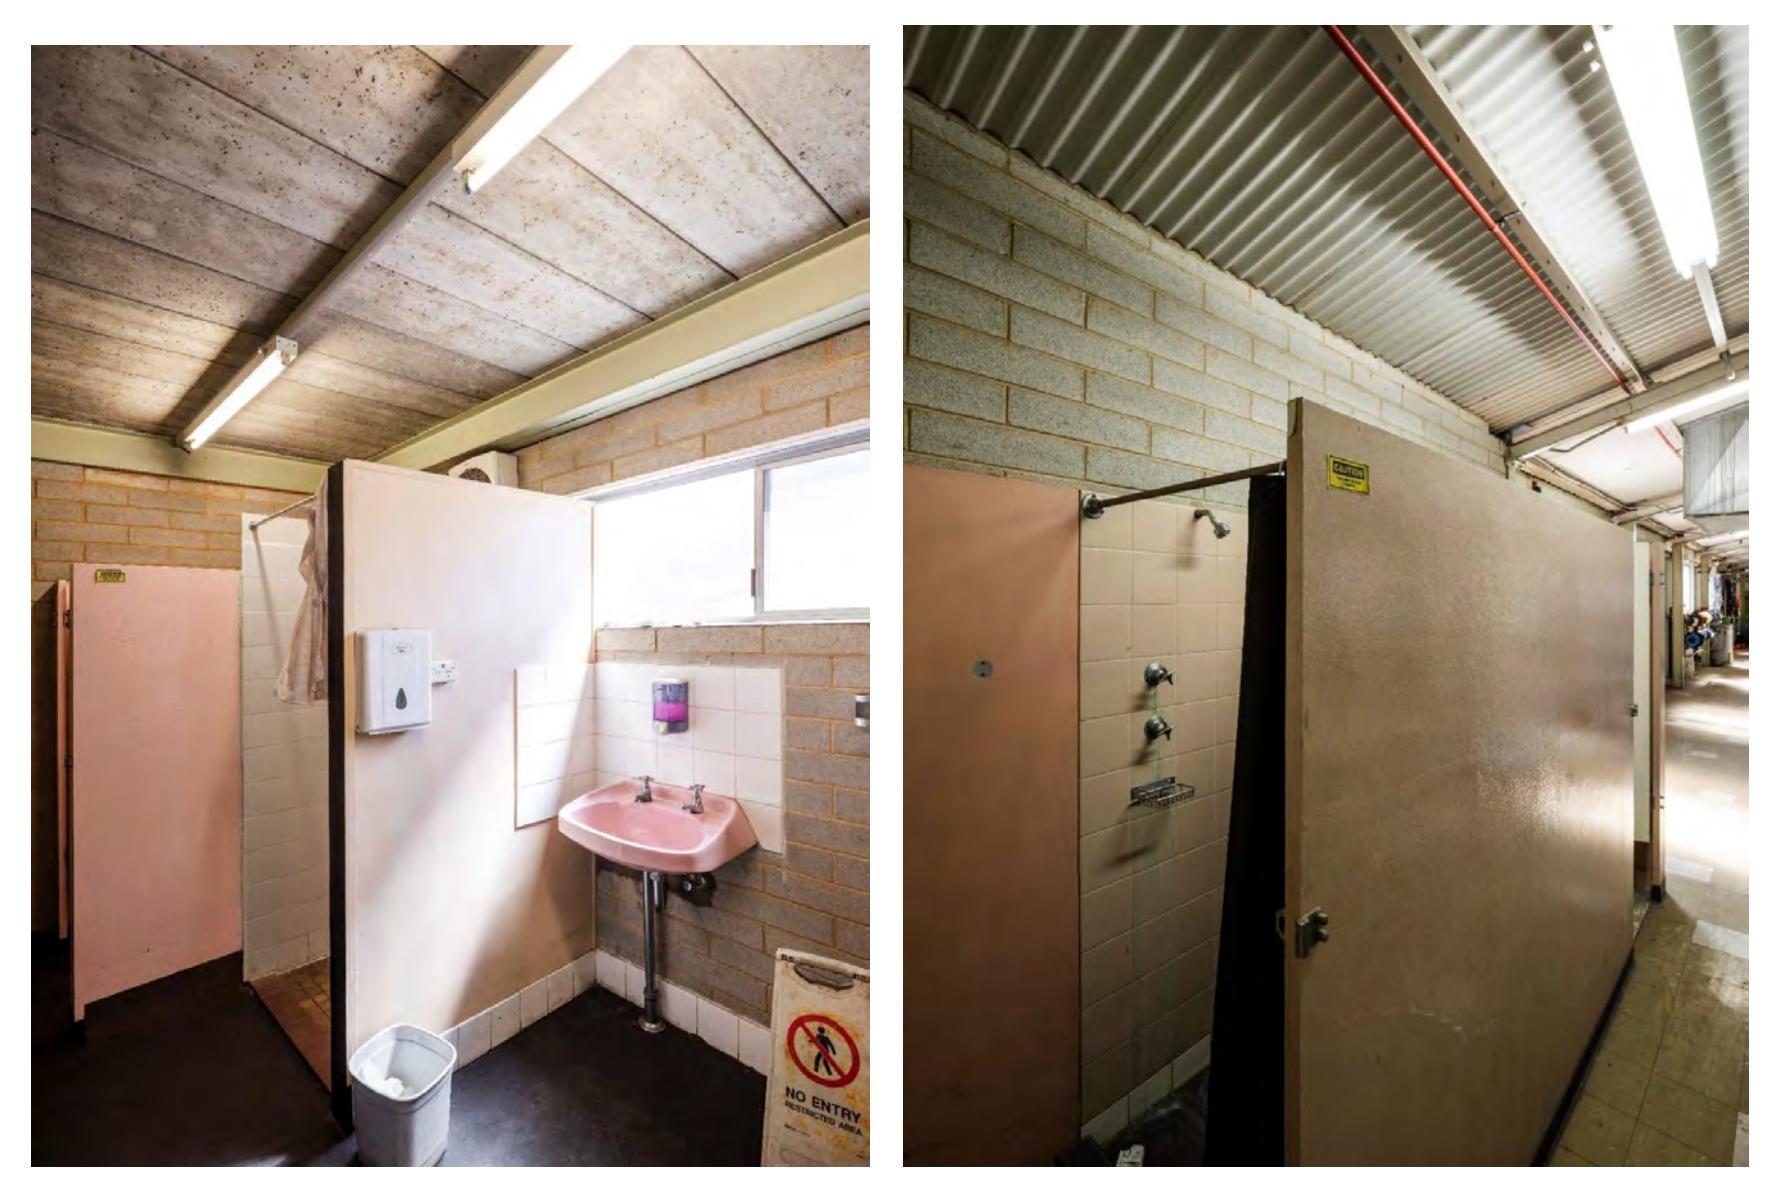
• Ladies toilets and shower – Transformer Workshop. Original 1950's fit out in very poor condition with asbestos cubicle panels.

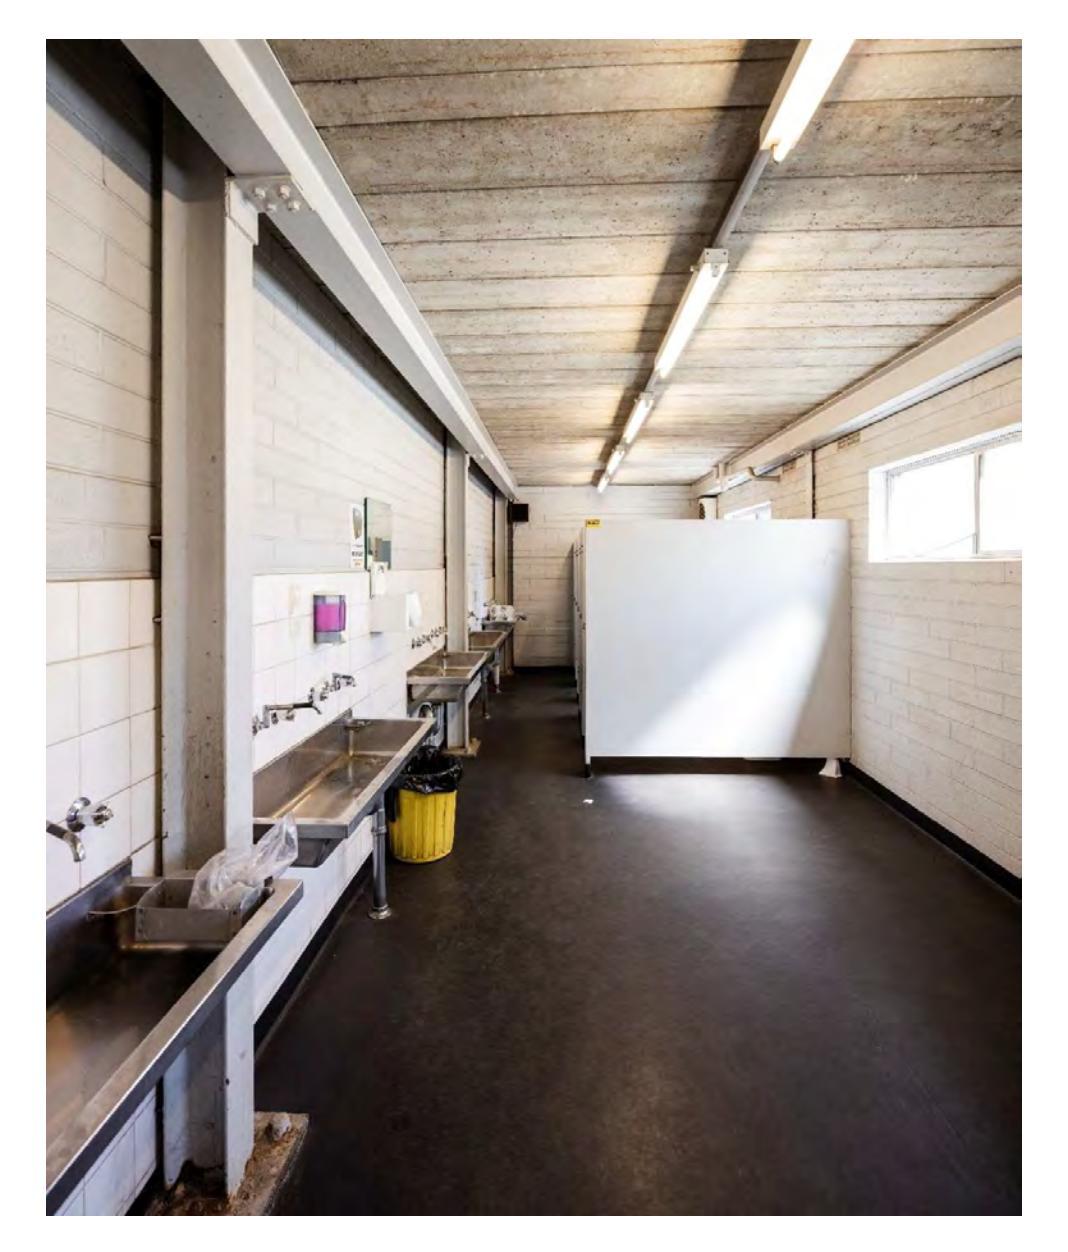
• Mens toilets– Transformer Workshop. Original 1950's fit out in very poor condition with asbestos cubicle panels.

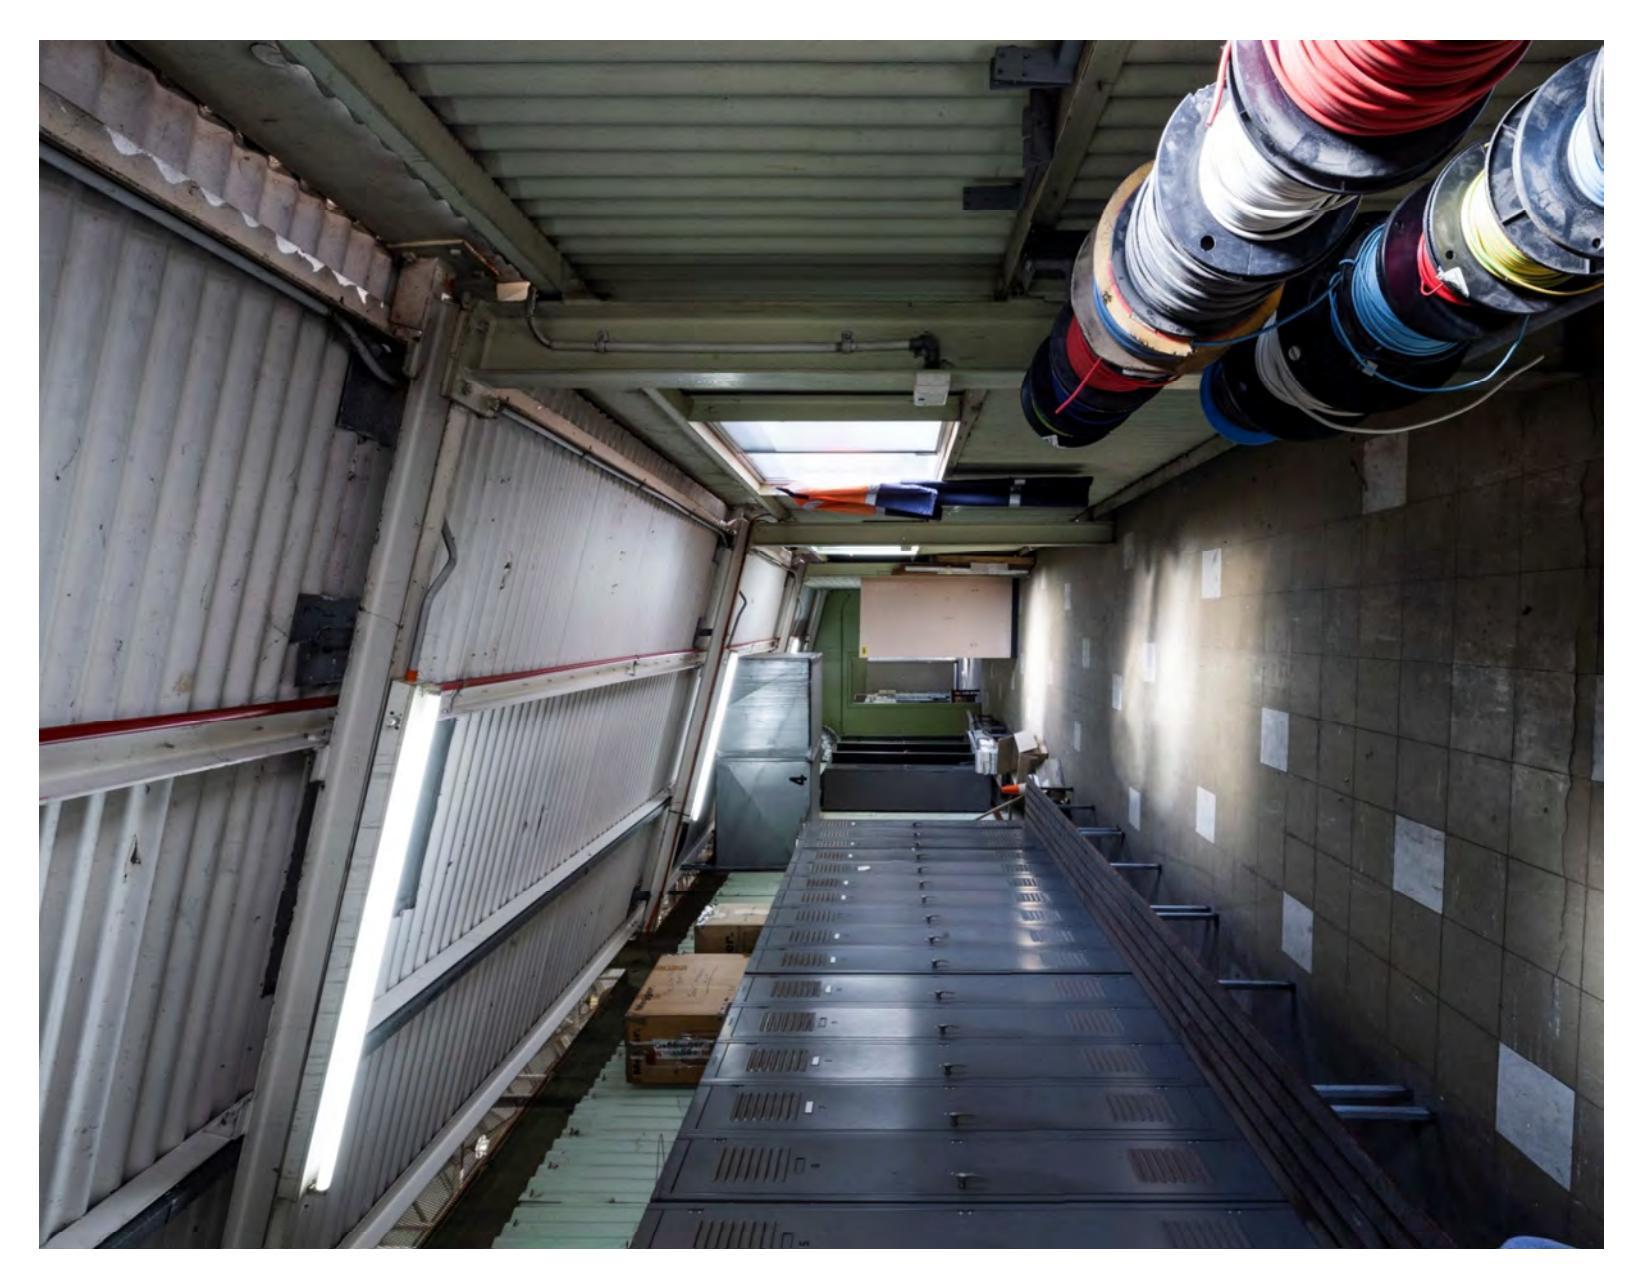
• Transformer Workshop Locker Room – Original 1950's fit-out in very poor condition.

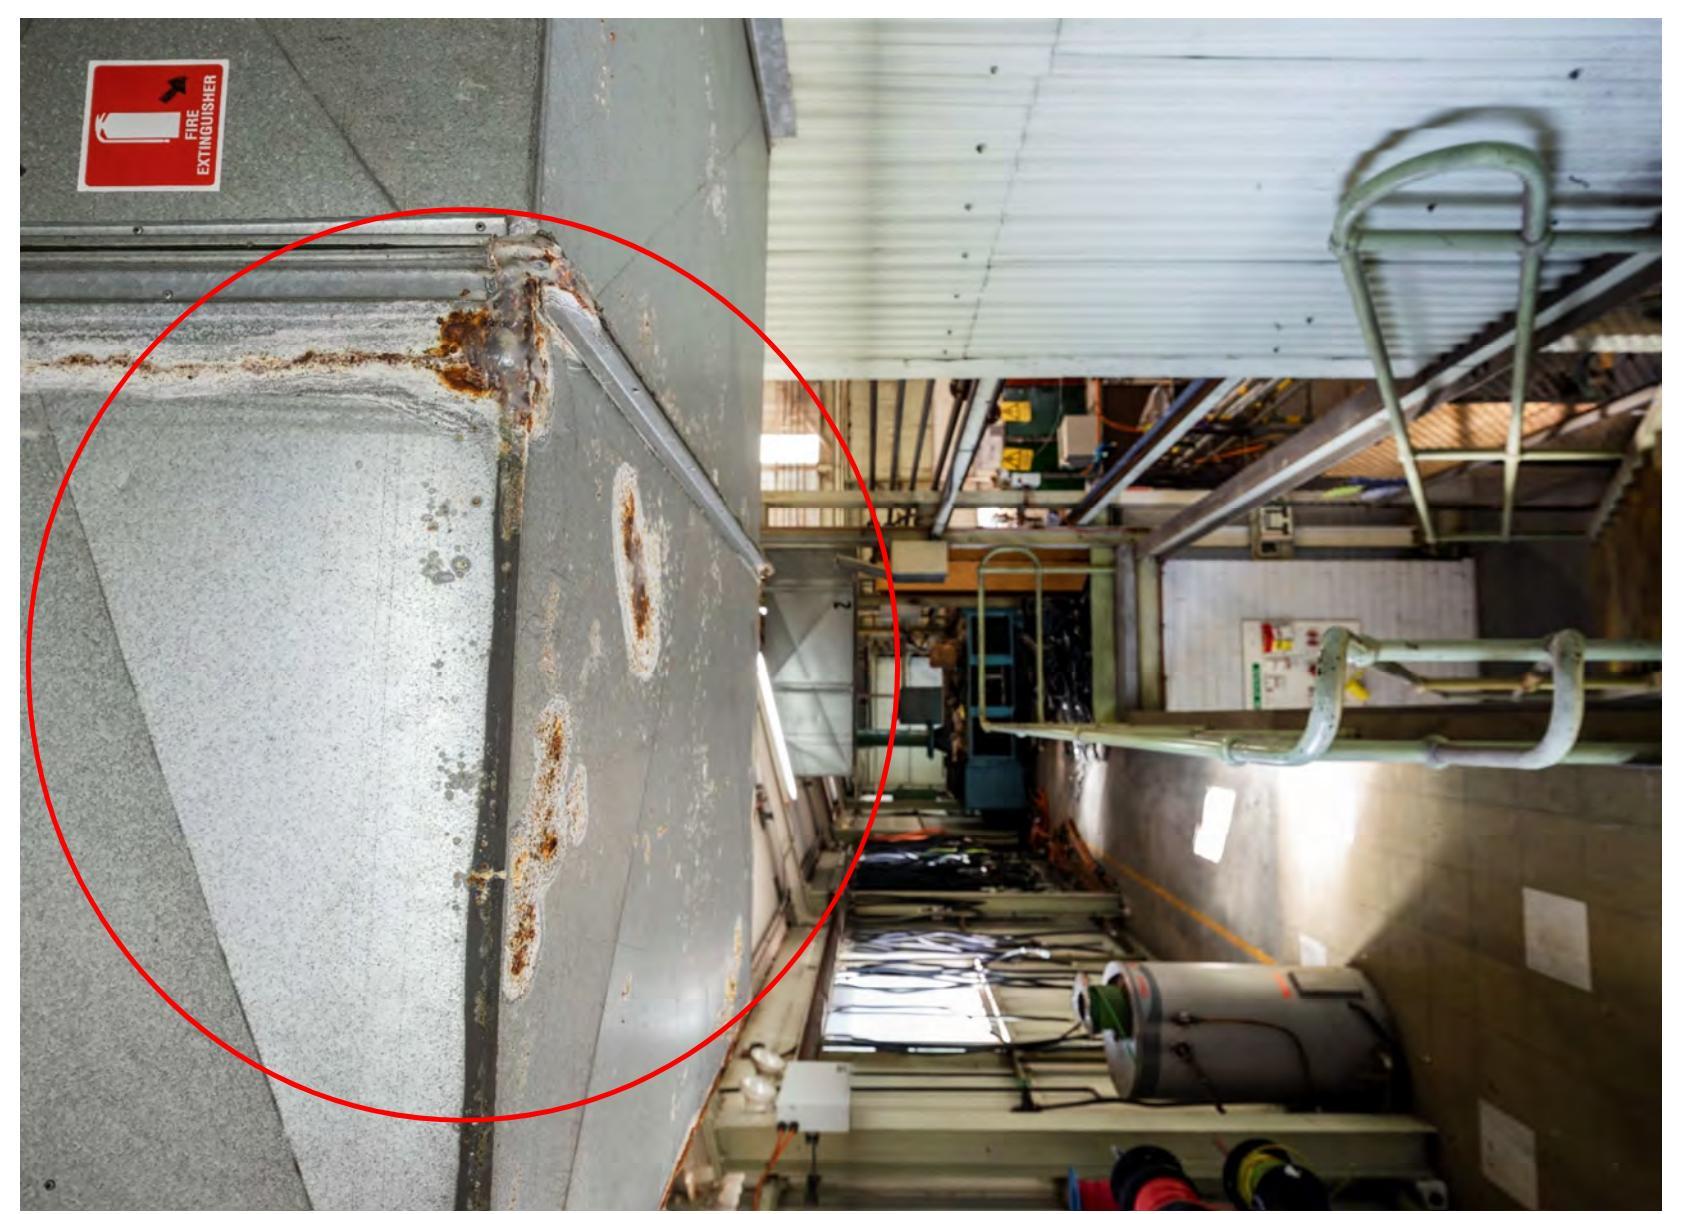
• Air-Conditioning Evap Units – Corroded through, previously repaired with silicone now beyond repairable life and tagged out of service.

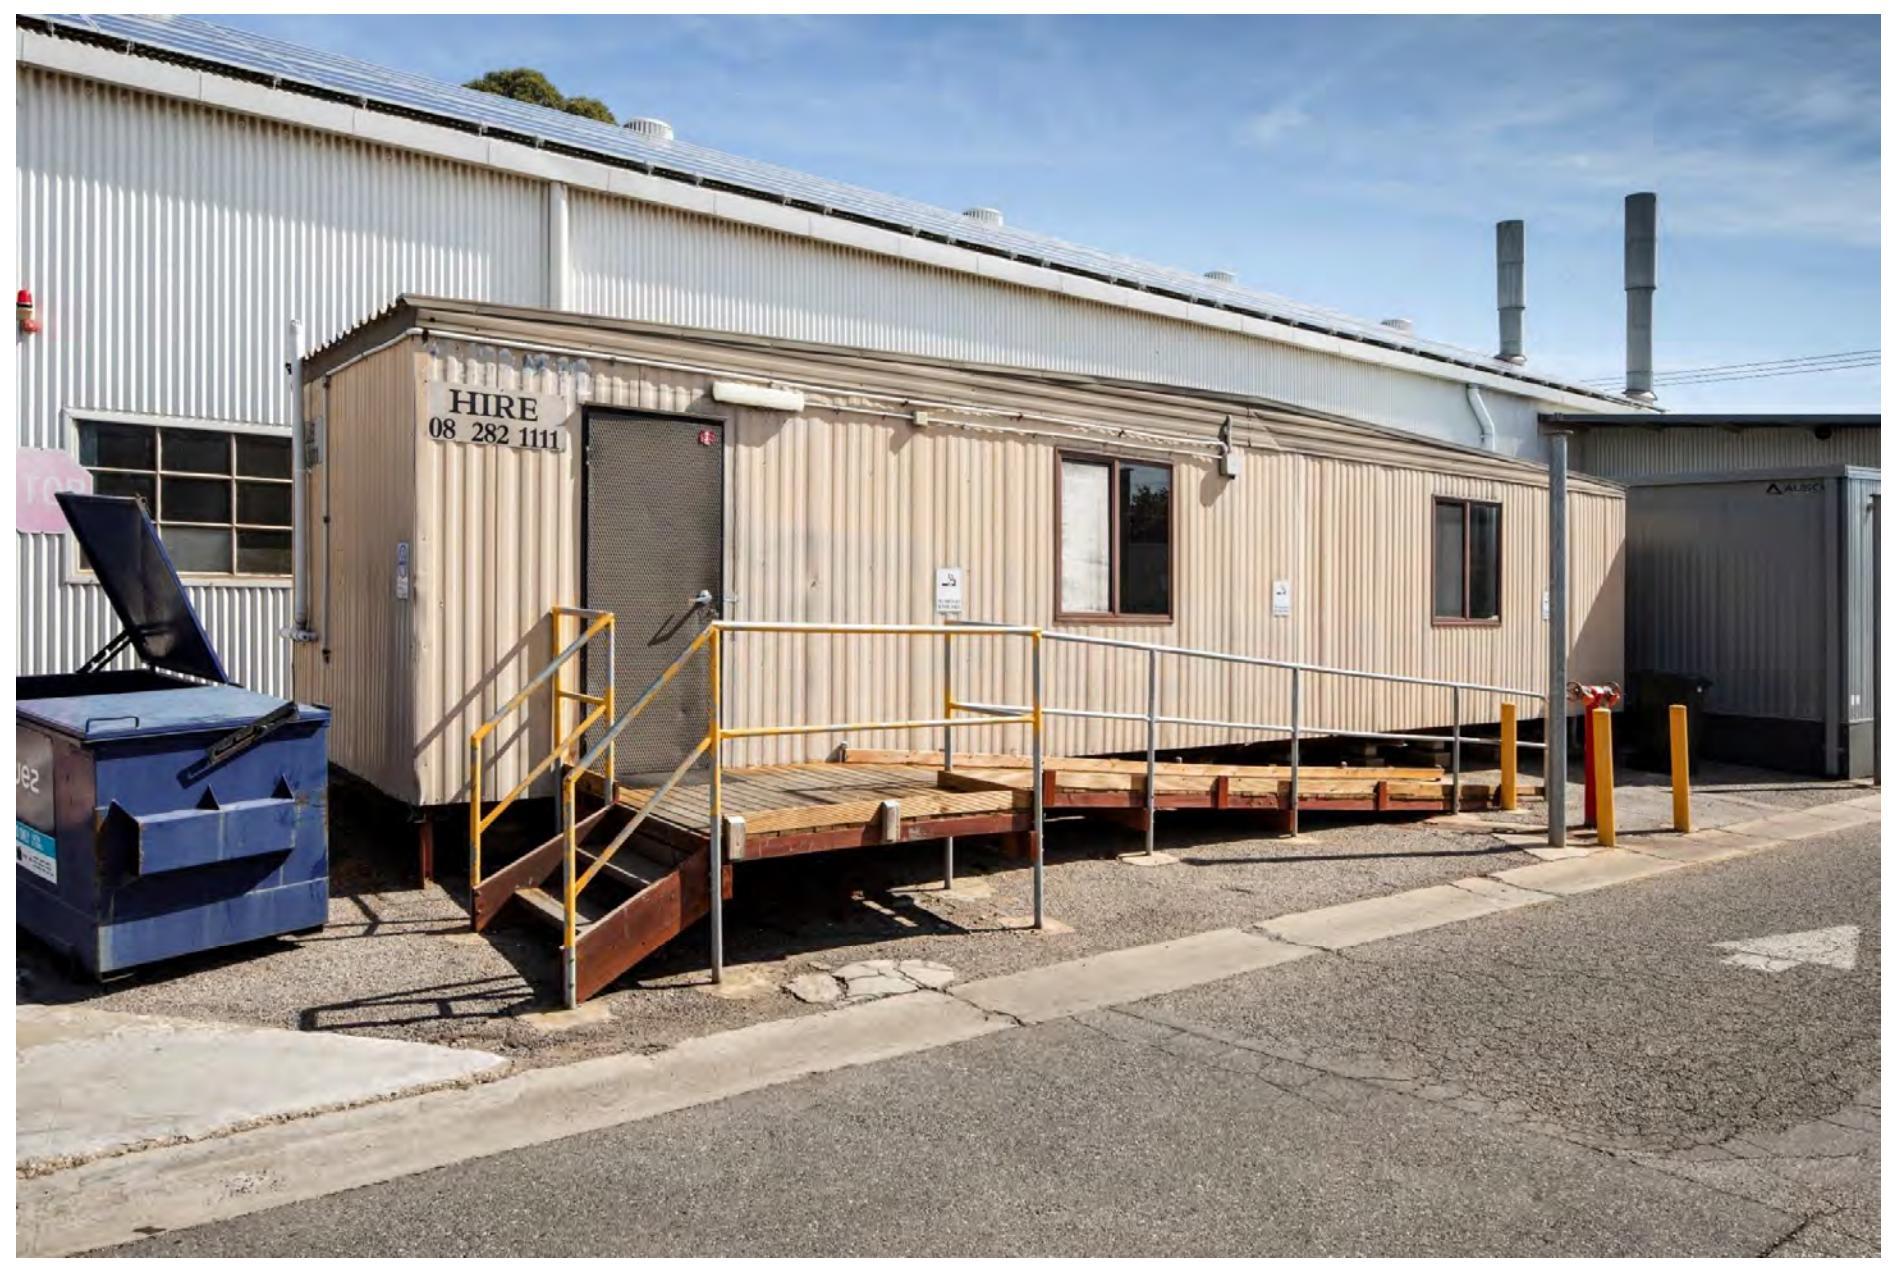
• Substation Construction Modular Lunchroom – Very Poor Condition – Beyond Repair.

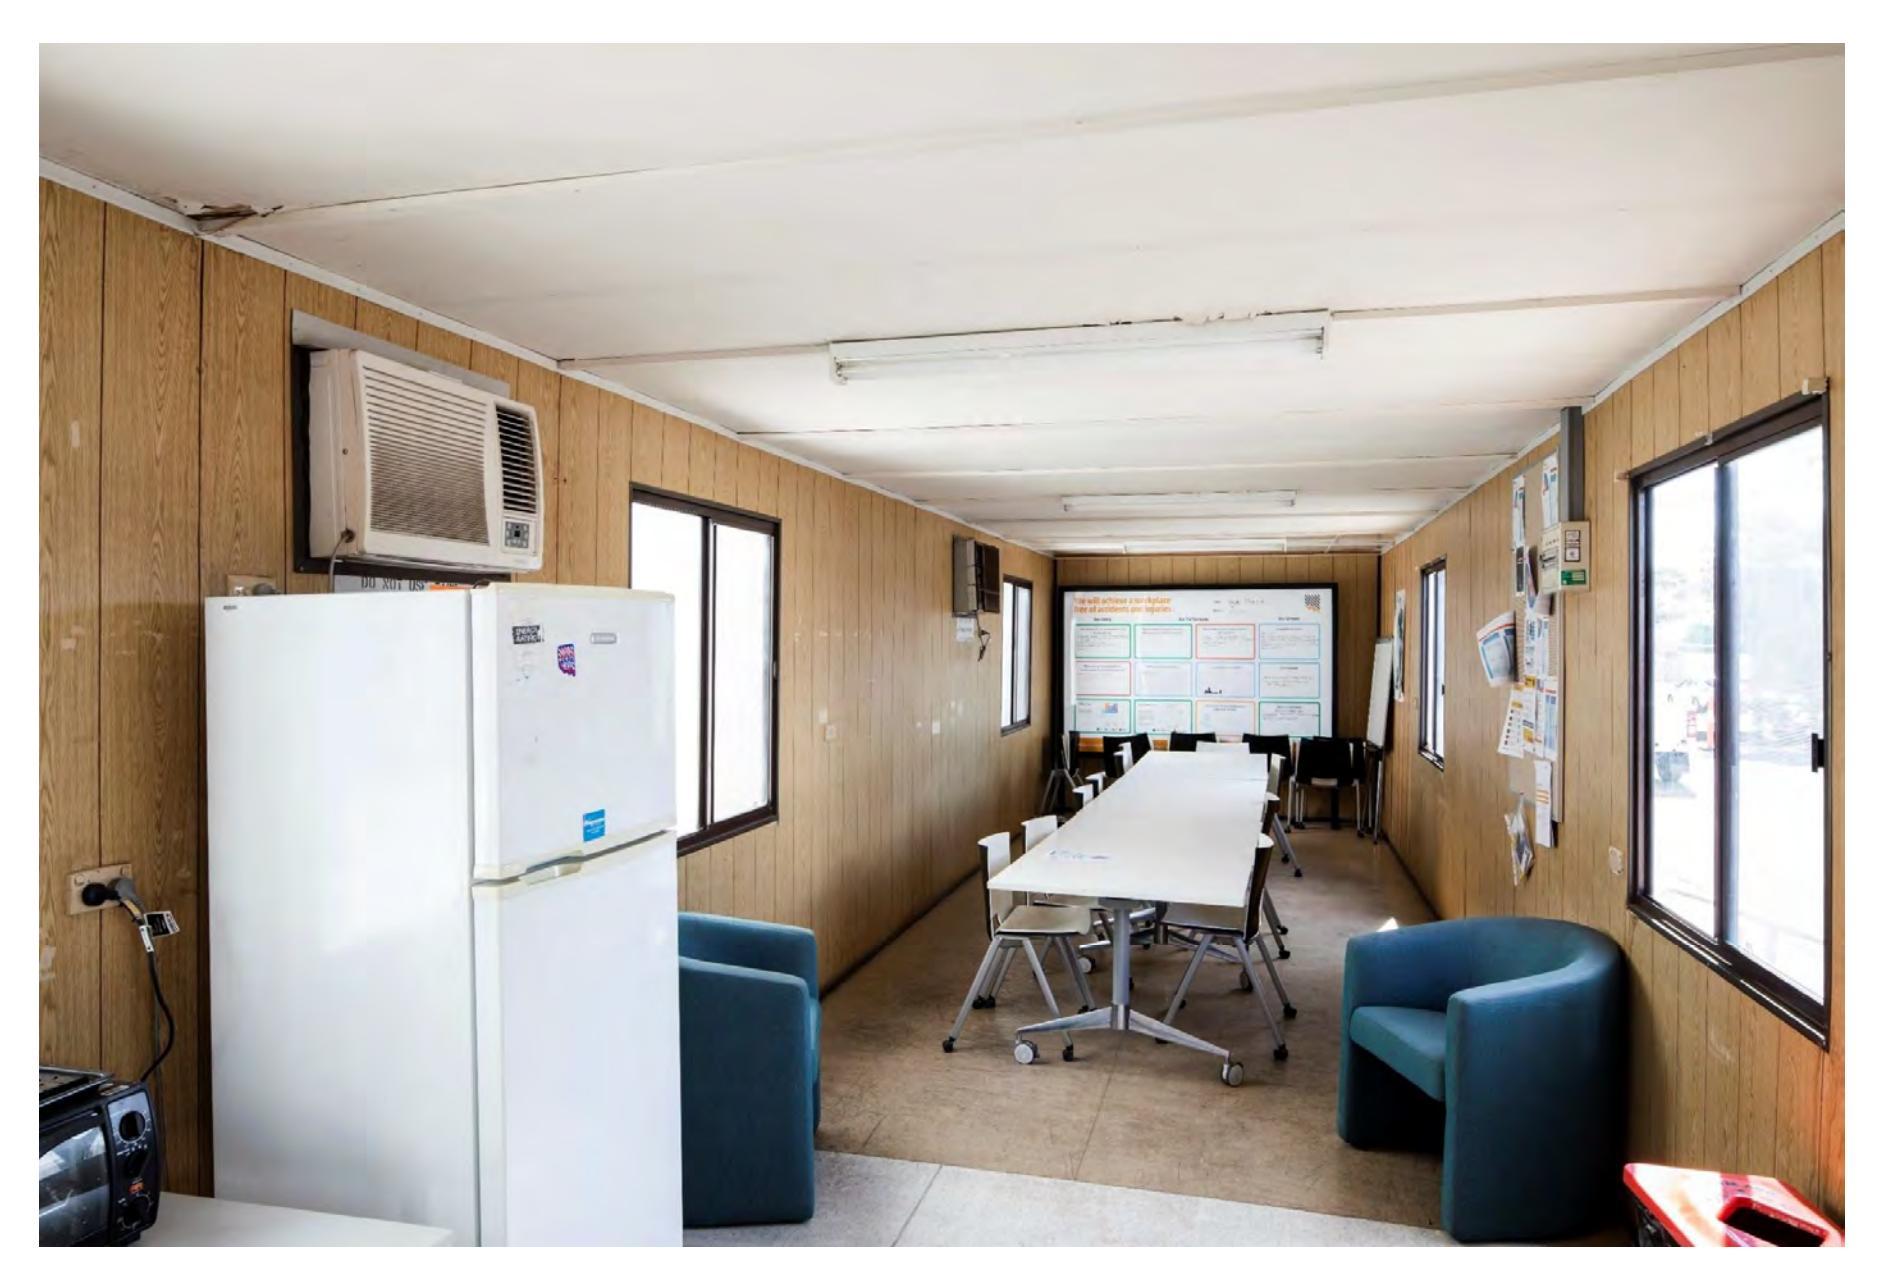
• Substation Construction Modular Lunchroom – Roof and floor collapsing. Well beyond useable life.

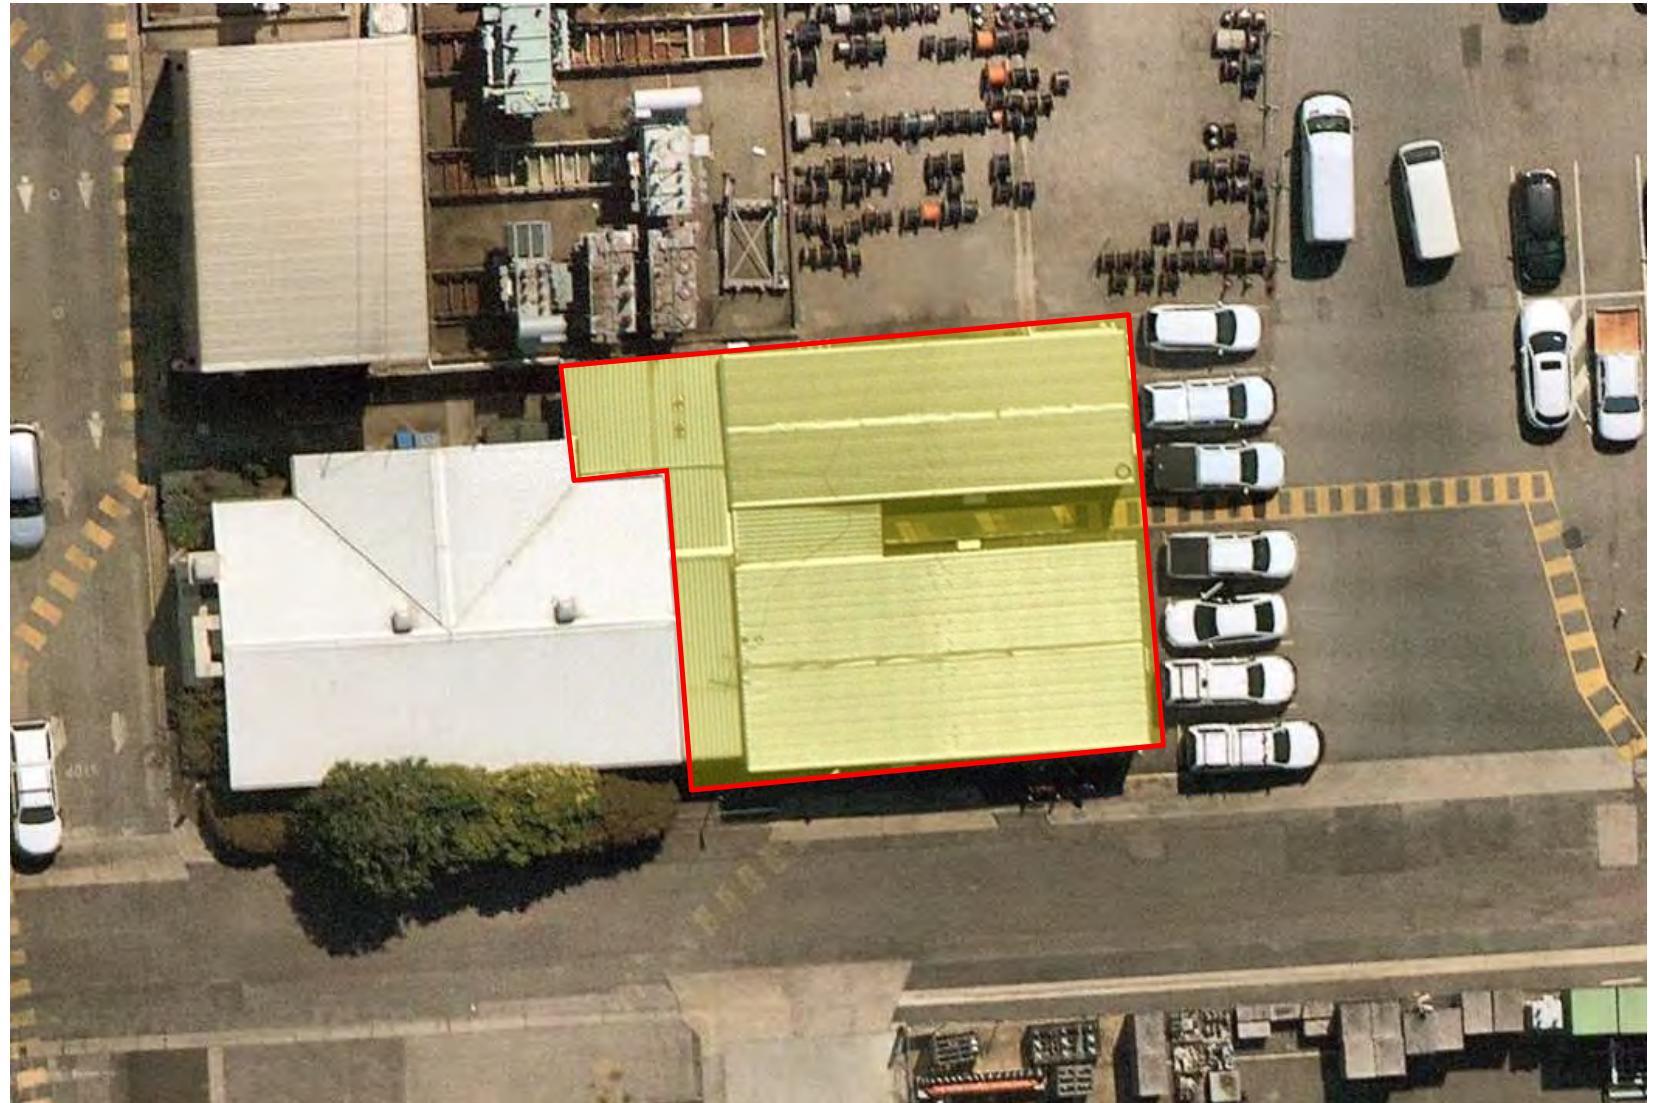
• ATCO Modular Style Buildings – Designed for temporary accommodation but have become permanent.

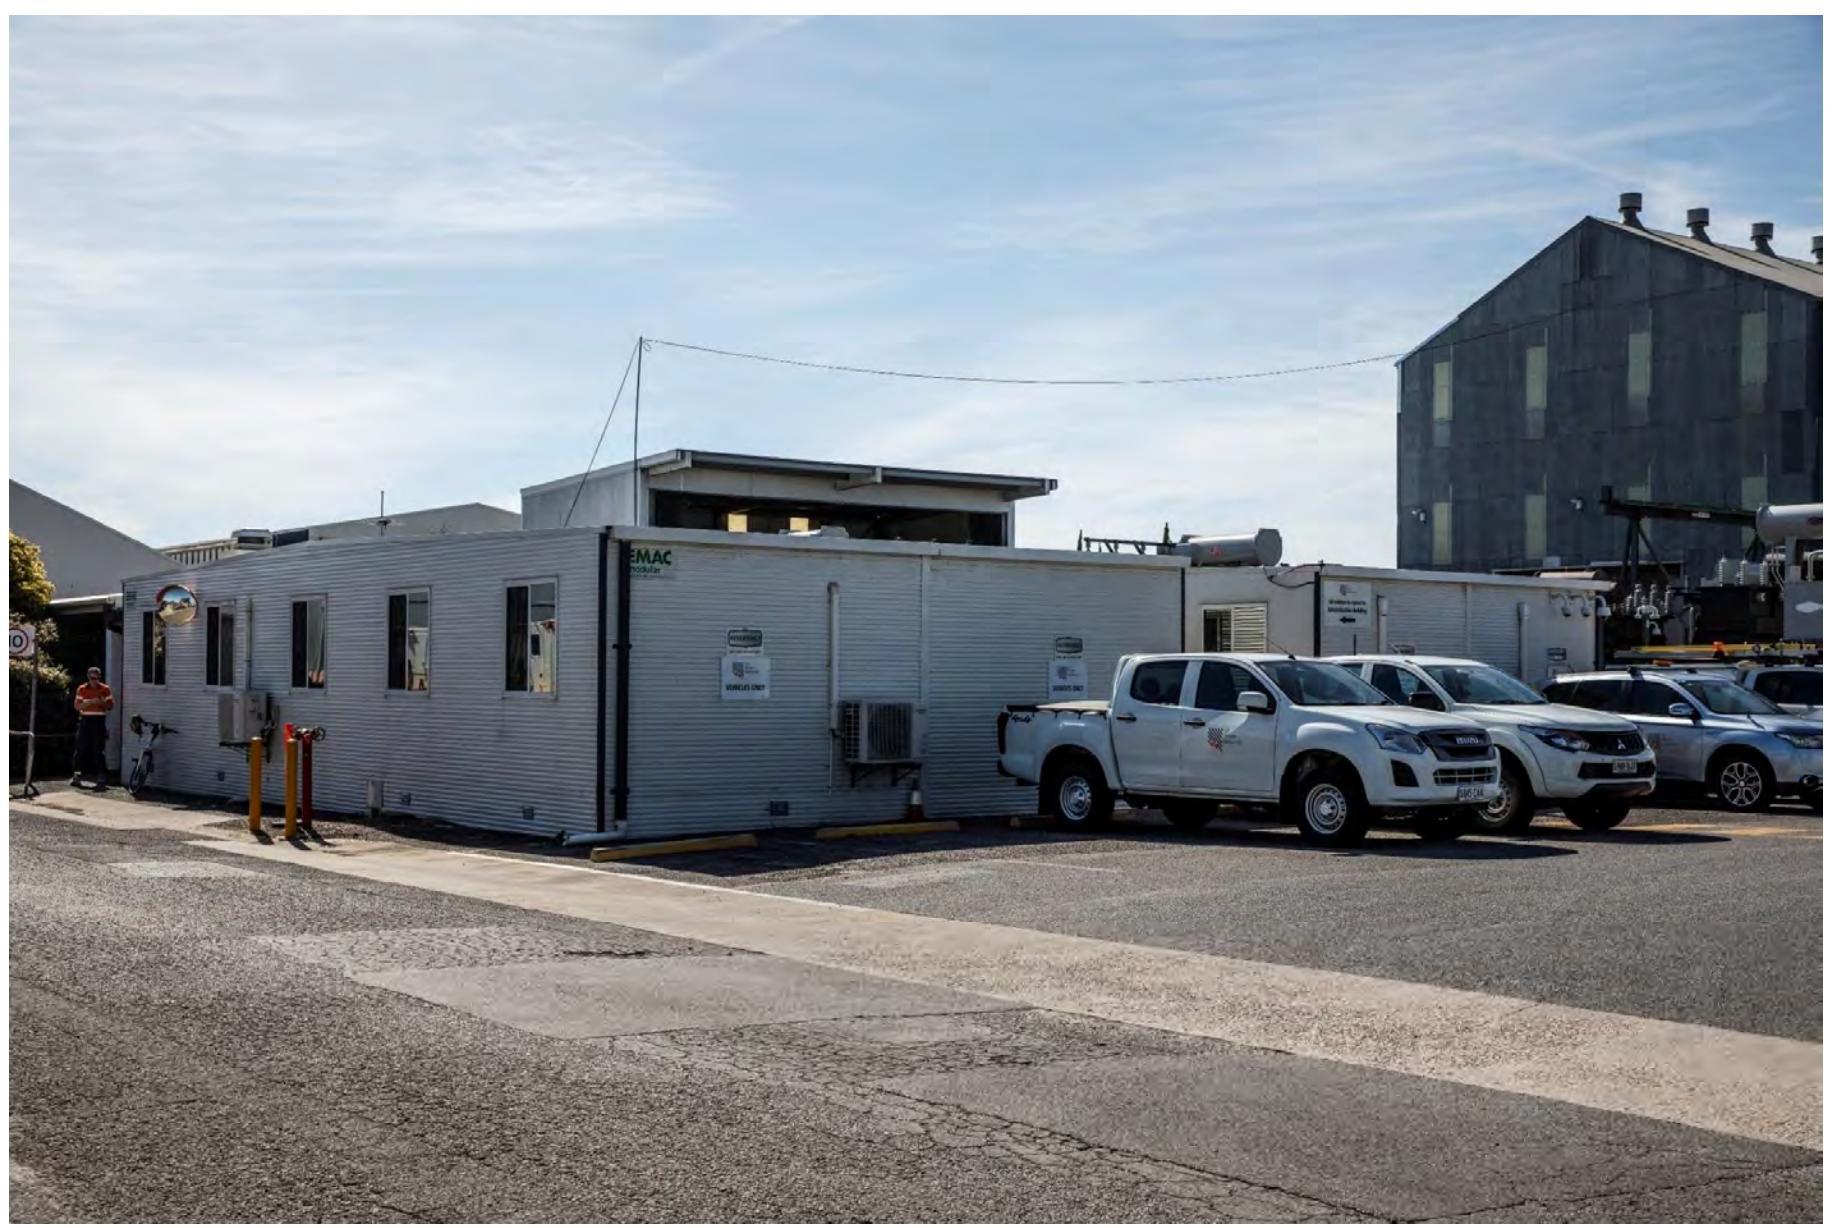
ATCO Modular Style Buildings – Admin office and substation maintenance office with bitumen cracking and previous patching.

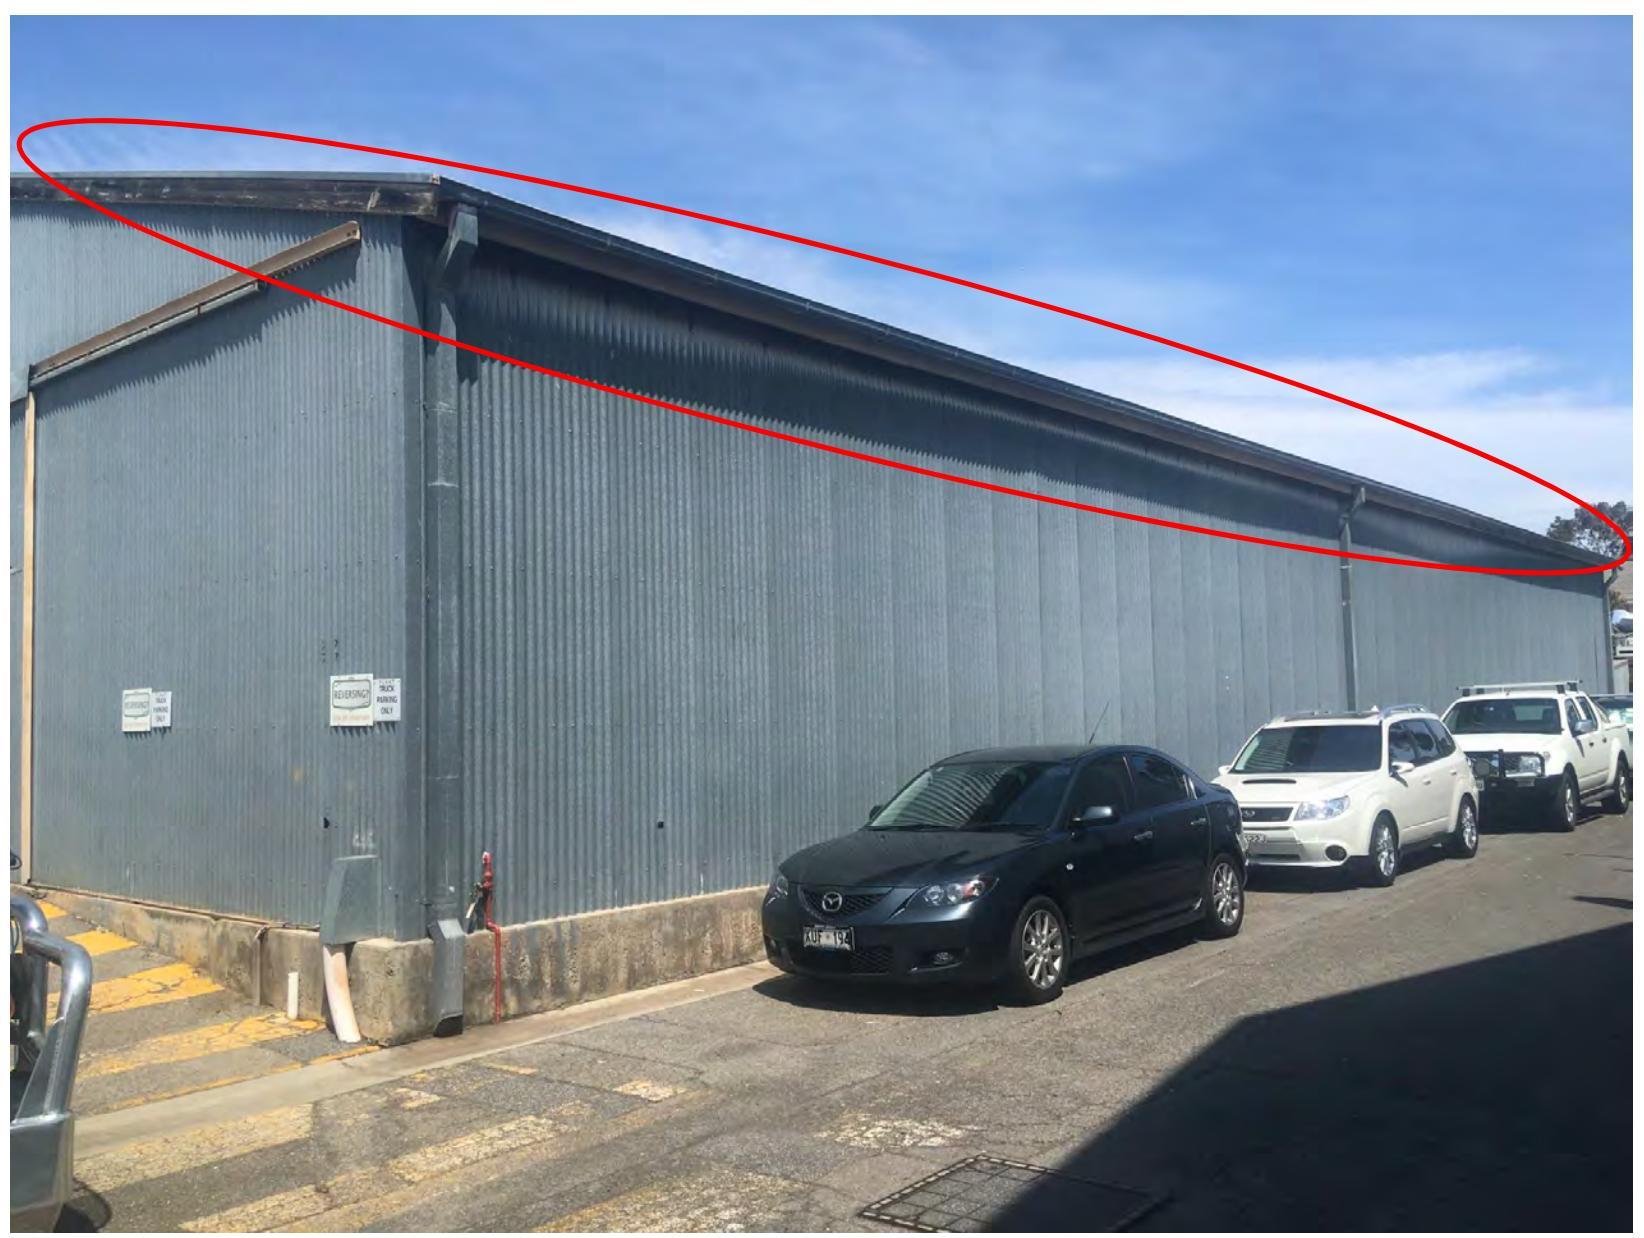
• Substation Store – Wood Rot to timber beams and gutter corrosion, with cracked bitumen to pedestrian walkway.

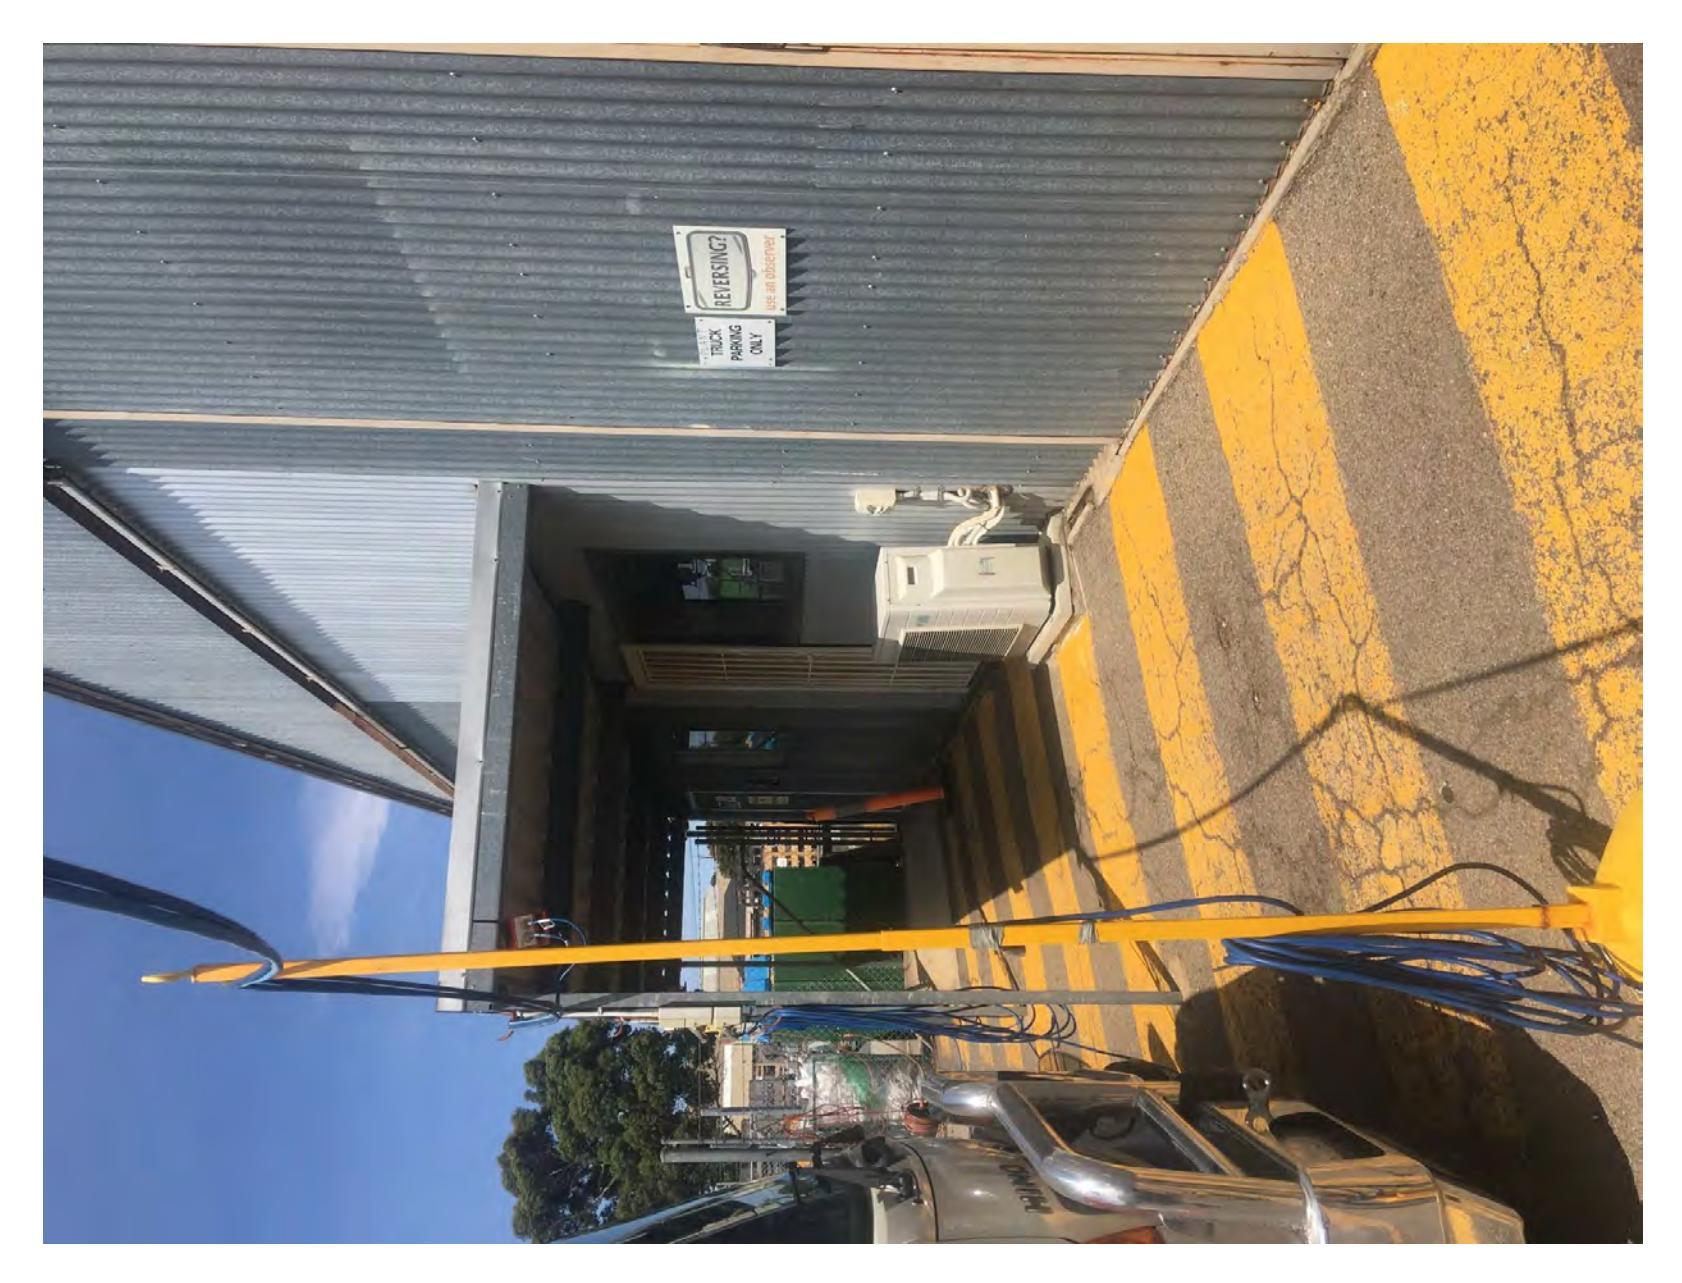
• Bitumen Cracking to pedestrian walkway
