Supporting document 5.24 St Marys Business Case

2020-25 Revised Regulatory Proposal 10 December 2019

St Marys Business Case

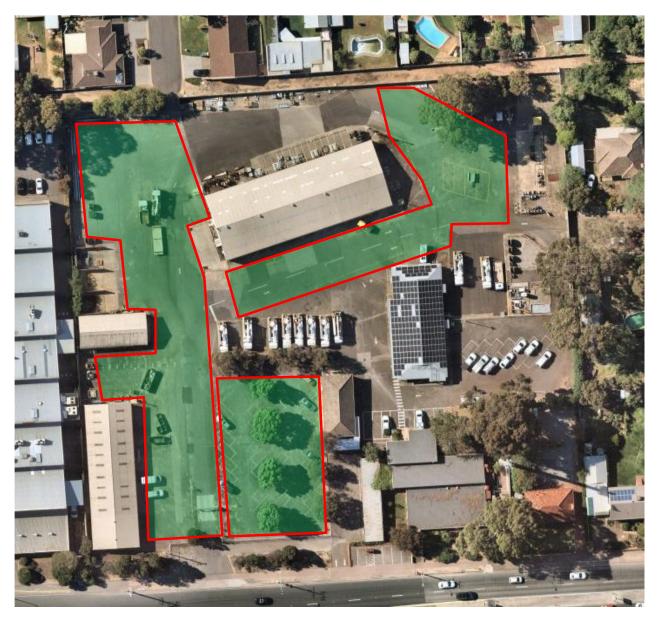
Figure 5 Diagram of pavement in poorer condition

The current pavement was original constructed in 1960. Since that time the volume and weight of the vehicles using the facility has increased. Because of the age of the pavement and its heavy use, there has been an increasing volume and severity of areas of the pavement with significantly degraded condition. Historically, we have been repairing the worst affected areas through a piecemeal reactive repair program. However, as was discussed in the previous section, we have only undertaken minor patched repair work in the current period.

Concrete areas are typically laid in block-like tile sections, with a filling material between the blocks. The surface of the blocks can degrade and wear, producing areas of sunken and uneven surface, or significant cracks can form. Alternatively, the joining edges of the blocks can get worn, chipped or the block can subside, such that an uneven step-change occurs between blocks.

The bitumen areas have similar issues with degradation and wear causing potholes and areas of sunken or uneven surface. The bitumen areas can also be affected during times of the extremely high temperature where the weight of the heavy vehicles, particularly at turning points, can cause ruts and uneven surfaces to form. Further, some of our heavy moveable storage and bins can leave deep spot indentations when left on bitumen for extended periods.

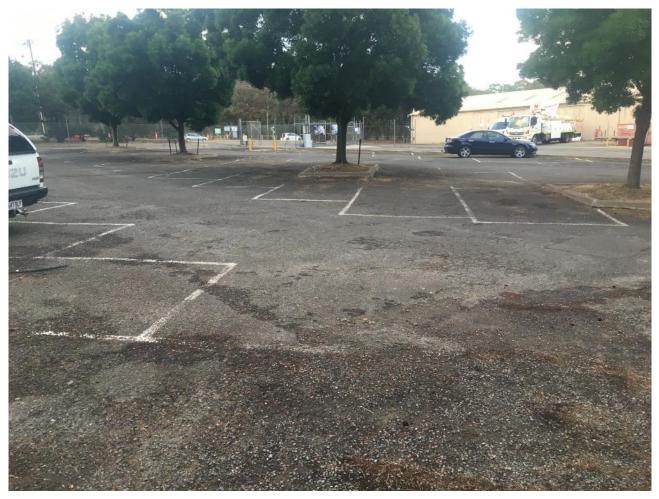
Figure 6 Example of complete breakdown of some areas of bitumen to the light vehicle car park and driveways.

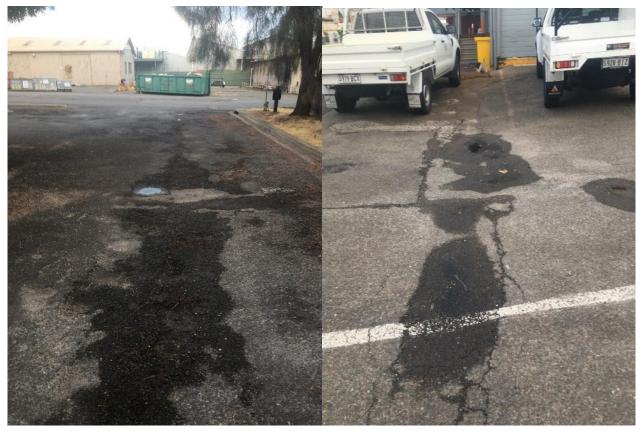
Figure 7 Example of full-thickness cracking, subsidence and potholing to main driveway and Car park area

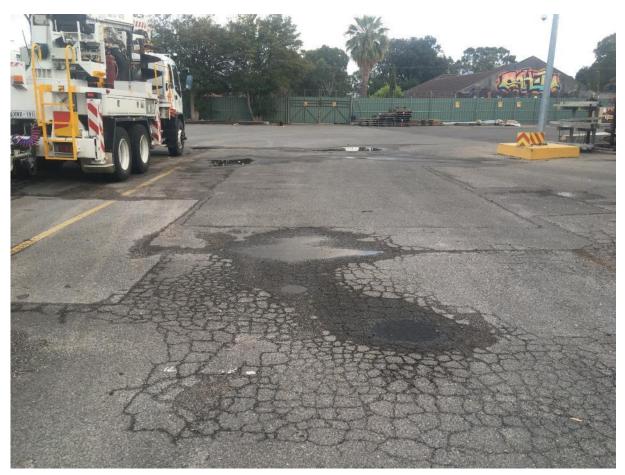
Figure 8 Example of full-thickness cracking, potholes and subsidence to heavy vehicle driveway. Also areas of previous repairs.

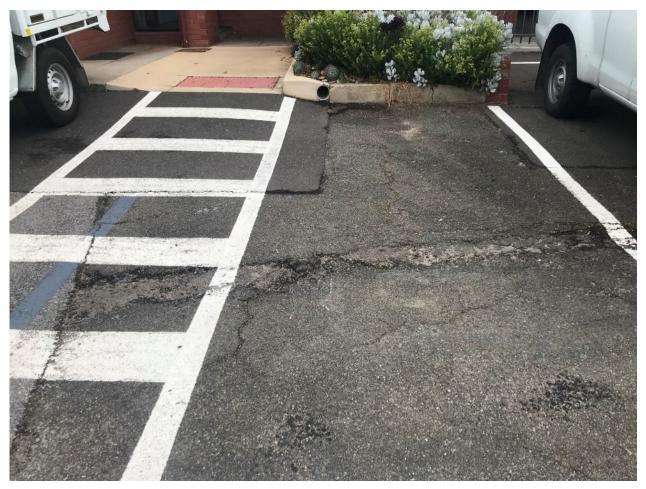
Figure 9 Example of cracking around pedestrian walkways

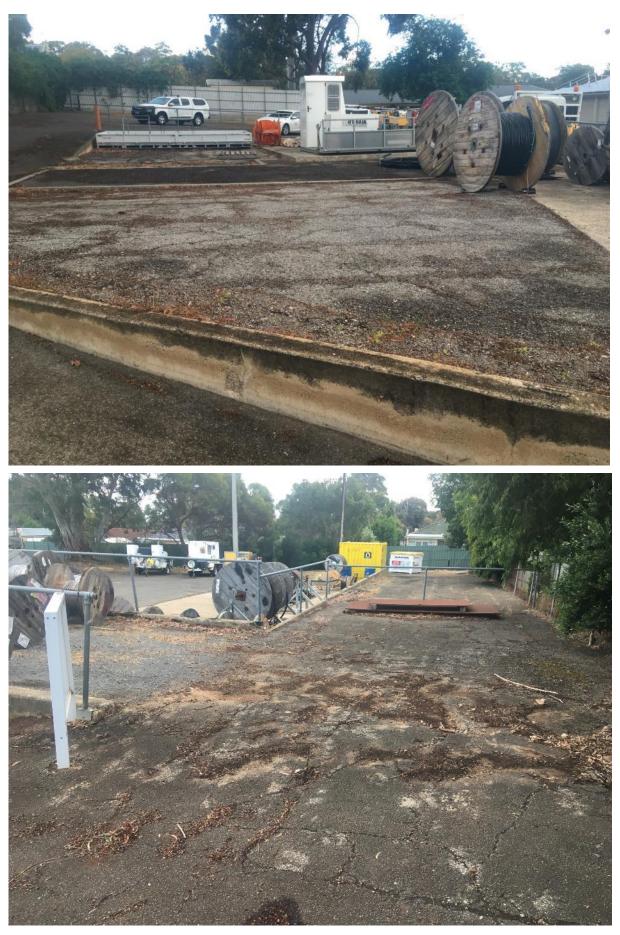
- The tree root uplift and subsidence Associated with the poor condition of the pavement, we also have extensive tree uprooting around the external storage bays, which is also damaging the pavement and causing subsidence.

Figure 10 Examples of cracking, subsidence and tree root uplift to storage areas.

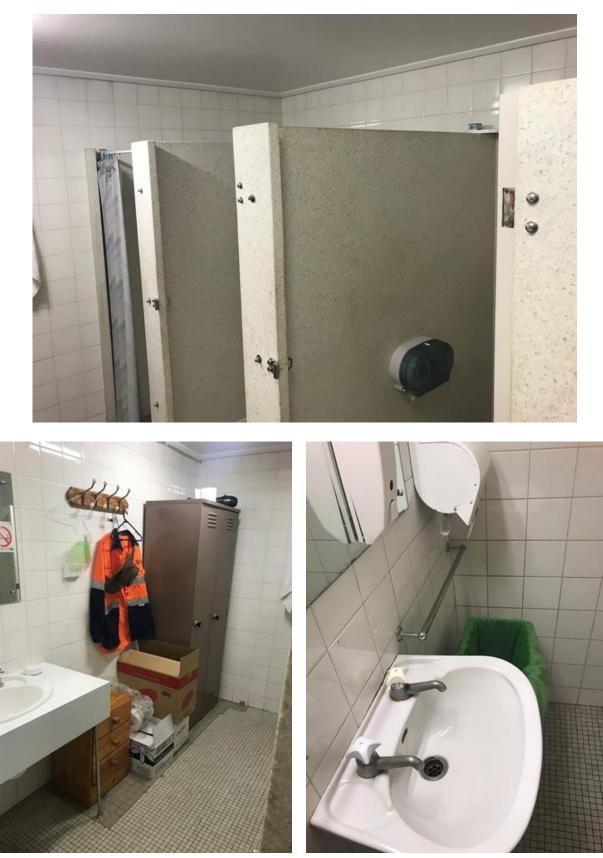
Figure 11 Original fit-out to shower and toilet cubicles

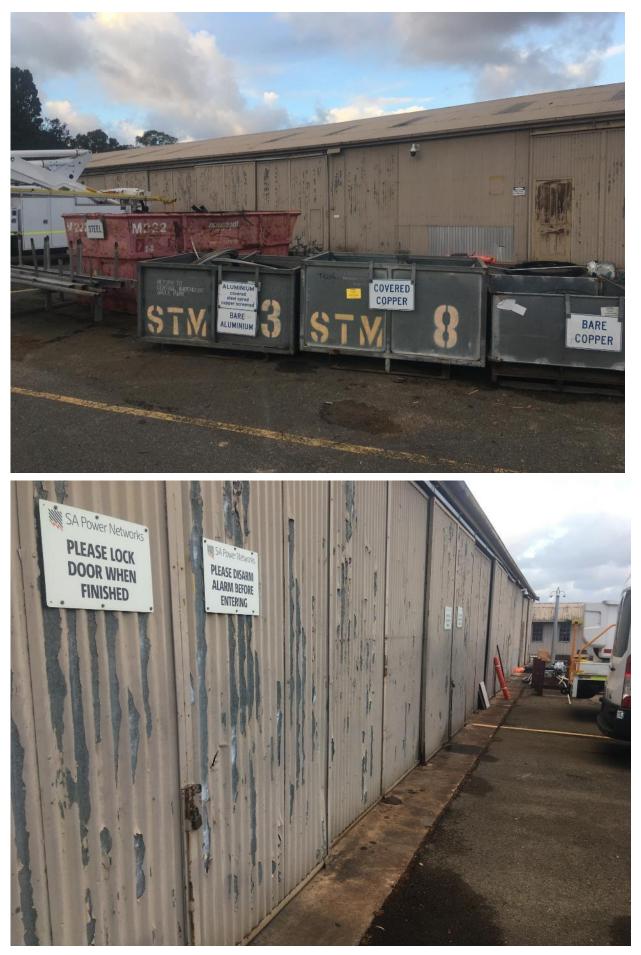
Figure 12 Examples poor condition of corrugated iron sheets of shed/workshops

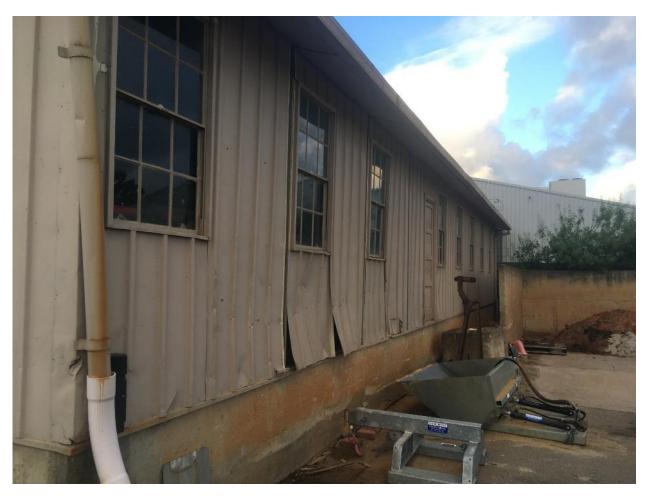
Figure 13 Examples poor condition of corrugated iron sheets of shed/workshops

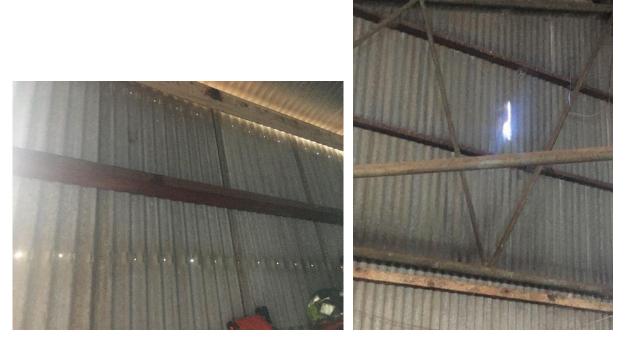
Figure 14 Examples original timber/steel framing of sheds/workshops
