Supporting document 5.25 Clare Business Case

2020-25 Revised
Regulatory Proposal
10 December 2019

SA Power Networks

Clare Business Case

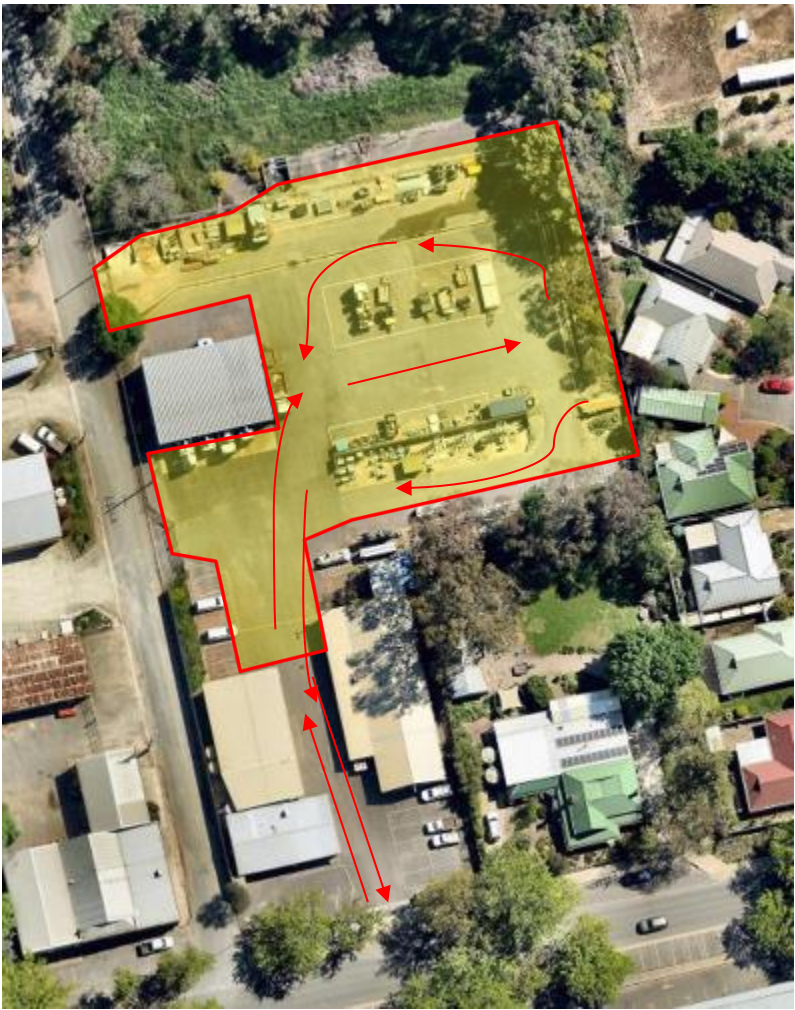
Figure 3 Diagram of poor condition pavement areas and general heavy vehicle flow paths at the site

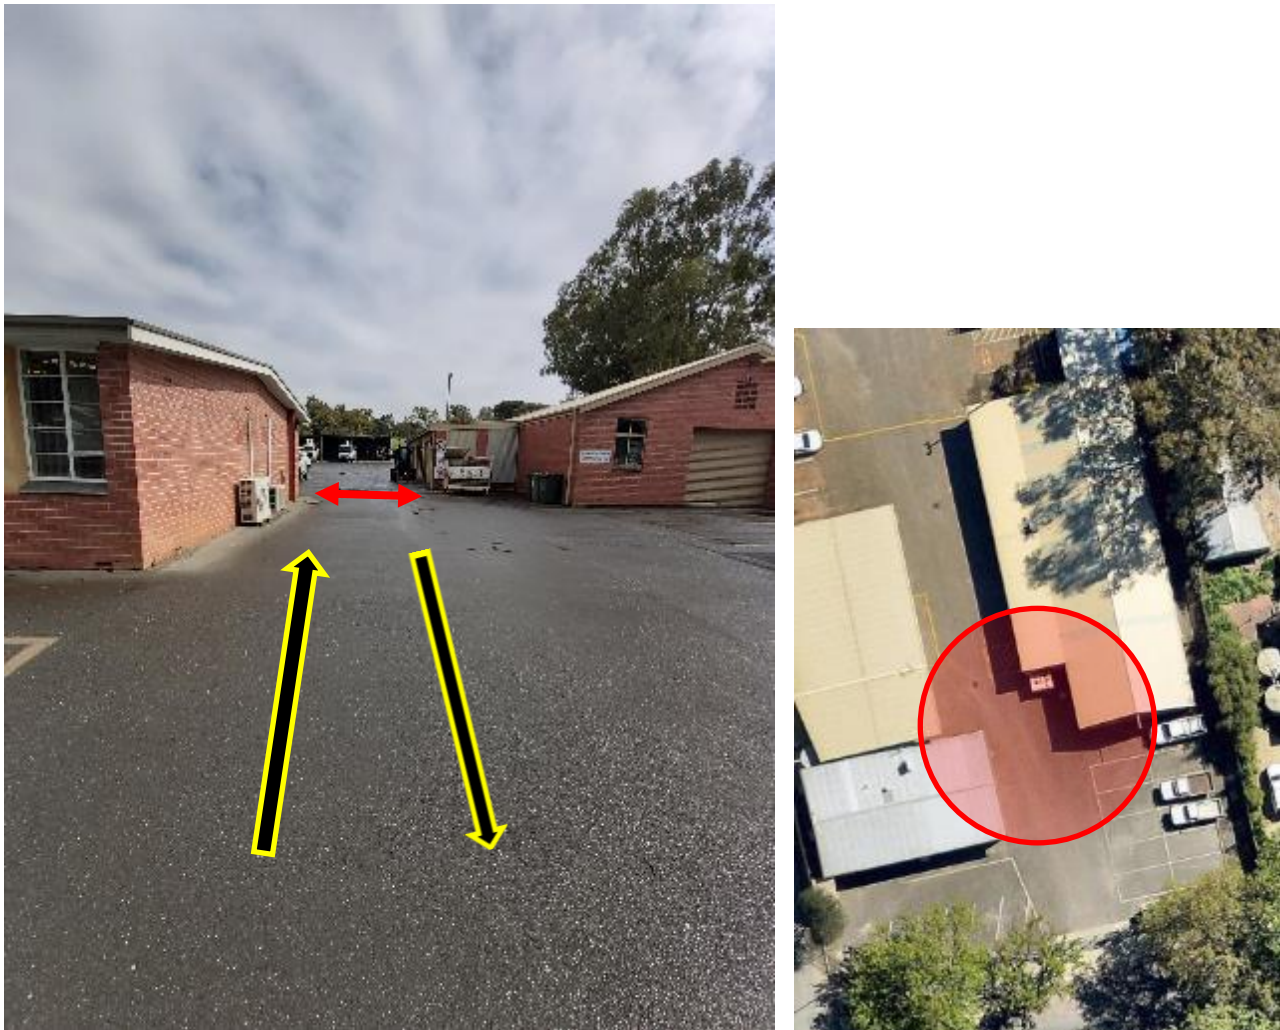
Figure 4 Diagram of poor condition pavement areas and general heavy vehicle flow paths at the site

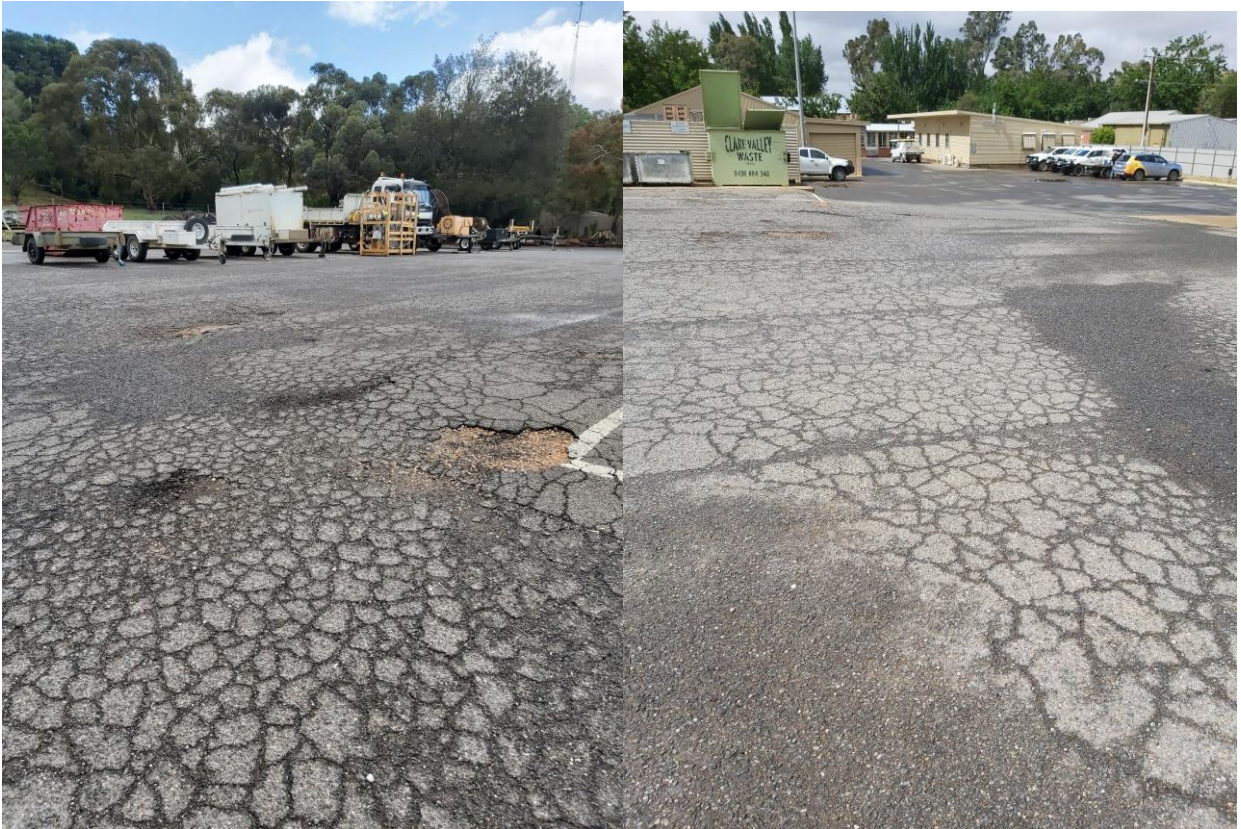
Figure 5 Examples of large areas of bitumen to the rear of the yard and heavy vehicle driveways in very poor condition with full-thickness cracking, potholing and subsidence.

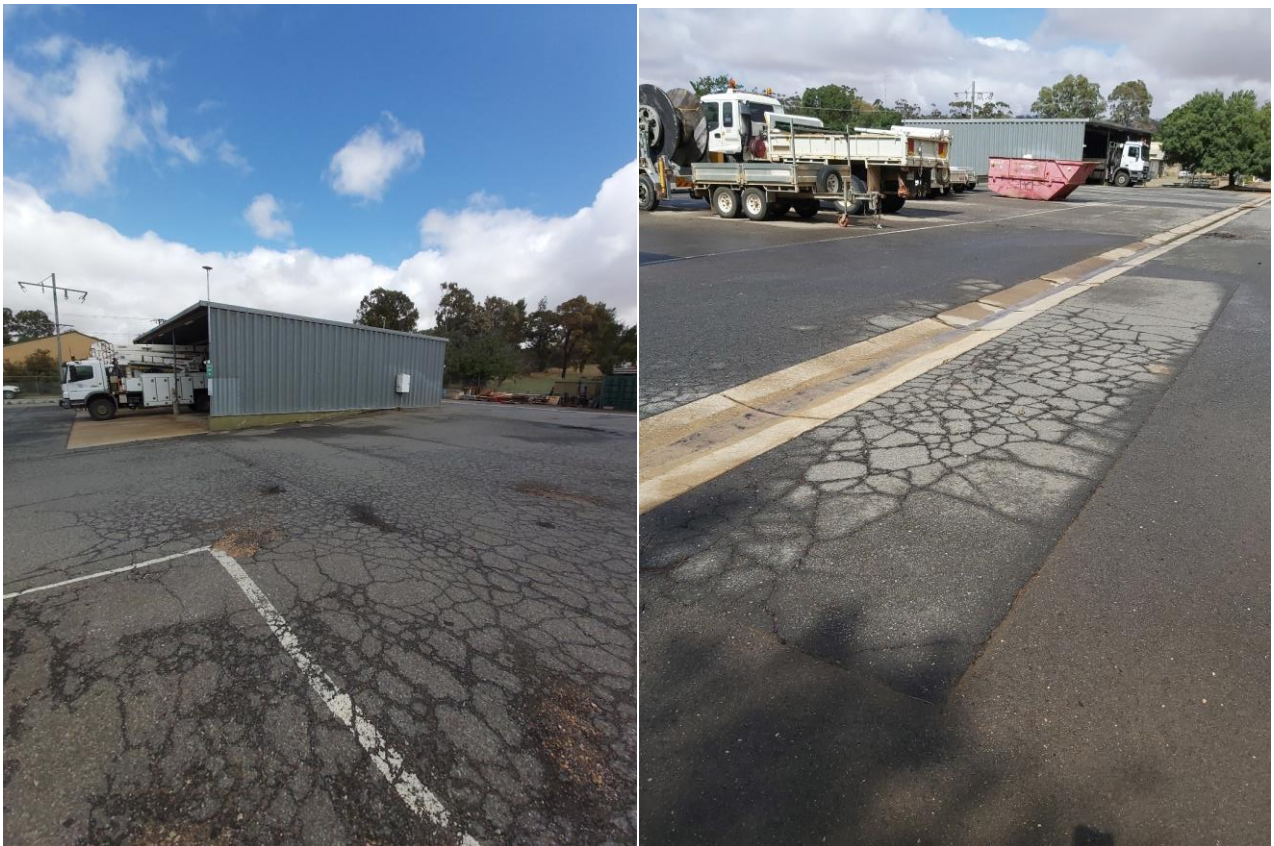
Figure 6 Examples of large areas of bitumen to the rear of the yard and heavy vehicle driveways in very poor condition.

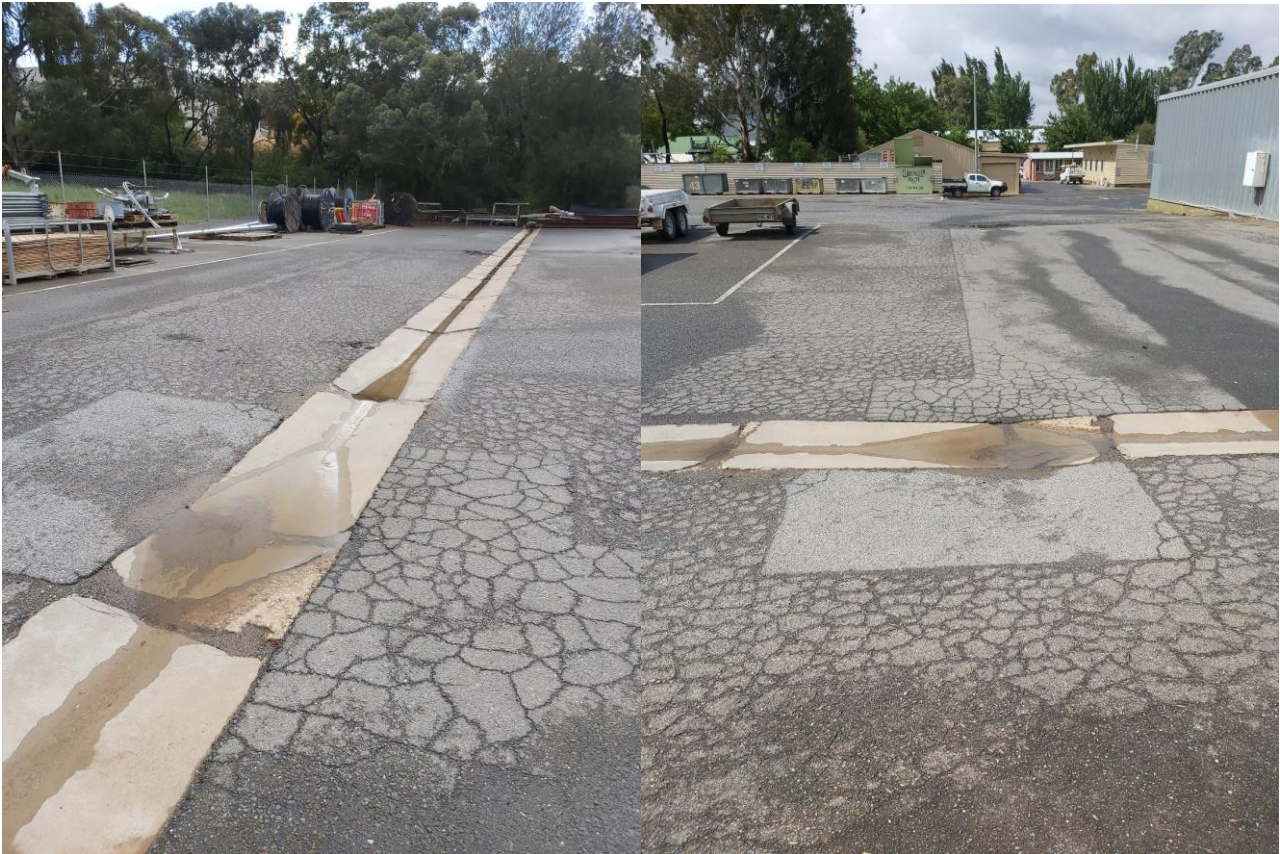
Figure 7 Examples of full-thickness cracking and breakdown of concrete drain and heavy vehicle driveway

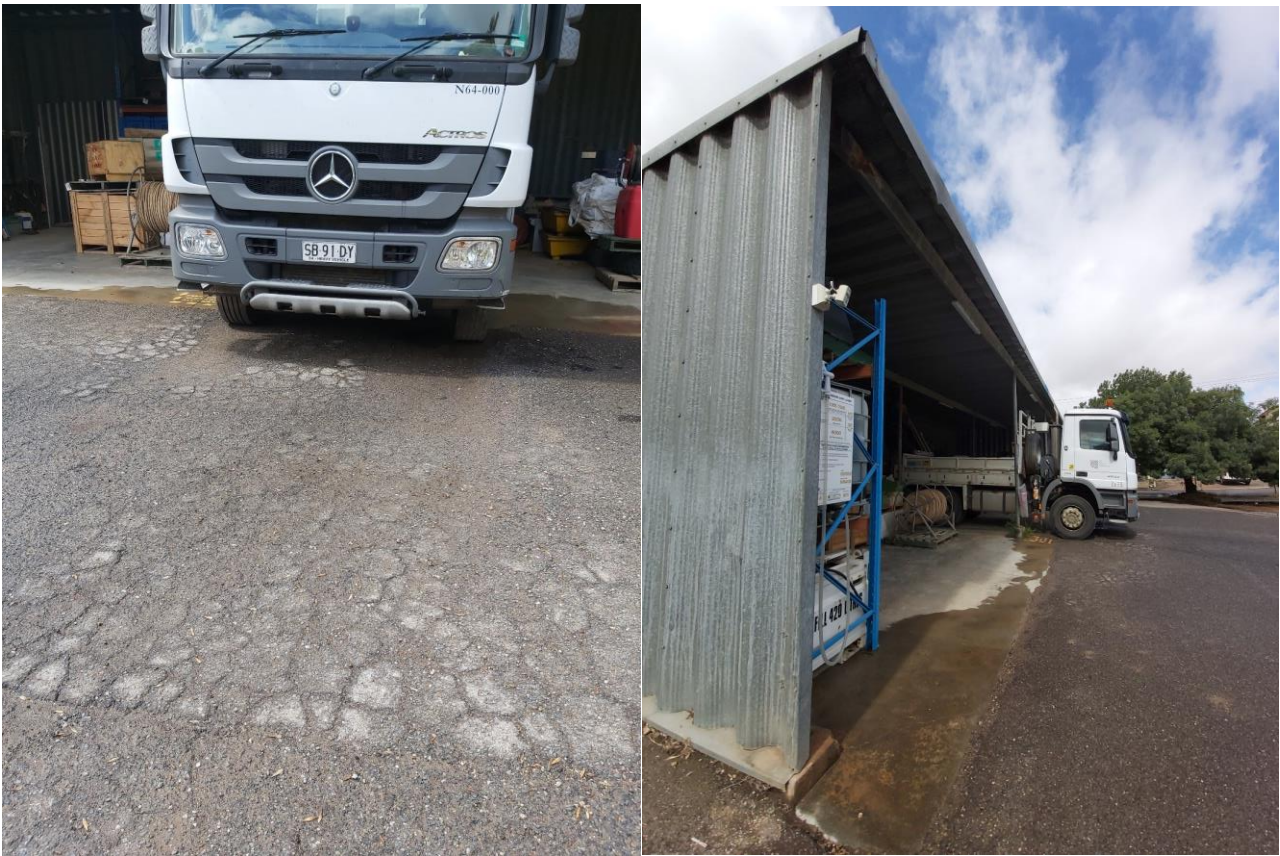
Figure 8 Broken and degraded pavements to the loading areas of the rear side of the truck store.

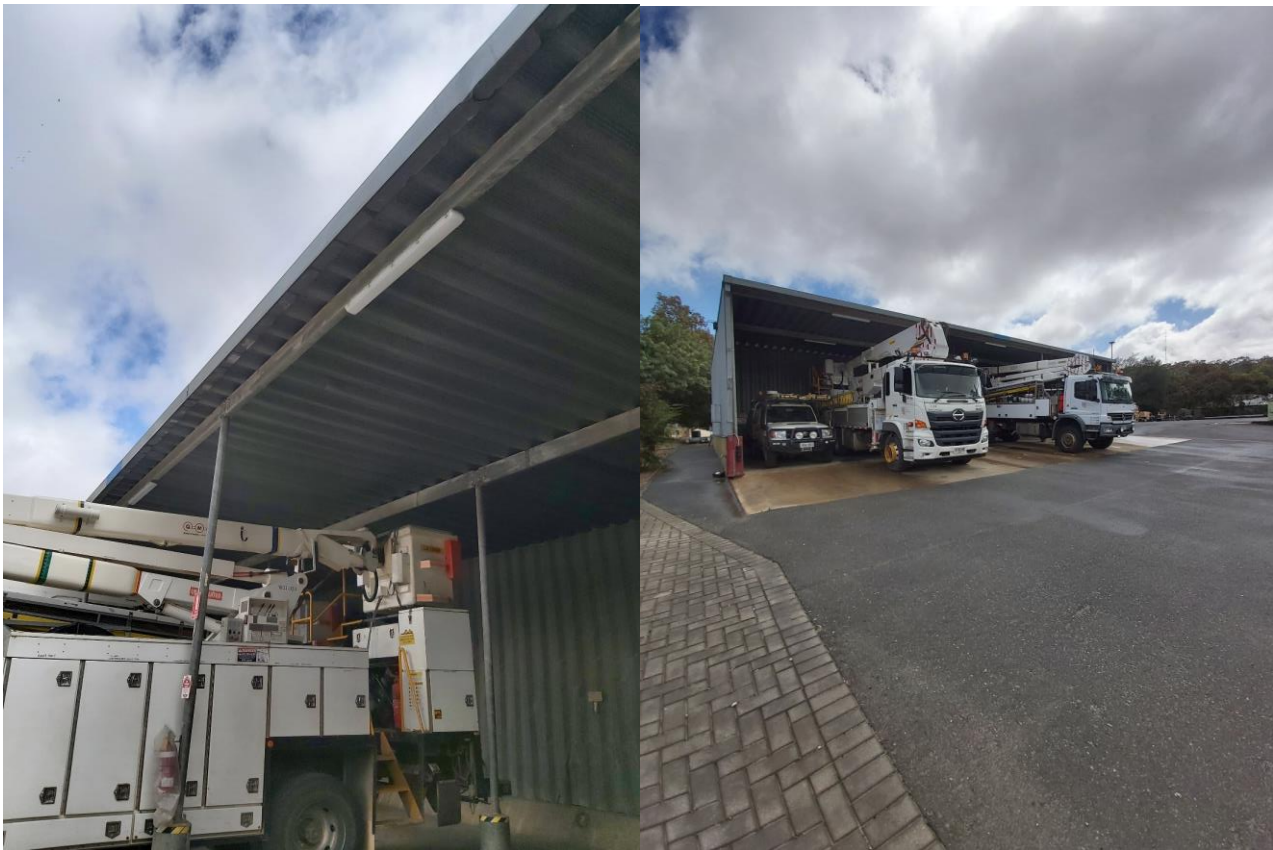
Figure 9 Current truck store from can only accommodate half the length of an EWP vehicle and other trucks

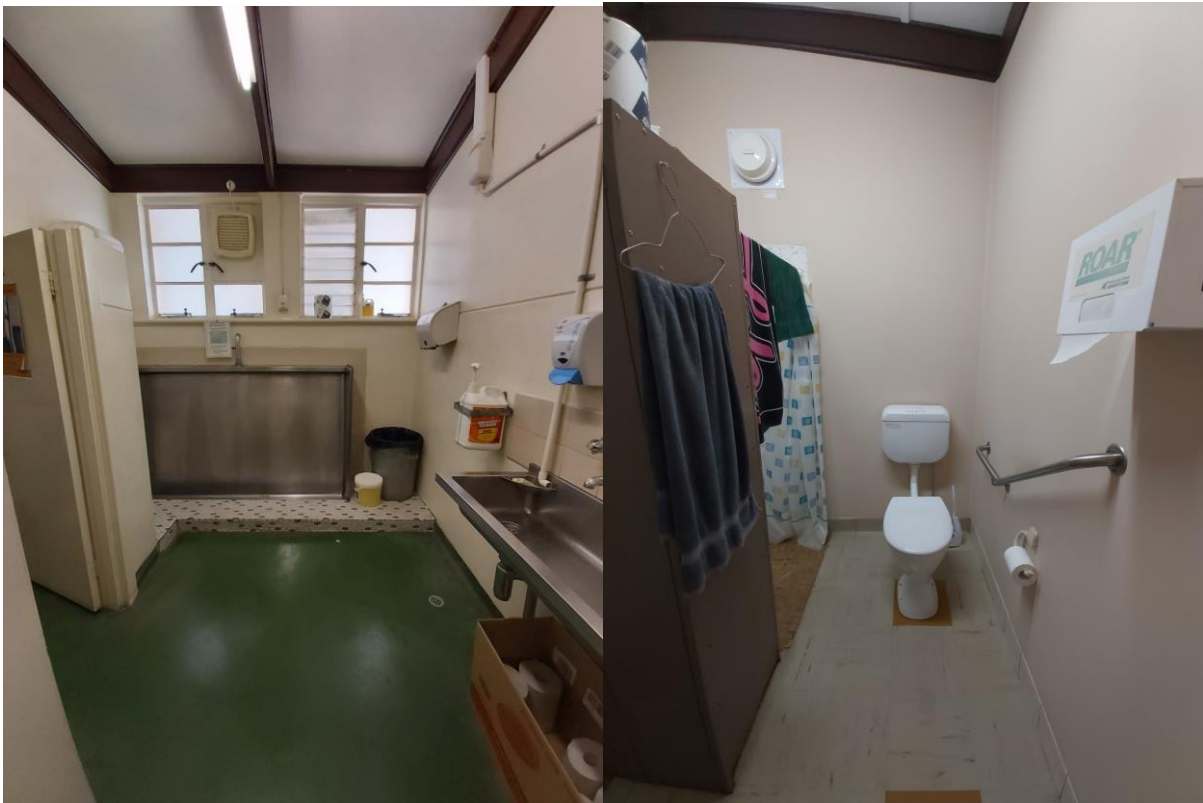
Figure 10 Male and female toilet and showers showing original aged fit-out and poor condition

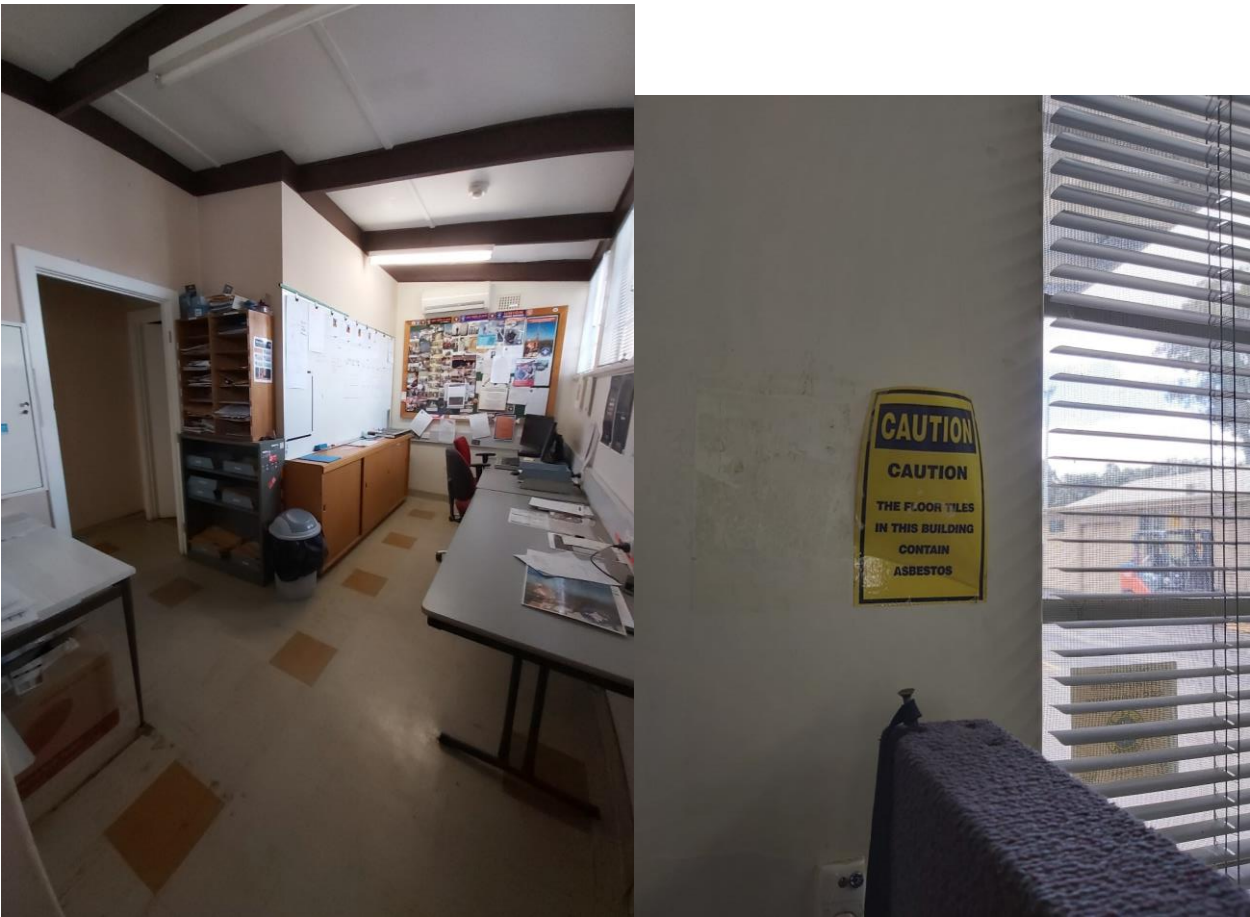
Figure 11 Administration building showing aged internal fit-out as per original, and signage indicating asbestos floor tiles

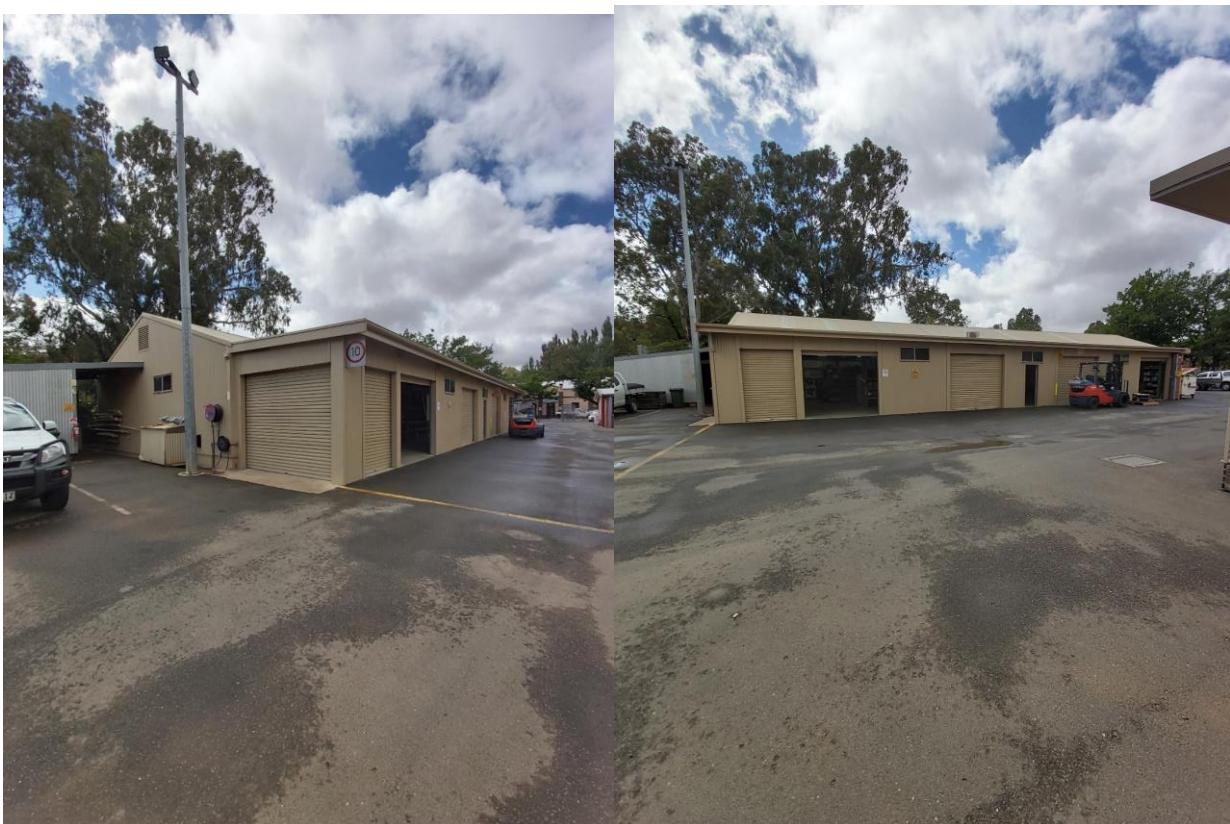
Figure 12 Workshop Building showing old circa 1967 design and construction

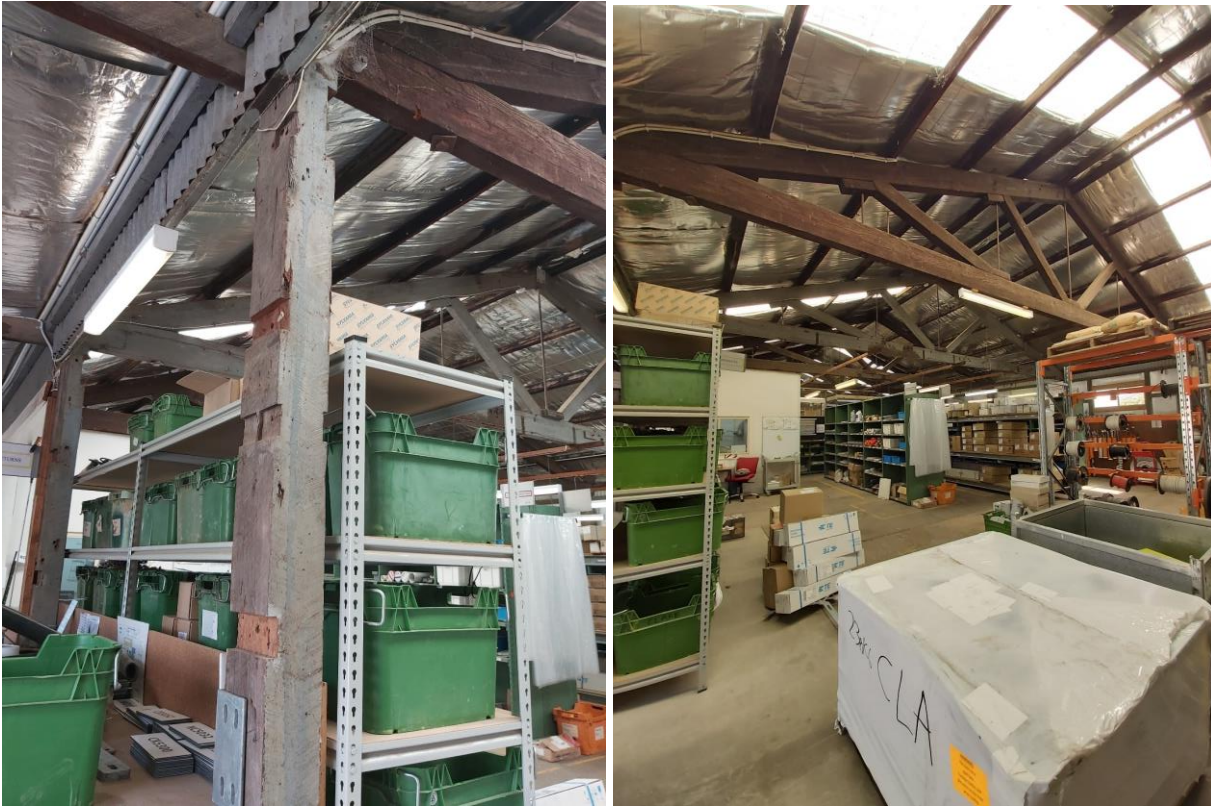
Issue	Explanation of issue
Timber frame	Whilst constructed of very large hardwood Jarrah members, the columns and trusses are showing signs of decay and cracking and have been cut into previously for shelving. The height of these beams also restricts the amount storage and racking space and forklifts have also knocked the columns in several locations.
Wall cladding	Original 1960's corrugated iron sheets (painted). Starting to show signs of corrosion.
Lighting	Remaining lighting requires upgrading to more compliant and energy efficient fittings.

Figure 13 Inside the workshop building, showing the aged working arrangements including original Jarrah columns and trusses starting to show signs of cracking, height restrictions to operations and lack of effective insulation
