Investment Evaluation Summary (IES)

Project Name:	Air Break Switches Unit Replacement
Project ID:	00481
Thread:	Overhead
CAPEX/OPEX:	CAPEX
Service Classification:	Standard Control
Scope Type:	A
Work Category Code:	REOHS
Work Category Description:	Replace OH Switchgear
Preferred Option Description:	Collection of asset information. Apply to 100% of units Replacement of whole ABS, with "see-saw" handle. Apply to approximately 10% of units. Management of risk exposure through implementation of operational practices. Apply to 100% of units. Removal of ABS from service. Apply to approximately 5% of units. Ongoing condition assessment as a part of five year pole inspection program. Apply to 100% of units. Ongoing maintenance as a part of twenty year program. Apply to 100% of units. Ongoing replacement of units. Apply to approximately five units per year.
Preferred Option Estimate (Nominal Dollars):	\$13,279,253

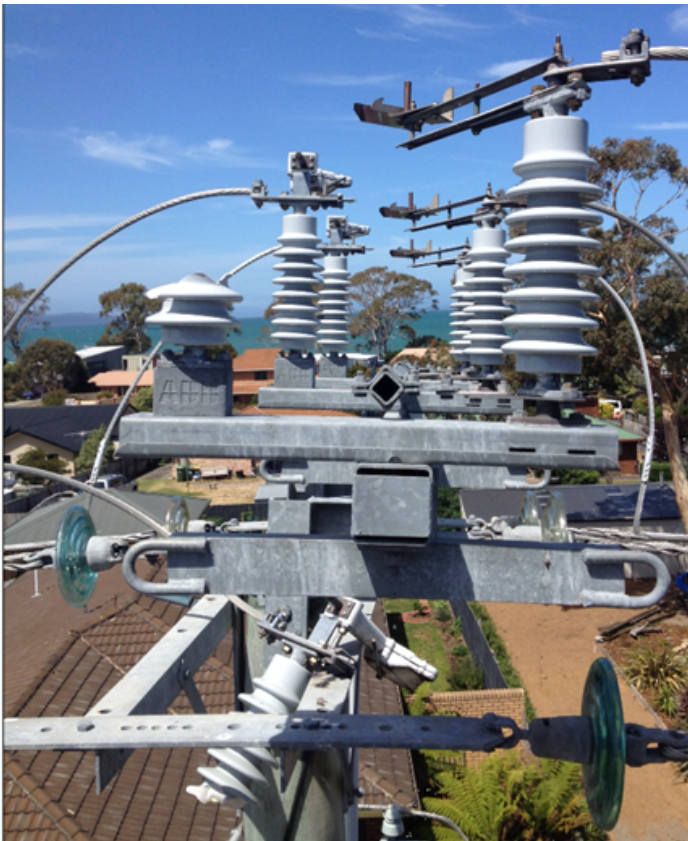
Recent failures show that the particular failure mode being restricted to Asea Brown Boweri (ABB) type ABSs. However, it is possible that similar failure may occur with ABSs produced by another manufacturer, or possibly other asset classes, with similar materials and construction process. Other Distribution Network Service Providers (DNSPs) on identification of failures as early as 2006, have issued Safety Alerts and Operating Restrictions for ABB "U", "R", and "S" series ABSs. These DNSPs indicated through correspondence that they have implemented programs for the replacement of these series of ABB ABSs.

Figure 1: Damaged ABB air break switch.

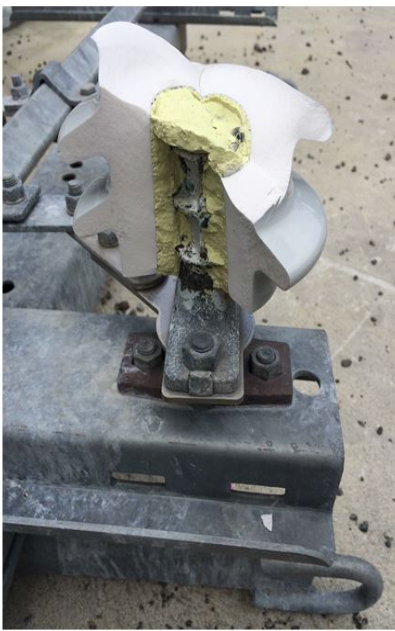
Figure 2 ABS porcelain insulator pin that has failed, as a result of steel corrosion.

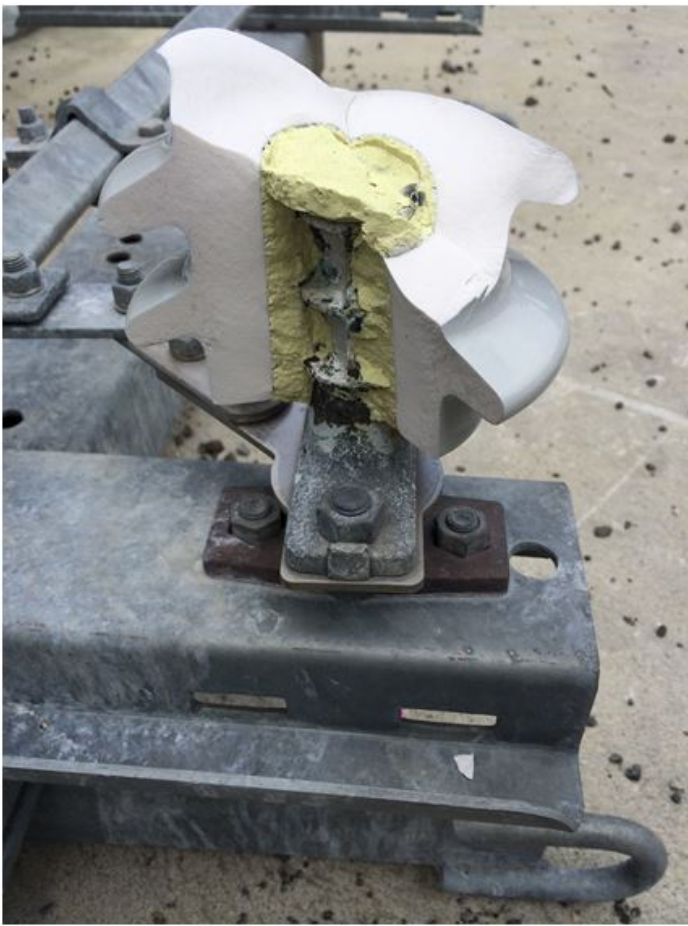
Since 2011, Aurora Energy and subsequently TasNetworks have seen a number of mechanical failures in the porcelain insulator pins of certain ABSs while the devices are being operated. The most likely mode of failure is a function of moisture ingress through the end connections of the porcelain insulators, resulting in pin corrosion and expansion. These forces are sufficient to compromise the structural integrity of the insulators causing the unit to fail when the device is next operated (see Figure 2).

Figure 2: Porcelain insulator pin that has failed, as a result of steel corrosion.

Under failure the pin insulator disintegrates, sending shards of broken porcelain falling to the ground and the field service operator on the ladder below. This presents an unacceptable health and safety risk to TasNetworks personnel.

Prior to November 2005, ABB used a hot-dip galvanized steel as the metal for the insulator pins (see Figure 2). In November 2005, ABB modified the design of these units to use a 304 stainless steel pin (keeping the same order number for both vertical and horizontally mounted units).
