## APA GROUP

### KATHERINE – DARWIN CITY GATE – CHANNEL ISLAND

### INVESTIGATION OF INDUCED VOLTAGE MITIGATION REQUIREMENTS

APA Group  
Investigation of Induced Voltage Mitigation Requirements  
Katherine – Darwin City Gate – Channel Island Pipelines

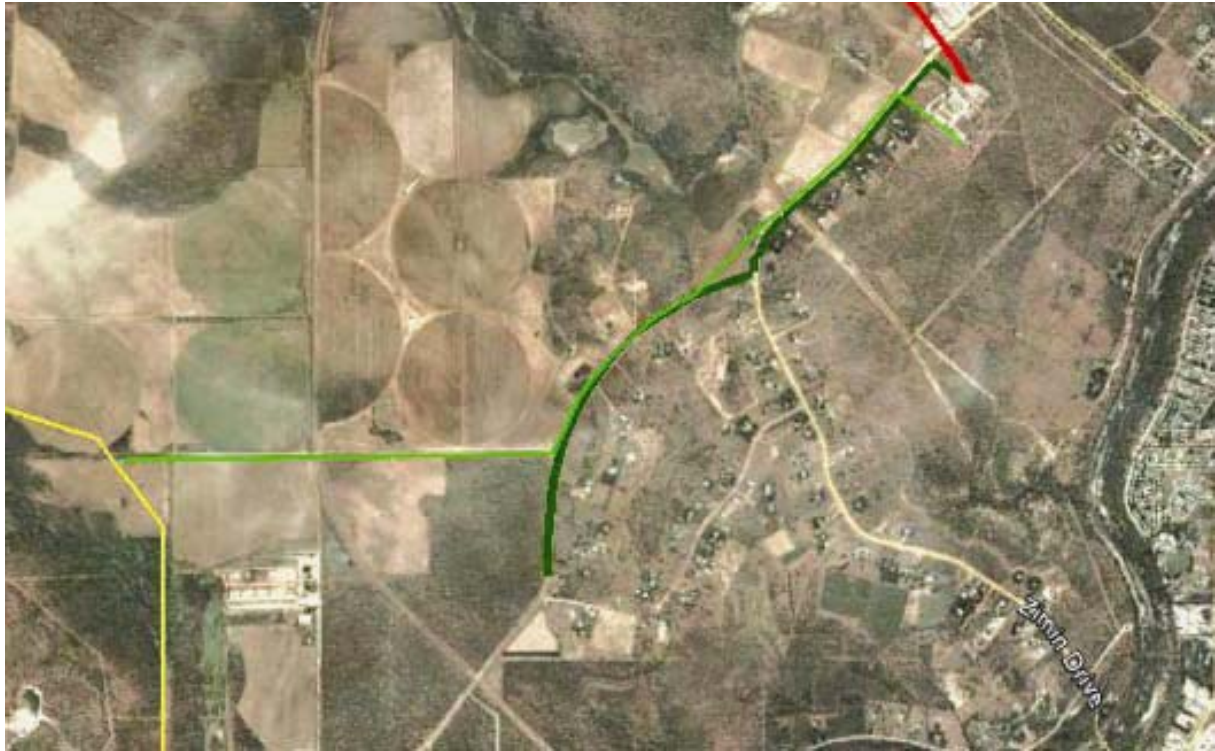
Figure 4.1 Katherine lateral pipeline (light green) and powerline alignment (dark green), with AGP in lower left (bright yellow).

More than half of the pipeline route runs in proximity to the relevant powerline, as shown above. Details of the offset distances can be seen in the software analysis as shown in Appendix 1.

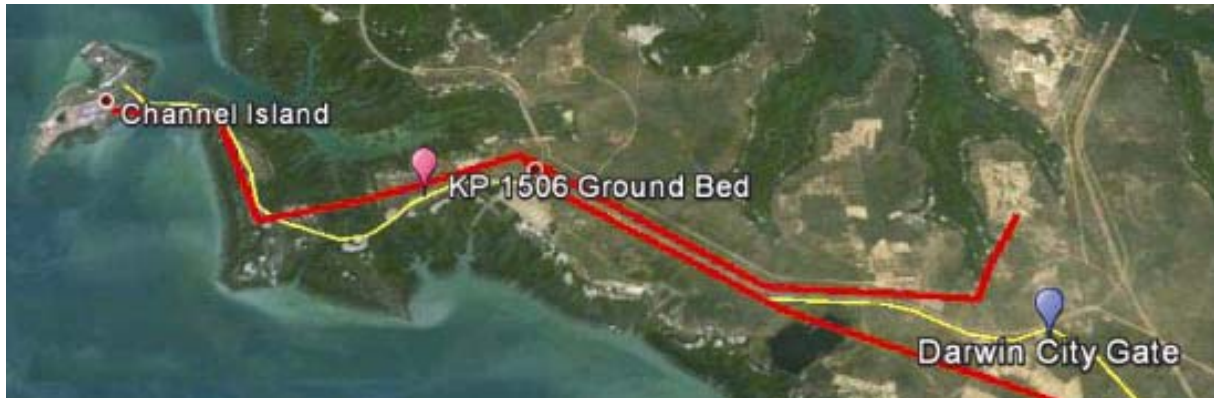
Figure 4.3 Channel Island spurline (yellow) and 132 kV powerlines (red).

Also in this area are 22 kV supplies between Channel Island and Weddell, which have not been shown above.

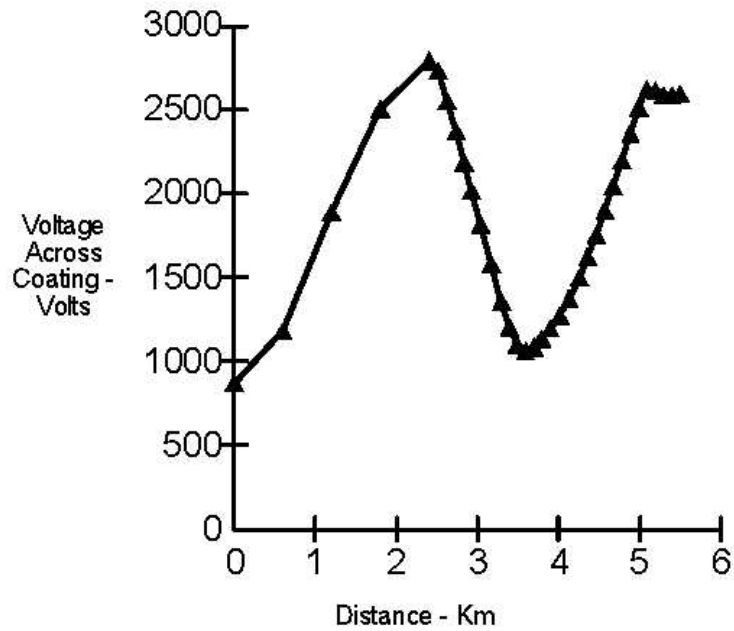
Fault Voltage  
Graph and Data

Pipe #1		Pipe #1 (cont.)	
Distance	Volts	Distance	Volts
0.00	868.9	4.88	2354.9
0.60	1184.0	4.98	2516.0
1.20	1890.1	5.09	2622.3
1.80	2505.8	5.19	2615.0
2.40	2789.5	5.29	2585.4
2.51	2729.6	5.39	2589.1
2.62	2548.2	5.49	2591.6
2.73	2368.2		
2.83	2188.1		
2.93	2011.0		
3.03	1813.7		
3.16	1576.9		
3.29	1357.5		
3.39	1202.2		
3.49	1099.0		
3.59	1061.1		
3.69	1086.5		
3.79	1137.5		
3.89	1196.5		
4.01	1272.8		
4.13	1375.1		
4.25	1494.3		
4.35	1620.8		
4.46	1754.1		
4.56	1895.7		
4.67	2043.9		
4.77	2197.3

Results of the LFI analysis can be seen in Appendix 1. This shows that voltages of approximately 2.8 kV could be induced under worst case conditions. It should be borne in mind that this voltage is somewhat theoretical as it is understood to be based on fault current into zero resistance earthing and the actual fault current to ground at the end of Florina Road is likely to be significantly less. Nevertheless for the purposes of safety it must be assumed that voltages of the order of the calculated value could be present.

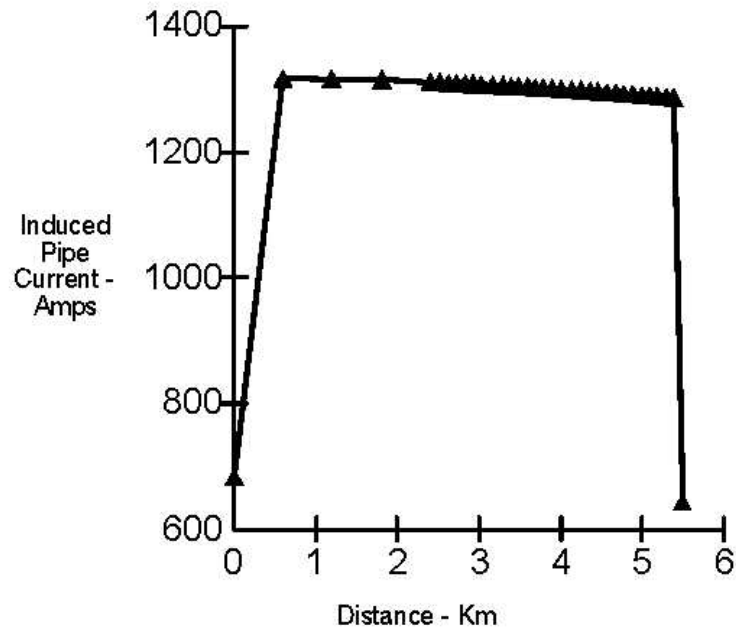
Fault Current  
Graph and Data

Pipe #1		Pipe #1 (cont.)	
Distance	Current	Distance	Current
0.00	683.3	4.88	1291.6
0.60	1316.6	4.98	1290.5
1.20	1316.1	5.09	1289.4
1.80	1314.3	5.19	1288.3
2.40	1310.9	5.29	1287.2
2.51	1310.2	5.39	1286.0
2.62	1309.5	5.49	643.8
2.73	1308.8		
2.83	1308.2		
2.93	1307.5		
3.03	1306.9		
3.16	1306.0		
3.29	1305.1		
3.39	1304.4		
3.49	1303.7		
3.59	1303.0		
3.69	1302.2		
3.79	1301.5		
3.89	1300.7		
4.01	1299.7		
4.13	1298.7		
4.25	1297.6		
4.35	1296.7		
4.46	1295.7		
4.56	1294.7		
4.67	1293.7		
4.77	1292.6

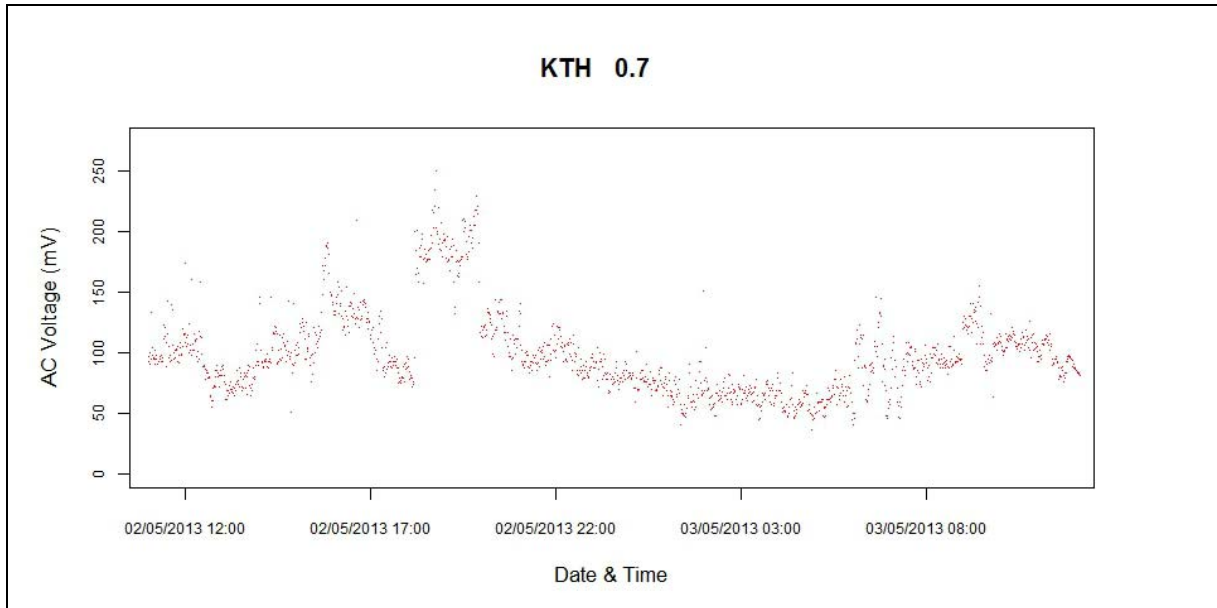
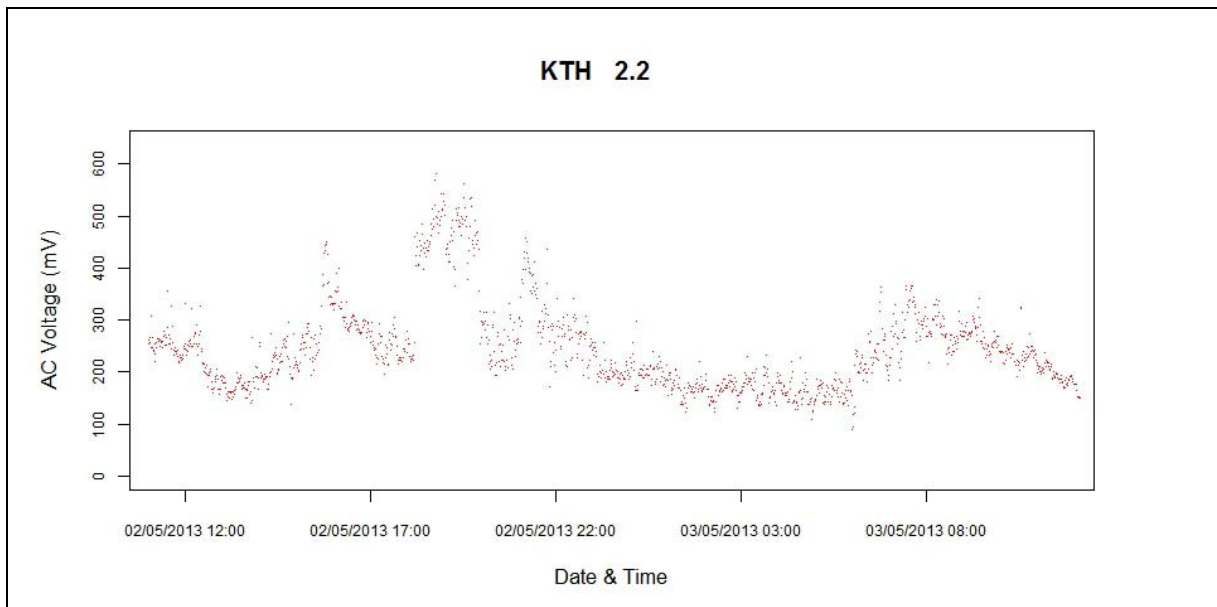
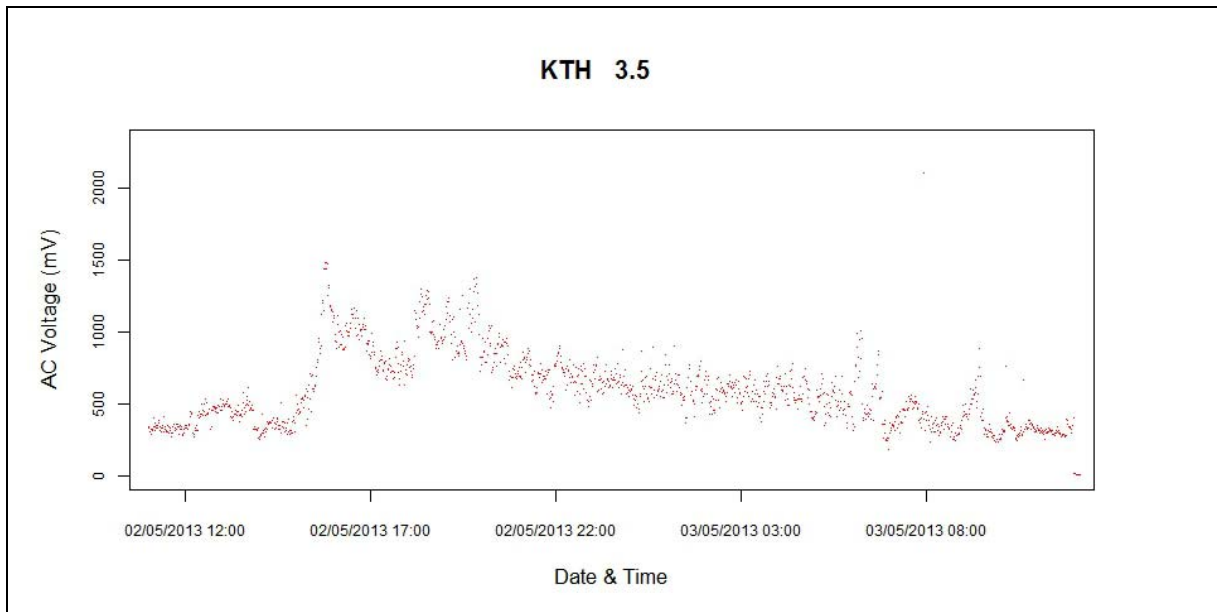
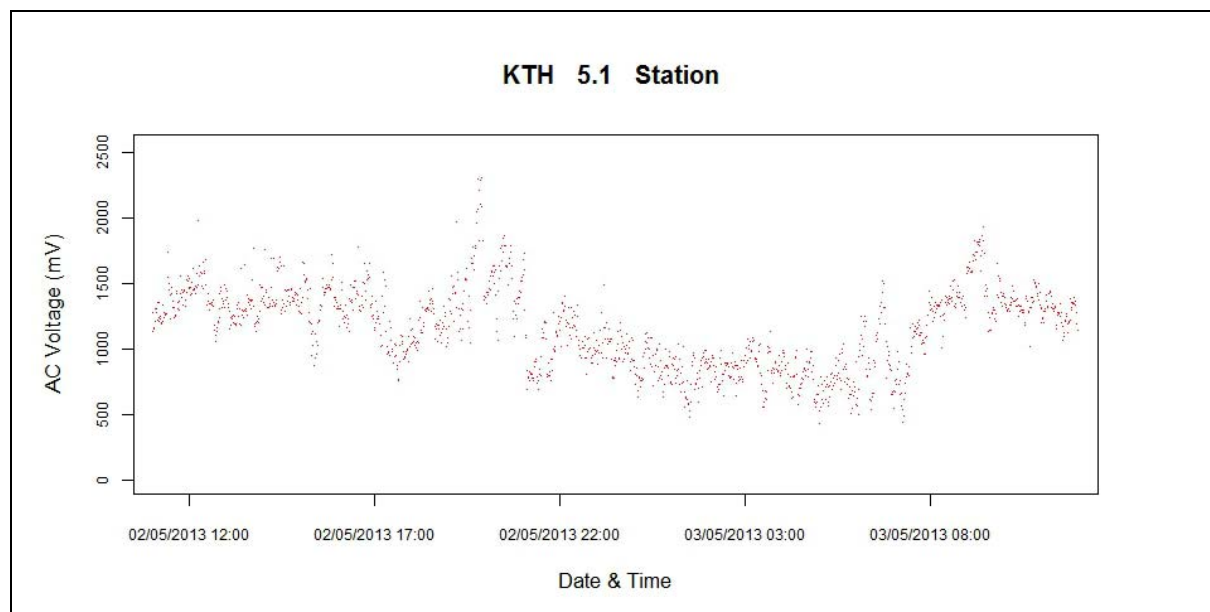
Katherine Lateral Pipeline  
AC Recording Data Logger Charts

Data logger recordings taken along the pipeline commencing from near the AGP follow below. Recordings were taken at KP 0.7, KP 2.2, KP 3.5, KP 4.9 and KP 5.1 as indicated on each chart respectively.

Data logger recordings indicate a maximum steady-state AC voltage of less than 2.5 V. This is within the CIGRE TB 290 currently recommended limits in relation to AC corrosion, hence no mitigation for steady state induction is required for compliance.

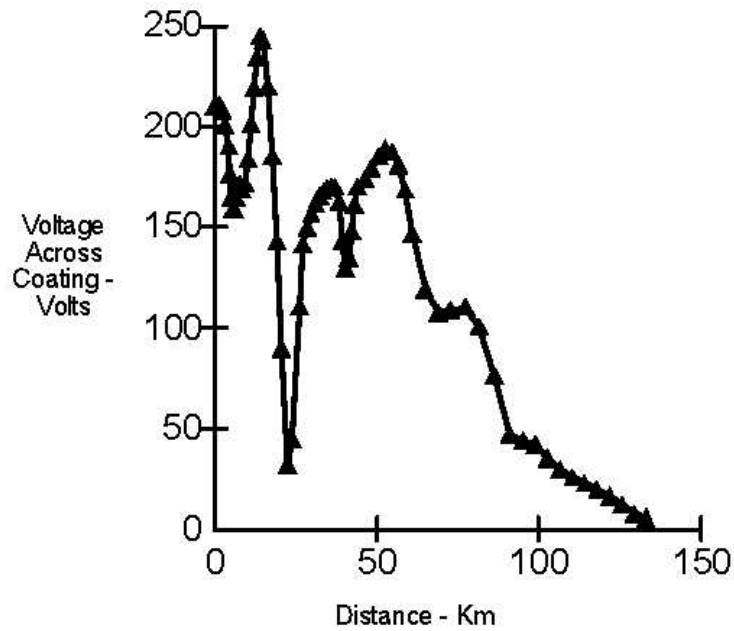
Fault Voltage  
Graph and Data

Pipe #1		Pipe #1 (cont.)		Pipe #1 (cont.)	
Distance	Volts	Distance	Volts	Distance	Volts
0.00	210.3	27.31	141.5	77.14	110.3
1.10	210.9	28.54	149.9	81.66	100.5

2.20	208.4	29.77	156.7	86.18	76.4
3.30	200.4	31.00	161.9	90.70	47.1
4.40	190.2	32.23	165.6	95.22	44.0
4.80	176.5	33.46	168.1	98.98	42.2
5.20	164.9	34.69	169.4	102.74	35.2

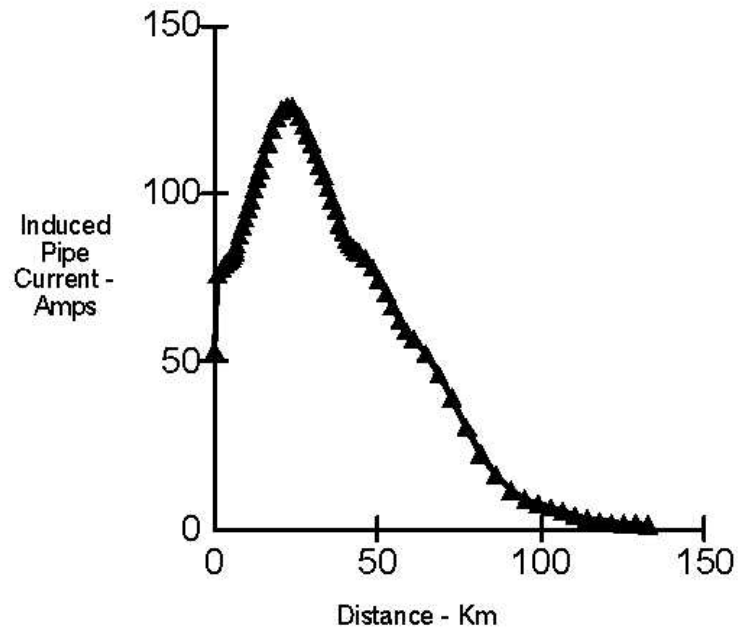
**Fault Current  
Graph and Data**

Pipe #1		Pipe #1 (cont.)		Pipe #1 (cont.)	
Distance	Current	Distance	Current	Distance	Current
0.00	53.3	27.31	120.5	77.14	30.6
1.10	75.8	28.54	117.7	81.66	22.5
2.20	77.5	29.77	114.8	86.18	16.2
3.30	78.9	31.00	111.7	90.70	11.7
4.40	80.0	32.23	108.5	95.22	8.9
4.80	80.5	33.46	105.2	98.98	7.6
5.20	81.0	34.69	101.7	102.74	6.5
5.60	81.8	35.92	98.2	106.50	5.4
6.00	82.6	37.15	94.6	110.26	4.3
6.40	83.6	38.38	91.0	114.02	3.3
6.80	84.8	39.38	88.3	117.78	2.4
7.70	87.5	40.38	86.3	121.54	1.9
8.60	90.1	41.38	84.8	125.30	1.7
9.50	92.7	42.28	83.9	129.06	1.7
10.40	95.4	43.18	83.1	132.82	1.2
11.30	98.1	44.08	82.5		
12.20	101.1	46.18	80.8		
13.10	104.2	48.28	77.9		
13.95	107.2	50.38	74.4		
14.80	110.2	52.48	70.3		
16.23	115.1	54.58	66.2		
17.66	119.1	56.68	62.3		
19.09	122.4	58.78	59.0		
20.72	125.0	60.88	56.6		
22.35	126.2	64.79	52.3		
23.98	125.9	68.71	46.4		
26.08	123.1	72.62	39.3

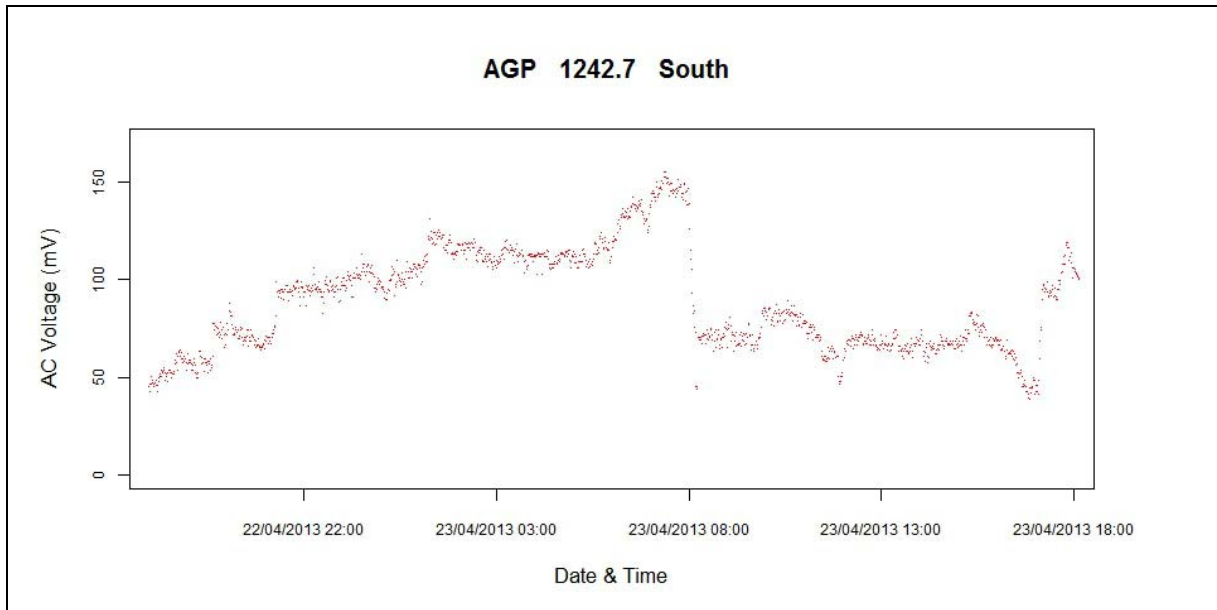
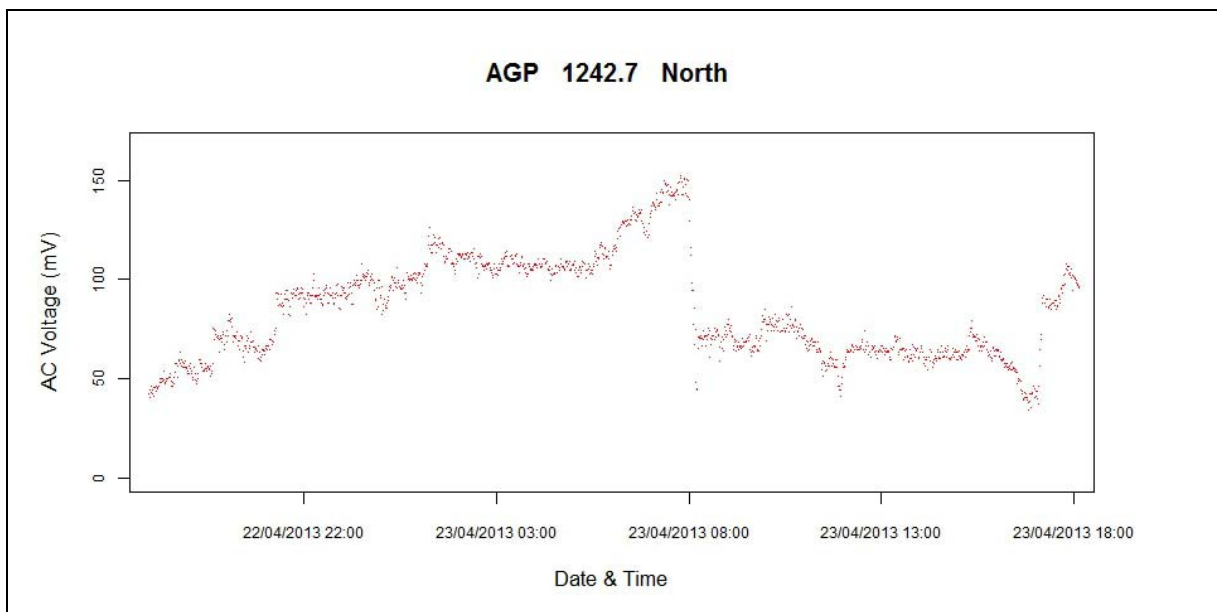
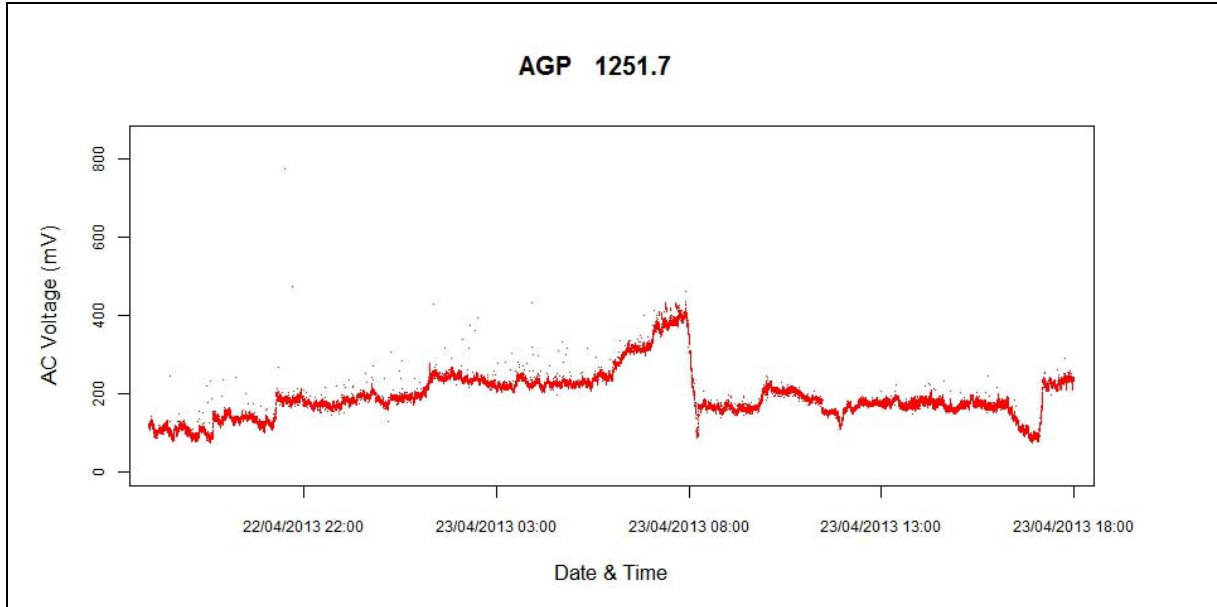
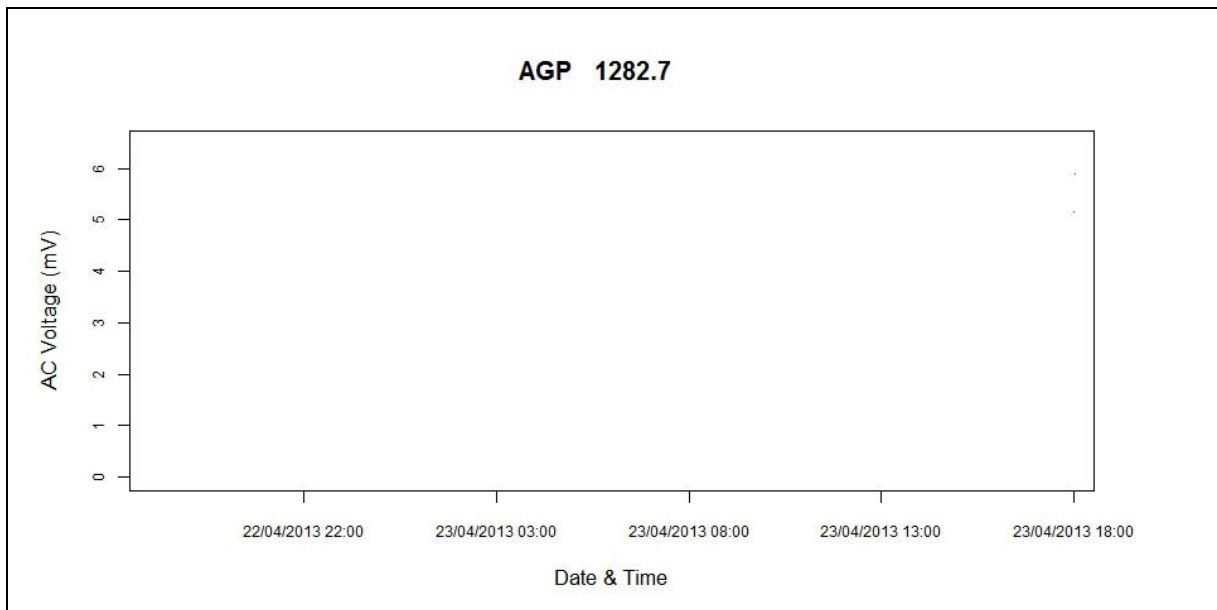
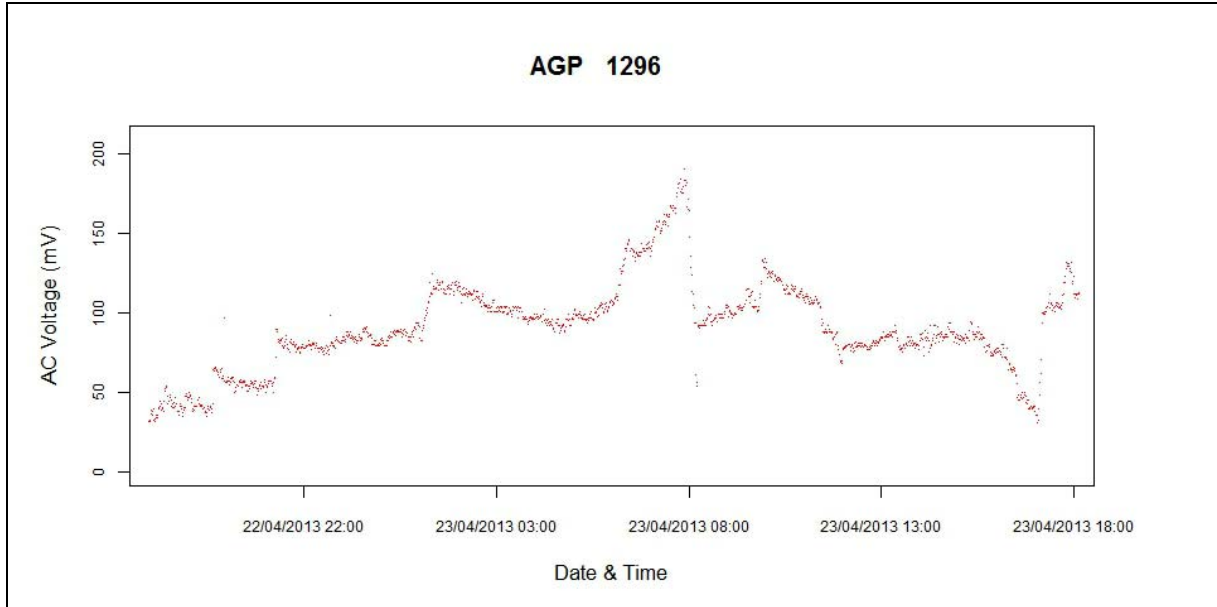
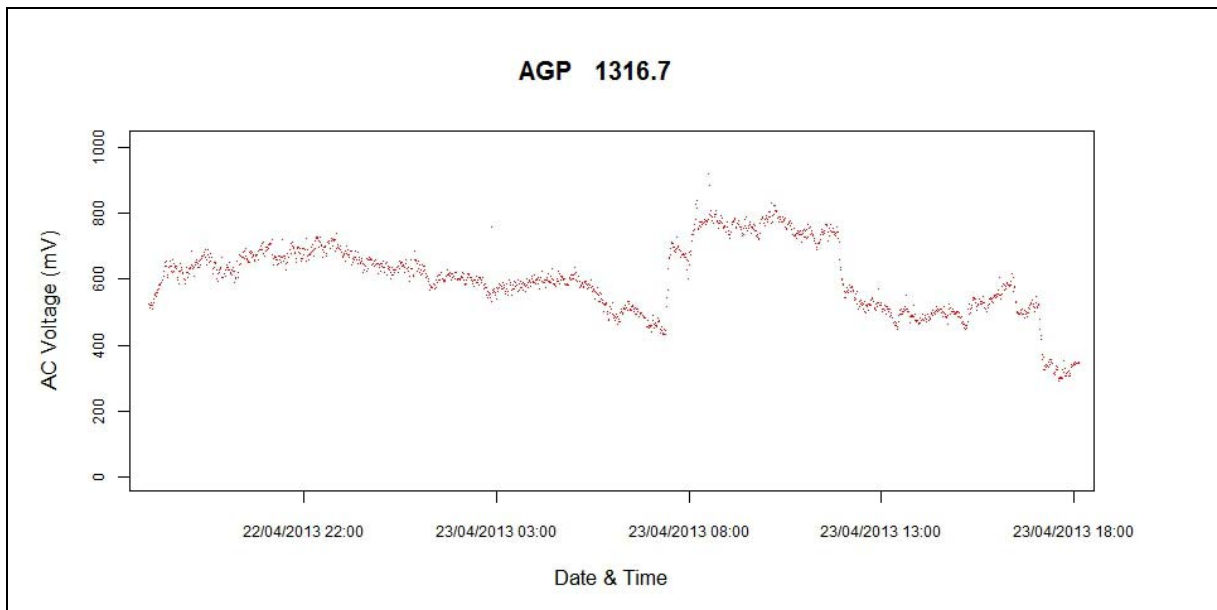
Helling to Ban Ban Springs  
AC Recording Data Logger Charts

Data logger recordings taken along the AGP between Helling and Ban Ban Springs follow below. Recordings were taken at KPs 1242.7 south, 1242.7 north, 1251.7, 1282.7, 1296, 1316.7, 1338.9, 1352.8, 1354.2 and 1374.9 as shown on each chart respectively.

Note: This chart appears to show no data, hence it is likely that an error has occurred in the data logging. As the recordings taken either side of this test point show low levels of AC there would appear to be no need for this recording to be repeated at this time.

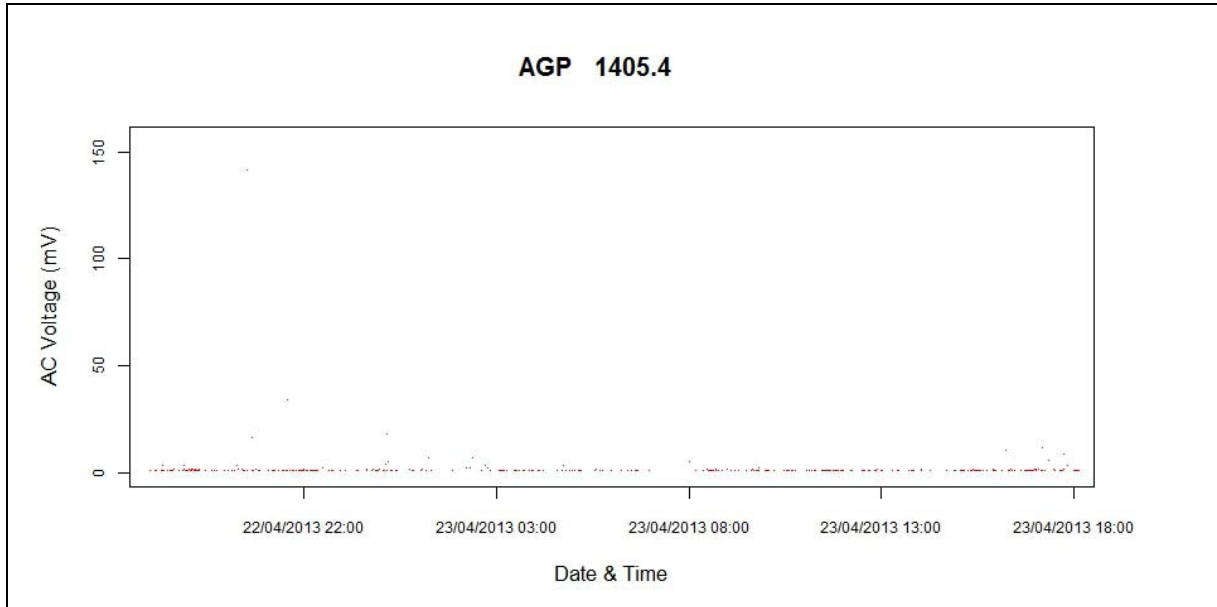
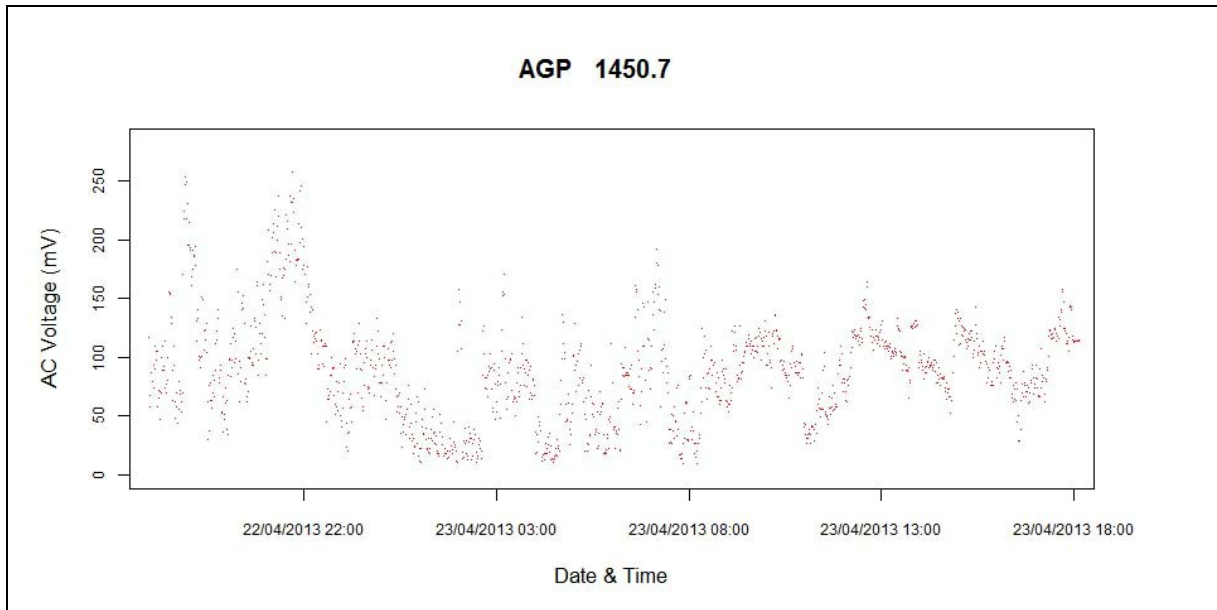
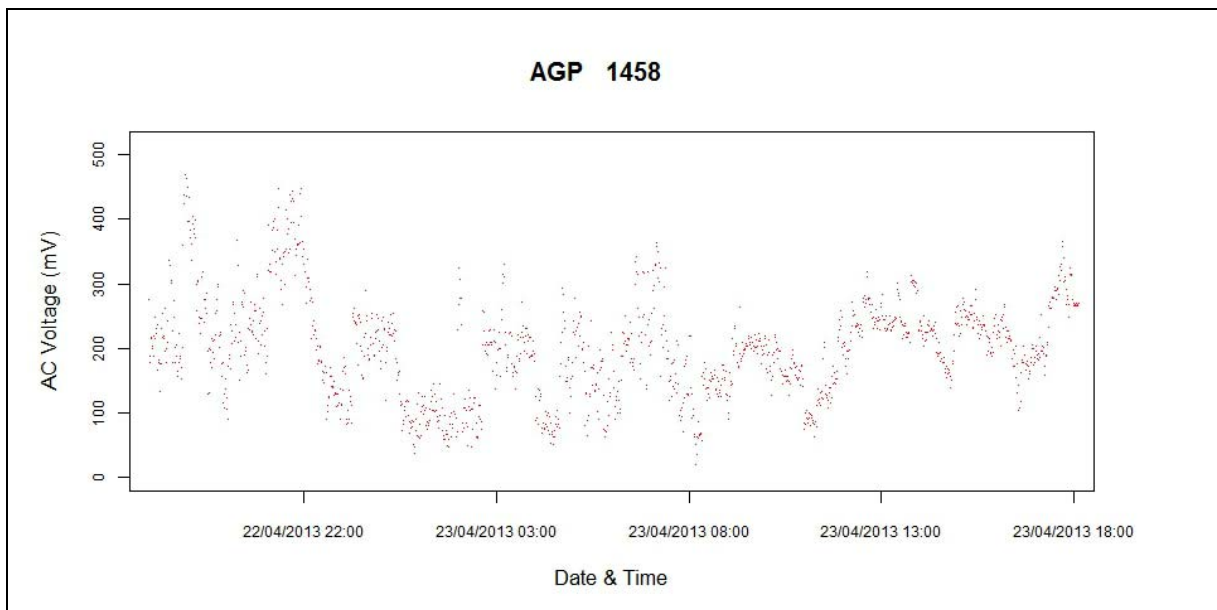
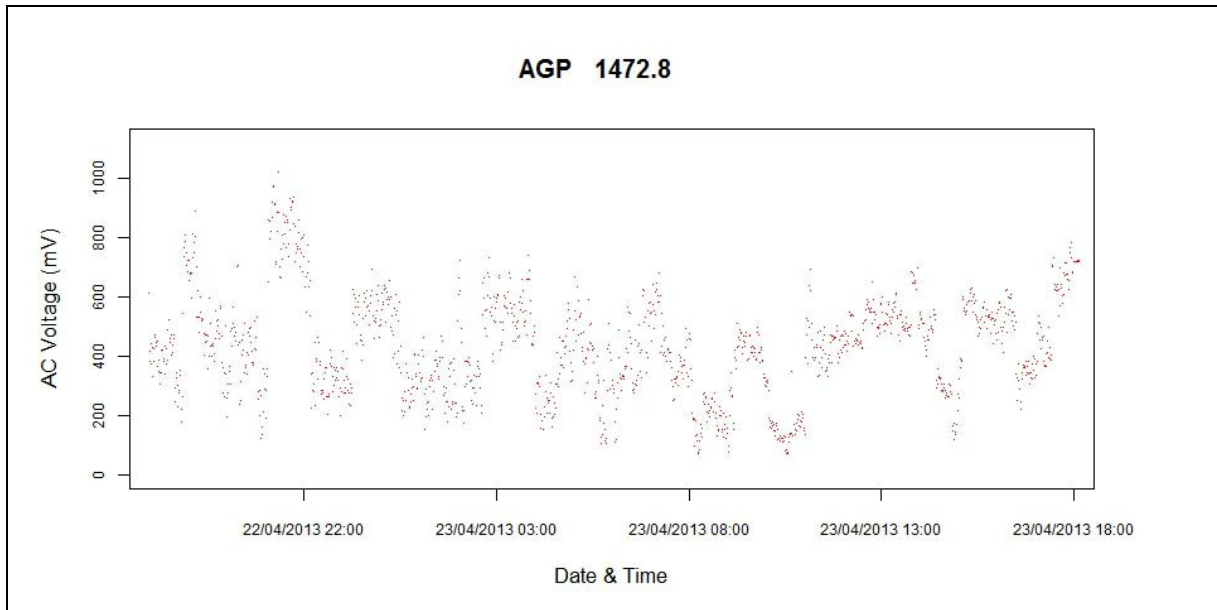
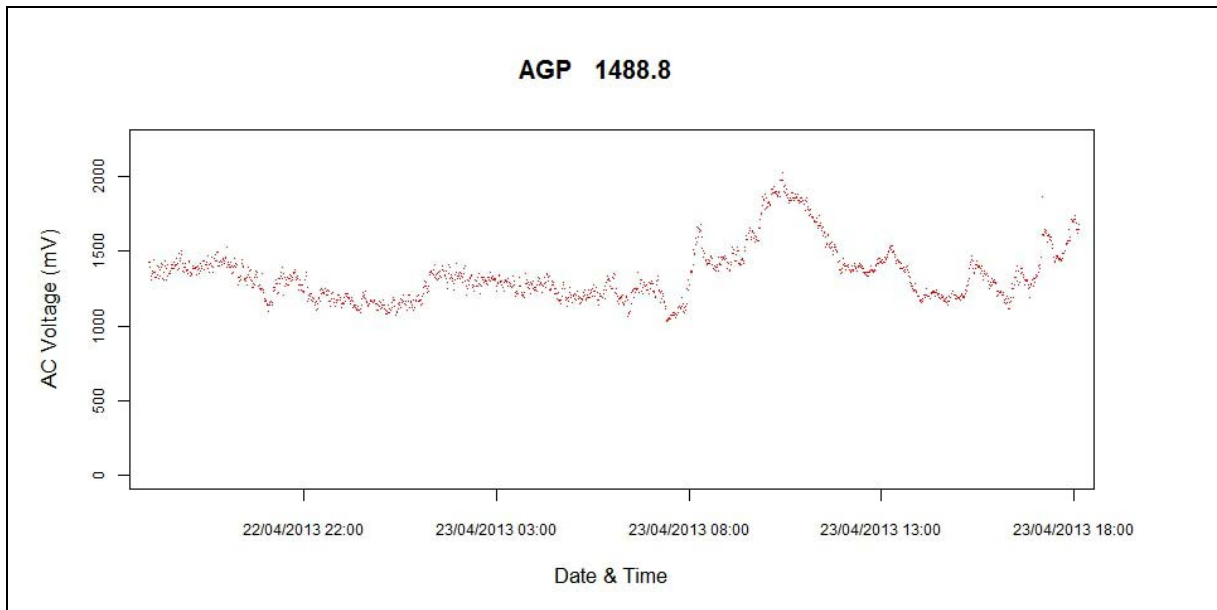
Ban Ban Springs to Darwin City Gate Springs  
AC Recording Data Logger Charts

Data logger recordings taken along the AGP between Ban Ban Springs and Darwin City Gate follow below. Recordings were taken at KPs 1405.4, 1442.4, 1450.7, 1458, 1472.8, 1488.8, 1494.4, 1497.2, as shown on each chart respectively.

Data logger recordings indicate a maximum steady-state AC voltage of less than 2 V. This is within the CIGRE TB 290 currently recommended limits in relation to AC corrosion, hence no mitigation of steady state induced voltages is required for compliance.

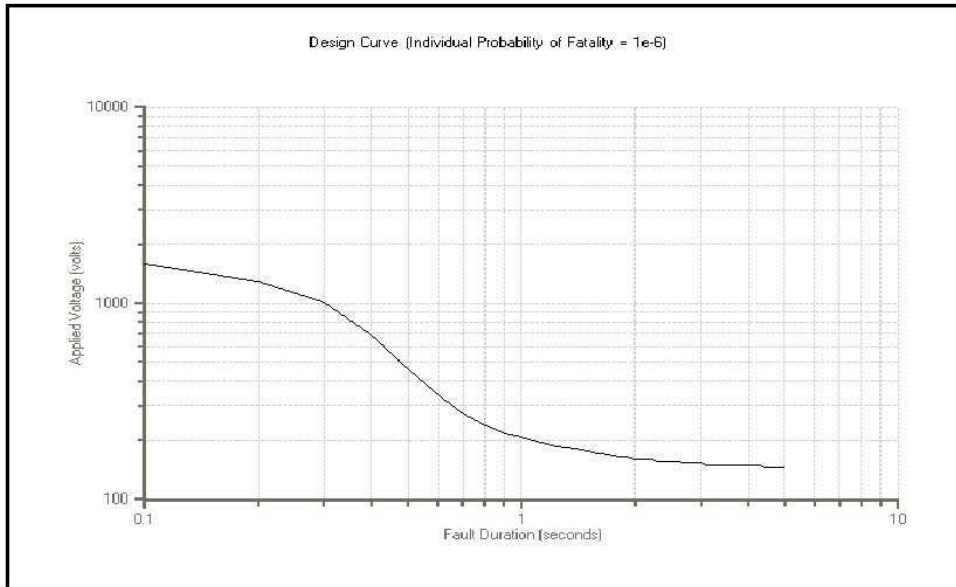
**Individual**

This curve is valid for designs which have contact, fault, and series resistance characteristics similar to those outlined in this report. Fault duration need not remain the same.
