# Preliminary Business Case Townsville Training Facility

This is a preliminary business case describing the need for investment in the Townsville Training Facility and the options to address that need. As a preliminary business case, the document has been developed for the purposes of forecasting the required investment in coordination with the revised revenue proposals to the Australian Energy Regulator (AER). Prior to investment, a Gate 3 business case will be prepared with further detail to be assessed in accordance with the established Energy Queensland investment governance processes.

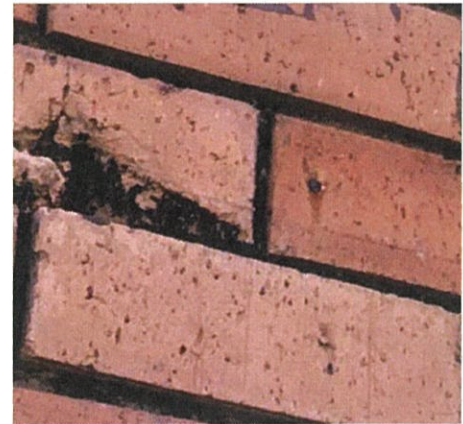
Figure 2: Deteriorated and cracked bricks (external wall)

Annually, approximately 1500 people spend time at the site and 13 staff members are permanently located in the aged building. The main building is an exposed cellular brick wall structure, which includes external brick facades and internal brick wall training room facilities. A typical issue with this type of construction, when aged, is that thin brick cracks occur and mortar joints deteriorate. In the event of heavy rainfall, the classroom walls absorb water through the thin cracks and mould

residues subsequently emerge. Despite frequent mould removal works by professionals, training participants report feeling unwell when spending time in the classrooms over a longer duration.

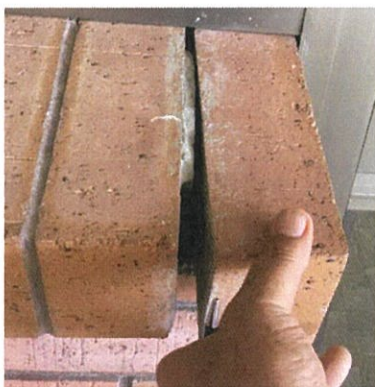
Figure 3: Deteriorated brick wall mortar joints due to age

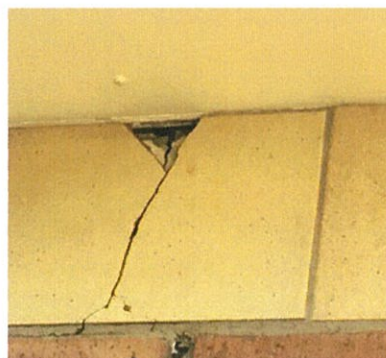
Figure 4: Bond beam reinforcement corrosion, reducing tie down capability. Structurally inadequate for a cyclone area.

A building condition assessment has identified structural issues including expanded cracks in concrete bond beams from corrosion. As such, the structural condition of Building A is inadequate for a building in a cyclone prone location such as Townsville.

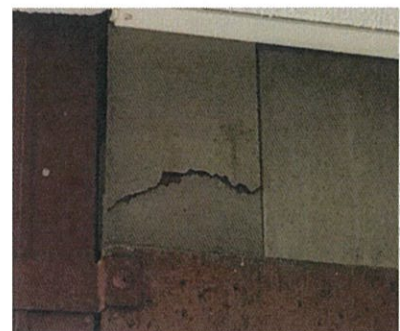
Figure 5: Edge concrete bond beam has expansion cracking from reinforcement corrosion, reducing tie down capability. Structurally inadequate for cyclone area.

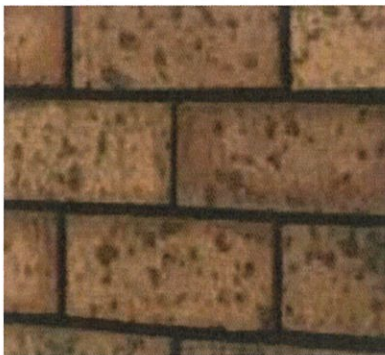
Figure 6: Water absorbing classroom brickwork

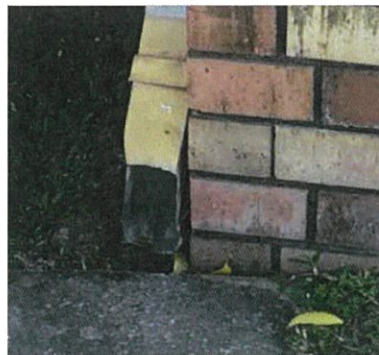
Figure 7: Stormwater downpipe isn't connected to protect footings from movement

Stormwater drainage infrastructure across the property is suboptimal, with downpipes not connected to a drainage system. Water captured through the stormwater downpipes is discharged onto the ground. This is a common infrastructure for low flows of water and was appropriate when the building was structurally sound. With the building now aged and deteriorated, internal walls frequently absorb water after heavy rainfall due to thin cracks in cellular bricks. The inadequacy of stormwater infrastructure has, over the last decades, deteriorated the property. Related issues include footings damage, movement in brickwork, movement in foundations and external tiled pathway movement away from the wall (tiled walkway adjoins the building wall) due to excessive moisture from stormwater.

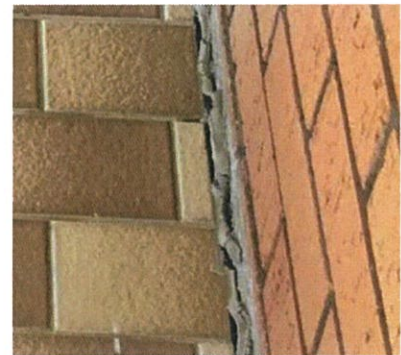
Figure 8: External paths moving away from wall due to excessive moisture

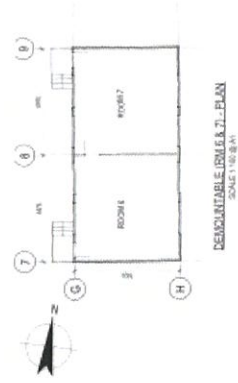
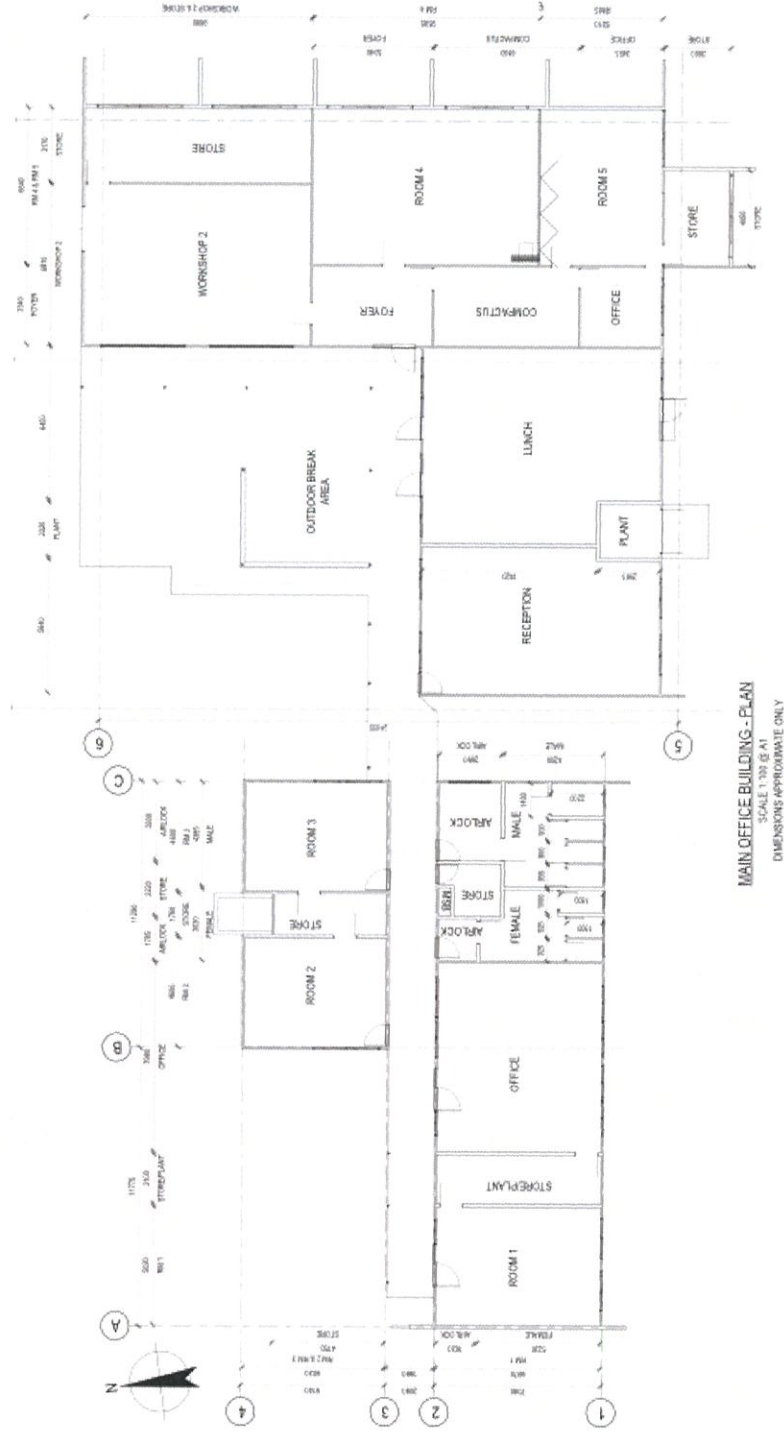
## Appendix D. Townsville Training Building Plan

Depicted below is the layout and size of the different training facilities at Townsville, which was designed and constructed to meet training needs in 1984.
