# Hillston Feeder Reinforcement Review

Bradley Trethewey

Essential Energy

5 June 2014

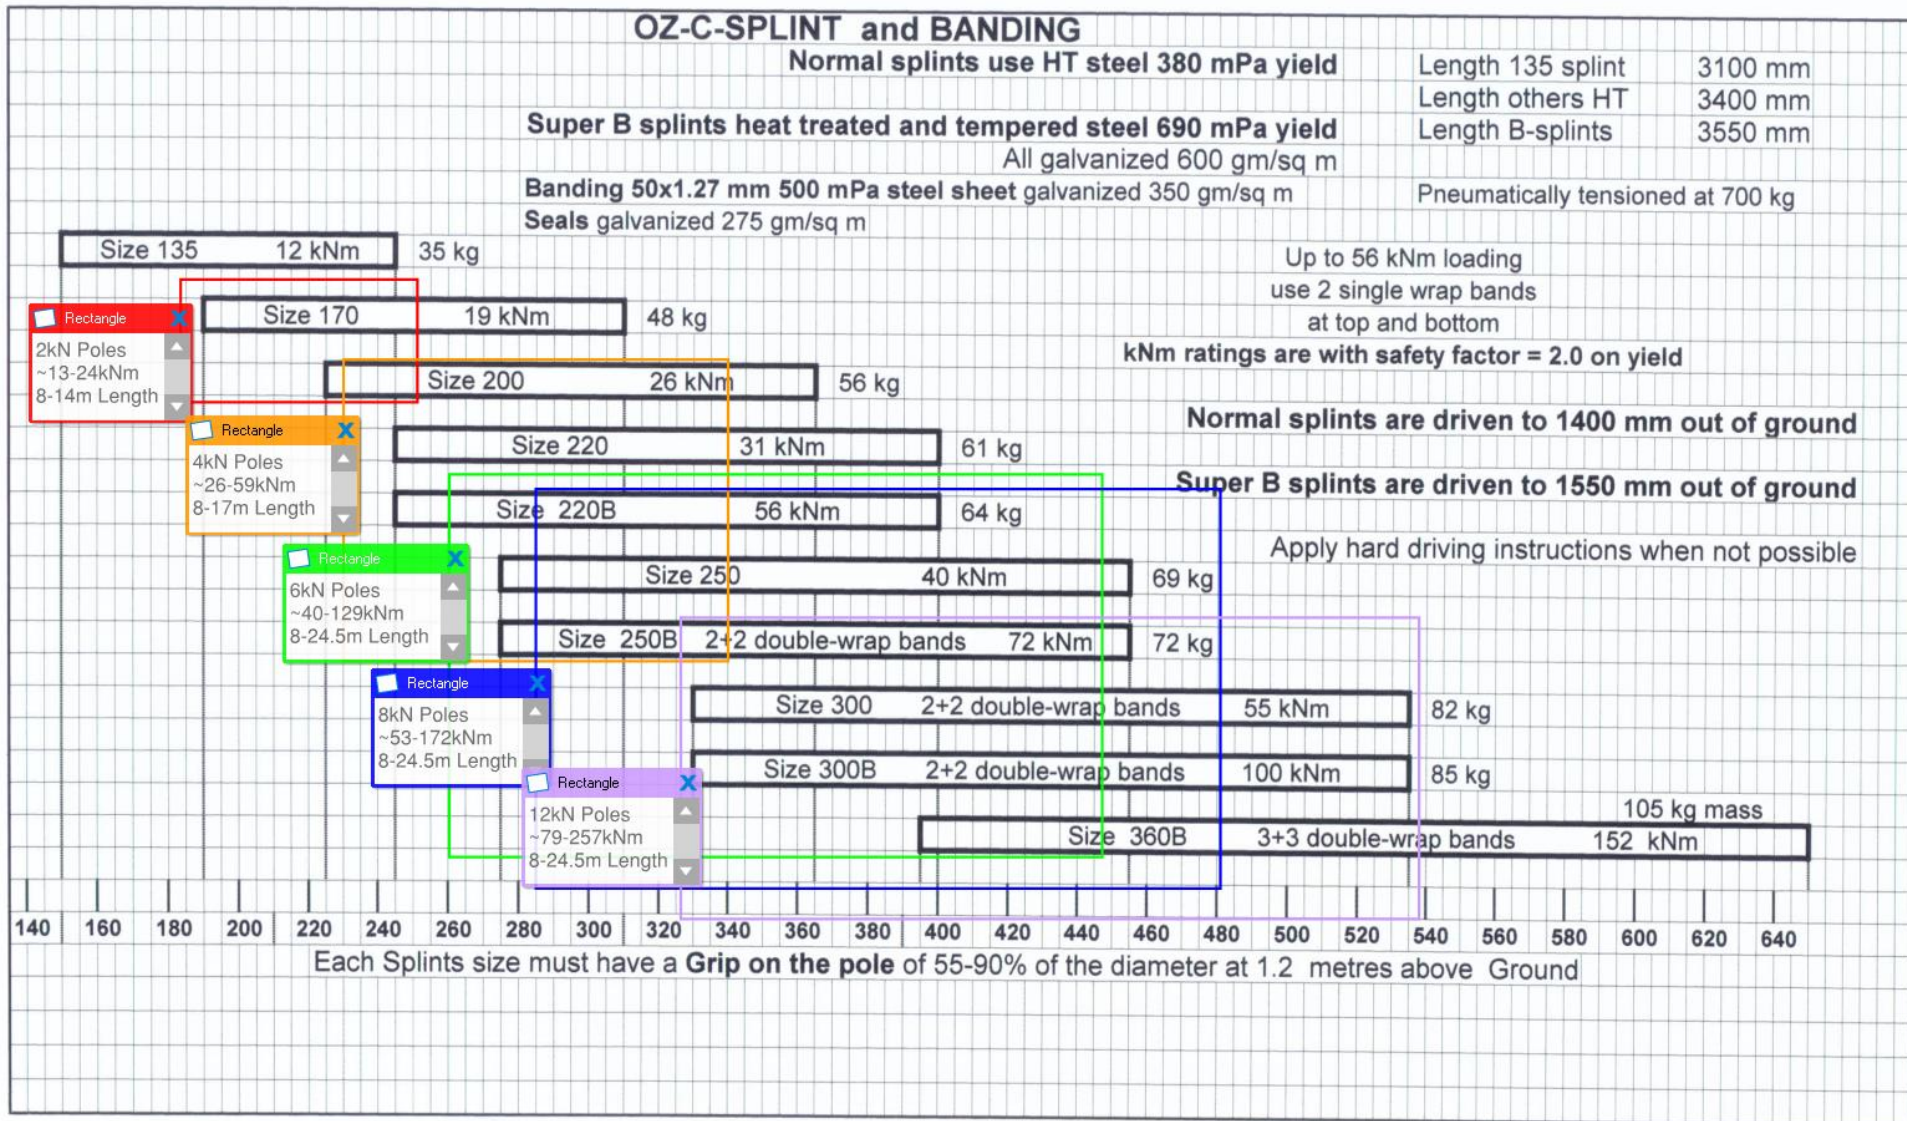
Figure 2: OZ-C-Splint published capacities with pole size and capacity ranges overlain.

- When comparing the unfactored capacity in the strong direction from the calculations in Appendix C to the nominated capacities (see Table 2), the nominated capacities are well above the calculated member capacities, and the section capacities in some cases. Upon discussion with the supplier, this is due to the original calculations being based on the plastic section capacity, rather than the elastic member capacity. Based on our experience, once a plastic section failure occurs, the pole will fall to the ground under its own weight, unless the conductors hold it up, which is unlikely to occur for long rural spans. In our experience, the elastic member capacity is much more appropriate and predicts the strength much closer than the plastic section capacity, and in some cases can over-predict strength by small amounts depending on the geometry of the splint/timber arrangement.

- 3 The literature provided appears to assume that the C-Splints are always installed so that the strong axis is always aligned with the axis of the critical load. However, there is no mention of this as being a requirement in any of the documentation we came across. This is a cause for significant concern if the installers are not aware of this requirement, because they are likely to install it in other orientations to avoid other attachments and clearance issues without knowing the effect this will have on the rated capacity. The weak axis capacities (the minimum rating for the two directions shown in Figure 3) are significantly below (approximately 33%–50%) the strong axis member capacities, which are already below the published capacities. This becomes critical, because a linear relationship between orientation and strength will give a 7% reduction in capacity with just a 10° misalignment with the load direction. A 30° misalignment will give a 22% strength reduction.

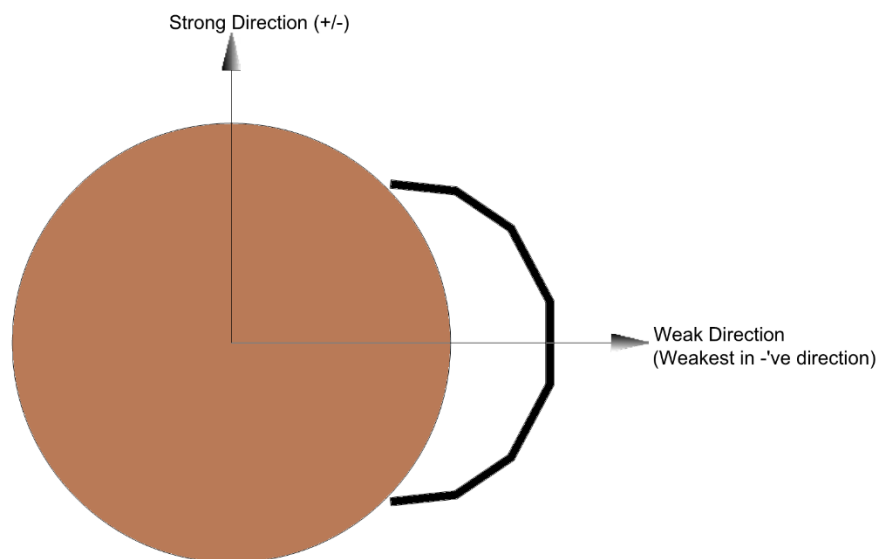
Figure 3: Reinforcement orientation.

- 3 Due to the significant difference between the capacity of the reinforcement in the weak and strong directions, there is a risk that even if the reinforcement is sized appropriately for the load

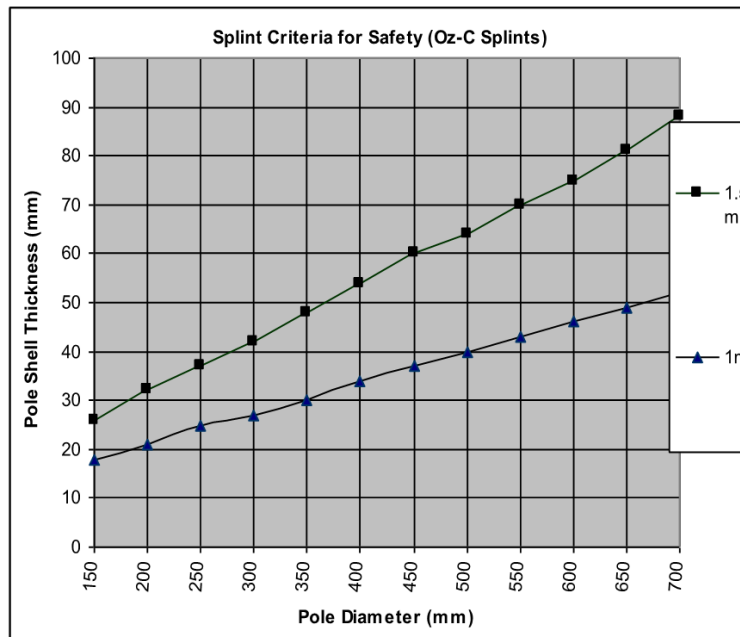
Figure 4: Minimum wall thickness criteria at the top of the splint for C-Splint reinforcement.

The strength of a reinforced pole not only relies on the capacity of the reinforcement at the ground line, it also relies on the strength of the timber at the top of the reinforcement. At the top of the reinforcement the timber needs to have a minimum strength so that the pole can transfer the load into the reinforcement, and so the pole does not fail prematurely above the reinforcement. Figure 4 shows the C-Splint criteria for timber wall thickness towards the top of the reinforcement.

It is assumed that the diameters in Figure 4 are the diameter at the point of wall thickness measurement. After doing some basic checks on the numbers in Figure 4, it is apparent that at 1m above ground line the pole is allowed to be reinforced with a timber FOS of 2.6 for a 150mm diameter pole, down to 1.9 for a 650mm diameter pole. This is based on loss of section and not fibre strength, and the assumption of a FOS = 4 to begin with.

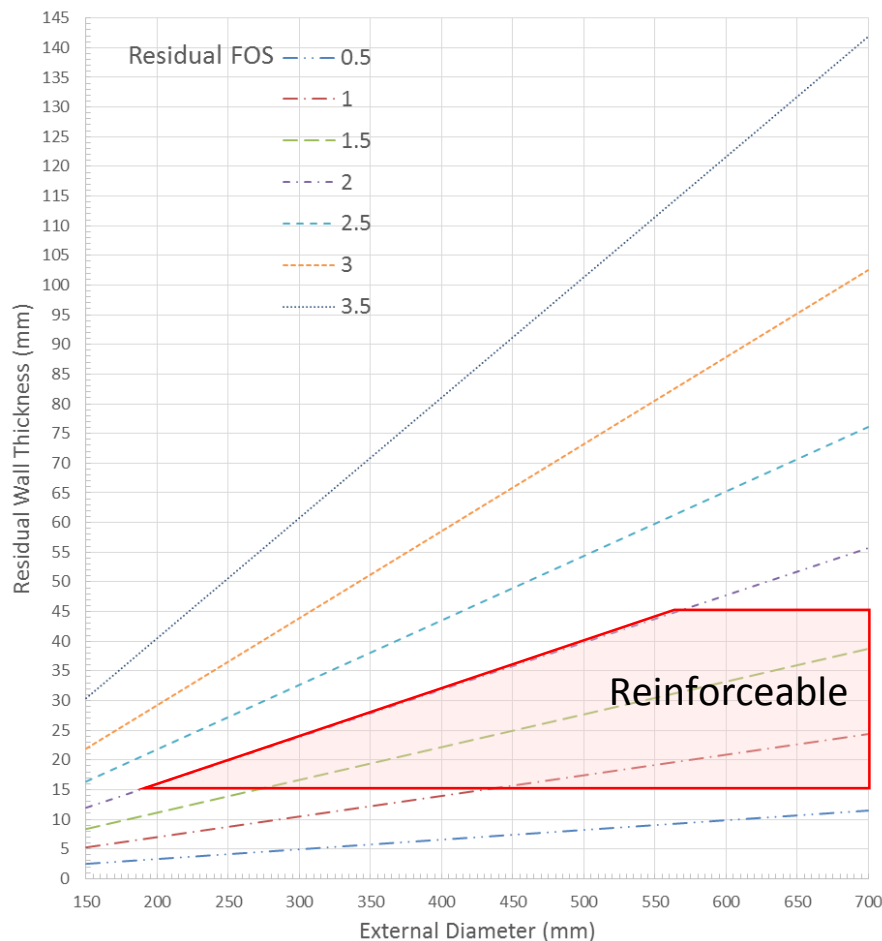
Figure 5: Residual factor of safety for a range of original diameter and wall thickness combinations. Red box outlines the ground line dimensions of poles that can be reinforced (does not consider capacity requirements).

Figure 5 shows a representation of the relationship between external diameter, wall thickness, and residual FOS for the pole (based on a FOS = 4 for the new pole). Using the Essential Energy reinforcement and replacement inspection criteria, the shaded red box outlines the situations in which a pole may be reinforceable. Note that using a wall thickness for replacement of 30mm will not see the FOS for the pole drop below 2 for poles less than 370mm diameter. If the pole isn't fully utilised strength-wise when new, this will be even worse. This explains why Essential Energy poles are rarely earmarked for reinforcement and are replaced instead.

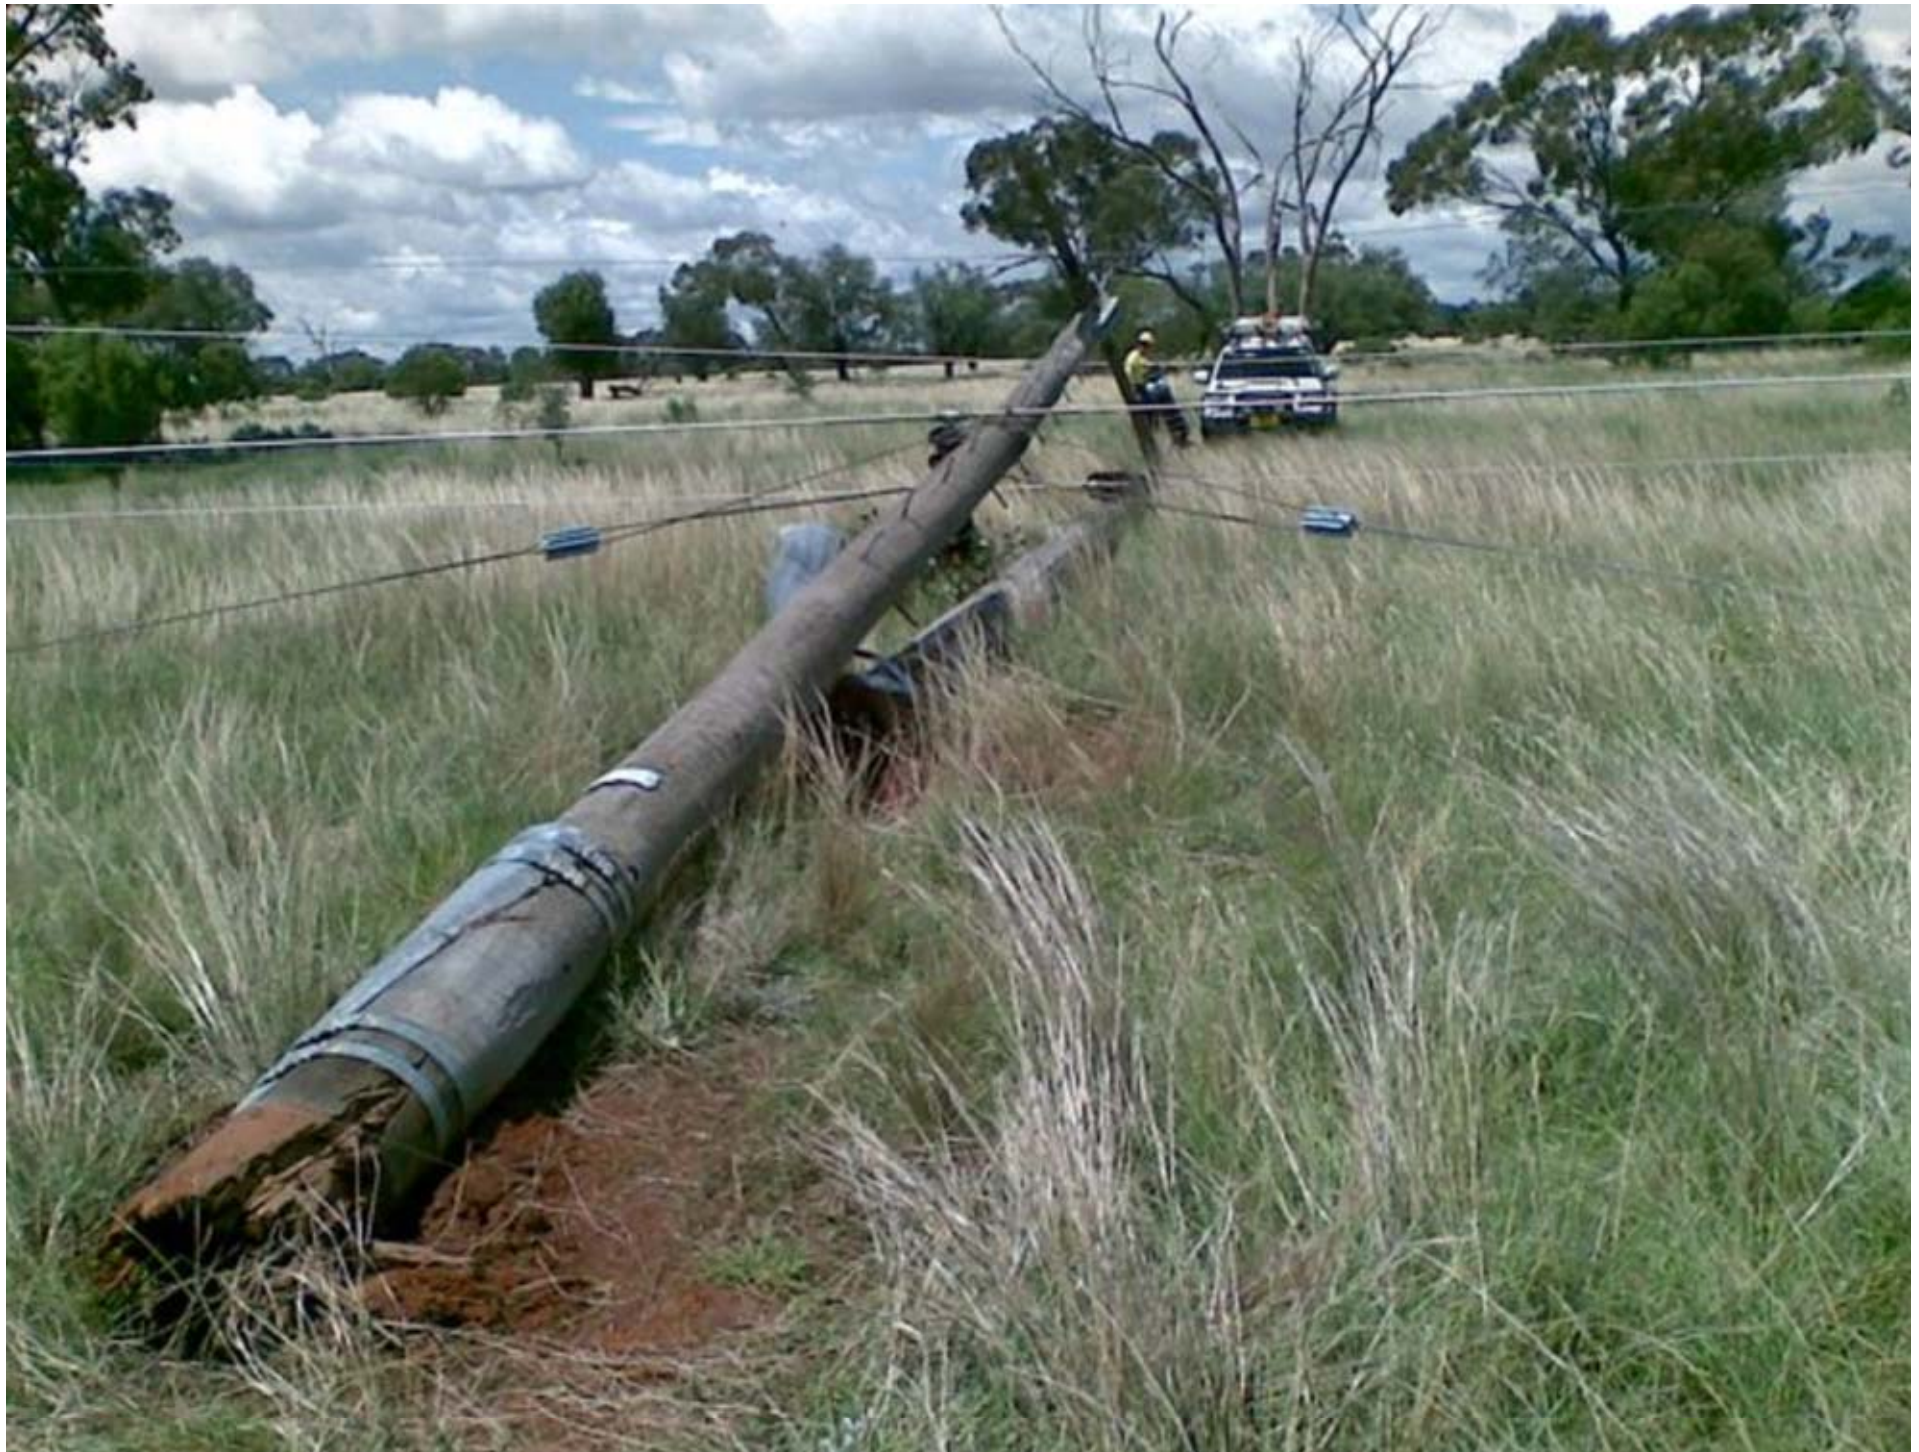
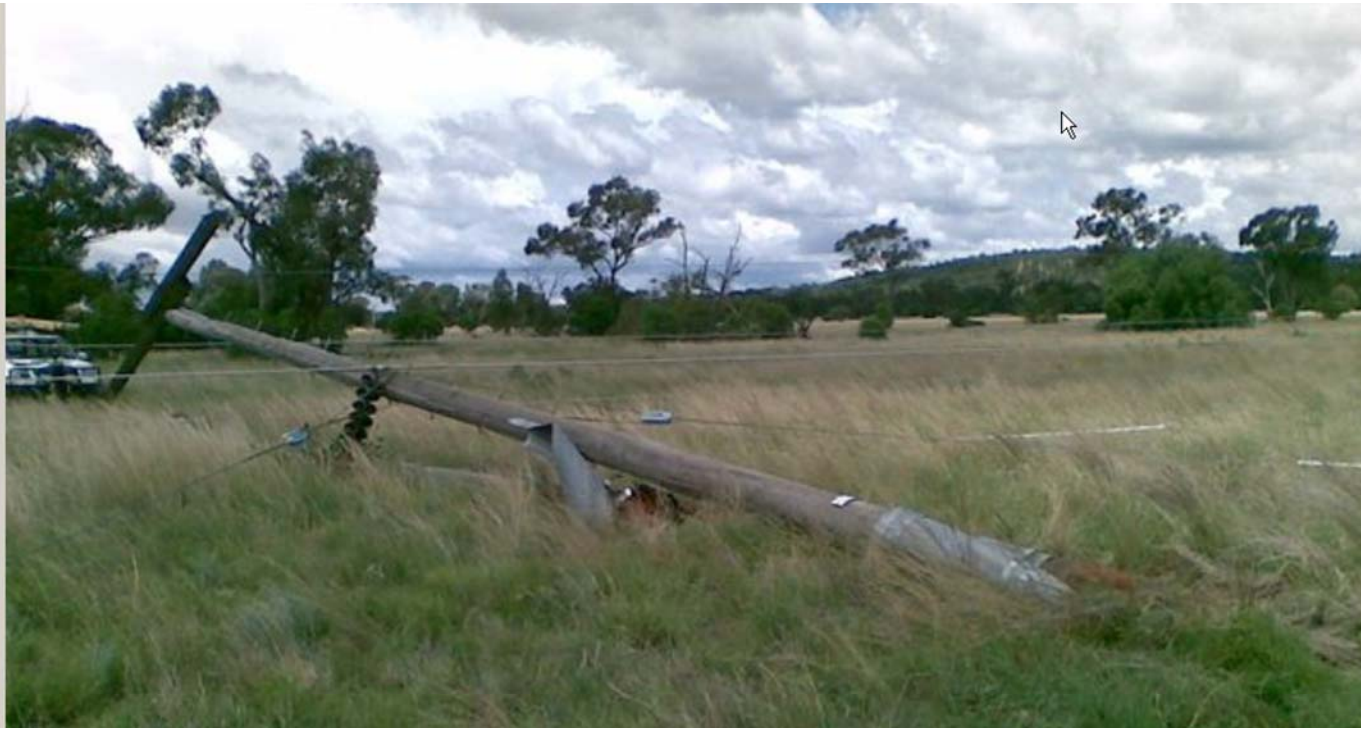
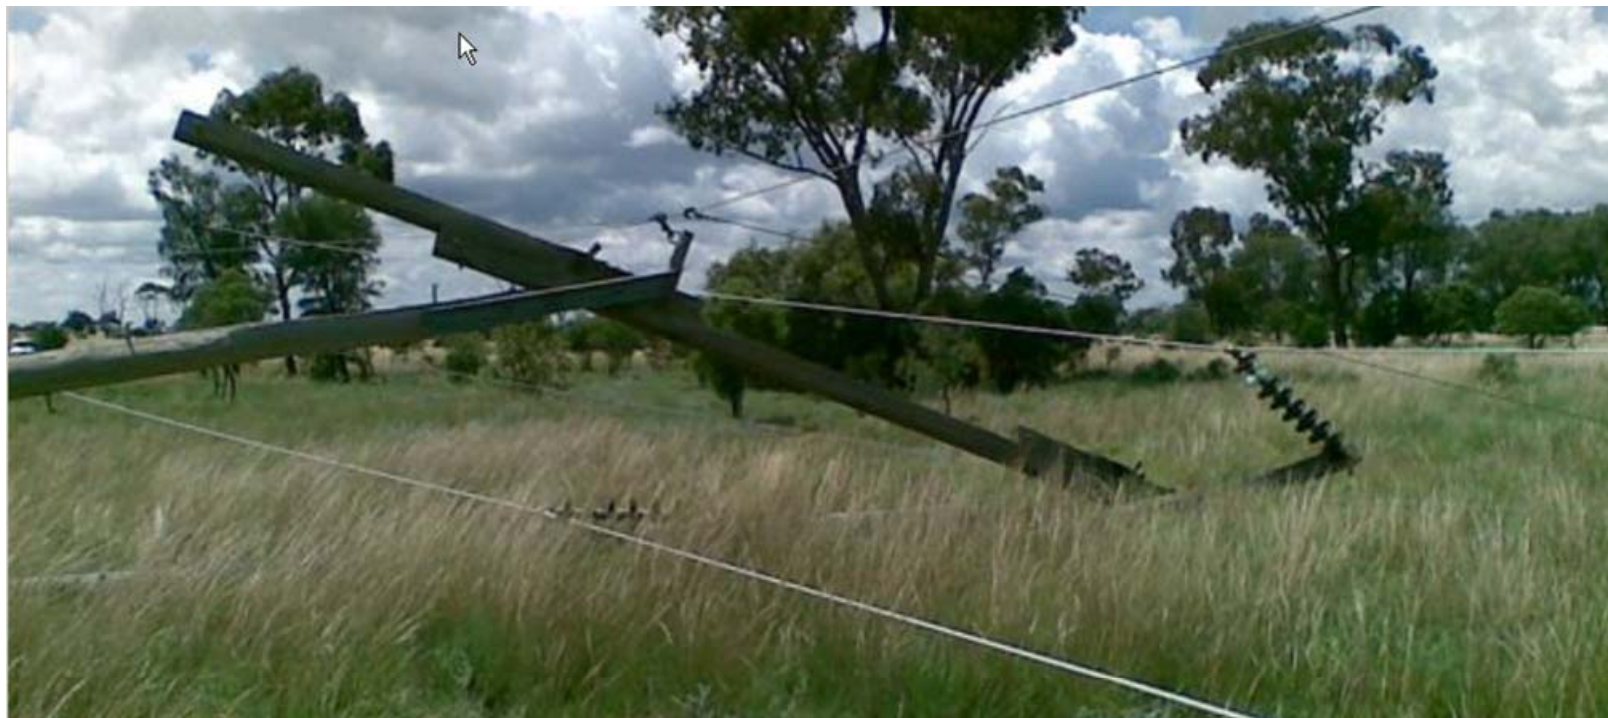
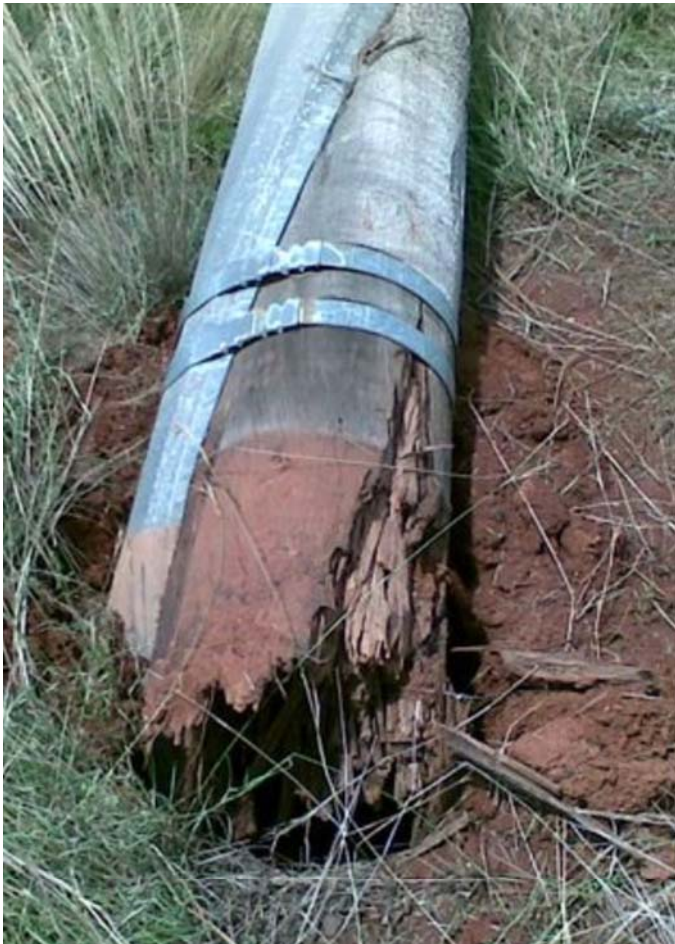
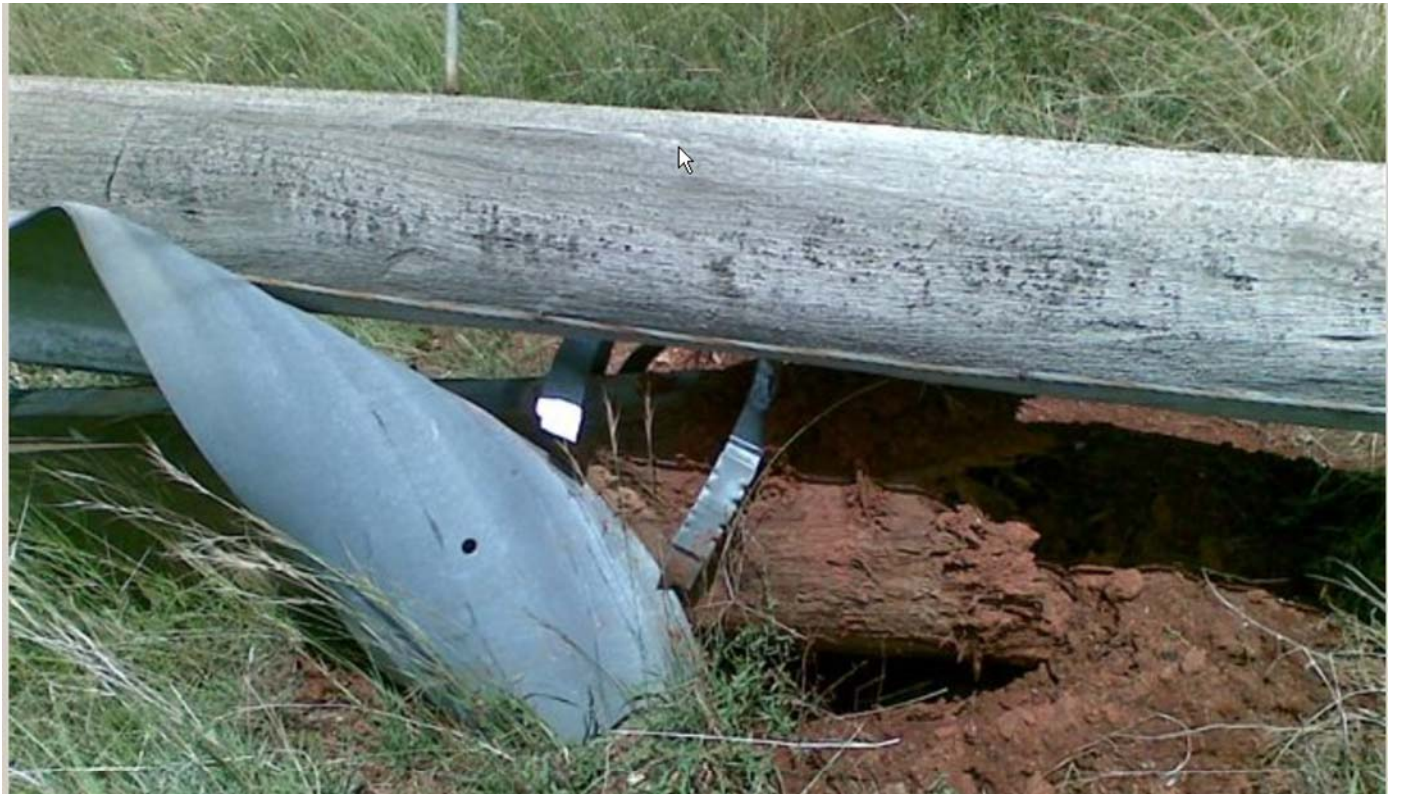
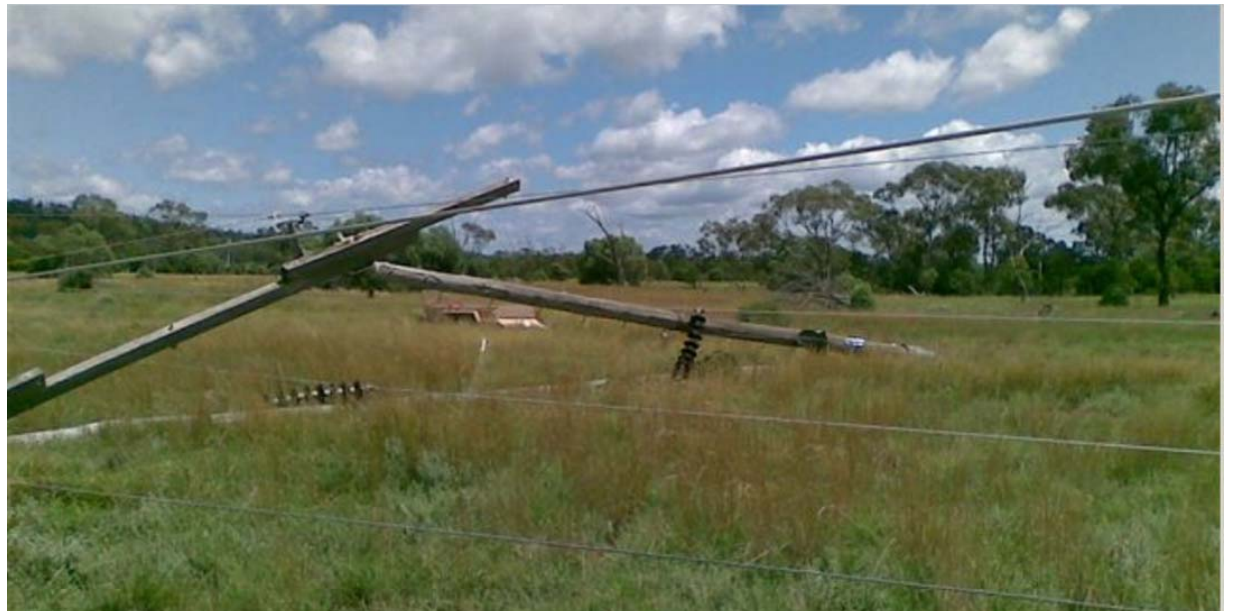
**APPENDIX C      NYNGAN – COBAR REINFORCEMENT FAILURE REPORT**

132kV Pole Failure  
Nyngan to Cobar  
Pre autopsy Details

All 4 straps were broken

C Splint - 300 61kNM– de-rated to 55kNM  
Date of installation August 2006 (8-6)  
Bent, twisted and deformed upon failure?

4 x double wrapped  
All 4 bands failed
