Asset Condition & Planning Summary

ACAPS4030 Low Voltage Underground CONSAC Cables (km)

March 2014

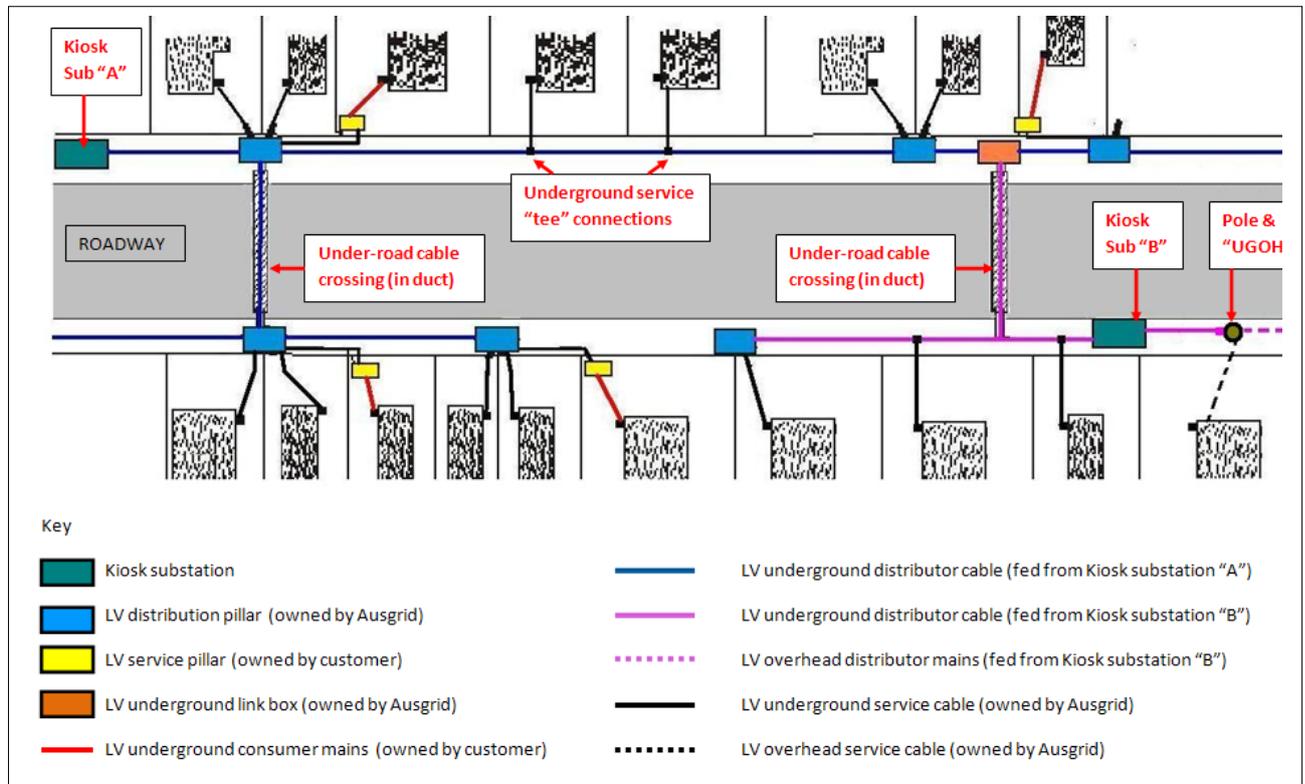
Figure 2 – Design of a typical LV underground distribution circuit with CONSAC cable

Figure 2 shows how LV underground cables move electricity from distribution substations via distributor cables to the point of supply for residential/business customers. They are located in areas where the electricity reticulation is primarily underground, or where they provide the connection between the underground distributor cables supplied from a distribution substation to an overhead network. LV underground cables also supply street lighting.

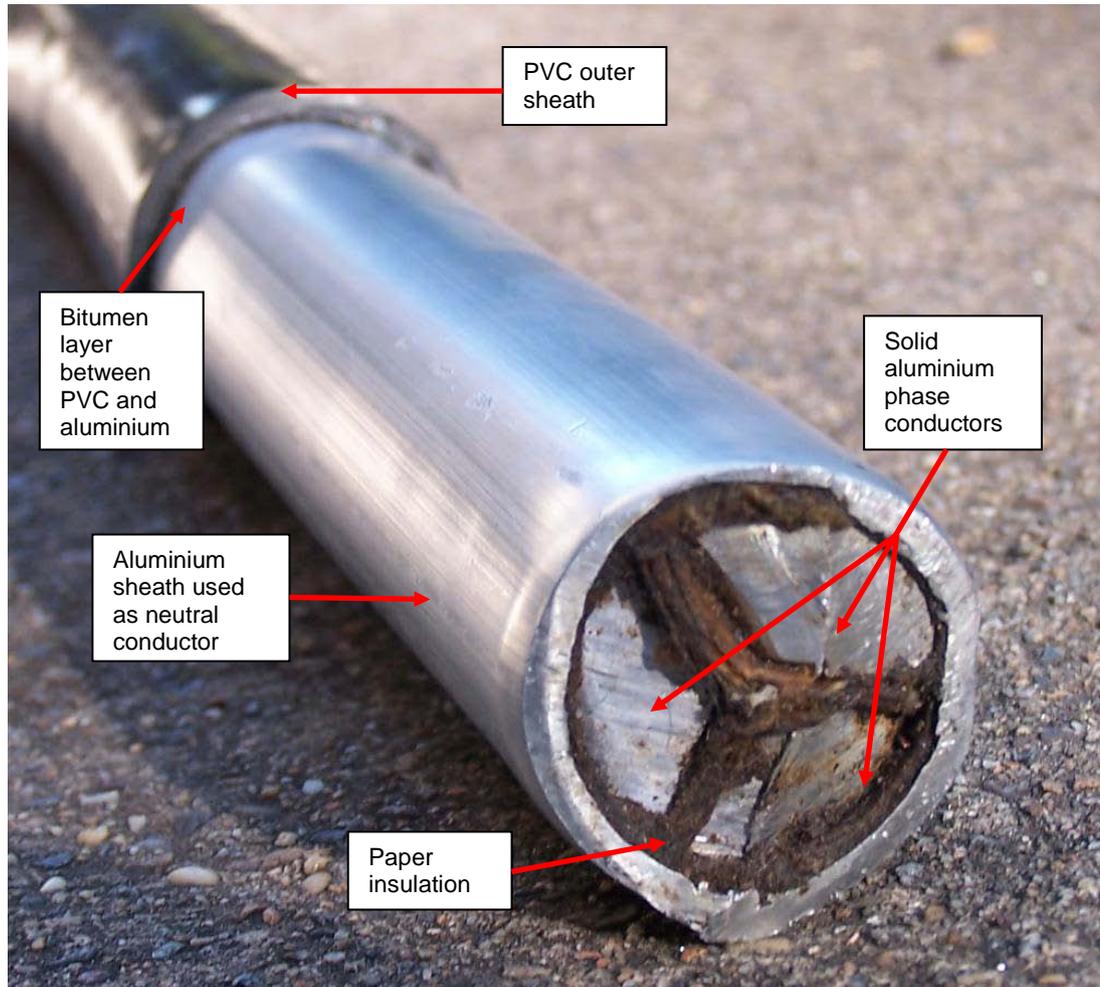
Figure 3 – A section of CONSAC cable showing its components and design

CONSAC cable used the concentric aluminium sheath as the neutral current return path, which allowed the cable design to be changed so it only required three conductors in the cable (one per phase) instead of four conductors (three phase conductors and a neutral conductor). In most cases, CONSAC cable used solid aluminium phase conductors instead of stranded cable. Figure 3 shows a section of CONSAC cable and the components included in its design.

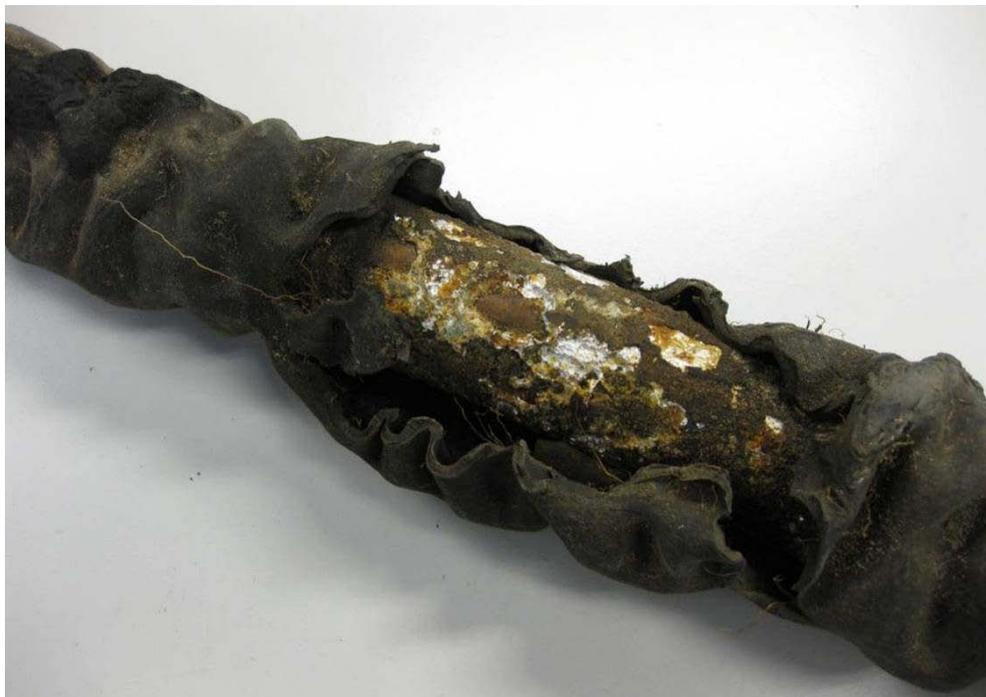
Figure 5 – A section of CONSAC showing corroded aluminium sheath

- Galvanic corrosion of the aluminium sheath as shown in Figure 5, and moisture ingress through PVC sheath damage or joints/terminations.

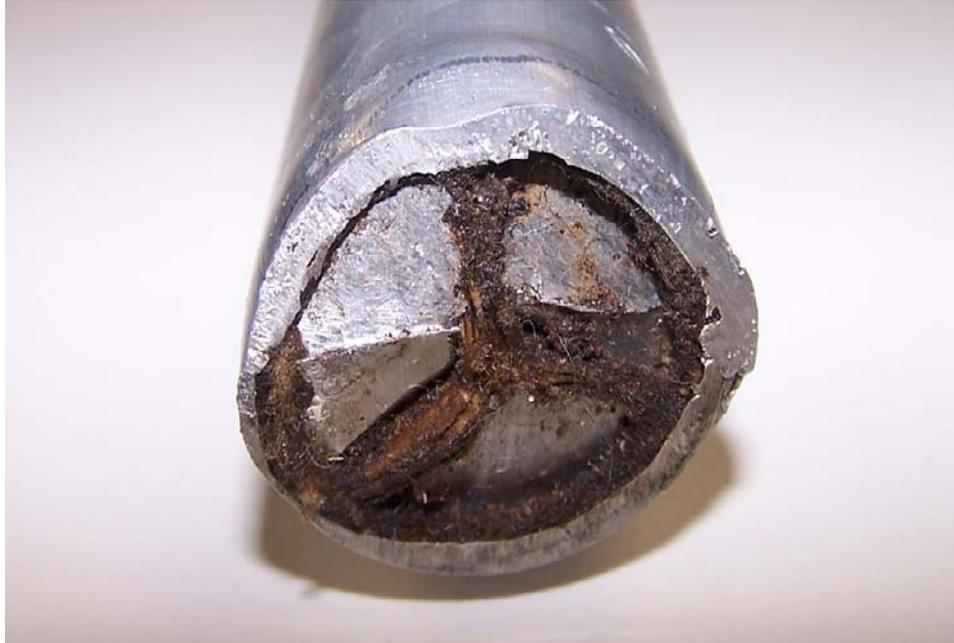
Figure 6 – A section of CONSAC showing deteriorated paper insulation (caused by moisture ingress)

- Reduced insulation resistance of the insulating paper (Figures 6 and 7) caused by moisture ingress through damage/corrosion of the aluminium sheath or joint, circuit overloading or mechanical fatigue (during jointing).

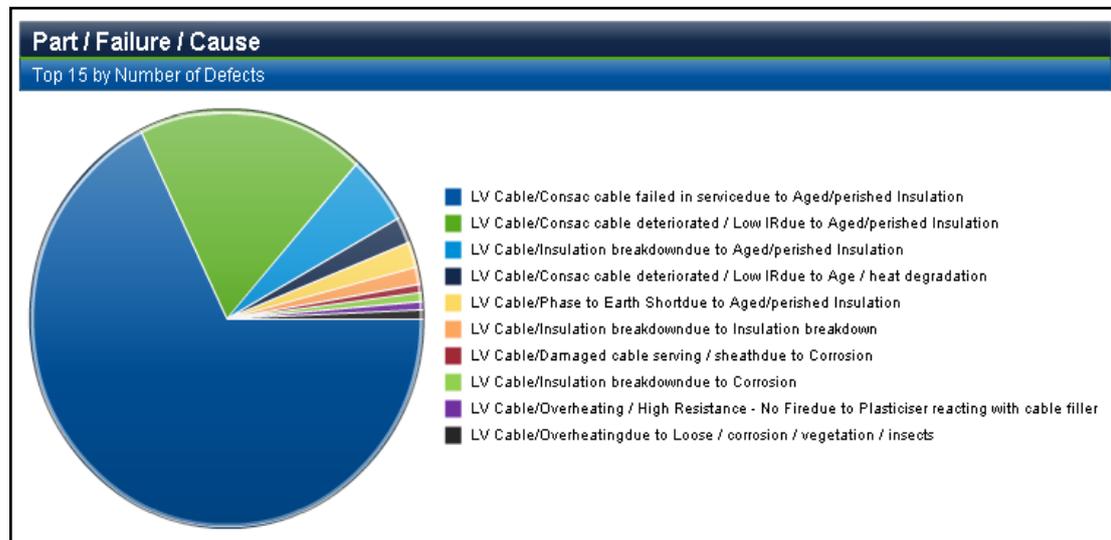
Figure 8 – CONSAC Part/failure/cause comparison

The failure outcomes of CONSAC cable condition issues are summarised in Table 7 below. The part/failure/cause information for CONSAC cables (drawn from notifications raised in SAP for CONSAC work) is shown in Figure 8.

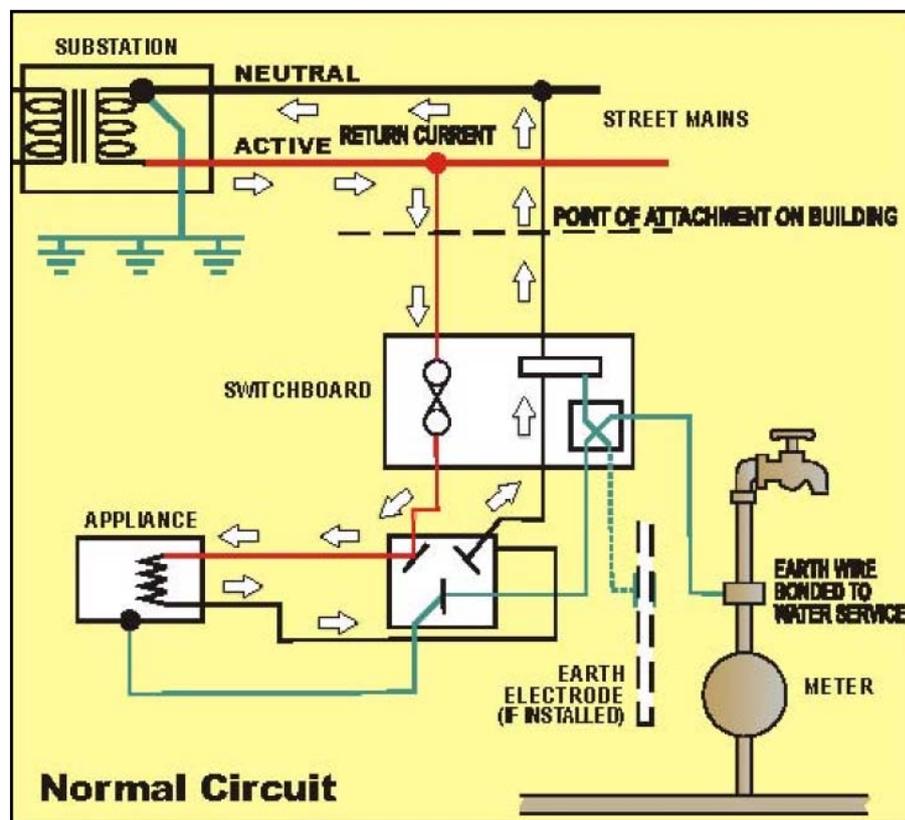
Figure 9 – Neutral current flow with neutral current return path in good condition

A distribution network is a balanced system in which all the phase current that leaves a source of supply (for example, a kiosk substation) returns to the source of supply. When the distribution network is in good condition, current returns to the source of supply via the neutral conductor. When CONSAC is used as the distributor or customer installation service cable, the aluminium sheath is the neutral conductor. The phase current from the source (shown as 'Active' in Figure 9) goes into the installation via the service fuse and meters, travels through appliances as they are used and then returns to the source of supply. The earth connection is used as a safety feature to make sure that if there is a short circuit between a phase and earth, the circuit breaker or fuse in the customer installation operates to disconnect the fault. An example of this is when a person inserts a knife into a toaster, causing a phase to earth fault – if there is no earth connection, the circuit breaker or fuse will not operate and the person is likely to receive an electrical shock because their body becomes the current return path.

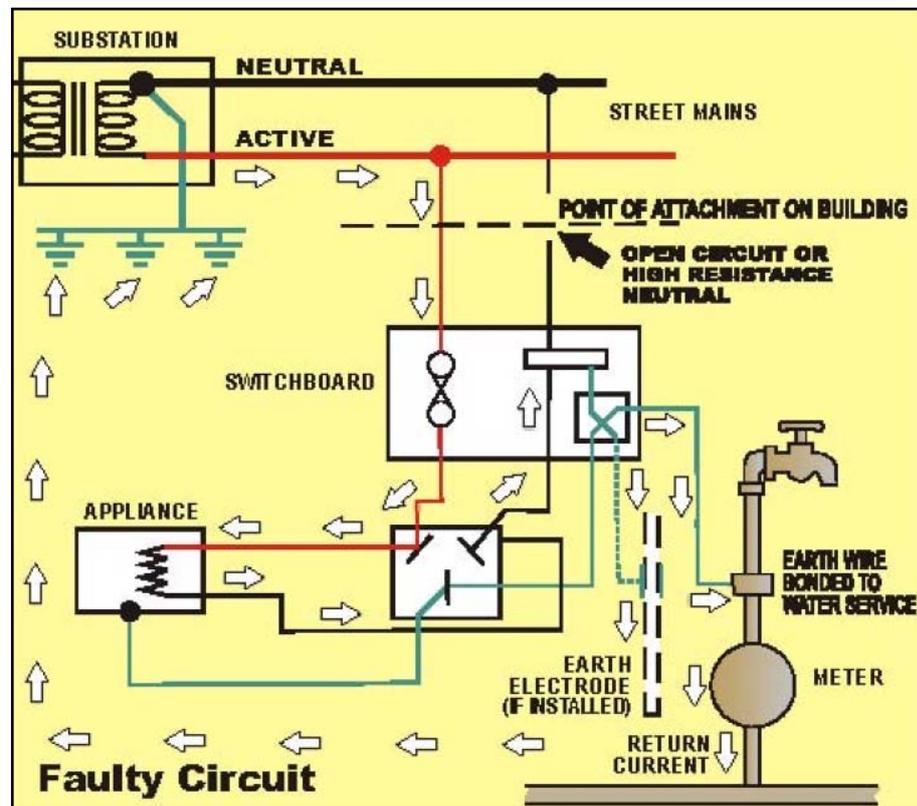
Figure 10 – Neutral current flow with a faulty neutral current return path

If the aluminium sheath of the CONSAC distributor or service cable deteriorates or fails, there is an increase in the electrical resistance of the neutral current path back to the source of supply. When this occurs, the phase current will find an alternative return path; this is usually through the customer's earthing connection or water pipes. This current flow is shown in Figure 10. The customer's earth connection is usually made to an earthing stake; however, it may simply be a connection to a metallic water pipe (as is the case for installations connected to the electricity network before the mid 1970s). These earth connections are not maintained by Ausgrid and therefore their condition is unknown.

Current passing through a customer's earthing connection can cause voltage complaints due to voltage unbalance; it also can create an electrical safety risk due to a voltage rise on appliances and water pipes/taps. This will result in a customer receiving an electrical shock in the shower or kitchen, and can be fatal. The CONSAC cable replacement program commenced in 2004, following a number of (non-fatal) shock incidents reported by Ausgrid customers and staff in a housing development at Singleton Heights. CONSAC had been widely used in the development and was found to have sheath corrosion and deterioration of paper insulation and neutral connections.

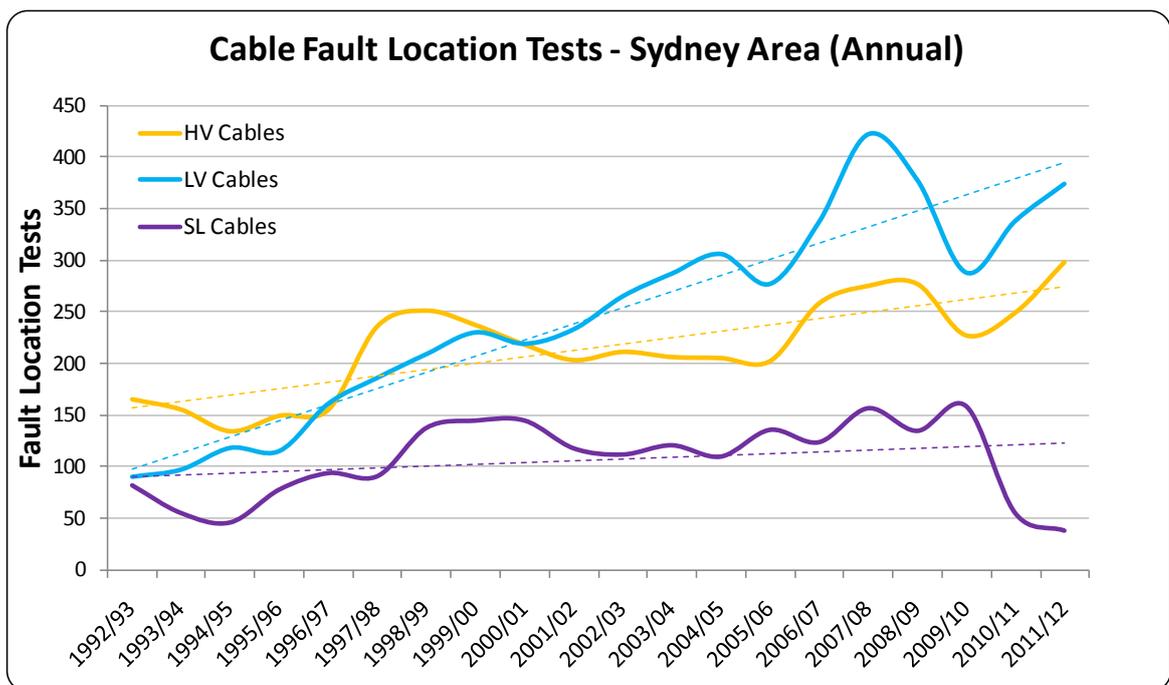
Figure 12 – Cable fault location testing performed by Network Test staff – Sydney area

Figure 12 shows the number of cable fault location tests carried out by Ausgrid's Network Test for high voltage, low voltage and street lighting cables during the past 20 years.

This analysis demonstrates that failures on LV and HV underground cables are increasing, but LV cables are increasing at a higher rate than HV cables. It was thought that these increases may be driven by rainfall. Ten years of rainfall data was obtained from the 'Bureau of Meteorology' (BOM) website for the Sydney area, and the average rainfall was found to be approximately 800mm per annum over this 10 year period. This rainfall data was then compared to the cable fault location information and is shown in Figure 13.

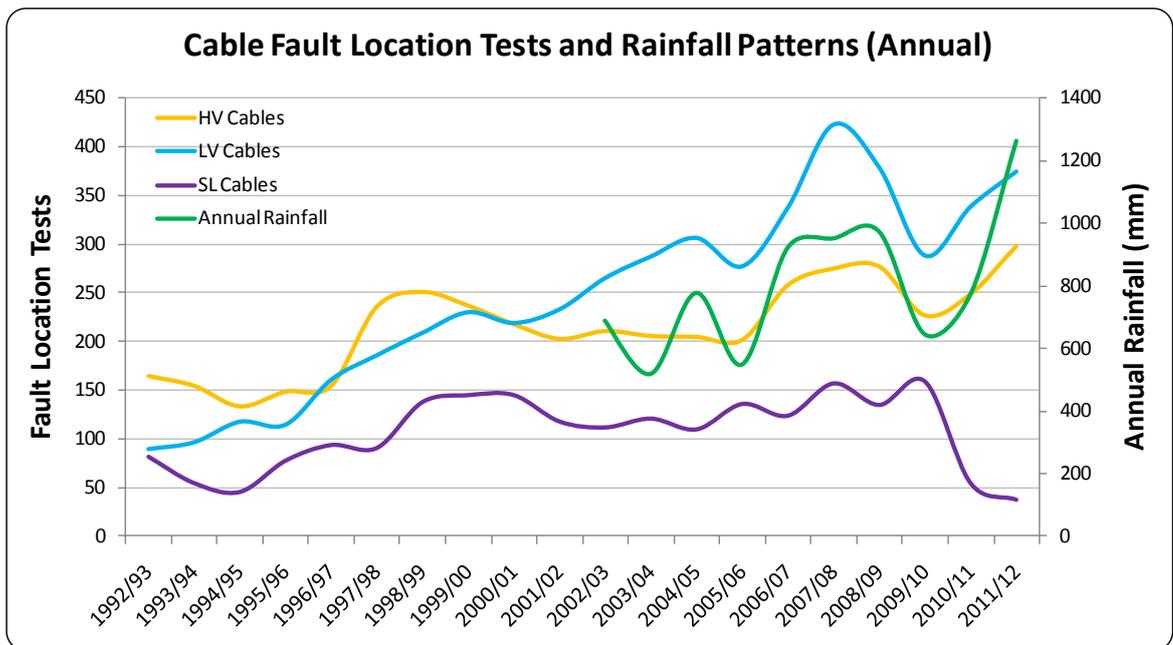
Figure 13 – Cable fault location testing performed by Network Test staff compared to rainfall

The first impression obtained from the graph in Figure 13 is that there is a high correlation between rainfall and LV and HV underground cables failures. Street lighting cable fault location testing has tapered off since the beginning of 2009-10, and this could be explained by a change in the work process as jointing staff now do the location testing for these cable failures instead of the Network Test staff.

The analysis shows that increases in rainfall invariably mean there will be an increase in HV and LV underground cable faults. This is usually due to moisture penetrating or saturating the soil and then, ultimately, the cable. This moisture can enter the cable structure through deteriorated joints or corroded/damaged cable screens. Penetration of moisture through these components causes deterioration of the electrical barrier that the cable insulation provides between phases or between a phase and earth. This results in a failure of the LV cable due to electrical leakage currents either from a phase to another phase or from a phase to earth.

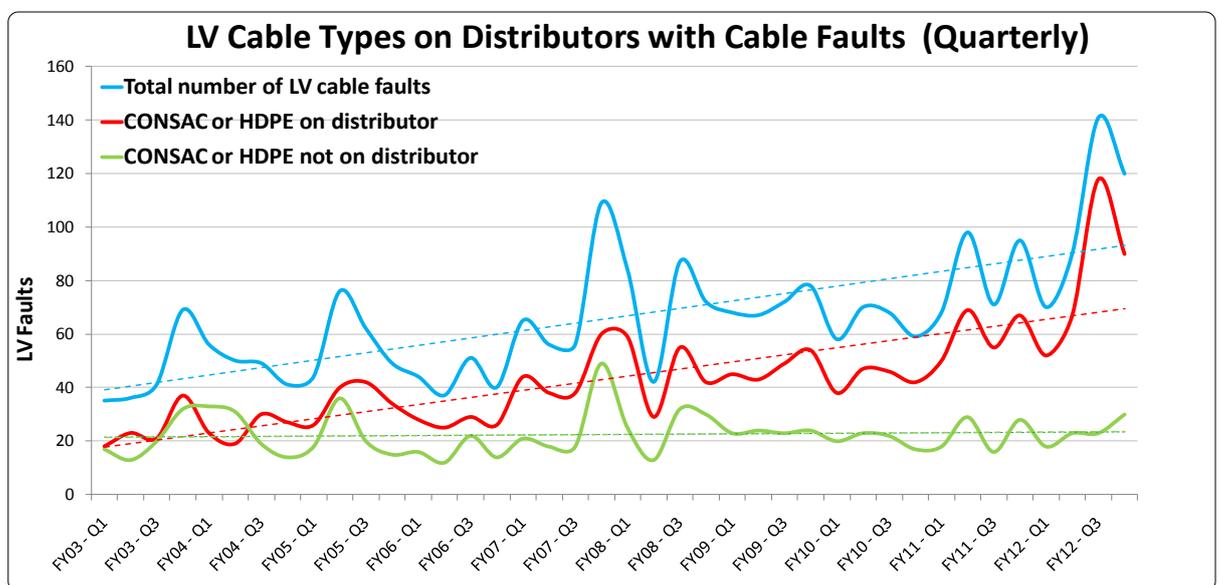
Figure 14 – Quarterly interruptions due to LV cable faults and presence of HDPE or CONSAC cable on distributor

Since the start of FY2009-10, analysis has been undertaken to determine whether distributors that have experienced an interruption due to an LV cable fault had CONSAC or HDPE cables installed on that distributor. Monthly extracts are taken from the Ausgrid GIS system to monitor the removal of these cable types from the LV network. A monthly extract from the Ausgrid Interruptions Database is also used to determine which LV distributors have experienced an LV cable fault. These two extracts are compared to gain a view of how many of the distributors with cable faults also have CONSAC or HDPE cable on the distributor. The results of this analysis are shown in Figure 14.

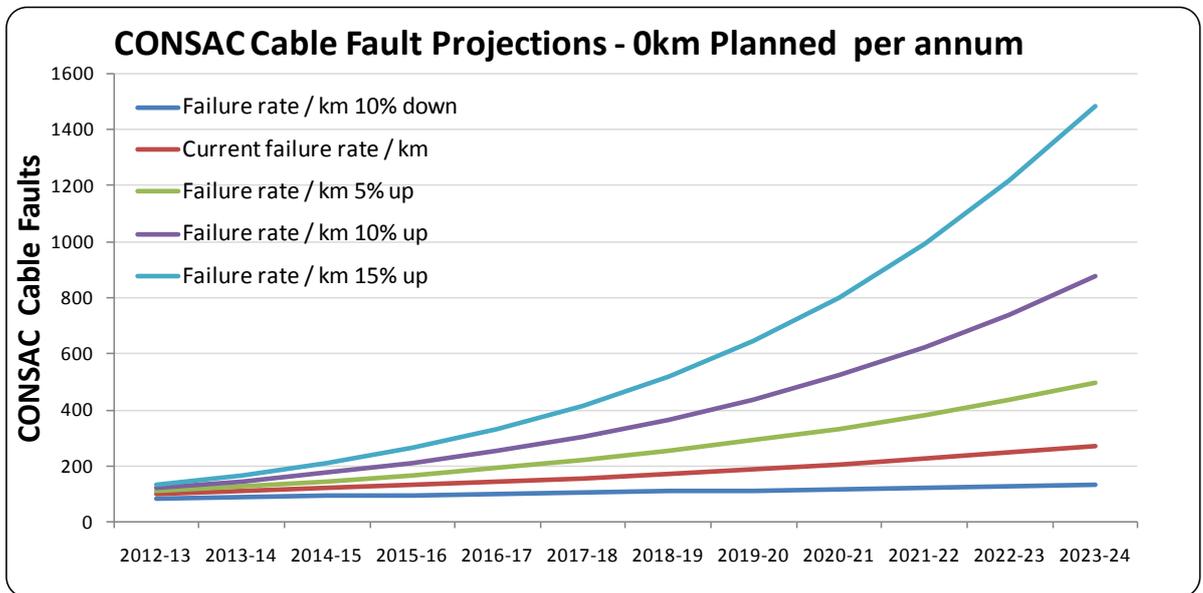
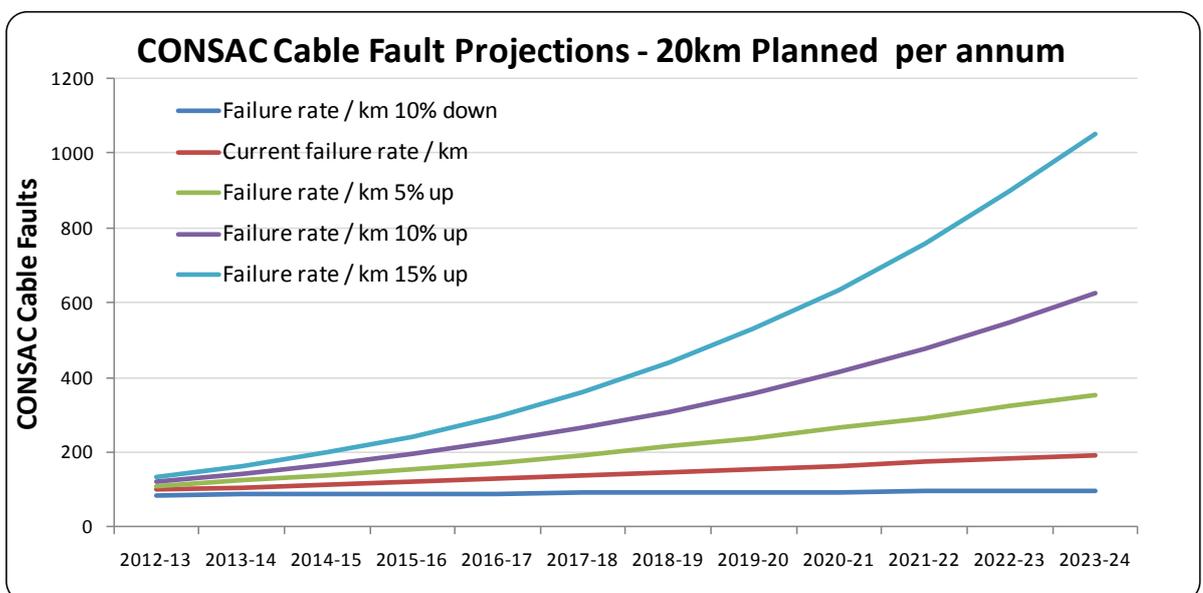
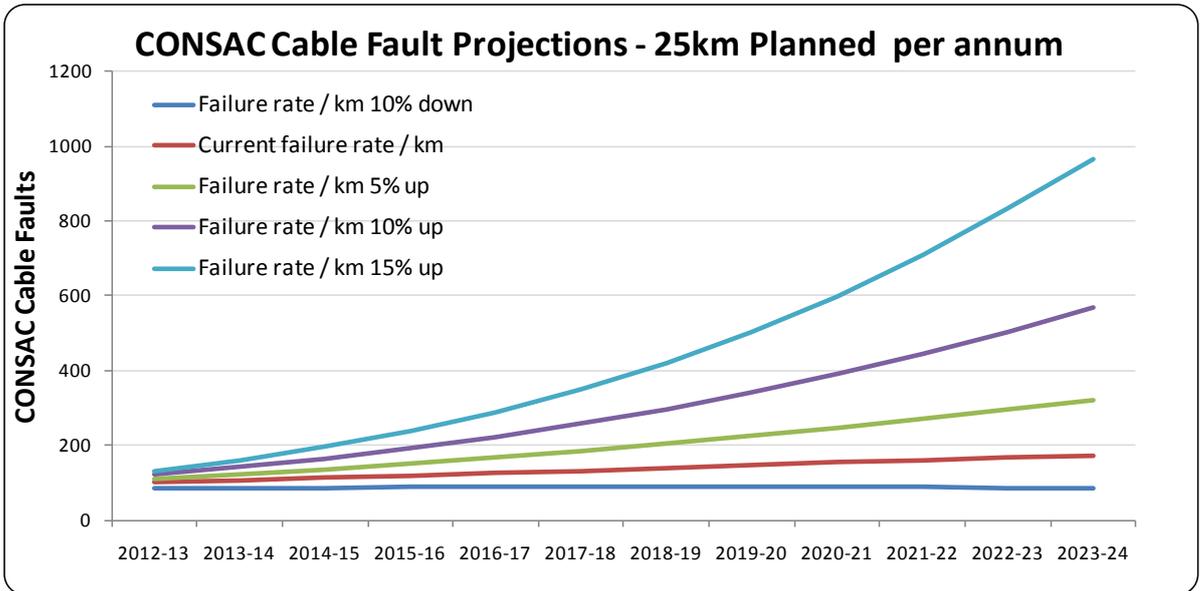
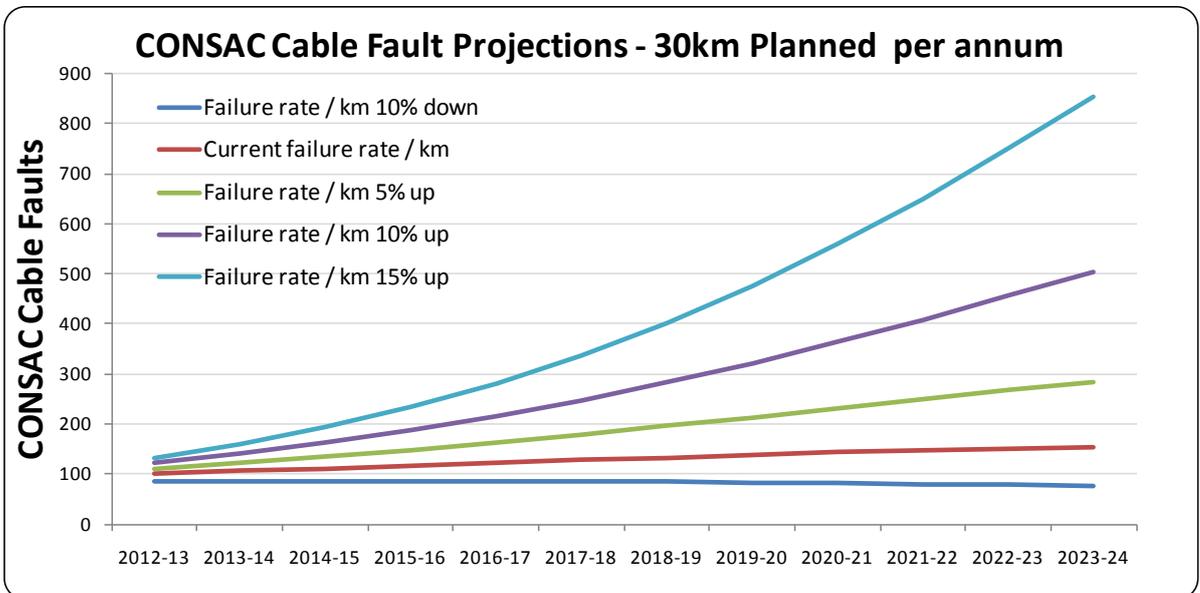
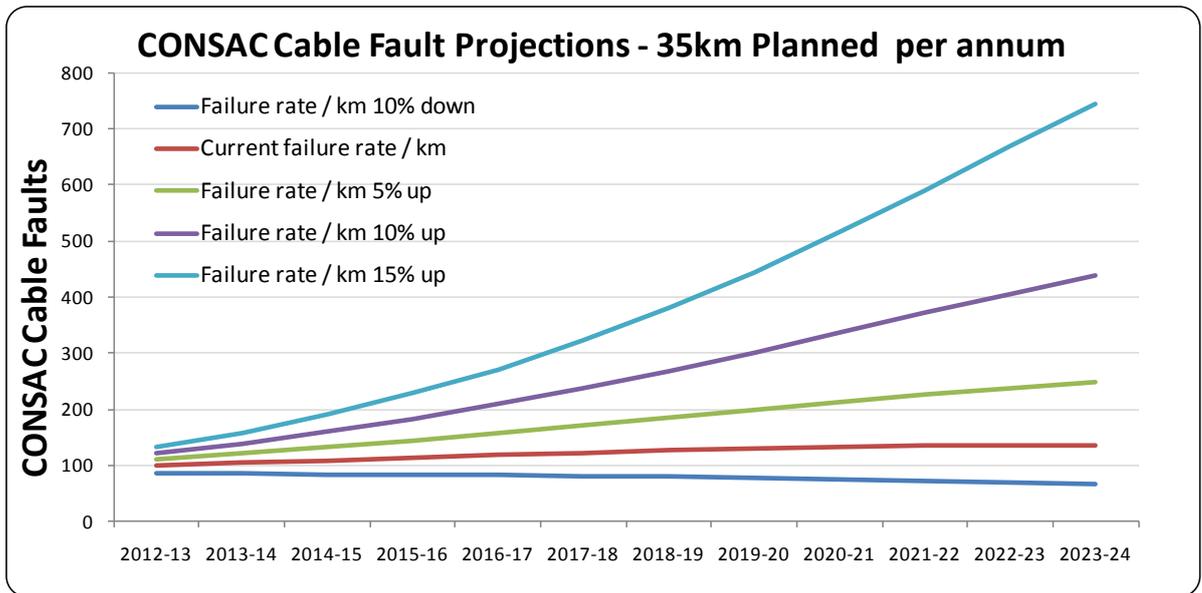
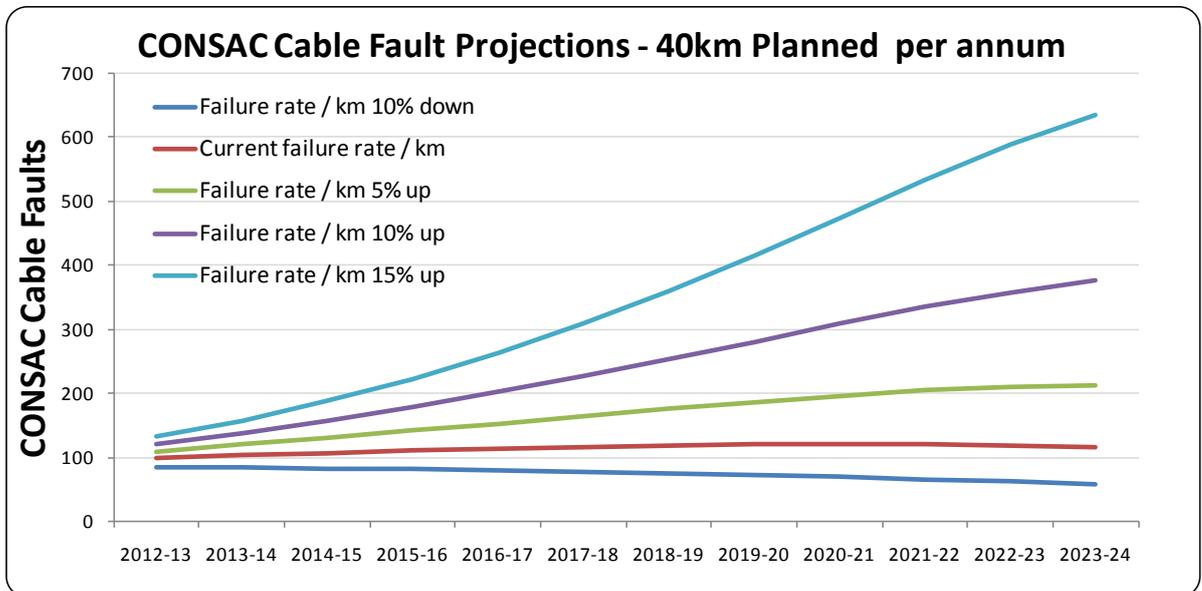
The following graphs (Figures 15 to 20) show CONSAC cable fault projections with different lengths of planned replacement and different failure rates per kilometre. A baseline of zero planned kilometres is included for reference purposes. A failure rate/kilometre reduction of 10 percent has been included in the graphs for reference purposes, but this outcome is unlikely given the condition issues associated with CONSAC cable.

Figure 15 – Sensitivity analysis of CONSAC cable faults with no planned replacement (baseline)

Figure 16 – Sensitivity analysis of CONSAC cable faults with 20km per year planned replacement

Figure 17 – Sensitivity analysis of CONSAC cable faults with 25km per year planned replacement

Figure 18 – Sensitivity analysis of CONSAC cable faults with 30km per year planned replacement

Figure 19 – Sensitivity analysis of CONSAC cable faults with 35km per year planned replacement

Figure 20 – Sensitivity analysis of CONSAC cable faults with 40km per year planned replacement

Figures 15 to 20 show that any planned CONSAC cable replacement of 35km per year or more will stabilise the projected number of failures in approximately 10 years based on the current growth rate in failures of 10 percent (that is, two-thirds of 14.8 percent). Any planned replacement less than 35km per year will stabilise the projected number of failures but over increasing periods.

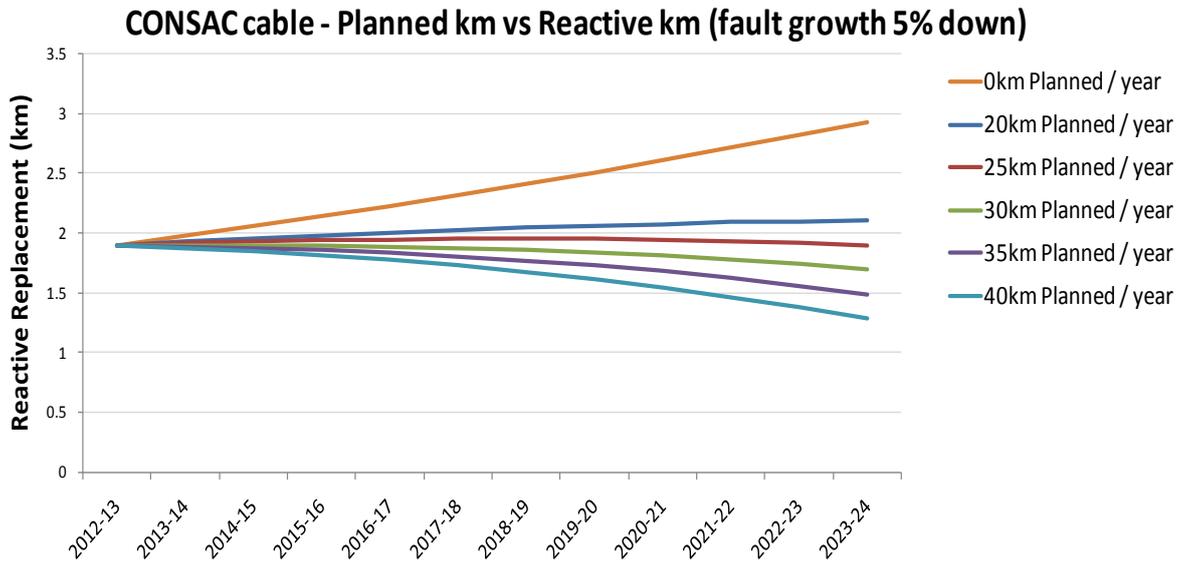
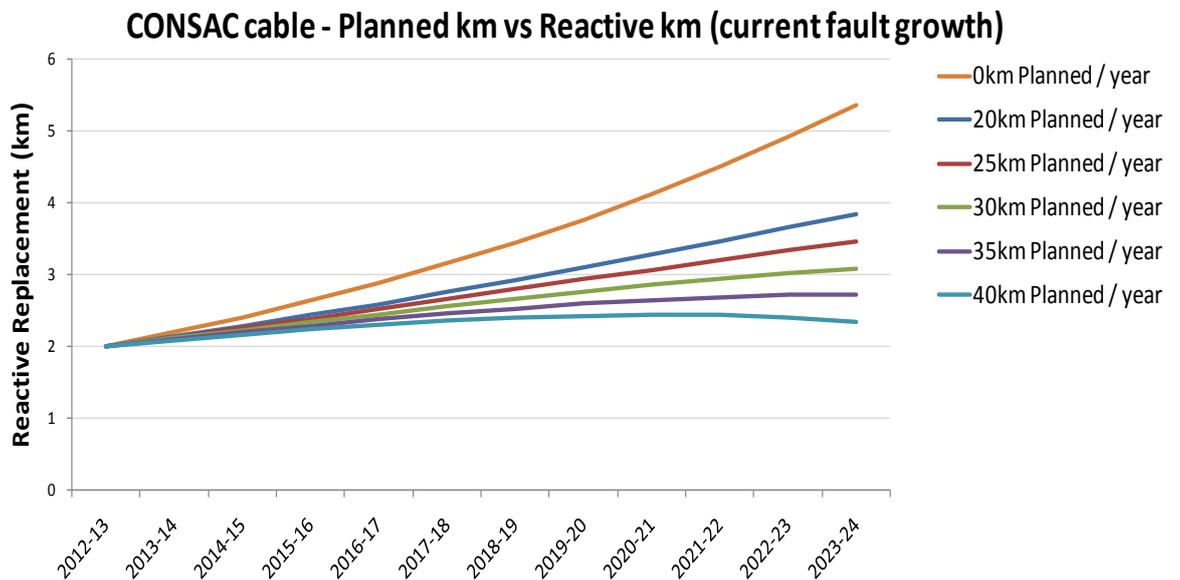
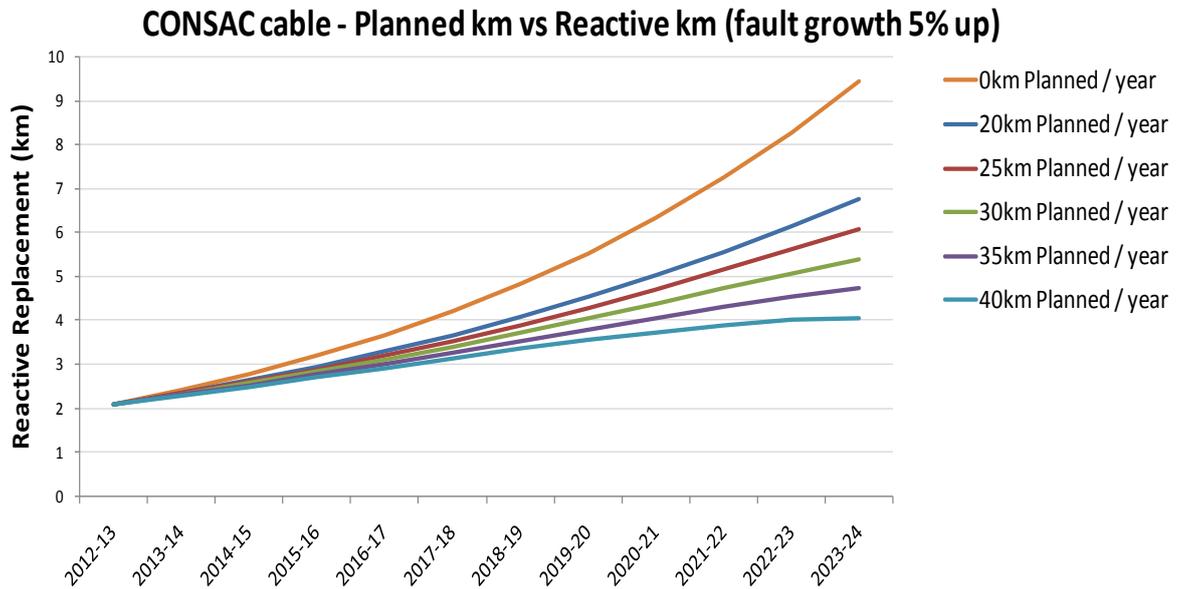
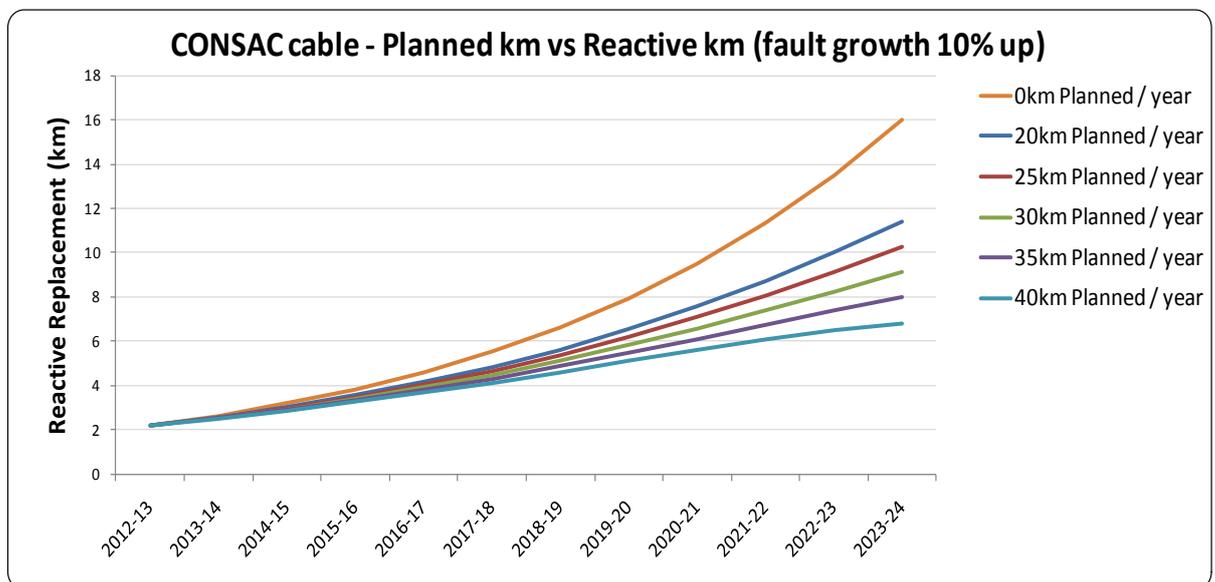
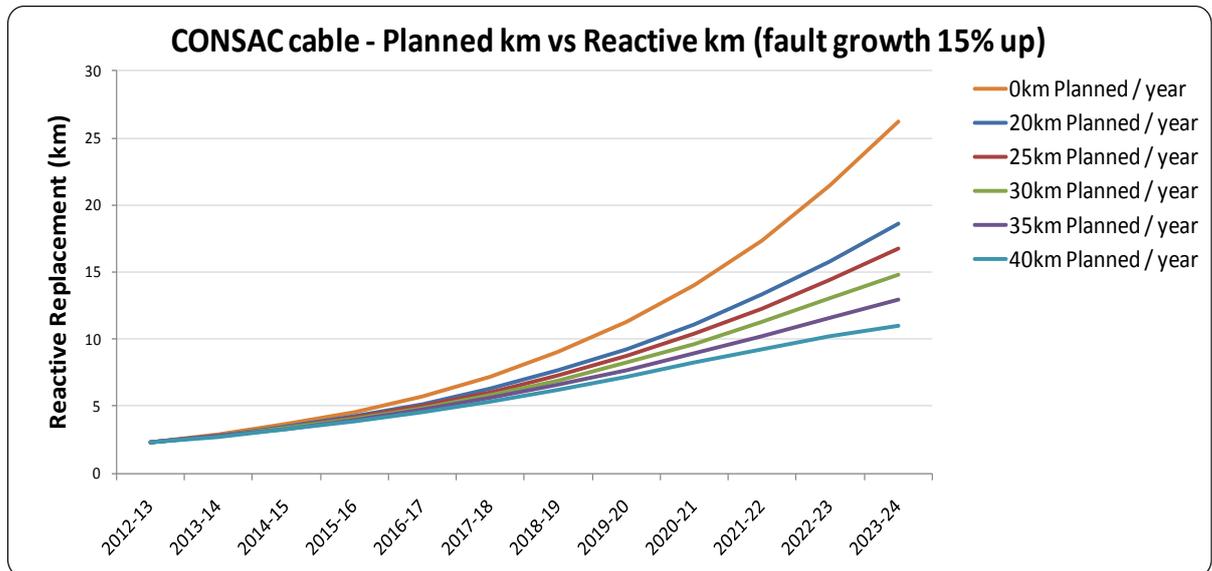
The following graphs show projected CONSAC cable reactive replacement lengths with different lengths of planned replacement and different annual growth rates for failures. Again, a baseline of zero planned kilometres has been included for reference purposes. A fault growth reduction of five percent has also been included in the graphs for reference purposes but this outcome is unlikely given the condition issues associated with CONSAC cable.

Figure 21 – Reactive replacement requirements with growth in faults per year current growth rate reduced by 5 percent

Figure 22 – Reactive replacement requirements with current growth per year in faults.

Figure 23 – Reactive replacement requirements with growth in faults per year with current rate increased by 5 percent

Figure 24 – Reactive replacement requirements with growth in faults per year with current rate increased by 10 percent

Figure 25 – Reactive replacement requirements with growth in faults per year with current rate increased by 15 percent

From Figures 21 to 25 it can be seen that any planned CONSAC cable replacement of 35km per year or more will stabilise the projected number of failures in approximately 10 years based on the current growth rate in failures of 10 percent (that is, two-thirds of 14.8 percent). Any planned replacement less than 35km per year will stabilise the projected number of failures but over increasing periods.

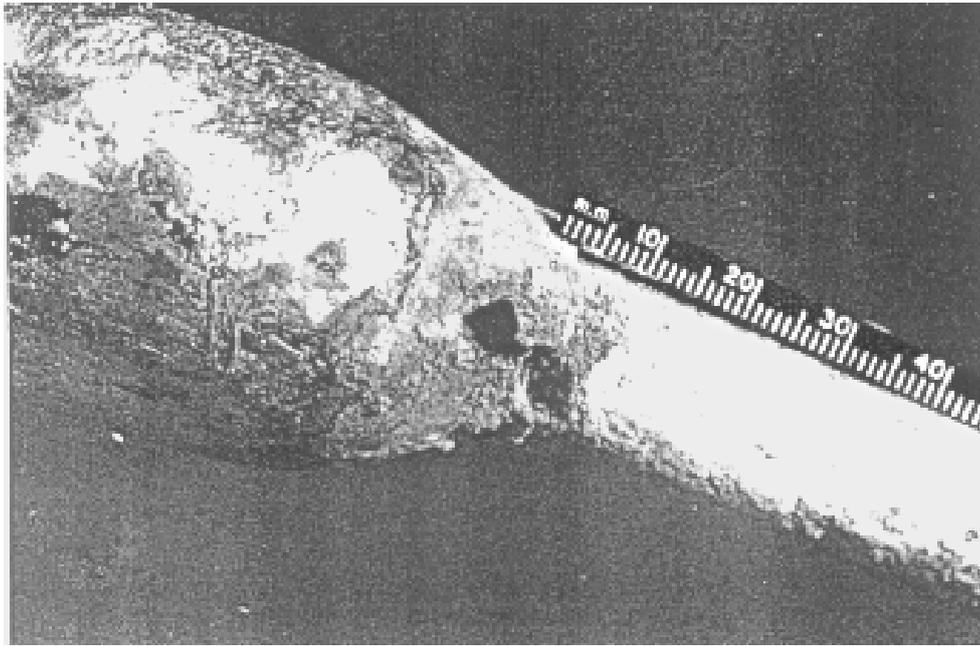
This photograph shows the corrosion that took place at the junction between a lead wipe and the aluminium sheath of a cable in a moist location. This happened in a very short time.

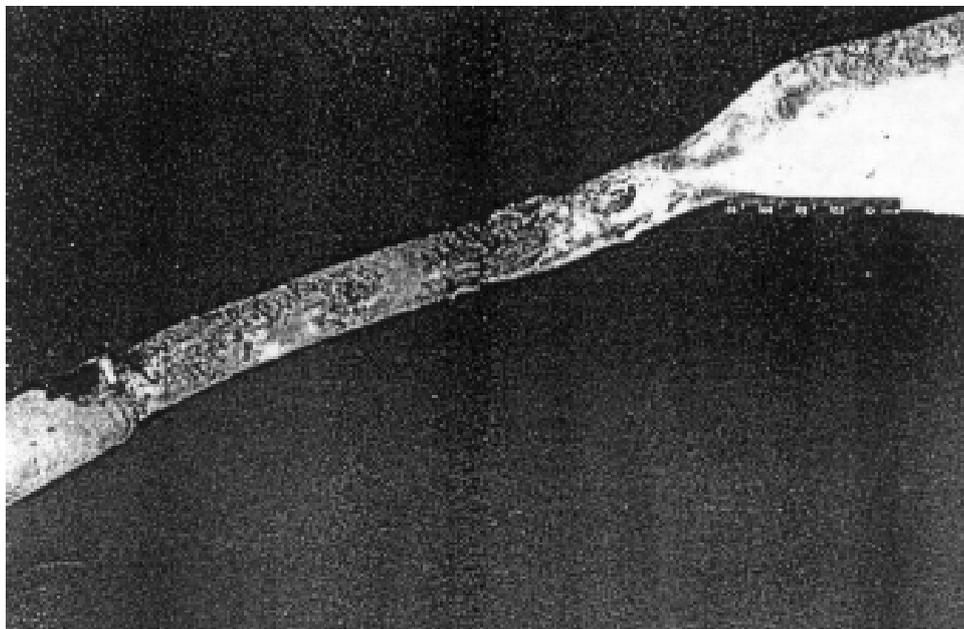
This is the effect of leaving an aluminium sheath in the ground without a protective covering.

REMEMBER: NEVER LEAVE ALUMINIUM SHEATH UNCOVERED

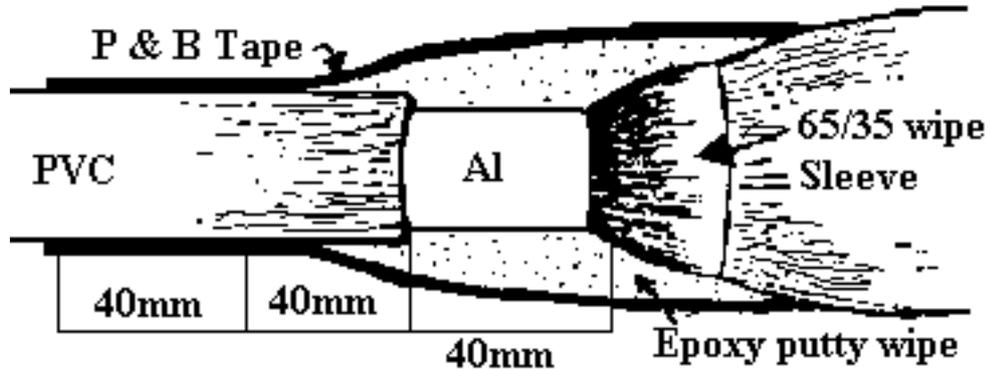
4.1 EPOXY PUTTY 'WIPES'

Jointing of aluminium sheathed cables introduces an area of possible corrosion where the aluminium is exposed to the lead sleeve. To exclude all moisture from this area, an epoxy putty wipe is made and this is then covered with two (2) half lapped layers

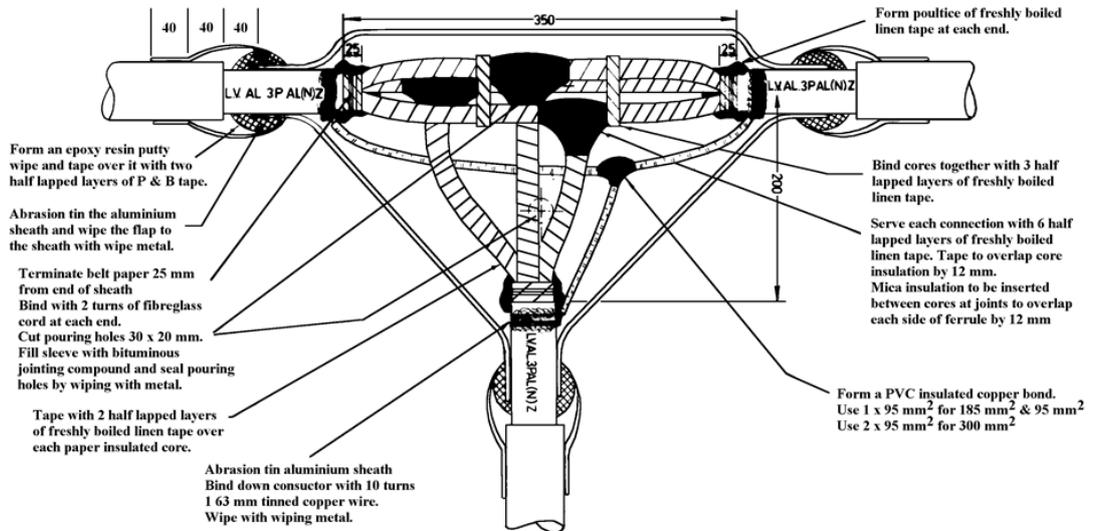
LV AL3PAL(N)Z to LV AL3PAL(N)Z
JOINTING INSTRUCTION

| NOTES: 1. Through cable not cut. | 4. Use Code No. 8 lead sheet for 'T' flap | 6. Protect the plastic heath serving with fibreglass tape while wiping of the flap to the aluminium sheath. |
