# Distribution Pillar Replacement

Regulatory Business Case (RBC) 2024-29

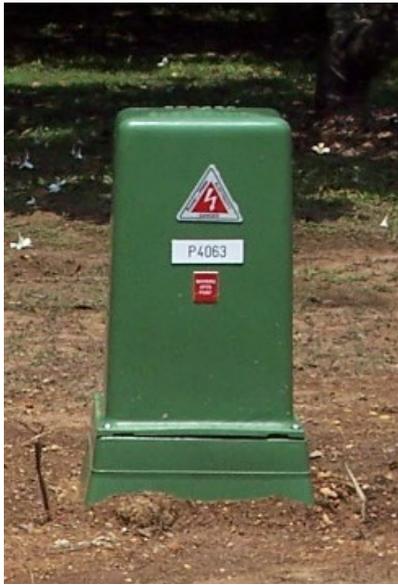
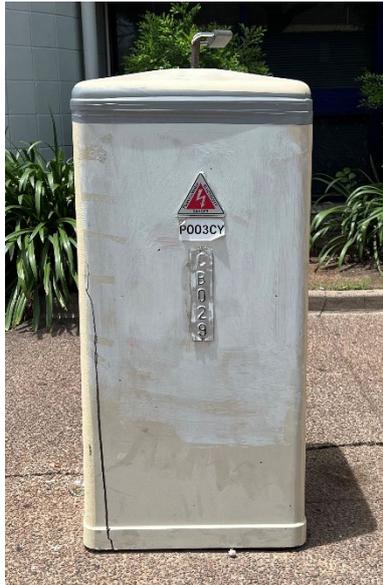
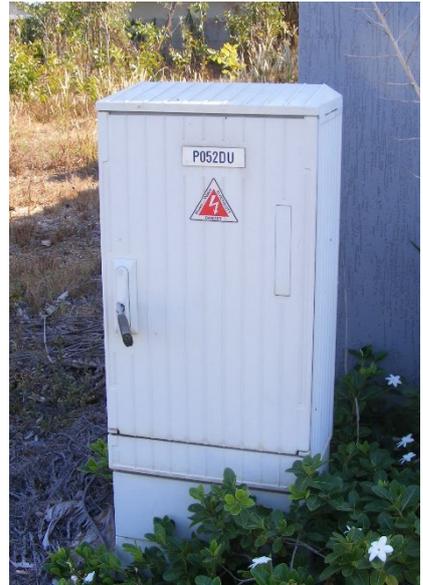
Figure 1 Pillar types

Type	Name	Description	Connection type	Volume
<b>Service Pillar / Link Pillar</b>	Green Turret Pillar	Predominately used in urban areas. Used from 1970-2010 and have a green PVC/Fibre glass cover.	Direct connect to busbar	5,118
<b>Fused Pillar</b>	Cream Turret Pillar	Cream domed pillars installed until 2000. Cables connected to the bus using fuse switchgear.	Striple fuse switchgear	350
<b>Fused Pillar</b>	Holec Pillar	The modern standard type used by Power and Water since 2000. Cabinet style opening at the front with cables connected to the bus with fused switchgear.	Striple fuse switchgear	2,770
<b>Total</b>				<b>8,238</b>

Green Turret Pillar

Cream Turret Pillar

Holec Pillar

This business case is focused on the Green and Cream pillar that have been found to be in deteriorated condition and are increasingly posing safety risks. The Holec pillars are typically repaired or replaced due to impact by third parties, and which are not related to age/deterioration.

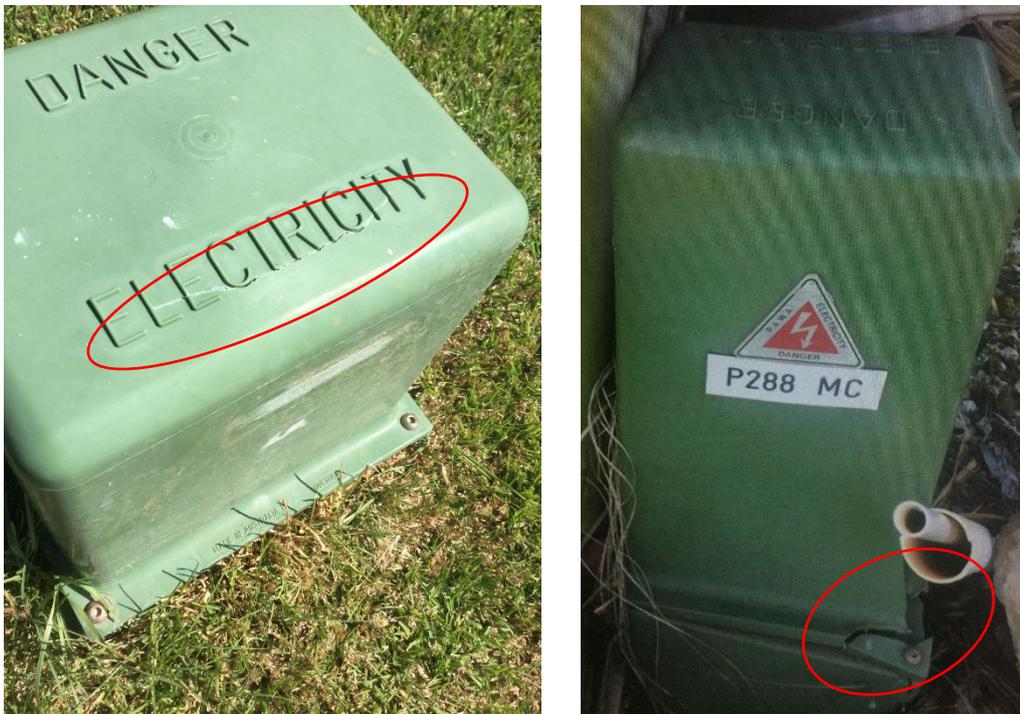
In most of the instances, pillars are exposed to Ultraviolet (UV) radiation. As a result, the pillar cover starts to weaken (become brittle). Common effects are cracks on its surface or breaking around the bolt holes that secure the cover to the concrete base. These failure modes are shown in Figure 12. Analysis of inspection results found that 127 (13.8%) of 926 pillars inspected were found to have issues related to cover damage.

Figure 12 Cracks in the pillar cover

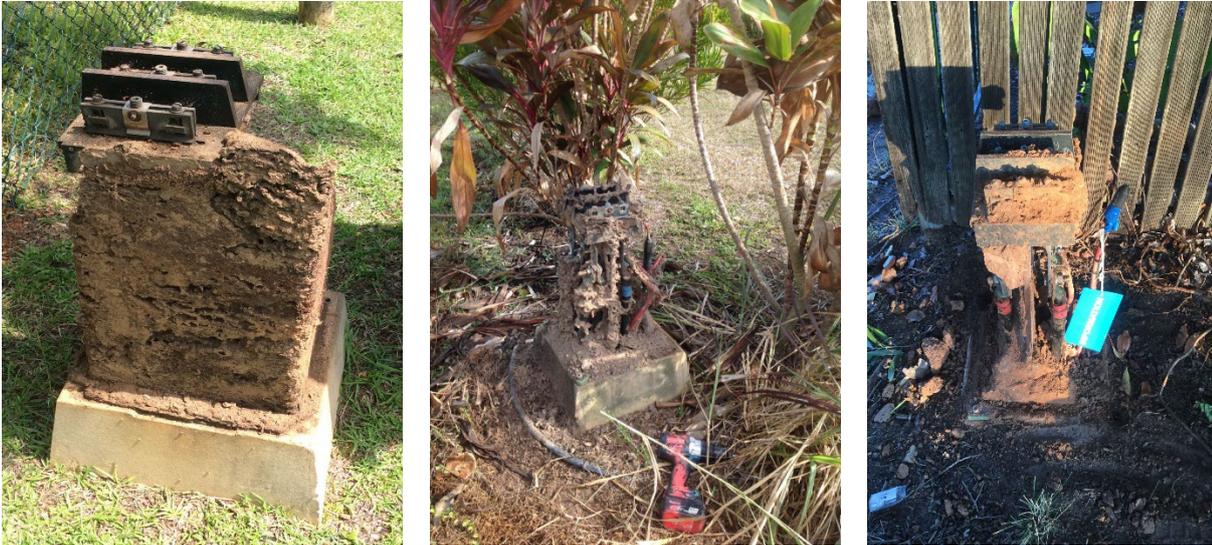
- The combination of the termite mound matter and absorbed moisture can cause a short circuit between LV terminals which will result in an outage, or other metallic components becoming live and causing a safety hazard.

Analysis of inspection results found that 96 (10%) of 926 inspected pillars were found to be infested with termites.

Figure 13 Examples of termite infestation

- Termite infestation which can lead to damage of cable terminations or a short circuit due to build-up of soil and absorption of moisture.

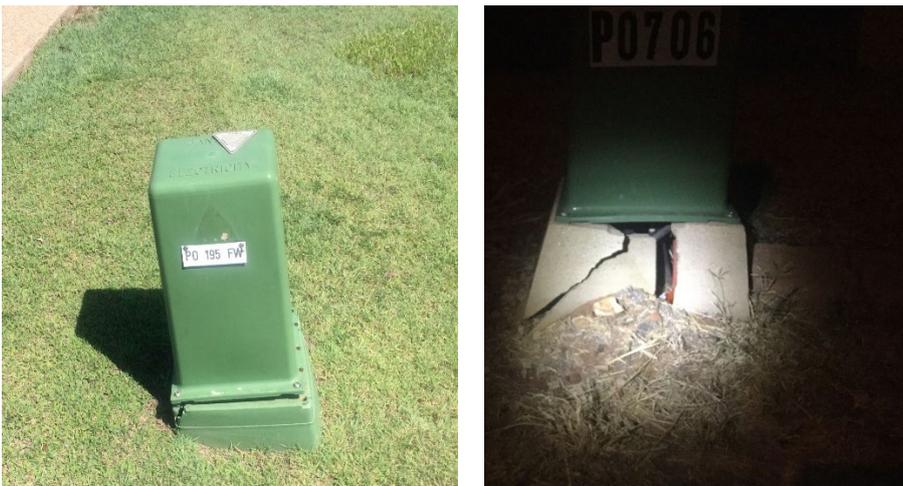
Due to the locations of a pillars, they have an increased probability of being hit by a third party, particularly residential vehicles. External impacts can damage to the pillar and expose live parts or make them more easily accessible. Figure 14 shows damage to access cover and pillar base caused by vehicles.

There were 54 incidents involving third party failures including external which caused damage to pillar or its associated components. As per ISR analysis, 54 (5.8%) of 926 inspected pillars were found to be damaged as result of external impact.

Figure 14 Examples of damage by vehicles
