Services replacement program

Regulatory Business Case (RBC) 2024-29

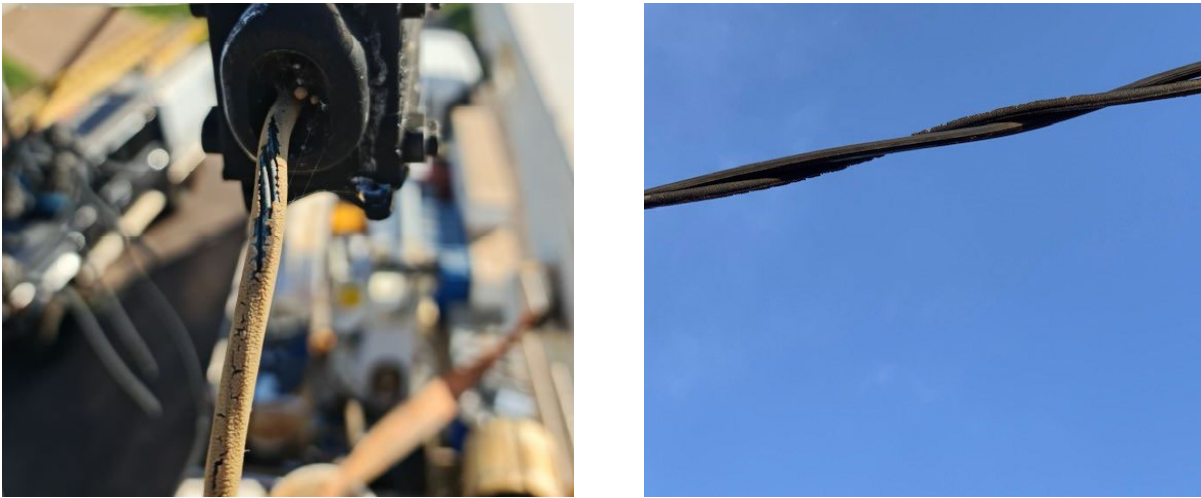
Figure 8 Insulation damage exposing conductors

The images in Figure 8 below show examples of insulation deterioration that can result in exposed service wires and pose a risk to safety.

The service conductor insulation deteriorates due to ageing, prolonged exposure to UV radiation (sunlight), and moisture ingress. As a result, conductors may become exposed and increase health and safety hazards for both the public and operational crews working in the vicinity of these assets. Of all the failure modes or defects, insulation damage is the most common cause of failure related to service wires as set out in the recent inspection report⁶. The inspection report identified various issues/defects and assigned criticality ratings based on the condition. Images of insulation damage exposing conductors and insulation damage due to ageing is captured in Appendix C.

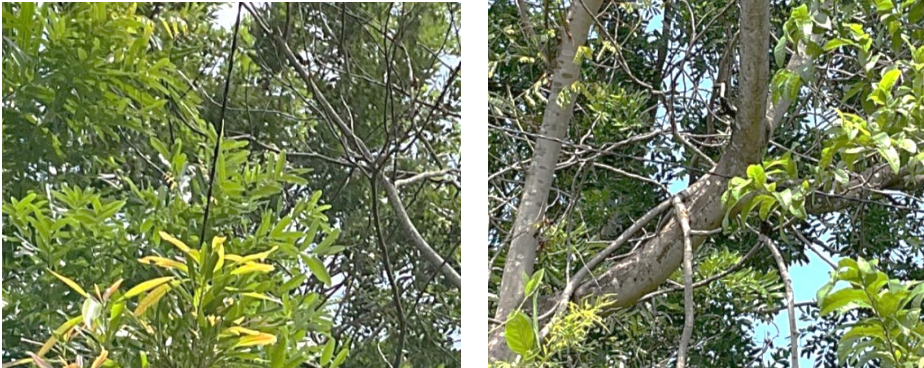
Figure 9 Vegetation Encroachment

The images in Figure 9 show vegetation encroachment on to service lines. This can result in damage to the insulation, excessive tension damaging the connection points or with the service line breaking and falling to the ground. If the service remains connected to the network, it can result in a live wire on the ground which poses a safety hazard to the public.

Vegetation encroachment can lead to physical damage to the service. This damage has the potential to result in creating an electric shock hazard if it touches conductive surfaces in the vicinity of the service or could cause the service to fall and remain as a live conductor on the ground.

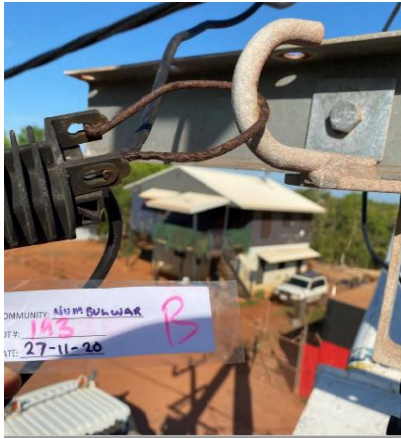
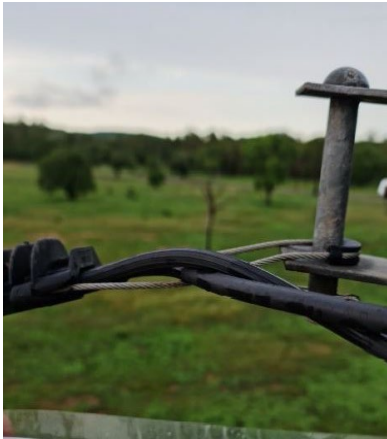
Figure 10 Service clamp defects

The images in Figure 10 below show different types of damage to clamps that attached the service to the network pole. From left to right they show:

- strap deterioration which can result in the strap breaking and the conductor falling to the ground
- conductor touching the strap which can cause it to raise the potential of the connected metallic material and therefore electric shock, or electrocution should somebody touch it
- Improper termination that can result in early asset failure

Service clamps are used to secure overhead services/conductors onto the pole. Some of the common issues/defects observed with service clamps are deterioration/damage due to ageing, conductor touching the strap, and incorrect/improper termination.

- Insulation damage of the conductor and strap will result in the strap and hook becoming energised and, depending on how the hook is secured, will elevate the risk of an electric shock.
- Improper termination of the strap to the bolt securing the insulator, rather than on the insulator itself, will result in energisation of the metallic bolt and will elevate the risk of an electric shock.

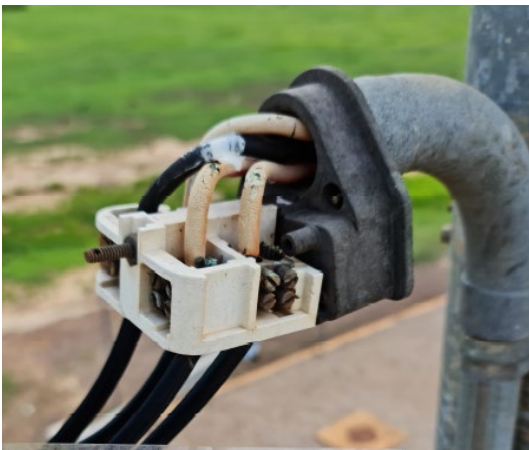
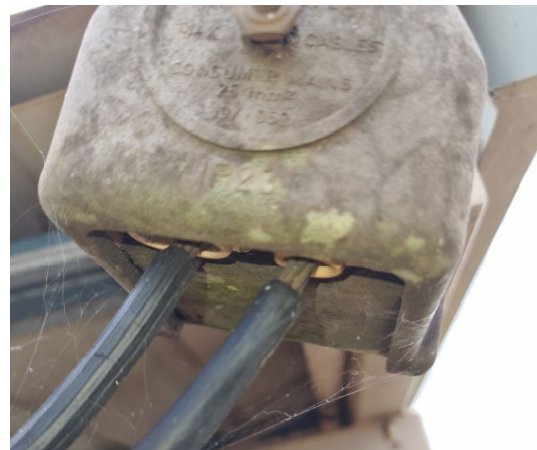
Figure 11 Common defects at Point of Attachment

The images in Figure 11 show common defect on the customer side point of attachment. These defects can result in the metallic components becoming live and cause electrocution, or failure of the connection and result in the service falling to the ground.

A common defect that occurs within the service connection assembly is at the point of attachment (POA). These defects include broken or missing lids for miniature circuit breakers (MCB) and exposed conductor at POA.

With a MCB lid missing, there is a possibility of an external object touching the MCB leading to an electric shock for anyone in the vicinity of the POA or connected conductive surfaces. It may also result in the service becoming disconnected, resulting in loss of supply and potentially a live conductor on the ground that is in a publicly accessible location.
