# 009 Store Hot Tap & STOPPLE® Fittings: Inspections Report

Oct, 2015

Prepared for: **APA Group Ltd.**

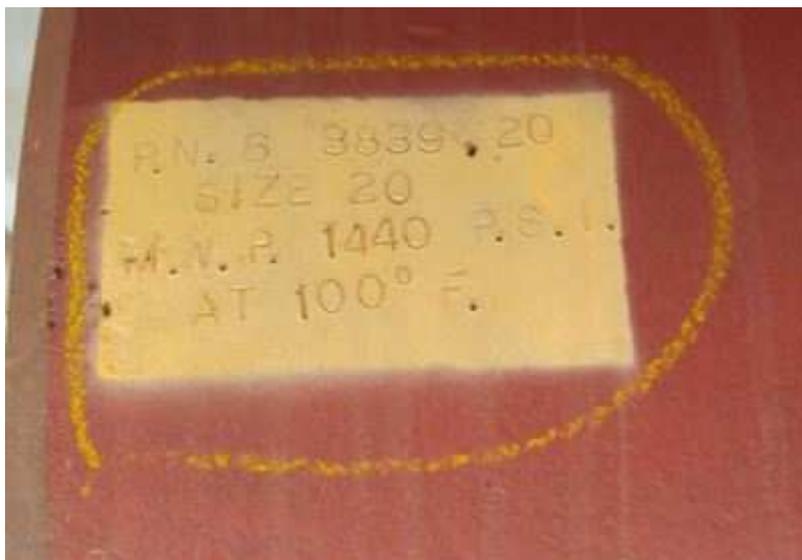
**Fig 2.1** Example of Part Number and M.W.P. Stamping.

In many cases the rated pressure (M.W.P.) of the fitting is stamped on the fitting with its reference temperature. It is stamped in the same location on the sleeve as the fitting part number. The M.W.P. is important as it can be less than the fitting flange rating.

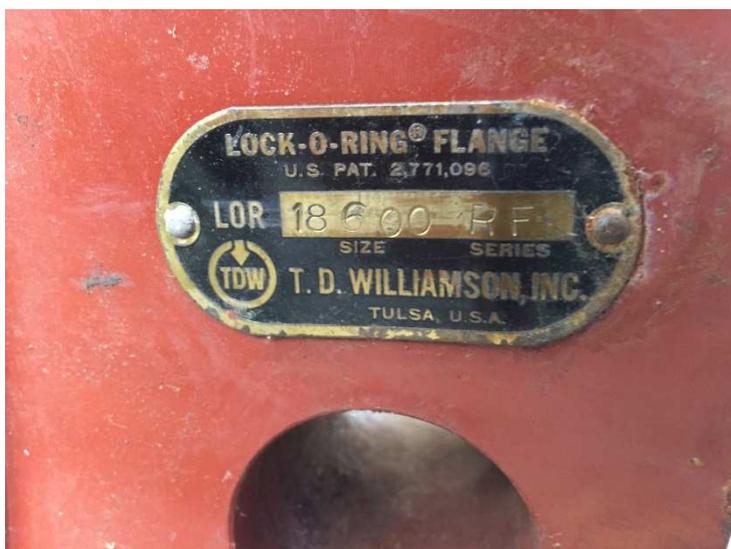
**Fig 2.2** Flange plate

In some cases the flange has its own plate which denotes the size of the flange and its class.

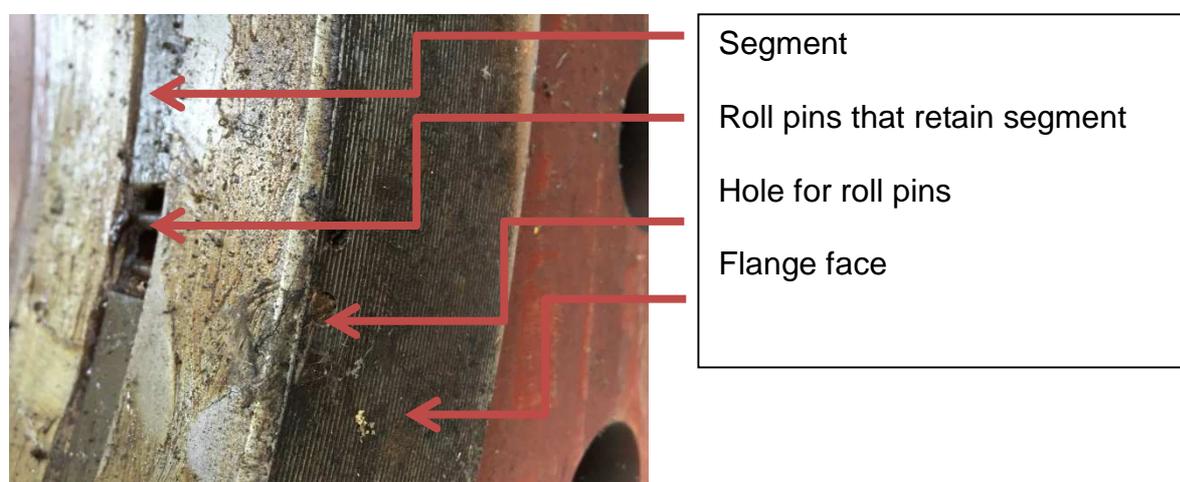
**Fig 2.3** 30" fitting showing 2 roll pins that retain the segment arcs. This is a "type 1" fitting.

In order to access the O-ring, the segment must be wound all the way in and then the roll pins that retain the segment from extending too far must be removed. The roll pins are not designed to be easy removed, as they are driven into a blind hole and flush at the flange face. Removal is only possible by gripping the roll pin in the segment groove and using manual leverage to remove. The age of fittings and sticking friction can make this a very difficult task.

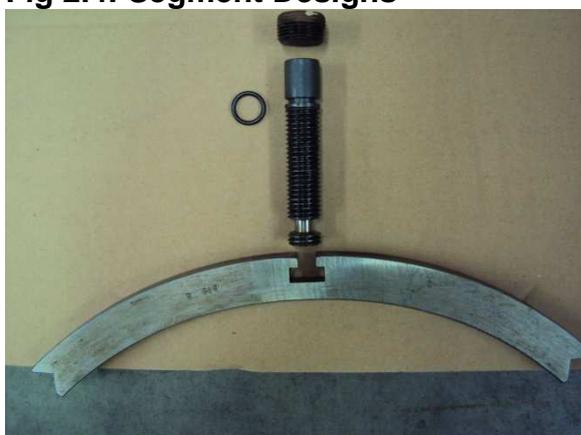
**Type 1**

**Type 1:** oldest design, which has long been obsolete. The segment arc and screw are two separate pieces, with the O-ring located on the screw.

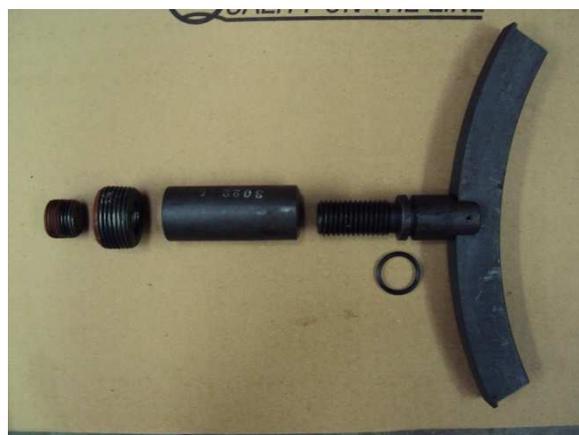
**Type 2**

**Type 2:** Like Type 1, this is also an obsolete design. The segment arc and inner screw is a one-piece design (two pieces attached by a pin). The O-ring groove located on the shank of the screw. Like Type 1, the roll pins must be removed and the segment removed to access the O-ring.

The other distinction of Type 2, compared to Type 1, is that the pipe plug (which acts as an outer cap on the assembly) is now threaded into a reducing bush, instead of directly into the internal thread on the flange. This is an easy means of telling Type 1 design from the others.

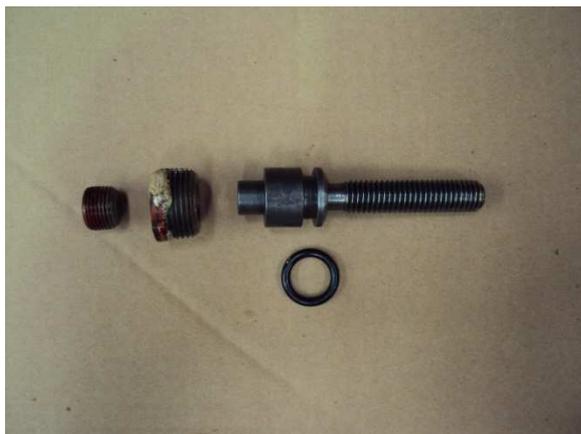
### Type 3: (segment not shown)

**Type 3:** This is the modern design of segment internals, whereby it is not necessary to remove the roll pins and segment arc to access the O-ring. The segment screw containing the O-ring, can be removed through the outer bushing. Obviously this greatly increases serviceability with the added benefit of being able to replace a leaking O-ring in the field.

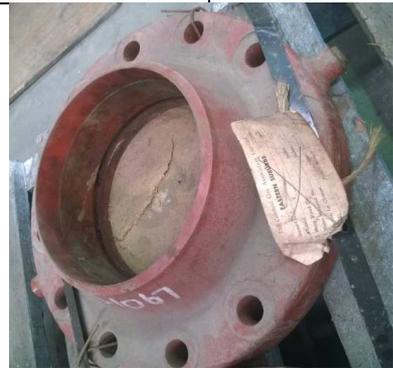
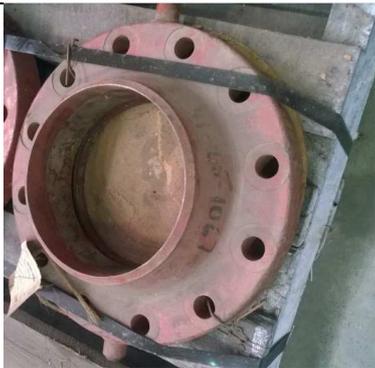
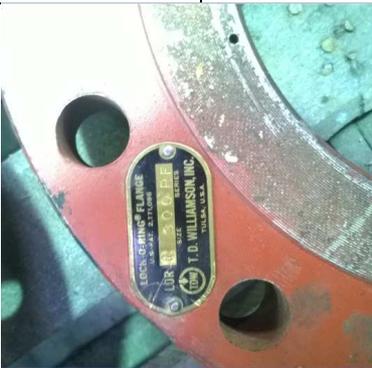
Item Number (ref table 3.1)	Part Code	Description	Flange Code	N/A
			Flange Class	300
			Fitting M.W.P	N/A
14	<b>Unknown</b>	<b>8" LOCK-O-RING FLANGE</b>

<b>Drawing Availability</b> <b>No</b>		<b>Ease of service</b> <b>5 - difficult</b>		<b>Utility</b> <b>LOW</b> Class 300 flange only, obsolete design
<b>Comments</b> This is a very old class 300 flange of obsolete design, with no available drawing. Fitting inspection revealed very difficult to service, it is recommended to scrap this fitting.

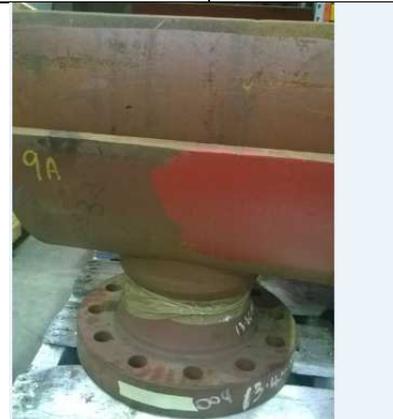
Item Number (ref table 3.1)	Part Code	Description	Flange Code	<b>Unknown</b>
			Flange Class	<b>Unknown</b>
			Fitting M.W.P	<b>Unknown</b>
11	<b>Unknown</b>	<b>18" x 8" HOT TAP SPLIT TEE</b>

<b>Drawing Availability</b> <b>No</b>		<b>Ease of service</b> <b>4 - difficult</b>		<b>Utility</b> <b>LOW</b> Unknown MWP, no back up strip groove.
<b>Comments</b> This is a very old hot tap fitting, with no identifying markings nor available drawing. It is recommended to scrap this fitting.

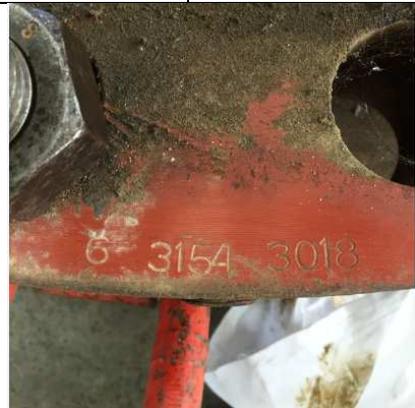
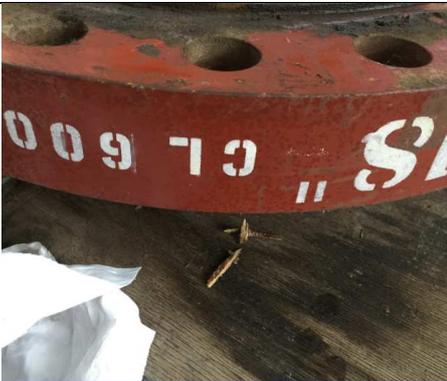
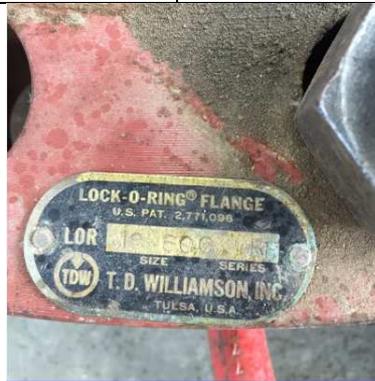
Item Number (ref table 3.1)  <b>40</b>	Part Code  <b>06-3154-3018</b>	Description  <b>18" LOCK-O-RING FLANGE</b>	Flange Code	N/A
			Flange Class	600
			Fitting M.W.P	<b>Unknown</b>

Drawing Availability <b>No</b>		Ease of service <b>5 - difficult</b>	Utility <b>LOW</b> : Flange only	
Comments This is an old design flange. Inspection revealed high difficulty of servicing. Low utility as flange only.

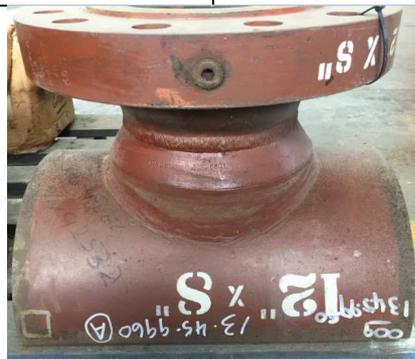
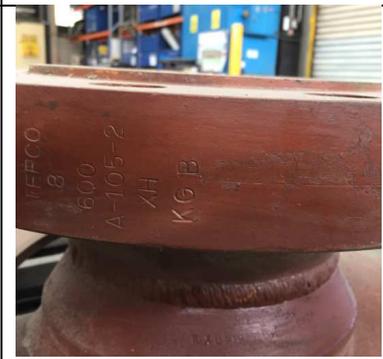
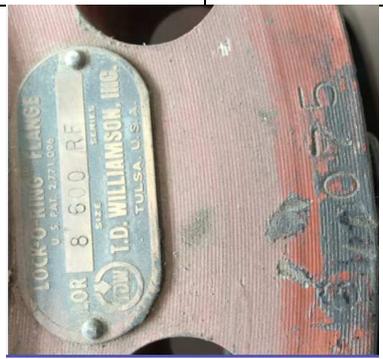
Item Number (ref table 3.1)  <b>39</b>	Part Code  <b>Unknown</b>	Description  <b>12" x 8" HOT TAP SPLIT TEE</b>	Flange Code	06-0075-0000
			Flange Class	600
			Fitting M.W.P	<b>Unknown</b>

Drawing Availability <b>No</b>		Ease of service <b>4 - difficult</b>	Utility <b>LOW</b> Unknown MWP, no back up strip groove.	
Comments This is a very old hot tap fitting, with no part number nor available drawing. M.W.P not verifiable. It is recommended to scrap this fitting.
