# BUILDING CONDITION REPORT

TransGrid

Cowra Sub-Station, Bulkhead Road, Cowra, NSW

6 May 2016

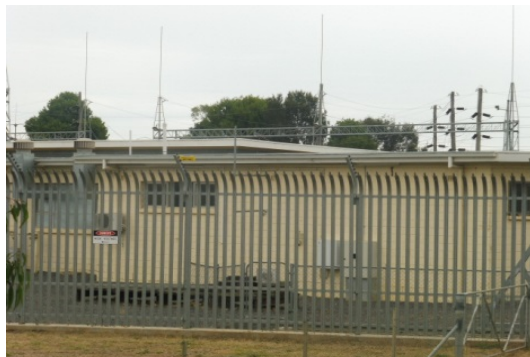
1.1	Roof															
1.1.1	Main Roof Coverings	Steel framed roof structure covered with profile metal sheeting.	In poor to fair overall condition.	Aged roof sheets beyond life expectancy with heavy corrosion. Allow for short term replacement as required.	CAP	2		\$	97,750.00		\$ 97,750.00

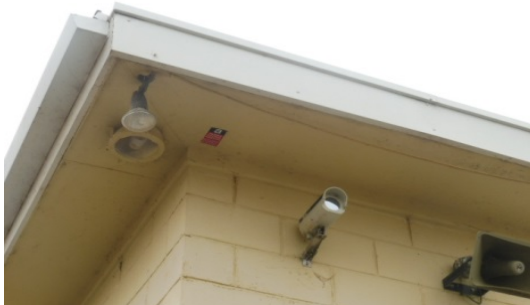
1.1.2	Fascia and Soffits	Suspect asbestos fascia and soffit boards.	In poor overall condition.	Peeling paintwork as asbestos. Allow for replacement as part of room replacement works. Costs include for asbestos removal.	CAP	2		\$	5,700.00		\$ 5,700.00

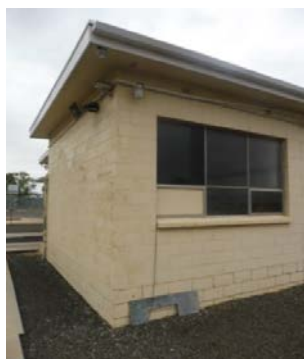
1.1.3	Roof Drainage															
1.1.3.1	Drainage	Metal eaves gutters draining to metal downpipes.	In poor to fair overall condition.	Aged gutters and downpipes but still performing. Allow for replacement as part of the roofing works.	CAP	2		\$	4,200.00		\$ 4,200.00

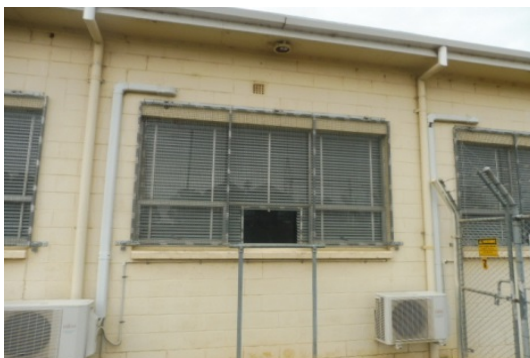
1.1.3.2	Drainage	Metal eaves gutters draining to metal downpipes.	In poor to fair overall condition.	The paintwork to the downpipes is in poor condition. No works given replacement has been recommended.	CAP	2			inc.		\$ -

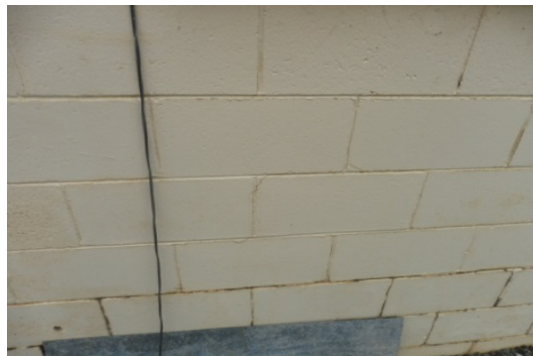
1.2 External Elevations												
.2.1	Façades	Painted block elevations.	In poor overall condition.	Localised cracking to block work and mortar joints. Allow for local repairs as required prior to repainting works.	R&M	2		\$	3,500.00		\$ 3,500.00

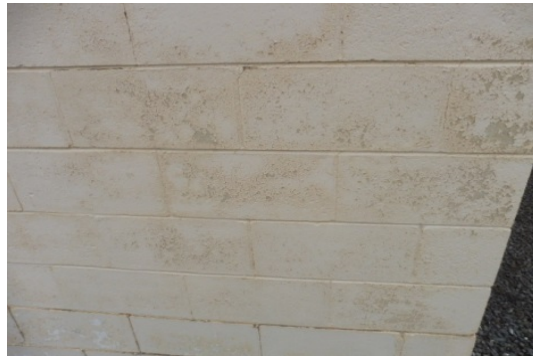
.2.2	Façades	Painted block elevations.	In poor overall condition.	Poor paintwork to finishes. Allow for repainting in the short term.	R&M	2		\$	5,000.00		\$ 5,000.00

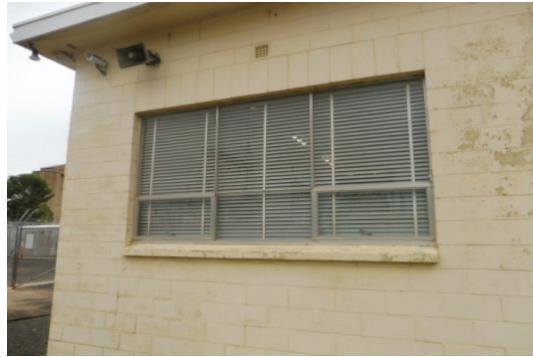
1.2.3 Windows & Doors												
.2.3.1	Windows	Metal framed single glazed windows.	In poor overall condition.	Aged windows beyond life expectancy with corroded frames in locations and panels boarded up with poor operations. Allow for short term replacement as required.	CAP	2		\$	20,000.00		\$ 20,000.00

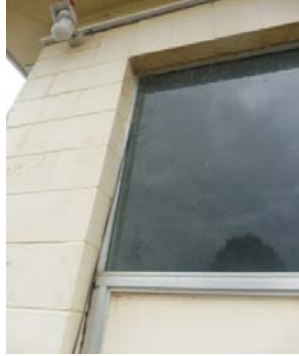
.2.3.2	Windows	Metal framed single glazed windows.	In poor overall condition.	A number of window seals are loose and require reinstating. Given we have recommended replacement in the short term no works required.	R&M	2			inc.		\$ -

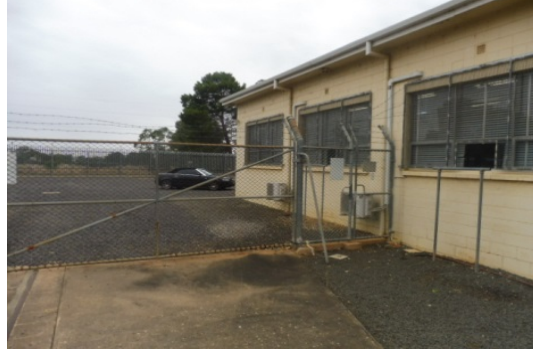
.2.3.3	Security Grills	Metal security grills fixed to external windows.	In fair overall condition.	Allow for replacement as part of the window upgrade works.	CAP	2		\$	3,000.00		\$ 3,000.00

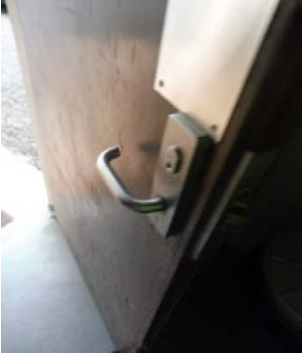
1.2.3.5	Joinery - Doors	Timber access doors with paint finish.	In poor to fair overall condition.	1 no. damaged door handle. Works covered in the above.	R&M	2	inc.			\$ -

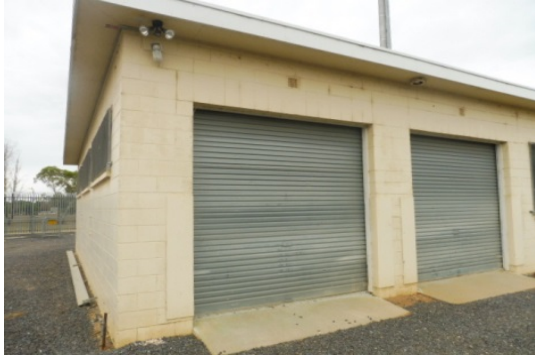
1.2.3.6	Joinery - Doors	Metal roller shutter doors.	In poor to fair overall condition.	3 no. roller doors are aged and would welcome replacement as part of the main upgrade works.	CAP	2	\$ 15,000.00			\$ 15,000.00

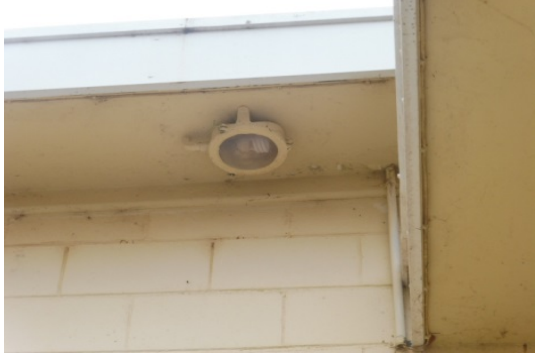
1.2.4 Fixtures & Fittings											
1.2.4.1	Fixtures & Fittings	Surface fixed spot light fittings.	In poor overall condition.	Aged lights and non energy efficient. Allow to replace with energy efficient lighting as required.	CAP	2	\$ 1,250.00			\$ 1,250.00

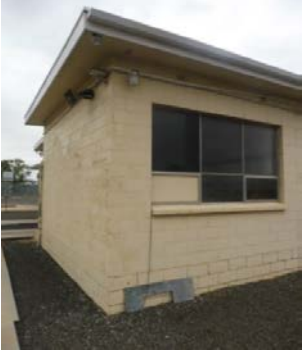
1.2.4.2	Fixtures & Fittings	CCTV with cameras externally and internally mounted.	In fair to good overall condition.	No major works required.	CAP	4				\$ -

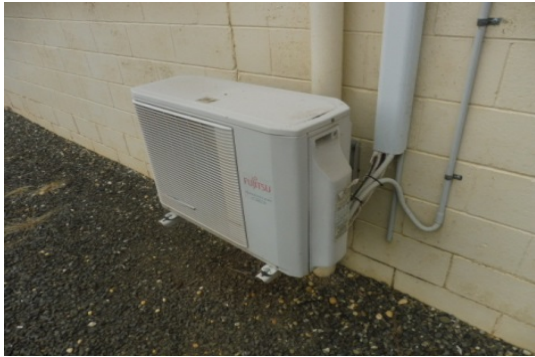
1.2.4.3	Fixtures & Fittings	Split System A/C units located to elevations.	In good overall condition.	Fujitsu R410A units in good condition. Allow for long term replacement due to life cycle of assets.	CAP	4			\$ 9,000.00	\$ 9,000.00

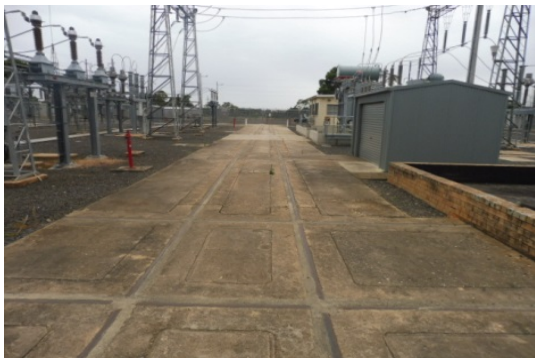
1.3.1.2	Access Roads within switchyard	Reinforced concrete hardstands.	In poor overall condition.	Aged footpaths but still operable. Allow to maintain or recover as required.	R&M	3	\$ 22,100.00			\$ 22,100.00

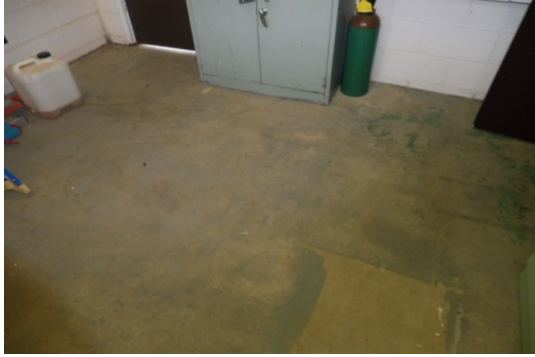
2.1.4	Floors	Exposed concrete floor.	In poor to fair overall condition.	No major works envisaged in reporting period. Allow for cleaning as required.	R&M	3	\$ 100.00	\$ 300.00	\$ 500.00	\$ 900.00

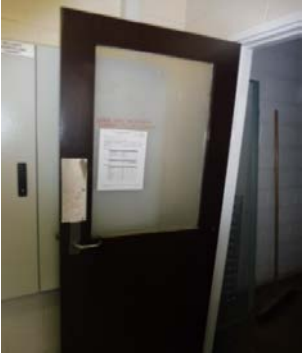
2.1.5	Joinery- Doors	Timber access doors with paint finish.	In poor to fair overall condition.	Aged internal timber doors. We would recommend replacing in the long term.	CAP	4			\$ 1,500.00	\$ 1,500.00

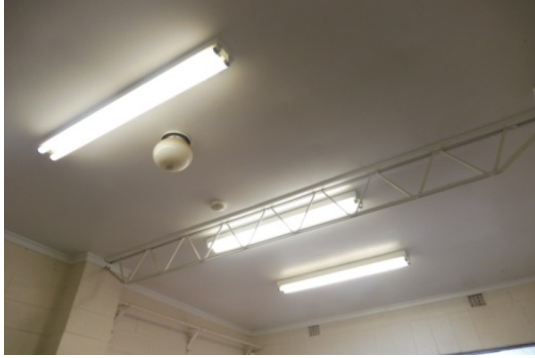
2.1.7	Windows	Metal framed single glazed windows.	In poor overall condition.	See external works.	CAP	2				\$ -	
2.1.8	Lighting	Surface mounted strip lights.	In poor overall condition.	Non energy Fluorescent strip lights. Allow for replacement in short term with new T5 or LED lights as required.	CAP	2	\$ 1,000.00			\$ 1,000.00

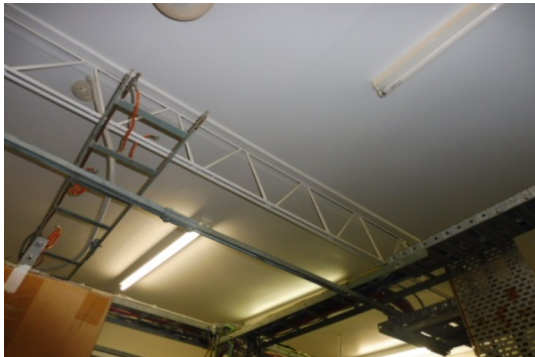
2.2.2	Ceilings	Suspended plasterboard ceiling with paint finish.	In fair overall condition.	Minor shrinkage cracking to ceiling. Allow for local repairs as part of any repainting works.	R&M	2	\$ 500.00			\$ 500.00

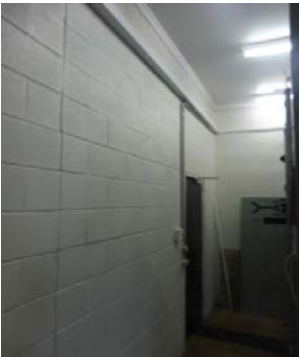
2.2.4	Walls	Painted masonry walls.	In poor to fair overall condition.	Allow for plaster skimming all walls to modernise the working conditions.	CAP	2	\$ 3,900.00			\$ 3,900.00

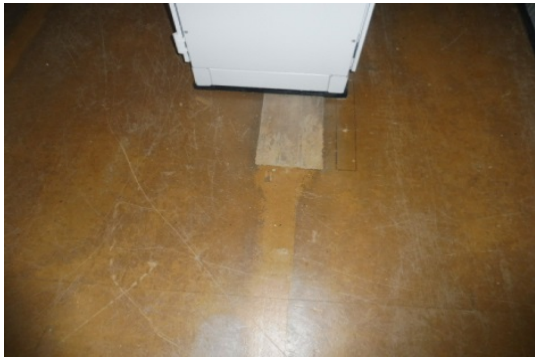
2.2.5	Walls	Painted masonry walls.	In poor to fair overall condition.	Allow for repainting works in the short term.	R&M	2	\$ 1,326.00			\$ 1,326.00	
2.2.6	Walls	Concrete floor with vinyl floor tiles laid over.	In poor overall condition.	Aged flooring and beyond life expectancy. Allow for replacement in the short term.	CAP	2	\$ 2,325.00			\$ 2,325.00

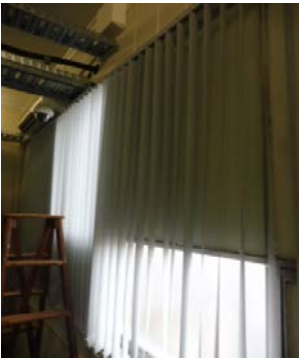
2.2.10	Windows	Metal framed single glazed windows with window blinds.	In poor overall condition.	See external works.	CAP	2				\$ -	
2.2.11	Window Blinds	Metal framed single glazed windows with window blinds.	In fair to good overall condition.	Allow for replacement of window blind as part of window replacement works.	CAP	3	\$ 200.00			\$ 200.00

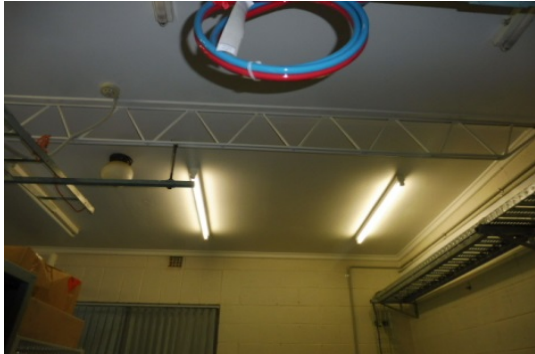
2.2.12	Lighting	Surface mounted strip lights.	In poor overall condition.	Non energy Fluorescent strip lights. Allow for replacement in short term with new T5 or LED lights as required.	CAP	2	\$ 2,500.00			\$ 2,500.00

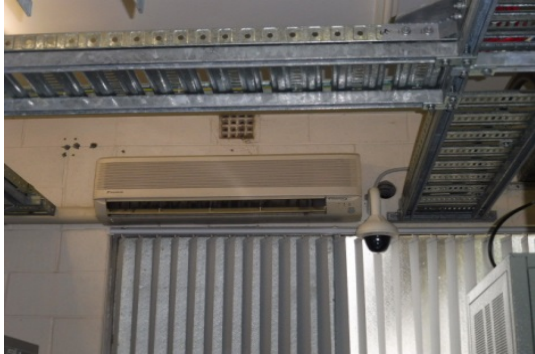
2.2.13	HVAC	Split A/C unit wall mounted.	In poor overall condition.	Aged Daikin unit and contains R22. Allow for short term replacement as required. See external works.	CAP	2	inc.			\$ -

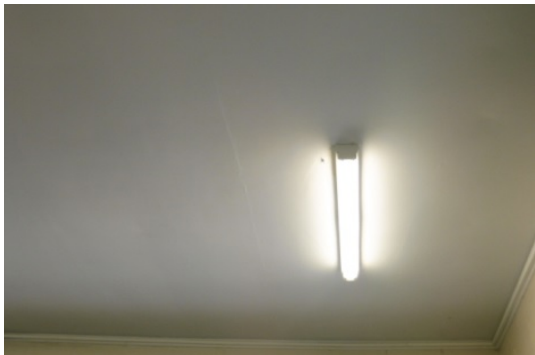
2.3.2	Ceilings	Suspended plasterboard ceiling with paint finish.	In fair overall condition.	Minor shrinkage cracking to ceiling in 6 locations. Allow for local repairs as part of any repainting works.	R&M	2		\$ 1,500.00		\$ 1,500.00

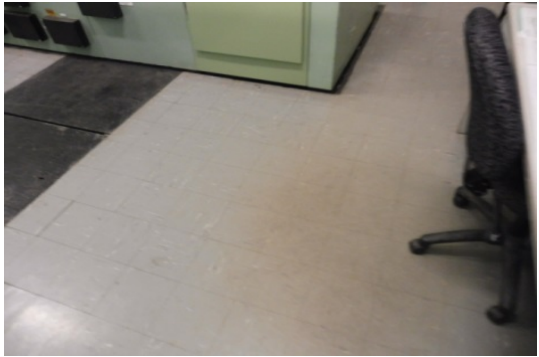
2.3.6	Walls	Concrete floor with vinyl floor tiles laid over.	In poor to fair overall condition.	Aged flooring and damaged in areas. Allow for replacement in the short term.	CAP	2	\$ 8,475.00			\$ 8,475.00

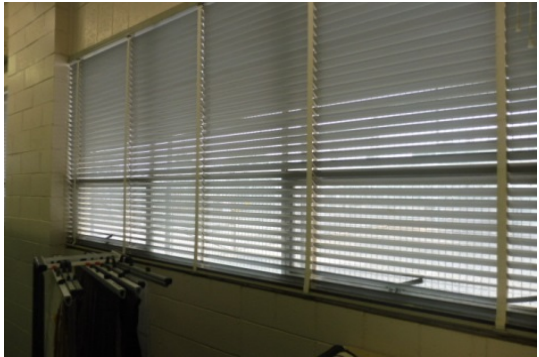
2.3.12	Window Blinds	Metal framed single glazed windows with window blinds.	In fair to good overall condition.	Allow for replacement of window blind as part of window replacement works.	CAP	3	\$ 1,200.00			\$ 1,200.00

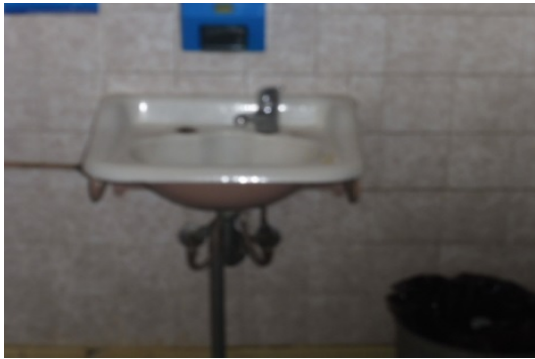
2.5.5	Walls	Painted masonry walls.	In poor to fair overall condition.	Allow for repainting works in the short term.	R&M	2	\$ 714.00			\$ 714.00	
2.5.6	Walls	Tiled splashback walls.	In poor overall condition.	Tiles date back to original construction. Allow for replacing all the tiles as part of modernisation works in short term.	CAP	2	\$ 5,000.00			\$ 5,000.00

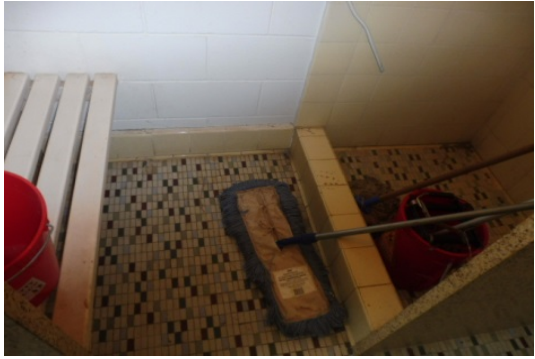
2.5.7	Floors	Concrete floor with ceramic tile floor covering.	In poor overall condition.	Tiles date back to original construction. Allow for replacing all the tiles as part of modernisation works in short term.	CAP	2	\$ 675.00			\$ 675.00

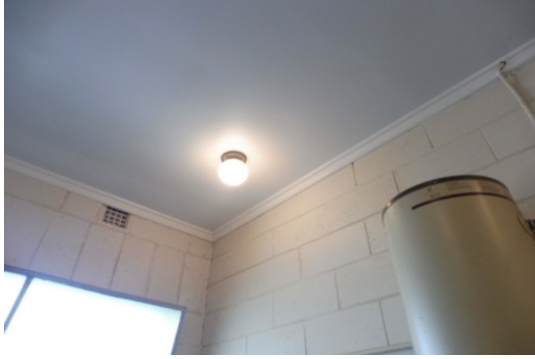
2.5.10	Windows	Metal framed single glazed windows.	In poor overall condition.	See external works.	CAP	2	inc.			\$ -	
2.5.11	Lighting	Surface mounted spot light.	In poor overall condition.	Non energy efficient light. Allow for replacement in short term with new T5 or LED lights as required.	CAP	2	\$ 750.00			\$ 750.00

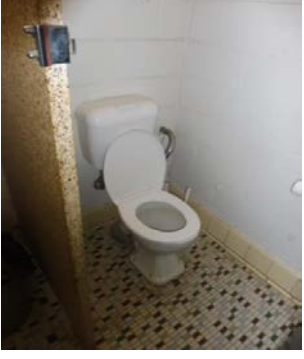
2.5.12	Fixtures and Fittings	Vitreous china WHBs, WCs and shower units.	In poor overall condition.	Dated sanitaryware. Allow for replacement works as part of toilet modernisation works.	CAP	2	\$ 13,500.00			\$ 13,500.00

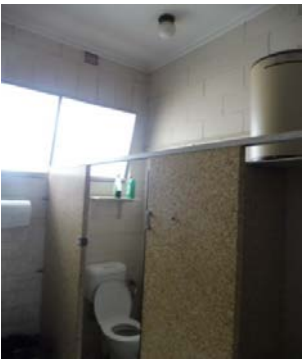
2.5.13	Fixtures and Fittings	Granite type original WC/shower cubicles.	In poor overall condition.	Cubicles date back to original construction. Allow for replacing all the cubicles as part of modernisation works in short term.	CAP	2	\$ 3,000.00			\$ 3,000.00

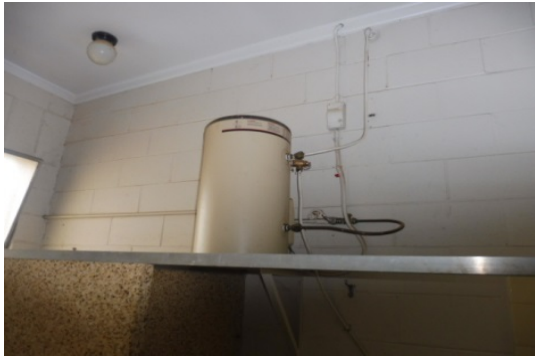
2.5.14	Hot water heater	Electric Hot Water tank.	In poor overall condition.	Beyond life expectancy. Supply and install new water heater in short term.	CAP	2	\$ 2,500.00			\$ 2,500.00

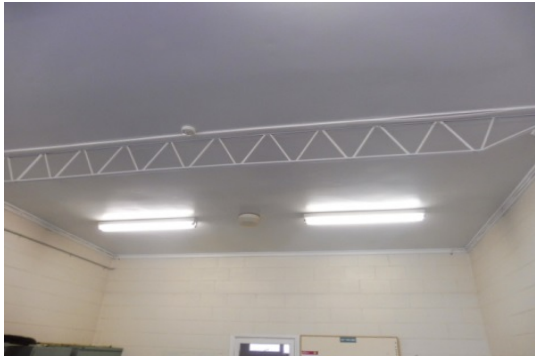
2.6.2	Ceilings	Suspended plasterboard ceiling with paint finish.	In fair overall condition.	Allow for repainting works in the medium term.	R&M	2		\$ 561.00		\$ 561.00

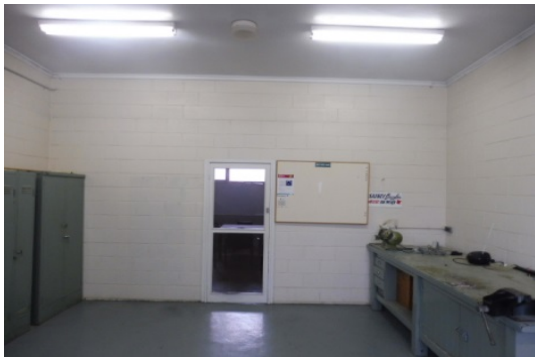
2.6.3	Walls	Painted masonry walls.	In poor to fair overall condition.	Allow for plaster skimming all walls to modernise the working conditions.	CAP	2	\$ 4,050.00			\$ 4,050.00

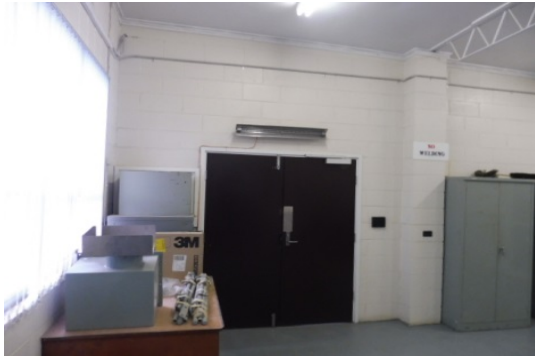
2.6.7	Joinery- Doors	Timber access doors with paint finish.	In poor to fair overall condition.	Aged internal timber doors. We would recommend replacing in the long term.	CAP	4			inc.	\$ -

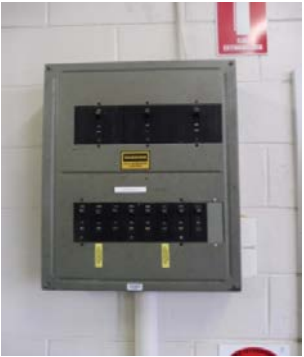
2.6.13	Distribution boards	Electrical distribution board(s).	In poor overall condition.	Beyond life expectancy and no RCD's. Given limitations on spare parts and upgrades required we would recommend a new board be installed.	CAP	2	\$ 5,000.00			\$ 5,000.00

The electrical services are generally in fair condition albeit aged and would welcome an overhaul in the reporting period given their age and parts becoming obsolete. There are distribution boards which do not contain RCD protection, which was required from the 18<sup>th</sup> February 2015 under Occupational Health and Safety Amendment (Residual Current Devices) Regulation 2011. The wiring to the property appears to be in fair condition and we do not expect any major rewiring is required within the reporting period.

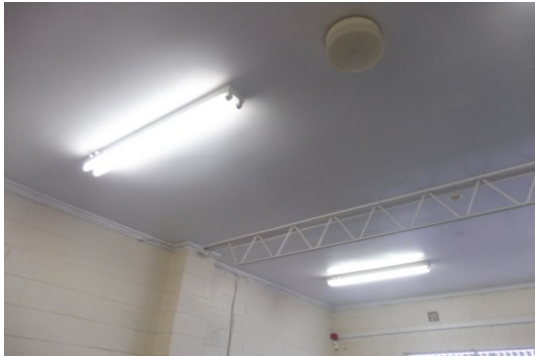
2.7.2	Ceilings	Suspended plasterboard ceiling with paint finish.	In fair overall condition.	Allow for repainting works in the medium term.	R&M	2		\$ 520.00		\$ 520.00

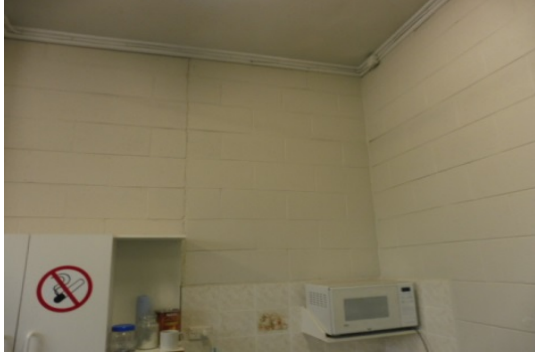
2.7.3	Walls	Painted masonry walls.	In fair overall condition.	Allow for plaster skimming all walls to modernise the working conditions.	CAP	2		\$ 3,550.00		\$ 3,550.00

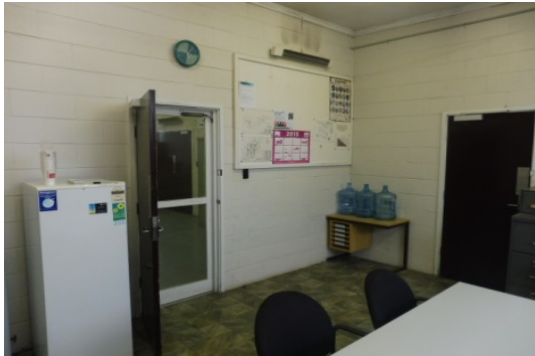
2.7.12	Fixtures and Fittings	Wall mounted electric wall heater.	In poor overall condition.	Aged heaters. Evidence of poorly functioning wall heater. Allow for short term replacement.	CAP	2	\$ 500.00			\$ 500.00

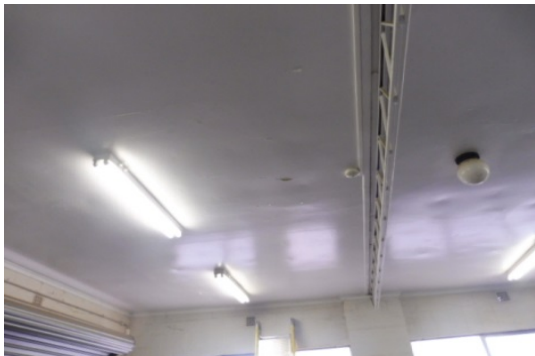
2.8.2	Ceilings	Suspended plasterboard ceiling with paint finish.	In poor to fair overall condition.	Peeling paint in locations. Allow for repainting works in the short term.		2	\$ 1,640.00			\$ 1,640.00

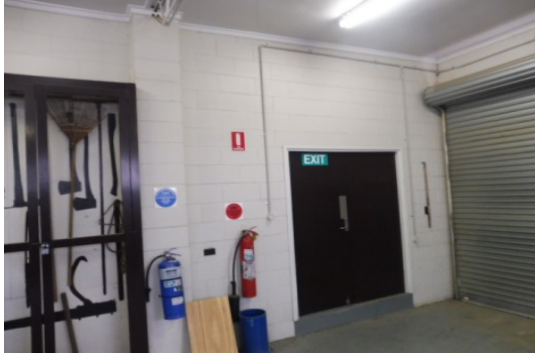
2.8.3	Walls	Painted masonry walls.	In poor to fair overall condition.	Allow for repainting works in the short term.	R&M	2	\$ 2,210.00			\$ 2,210.00

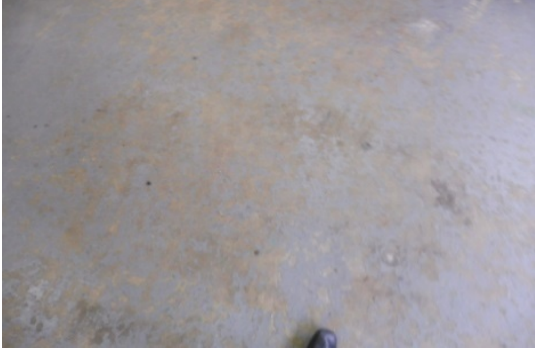
2.8.4	Floors	Concrete floor with an epoxy painted membrane.	In poor overall condition.	Allow for repainting the floor in the short term.	CAP	2	\$ 2,460.00			\$ 2,460.00

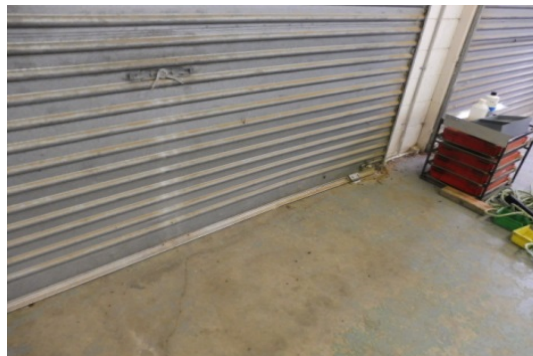
2.8.5	Floors	Concrete floor with an epoxy painted membrane.	In poor overall condition.	Local settlement cracking to floor. Repair as part of the repainting works.	R&M	2		\$	3,500.00		\$	3,500.00

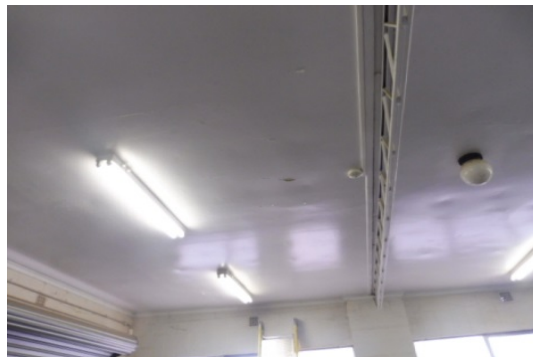
2.8.10	Lighting	Surface mounted strip lights.	In poor overall condition.	Non energy Fluorescent strip lights. Allow for replacement in short term with new T5 or LED lights as required.	CAP	2		\$	2,250.00		\$	2,250.00

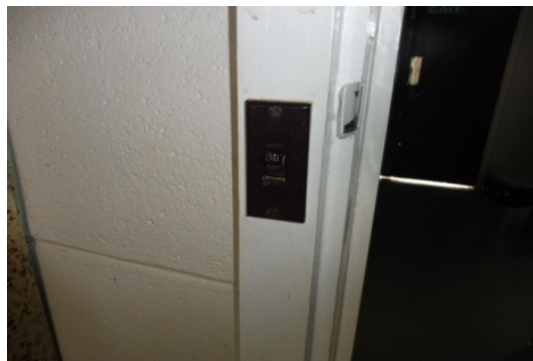
3.14	Building Services Generally	Mains Distribution board and switchboards.	In poor overall condition.	See above allocations as required.	CAP	2							\$	-
