BUILDING CONDITION REPORT

TransGrid

Sydney East (Belrose) Substation, Wyatt Avenue, Belrose NSW 2085

6 May 2016

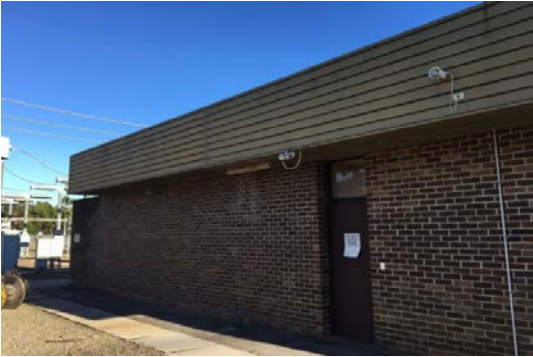
1.1.2	Fascia and Soffits	Metal fascias and soffits.	In poor to fair overall condition.	Isolated corrosion and deterioration noted. Allow to replace coverings in the medium term in conjunction with main roof.	CAP	4				\$ 10,500.00	\$ 10,500.00

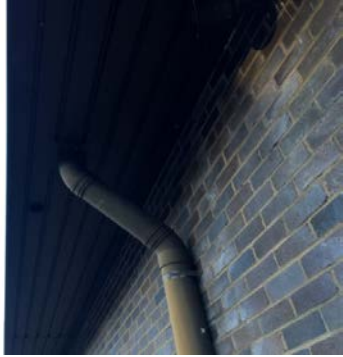
1.1.3	Roof Drainage										
1.1.3.1	Drainage	Metal and uPVC rainwater goods.	In fair to good overall condition.	Allow to replace rainwater goods in-line with roof coverings in the medium term.	CAP	4				\$ 3,500.00	\$ 3,500.00

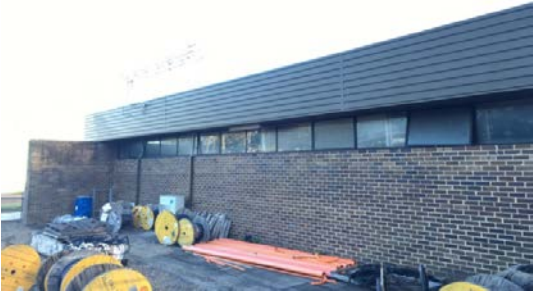
1.2.1	Façades	Fair faced cavity brick elevations.	In fair to good overall condition.	No action required.	CAP	4				\$ -

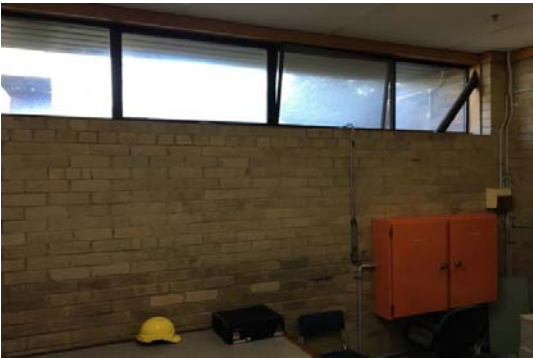
1.2.2.1	Windows	Metal framed single glazed windows	In fair to good overall condition.	Allow for long term overhaul to replace seals, gaskets etc.	CAP	4				\$ 10,000.00	\$ 10,000.00

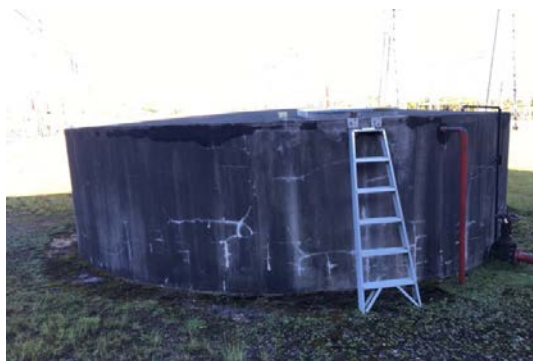
1.3.3 External Ancillary Buildings												
1.3.3.1	Water tanks	Circular concrete water storage tank.	In fair overall condition.	Allow for lifecycle replacement of 2 no tank in the medium term.	CAP	3		\$	40,000.00	\$	40,000.00

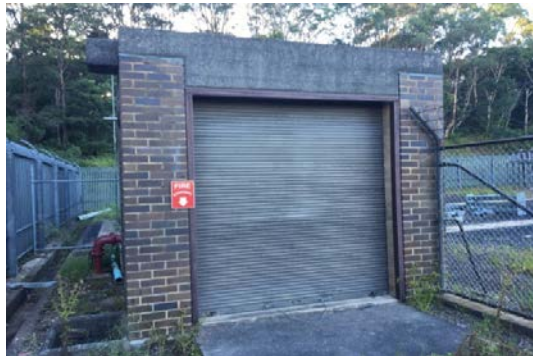
1.3.3.2	Diesel Generator / Pump Room	Brickwork walls with timber framed roof and tiled roof coverings draining to metal rainwater goods. Metal faced timber access doors.	In fair to good overall condition.	Allow for short term overhaul of doors, roof repairs and redecoration of previously painted surfaces.	R&M	3		\$	1,500.00	\$	1,500.00

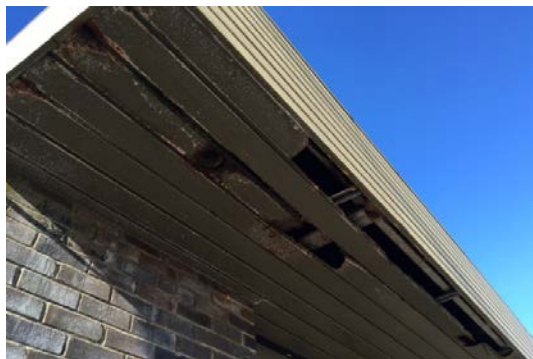
1.3.3.3	415 KV Outbuilding	Brickwork walls with profile sheet roof coverings draining to metal rainwater goods. Note - this building may be disused.	In poor to fair overall condition.	Allow to replace coverings and rainwater goods in the medium term.	CAP	3		\$	67,500.00	\$	67,500.00

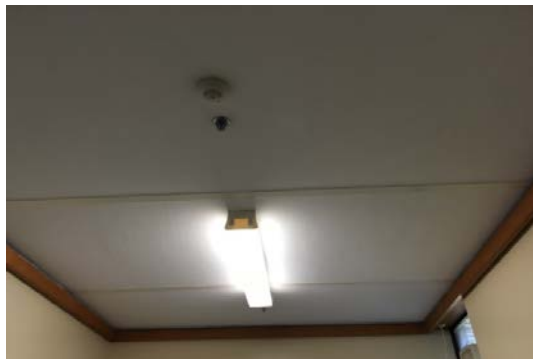
2.1.1	Ceilings	Suspended ceiling with exposed grid and lay-in tiles.	In fair to good overall condition.	No action required.	CAP	4				\$	-

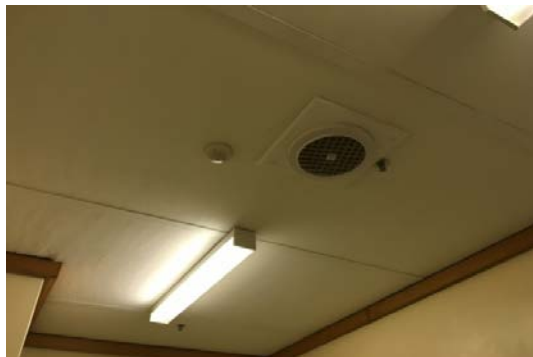
2.2.1	Ceilings	Suspended plasterboard ceiling with paint finish.	In fair to good overall condition.	Allow to repaint surfaces.	R&M	3			\$	300.00		\$ 300.00

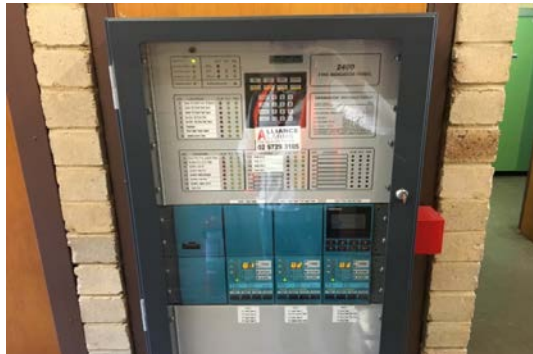
3.4	Building Services Generally	FIP	In good overall condition.	We don't envisage any major replacement works in the reporting period. Maintain annually.	R&M	1	inc.	inc.	inc.	inc.	\$ -

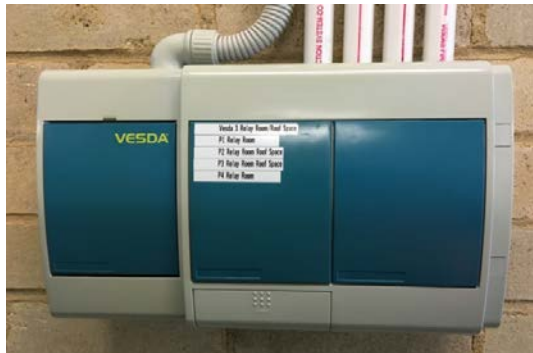
3.5	Building Services Generally	VESDA system.	In good overall condition.	We don't envisage any major replacement works in the reporting period. Maintain annually.	R&M	2	\$ 5,000.00	\$ 10,000.00	\$ 15,000.00	\$ 25,000.00	\$ 55,000.00

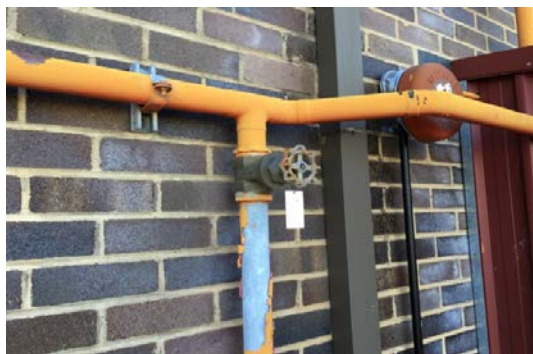
3.8	Building Services Generally	Pipework and pumps.	In poor overall condition.	Allow for repainting in the immediate term to prevent further deterioration.	R&M	1	\$ 7,500.00				\$ 7,500.00

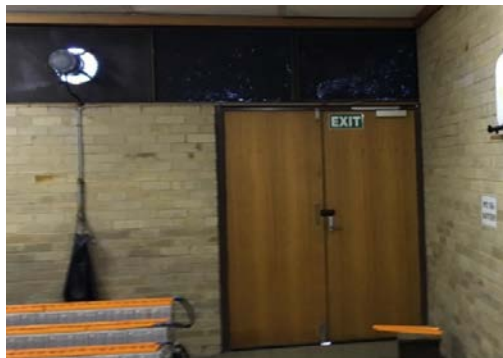
3.9	Building Services Generally	Emergency Exit lights.	In poor overall condition.	Missing and not BCA compliant. Allow for installation in the short term as required.	BCA	1	\$ 20,000.00				\$ 20,000.00

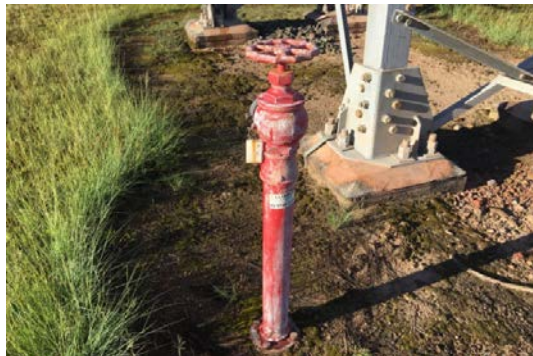
3.10	Building Services Generally	Fire Hydrants site wide.	In fair overall condition.	Allow for repainting and testing and tagging as required.	R&M	1	\$ 2,000.00	\$ 4,000.00	\$ 6,000.00	\$ 10,000.00	\$ 22,000.00

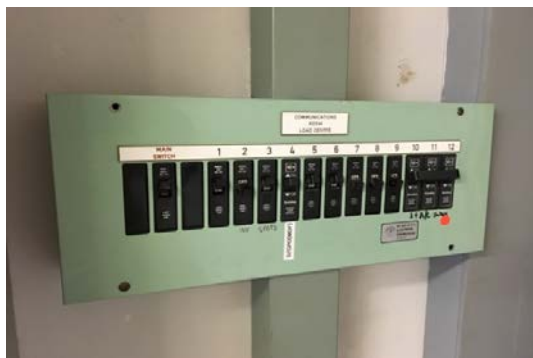
3.11	Building Services Generally	Mains Distribution board and switchboards.		Aged but still performing. 1no board noted with RCDs, remainder contain no RCDs. Allow for short term replacement of the affected boards.	CAP	2		\$ 10,000.00			\$ 10,000.00

The electrical services are generally in fair condition albeit aged and would welcome an overhaul in the reporting period given their age and parts becoming obsolete. There are distribution boards which do not contain RCD protection, which was required from the 18th February 2015 under Occupational Health and Safety Amendment (Residual Current Devices) Regulation 2011. The wiring to the property appears to be in fair condition and we do not expect any major rewiring is required within the reporting period.
