BUILDING CONDITION REPORT

TransGrid

Wellington Sub Station, Gulgong Road, Wellington, NSW

6 May 2016

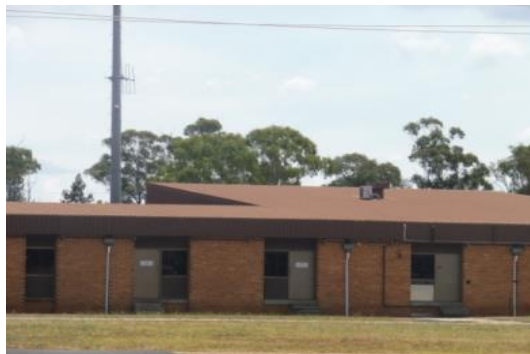
1.1	Roof											
1.1.1	Main Roof Coverings	Fibre glass and asbestos roof sheets.	In poor overall condition.	Aged and beyond life cycle. Allow for replacement in the short term.	CAP	2		\$ 169,000.00			\$ 169,000.00

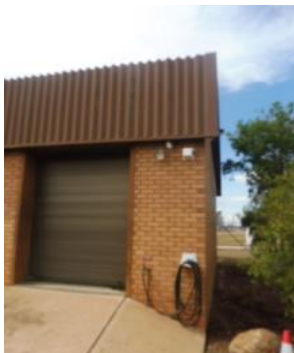
1.1.2	Fascia and Soffits	Fibre glass and asbestos fascia and soffit boards.	In poor overall condition.	Aged and beyond life cycle. Allow for replacement in the short term.	CAP	2		\$ 11,775.00			\$ 11,775.00

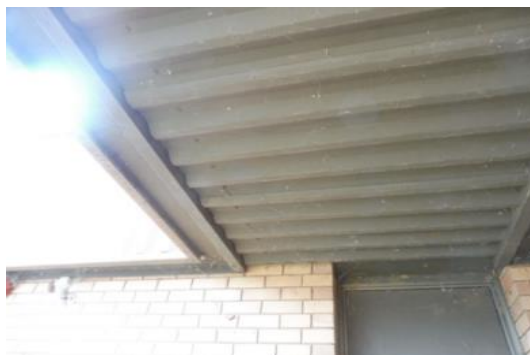
1.1.3	Fascia and Soffits	Metal soffit board to main entrance.	In poor overall condition.	Aged and beyond life cycle. Allow for replacement in the short term.	CAP	2		\$ 1,250.00			\$ 1,250.00

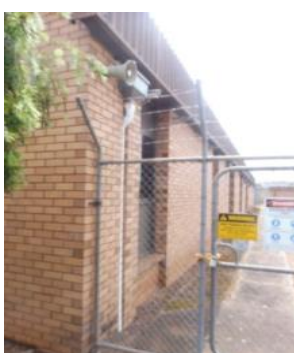
1.1.4	Roof Drainage											
1.1.4.1	Drainage	Metal box gutters with hopper heads and UPVC downpipes.	In poor to fair overall condition.	Aged and beyond life cycle. Allow for replacement in the short term as part of the proposed roofing works.	CAP	2		\$ 11,775.00			\$ 11,775.00

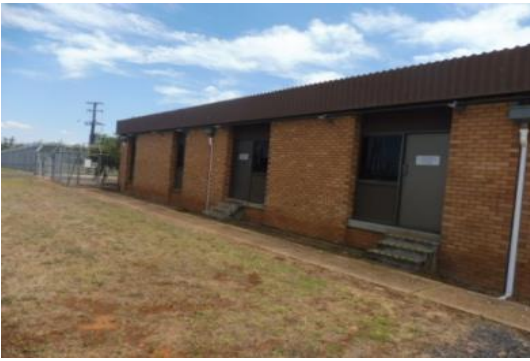
1.2.2	Façades	Fair faced blockwork elevations.	In poor to fair overall condition.	Minor discolouration to low level brick work in R&M locations. Allow for cleaning as required.	R&M	3	\$ 1,500.00			\$ 1,500.00

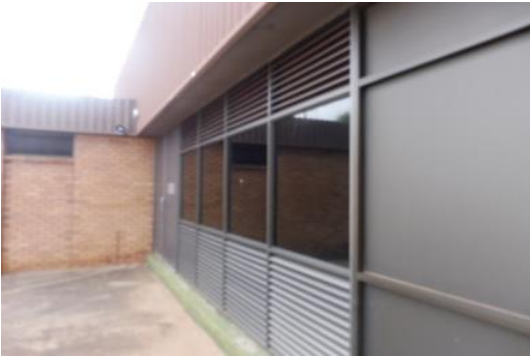
1.2.3	Windows & Doors										
1.2.3.1	Windows	Metal framed single glazed windows.	In poor to fair overall condition.	Windows still performing but aged and beyond life cycle. Allow for long term replacement as required.	CAP	4			\$ 27,000.00	\$ 27,000.00

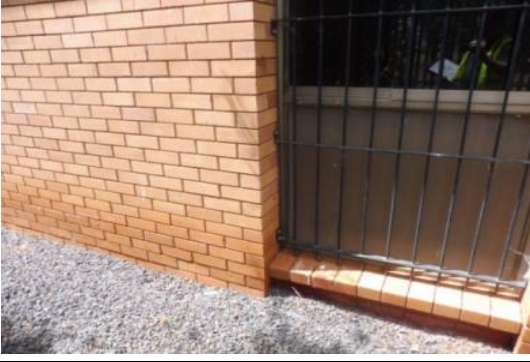
1.2.3.2	Windows	Metal framed single glazed windows with security bars.	In poor to fair overall condition.	Windows and bars are still performing but aged and beyond life cycle. Allow for long term replacement as required.	CAP	4			\$ 1,500.00	\$ 1,500.00

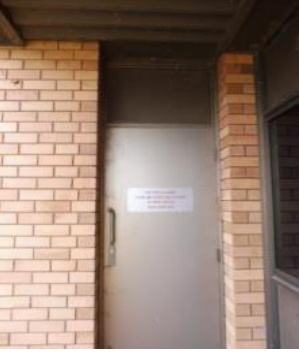
1.2.3.4	Doors	Metal framed access doors with powder coated finish.	In poor to fair overall condition.	Doors still performing but aged and beyond life cycle. Allow for long term replacement as required.	CAP	4			\$ 14,000.00	\$ 14,000.00

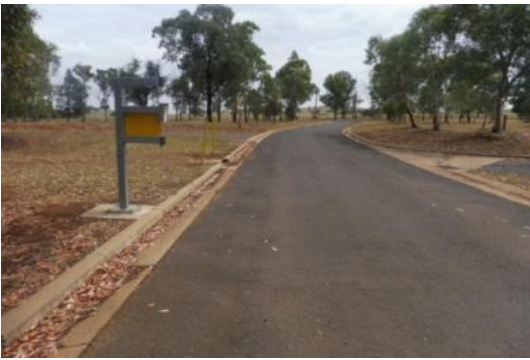
1.3.1.5	Access Roads	On-grade tarmacadam road surfaces.	In fair overall condition.		2		\$ 5,000.00			\$ 5,000.00

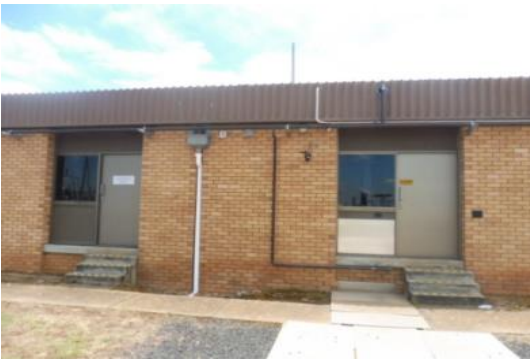
1.3.1.6	Steps	Concrete steps.	In poor to fair overall condition.	R&M	2		\$ 500.00			\$ 500.00

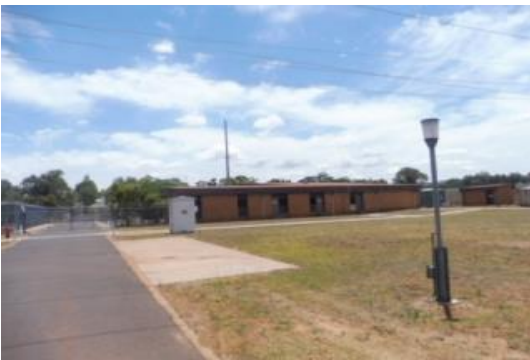
1.3.1.7	Switchyard Access Roads	On-grade tarmacadam road surfaces.	In fair to good overall condition.	R&M	4				\$ 10,000.00	\$ 10,000.00

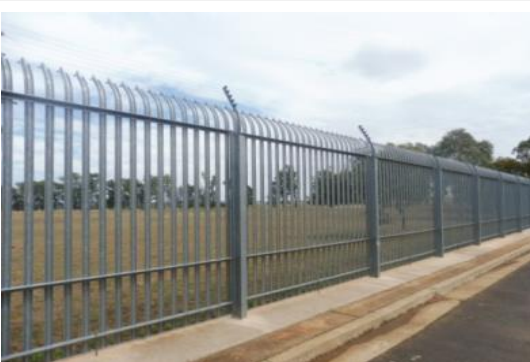
1.3.2.1	Perimeter Fencing	Metal palisade fencing.	In fair overall condition.	CAP	4					\$ -

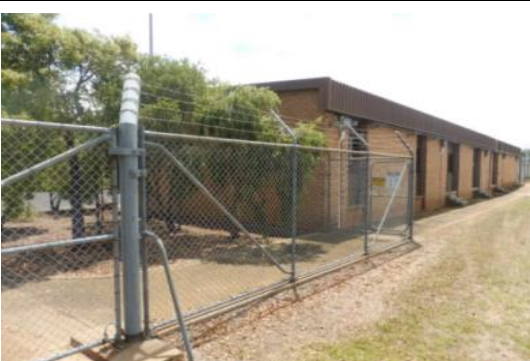
1.3.2.2	Switchyard internal Fencing	Metal post and chain wire fence.	In poor to fair overall condition.	CAP	3		\$ 9,750.00			\$ 9,750.00

- The main access road is in fair condition with isolated areas of wear evident;
- The boundary fencing is considered to be in fair condition. We would recommend the chain link fence be replaced in the medium term due to corrosion. In addition regular maintenance of the associated security/entry gates will be required over the reporting period.

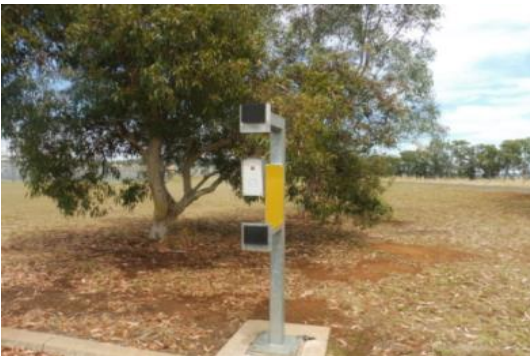
1.3.2.3	Entry Gates	Mechanically operated sliding metal entry gate and control.	In fair to good overall condition.	No major capital works envisaged in the reporting period.	CAP	4				\$ -

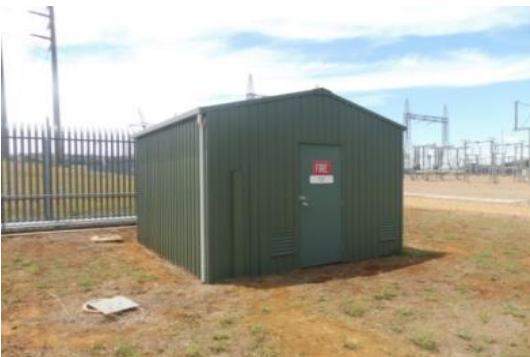
1.3.3 External Ancillary Buildings											
1.3.3.1	Sprinkler Control Room	Steel framed storage shed with metal profiled cladding (small).	In good overall condition.	No major capital works envisaged in the reporting period.	CAP	4				\$ -

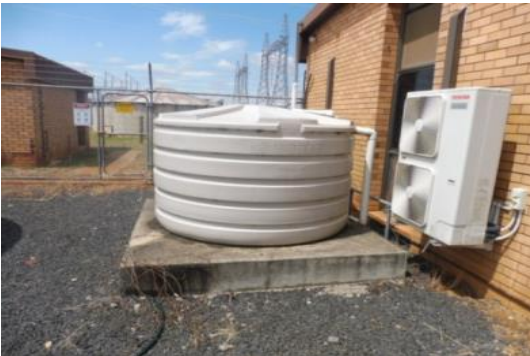
1.3.3.2	Water tanks	Circular UPVC storage tanks.	In good overall condition.	No major capital works envisaged in the reporting period.	CAP	4				\$ -

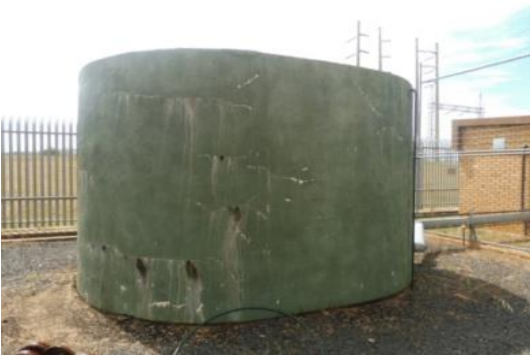
1.3.3.3	Water tanks	Circular concrete water storage tank.	In poor overall condition.	Localised cracking to concrete tank and dates back to original construction. Allow for short term repairs and medium term replacement subject to use of tank.	CAP	2	\$ 1,500.00	\$ 20,000.00		\$ 21,500.00

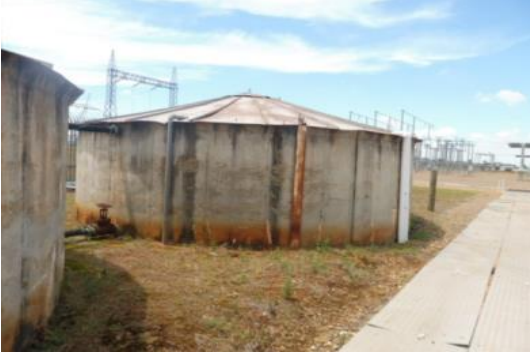
1.3.3.4	Water tanks	Circular concrete water storage tank.	In poor overall condition.	Water tanks date back to original construction date with cracking and water staining. Given their age and condition these should be replaced in the short term.	CAP	2	\$ 40,000.00			\$ 40,000.00

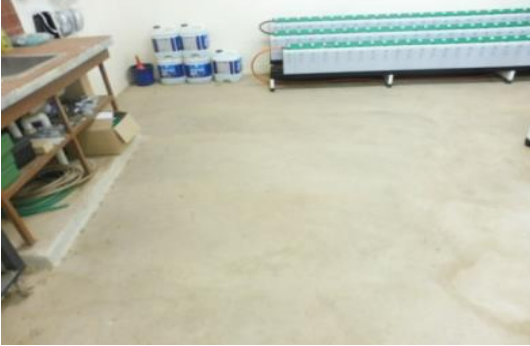
2.1.7	Floors	Exposed concrete floor.	In poor to fair overall condition.	Allow for correctly waterproofing and bunding the floor as required in the short term.	R&M	2	\$ 3,600.00			\$ 3,600.00

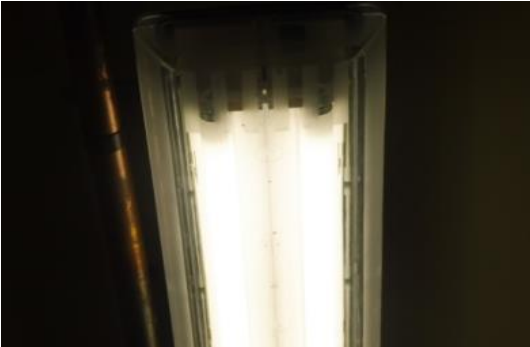
2.1.9	Lighting	IP rated double rated fluorescent surface mounted lights.	In fair to good overall condition.	Modern light fittings. No major works required in reporting period. Budget for replacement tubes as required.	R&M	2		\$ 500.00		\$ 500.00

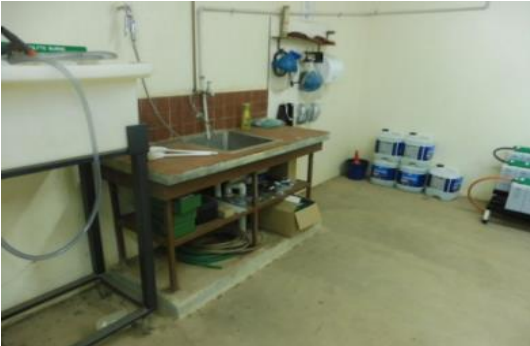
2.1.10	Fixtures and Fittings	Stainless steel sink housed in concrete and metal vanity unit with tile splash back.	In poor overall condition.	Allow for replacement of unit in the short term.	CAP	2	\$ 5,000.00			\$ 5,000.00

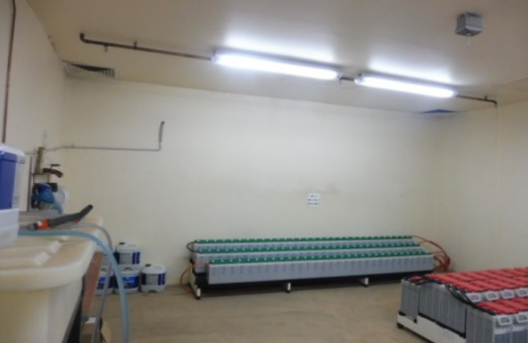
2.1.11	Emergency shower and eyewash station	Small hose pipe provided but not compliant to modern standards.	In poor overall condition.	Install new emergency shower and eyewash station as required to meet current standards.	BCA	1	\$ 10,000.00			\$ 10,000.00

There is no WH&S Emergency shower and eyewash station within one battery room. We have budgeted for immediate replacement of this item.

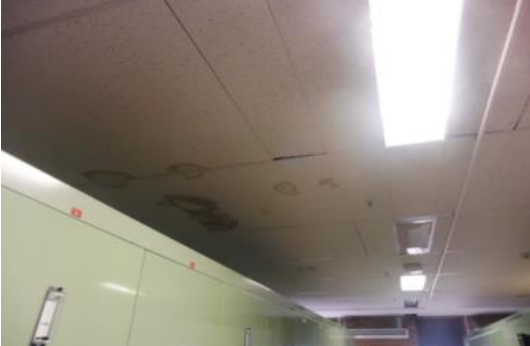
2.2	Relay Room										
2.2.1	Ceilings	Suspended ceiling with exposed grid and lay-in tiles.	In poor overall condition.	Aged ceiling tiles with a number of water damaged tiles from roof leaks. We would recommend replacement of all tiles as part of the roofing works in the short term.	CAP	2	\$ 13,800.00			\$ 13,800.00

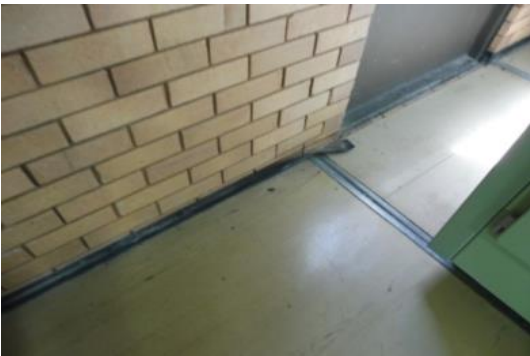
2.2.3	Walls	Fair faced brick walls with coved skirting.	In fair overall condition.	Allow for replacement of coved skirting as part of floor works.	CAP	2	\$ 1,350.00			\$ 1,350.00

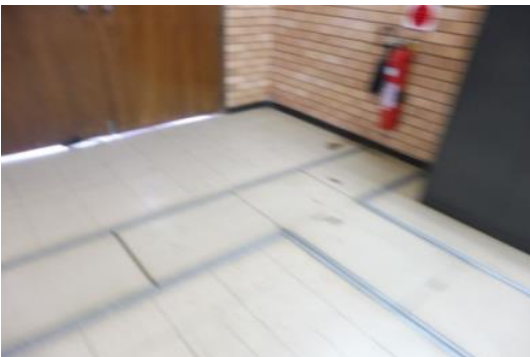
2.2.4	Floors	Concrete floor with vinyl floor tiles laid over.	In poor overall condition.	Aged floor coverings with local damage and heavily soiled. Allow for short term replacement as required.	CAP	2	\$ 13,800.00			\$ 13,800.00

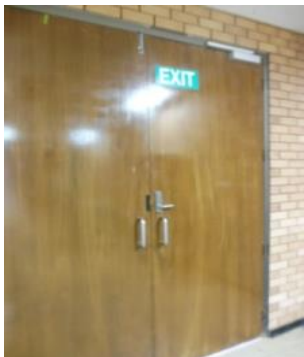
2.2.6	Joinery- Doors	Pre-finished timber access doors.	In poor to fair overall condition.	Aged doors. Allow for medium term replacement as required.	CAP	2		\$ 2,000.00		\$ 2,000.00

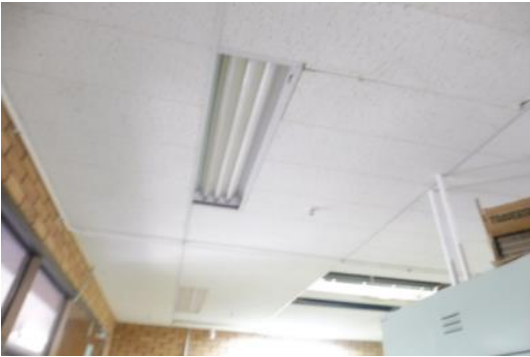
2.2.7	Windows	Metal framed single glazed windows.	In poor to fair overall condition.	See external works.	CAP	4			inc.	\$ -	
2.2.8	Lighting	Recessed strip light fittings with diffusers.	In poor overall condition.	Non energy Fluorescent strip lights. Allow for replacement in short term with new T5 or LED lights as required.	CAP	2	\$ 5,000.00			\$ 5,000.00

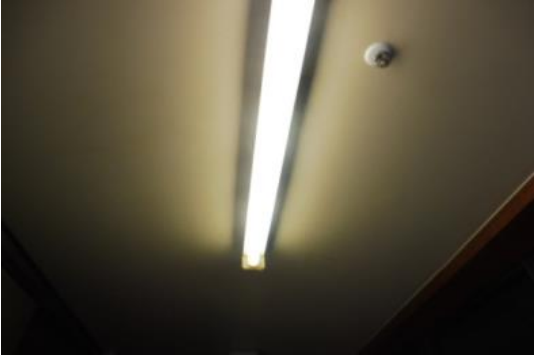
2.3.6	Windows	Metal framed single glazed windows.	In poor to fair overall condition.	See external works.	CAP	4			inc.		
2.3.7	Lighting	Surface mounted strip lights.	In poor overall condition.	Non energy Fluorescent strip lights. Allow for replacement in short term with new T5 or LED lights as required.	CAP	2	\$ 1,250.00			\$ 1,250.00

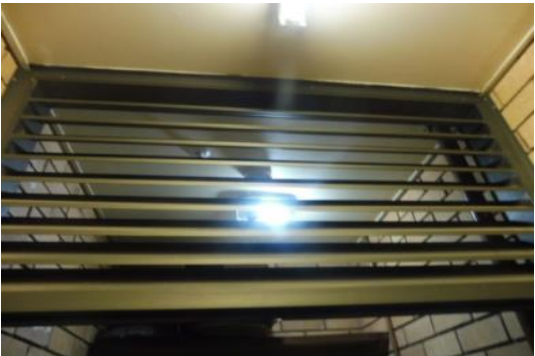
2.4.3	Ceilings - cleaners	Suspended plasterboard ceiling with paint finish.	In poor overall condition.	Allow for repainting in the short term.	R&M	2	\$ 200.00			\$ 200.00

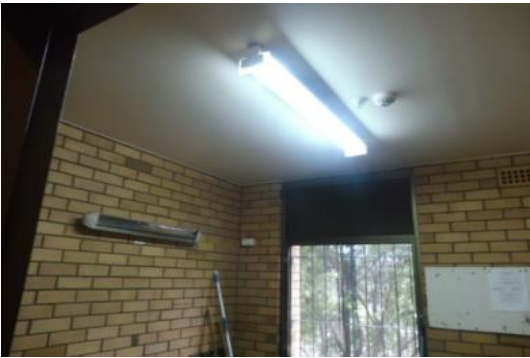
2.6.2	Ceilings	Suspended plasterboard ceiling with paint finish.	In fair overall condition.	Allow for repainting in the medium term.	R&M	3		\$ 160.00		\$ 160.00

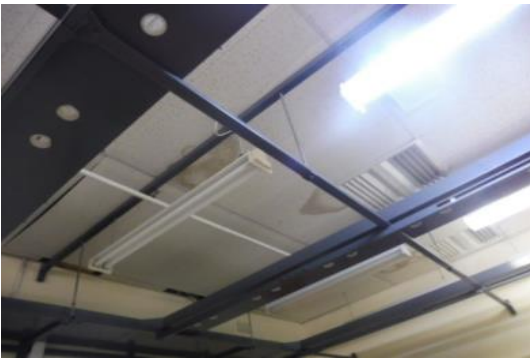
2.8.12	Ventilation	Mechanical extract fan ceiling mounted.	In fair overall condition.	Allow for replacement as part of the proposed CAP ceiling replacement works.	4				\$ 1,500.00	\$ 1,500.00

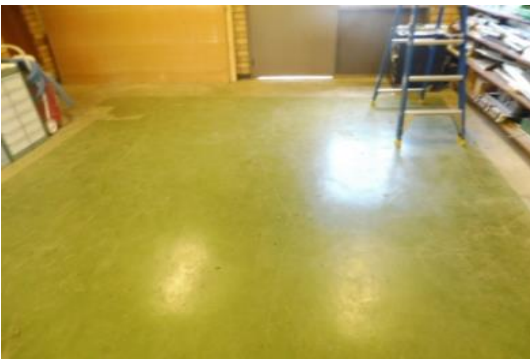
2.10.5	Floors	Concrete floor with an epoxy painted membrane.	In poor overall condition.	Faded paint to floor. Allow for repainting in the reporting period.	CAP	3		\$ 900.00		\$ 900.00

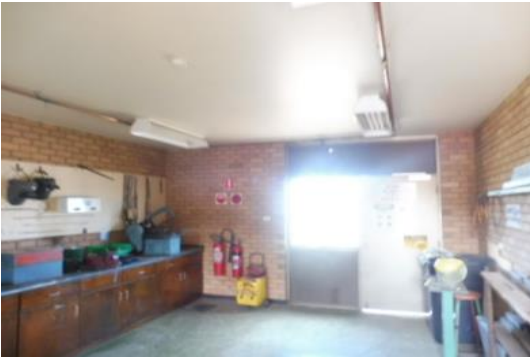
2.11.2	Ceilings	Suspended plasterboard ceiling with paint finish.	In poor to fair overall condition.	Allow for repainting in the short term.	R&M	3	\$ 600.00			\$ 600.00

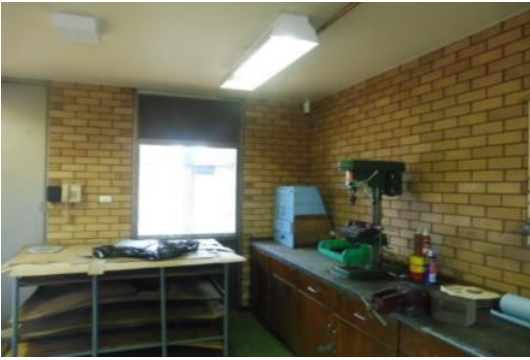
2.11.4	Walls	Fair faced brick walls with coved skirting.	In poor to fair overall condition.	Allow for replacement of coved skirting as part of floor works.	CAP	3	\$ 575.00			\$ 575.00

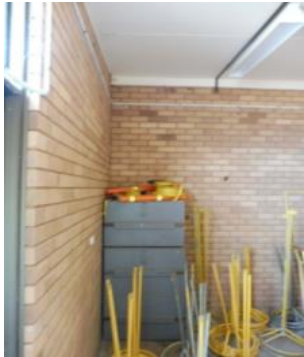
2.14.9	Lighting	Surface mounted strip lights.	In poor overall condition.	Allow for short term replacement subject to current and future use of the building.	CAP	2		\$ 2,500.00		\$ 2,500.00

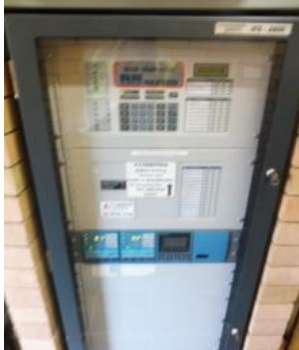
3.5	Building Services Generally	Fire indicator panel - Analogue	In poor to fair overall condition.	Allow for modernisatin works and new digital panel as required in the reporting period.	CAP	2			\$ 45,000.00		\$ 45,000.00

The fire control panel is analogue. We would recommend modernisation works in the reporting period.

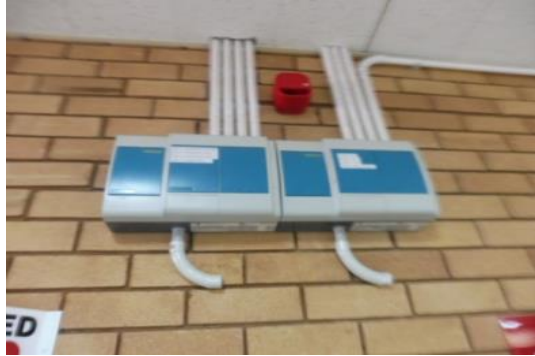
3.6	Building Services Generally	VESDA system.	In good overall condition.	We don't envisage any major replacement works in the reporting period. Maintain annually.	R&M	2	\$ 2,000.00	\$ 4,000.00	\$ 6,000.00	\$ 10,000.00	\$ 22,000.00
