BUILDING CONDITION REPORT

TransGrid

Wallerawang 330 Sub Station, Main Street, Wallerawang, NSW

6 May 2016

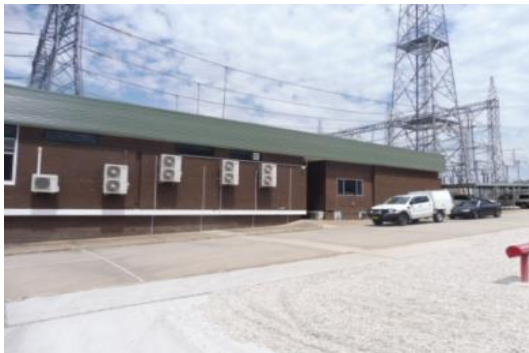
1.1	Roof																
1.1.1	Main Roof Coverings	Steel framed roof structure covered with profile metal sheeting.	In poor overall condition.	Roof dates back to the original construction date and beyond life cycle. Allow for replacement in the short to medium term.	CAP	2	\$	154,000.00		\$	154,000.00

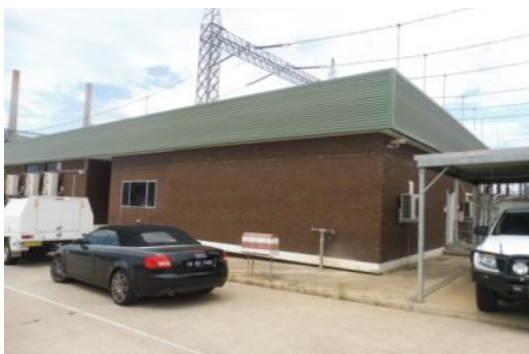
1.1.2	Fascia & Soffits	Metal fascia boards with assumed asbestos soffits	In poor overall condition.	Fascia boards date back to the original construction date and beyond life cycle. Allow for replacement in the short to medium term.	CAP	2	\$	17,400.00		\$	17,400.00

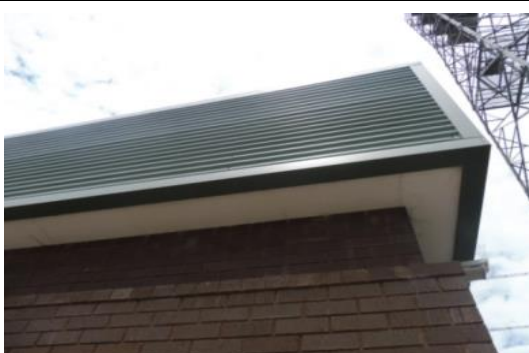
1.1.3	Fascia & Soffits	Metal fascia boards with assumed asbestos soffits	In poor overall condition.	Soffit boards date back to the original construction date, are suspect asbestos and beyond life cycle. Allow for replacement in the short to medium term.	CAP	2	\$	8,700.00		\$	8,700.00

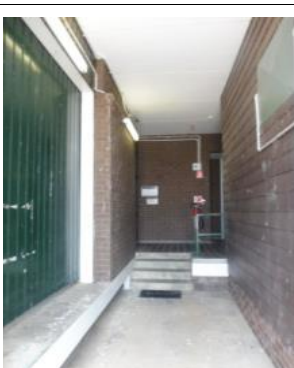
1.1.4	Entrance soffits	Assumed asbestos soffits.	In poor overall condition.	Soffit boards date back to the original construction date, are suspect asbestos and beyond life cycle. Allow for replacement in the short to medium term.	CAP	2	\$	1,500.00		\$	1,500.00

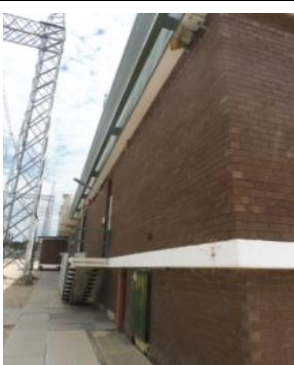
1.1.5.1	Drainage	Metal eaves gutters draining to metal downpipes.	In poor overall condition.	Roof drainage dates back to the original construction date and beyond life cycle. Allow for replacement in the short to medium term as part of the roofing works.	CAP	2	\$	8,700.00		\$	8,700.00

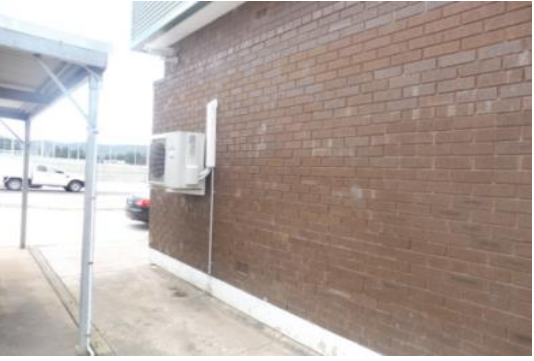
1.2.1	Façades	Fair faced cavity brick elevations.	In poor to fair overall condition.	Efflorescence staining and aged brickwork. Subject to future use of building allow for cleaning brickwork as required.	R&M	3	\$ 1,625.00			\$ 1,625.00

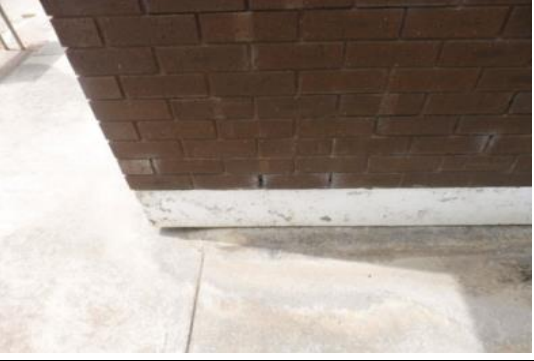
1.2.2	Façades	Fair faced cavity brick elevations.	In poor overall condition.	Local cracking to concrete edge beam by entrance. Allow for local repairs as required.	R&M	2	\$ 1,000.00			\$ 1,000.00

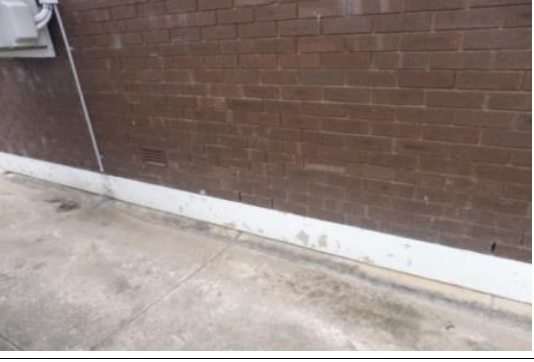
1.2.3	Façades	Steel framed roof structure covered with profile metal sheeting.	In poor overall condition.	Peeling paintwork at low level to the concrete edge beam. Allow for repainting in short term.	R&M	2	\$ 3,480.00			\$ 3,480.00

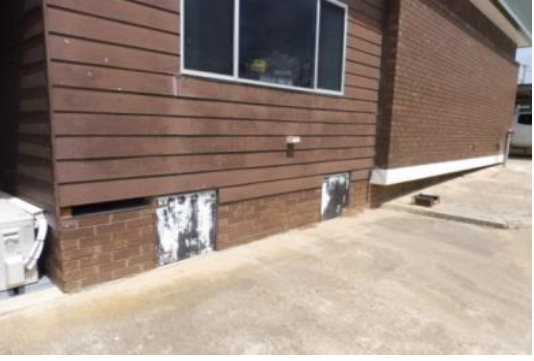
1.2.5	Façades	UPVC timber effect cladding panels.	In poor to fair overall condition.	Cladding panels are beginning to fade with local damaged/missing panels. Allow for local repairs followed my medium to long term replacement of panels.	CAP	2	\$ 1,500.00			\$ 1,500.00

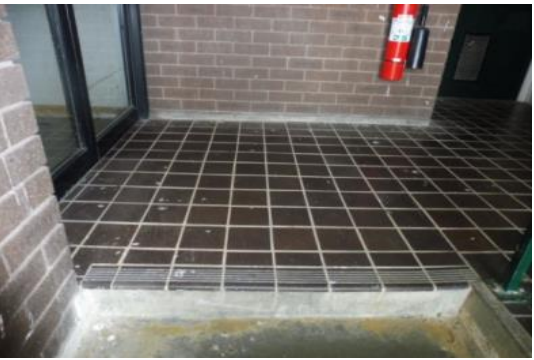
1.2.6	Entrance steps	Tiled floor coverings to entrance with concrete and tiled steps.	In poor overall condition.	Allow to remove the floor tiles and replace in the short term as part of any building modernisation works.	CAP	2	\$ 600.00			\$ 600.00

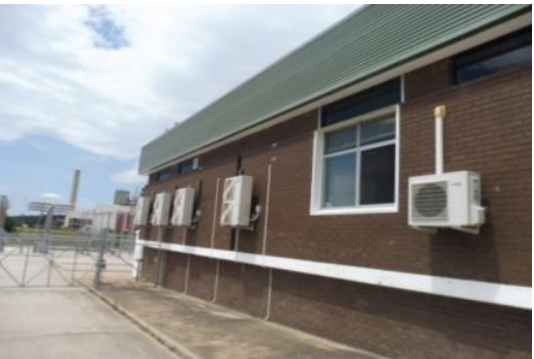
1.2.7	General Elevations	Painted finishes generally to parts of the elevations.	In poor overall condition.	Allow for repainting of the painted surfaces in the short term as required.	R&M	2	\$ 5,000.00			\$ 5,000.00

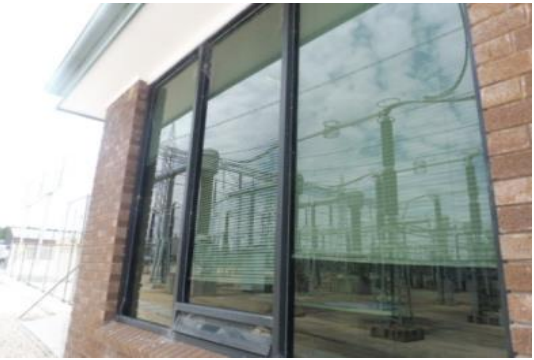
1.2.8 Windows & Doors											
1.2.8.1	Windows	Metal framed single glazed windows.	In poor overall condition.	The windows date back to the original construction date and beyond life cycle. Allow for replacement in the short to medium term.	CAP	2	\$ 25,000.00			\$ 25,000.00

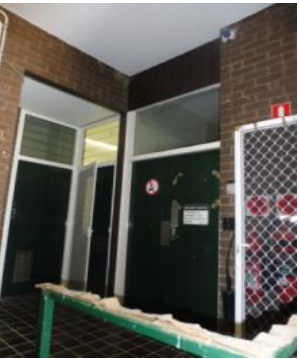
1.2.8.2	Joinery - Doors	Timber access doors with paint finish.	In poor overall condition.	The doors date back to the original construction date and beyond life cycle. Allow for replacement in the short to medium term.	CAP	2	\$ 16,000.00			\$ 16,000.00

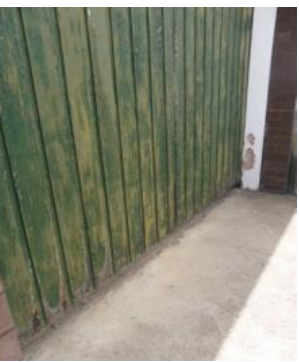
1.2.8.3	Joinery - Doors	Timber access doors with paint finish.	In poor overall condition.	Aged and written timber doors (latt style). Replace in the short term.	CAP	2	\$ 8,000.00			\$ 8,000.00

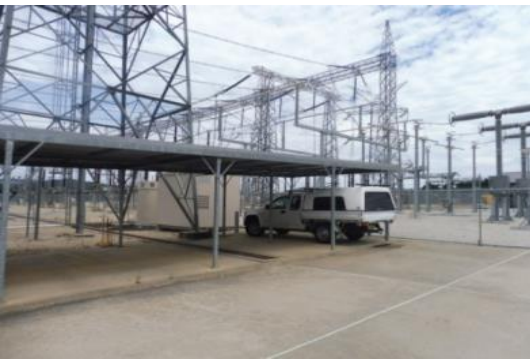
1.3.3.4	Vehicle undercover shed	Steel framed canopy with metal profiled roof sheets.	In fair overall condition.	Allow for long term replacement of the structure or roofing sheets subject to use of the main building and site.	CAP	4			\$ 14,000.00	\$ 14,000.00

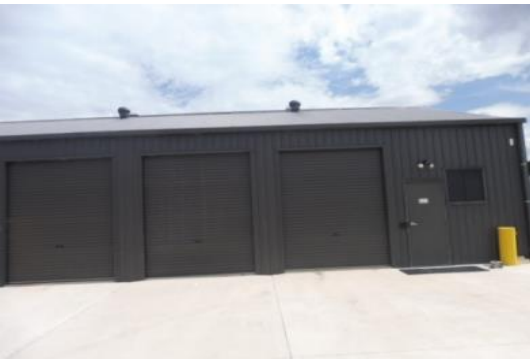
1.3.4.2	Roof	Steel framed storage shed with metal profiled cladding (large).	In poor overall condition.	No major works envisaged in the reporting period.	CAP	4				\$ -

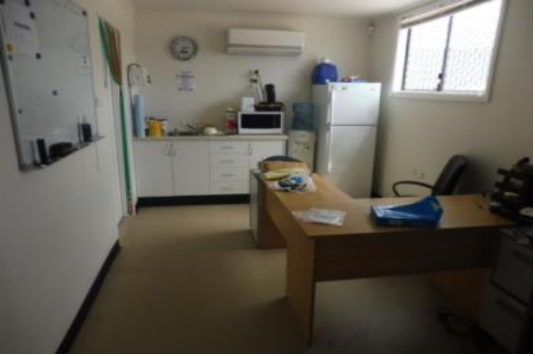
1.3.4.4	Office/Kitchen	Vinyl floor with plaster painted walls and ceilings and surface mounted strip lights and kitchen worktop and sink.	In good overall condition.	Budget for redecoration works in the reporting period.	R&M	4			\$ 1,200.00	\$ 1,200.00

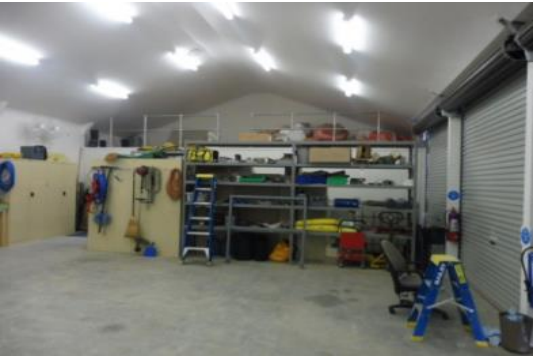
1.3.4.8	Fixtures & Fittings	Split System A/C units located to elevations.	In fair overall condition.	1 no. Mitsubishi A/C units with R410. Allow for long term replacement based on life cycle of units.	CAP	4			\$ 3,000.00	\$ 3,000.00	
2	Internals

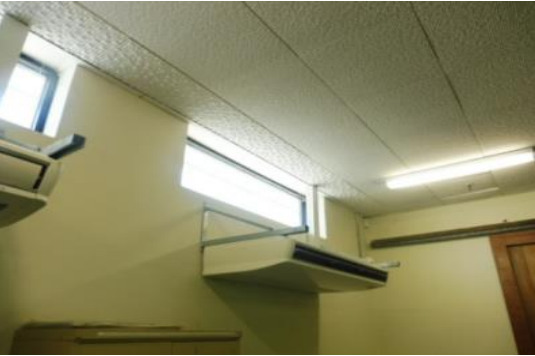
2.1	Relay Room										
2.1.1	Ceilings	Suspended ceiling with aged exposed fibre tiles.	In poor overall condition.	The ceiling tiles appear to date back to the original construction date and beyond life cycle. Allow for replacement in the short term as part of proposed internal modernisation works.	CAP	2	\$ 8,640.00			\$ 8,640.00

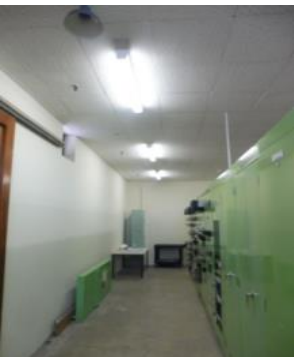
2.1.3	Walls	Painted rendered walls and partitions.	In poor overall condition.	Undertake repainting works in the short term.	R&M	2	\$ 2,686.00			\$ 2,686.00

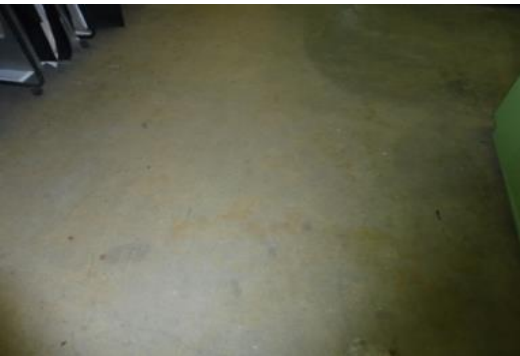
2.1.5	Floors	Exposed concrete floor.	In poor to fair overall condition.	Allow for the installation of a new floor covering as required in the short term.	CAP	2	\$ 10,800.00			\$ 10,800.00

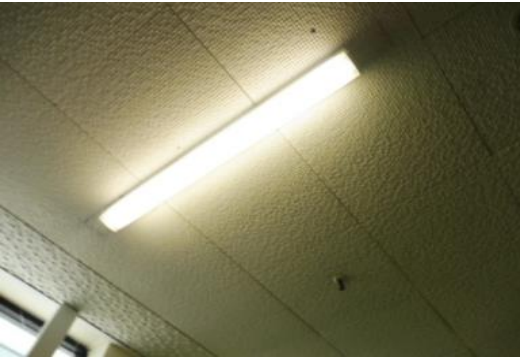
2.1.9	Lighting	Drop pendant lighting.	In poor overall condition.	Unused. Allow for removal as part of ceiling replacement works.	CAP	2	\$ 500.00			\$ 500.00

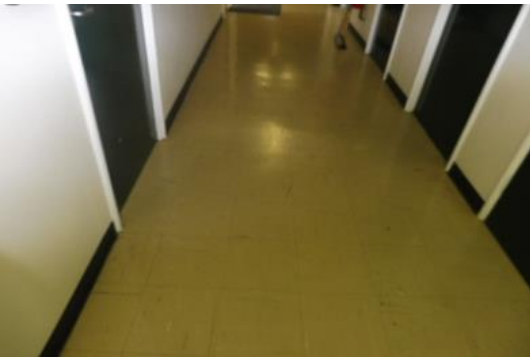
2.2.4	Floors	Concrete floor with vinyl floor tiles laid over.	In poor overall condition.	Allow cost for testing and removal of possible asbestos sealant as required.	R&M	2	\$ 1,260.00			\$ 1,260.00

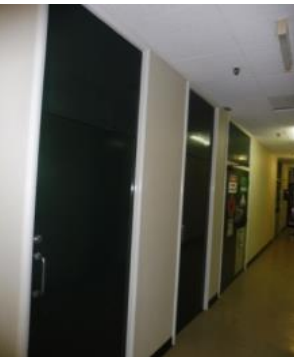
2.2.6	Lighting	Surface mounted strip lights.	In poor overall condition.	Non energy Fluorescent strip lights. Allow for replacement in short term with new T5 or LED lights as required.	CAP	2	\$ 2,000.00			\$ 2,000.00

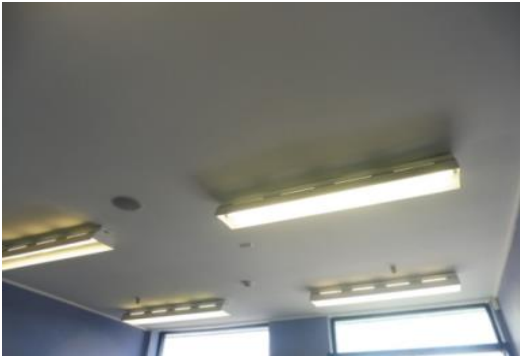
2.3.2	Ceilings	Suspended plasterboard ceiling with paint finish.	In fair to good overall condition.	Allow for redecoration works in the short term as part of the modernisation works proposed.	R&M	2	\$ 640.00			\$ 640.00

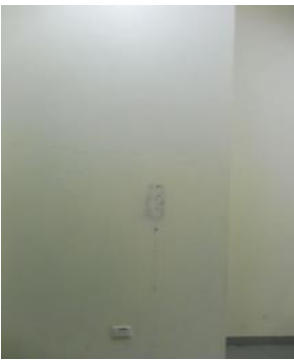
2.6.5	Walls	Painted rendered walls with painted coved skirting	In poor to fair overall condition.	Allow for redecoration works in the short term as required.	R&M	2	\$ 680.00			\$ 680.00

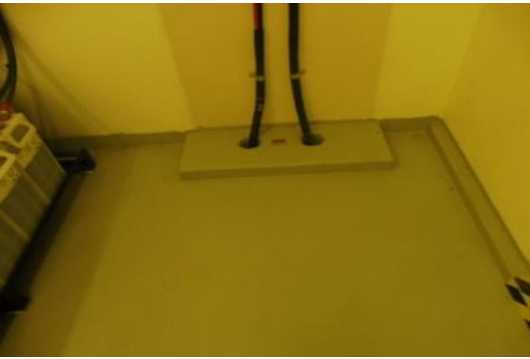
2.6.8	Joinery- Doors	Timber access doors with paint finish.	In poor overall condition.	The internal doors appear to date back to the original construction date and beyond life cycle. Allow for replacement in the short term as part of proposed internal modernisation works.	CAP	2	inc.			\$ -

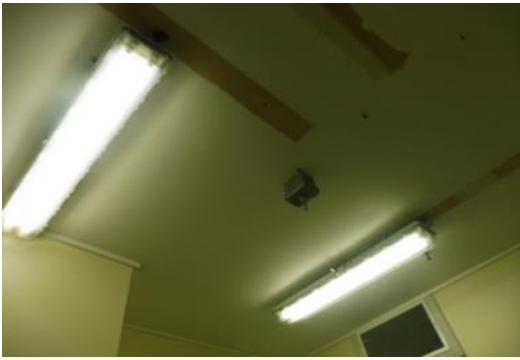
2.6.9	Lighting	IP rated double rated fluorescent surface mounted lights.	In fair to good overall condition.	Lighting appears to be modern. No major works required. Budget for replacement light tubes as required.	R&M	3	\$ 200.00	\$ 300.00	\$ 500.00	\$ 1,000.00

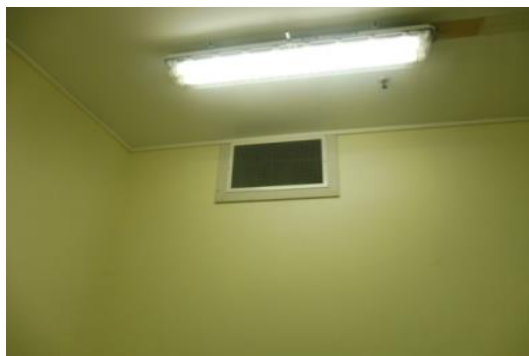
2.6.11	Emergency shower and eyewash station	No facilities provided.	N/A	Install new emergency shower and eyewash station as required.	BCA	1	\$ 10,000.00				\$ 10,000.00

There is no WH&S Emergency shower and eyewash station within one battery room. We have budgeted for immediate replacement of this item.

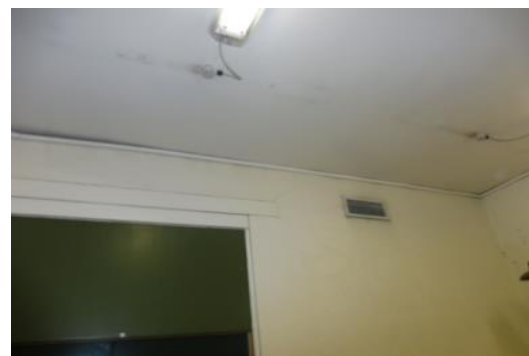
2.7.2	Ceilings	Suspended plasterboard ceiling with paint finish.	In poor overall condition.	Allow for redecoration works in the short term as required.	R&M	2	\$ 480.00				\$ 480.00

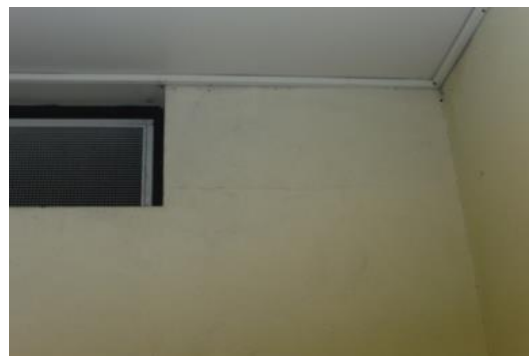
2.7.5	Walls	Painted rendered walls with painted coved skirting	In poor overall condition.	Allow for redecoration works in the short term as required.	R&M	2	\$ 986.00				\$ 986.00

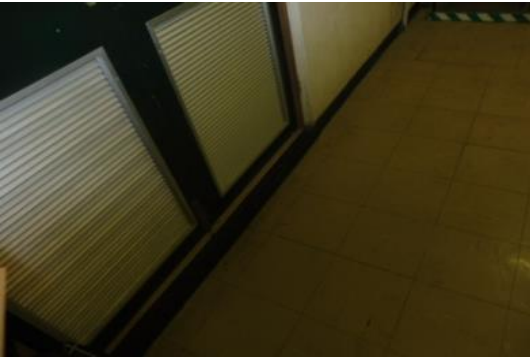
2.7.8	Floors	Concrete floor with vinyl floor tiles laid over.	In poor overall condition.	Allow cost for testing and removal of possible asbestos sealant as required.	R&M	2	\$ 480.00			\$ 480.00

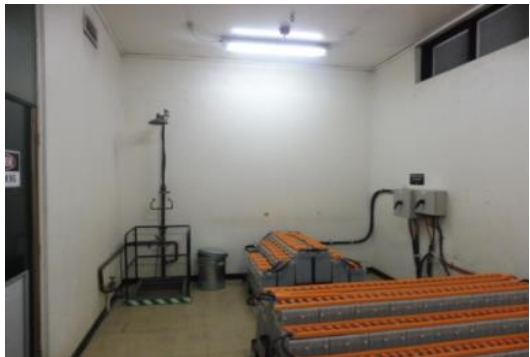
2.7.10	Windows	Metal framed single glazed windows.	In poor overall condition.	See external works.	CAP	2				\$ -	
2.7.11	Lighting	IP rated double rated fluorescent surface mounted lights.	In fair to good overall condition.	Lighting appears to be modern. No major works required. Budget for replacement light tubes as required.	R&M	3	\$ 200.00	\$ 300.00	\$ 500.00	\$ 1,000.00

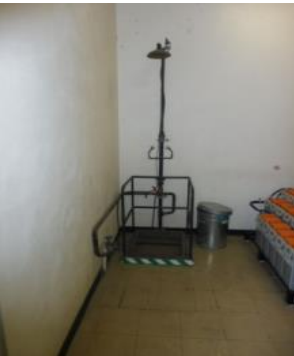
2.7.13	Emergency shower and eyewash station	Emergency shower wash.	In poor overall condition.	Aged and dates back to the original construction. Allow to install a new emergency shower and eyewash station as required.	BCA	2	\$ 10,000.00			\$ 10,000.00

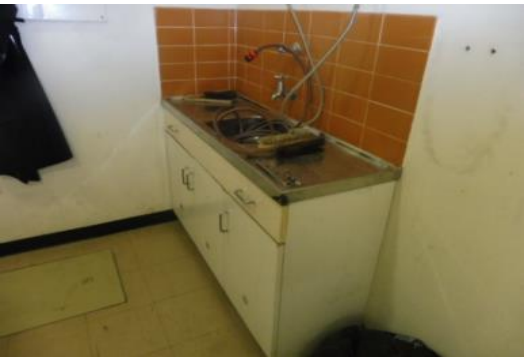
2.7.14	Fixtures and Fittings	Floor mounted stainless steel sink and tapware housed in vanity unit.	In poor overall condition.	Replace in the short term.	CAP	2	\$ 3,000.00			\$ 3,000.00

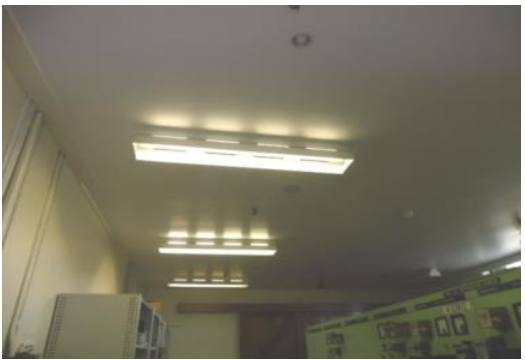
2.8.3	Walls	Painted rendered walls with coved skirting.	In poor overall condition.	No major works required in the reporting period.	CAP	4				\$ -	
2.8.4	Walls	Painted rendered walls with coved skirting.	In poor overall condition.	Allow for redecoration works in the short term as required.	R&M	2	\$ 1,615.00			\$ 1,615.00

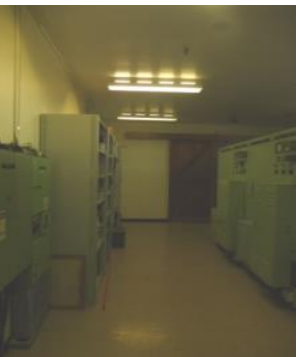
2.8.5	Floors	Concrete floor with vinyl floor tiles laid over.	In poor overall condition.	The vinyl floor coverings appear to date back to the original construction date and beyond life cycle. Allow for replacement in the short term as part of proposed internal modernisation works.	CAP	2	\$ 5,100.00			\$ 5,100.00

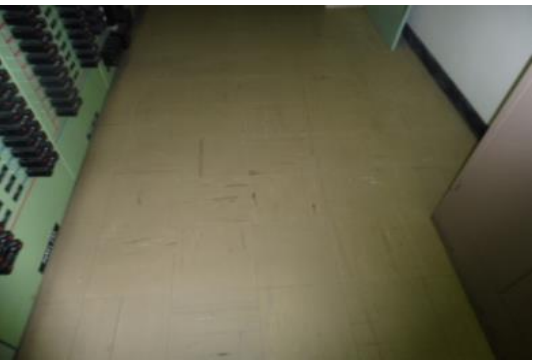
2.8.6	Floors	Concrete floor with vinyl floor tiles laid over.	In poor overall condition.	Allow cost for testing and removal of possible asbestos sealant as required.	R&M	2	\$ 1,360.00			\$ 1,360.00

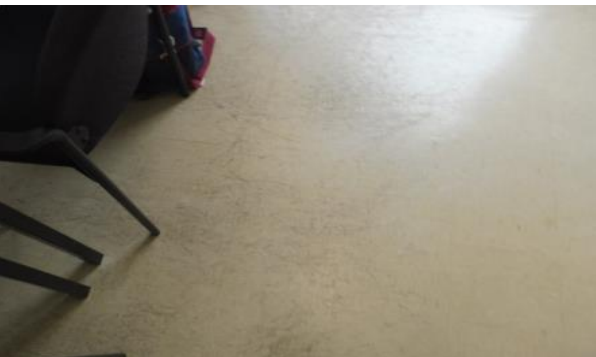
2.12.8	Floors	Concrete floor with vinyl floor tiles laid over.	In poor overall condition.	Allow cost for testing and removal of possible asbestos sealant as required.	R&M	2		\$ 400.00		\$ 400.00

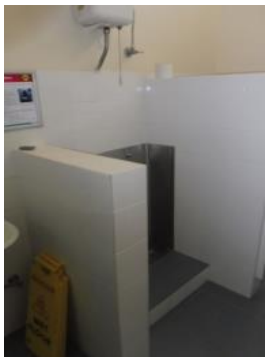
2.13.5	Walls	Tiled splashback walls.	In fair overall condition.	Allow for replacement tiles as part of the proposed modernisation works.	CAP	3		\$ 1,380.00		\$ 1,380.00

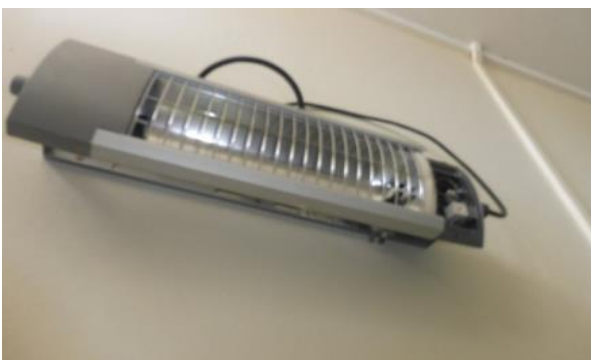
2.13.11	Fixtures and Fittings	Wall mounted electric wall heater.	In poor overall condition.	Aged and dates back to original construction. CAP Allow for replacement in the short term.	2		\$	500.00		\$	500.00

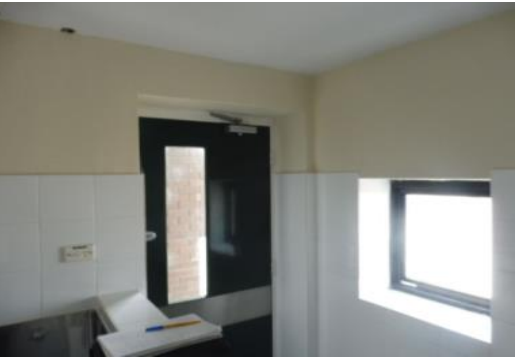
2.15.6	Walls	Tiled splashback walls.	In fair overall condition.	Allow for replacement tiles as part of the proposed modernisation works.	CAP	3		\$ 600.00		\$ 600.00

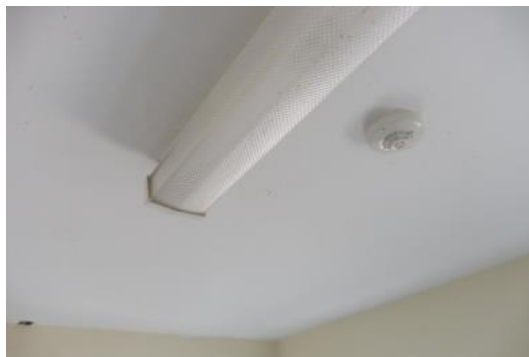
2.15.9	Windows	Metal framed single glazed windows.	In poor overall condition.	See external works.	CAP	2		inc.			\$	-					
2.15.10	Lighting	Surface mounted strip lights.	In poor to fair overall condition.	Non energy Fluorescent strip lights. Allow for replacement in short term with new T5 or LED lights as required.	CAP	2			\$	200.00	\$	200.00

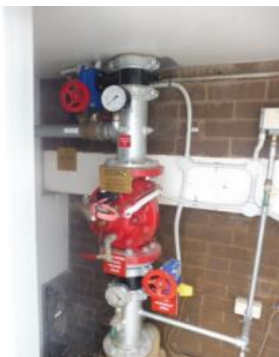
3.3	Building Services Generally	General fire systems throughout the building.	In fair to good overall condition.	We don't envisage any major replacement works in the reporting period. Maintain annually.	R&M	1	\$	3,500.00	\$	7,000.00	\$	10,500.00	\$	17,500.00	\$	38,500.00

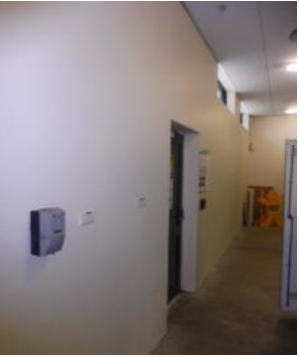
3.17	Building Services Generally	Dated power and lighting sockets throughout.	In poor overall condition.	Allow for a full rewire to the building including new light switches and power sockets.	CAP	2	\$ 20,000.00			\$ 20,000.00
